1. Report No. FHWA/TX-01/1792-2		2. Government Accession No.		3. Recipient's Catalog No.	
4. Title and Subtitle IMPACT PERFORMANCE EVALUATION OF WORK ZONE TRAFFIC CONTROL DEVICES				5. Report Date December 2000

6. Performing Organization Code	
7. Author(s) Roger P. Bligh, D. Lance Bullard, Wanda L. Menges, and Sandra K. Schoeneman				8. Performing Organization Report No. Report 1792-2

IMPACT PERFORMANCE EVALUATION OF WORK ZONE TRAFFIC CONTROL DEVICES

December 2000

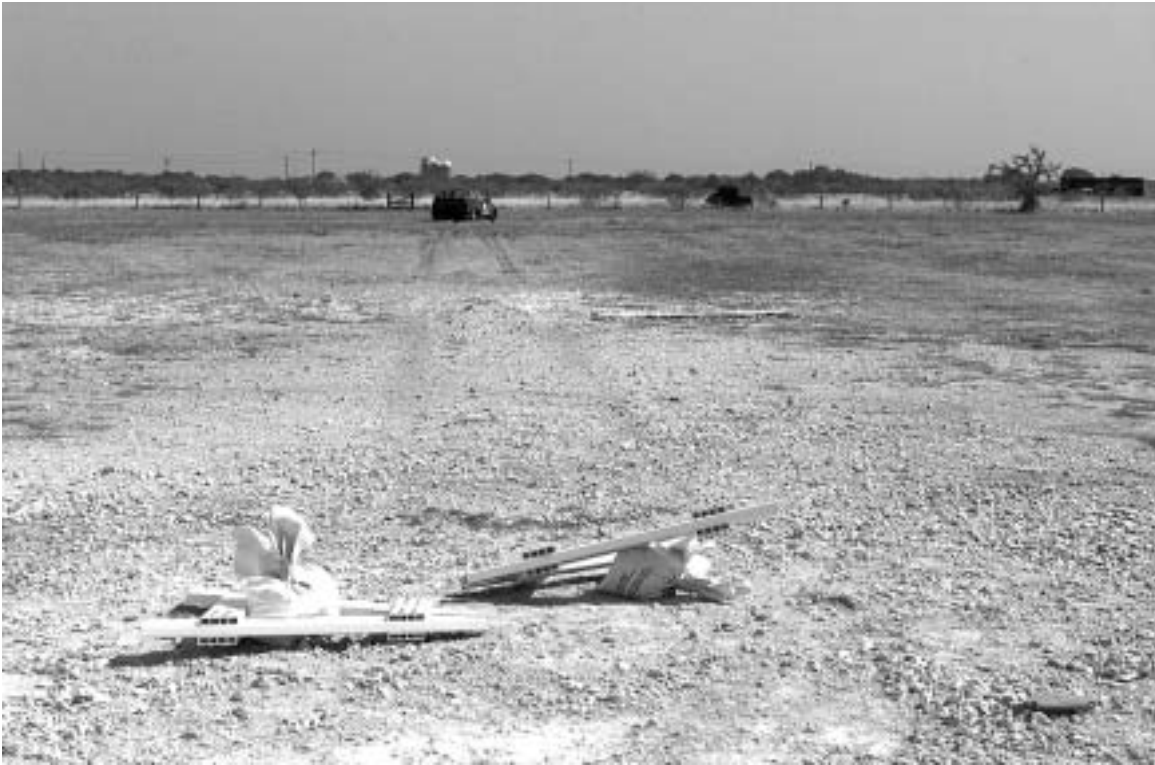
Figure 27. After Impact Trajectory for Test 417928-6.

The plastic barricade shattered the base of the windshield, but it did not penetrate or show potential to penetrate the occupant compartment, or present undue hazard to others in the area. No deformation or intrusion of the occupant compartment occurred.

None of the detached elements or vehicle damage would block the driver's vision or cause the driver to lose control of the vehicle.

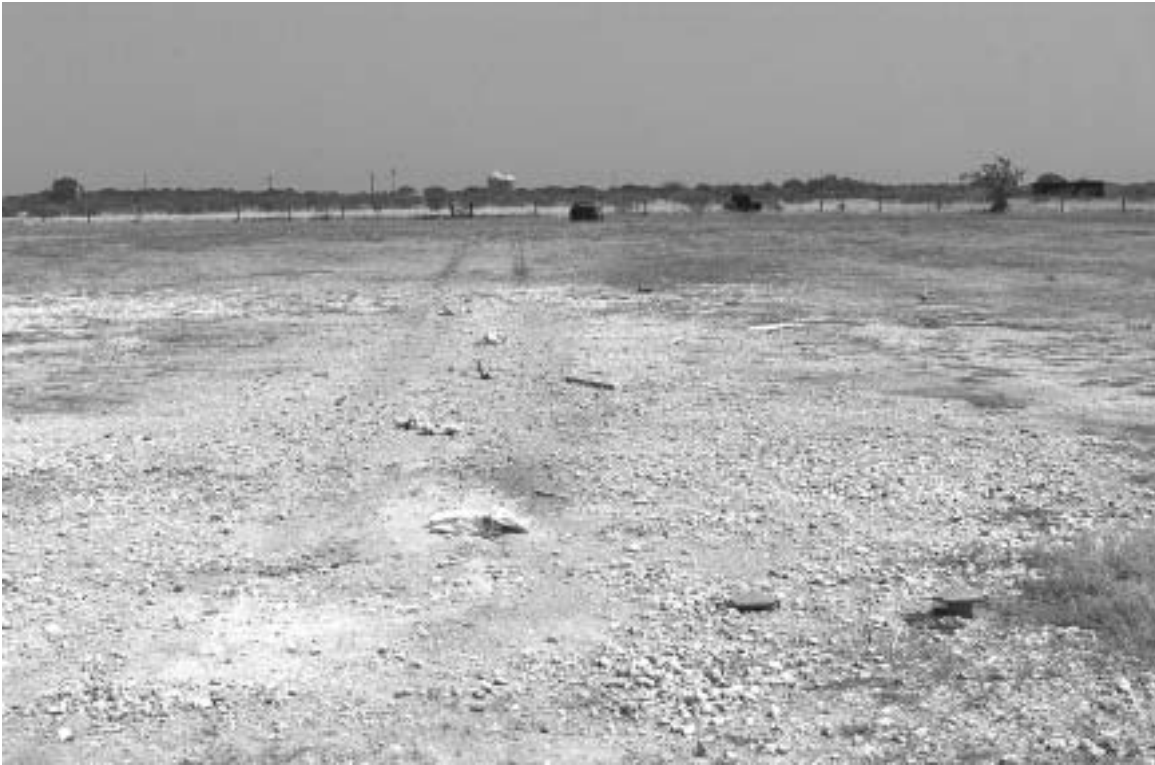
Figure 35. After Impact Trajectory for Test 417928-7.

The steel barricade did not penetrate or show potential to penetrate the occupant compartment, or present undue hazard to others in the area. No deformation or intrusion of the occupant compartment occurred.

None of the detached elements or vehicle damage would block the driver's vision or cause the driver to lose control of the vehicle.

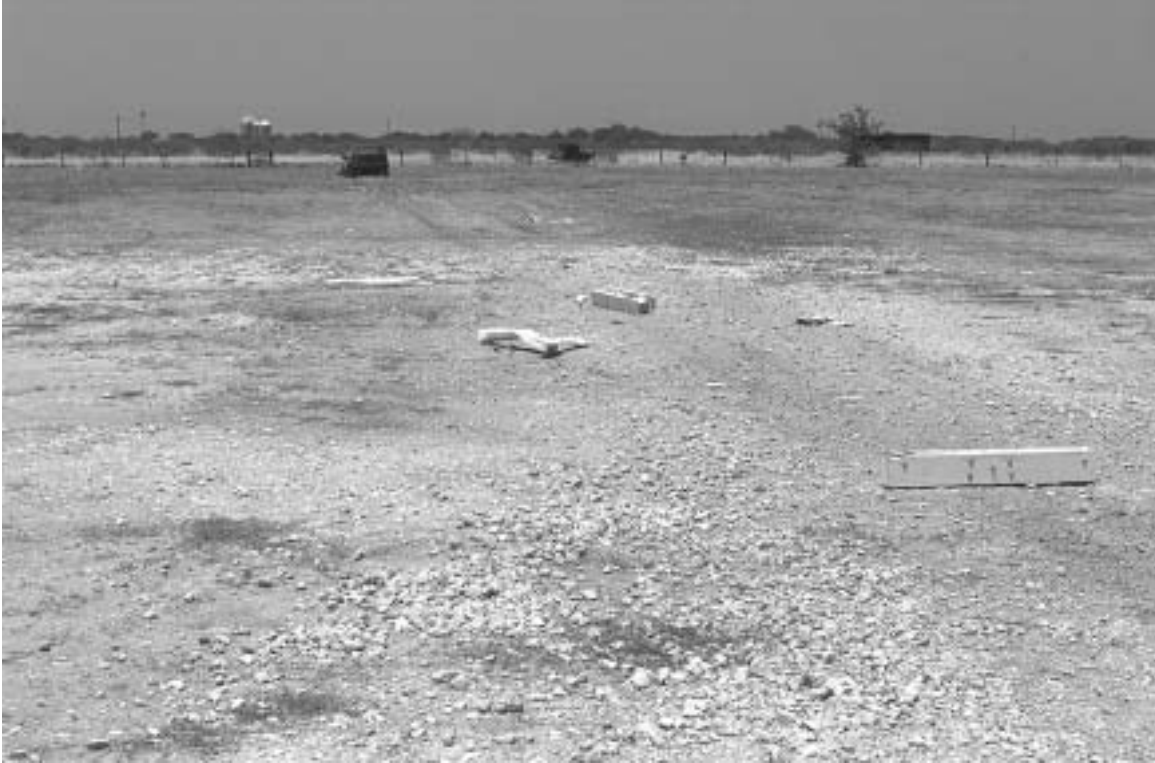
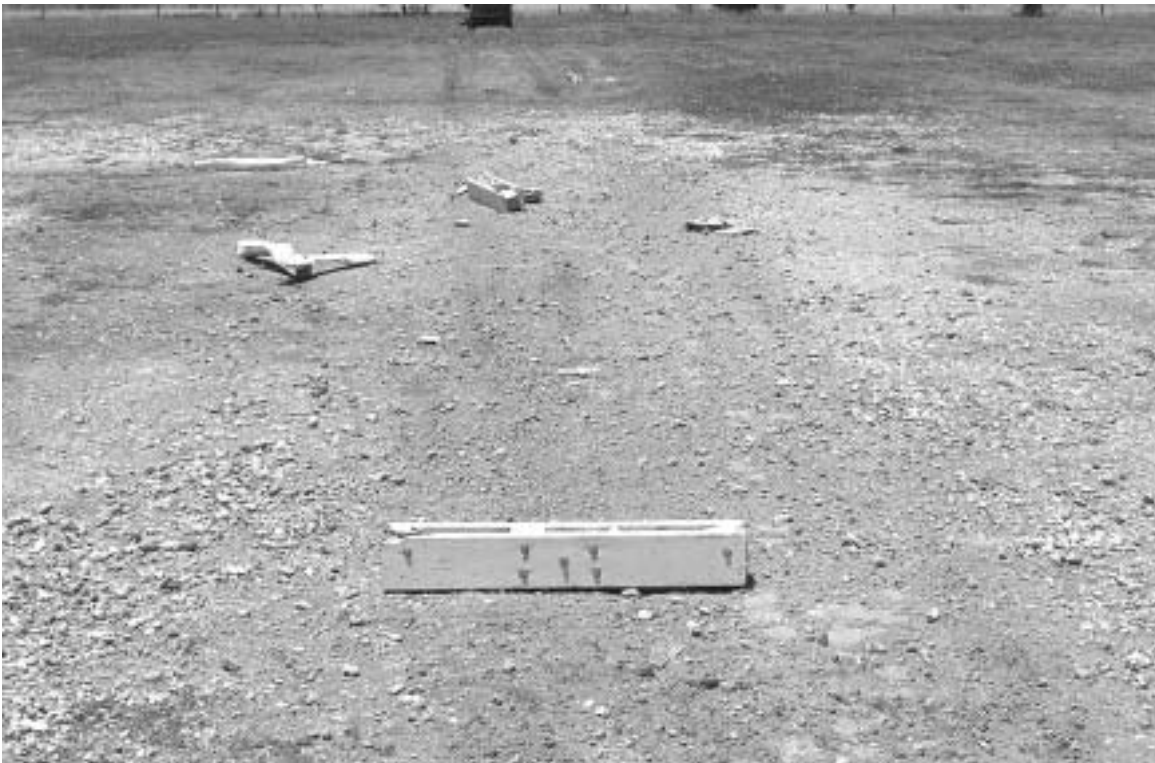
Figure 43. After Impact Trajectory for Test 417928-8.

The plastic barricade did not penetrate or show potential to penetrate the occupant compartment, or present undue hazard to others in the area. No deformation or intrusion of the occupant compartment occurred.

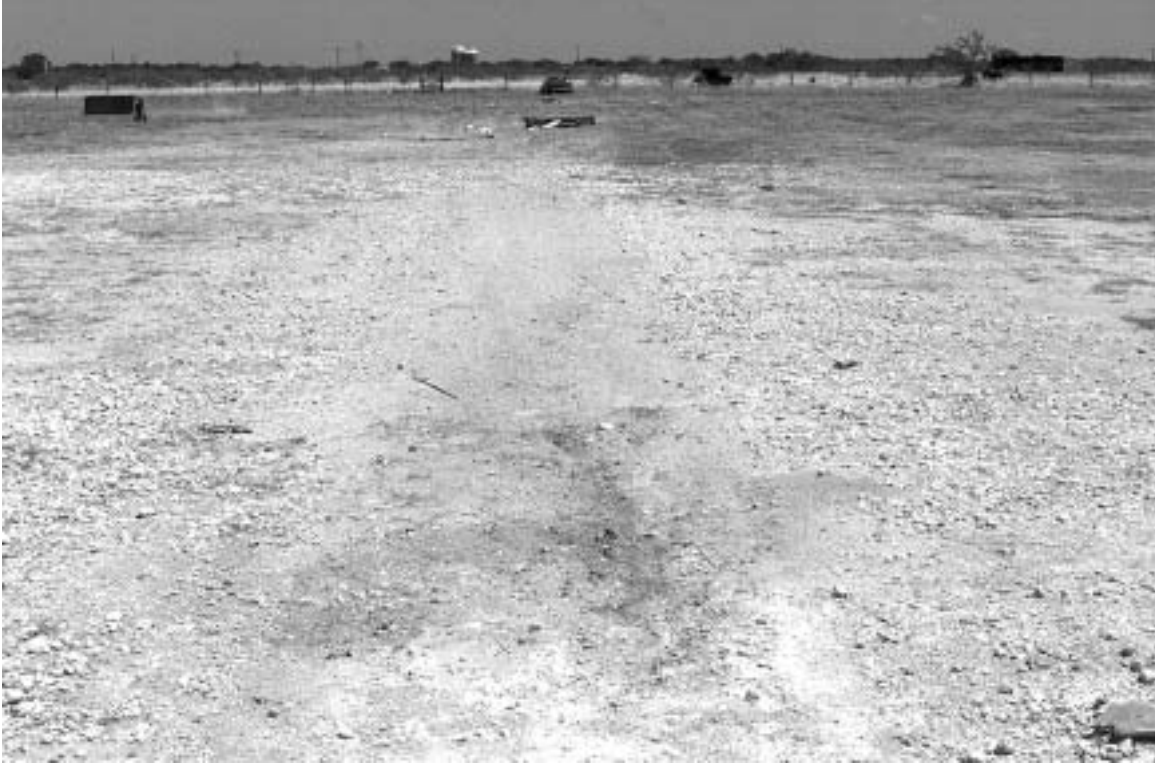
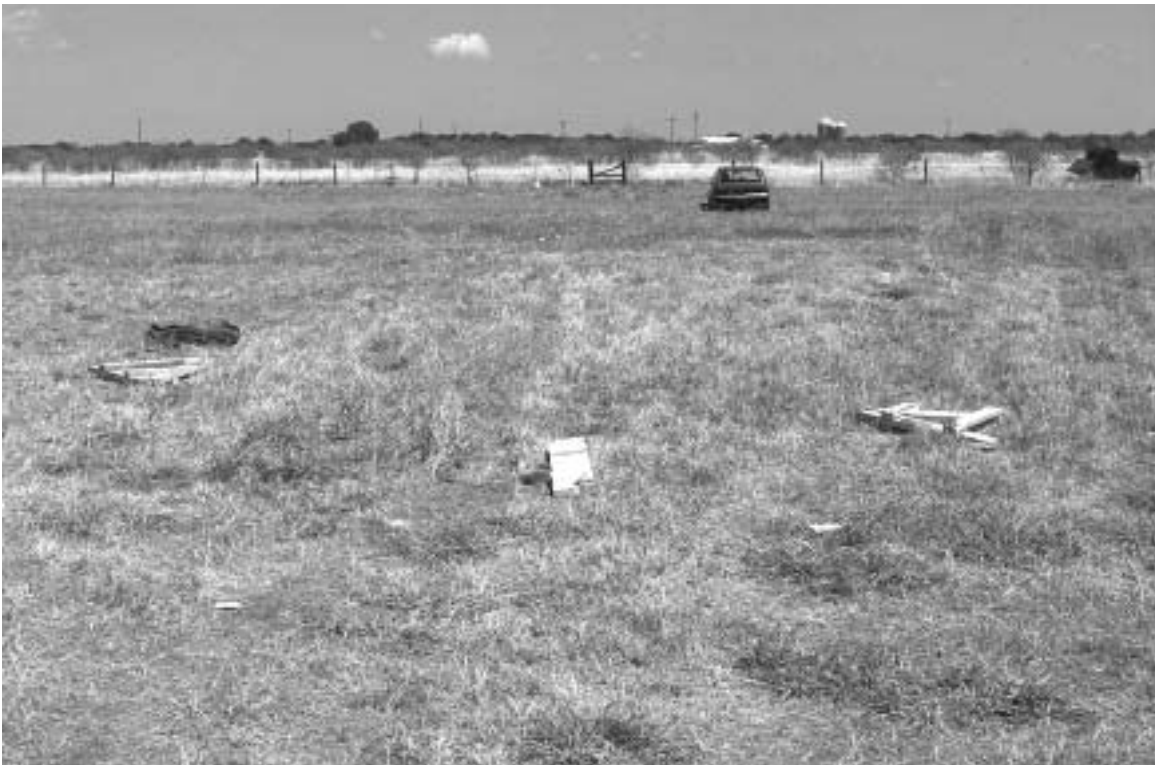
Figure 59. After Impact Trajectory for Test 417928-17.

The barricade traveled with the vehicle but did not penetrate or show potential to penetrate the occupant compartment, or present undue hazard to others in the area. No deformation or intrusion of the occupant compartment occurred.

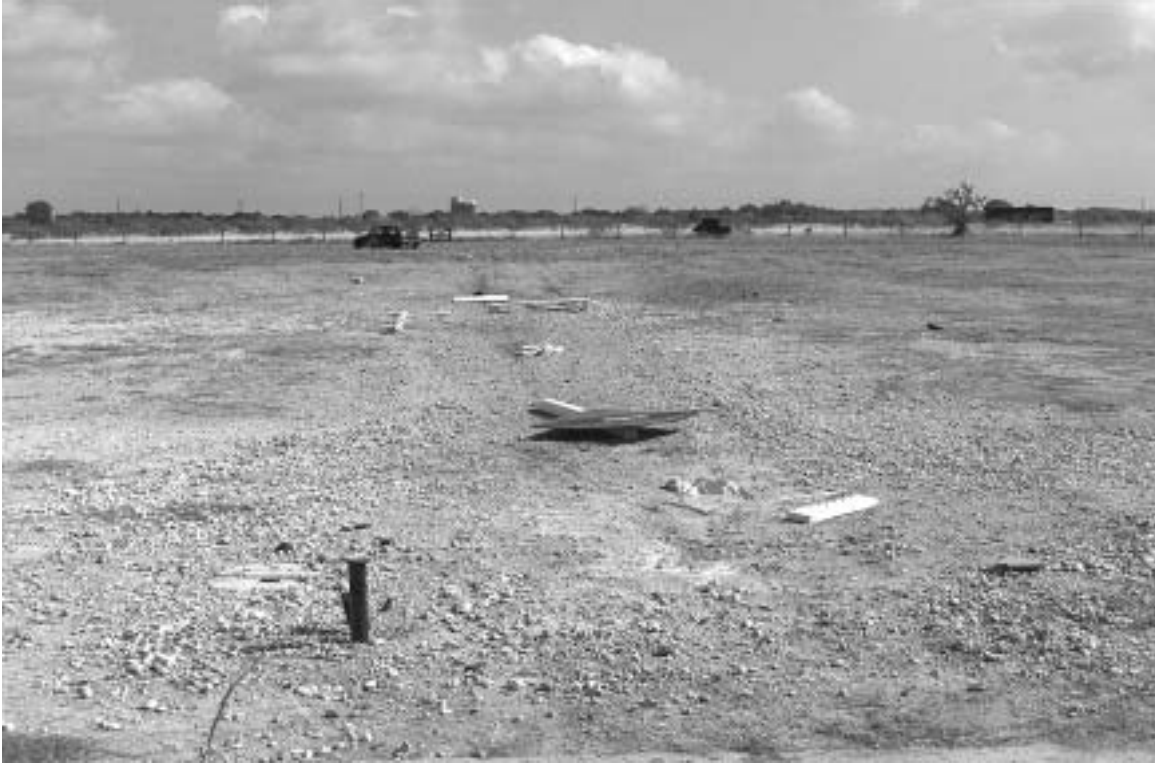
Figure 99. After Impact Trajectory for Test 417928-10.

The sign support did not penetrate or show potential to penetrate the occupant compartment, or present undue hazard to others in the area. No deformation or intrusion of the occupant compartment occurred.

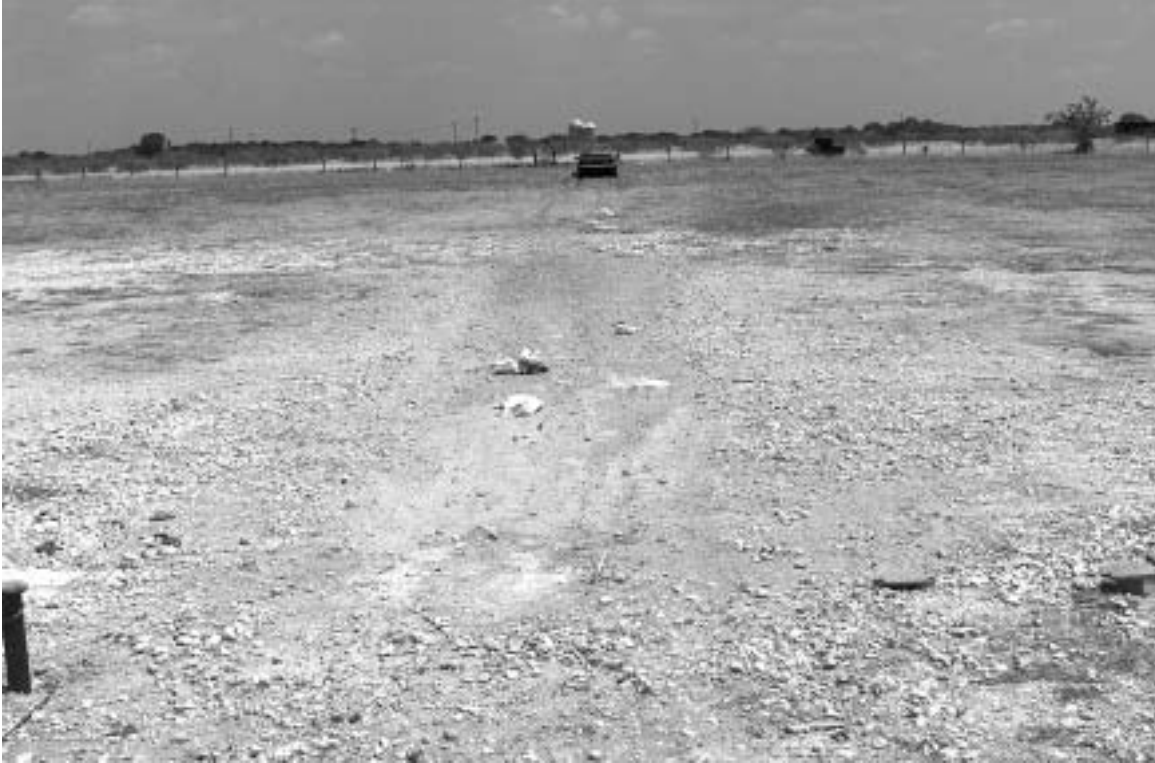
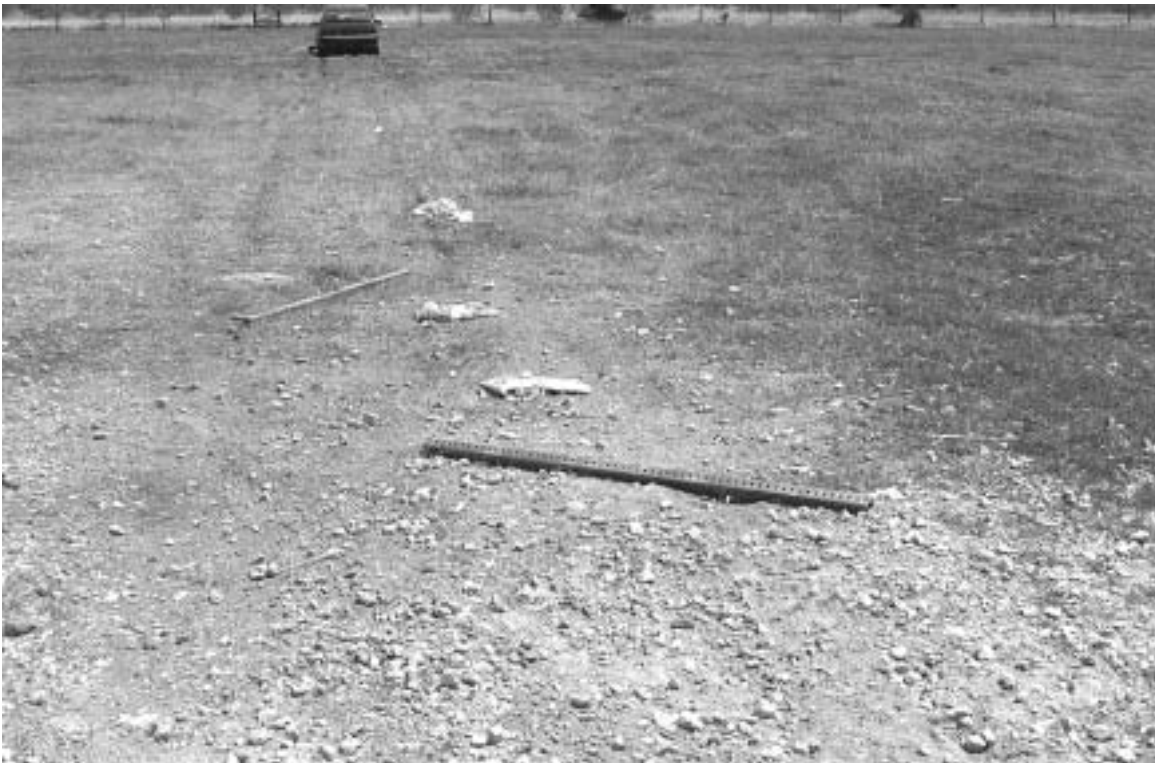
Figure 107. After Impact Trajectory for Test 417928-11.

The steel sign support penetrated the occupant compartment in the windshield area and deformed the roof. Maximum deformation into the

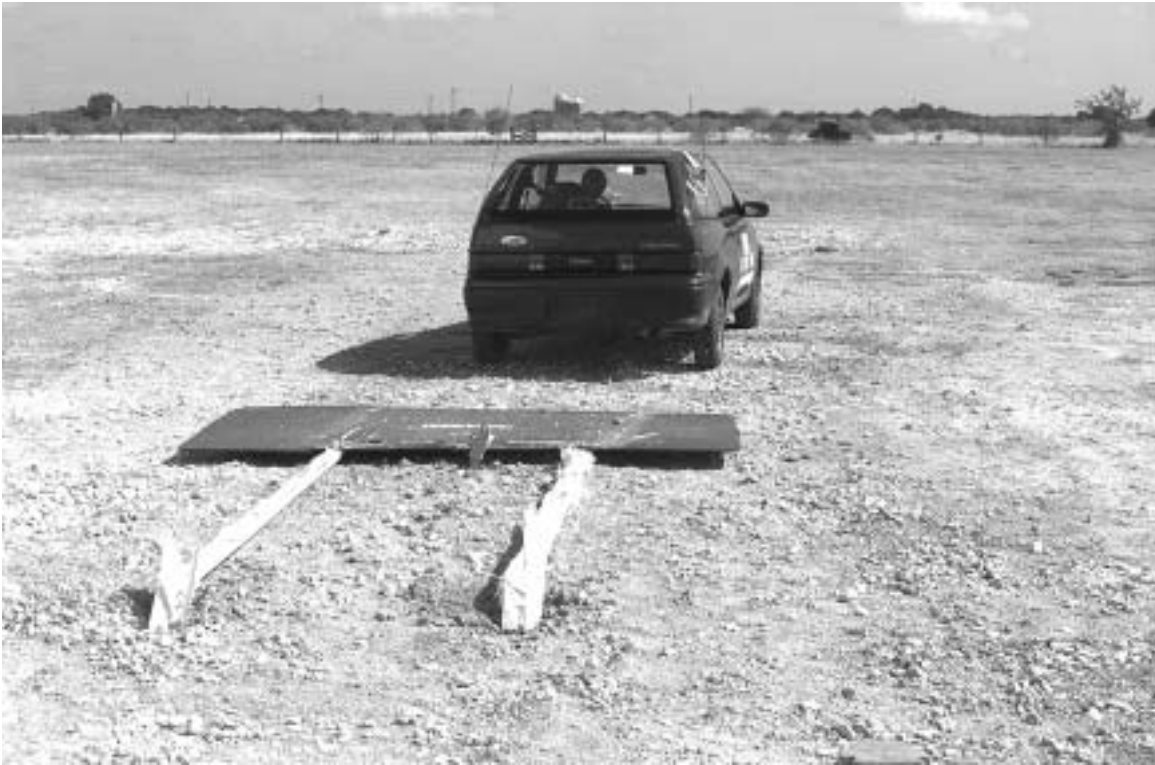
Figure 115. After Impact Trajectory for Test 417928-4.

The sign panel shattered the windshield, but it did not penetrate or show potential to penetrate the occupant compartment, or present undue hazard to others in the area. No deformation or intrusion of the occupant compartment occurred.

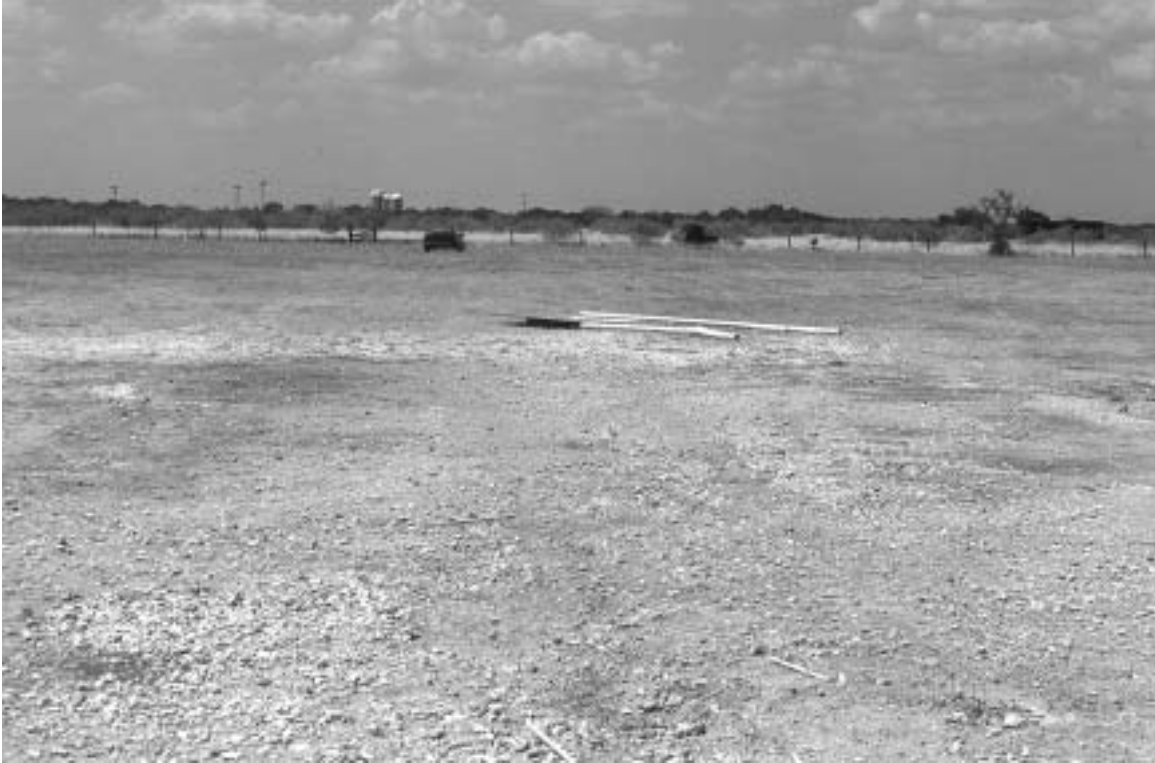
Figure 123. After Impact Trajectory for Test 417928-5.

The sign panel contacted the roof and cracked the windshield, but it did not penetrate or show potential to penetrate the occupant compartment, or present undue hazard to others in the area. No deformation or intrusion of the occupant compartment occurred.

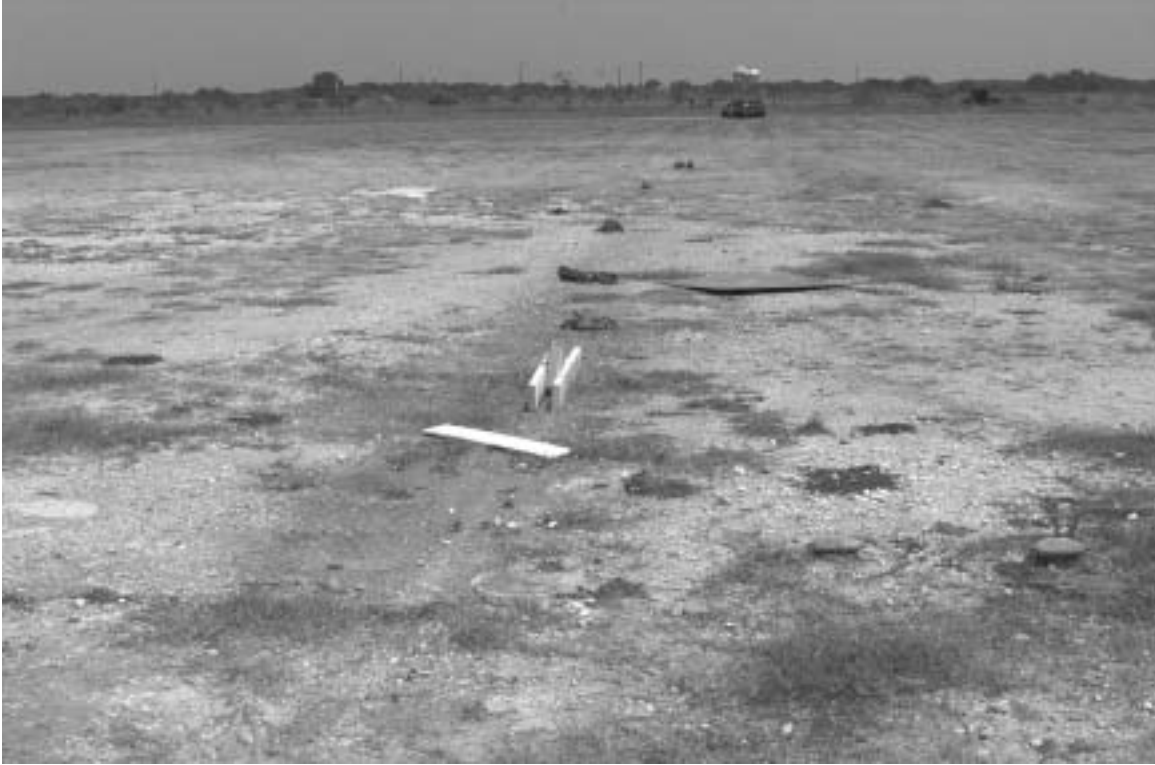
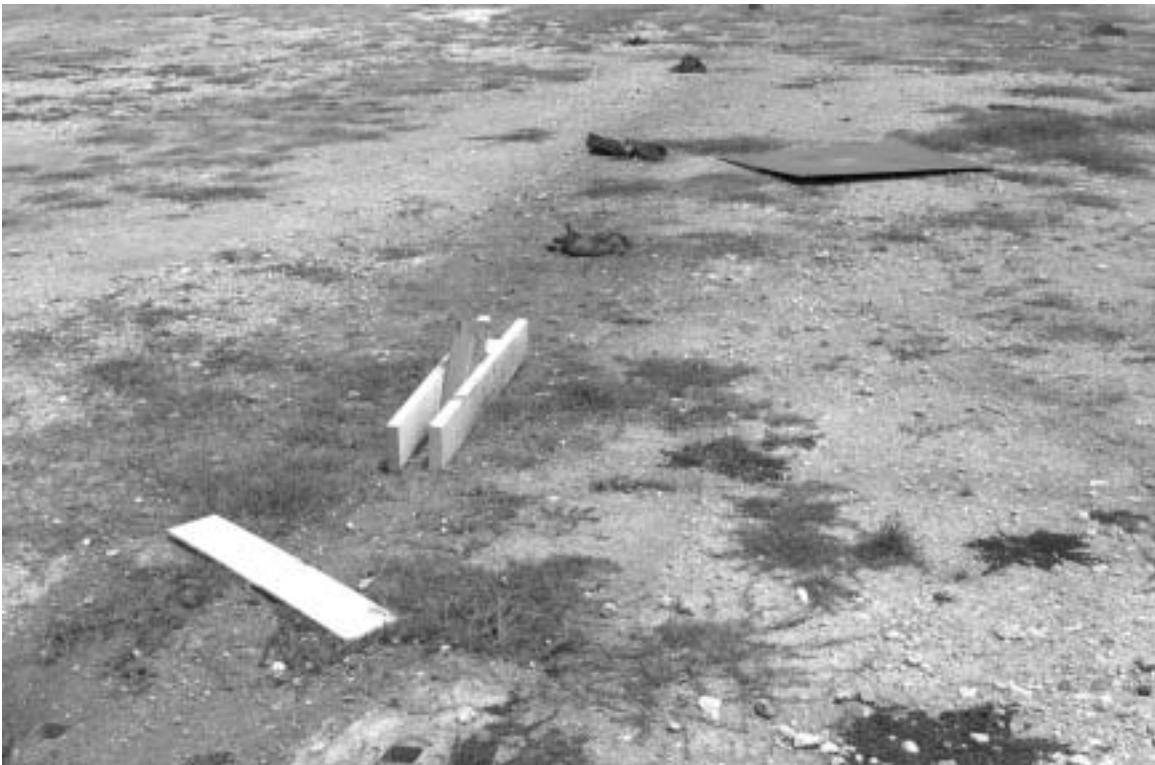
Figure 187. After Impact Trajectory for Test 417929-11.

The windshield shattered, and glass was sprayed on the dash of the vehicle. At the center of the roof line, there was a dent that measured 60 mm × 120 mm × 10 mm (2 inch × 5 inch × 0.4 inch) from the fiber board sign panel. Although the sign panel did not penetrate, it demonstrated potential for penetrating the occupant compartment.

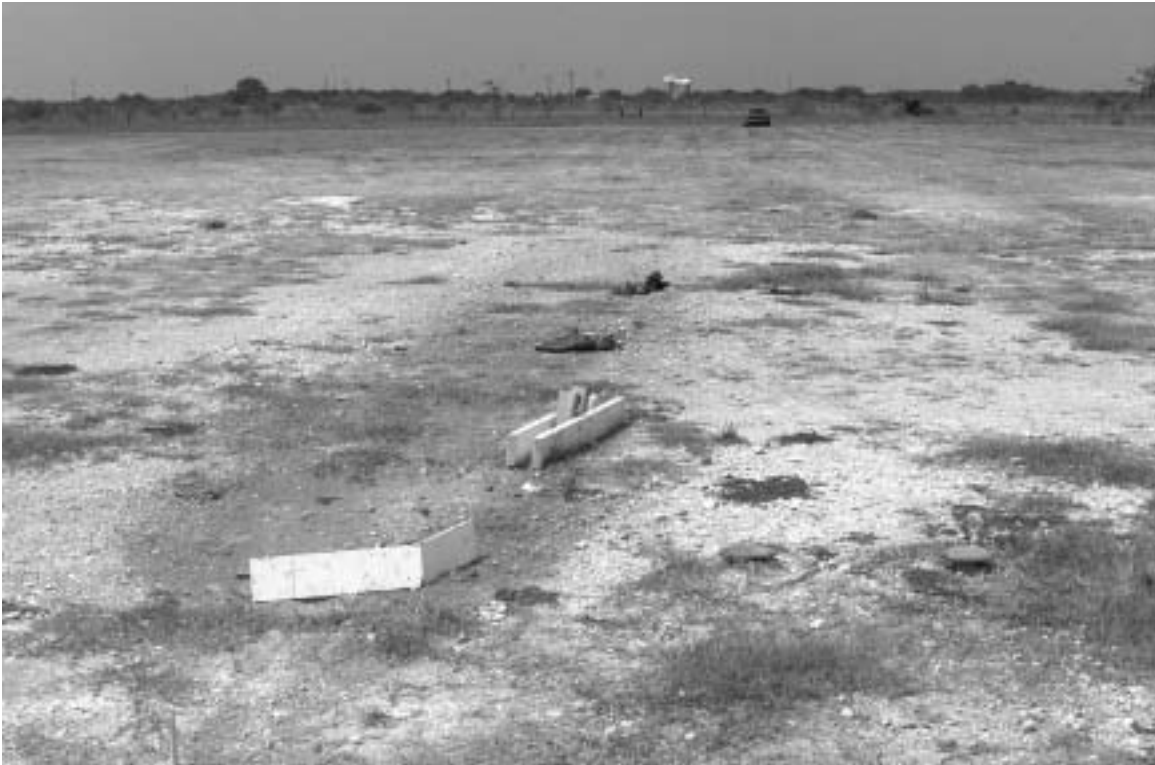
Figure 195. After Impact Trajectory for Test 417929-12.

The support cracked the windshield at the roof line in the center, but it did not penetrate or show potential to penetrate the occupant compartment, or present undue hazard to others in the area. No deformation or intrusion of the occupant compartment occurred.

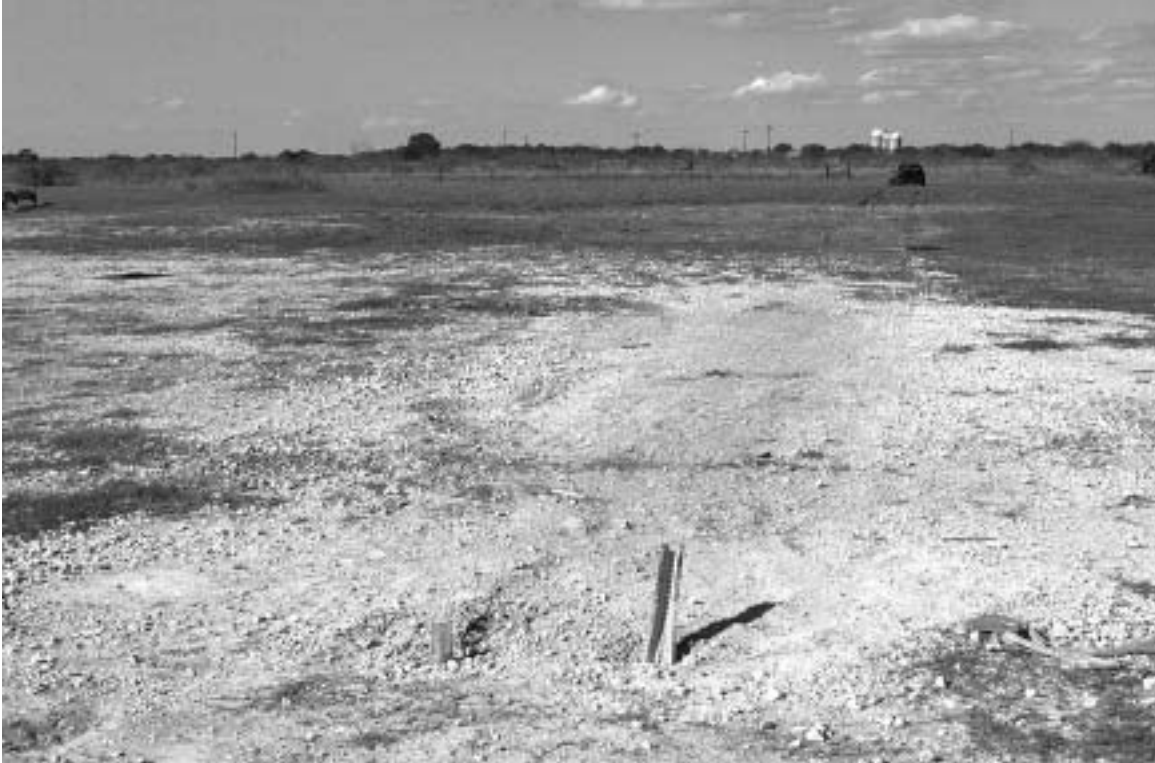
Figure 203. After Impact Trajectory for Test 417929-3.

The thin-wall tube and the U-channel supports met the requirements for structural adequacy by yielding to the vehicle.
