1. Report No. FHWA/TX-01/1792-6		2. Government Accession No.		3. Recipient's Catalog No.	
4. Title and Subtitle TESTING AND EVALUATION OF MOLDED PLASTIC MAILBOXES				5. Report Date September 2001

# TESTING AND EVALUATION OF MOLDED PLASTIC MAILBOXES

Report 1792-6  
Project Number 0-1792  
Research Project Title: Roadside Safety Hardware  
for Traffic Control Devices

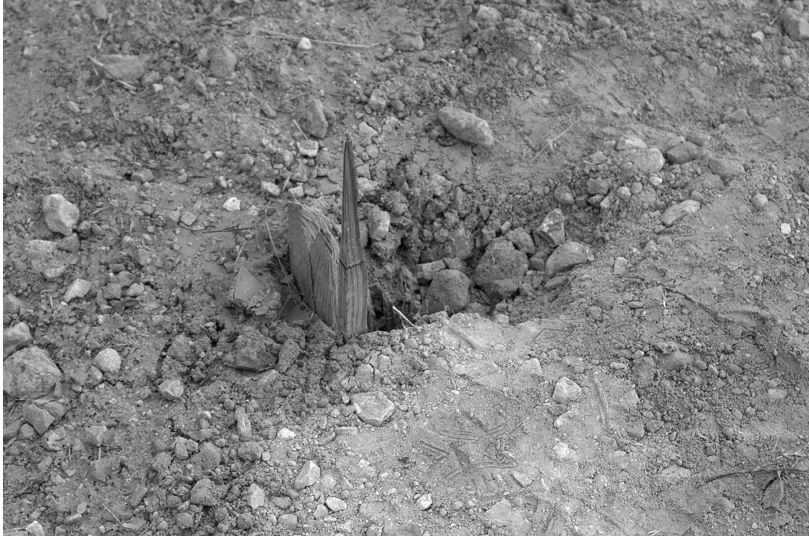
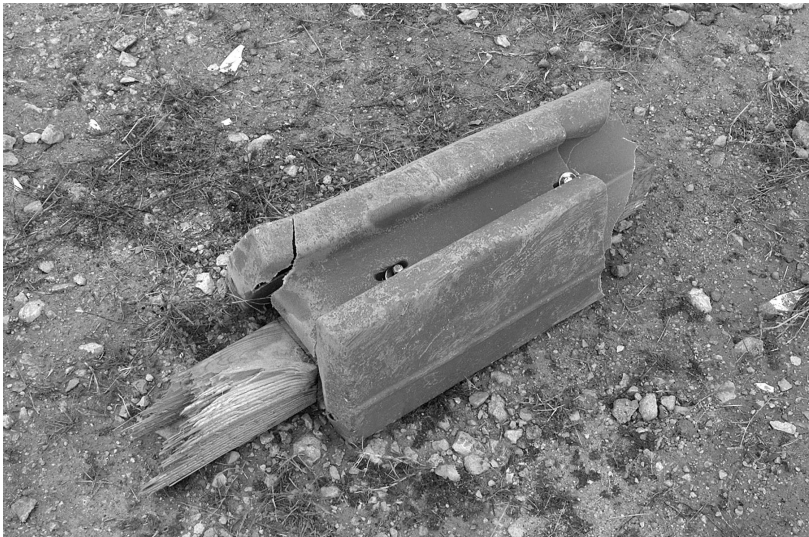
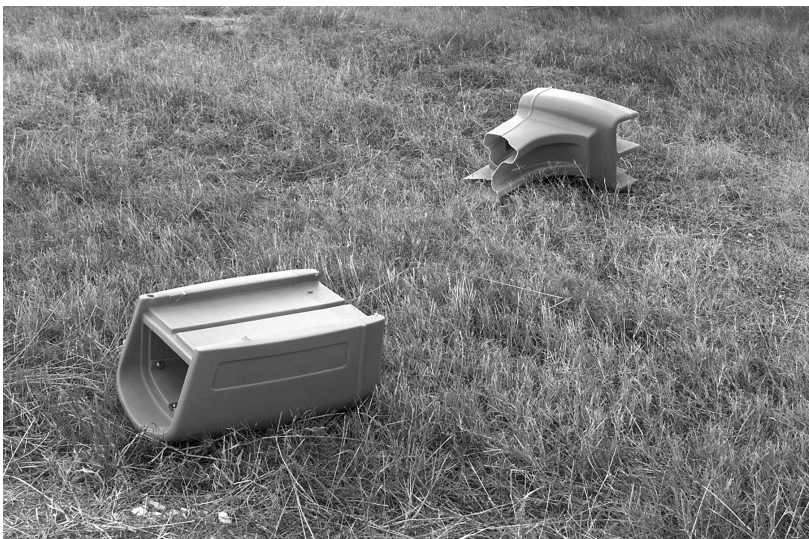
Figures 9 and 10 show damage to the test installation. The 4x4 timber support pulled out of the ground 3.5 in. before fracturing flush with ground level. The mailbox separated into several pieces, the heaviest of which weighed 12 lb-2 oz. The debris pattern extended 77.5 ft downstream, 20.0 ft to the left, and 25 ft to the right of the point of impact.

**Figure 10. Step 2 Mailbox on Timber Post after Test 417921-2.**

Results: The 4×4 timber post on which the Step 2 mailbox was mounted fractured at ground level. (*pass*)

Results: The timber post fractured at ground level, and the mailbox separated into several pieces. The largest, heaviest piece was the lower base portion of the mailbox attached to the upper section of the fractured wooden support post, which had a combined weight of 12 lb-2 oz. However, neither this piece nor any of the

Results: The change in velocity was 4.25 ft/s. The timber post fractured at ground level leaving only splinters projecting upward. (*pass*)

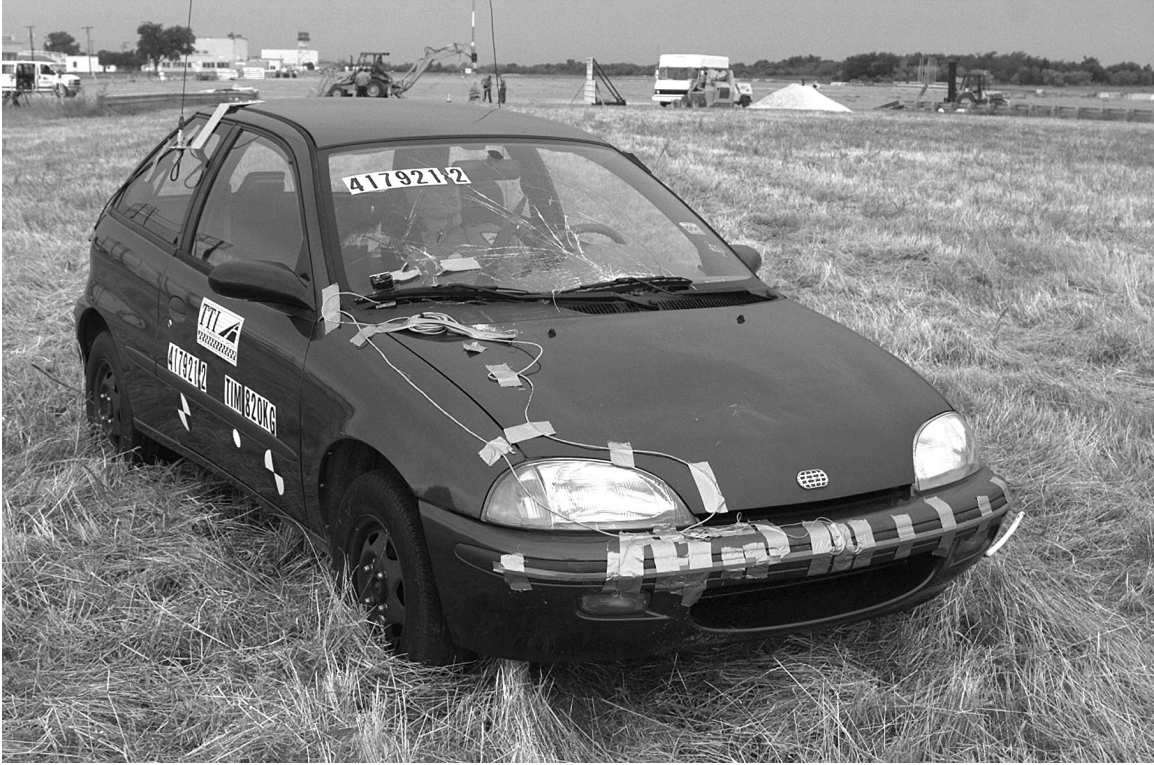
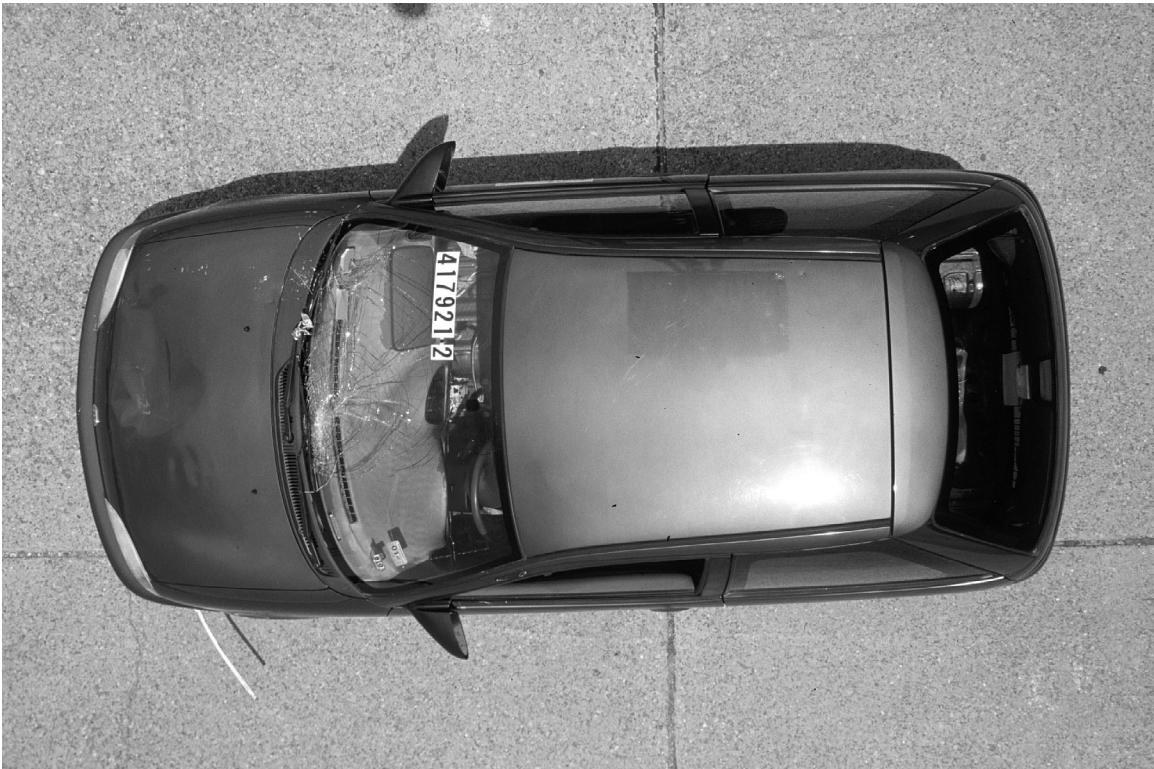
As shown in [Figure 11](#), damage to the vehicle was minimal. The windshield was cracked (Case 4 of the Federal Highway Administration (FHWA) Windshield Damage Guidance) due to contact with the upper portion of the mailbox unit. However, there were no holes in the windshield nor any deformation of the windshield into the passenger compartment, and visibility was not restricted. No other occupant compartment deformation was noted. The hood was deformed over an area 16 in. long × 19.68 in. wide × 0.40 in. deep. Photographs of the interior of the vehicle are shown in [Figure 12](#). Exterior crush measurements and occupant compartment measurements are provided in [Appendix B, Tables 4 and 5](#).

**Figure 11. Vehicle after Test 417921-2.**

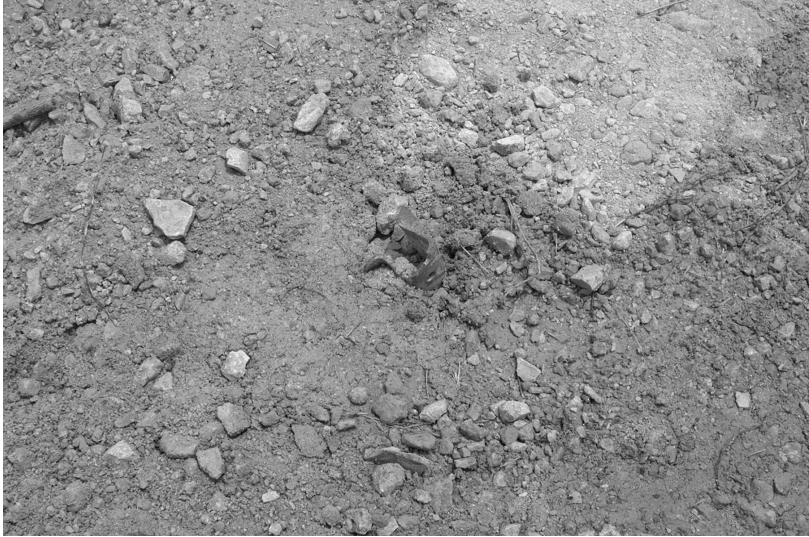
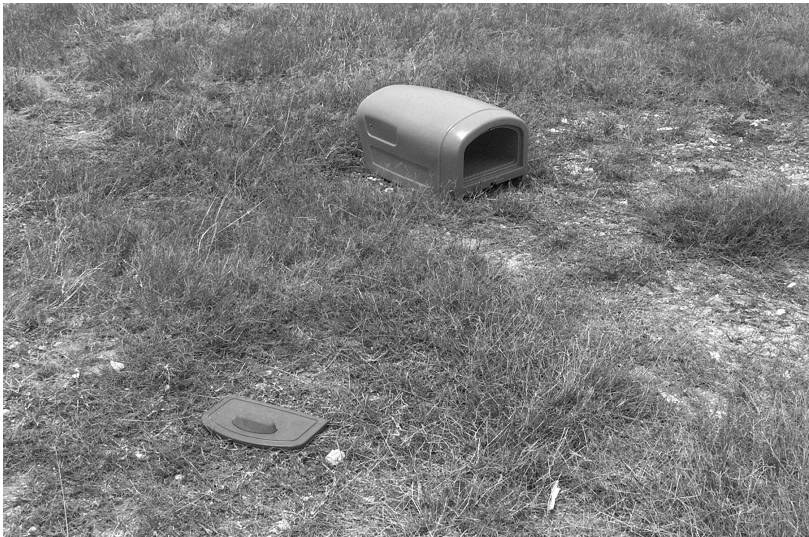
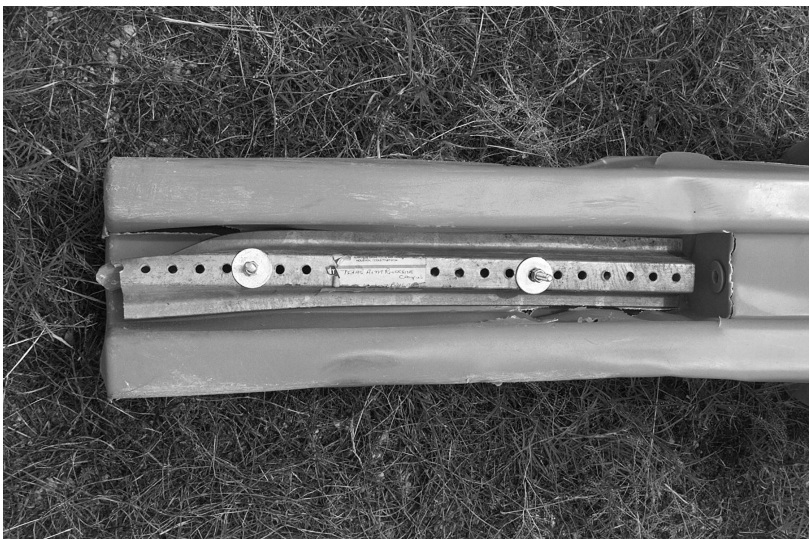
Damage to the test installation is shown in Figures 16 and 17. The impact caused the upper portion of the mailbox unit to separate from the lower base portion. The steel U-channel fractured at ground level with the lower molded plastic base portion still attached. The ground stub remaining from the U-channel projected 1.75 in. above ground level. The molded plastic mailbox separated into several pieces, the heaviest of which weighed 13 lb-8 oz. The debris pattern extended 80.0 ft downstream and 15.0 ft to the left of the point of impact.

**Figure 17. Step 2 Mailbox on Steel U-Channel after Test 417921-3.**

Results: The steel U-channel on which the MailMaster Deluxe mailbox was mounted fractured at ground level. (*pass*)

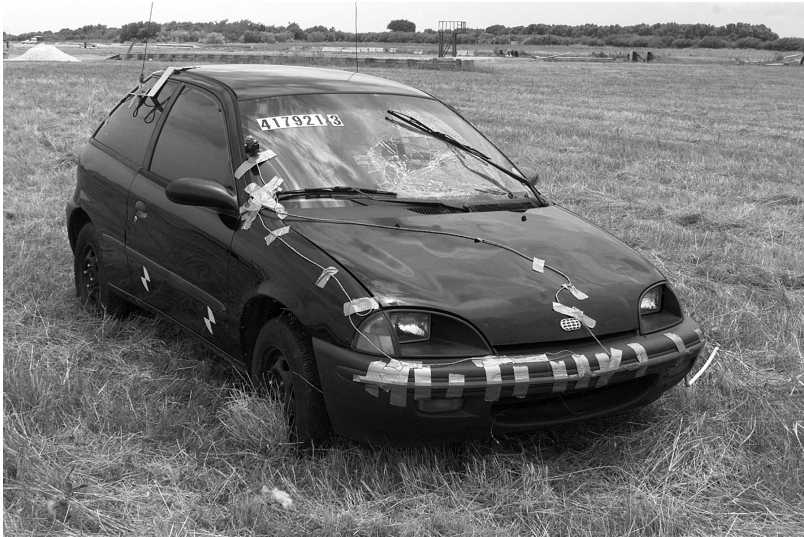
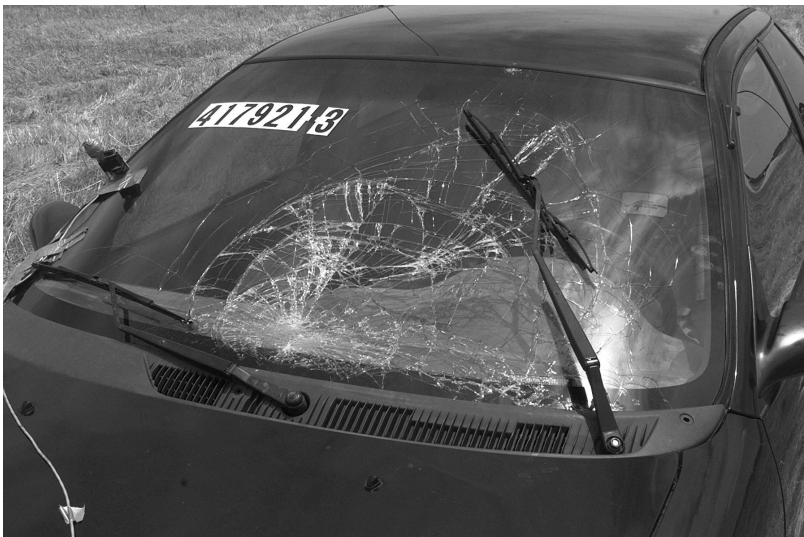
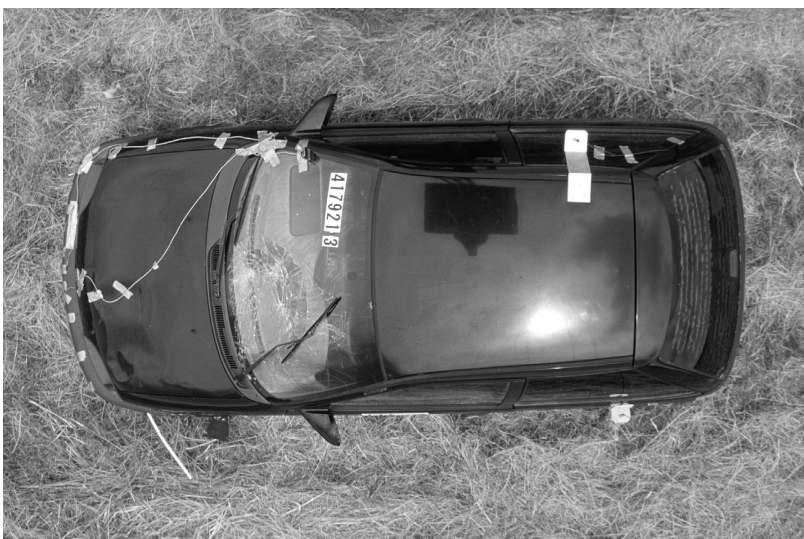
As shown in [Figure 18](#), damage to the vehicle was minimal. The windshield was cracked and deformed inward 1.5 in. (Case 4 of the FHWA Windshield Damage Guidance), but there was no hole and visibility was not restricted. No other occupant compartment deformation was noted. The hood was deformed over an area 13.00 in. long × 20.87 in. wide × 0.20 in. deep. Photographs of the interior of the vehicle are shown in [Figure 19](#). Exterior crush measurements and occupant compartment measurements are detailed in [Appendix B](#), Tables 6 and 7.

**Figure 18. Vehicle after Test 417921-3.**

Results: The upper portion of the mailbox separated from the lower base section upon impact. The lower base section remained attached to the U-channel support post and had a combined weight of 13 lb-8 oz. However, this piece and several smaller pieces of the mailbox did not penetrate nor show potential for penetrating the occupant compartment. Further, these pieces remained near the vehicle path and did not present undue hazard to others in the area. Maximum occupant compartment deformation was 1.5 in. in the windshield area. (*pass*)

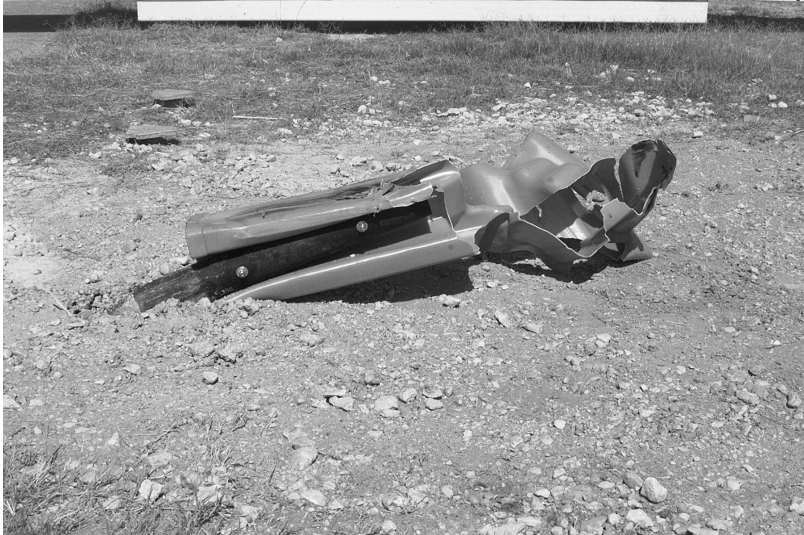
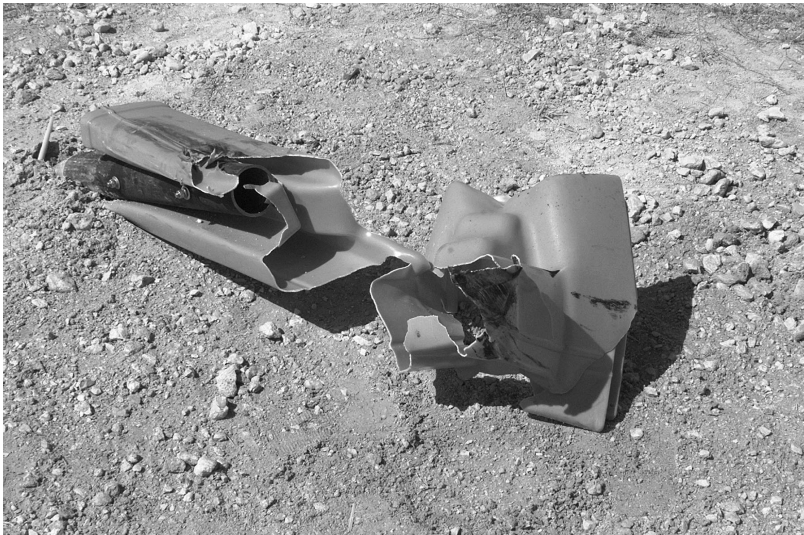
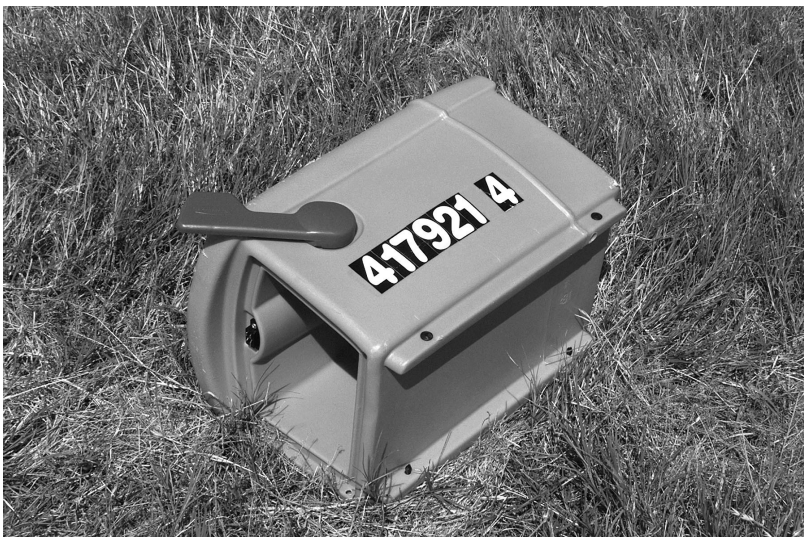
Damage to the test installation is shown in [Figures 23 and 24](#). The steel pipe support yielded and bent near ground level. As the vehicle rode over the pipe support, most of the lower molded plastic base section of the mailbox was pulled off the support post. The upper portion of the deformed steel pipe had a maximum height of 5.1 in. above ground level. The mailbox separated into several pieces, none of which was considered heavy enough to cause physical threat. The debris pattern extended 45.0 ft downstream, 18 ft left, and 10 ft right of the point of impact.

**Figure 24. Rubbermaid Mailbox on Steel Pipe after Test 417921-4.**

Results: The change in velocity was 7.72 ft/s. The steel pipe yielded and laid over as the vehicle rode over it. The pipe remained laid over at a maximum height of 5.1 in. at the upper end of the pipe. Because the pipe laid over in the direction of vehicle travel, it did not constitute a snagging hazard for the vehicle undercarriage. However, if the damaged pipe was subsequently hit by another vehicle from the opposite direction before it could be repaired, it could potentially snag on the vehicle undercarriage. (*marginal*)

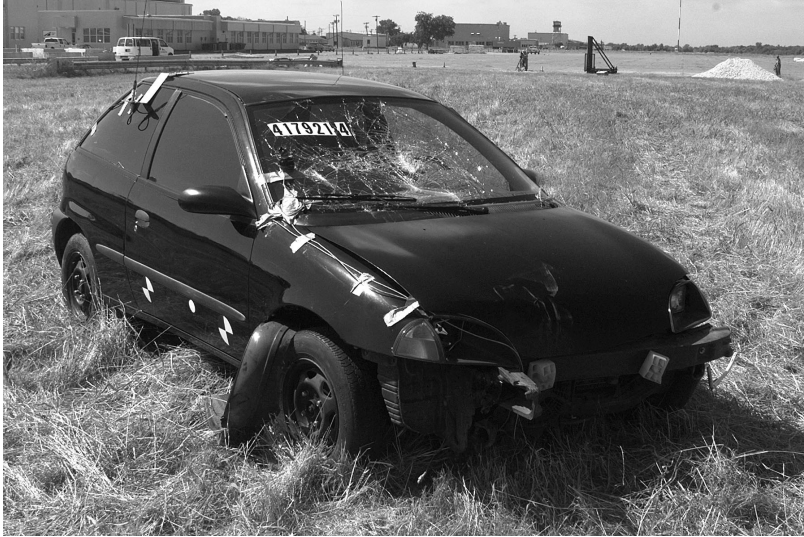
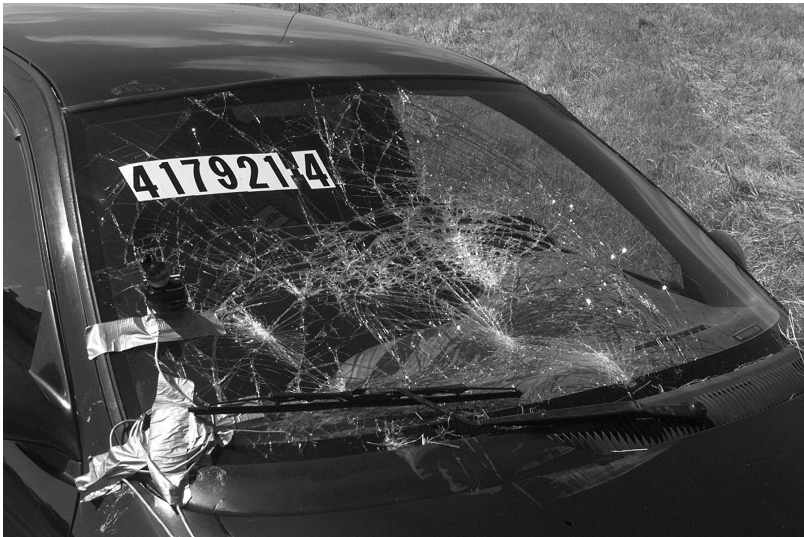
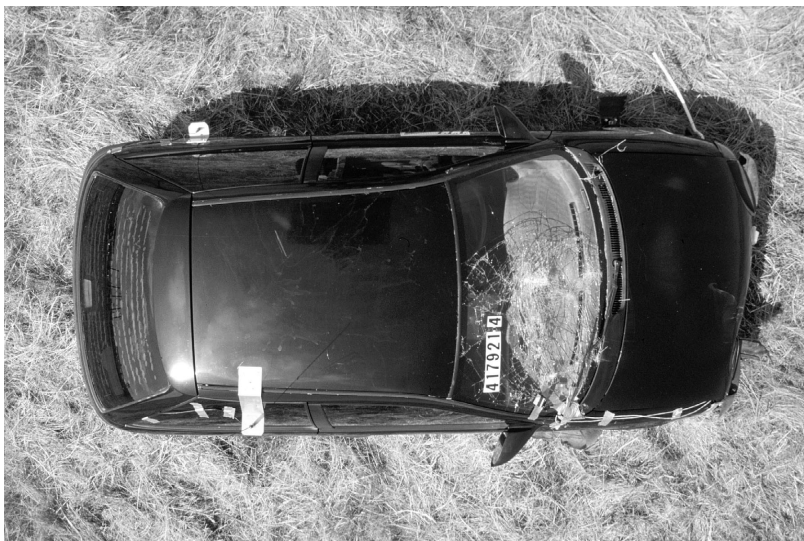
Damage to the vehicle is shown in [Figure 25](#). A 0.5-in. long tear was noted in the windshield, and the windshield was deformed inward 2.75 in (Case 1 of the FHWA Windshield Damage Guidance). Visibility was not restricted. No other occupant compartment deformation was noted. The right motor mount and radiator support were damaged and there was a dent in the oil pan. Also damaged were the front bumper, hood, radiator, compressor, and condenser. Maximum exterior crush to the vehicle was 9.8 in. at the right front quarter point. Photographs of the interior of the vehicle are shown in [Figure 26](#). Exterior crush measurements and occupant compartment measurements are detailed in [Appendix B, Tables 7 and 8](#).

**Figure 25. Vehicle after Test 417921-4.**

Results: The upper portion of the mailbox separated from the lower base section and contacted the windshield. This contact caused the windshield to deform inward 2.75 in. and induced a small tear (0.5 in. long) in the windshield. No other deformation of the occupant compartment was noted. None of the pieces of debris from the mailbox were considered heavy enough to cause physical threat. (*marginal*)
