1. Report No. FHWA/TX-90/187-17	2. Government Accession No.	3. Recipient's Catalog No.	
4. Title and Subtitle ENGINEERING FABRICS AND ASPHALT OVERLAY PERFORMANCE		5. Report Date November, 1989

ENGINEERING FABRICS
AND
ASPHALT OVERLAY PERFORMANCE

Research Report 187-17
Research Study 2-9-77/9-187

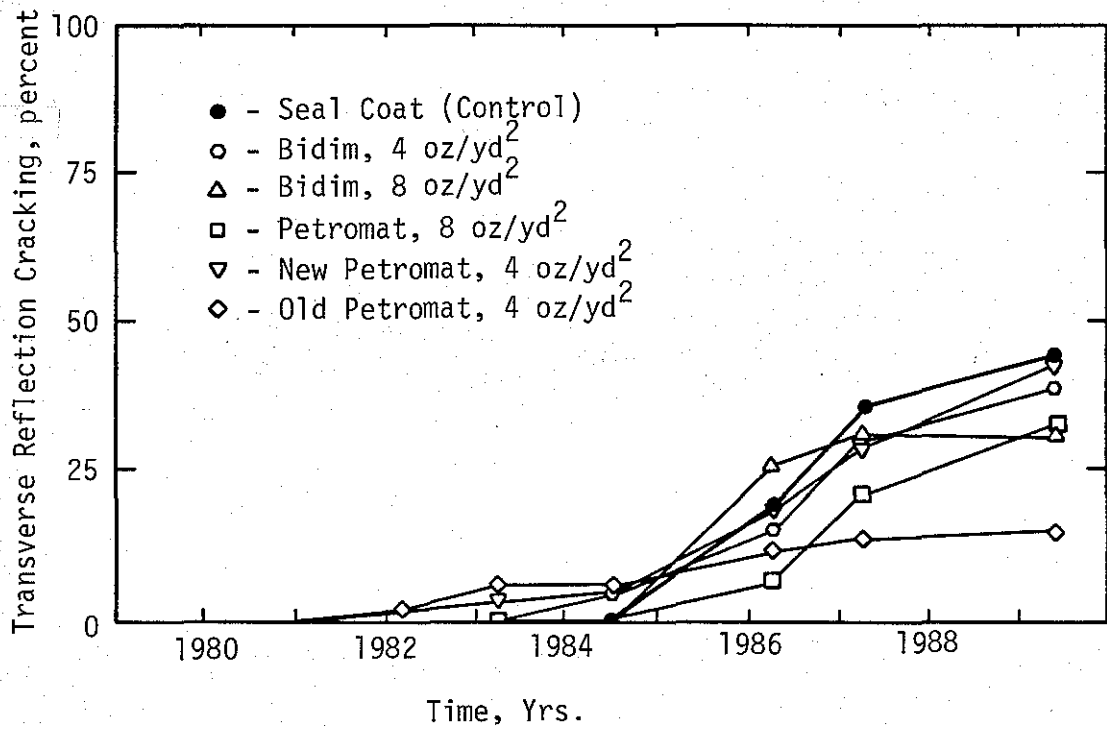
Transverse, longitudinal, and total reflection cracking computed as a percentage of the original cracks of similar type were plotted as a function of time for the 10-year evaluation period. These data were collected in three representative 100-foot segments of pavement in the WB and EB lanes. These plots are shown in Figures 2 through 7. In the WB lanes, the Petromat products most often exhibited the best resistance to reflective cracking; however, their performance is not a notable improvement over that of the seal coat interlayer or the Bidim products. Although little cracking has occurred to date in the EB lanes, the seal coat interlayer is outperforming the fabrics interlayers. Observations after rainfall indicate the fabrics may be reducing pumping well after cracks appear at the pavement surface.

Figure 2. Percent Transverse Reflection Cracking as a Function of Time for Westbound Test Pavements on IH-10 Near Ozona, Texas.

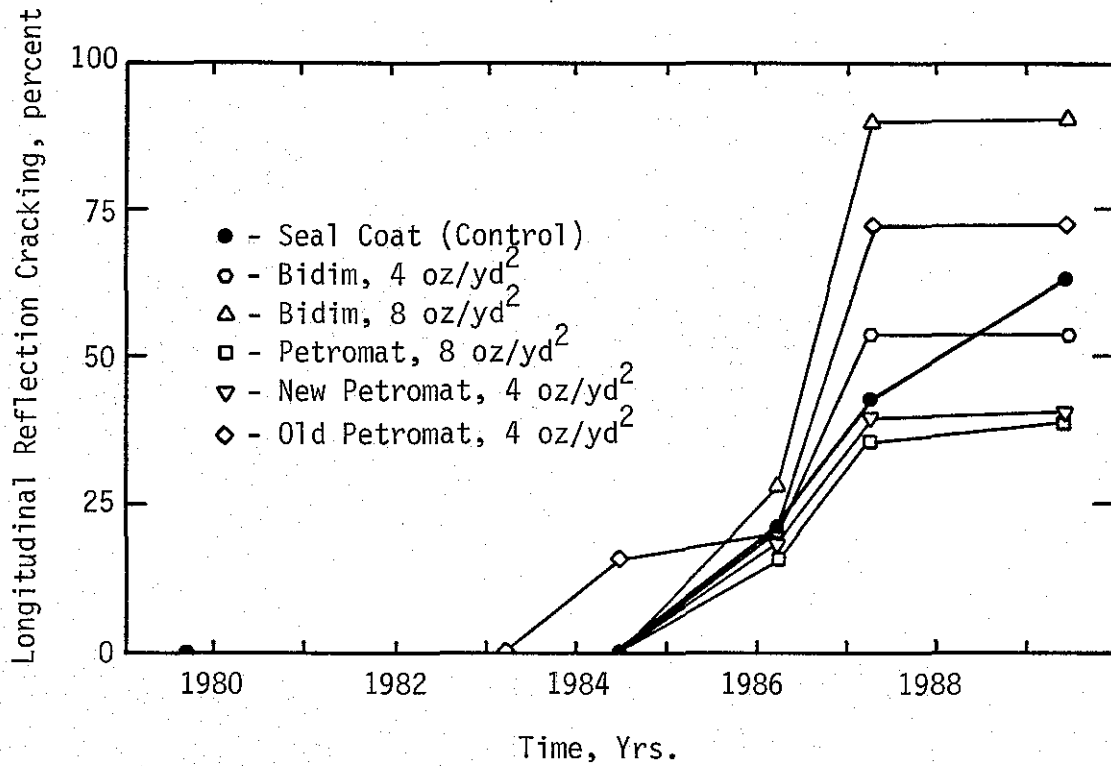
Figure 3. Percent Longitudinal Reflection Cracking as a Function of Time for Westbound Test Pavements on IH-10 near Ozona, Texas.

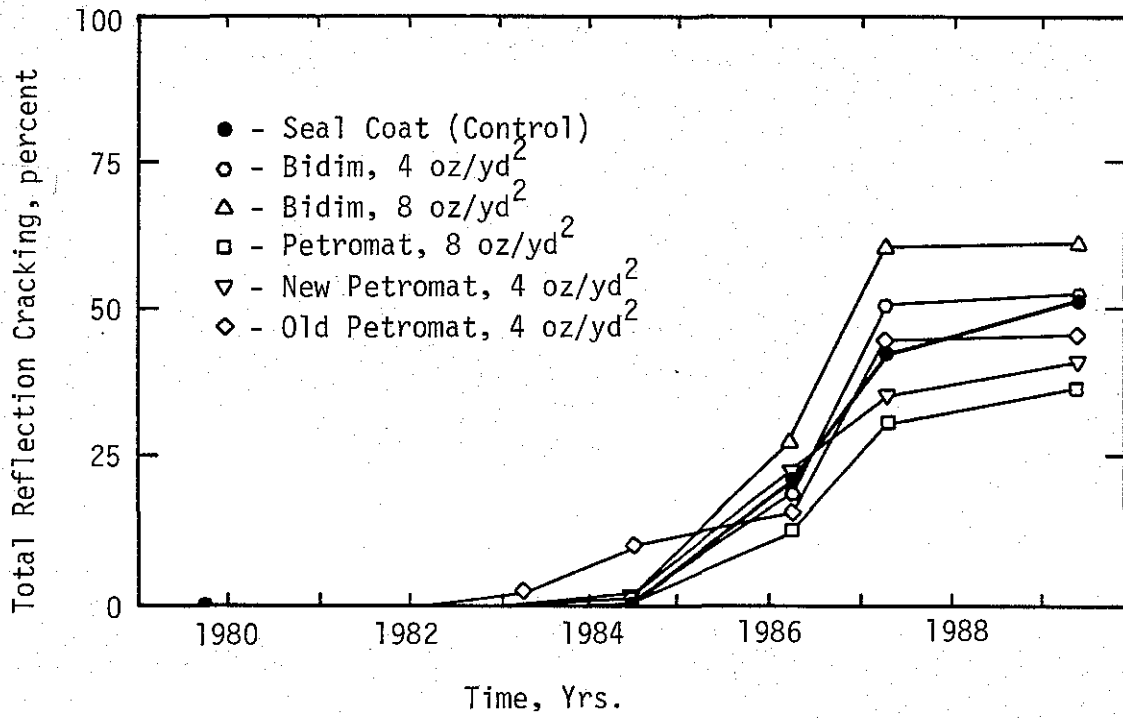
Figure 4. Percent Total Reflection Cracking as a Function of Time for Westbound Test Pavement on IH-10 Near Ozona, Texas.

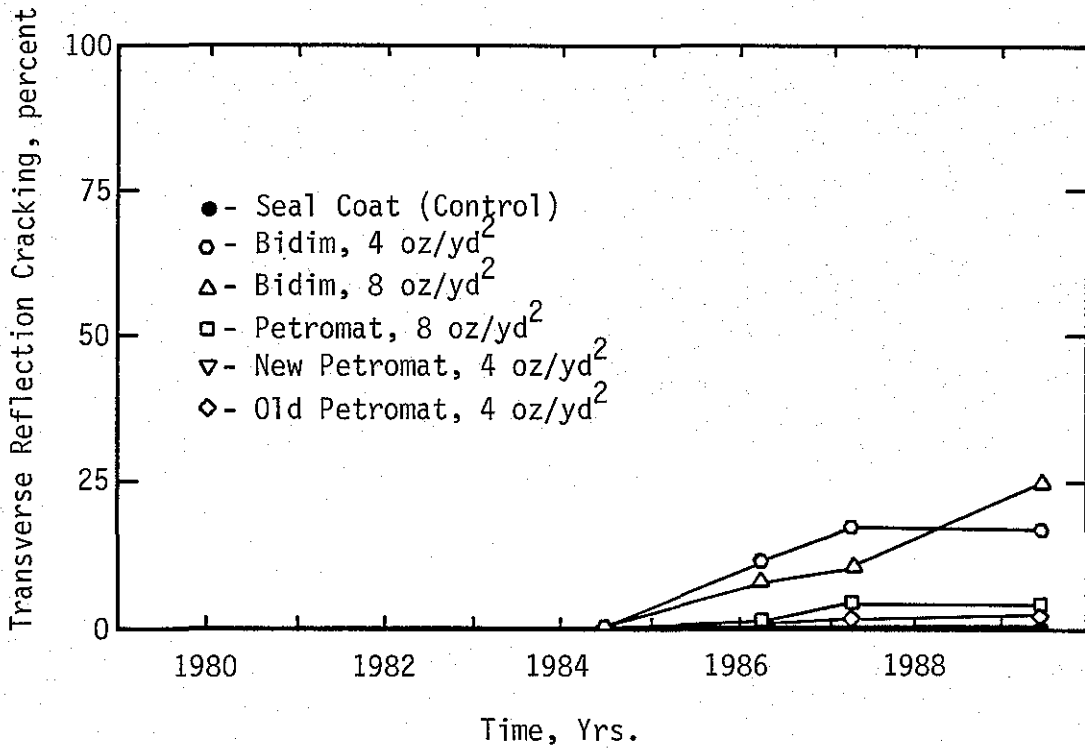
Figure 5. Percent Transverse Reflection Cracking as a Function of Time for Eastbound Test Pavements on IH-10 near Ozona, Texas.

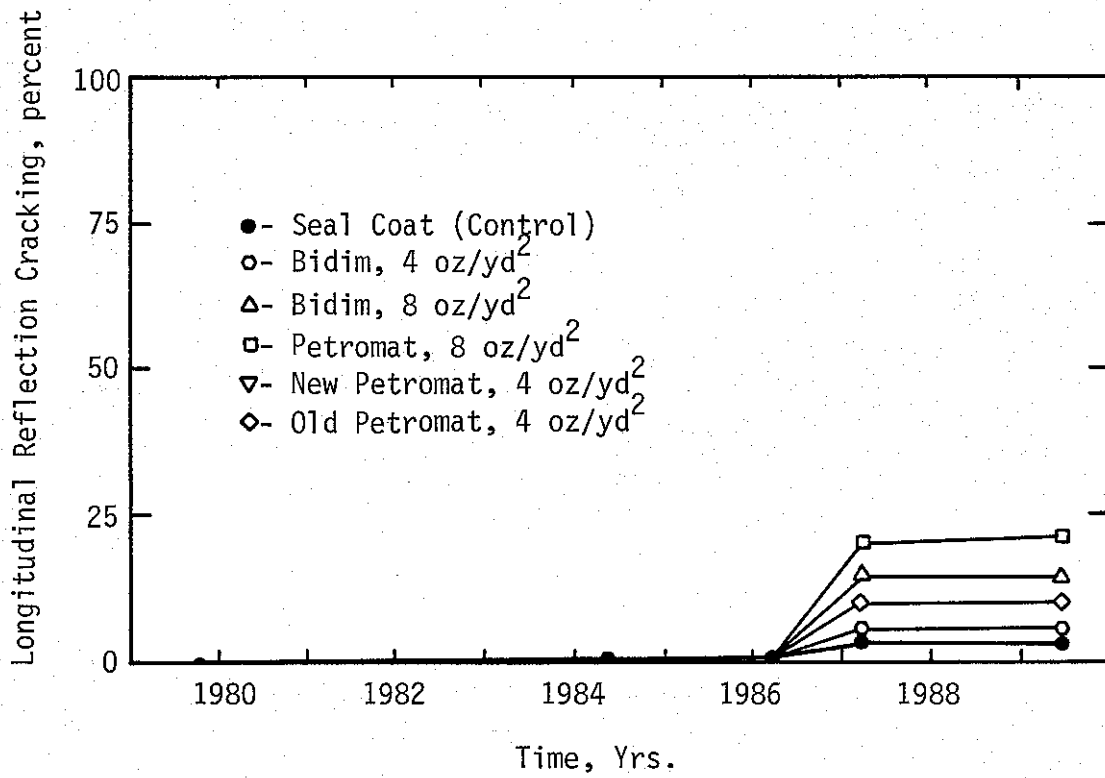
Figure 6. Percent Longitudinal Reflection Cracking as a Function of Time for Eastbound Test Pavements on IH-10 near Ozona, Texas.

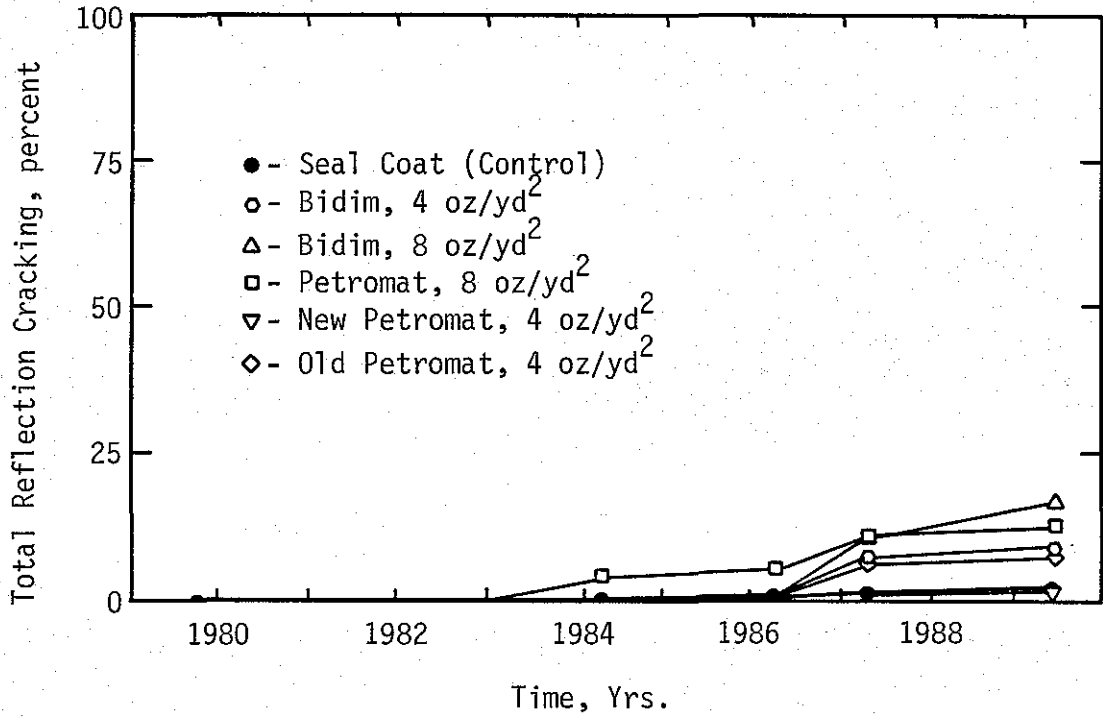
Figure 7. Percent Total Reflection Cracking as a Function of Time for Eastbound Test Pavements on IH-10 near Ozona, Texas.

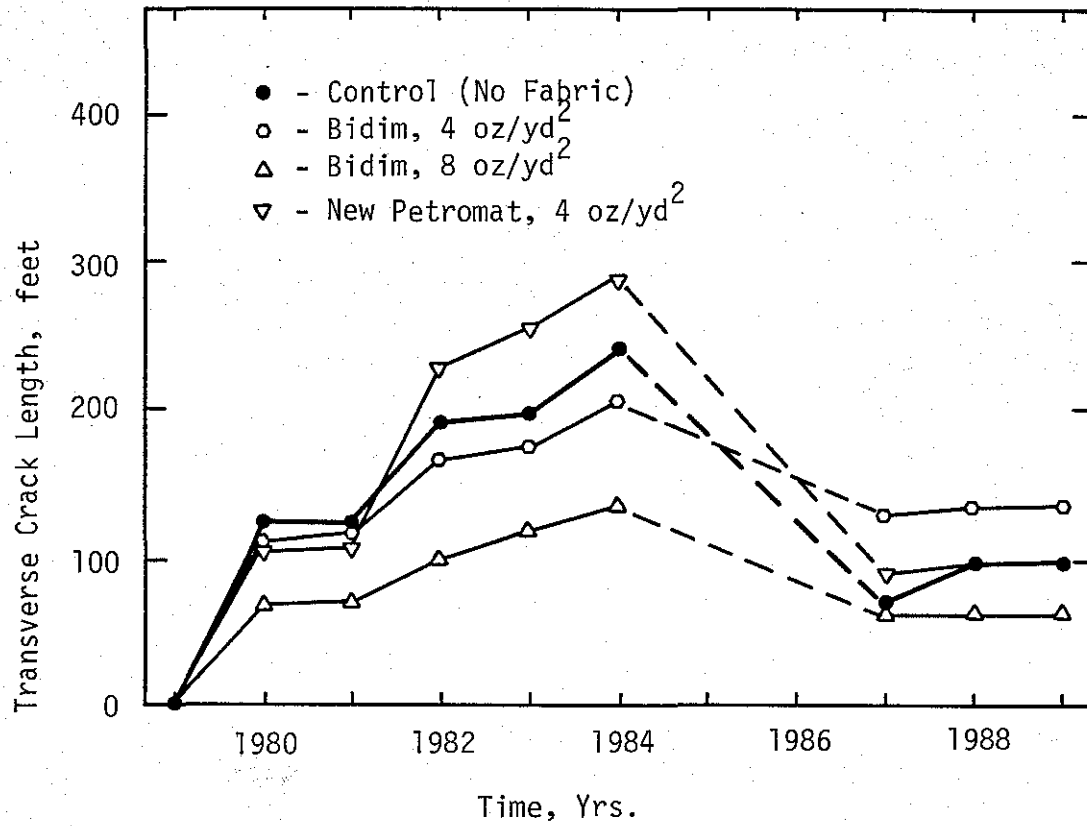
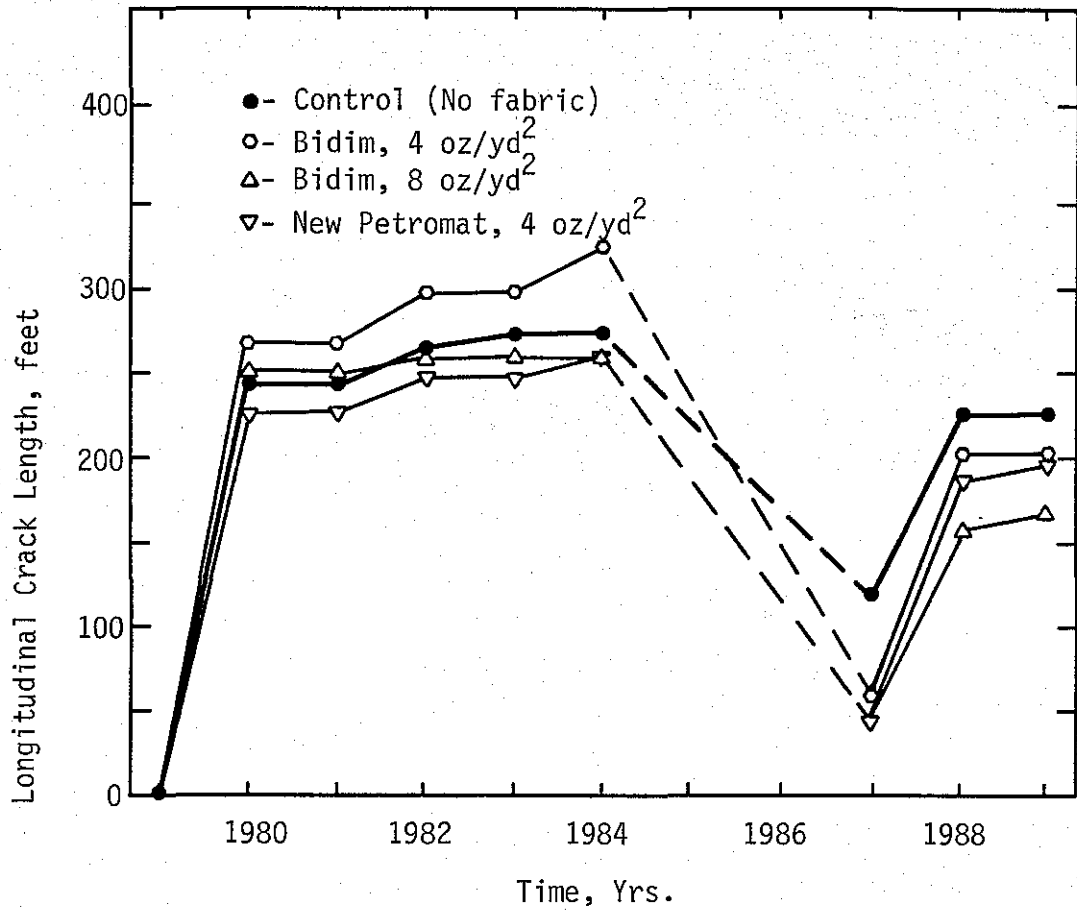
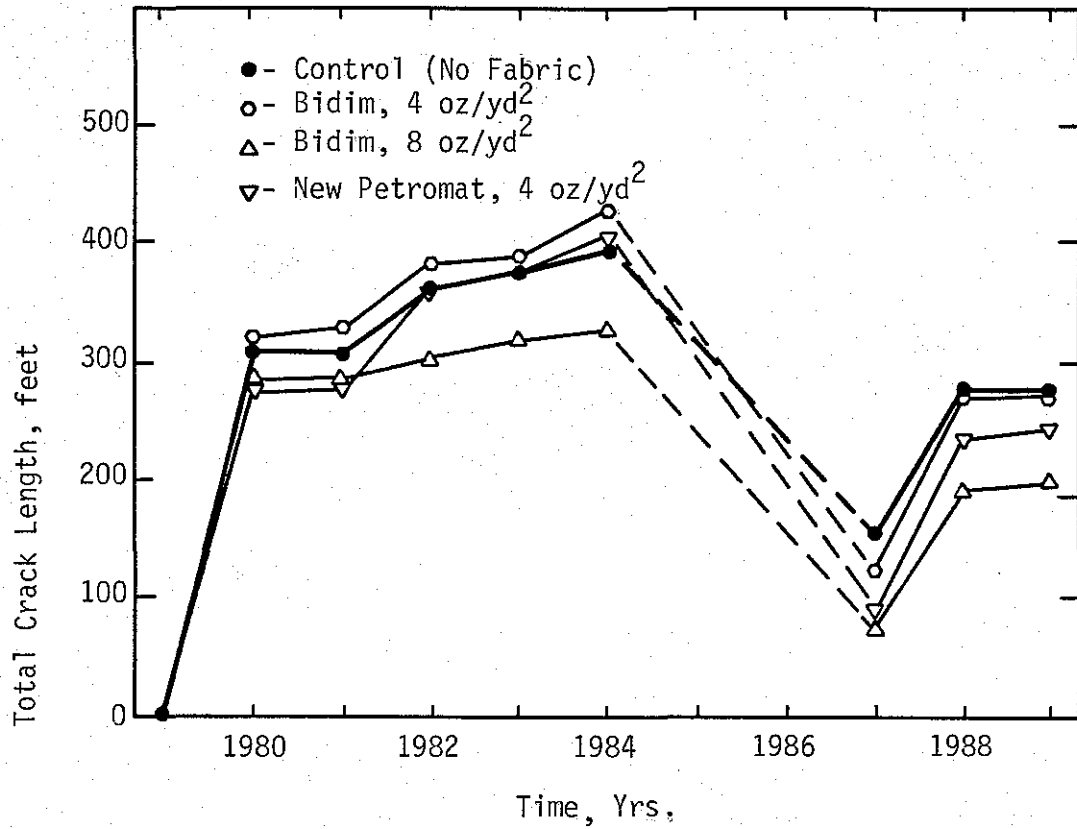
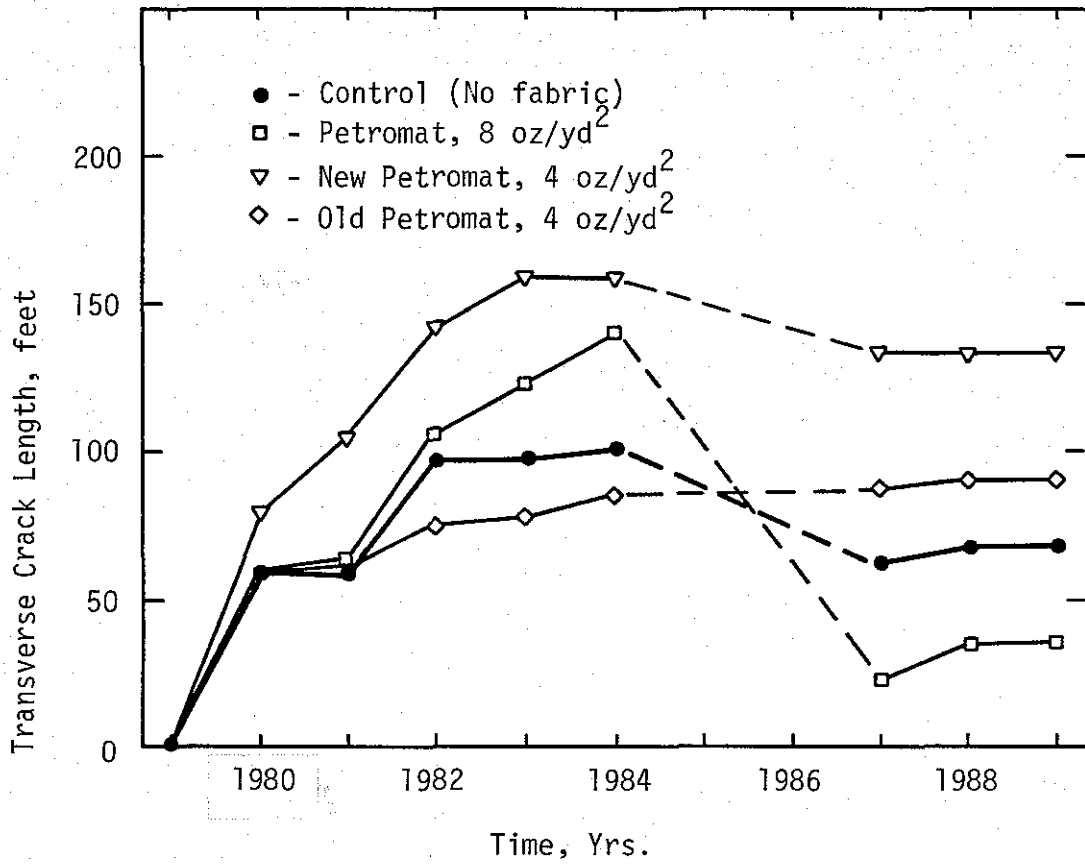
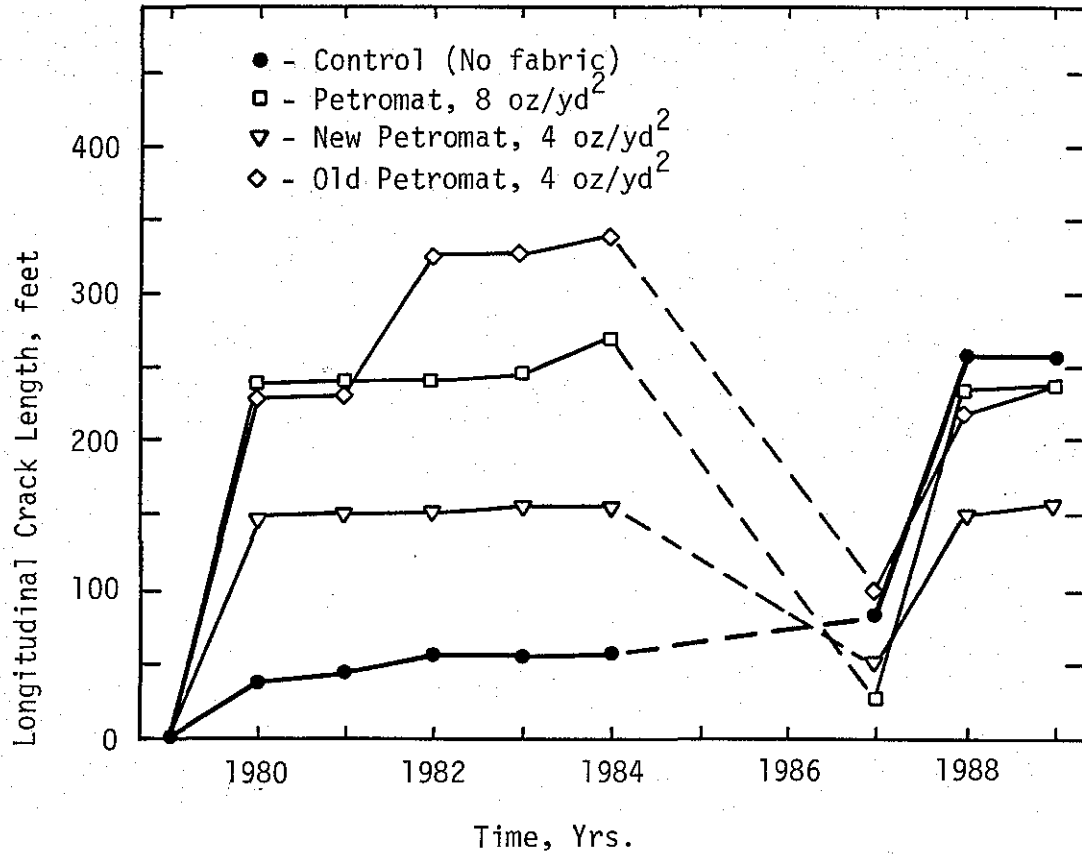
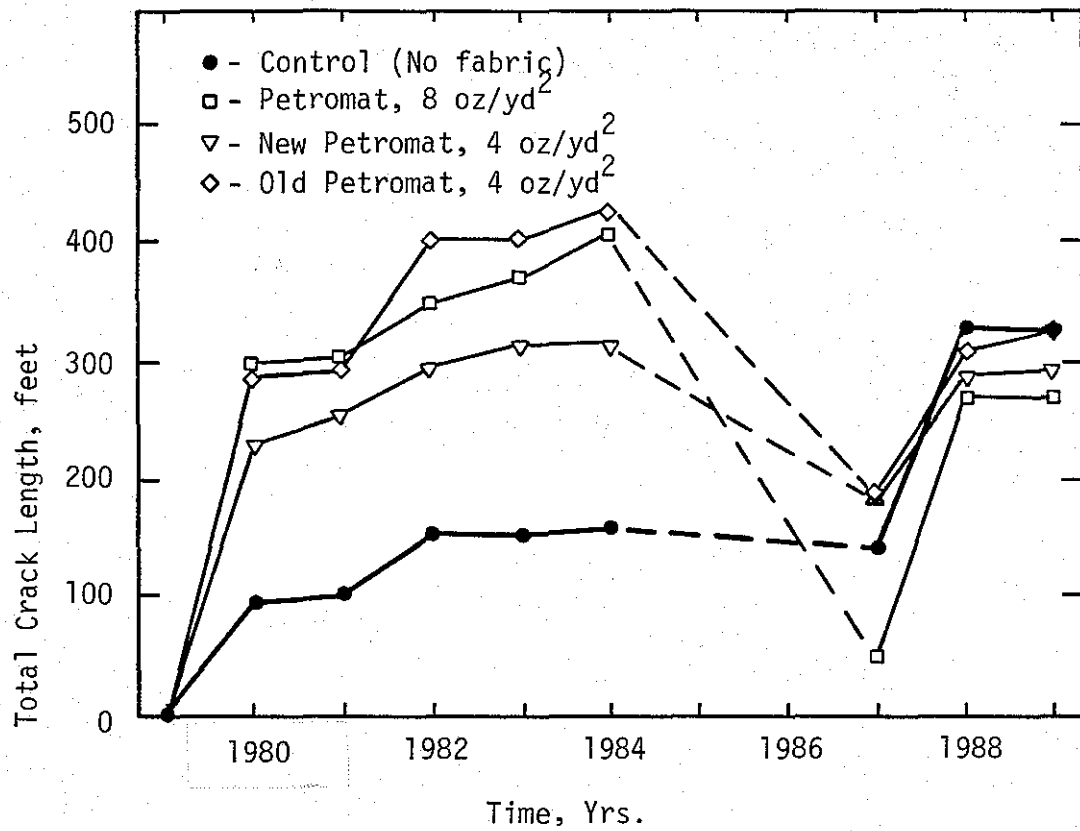
quantity of cracks. Figures 8 through 13 show the cracks have continued to grow but at a slower rate. Since original crack patterns were not recorded, only crack length is shown in the figures and not percentage reflection cracking. In 1985, the pavements were heater scarified to a depth of 0.75 inches, an asphalt rubber seal consisting of 0.65 gallons per square yard of binder and 1 cubic yard of grade 3 precoated aggregate per 75 square yards of surface was applied, and then overlaid with 2 inches of Type D HMAC.

Prior to the maintenance activity in 1985, the control pavements exhibited about the same or less cracking than the sections containing a fabric. After the maintenance activity in 1985, the control pavements, on the average, exhibited more cracks in the new surface than the pavement sections containing a fabric. However, in most cases, the differences in crack lengths between the different sections are not considered to be significant. (The nature of these data did not lend itself to a formal statistical analysis). In these tests, the 8-ounce-per-square-yard products exhibited the best resistance to cracking in the overlay applied in 1985 but not in the original overlay. No single type of fabric consistently improved resistance to cracking throughout the 10-year evaluation period.

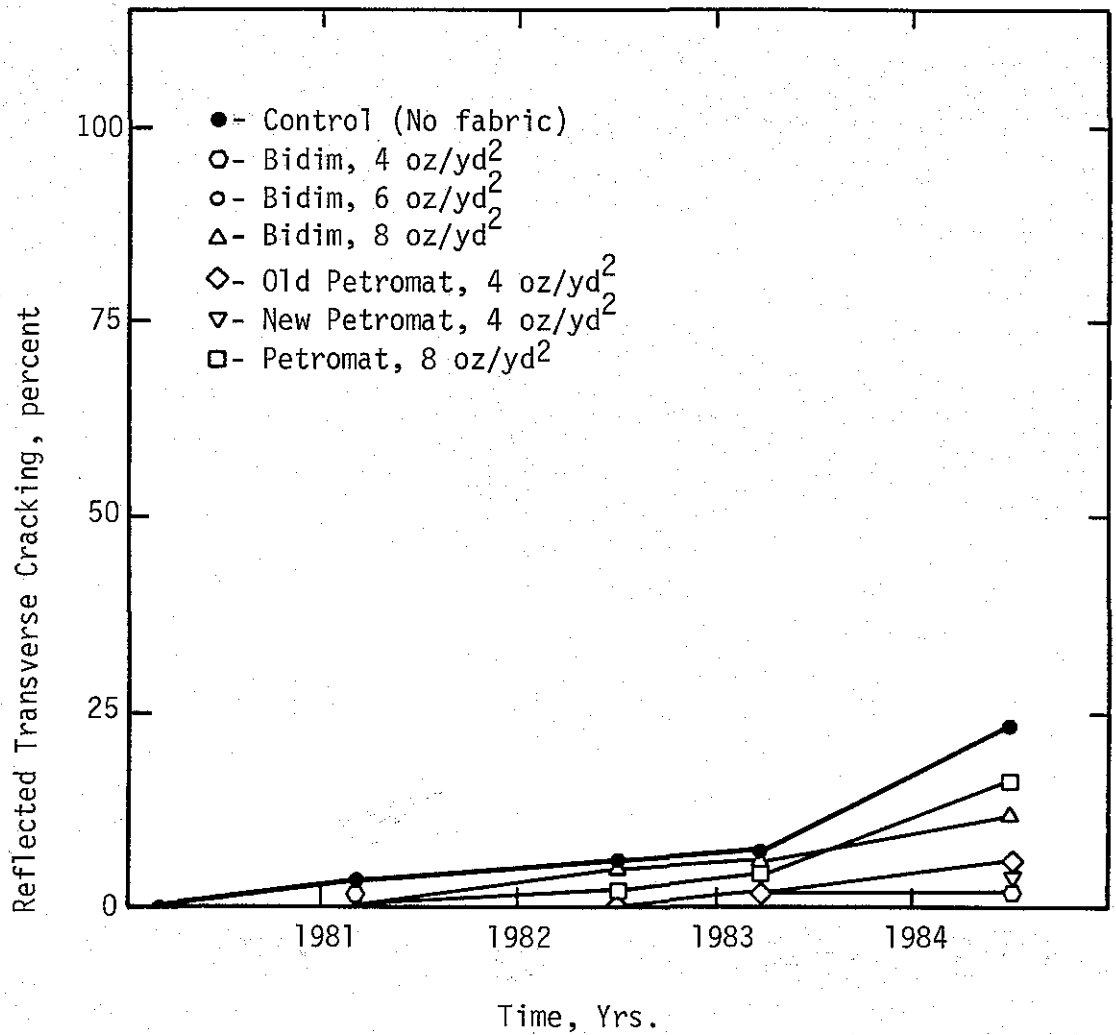
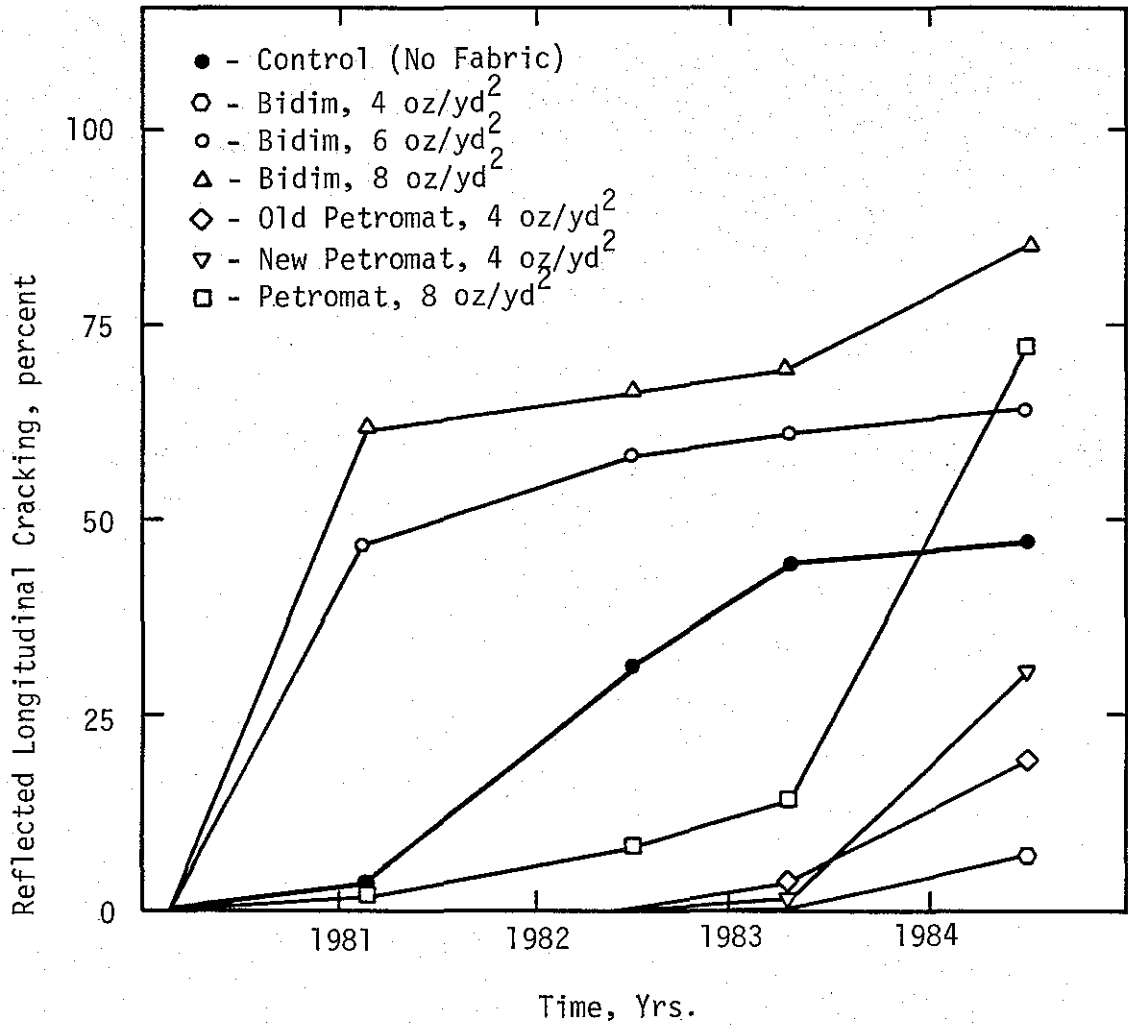
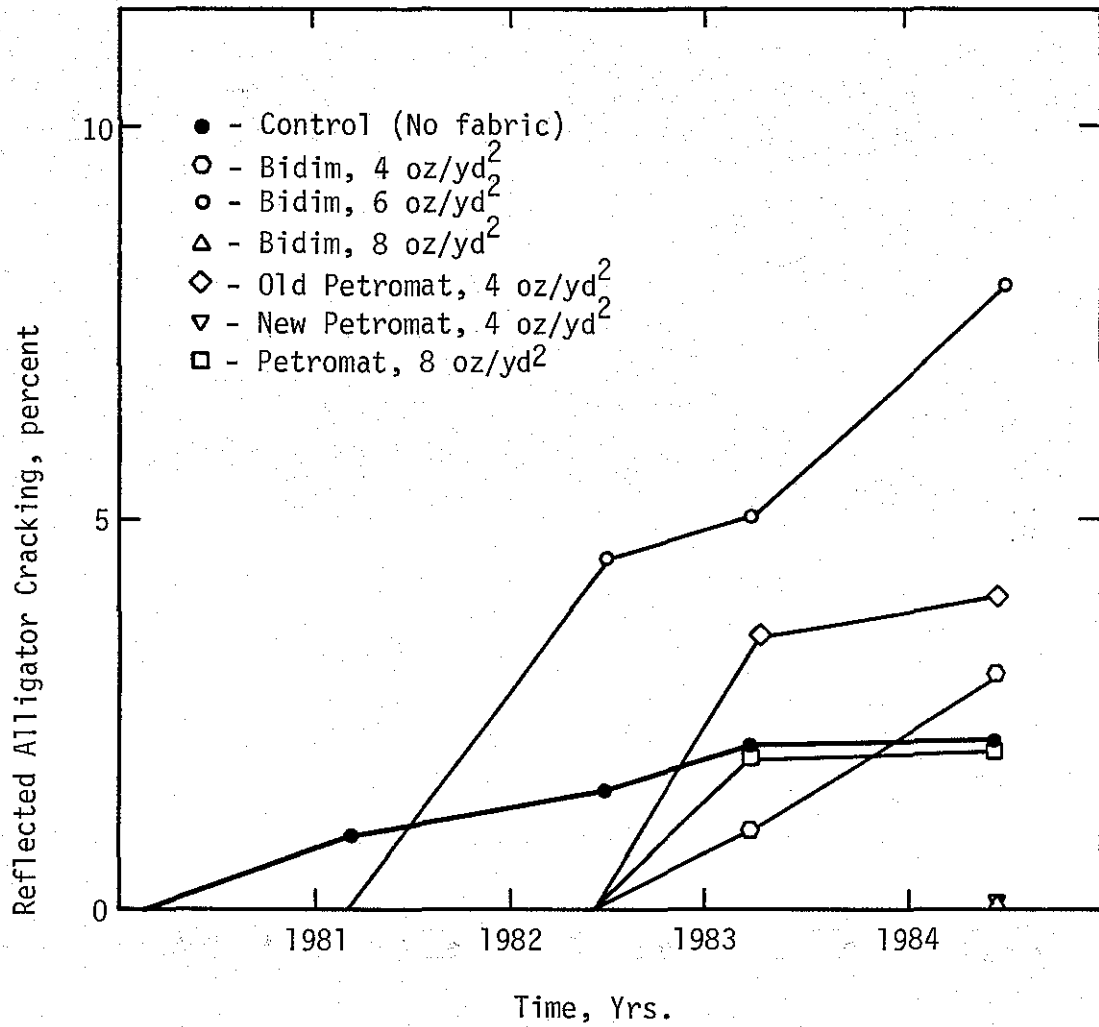
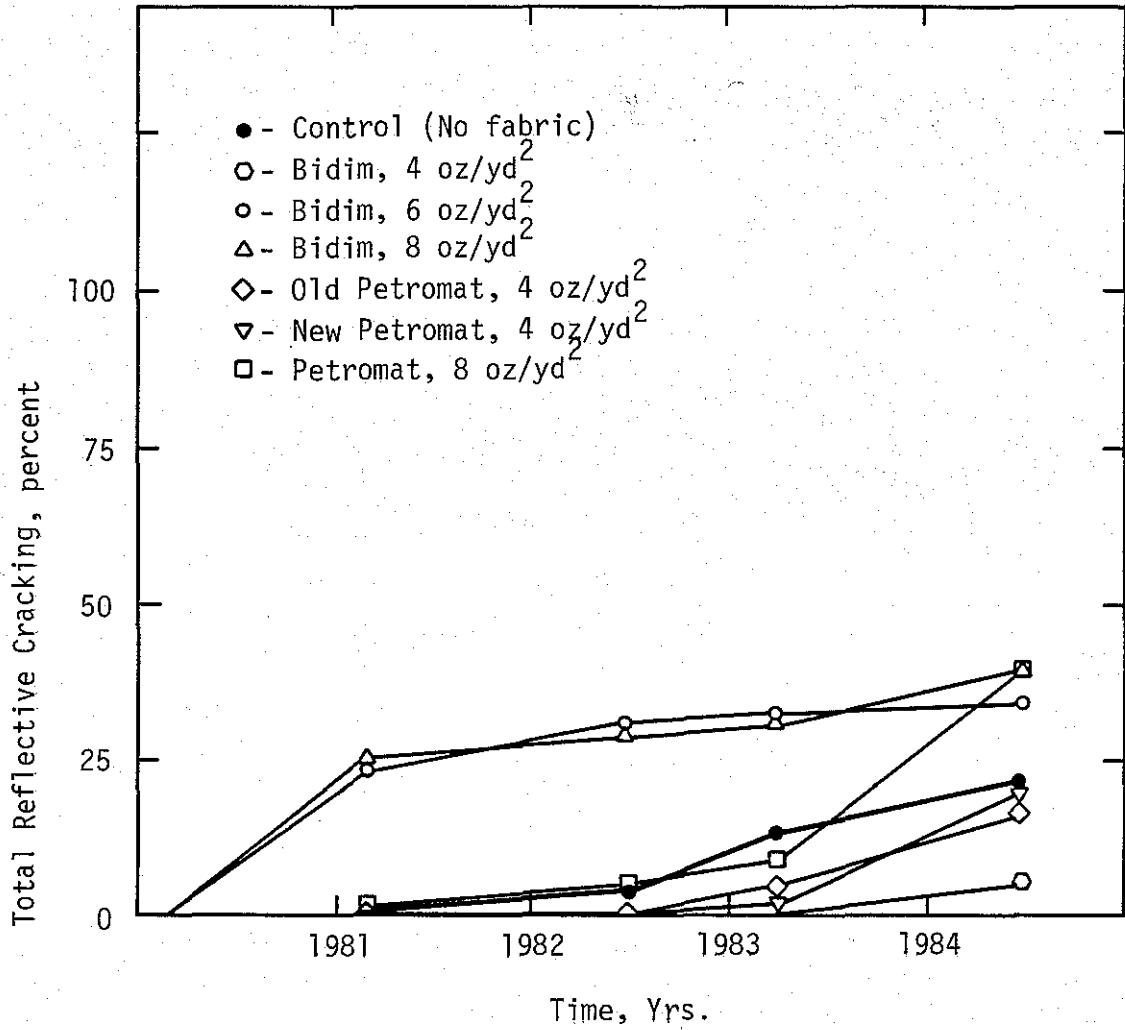
Annual inspections of the test pavements were performed from 1980 to 1984 to quantify pavement distress. Cracks were mapped and compared to the cracking patterns in the original pavement surface. Most of the cracking that appeared was confirmed to be reflection cracking. Figures 14 through 17 show percent reflection cracking as a function of time for longitudinal,

transverse, alligator, and total cracking, respectively. These data indicate that, overall, Bidim C-22 (4 ounce per square yard) exhibited the best resistance to reflection cracking. In fact, all the 4-ounce fabrics outperformed the heavier fabrics. By comparison to the control section, the fabrics resisted transverse cracking better than they resisted longitudinal or alligator cracking. Fabrics, in general, did not consistently reduce or delay reflection cracking better than the control section which contained no interlayer.
