**FIELD PERFORMANCE OF MAINTENANCE TREATMENTS
CONSTRUCTED WITH RECLAIMED ASPHALT PAVEMENT (RAP)**

Research Report 187-24
Research Study Number 0-187, Task 13
Research Study Title: Monitoring Reclaimed Asphalt Pavement
Test Sections (Follow-up to Research Study 1272)

November 1994

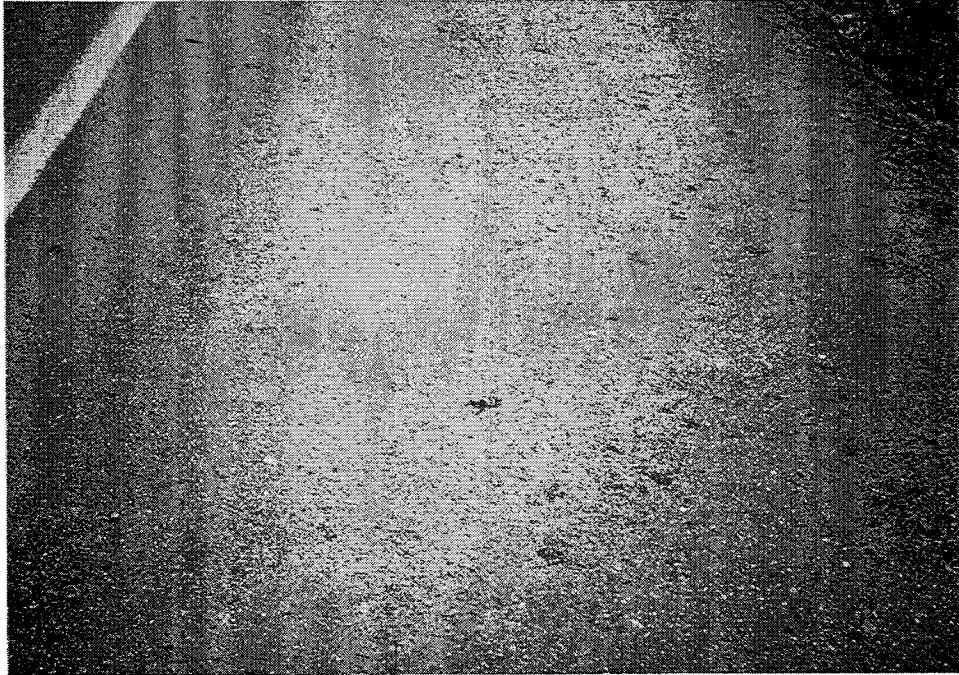
Figure 3. McKinney Test Section No. 1: HMCL.

This section was in excellent condition with the exception of one 2.5 square meter (25 square foot) area which was exhibiting slight bleeding. A photograph of this section is shown in Figure 3.

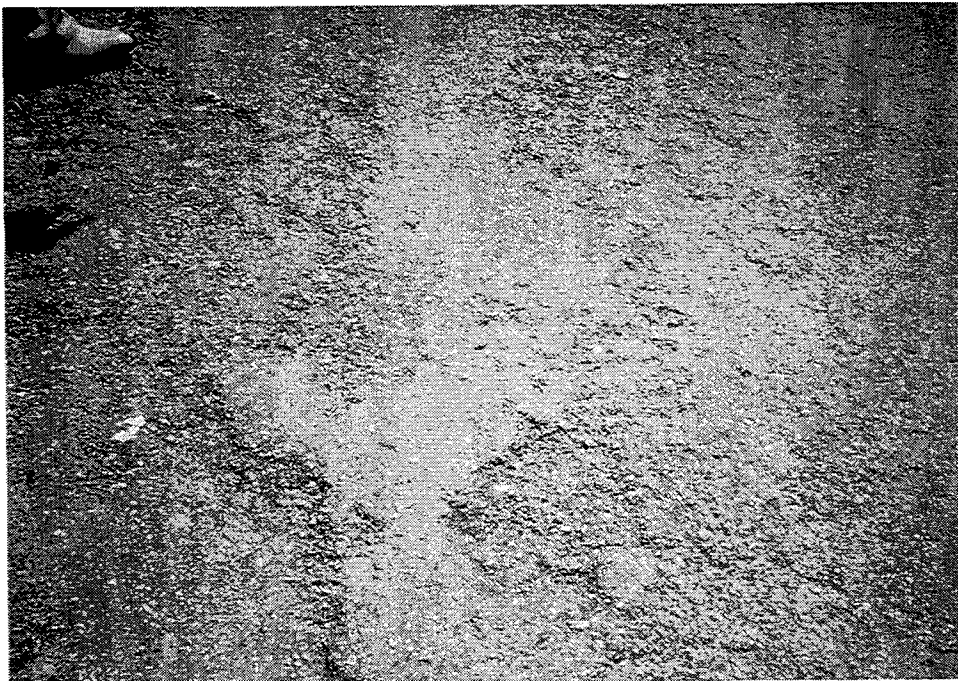
Figure 4. McKinney Test Section 2: Close-up of HMCL/Untreated RAP, 45/55 Ratio.

The portion with the highest RAP percentage 45/55 ravelled quite severely within the first 24 hours after construction. Surprisingly, however, this raveling did not progress any further throughout the monitoring period. See Figure 4.

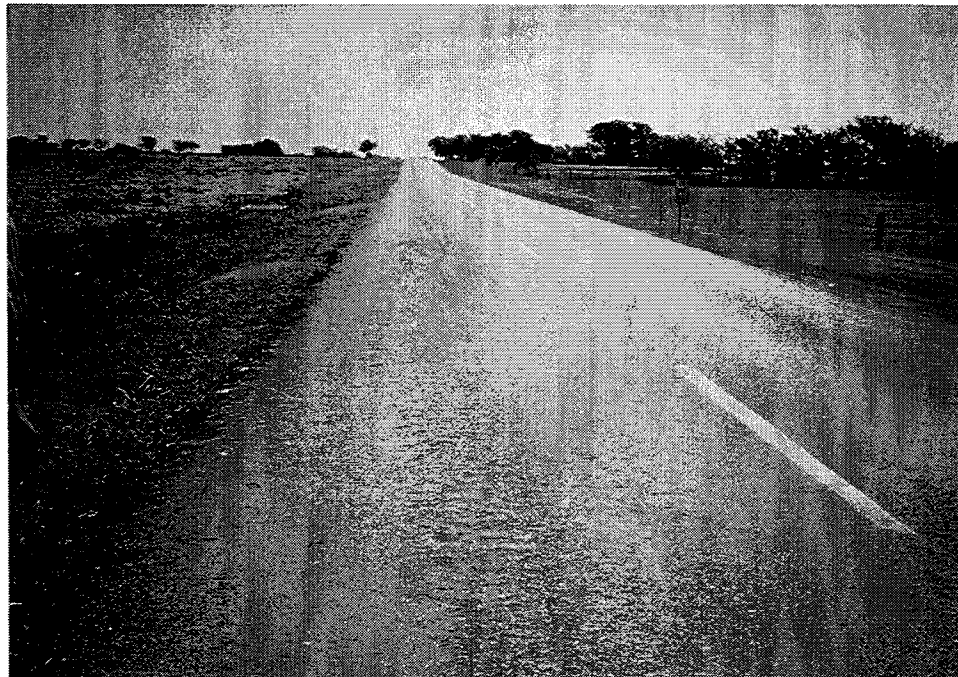
Figure 5. McKinney Test Section 2: HMCL/Untreated RAP Blend.

The 55/45 blend and the 70/30 blend of HMCL/Untreated RAP were in good condition; only slight raveling was evident. The surface texture was somewhat rough but not particularly detectable by a subjective ride quality assessment. There was almost no discernable difference between the 55/45 blend and the 70/30 blend. Figure 5 shows this test section. The 45/55 HMCL/Untreated RAP blend is shown in the foreground of the left lane in Figure 5. The 55/45 blend is in the background portion of the photo of the left lane and the 70/30 HMCL/Untreated RAP is shown in the right lane of Figure 5.

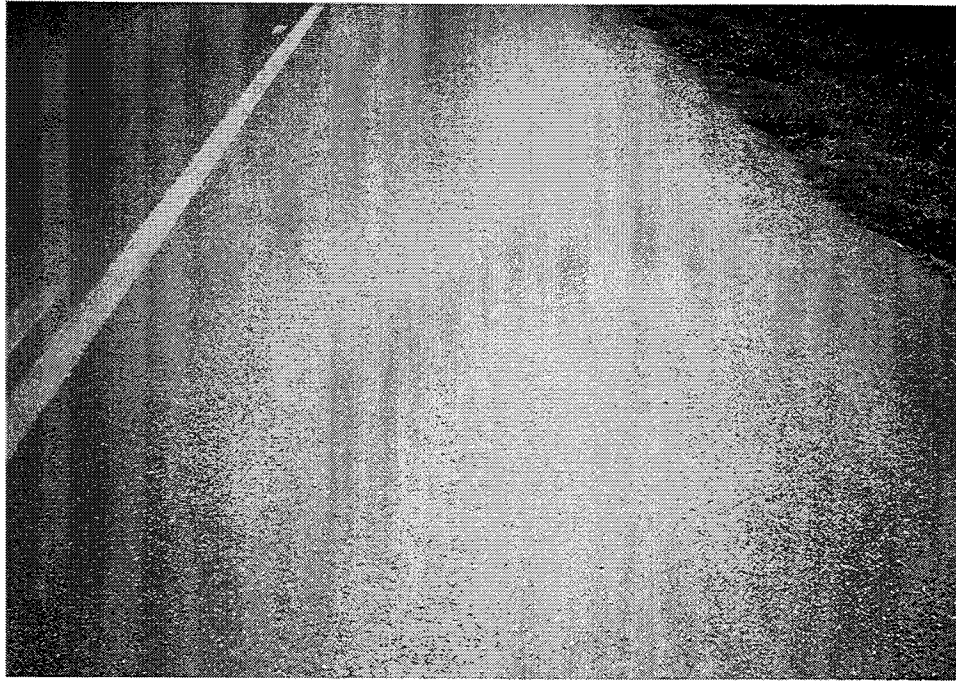
Figure 6. McKinney Test Section 3: HMCL/Treated RAP Blend.

which had been treated with AES-300RP. This section was in very good condition with slight raveling noted. This section was not particularly better than the previous section which had 55/45 HMCL/Untreated RAP. The HMCL/Treated RAP test section is shown below in Figure 6.

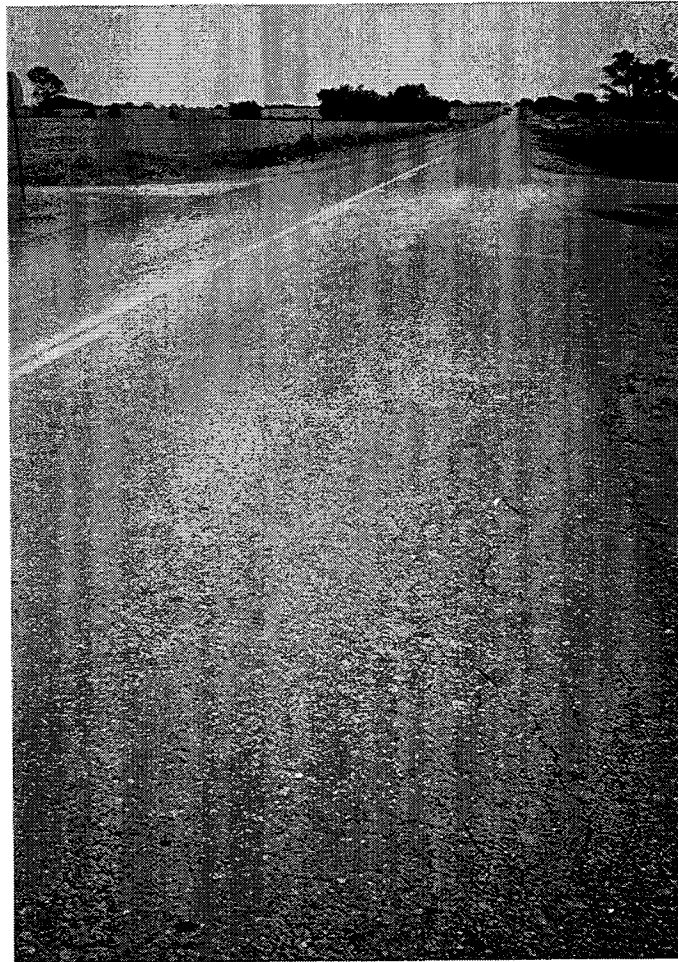
Figure 7. McKinney Test Section 4: LRA/Untreated RAP Blend.

This test section was constructed with a blend of 60 percent LRA and 40 percent untreated RAP. This test section performed relatively well throughout the monitoring period. It appeared to be slightly more ravelled than test section 3 and exhibited some slight cracking as shown in Figure 7. It also contained a very small pothole (100 millimeters or 4 inches in diameter).

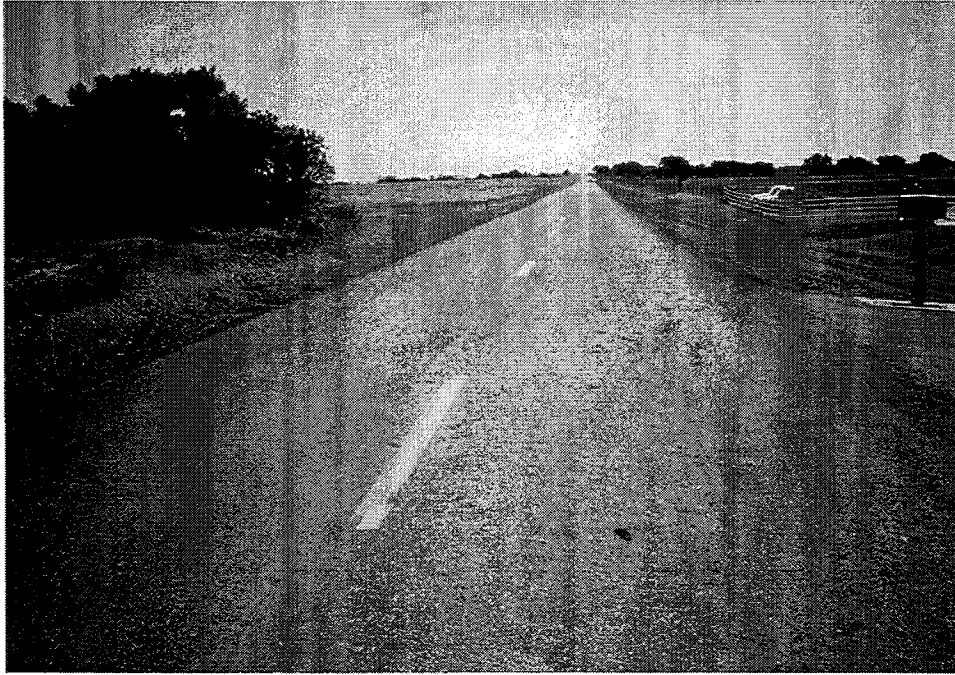
Figure 8. McKinney Test Section 5: LRA/Treated RAP Blend.

The material blend used to construct this test section was composed of 50 percent LRA and 50 percent RAP treated with AES-300RP. This test section performed very well with no distress noted. A photograph of this section is shown in Figure 8.

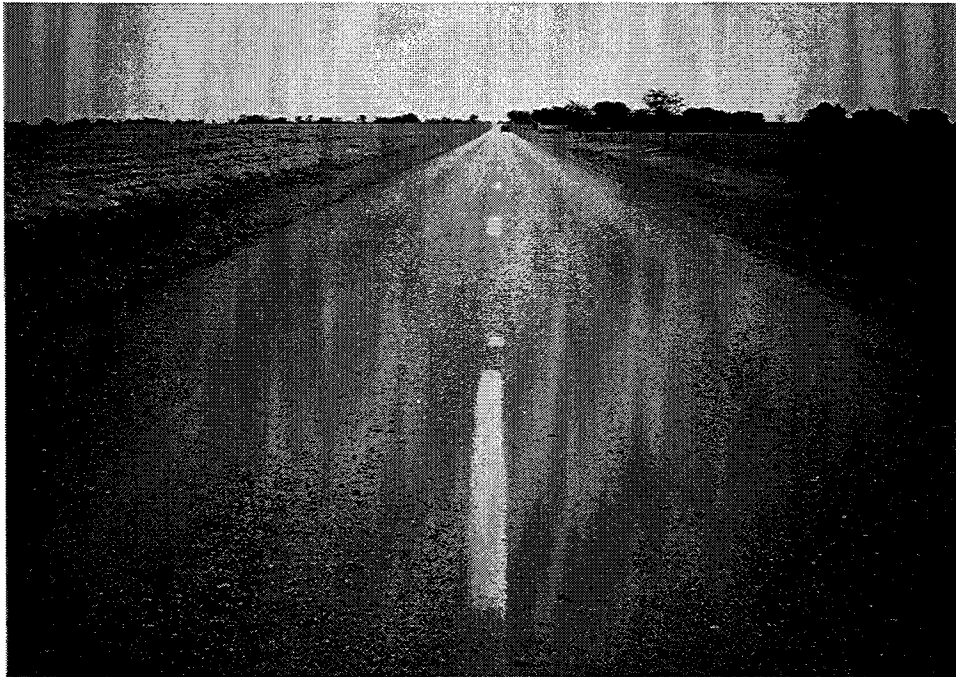
Figure 9. McKinney Test Section 6: LRA.

This test section served as a control section and was constructed with 100 percent LRA. This test section performed very well with no distress noted (see Figure 9).

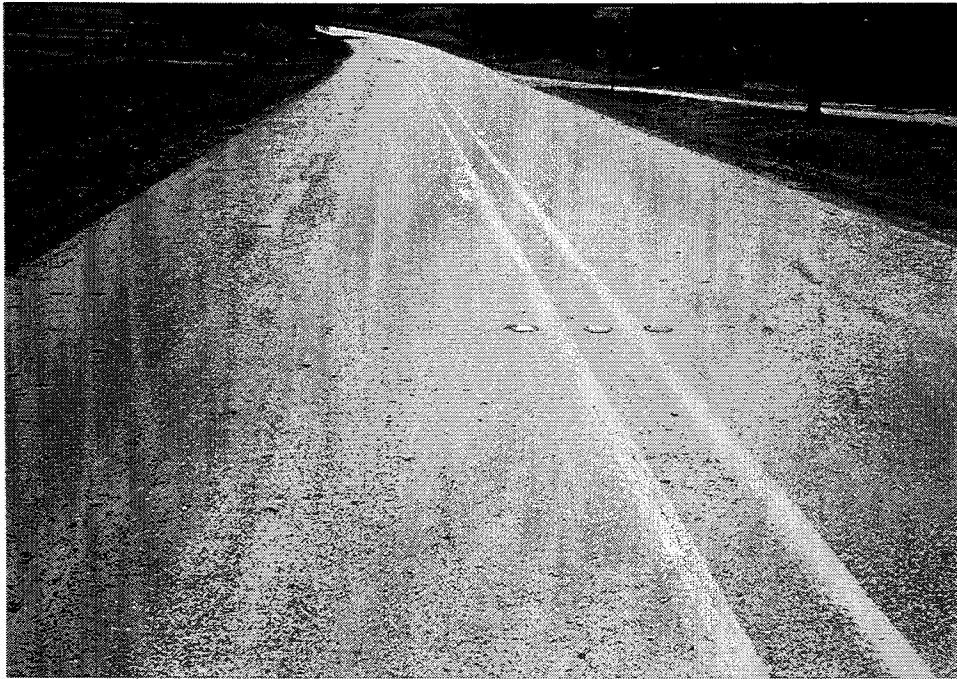
Figure 12. Cleburne Test Section 2: HMCL/Untreated RAP Blend.

This test section was constructed with a blend of 70 percent HMCL and 30 percent RAP. This section was in very good condition with the exception of some slight ravelling. Most of this ravelling occurred immediately after construction. This test section is shown in Figure 12.

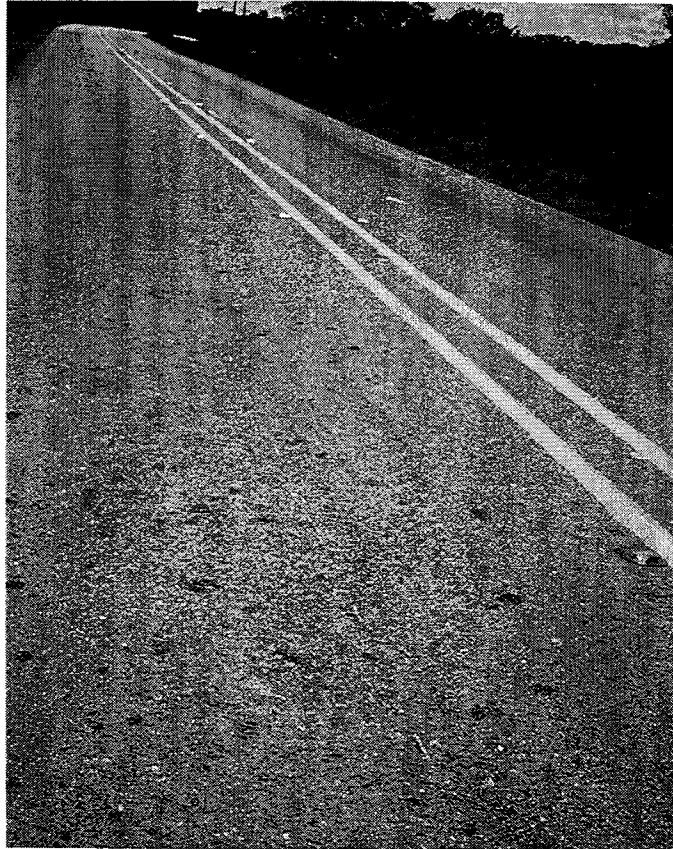
Figure 13. Cleburne Test Section 3: HMCL/Treated RAP Blend.

This test section was constructed with a blend of 50 percent HMCL and 50 percent treated RAP. This section was in very good condition throughout the study with the exception of some ravelling. Again, this ravelling occurred immediately after construction and did not progress throughout the monitoring period (see Figure 13 below).

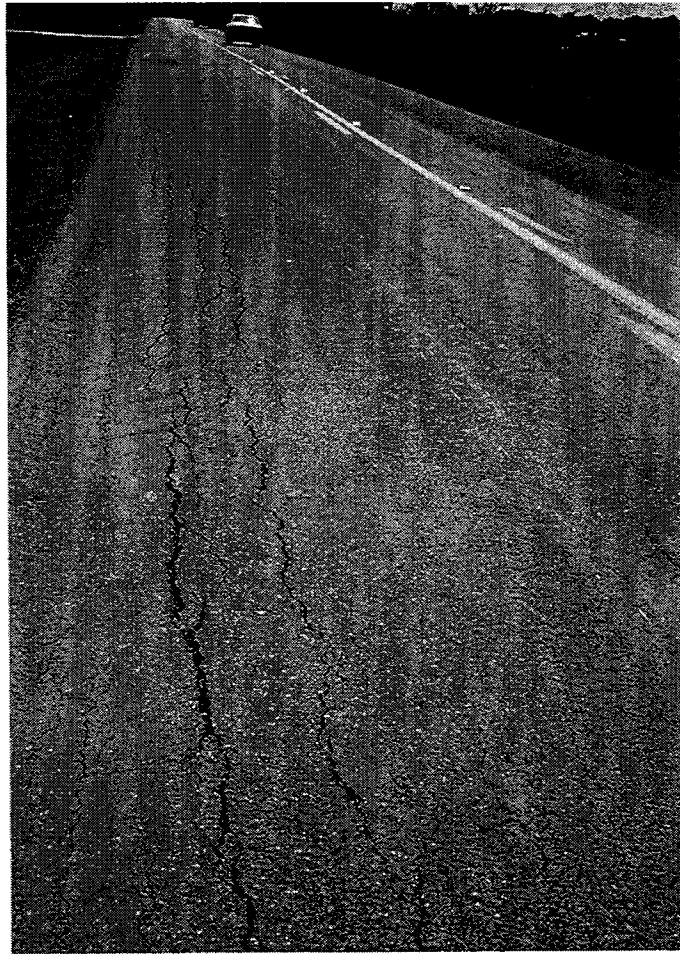
Figure 14. Cleburne Test Section 4: LRA.

This test section served as a control material and was constructed of 100% LRA. This section exhibited severe longitudinal cracking as shown below in Figure 14 and significantly more ravelling than sections 1 through 3. Typically, this type of pavement failure evidenced in the surface would be associated with a subgrade failure. However, in this case it appears the cracking is

occurring in the surface material only. The surface overlay is very thin (25 mm or 1 inch) and in some places the cracks were wide enough to see the underlying pavement layer which was not cracked. It was also noted that beyond the experimental sections, the pavement was not exhibiting this type of distress. The researchers believe that there is slippage between the surface layer and underlying pavement which is causing these types of cracks to appear. This particular section (Number 4) is the worst of the 5 sections in Cleburne.

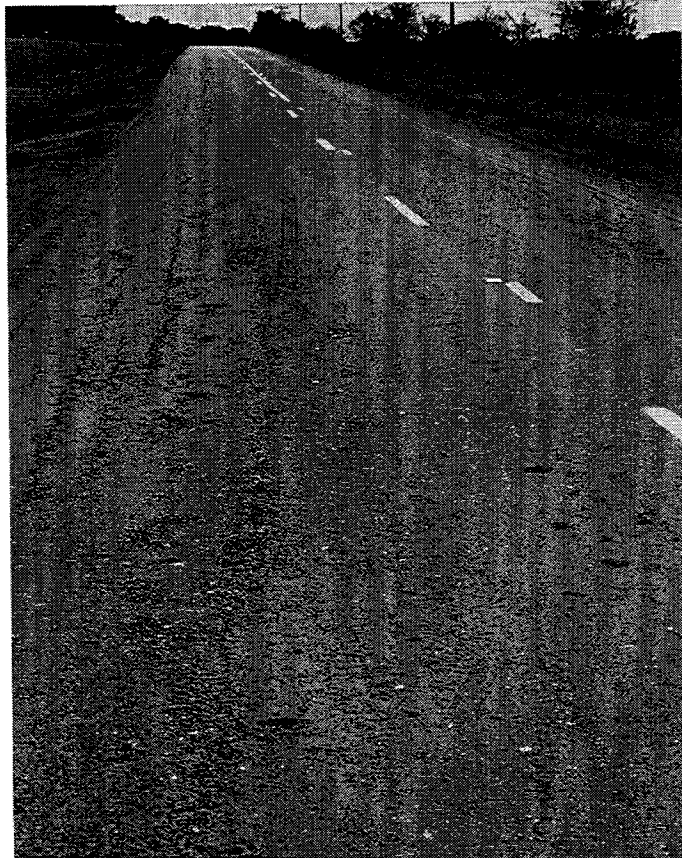
Figure 15. Cleburne Test Section 5: LRA/Treated RAP Blend.

Test section 5 was constructed with a blend of LRA and treated RAP at a 50/50 ratio. This test section also exhibited a significant amount of ravelling and cracking; however, it was not as severe as that in section 4. In this particular

case, it appears that the addition of the treated RAP to the LRA actually improved its performance. Perhaps the addition of emulsion to the RAP increased the overall binder content of the blend, thereby improving its cohesive properties. This section is shown below in Figure 15.

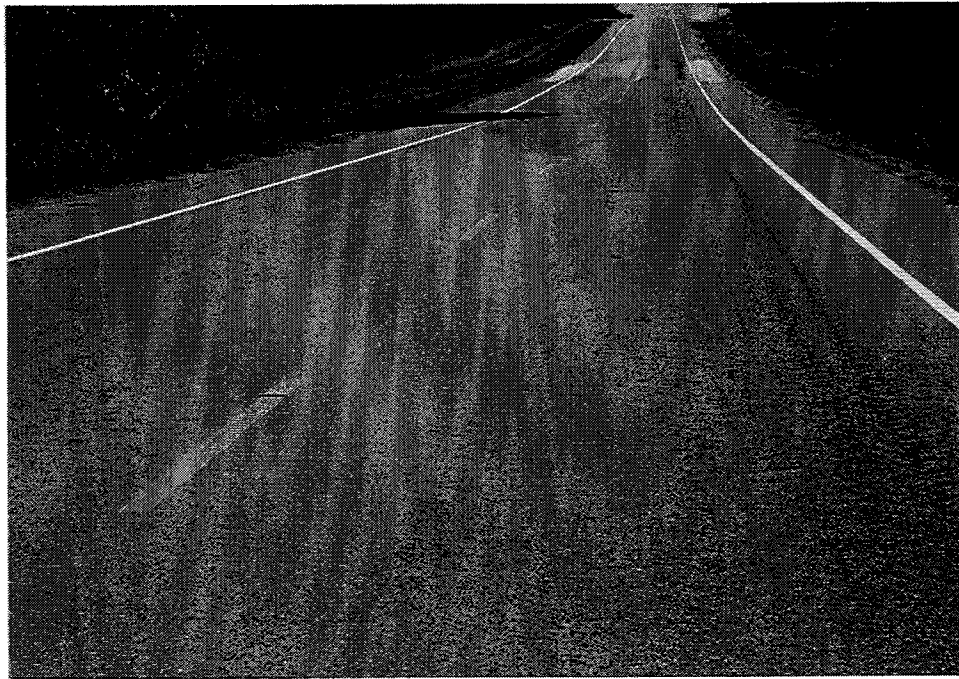
Figure 17. Pleasanton Test Section 1: HMCL/Untreated RAP.

This test section was constructed with a blend of 60 percent HMCL and 40 percent RAP. It performed very well throughout the study with the exception of minor ravelling. This test section is shown in Figure 17.

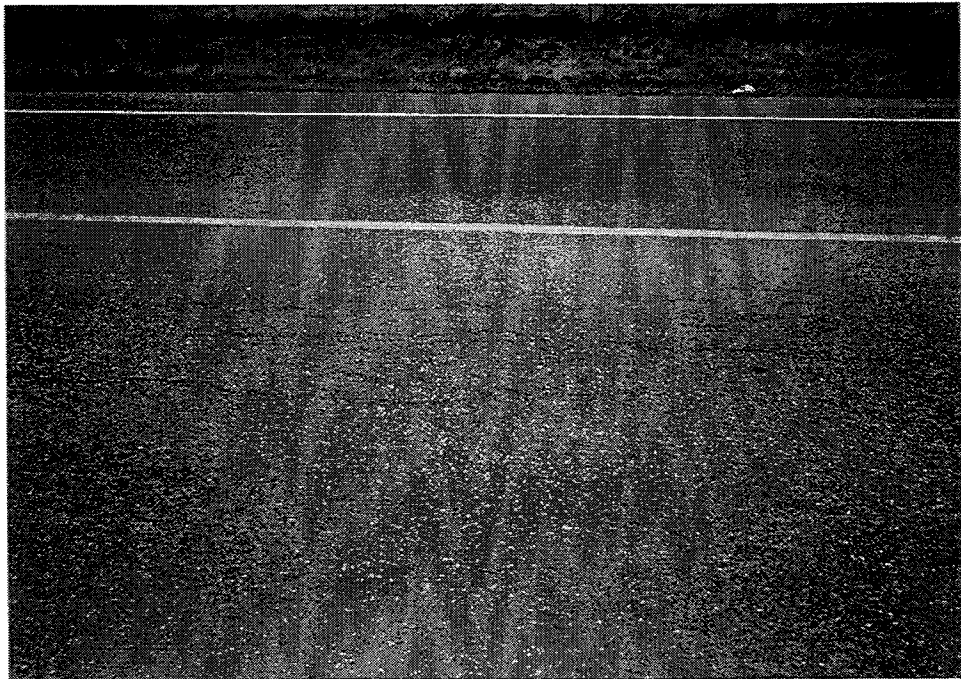
Figure 19. Pleasanton Test Section 3: LRA/Treated RAP.

This test section was constructed using LRA blended with treated RAP at a 50/50 ratio. This section showed more distress than any of the other five test sections: the primary distress was longitudinal cracking. However, the cracking did not cover an extensive area and the cracks themselves could be considered slight in severity. See Figure 19 below.

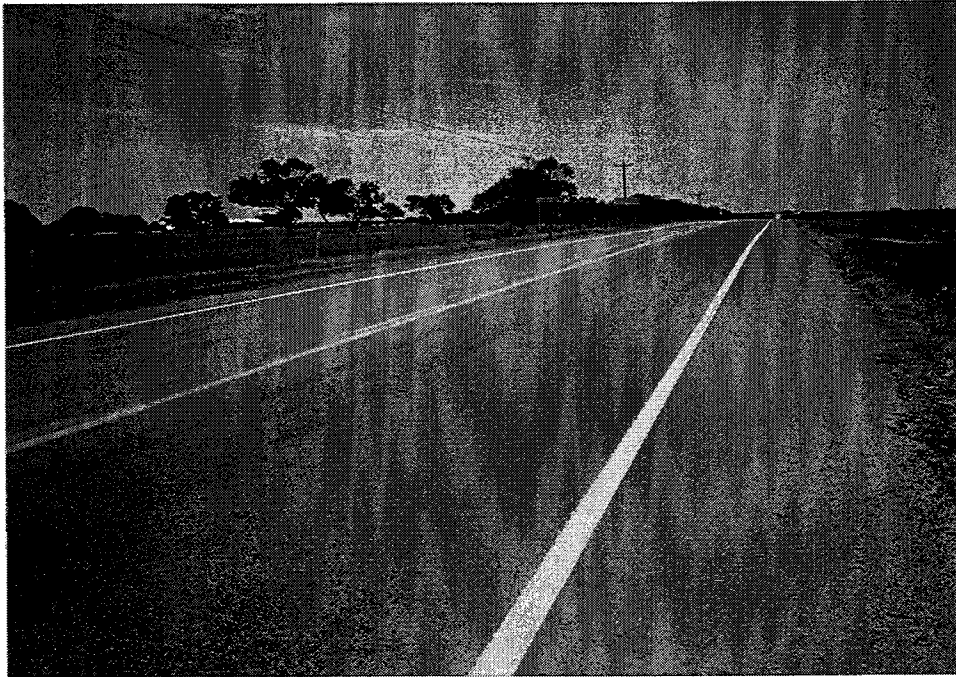
Figure 20. Pleasanton Test Section 4: LRA.

Test section 4 was constructed as a control section using 100% LRA. This test section performed very well but showed very minor signs of ravelling. See Figure 20 below.

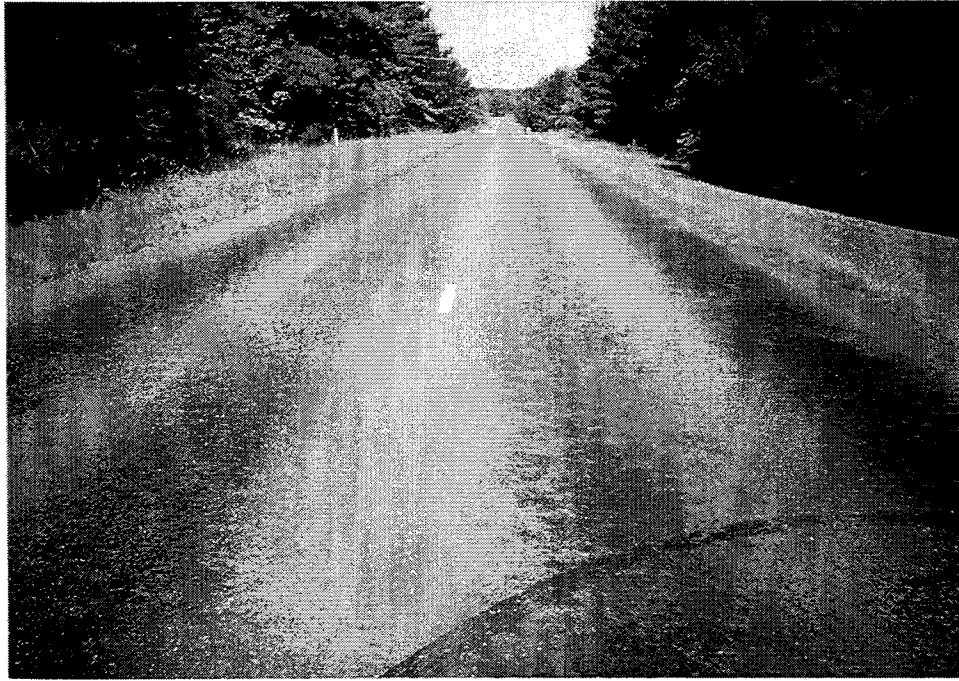
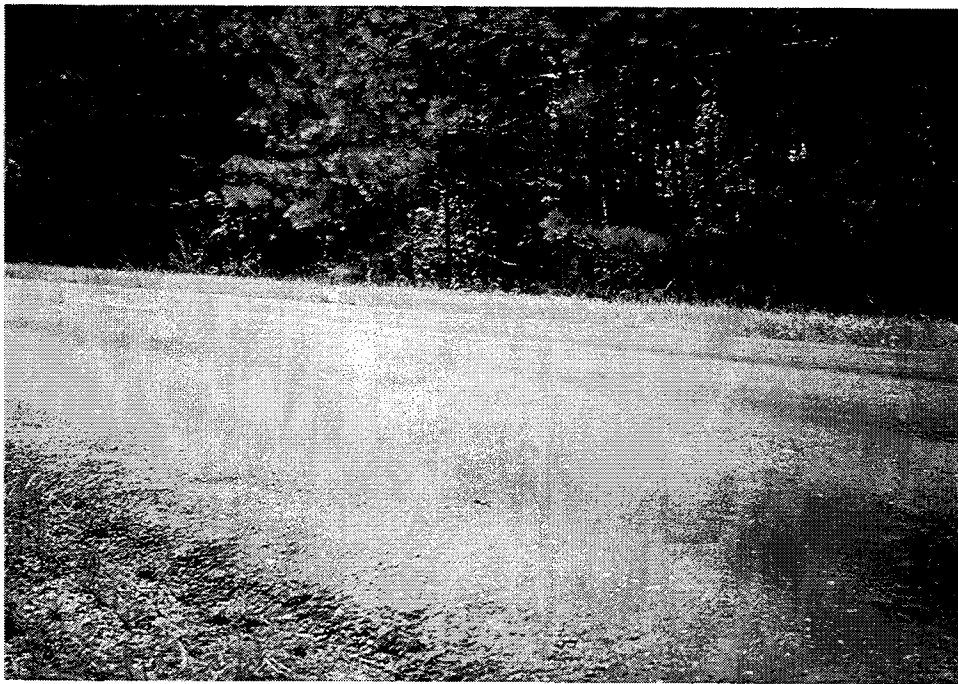
This test section was constructed using RAP which had been treated with AES-300RP as previously described. By the end of the first year, this test section was experiencing serious signs of flushing and rutting in the wheelpaths. By the end of the second year, about 70 percent of the area was flushed and ruts were as deep as 25 millimeters (1 inch). See Figures 22 and 23.

In summary, the treated RAP test section performed poorly as might have been predicted by the extremely low Hveem stability laboratory values. The poor performance is attributed to excess binder added to the RAP. The HMCL test section performed acceptably despite some minor flushing.

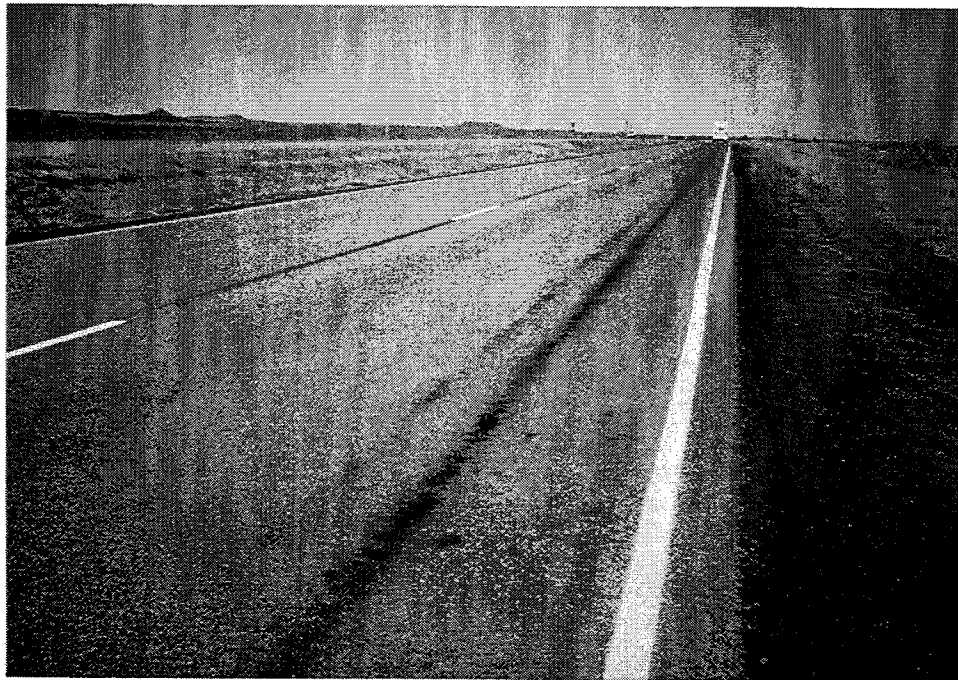
Figure 26. Childress Test Section - ARE/68 RAP Blend.

The ARE-68 treated RAP began to exhibit rutting soon after construction. By the end of two years, the rutting in the wheel paths was about 12 to 19 millimeters (1/2 to 3/4 inches) deep. District personnel attribute the rutting to inadequate density achieved in the compacted mixture; however, some signs of flushing indicate there may have been excessive binder in the mix. See Figure 26.

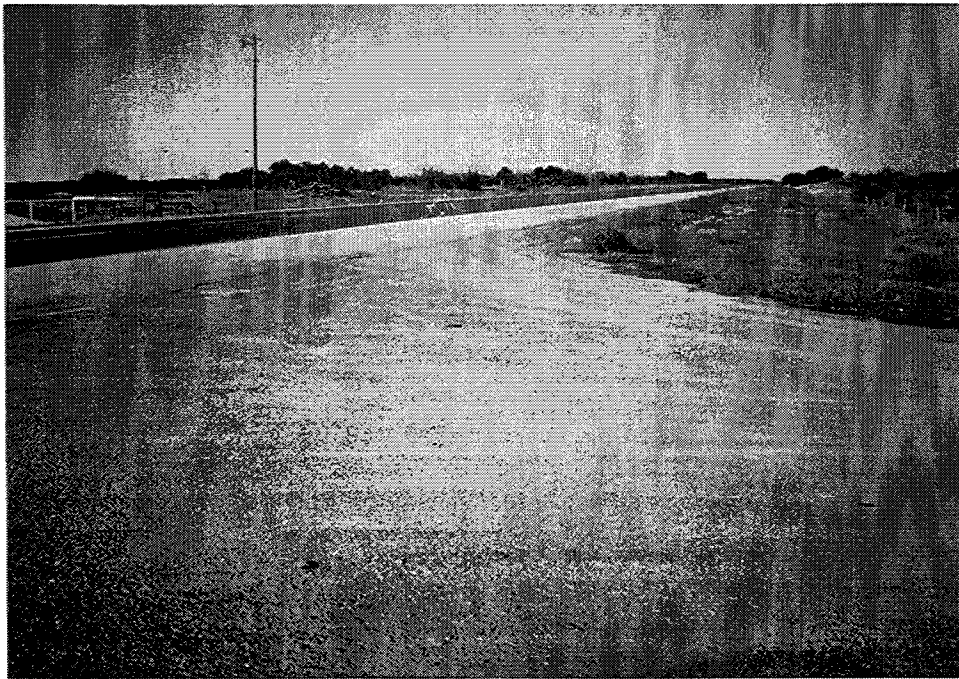
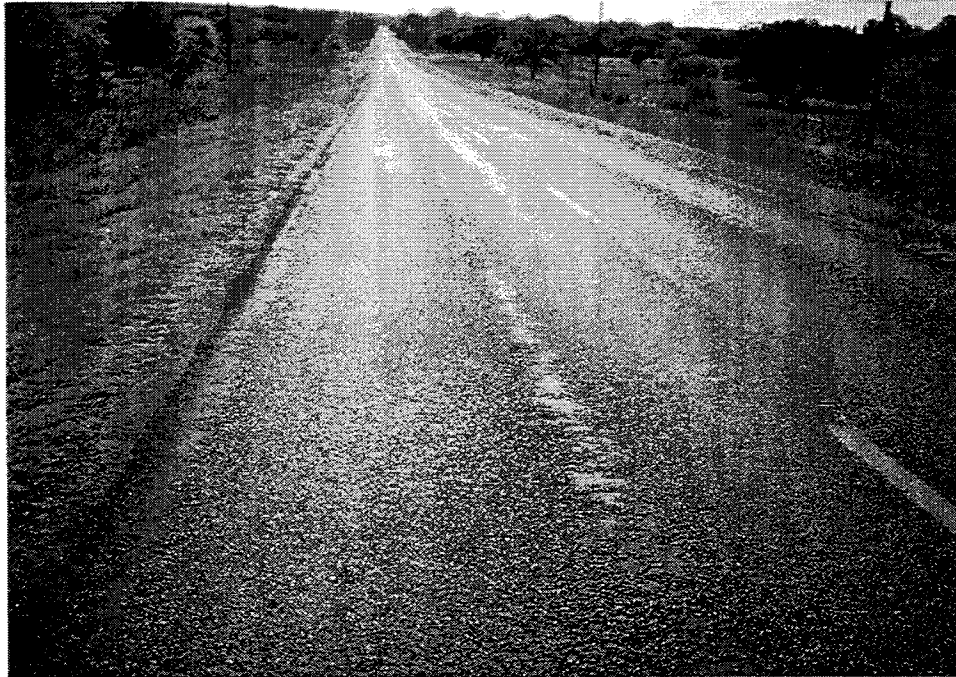
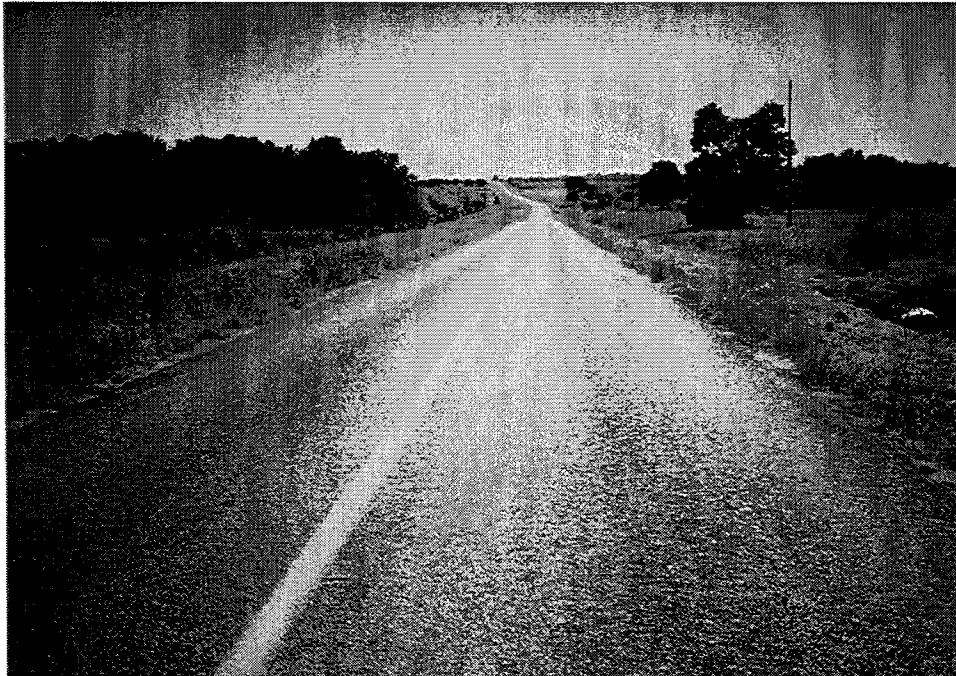
The performance of these test sections was observed for a period of three years. The county road intersection performed well with only some slight ravelling. The level up and base repair were surfaced with a chip seal within the first year of the monitoring study; however, they both performed well with no signs of distress. See Figures 27 through 29 below for a recent view of their performance.

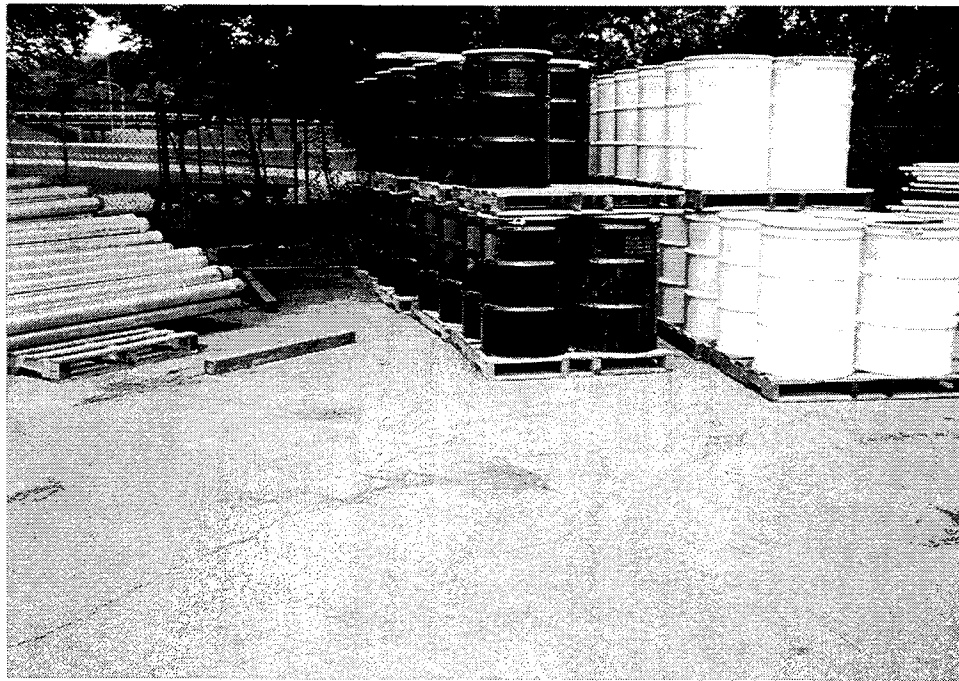
Figure 30. Houston District - Base Construction.

A large part of this parking lot around the perimeter appears to be used for storage of materials such as pipes, drums of paint, and 5-gallon cans of patching material. In these areas, particularly under the stored materials, some minor cracks have developed as shown below in Figure 30. Overall, however, the parking lot is performing very well.
