IMPROVED END TREATMENT
FOR METAL BEAM GUARDRAIL

Research Report 189-1(Final)

Research Study No. 2-10-76-189
Development of Effective Highway Safety Appurtenances

Texas Transportation Institute
Texas A&M University
College Station, Texas

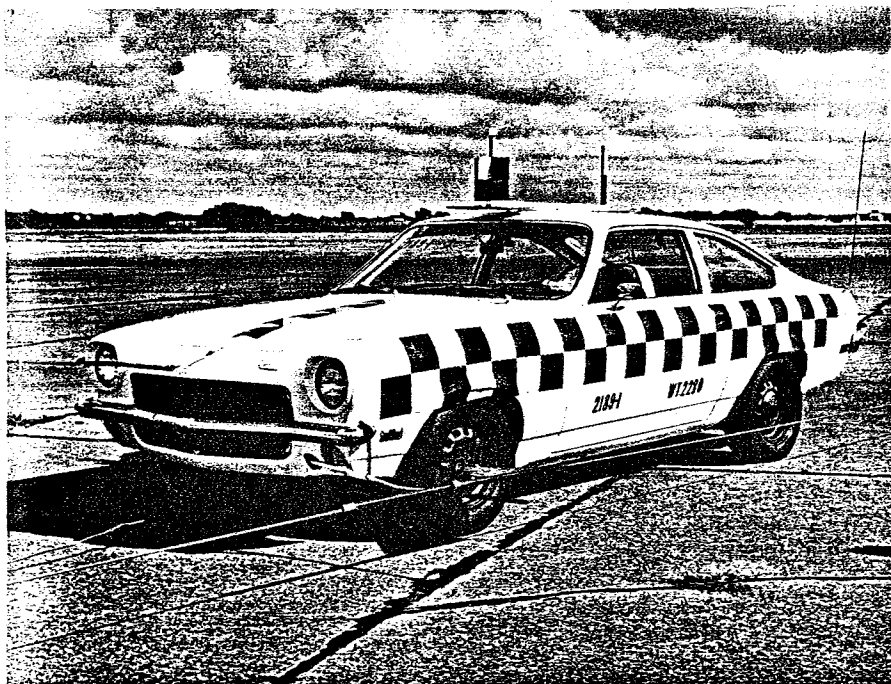
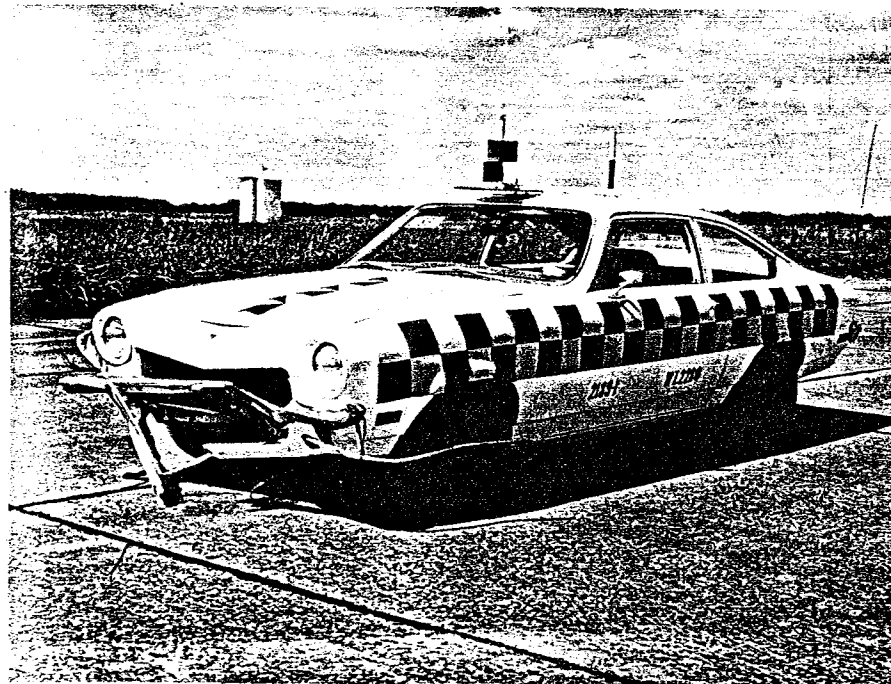
FIGURE 6. TEST VEHICLE BEFORE AND AFTER TEST 1.

After crossing the rail, the vehicle was airborne for a short distance then exhibited oscillatory roll displacement (see Appendix A). The maximum roll displacement was about 29 degrees. The vehicle did not roll over, and performance of the terminal and vehicle were considered good. The critical roll angle of such a Vega is about 53.4 degrees before rollover is possible. Results of this test are summarized in Table 1. Accelerometer traces obtained from vehicle mounted accelerometers and sequential photographs are presented in the Appendices. The TAD (1) vehicle damage classification was FC-2 (Figure 6). Photographs of the rail after the test are shown in Figures 7 and 8. One post and two 25 ft. pieces of W-section had to be replaced to repair the guardrail.

Bumper damage by impact with first post which broke away.

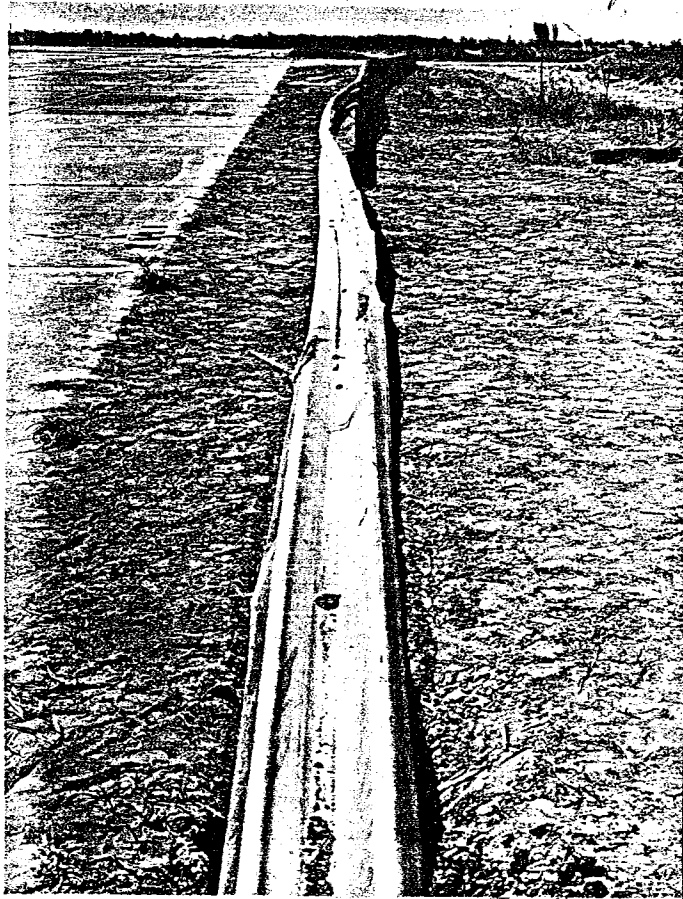
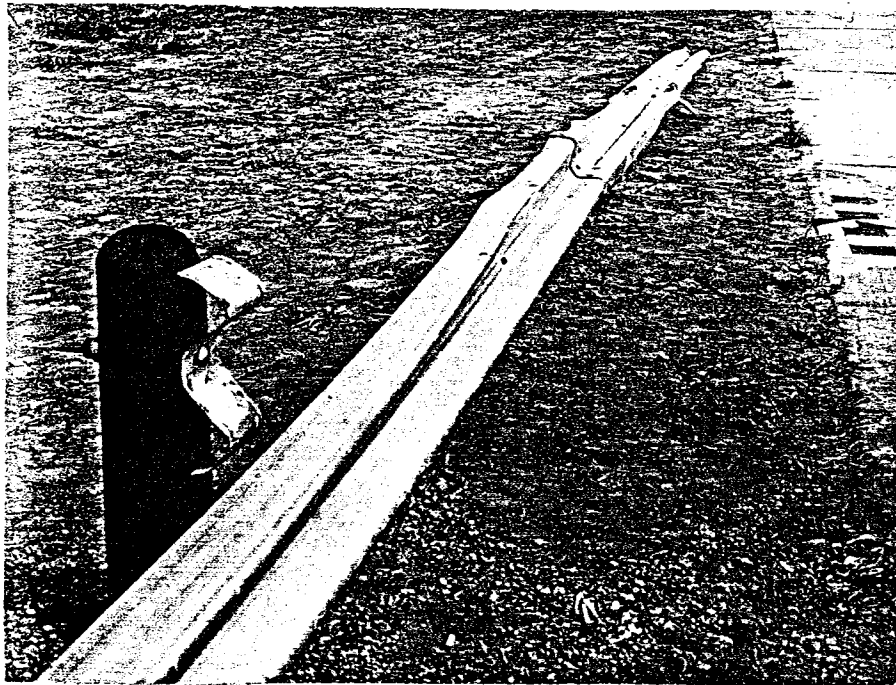
FIGURE 7. GUARDRAIL'S TURNED DOWN END AFTER TEST 1.

These slight modifications would have no influence on the results of Test 1 since when the vehicle engaged the terminal and pushed it down, the rail rotated away from the posts and backup plates (see Figures 7 and 8).

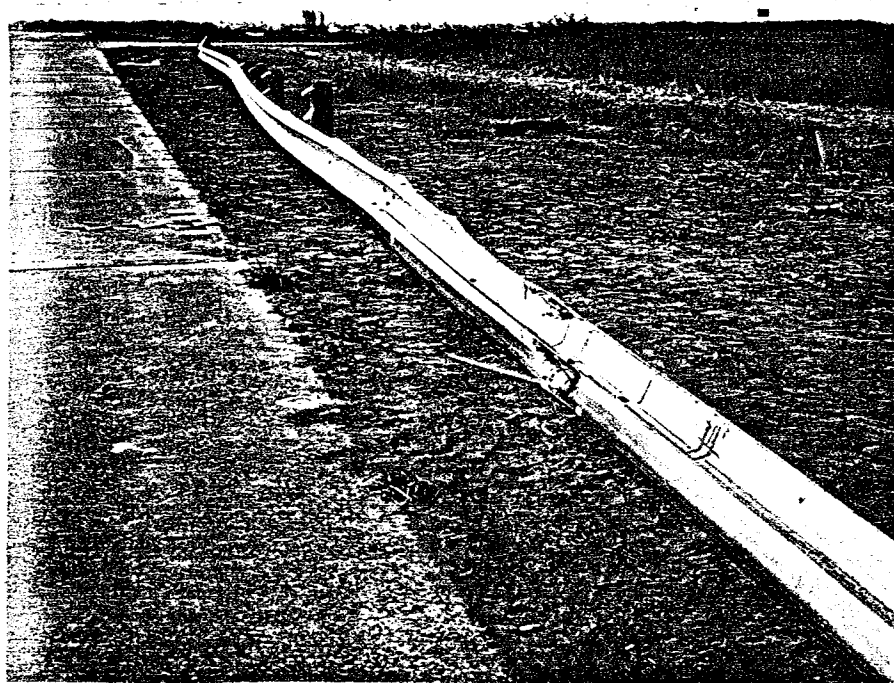
FIGURE 8. GUARDRAIL TEST SITE AFTER TEST 1.

Posts shown are numbers 3, 5, 6, and 7. Post no. 1 was knocked out by vehicle.

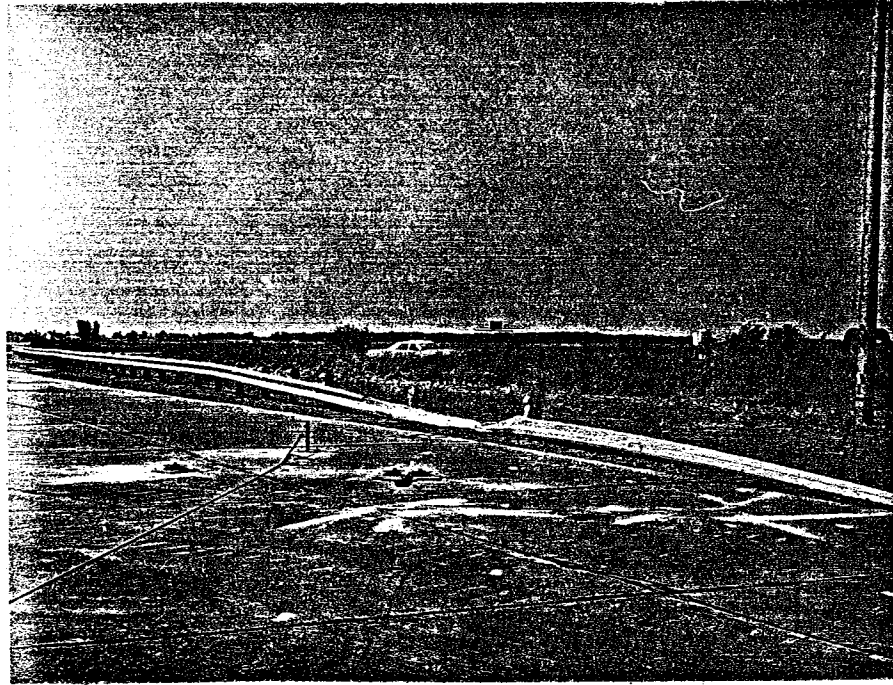
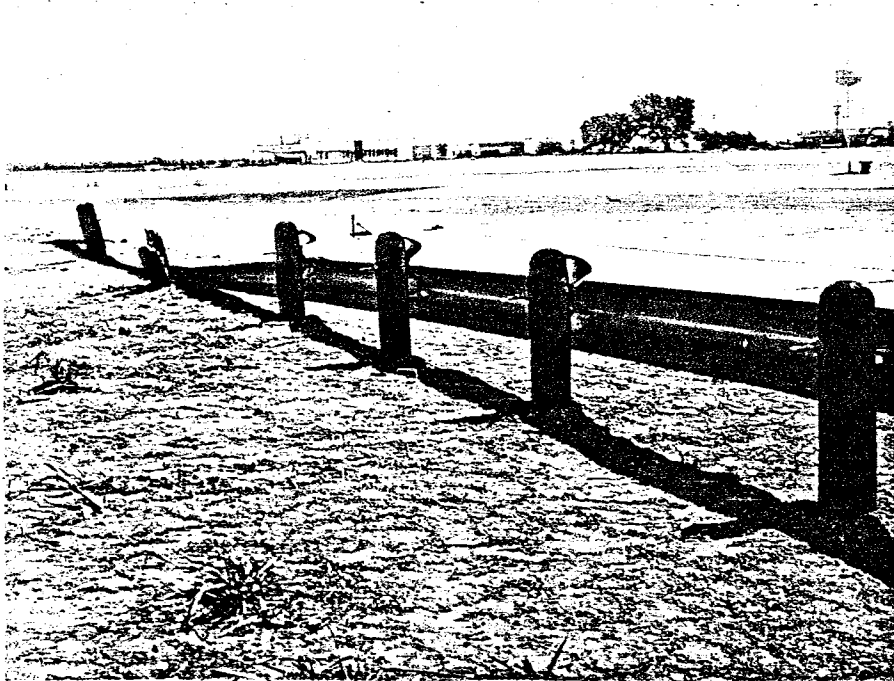
FIGURE 12. GUARDRAIL TEST SITE AFTER TEST 2A.

The original objective of Test 2A was to impact the rail along the "length-of-need" and obtain a redirection of the vehicle. The vehicle, however, pushed down the rail and rode over it without rollover. This happened for several apparent reasons: (1) the vehicle's right front bumper actually impacted the rail 1 ft. upstream of post no. 1 on the terminal and not on the "length-of-need", and (2) the rail was only 24 in. high at post no. 1 as a result of repairs after Test 1 (see Figure 10), consequently the Chrysler bumper got on top of the terminal and pushed it down. Several modifications were made in the installation and in the conduct of Test 2B to eliminate these shortcomings. Test 2A was still considered a success in that the vehicle struck the terminal, pushed it down, and rode over it without experiencing rollover.

As a result of the barrier and vehicle behavior in Test 2A several changes were made in the guardrail and test procedure.

- (1) The vehicle impact point was moved 1 ft. downstream from post no. 1 into the "length-of-need".
- (2) Care was taken in the repair of the rail and terminal to insure the rail was 27 in. high at post no. 1. During installation the terminal piece of rail was bolted to post no. 1, then pre-twisted through an angle of slightly more than 180° to achieve a 90° twist permanent set in the terminal piece. Then when the bolt was removed from post no. 1 and backup plates installed, a neater fit and closer dimensional tolerance were obtained.
- (3) The length of the backup plates was increased from 6 in. to 12 in. and posts no. 2 and 4 were added to make the guardrail post spacing a uniform 6 ft. 3 in. throughout. This was done to strengthen and stabilize the rail for vehicle redirection when impacted on the "length-of-need".

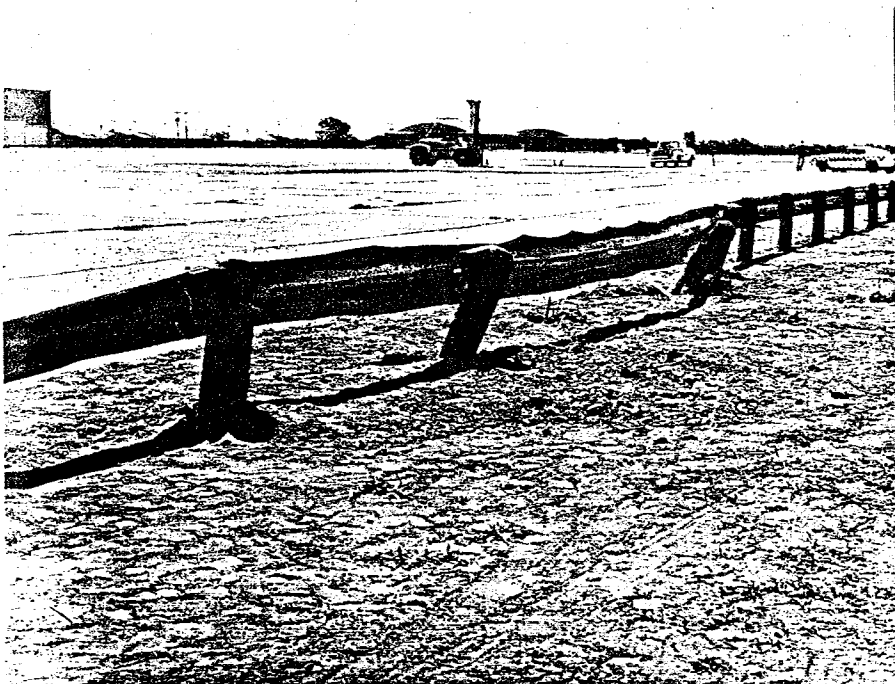
FIGURE 17. PHOTOGRAPHS OF THE GUARDRAIL AND POSTS
NEAREST THE POINT OF IMPACT AFTER TEST 2B.

guardrail with another impact approximately 200 ft. downstream. During redirection, some interaction between the vehicle front wheel and the guardrail posts did occur but no snagging effect was evident. Damage to the vehicle (TAD classification, RFQ 5) is shown in Figure 16. Photographs of the guardrail after the test are shown in Figure 17. As evidenced by this figure, the rail remained nested in the backup plates and at the intended height. Post number 3 was broken off at ground level and posts number 2 and 4 were bent back considerably.

Repairs to the rail consisted of replacing one post and one 25 ft. section of flexbeam rail. This test at the beginning of length-of-need was considered very successful.

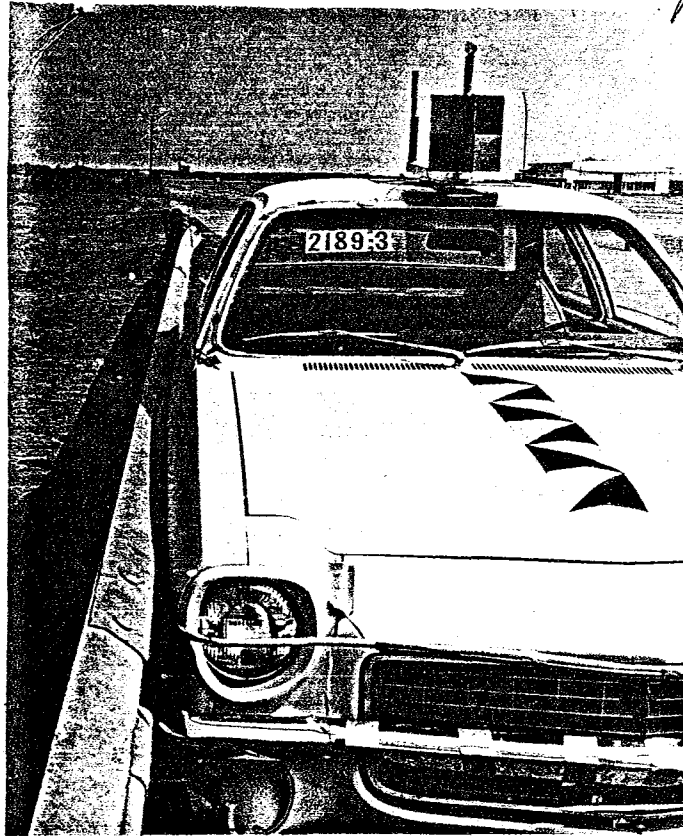
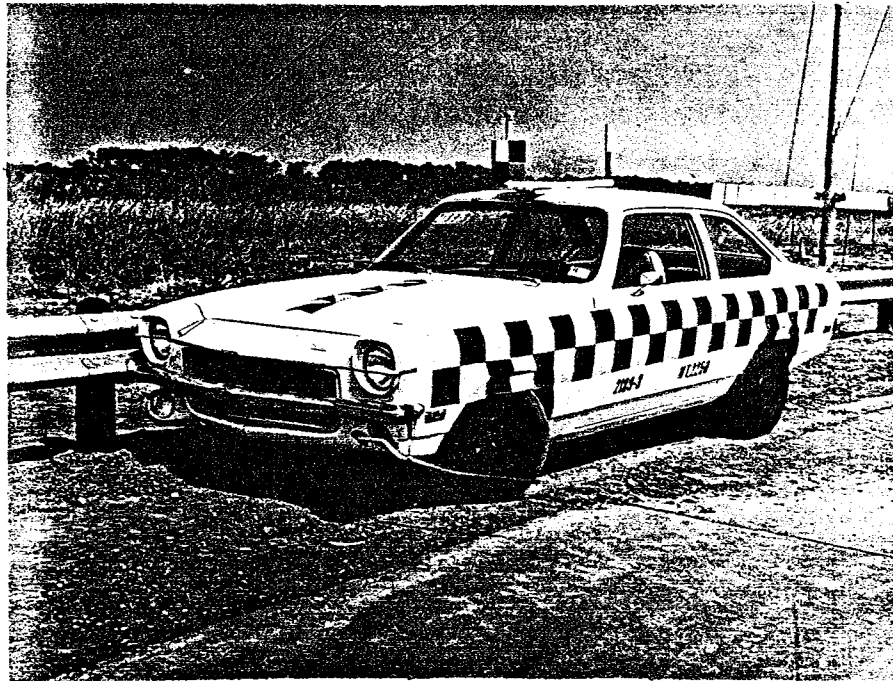
FIGURE 19. TEST VEHICLE AFTER TEST 3.

Test 3 was essentially a head-on test of the terminal with a small vehicle. The 2250 lb. Vega (1971) impacted the terminal at a negative angle of 3.5 degrees at 29.5 mph (47.5 km/hr). Upon initial contact with the turned down terminal section, the vehicle began to ride up as shown in the sequential photographs in Appendix A. The rail disengaged from the backup plates and was depressed. The right front corner of the vehicle bumper impacted the first post splitting it vertically. The vehicle continued forward, riding over the rail and returning to the roadway side of the guardrail. The vehicle finally came to rest against the rail in the position shown in Figure 19.

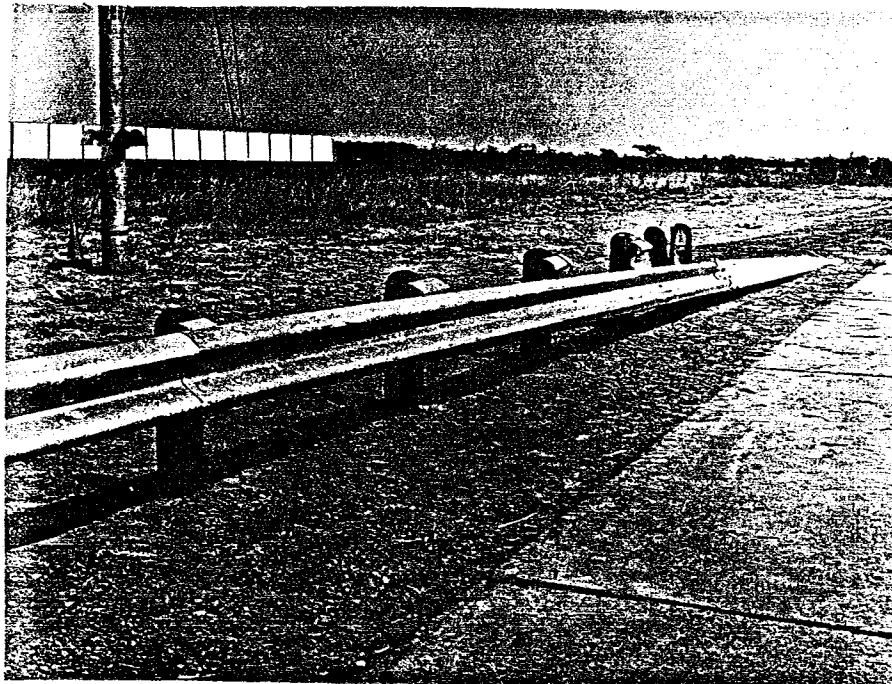
FIGURE 21. GUARDRAIL TEST SITE AFTER TEST 3.

Note that when the rail was depressed it rotated away from the posts and off the backup plates.

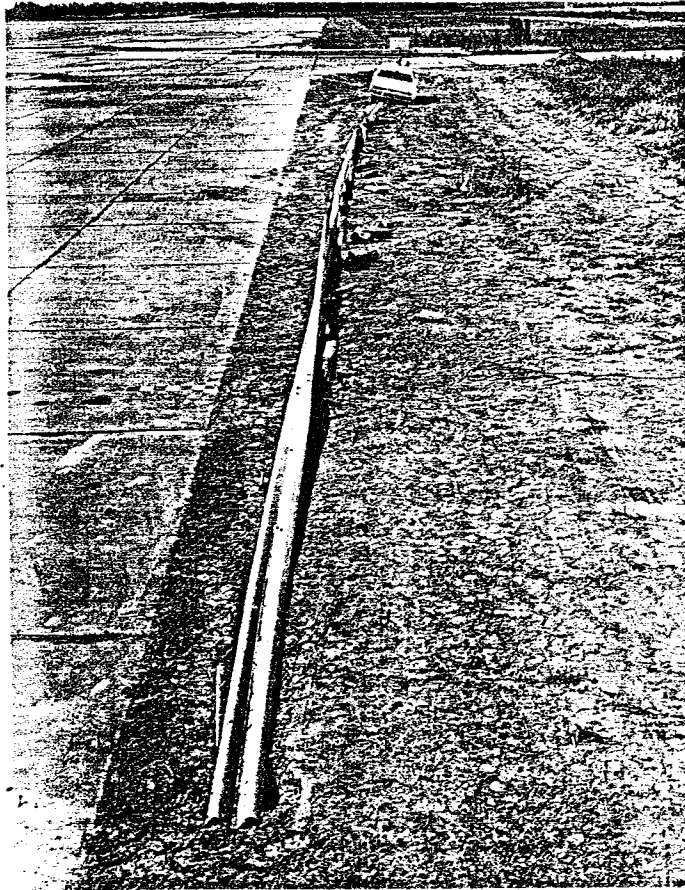
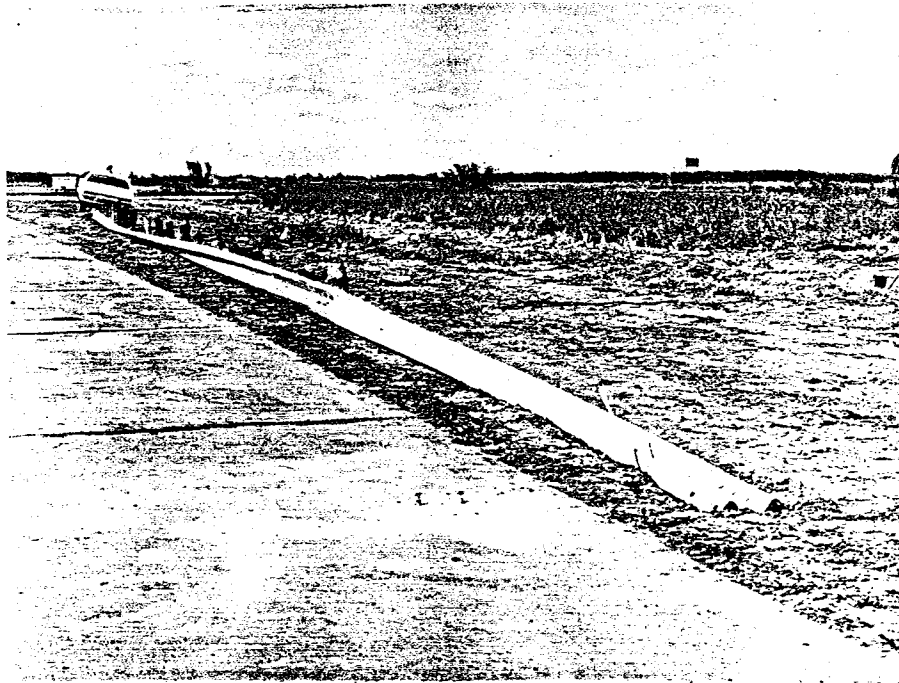
FIGURE 23. GUARDRAIL TEST SITE AFTER TEST 4.

the end anchor (Figure 23). Twenty-six posts were split, broken, or bent over by the vehicle. The average longitudinal deceleration was 0.54 g's over the stopping distance. The maximum .050 sec average longitudinal deceleration was approximately 3 g's and peak values were all below 6 g's (see Appendix B). Extensive damage to the undercarriage of the vehicle occurred (Figure 24). Repair of the guardrail required replacing twenty-six posts and eight 25 ft. sections of rail.

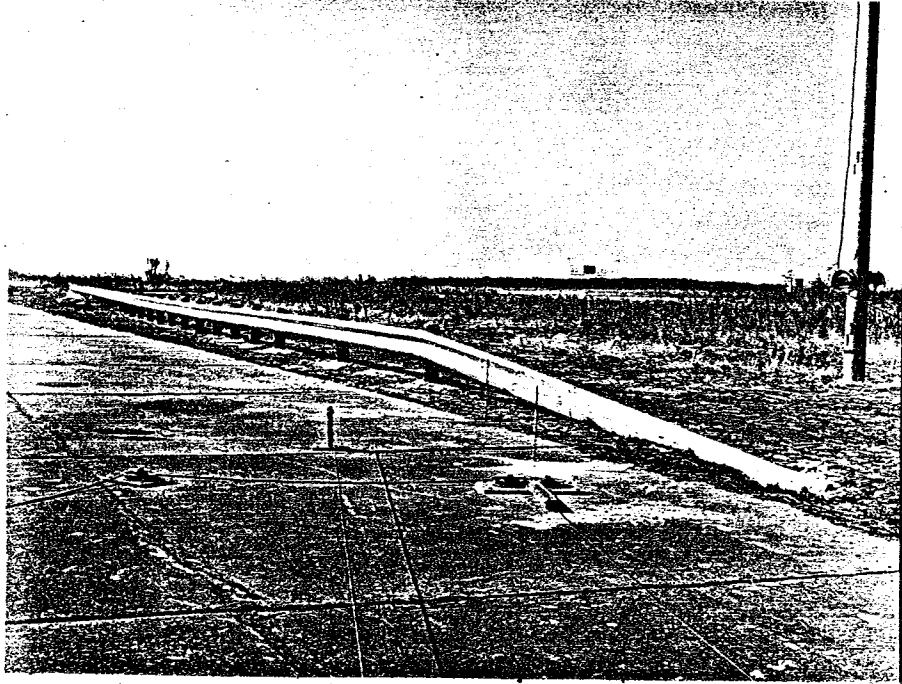
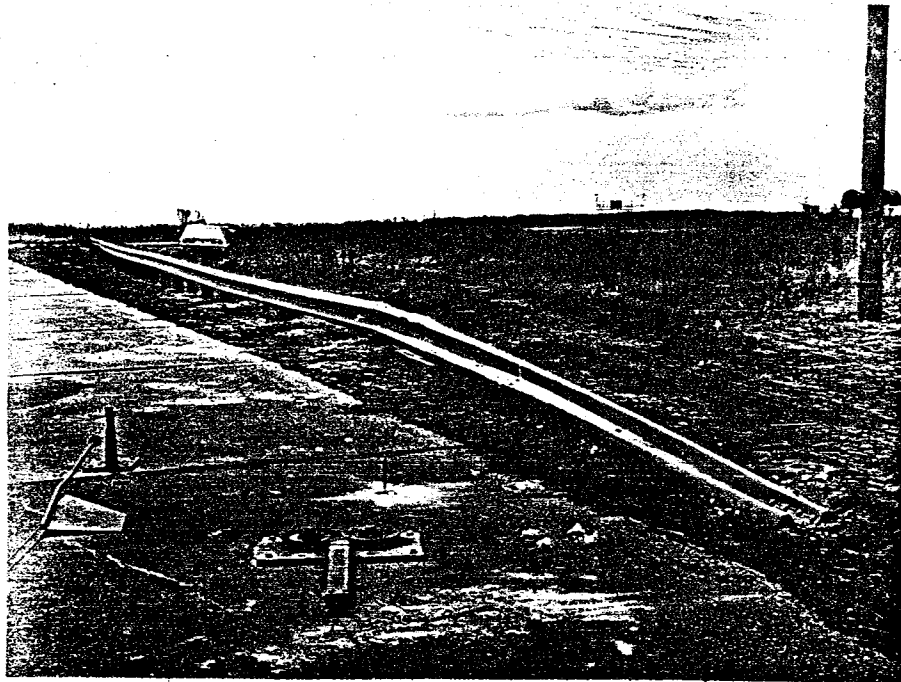
FIGURE 33. TURNED-DOWN END GUARDRAIL
BEFORE AND AFTER TEST 6.

Immediately after initial impact, the rail did not drop quickly to the ground as intended and this caused the vehicle to vault several feet into the air. While the vehicle ended up right side up, its maximum roll angle during the collision event was 76° . The critical roll angle of such a vehicle would be about 60° , however because of complex dynamic behavior, the vehicle did right itself after the 76° maximum roll angle.

Damage to the vehicle is shown by Figure 35. Damage to the guardrail and terminal is shown by Figures 33 and 34.
