**TESTING AND EVALUATION OF  
WORK ZONE TRAFFIC CONTROL DEVICES**

Research Report 1917-1F

Texas Department of Transportation

Texas Transportation Institute  
Texas A&M University System  
College Station, Texas 77843

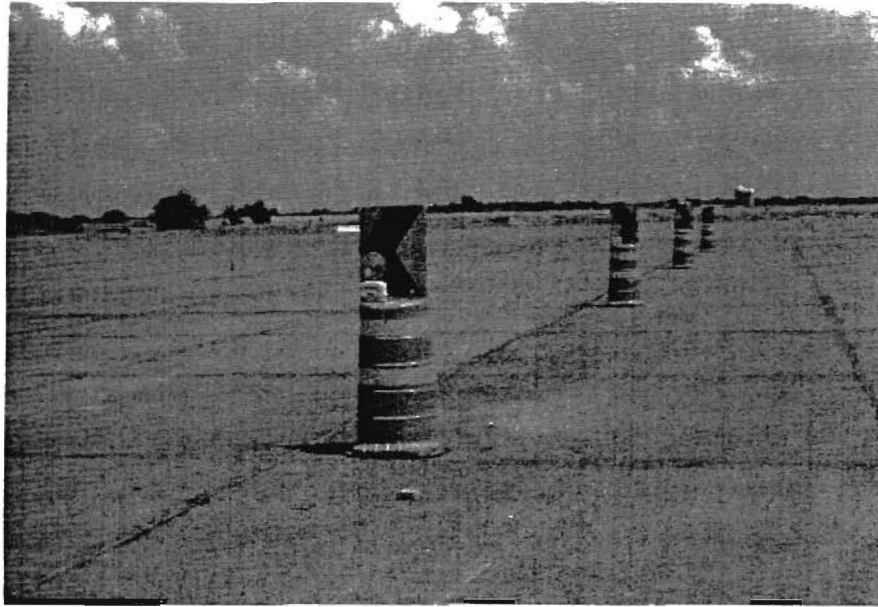
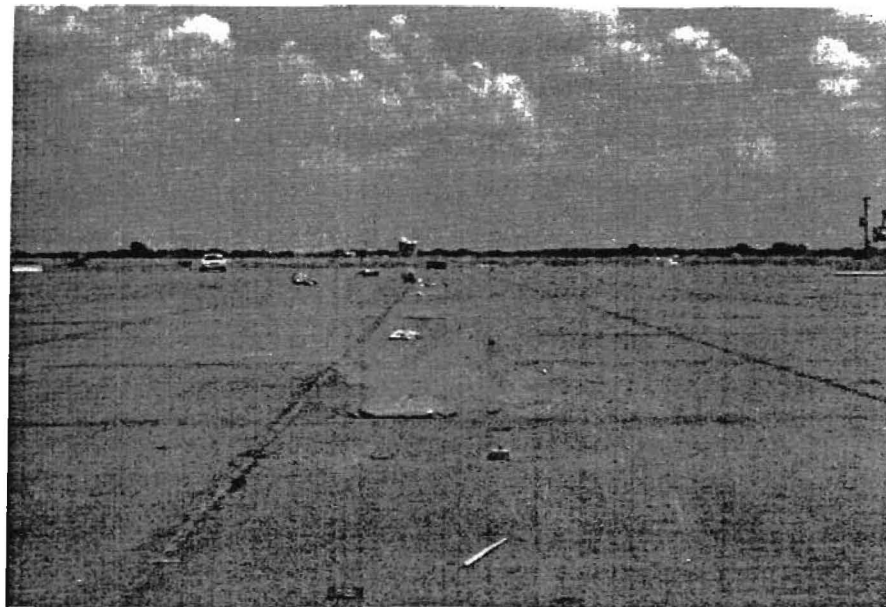
Figure 6. Test site before and after test 1917-1

The test vehicle was travelling at a speed of 44.1 mi/h as it contacted the first device. The plastic drum snapped loose from the first base and travelled with the vehicle as it contacted the second device. The chevron of the first drum slapped the hood of the vehicle as the drum snapped loose from the second base, and then both drums went up, over, and to the left of the vehicle. The drum snapped loose from the third base and travelled with the vehicle until it came to rest. The fourth drum also snapped loose from the base and travelled with the vehicle for a short distance, and then went off to the left side on the ground. The test site before and after the test is shown in Figure 6.

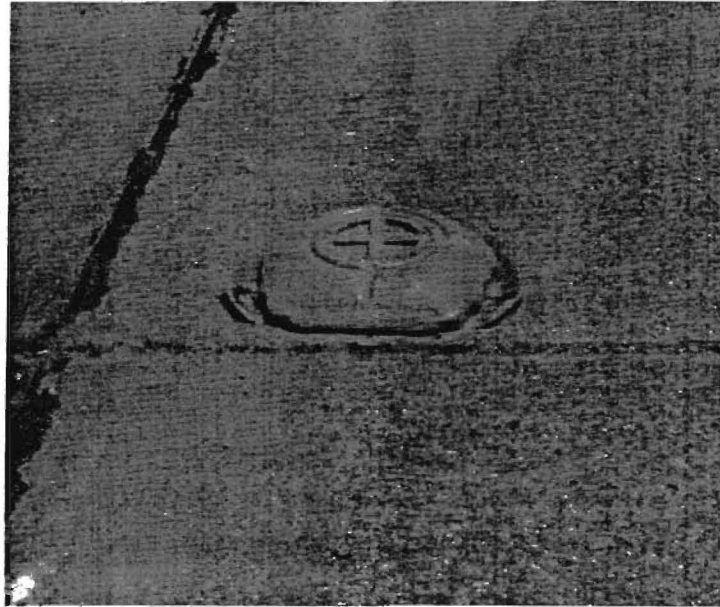
Figure 8. Damage to second device, test 1917-1

Base moved 2 in down

Drum 158 ft down, 3 ft left

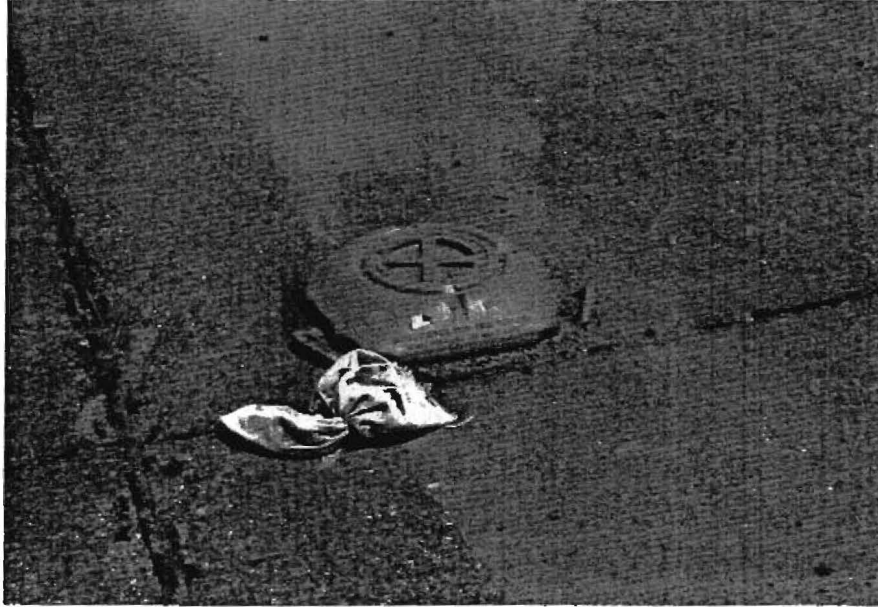
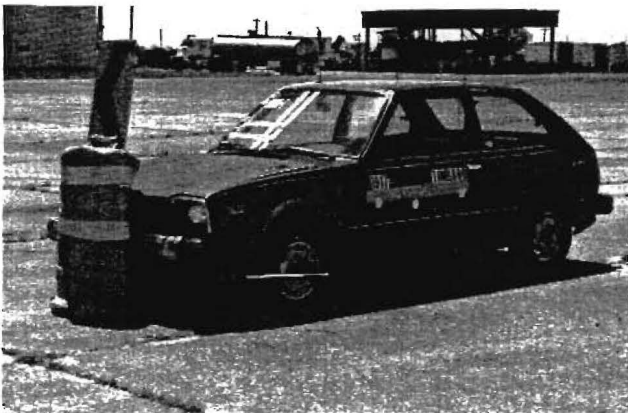
Figure 9. Damage to third device, test 1817-1

Base moved 2 in down

Drum stayed with vehicle

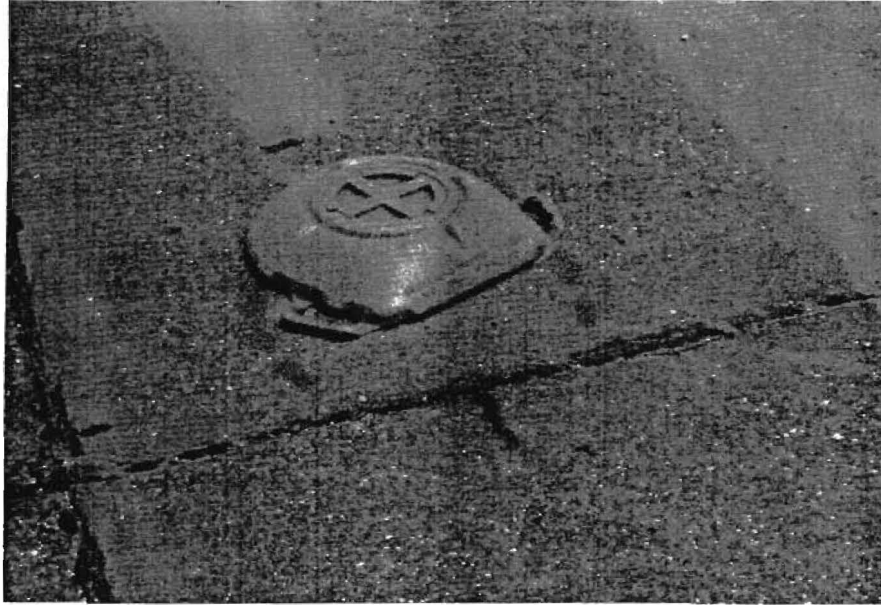
Figure 10. Damage to fourth device, test 1917-1

Base moved 10 in down, rotated slightly

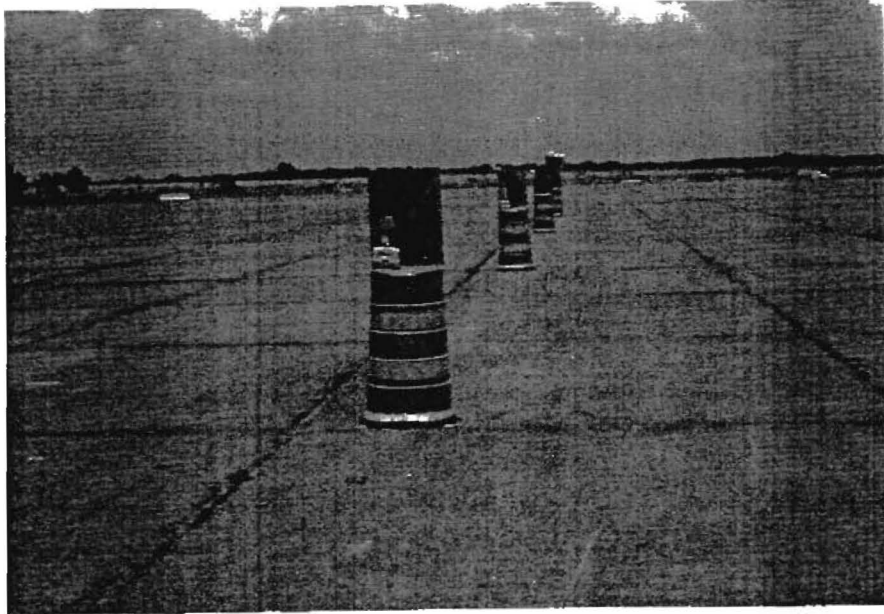
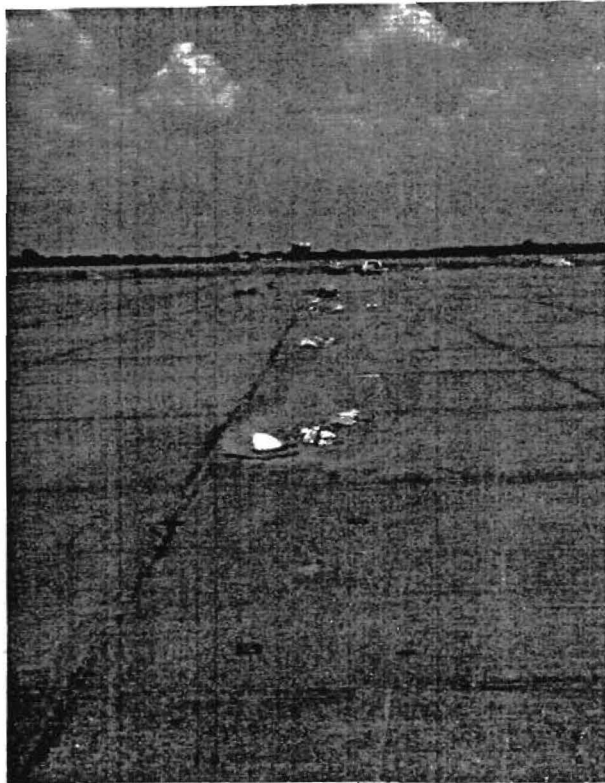
Figure 16. Test site before and after test 1917-3.

The vehicle contacted the first device at a speed of 47.6 mi/h. The drum snapped loose from the base and rode along on the front of the vehicle. As the vehicle impacted the second device, the drum snapped loose from its base and went up and over the left side of the vehicle moving the first drum up onto the hood. The first drum rode along on the windshield until the vehicle made contact with the third device when it went over the vehicle. The third drum snapped loose from its base and rode along with the vehicle until it came to a complete stop. When the vehicle contacted the fourth device, the drum snapped loose from the base and went off to the left side of the vehicle. The test site before and after the test is shown in Figure 16.

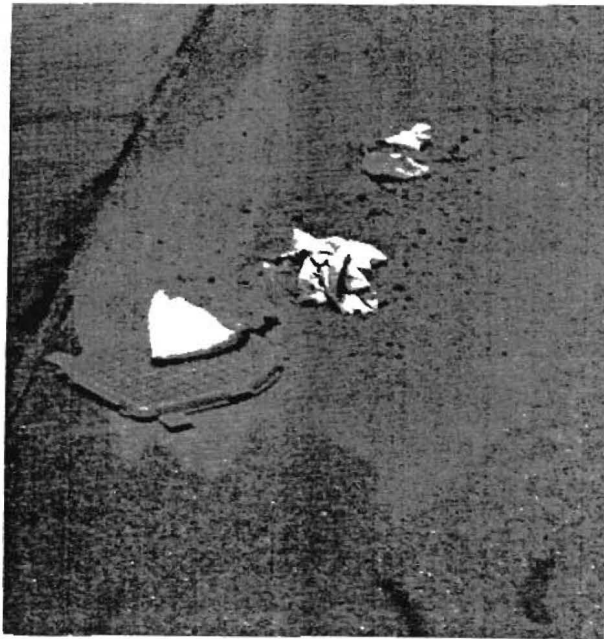
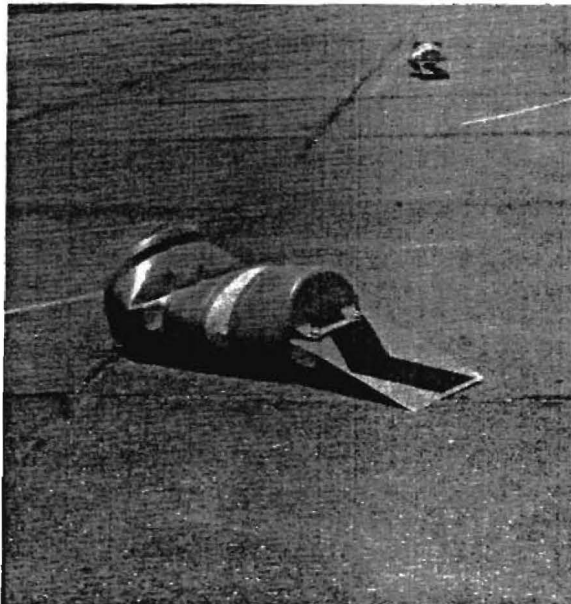
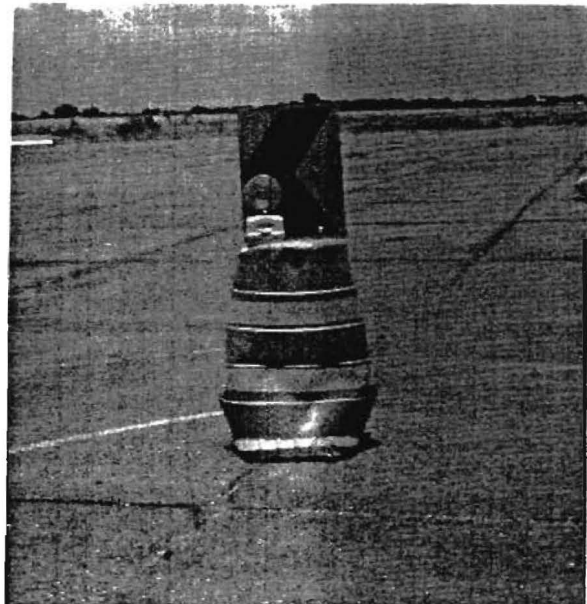
Figure 17. Damage to first device, test 1917-3

The first base moved back 4 feet and 12 inches to the left. One sandbag was found split open on the edge of the base 5 feet down and 12 inches to the left, another was bursted 7 feet down and 4 inches to the right, and the third was also bursted 12 feet down and 18 inches to the right. The drum was 180 feet down and 16 feet to the left of its original location. The positions of the base, sandbags, and drum is shown in Figure 17.

Base moved 4 ft down, 12 in left

Drum 180 ft down, 16 ft left

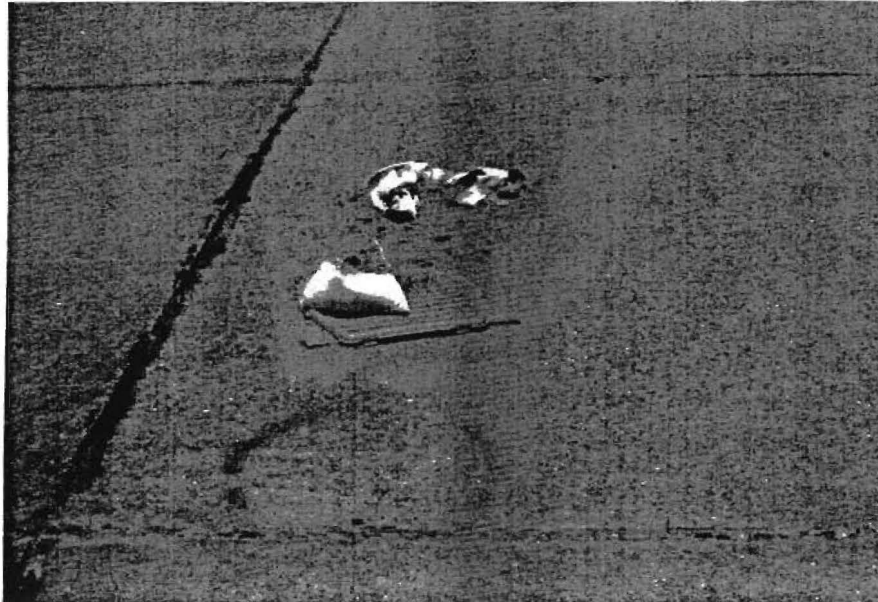
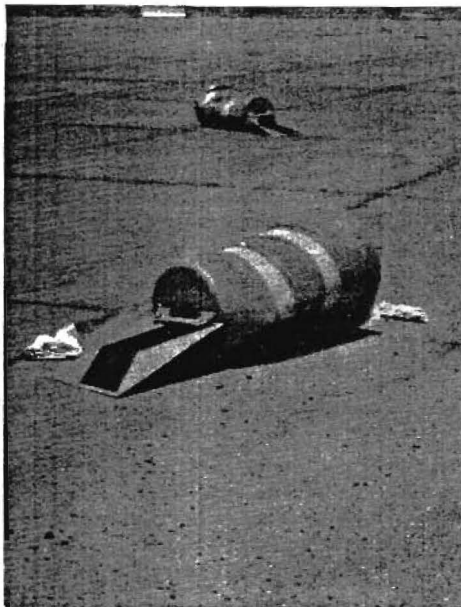
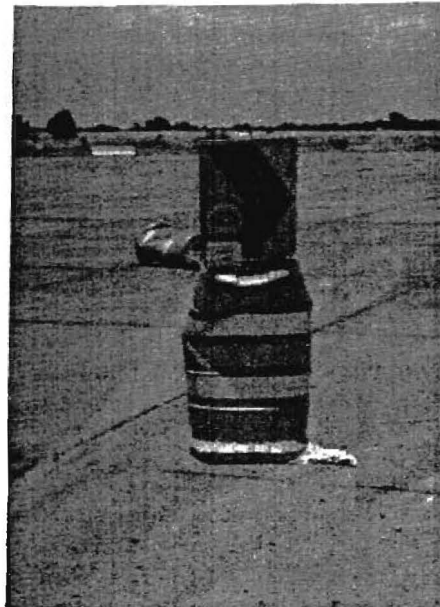
Figure 18. Damage to second device, test 1917-3

Base moved 3 ft down

Drum 120 ft down, 4 ft right

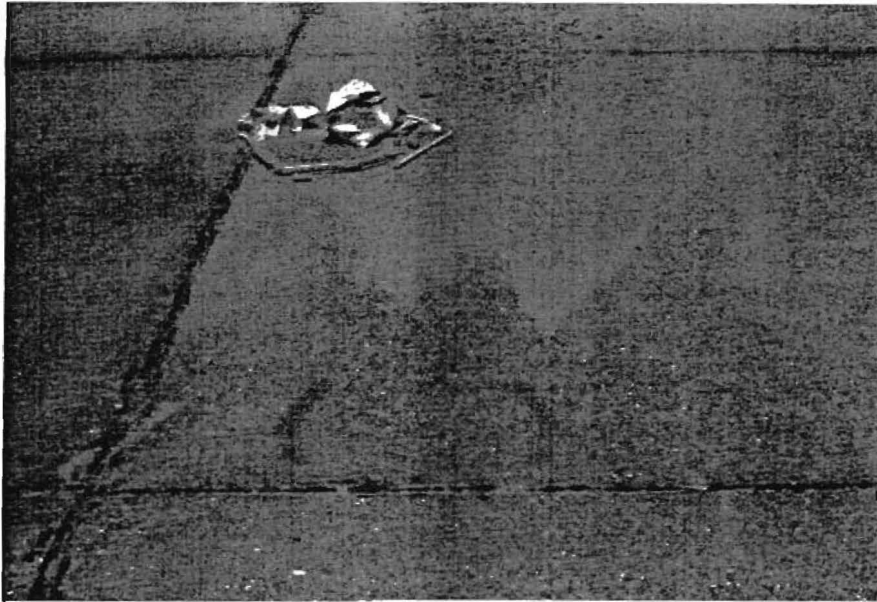
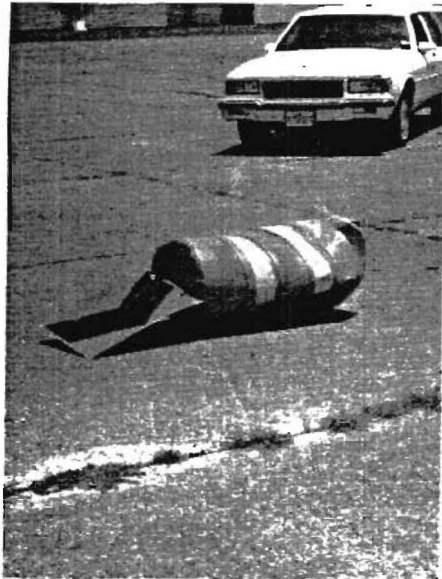
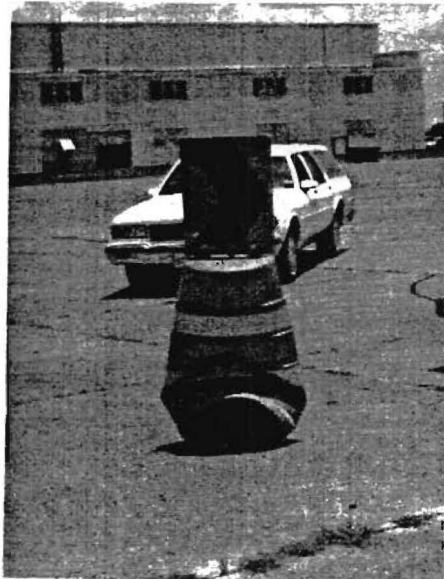
Figure 19. Damage to third device, test 1917-3

The third base, shown in Figure 19, was found 9 feet back and 18 inches to the left of its initial position. All three sandbags bursted; one was found 10 feet down and 12 inches to the left, the second 11 feet down and 12 inches to the left while the third was 24 feet down and 2 feet to the right. The drum stayed with the vehicle.

Base moved 9 ft down, 18 in left

Drum stayed with vehicle

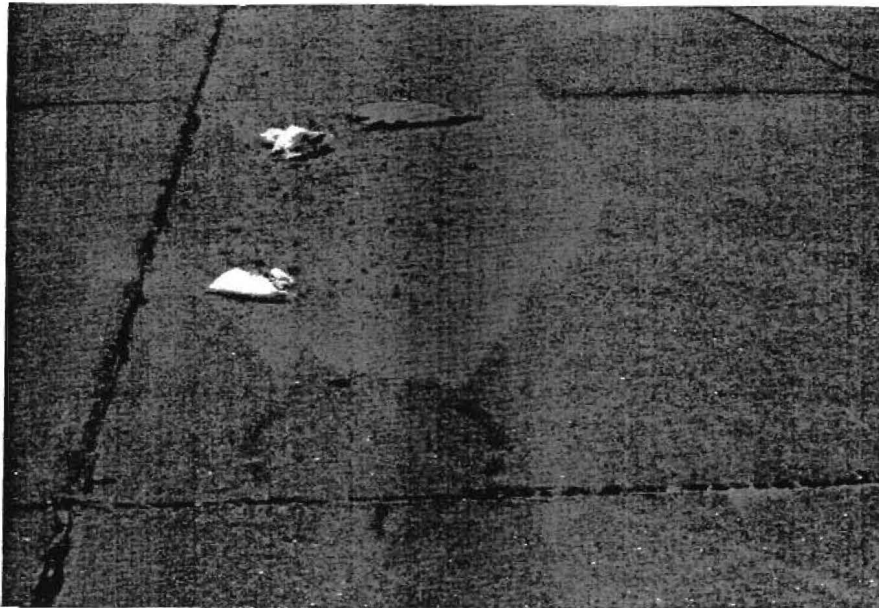
Figure 20. Damage to fourth device. test 1917-3

The fourth base was 11 feet down and 12 inches to the right and all three sandbags were bursted. One sandbag was lying 3 inches down and 12 inches to the left, another was 9 feet down and 12 inches to the left, and the last was 85 feet down and 2 feet to the right. The drum (shown in Figure 20) was found 120 feet down and 12 feet to the left of its original position.

Base moved 11 ft down, 1 ft right

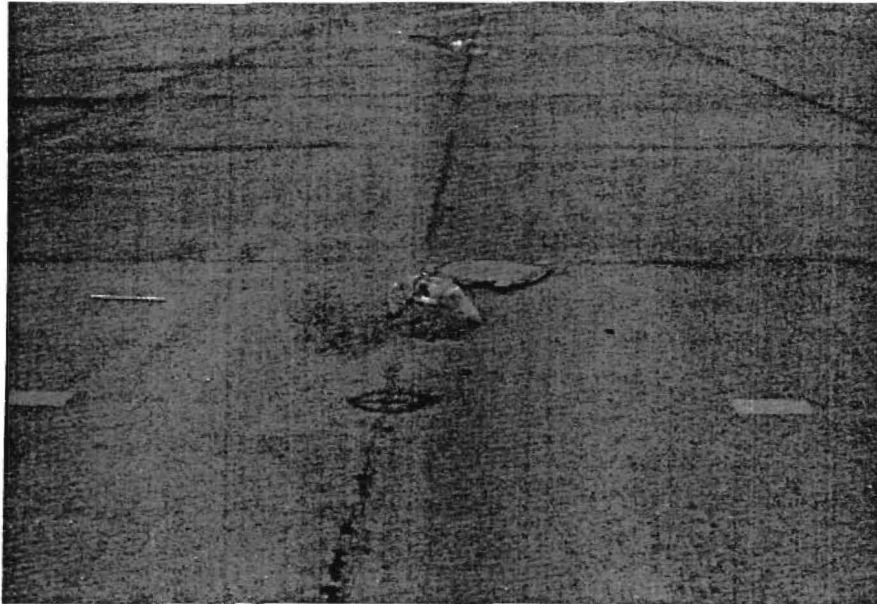
The base of the first device was 6 feet back and 12 inches to the right. All three sandbags had bursted and one was found 4 feet down and 4 inches to the right, another was 5 feet down and 4 inches to the right, and the third was 60 feet down and 18 inches to the right. The drum travelled along the front of the vehicle. The base and drum are shown in Figures 21 and 22.

Base moved 6 ft down, 1 ft right

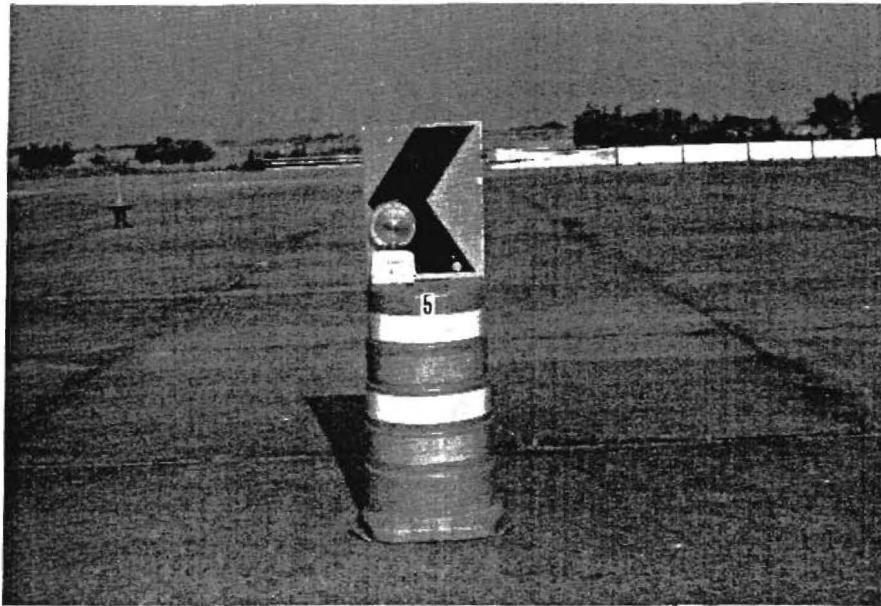
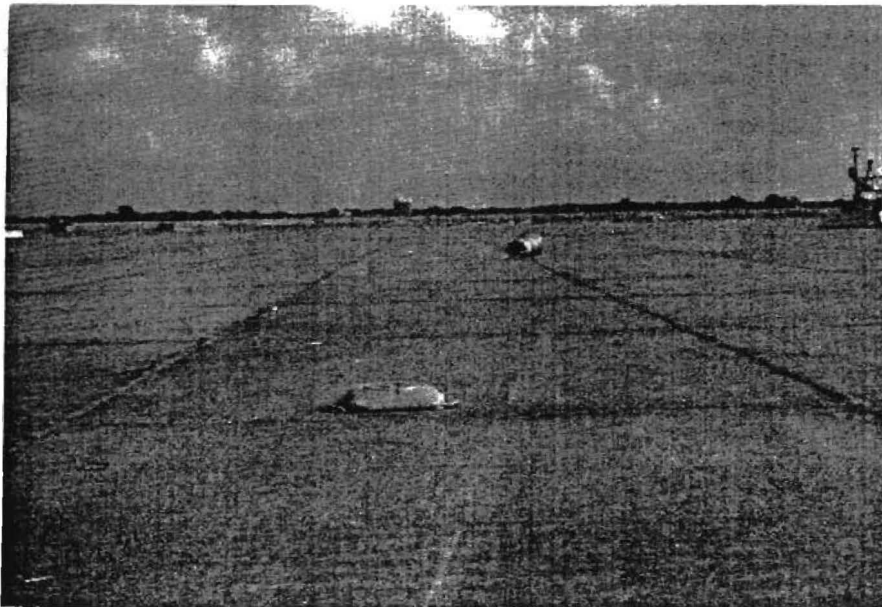
Figure 24. Test site before and after test 1917-5

The vehicle contacted the device while travelling at a speed of 42.3 mi/h. The drum snapped loose from the base and flipped over to the right side of the vehicle but did not touch the vehicle. The San-fill base was not damaged and was moved back 4 inches and 2 inches to the left of its initial position. The drum landed 75 feet down and 8 feet to the right and was only dented and scraped slightly. The test site and damage to the device are shown in Figures 24 and 25. The vehicle was not damaged at all.

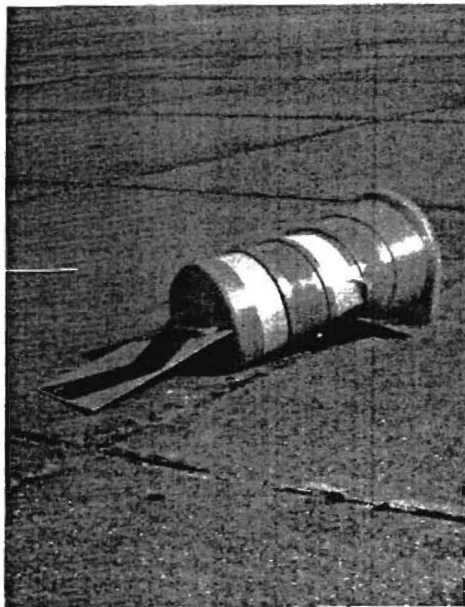
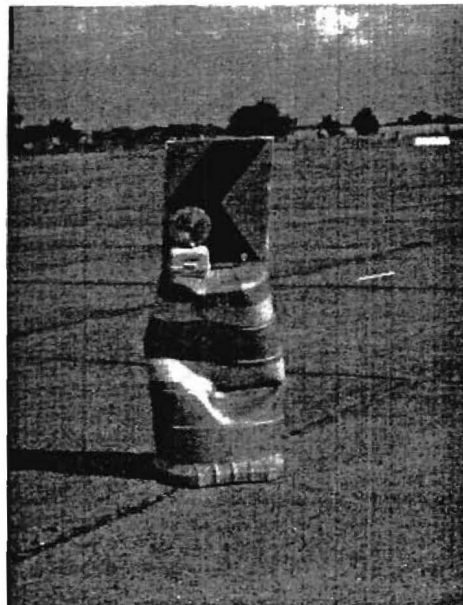
Figure 25. Damage to device, test 1917-5

Base moved 4 in down, 2 in right

Drum moved 75 ft down, 8 ft right

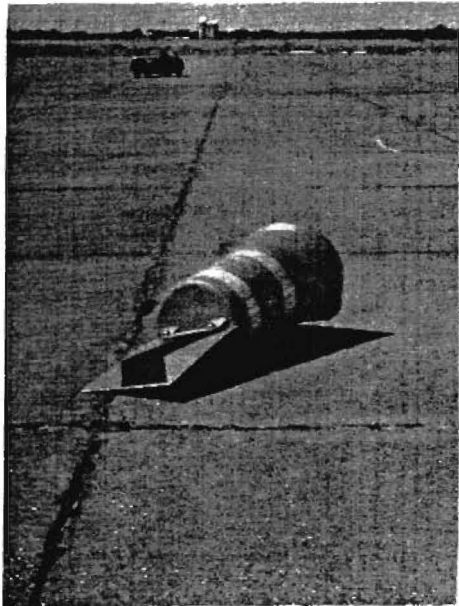
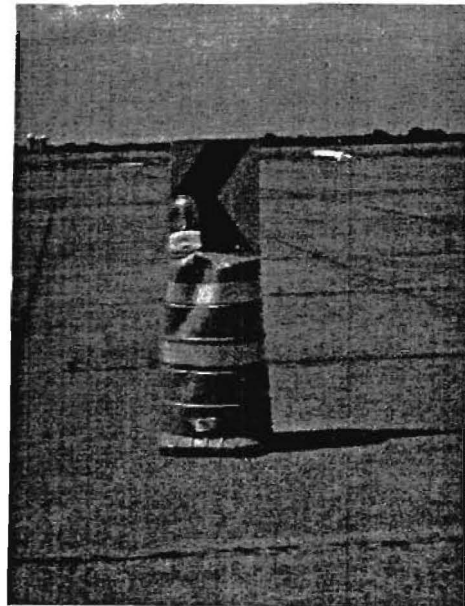
Figure 28. Damage to device, test 1917-6

Base moved 18 in down, 6 in right

Drum 75 ft down, 14 ft right

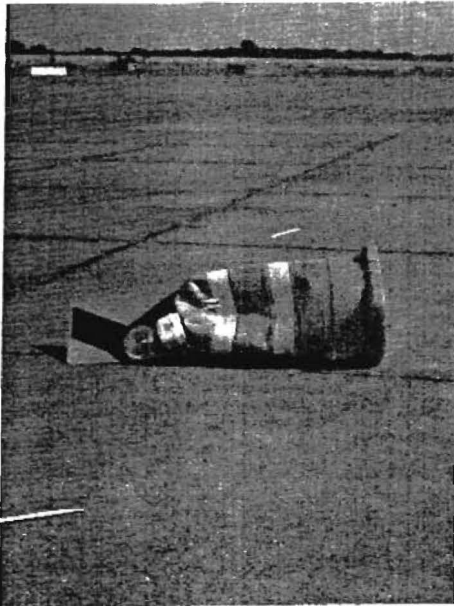
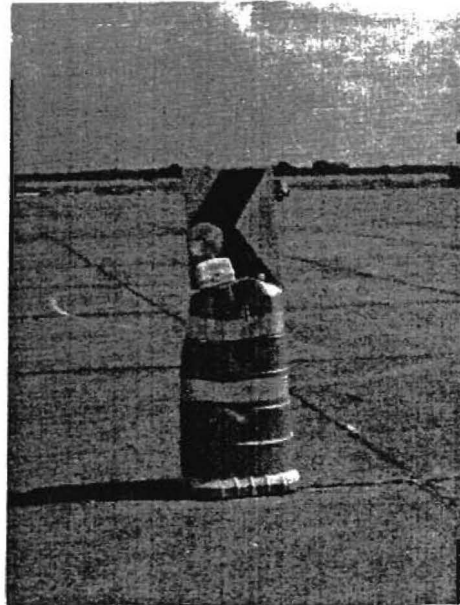
Figure 30. Damage to device, test 1917-7

other was 8 feet down. The drum was dented and scraped and was found 90 feet down and 3 feet to the right of its original position. The test site and device are shown in Figures 29 and 30. The chevron was slightly torn at one of the bolt connections. The vehicle was only scratched slightly on the right side.

Base moved 4 ft down, 6 in left

Drum 90 ft down, 3 ft right Chevron torn

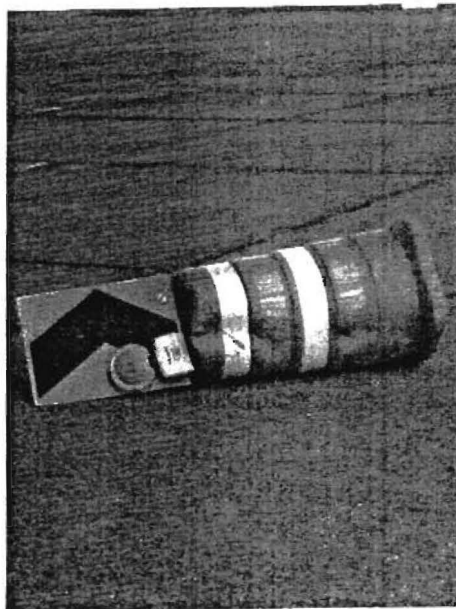
Figure 32. Damage to device, test 1917-8

Base moved 8 ft down, 6 in right

Drum 69 ft down, 15 ft right

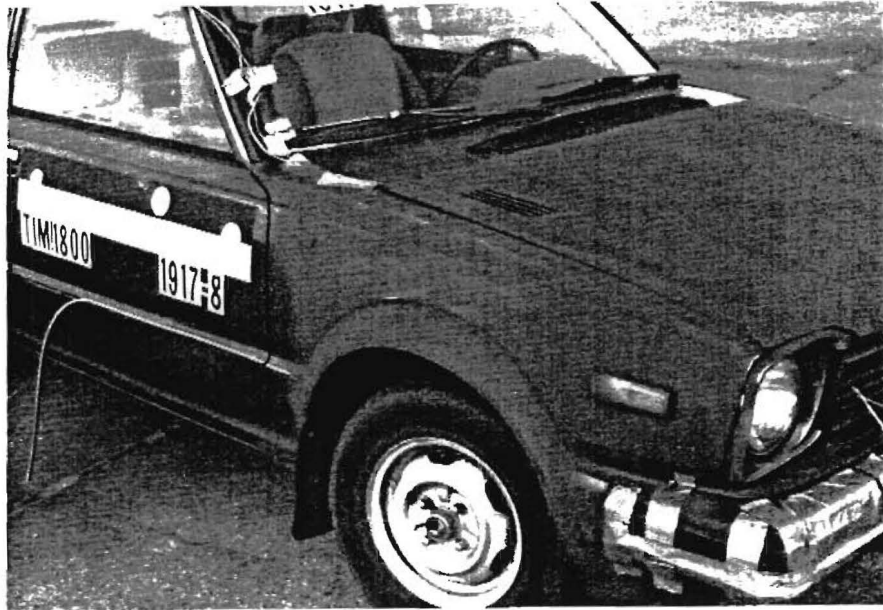
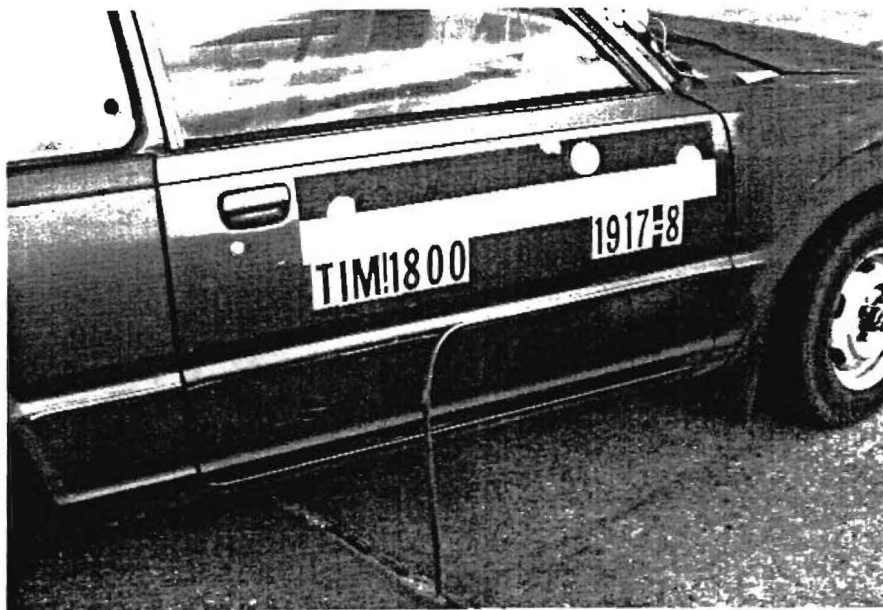
Figure 33. Damage to vehicle after test 1917-8

As the vehicle impacted the device travelling at a speed of 62.0 mi/h, the plastic drum snapped free of the base. The drum flipped hard to the right side of the vehicle, making contact with the right front quarter panel and the right door. The flat base was not damaged and was moved 8 feet back and 6 inches to the right. The first sandbag was not damaged and was found 5 feet down and 3 feet to the right; however, the second sandbag was split and was lying 11 feet down and 1 foot to the right. The drum was found 69 feet down and 15 feet to the right of its initial position. The site and device after the test can be seen in Figures 31 and 32. As shown in Figure 33, the right front quarter panel and right door of the vehicle was scratched.

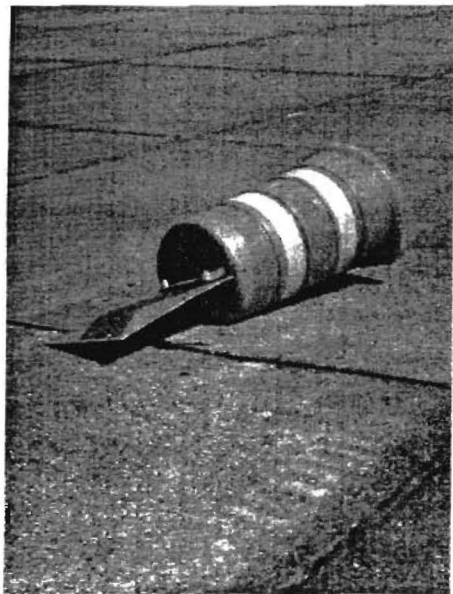
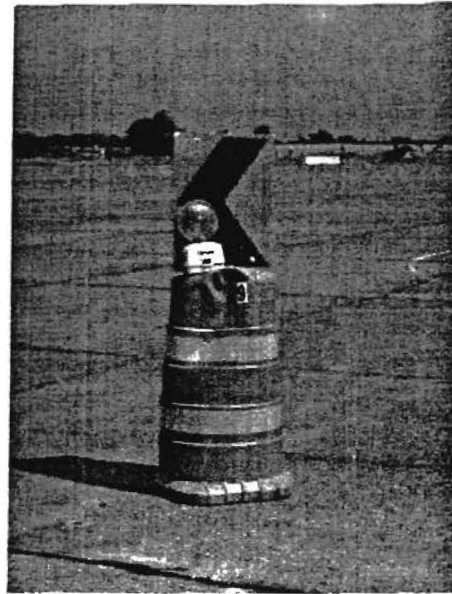
Figure 35. Damage to device, test 1917-9

Base moved 8 in down, 5 in right

Drum moved 78 ft down, 15 ft right

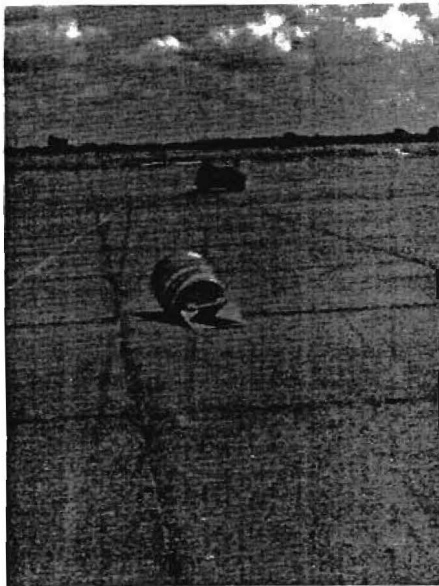
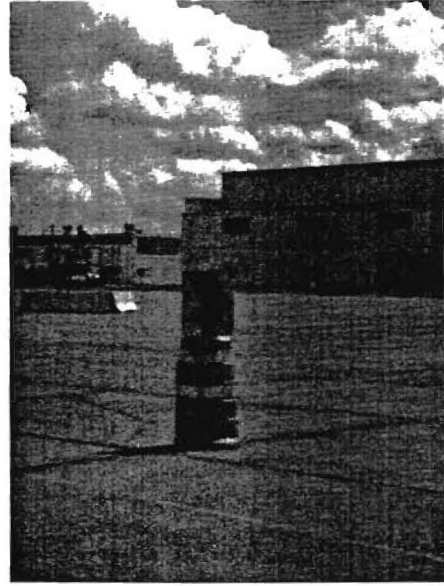
Figure 37. Damage to device, test 1917-10

of the vehicle and the top of the base was knocked off. The site and damage to the base and drum are shown in Figures 36 and 37. The base was moved back 16 feet and 3 feet to the right and the sandbag was bursted 19 feet down and 2 feet to the right. The drum was dented and scraped and came to rest 105 feet down and 12 inches to the left of its initial position. The hood of the vehicle was dented as shown in Figure 38, and the right front strut was damaged. The vehicle was not used for further tests.

Base moved 16 ft down, 3 ft right

Drum 105 ft down, 1 ft left

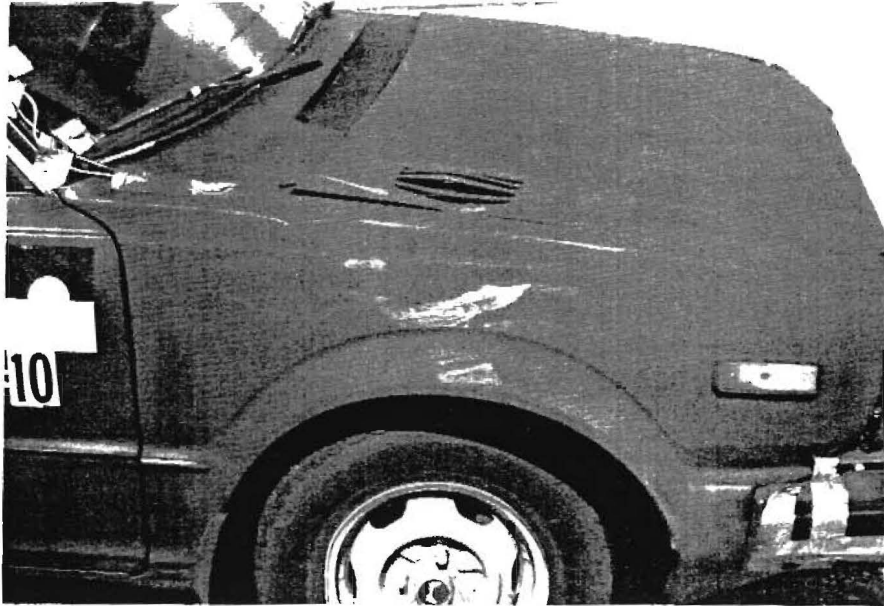
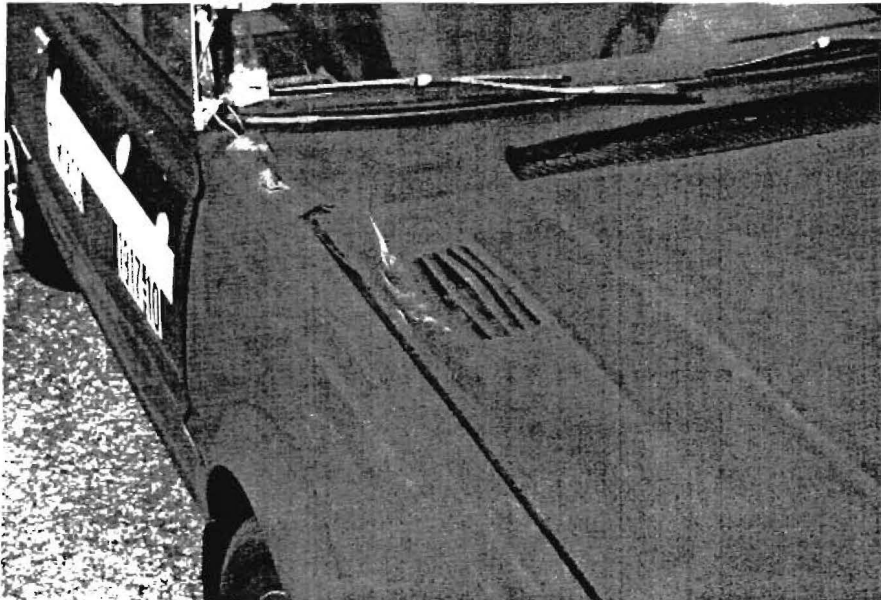
Figure 38. Damage to vehicle, test 1917-10  
(right front strut was also damaged)

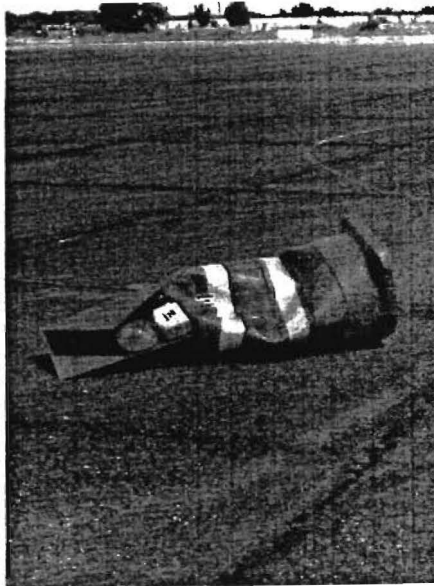
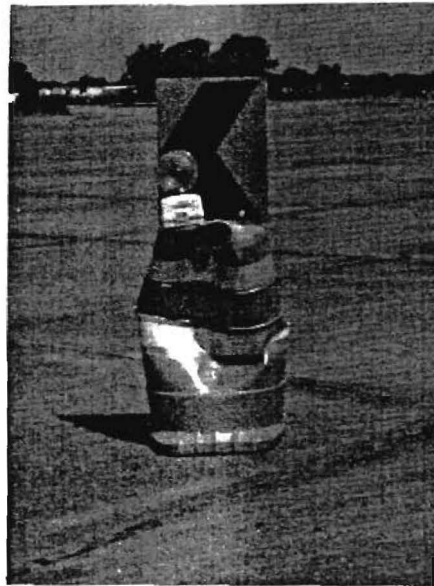
Figure 40. Damage to device, test 1917-11

Base moved 16 in down, 8 in right

Base moved 85 ft down, 16 ft right

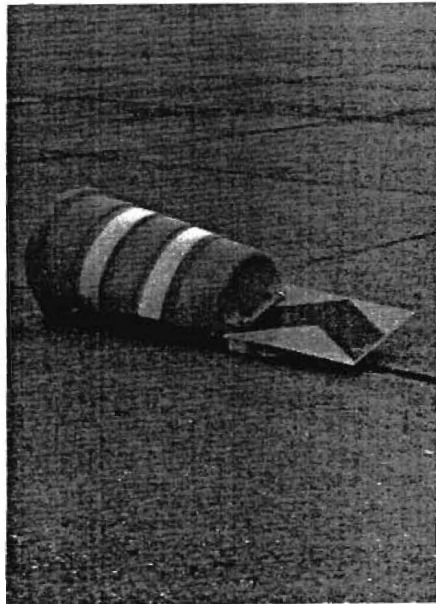
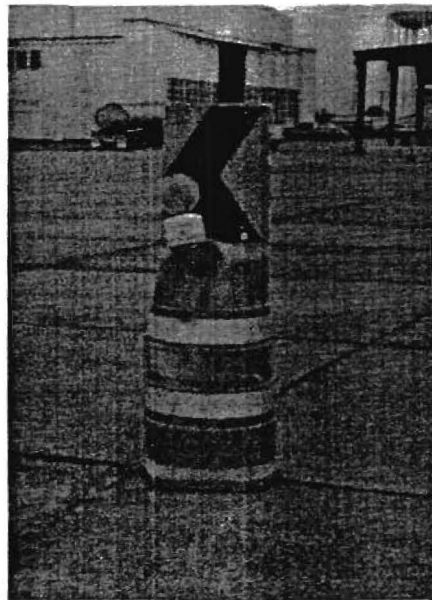
Figure 42. Damage to device after test 1917-12

Base moved 18 in down, 6 in right

Drum 57 ft down, 9 ft right

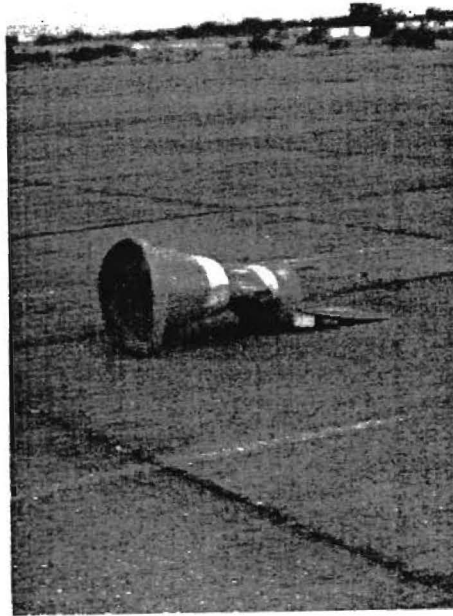
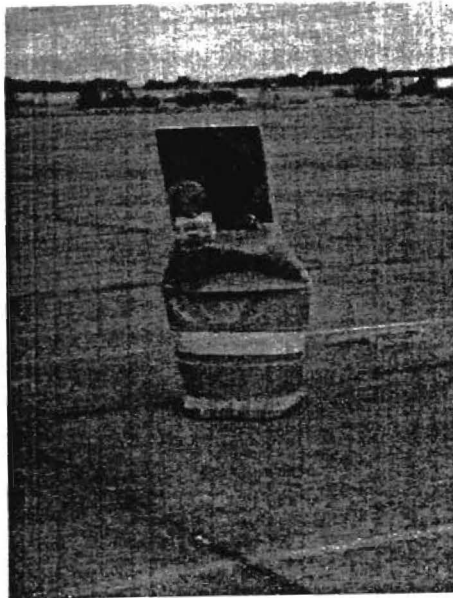
Figure 44. Damage to drum, test 1917-13

Drum 110 ft down, 10 ft right

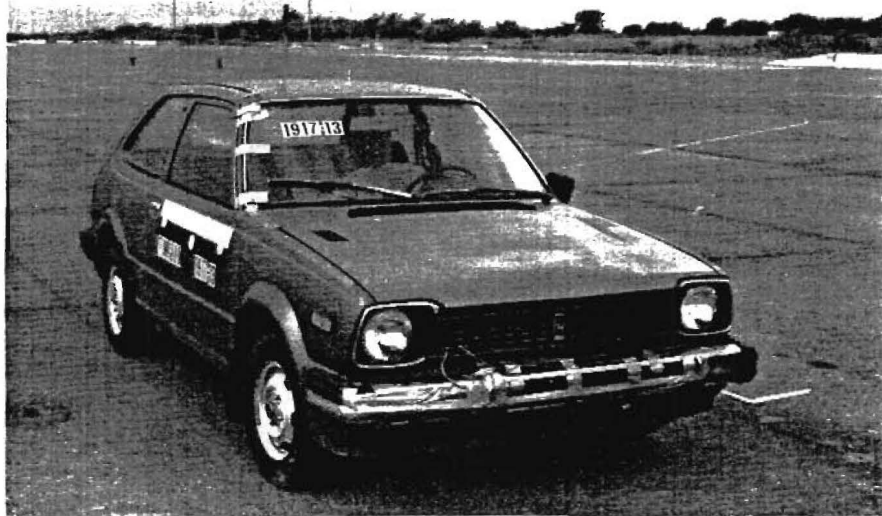
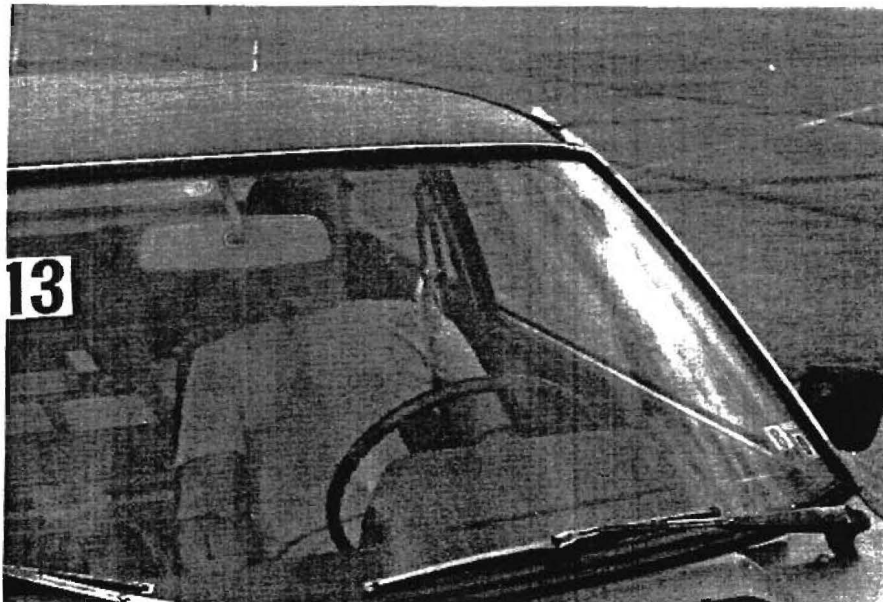
Figure 45. Vehicle after test 1917-13

Plastic film on windshield

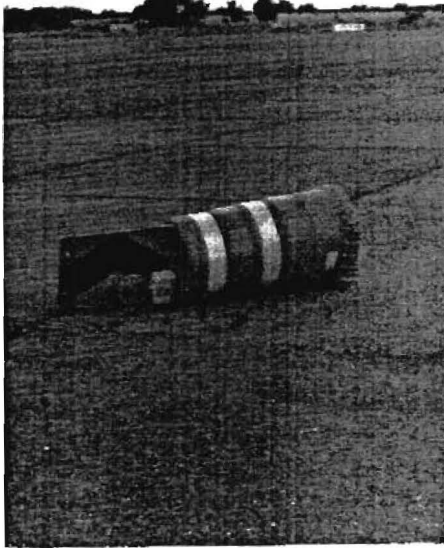
Figure 47. Damage to device, test 1917-14

Base moved 12 ft down

Drum 48 ft down, 12 ft right
