1. Report No. TX-94/1945-2F		2. Government Accession No.		3. Recipient's Catalog No.	
4. Title and Subtitle MAILBOX BRACKET CRASH TESTS				5. Report Date November 1993

MAILBOX BRACKET CRASH TESTS

Research Report 1945-2F
Research Study No. 7-1945
Study Title: Mailbox Bracket Crash Tests

TEXAS TRANSPORTATION INSTITUTE
The Texas A&M University System
College Station, Texas 77843-3135

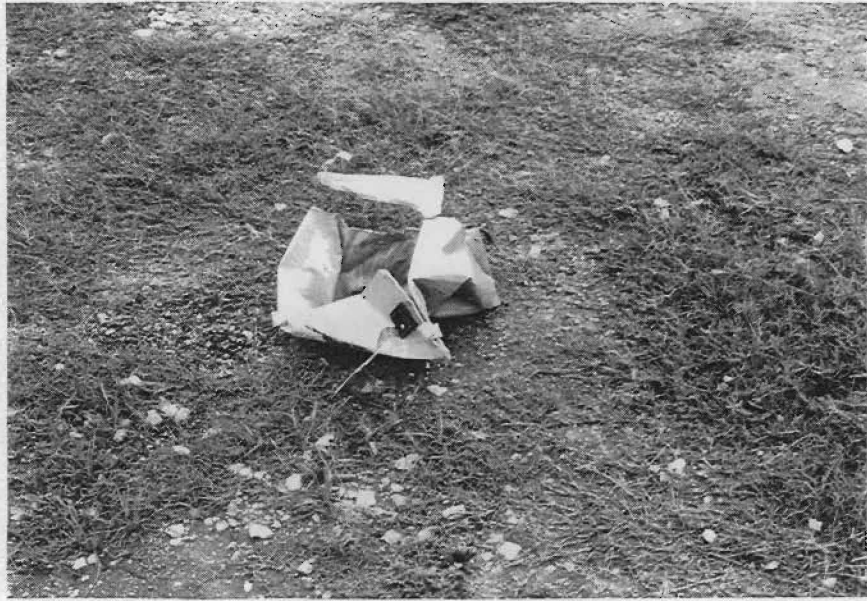
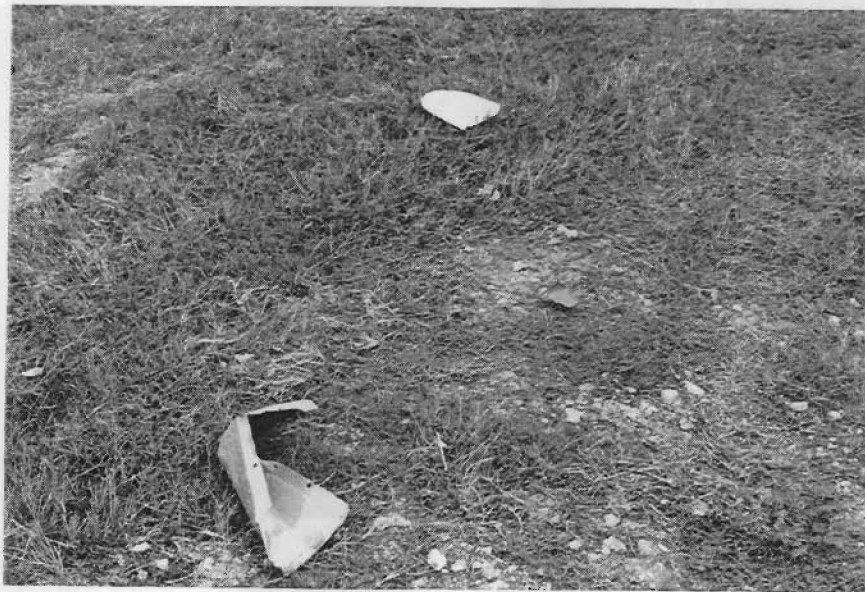
Figure C-7. Test installation after test 19452-1.

Figures C-7 and C-8 show test article damage. As shown, the support bent at ground level and the mailbox attachment bracket remained attached to the support. The mailbox components came to rest approximately 72.5 ft (22.1 m) from the point of impact. The vehicle sustained only minor damage to the bumper and hood as shown in Figure C-9.

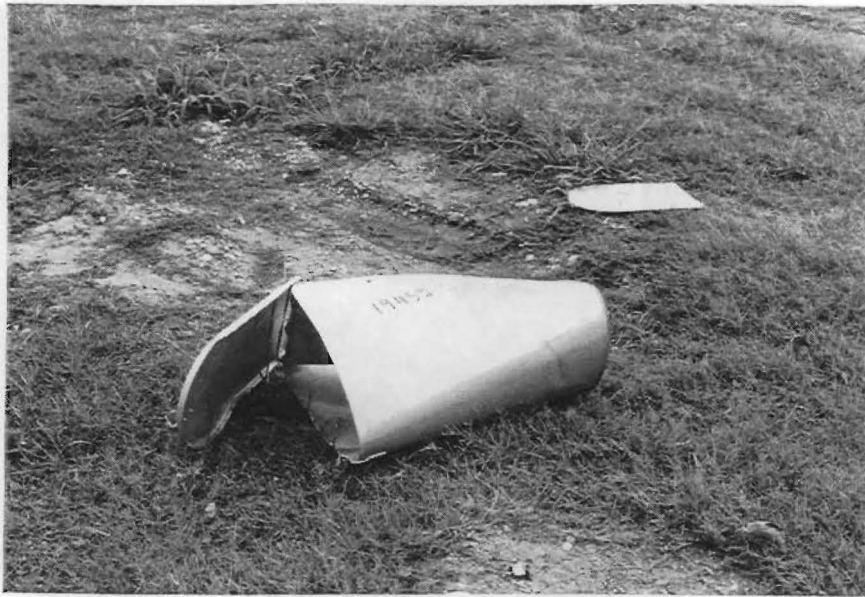
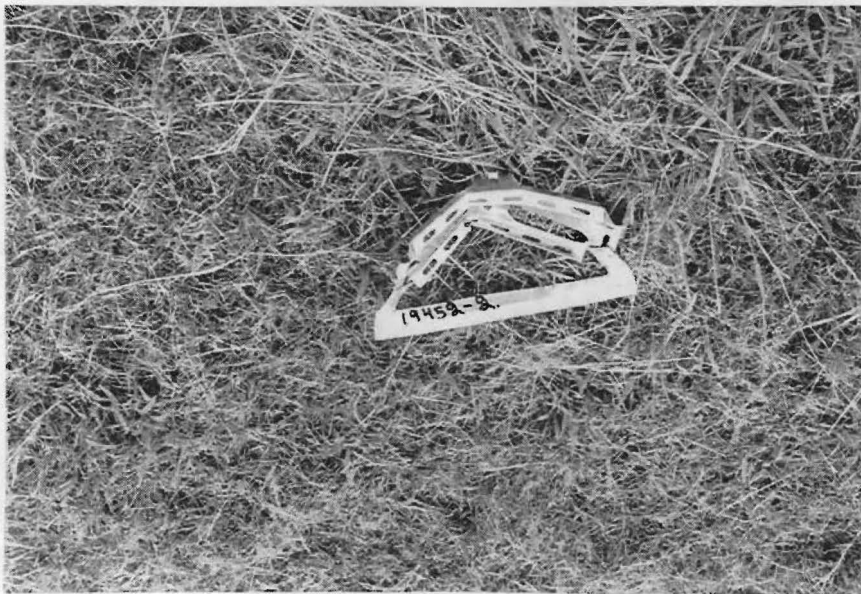
Figure D-6. Test installation after test 19452-2.

Figures D-6 and D-7 shows the test article damage. As shown, the support bent at ground level and the mailbox attachment bracket became detached from the support, coming to rest approximately 153 ft (46.6 m) from the impact point. Other mailbox components came to rest approximately 101.3 ft (30.9 m) from the impact point. Figure D-8 shows the vehicle sustained only minor damage to the bumper, hood, and windshield.

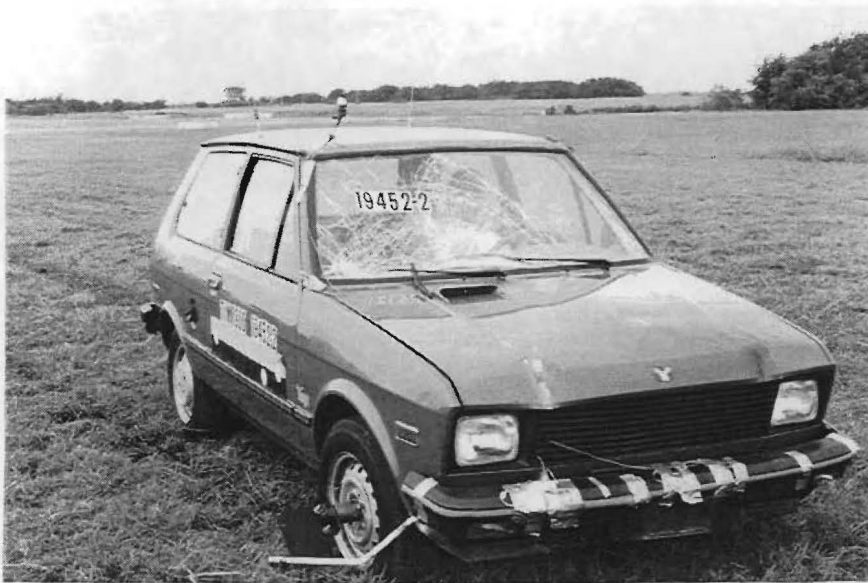
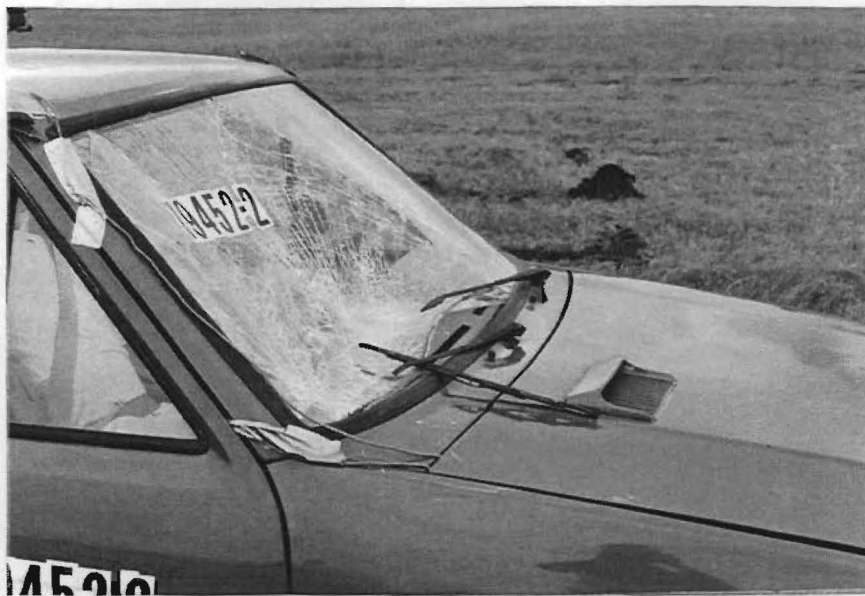
Figure D-7. Damage to mailbox and bracket after test 19452-2.

In summary, the test was marginally acceptable. The only concern was that the windshield was broken and dished during impact. The researchers concluded that changes could and should be made in the design to eliminate this concern.

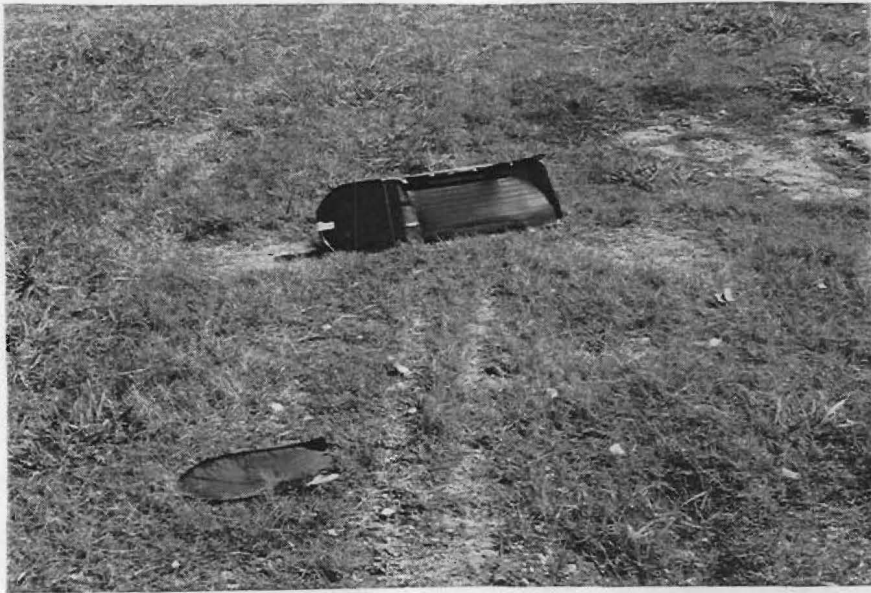
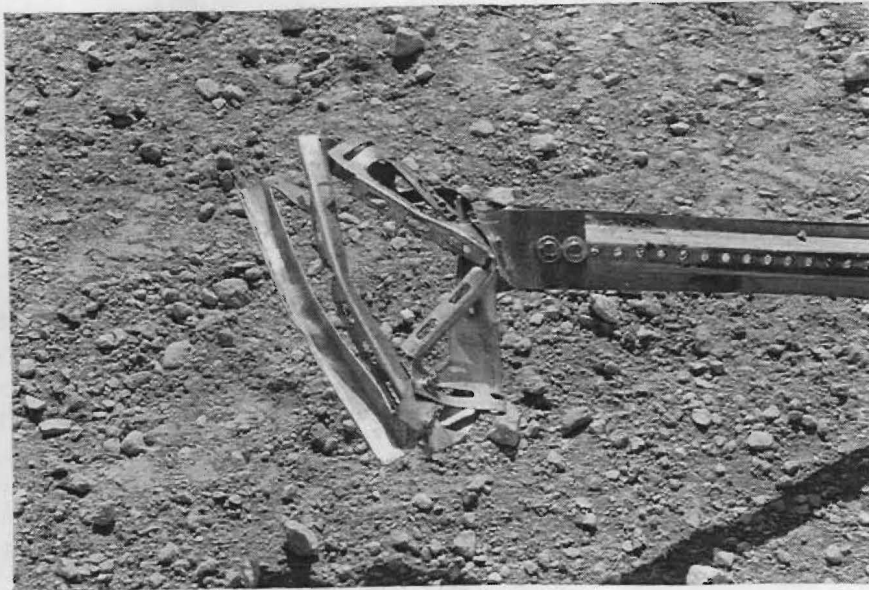
Figure E-7. Test installation after test 19452-3.

Figures E-7 and E-8 show test article damage. As shown, the support bent at ground level and the mailbox attachment bracket remained with the support, but the mailbox itself was torn from the attachment bracket. Other mailbox components came to rest approximately 96.3 ft (29.3 m) from the impact point. The vehicle sustained only minor damage to the bumper, hood, and windshield as shown in Figure E-9.

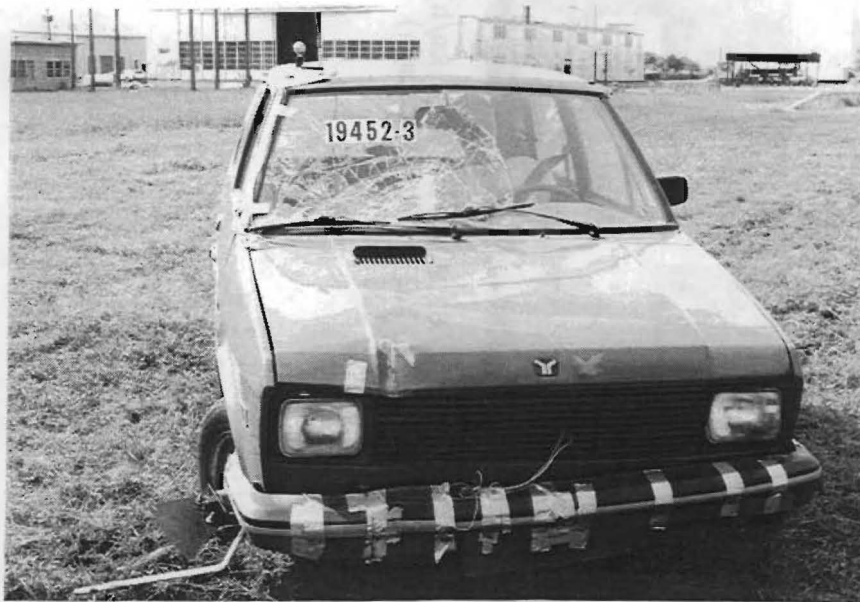
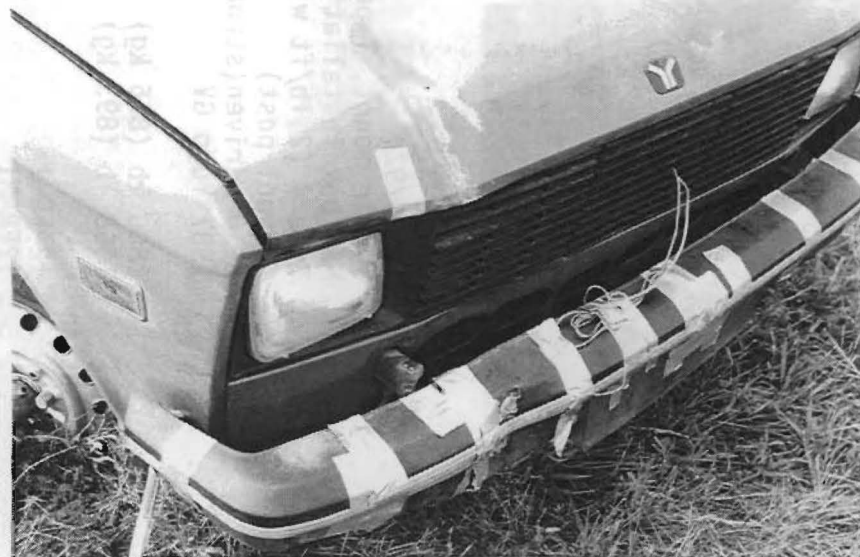
Figure E-8. Damage to mailbox and bracket after test 19452-3.

In summary, the test was marginally acceptable. The only concern was that the windshield was broken and dished during impact. Researchers concluded that changes could and should be made in the design to eliminate this concern.

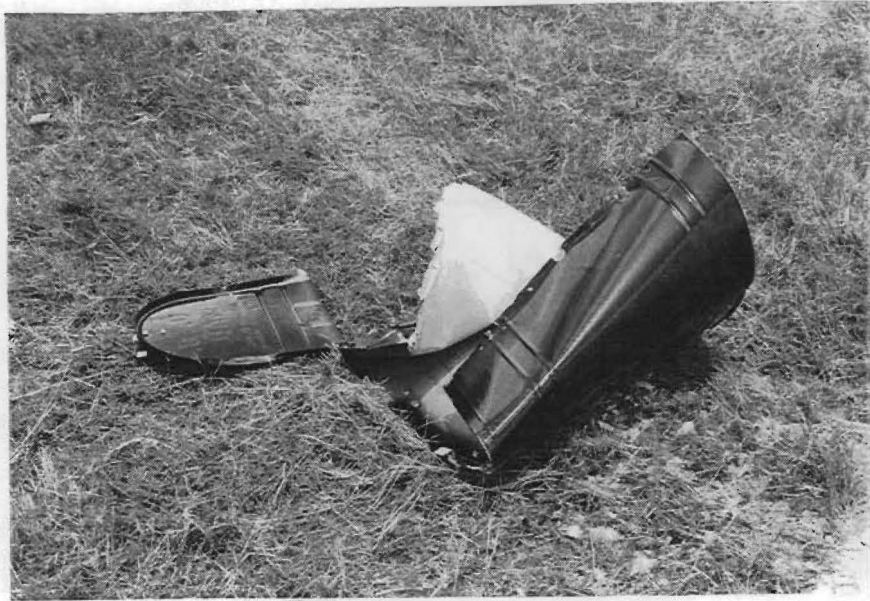
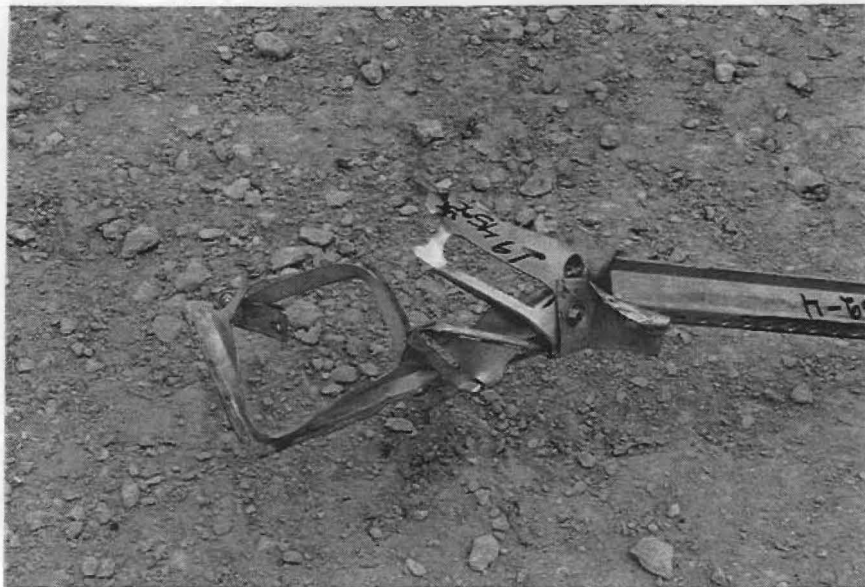
Figure F-6. Test installation after test 19452-4.

Figures F-6 and F-7 show the test article damage. As shown, the support bent at ground level and the mailbox attachment bracket remained with the support, but the mailbox itself was torn from the attachment bracket. Other mailbox components came to rest approximately 90 ft (27.4 m) from the impact point. The vehicle sustained only minor damage to the bumper and hood as shown in Figure F-8.

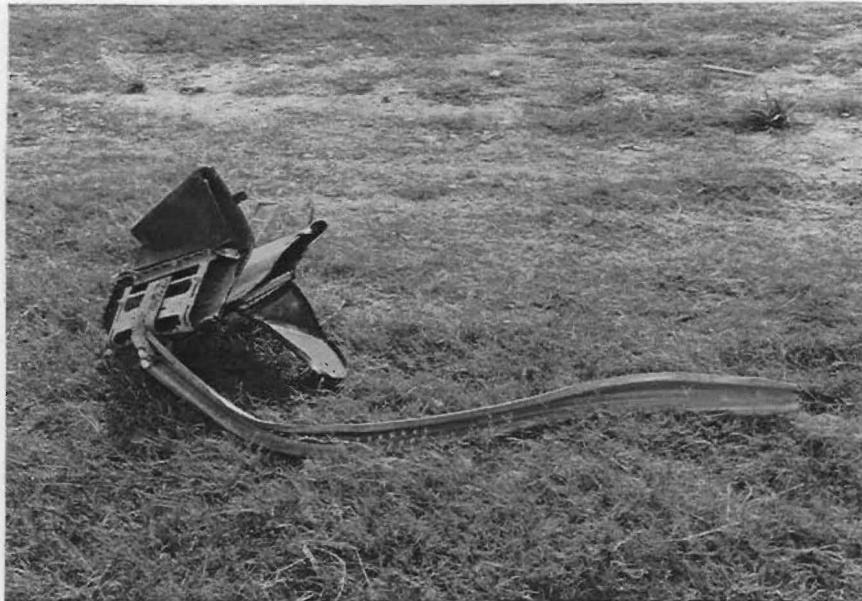
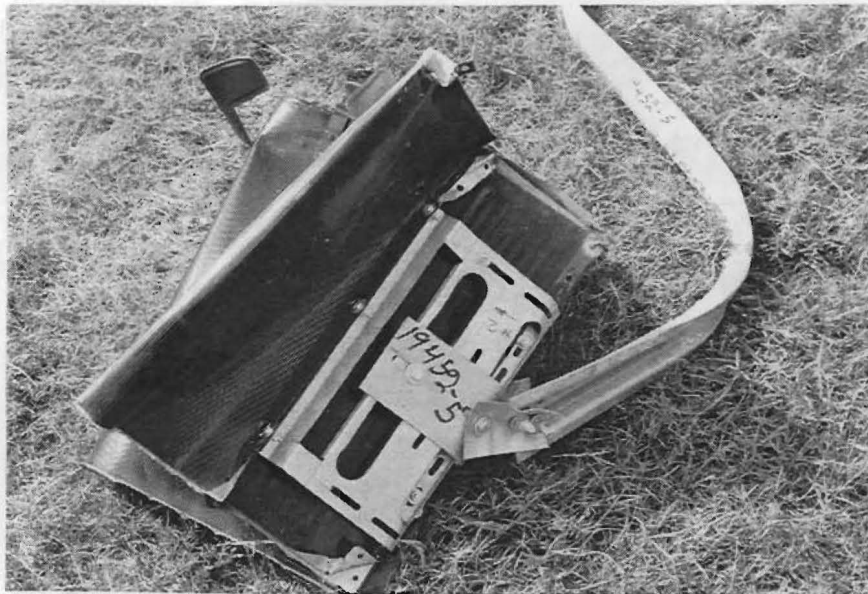
Figure G-7. Test installation after test 19452-5.

Figures G-7 and G-8 show test article damage. As shown, the support was pulled from the ground. The mailboxes remained attached to the support post. The mailboxes and support came to rest approximately 85 ft (25.9 m) from the impact point. Doors and back sides of the mailboxes were detached and distributed along the vehicle's path. The vehicle sustained only minor damage to the bumper and hood as shown in Figure G-9.

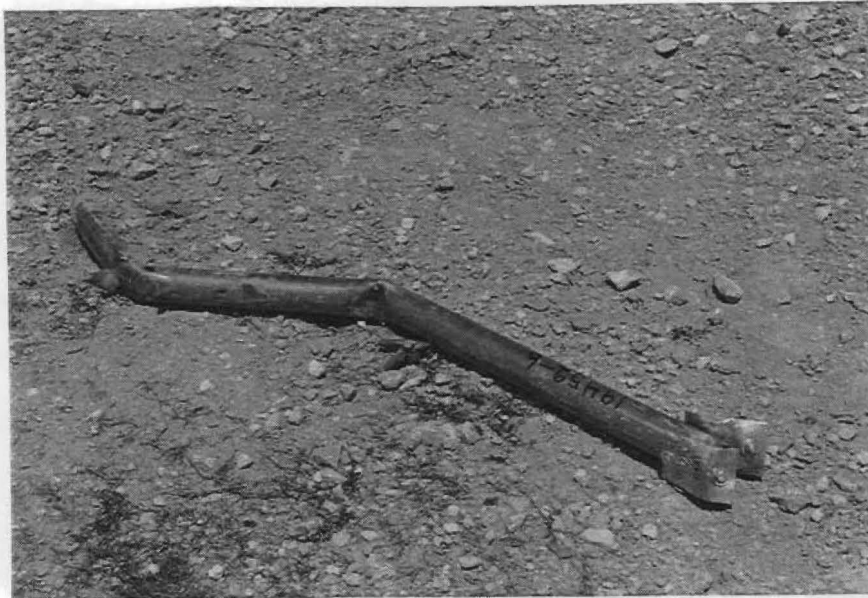
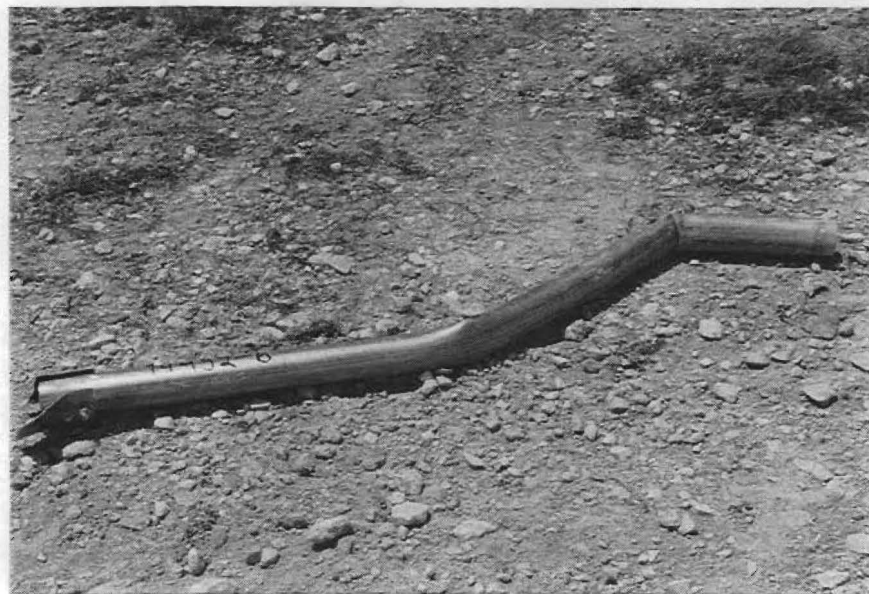
Figure H-7. Damage to support after test 19452-6.

Figures H-7 through H-9 shows the test article damage. As shown, the support was pulled from the ground socket and came to rest 20 ft (6.1 m) from the impact point. The mailbox came to rest approximately 108 ft (32.9 m) from the impact point. The vehicle sustained only minor damage to the bumper and hood as shown in Figure H-10.

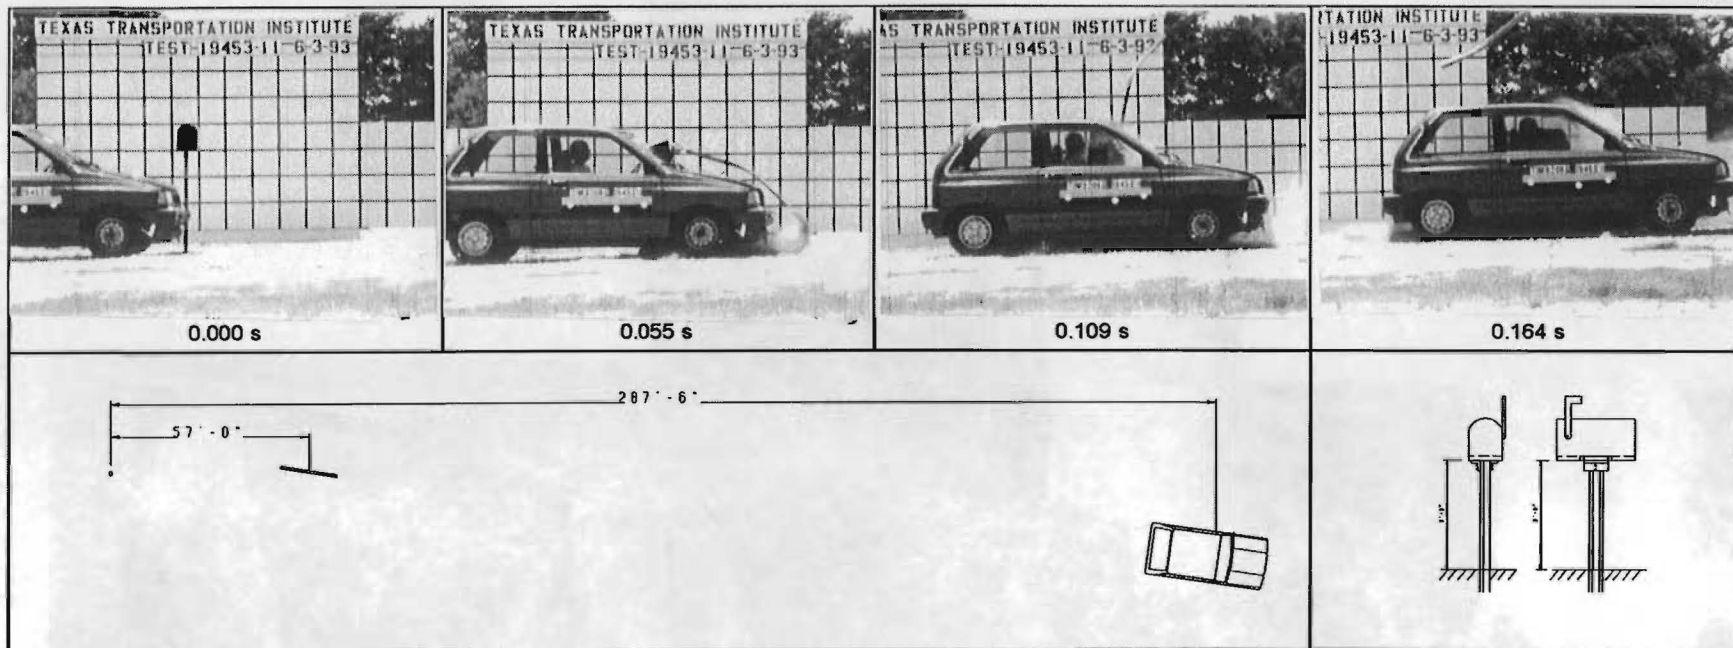
Figure M-9. Details of occupant compartment intrusion after test 19543-11.

A vandal-proof size no. 1½ mailbox fabricated from ¼-in. (0.64 cm) steel plate mounted on a 2 lb/ft (3 kg/m) steel winged channel post is unacceptable. Upon impact, the box penetrated the occupant compartment at a high relative speed and would have caused serious or fatal injuries. Use of this box on high-speed roadways should not be permitted. Its use on low-speed roadways is not recommended unless it can be demonstrated to be acceptable through crash testing.

Results of this test were unacceptable. Use of this box on high-speed roadways clearly should not be permitted. Its use on low-speed roadways is not recommended unless it can be demonstrated to be acceptable through crash testing.
