1. Report No. <b>TX-94/1959-1</b>		2. Government Accession No.		3. Recipient's Catalog No.	
4. Title and Subtitle <b>DEVELOPMENT OF A LIMITED-SLIP PORTABLE CONCRETE BARRIER CONNECTION</b>				5. Report Date <b>November 1993</b>

**DEVELOPMENT OF A LIMITED-SLIP PORTABLE  
CONCRETE BARRIER CONNECTION**

Research Report 1959-1  
Contract No. 7-1959, Task A

TEXAS TRANSPORTATION INSTITUTE  
The Texas A&M University System  
College Station, Texas 77843-3135

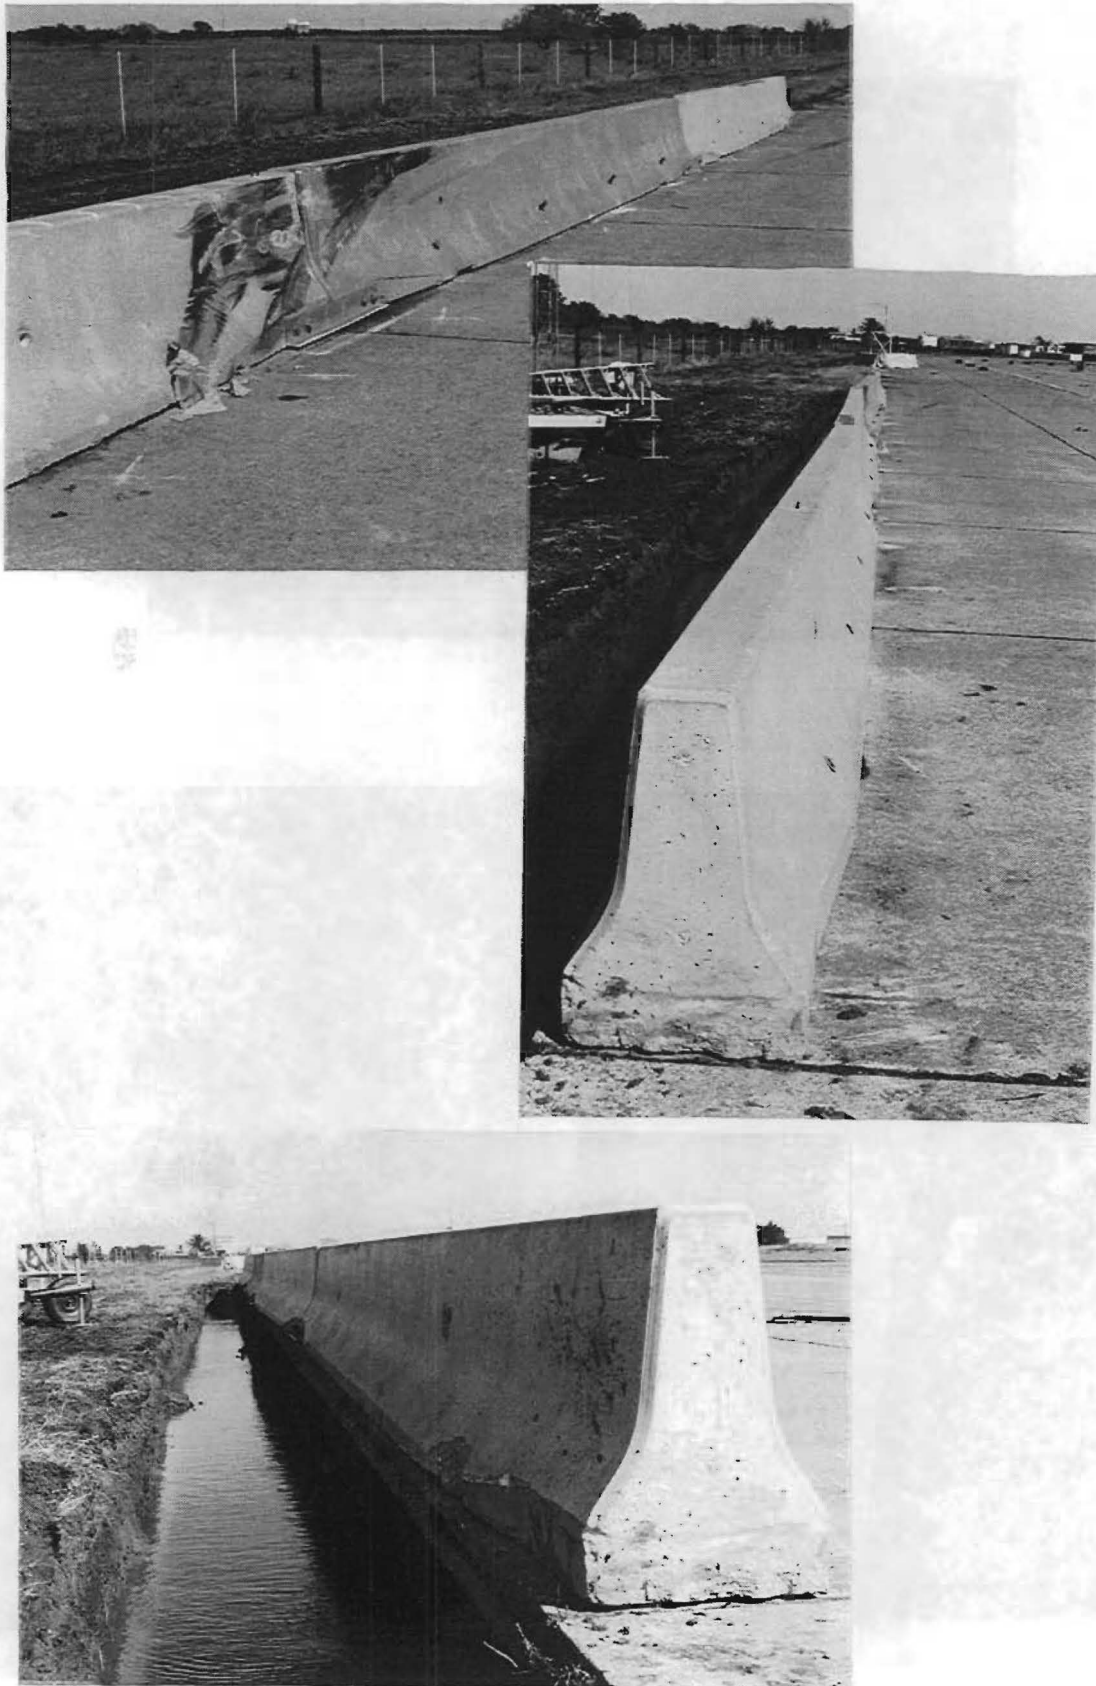
Figure 15. Post test damage to limited-slip concrete barrier connection installation (1959A-1).

As can be seen in Figures 15 and 16, the barrier received minimal damage, although there was cosmetic damage (i.e., tire marks) on the face of the barrier. Maximum permanent movement of the barrier was 16.1 in. (40.8 cm). The vehicle was in contact with the barrier for 65.0 ft (19.8 m).

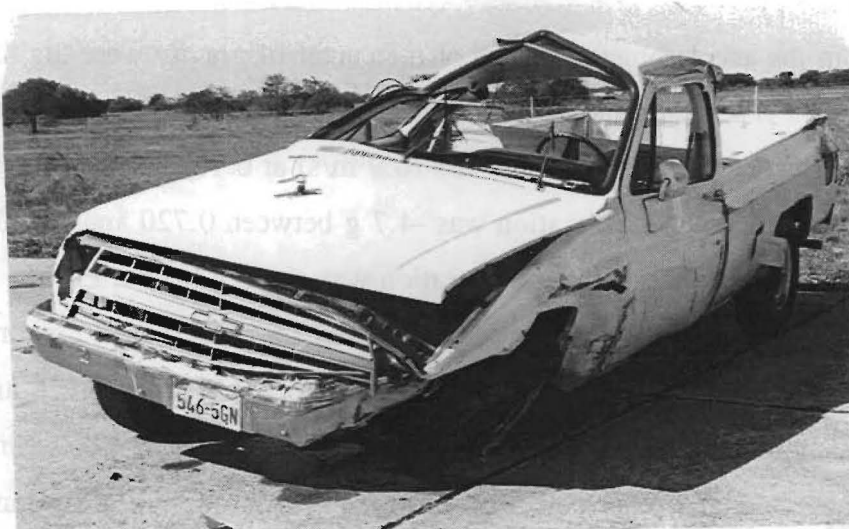
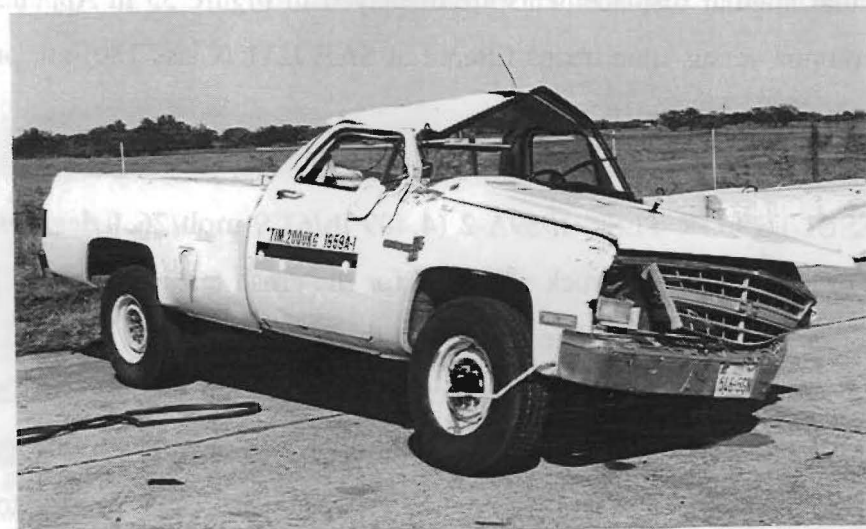
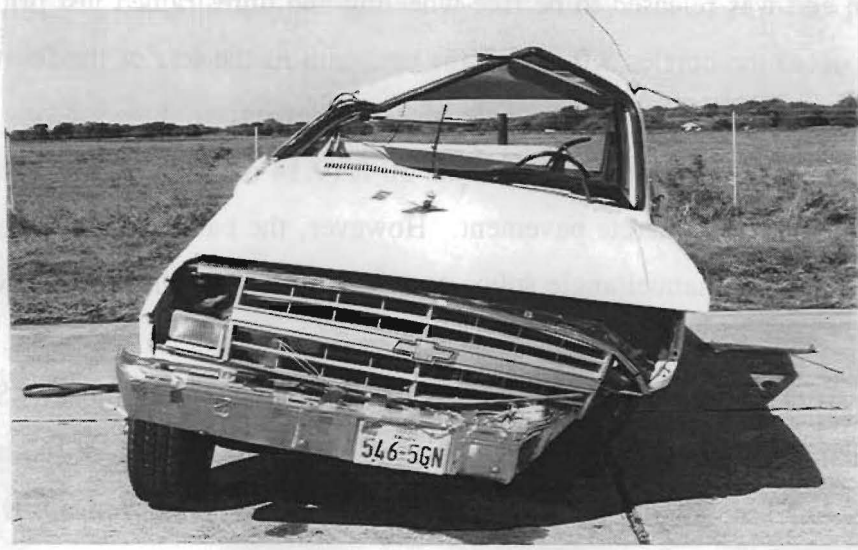
Figure 17. Post test damage to vehicle (test 1959A-1).

The entire vehicle sustained extensive damage as shown in Figure 17. Maximum crush at the left front corner of the vehicle was 16.5 in. (42.0 cm). The left front wheel was pushed rearward 8.3 in. (21.0 cm) and the roof was shifted 9.5 in. (24.0 cm). The floor, roof, and dashboard in the occupant compartment area were deformed. In addition, damage was sustained to the front bumper, grill, hood, radiator, windshield, and left front control arms, and all of the body panels were dented.

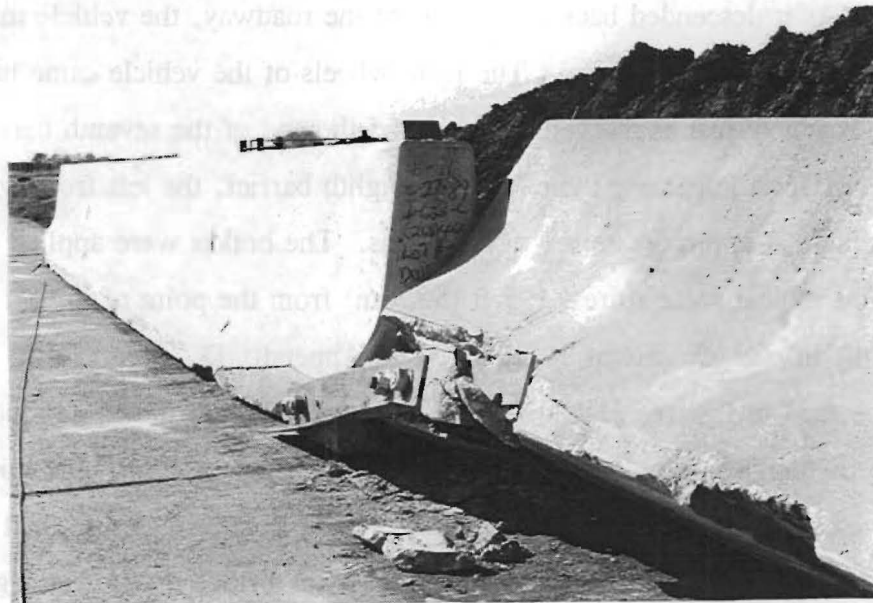
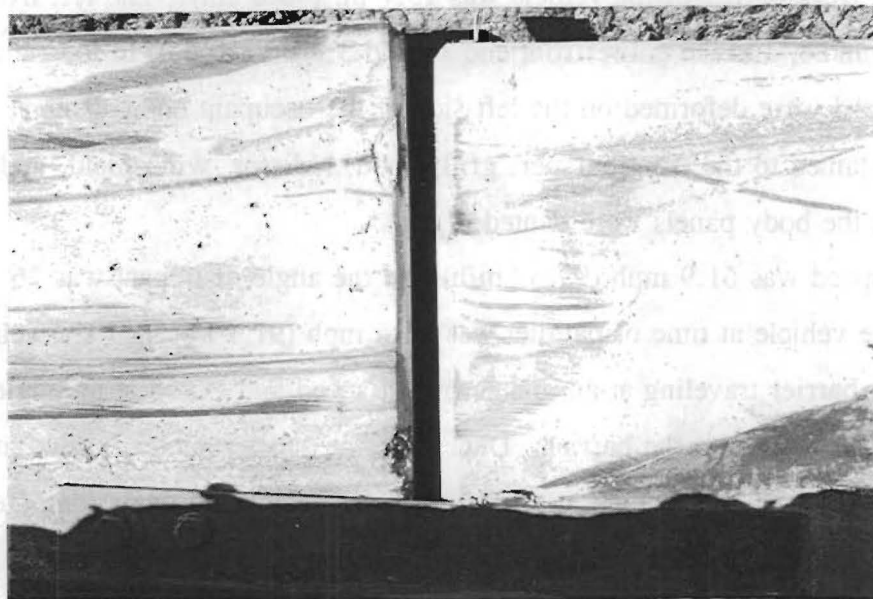
Figure 21. Details of damage to concrete barrier anchorage points(test 1959A-2).

As can be seen in Figures 21 and 22, the barrier received a moderate amount of damage. All of the barrier segments downstream from the impact point were knocked off the concrete pavement. The majority of the damage to the barrier was sustained by the torsional forces placed on the barrier while falling from the bridge deck. Damage to the face of the barrier was only cosmetic (i.e., tire marks). The vehicle was in contact with the barrier for 155.0 ft (47.3 m).

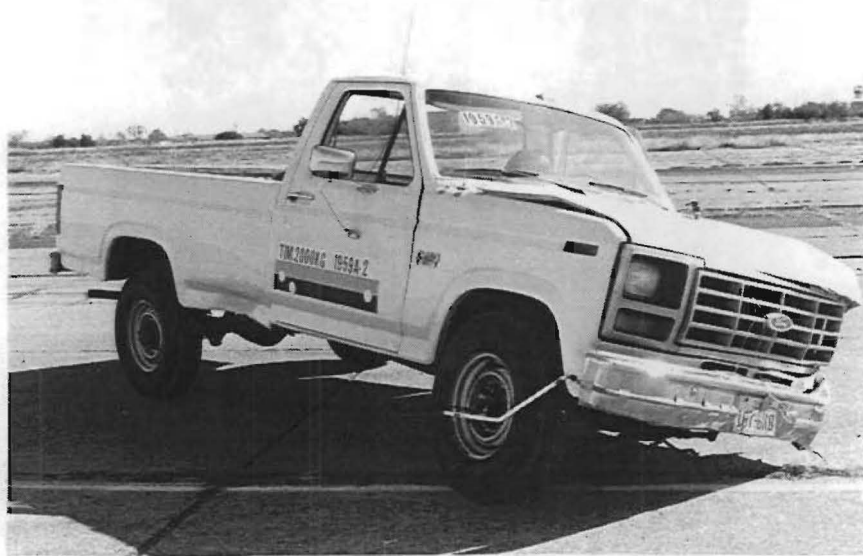
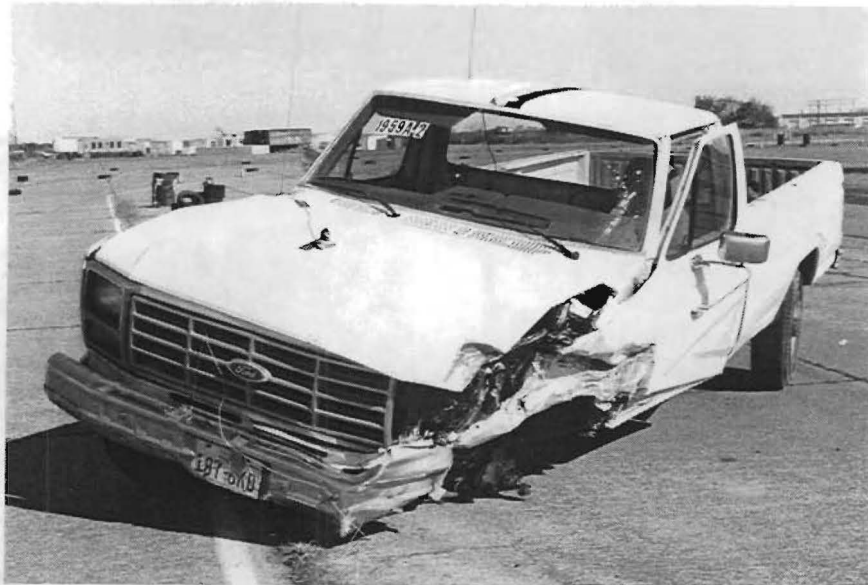
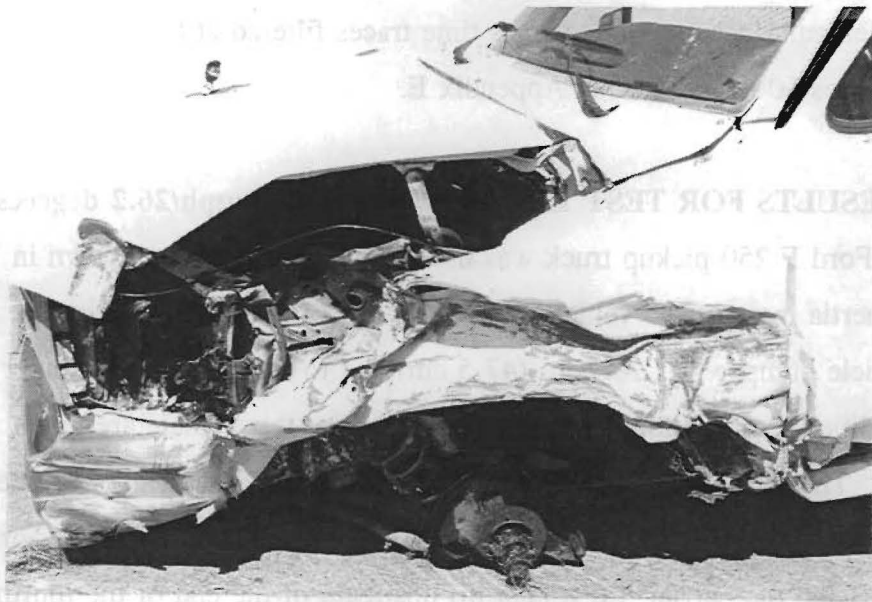
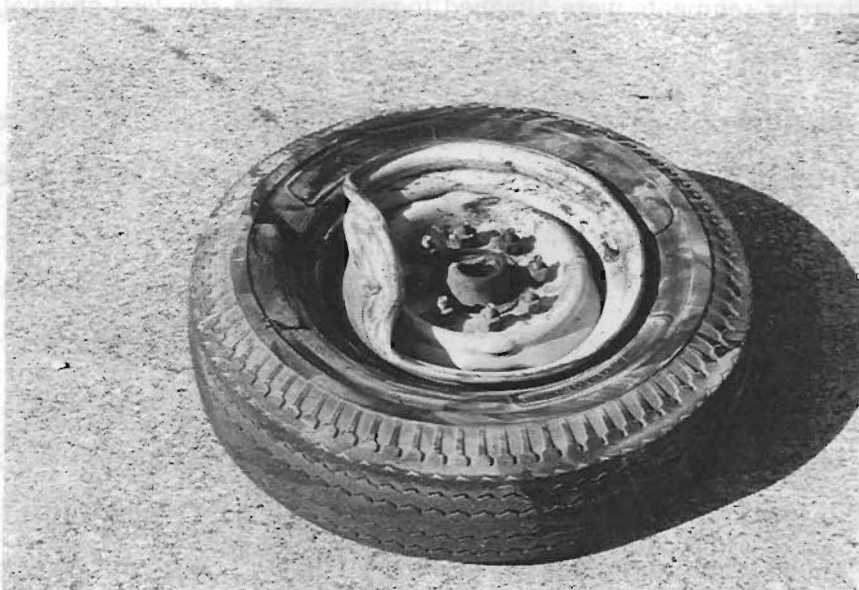
Figure 23. Post test damage to vehicle (test 1952A-2).

The entire vehicle sustained extensive damage as shown in Figure 23. Maximum crush at the left front corner of the vehicle was 15.7 in. (40.0 cm). The left front wheel was torn from the spindle, and the entire front end shifted 3.9 in. (10 cm) to the right. The floor pan and dashboard were deformed on the left side of the occupant compartment. In addition, damage was sustained to the front bumper, grill, hood, radiator, windshield, and left front axle beam. All the body panels were dented.

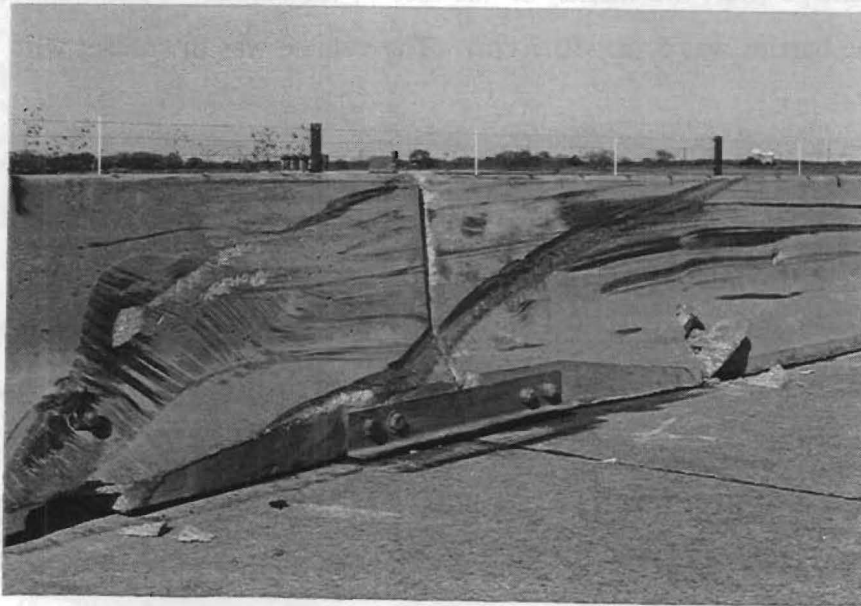
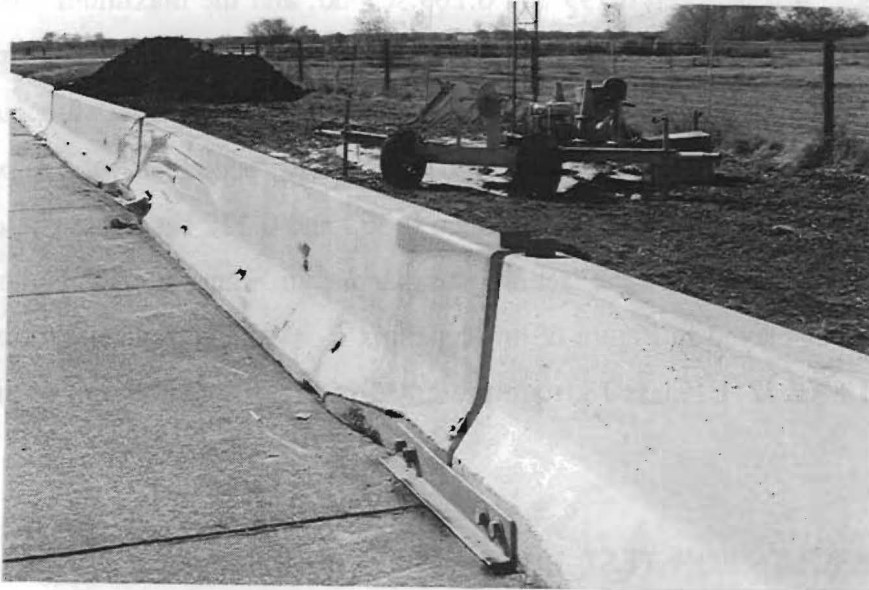
Figure 28. Post test damage to limited slip concrete barrier connection installation (1959A-3).

As can be seen in Figures 28 and 29, the barrier received minimal damage. There was cosmetic damage (i.e., tire marks) on the face of the barrier. Maximum permanent movement of the barrier was 5 in. (12.7 cm). The vehicle was in contact with the barrier for 155.0 ft (47.3 m).

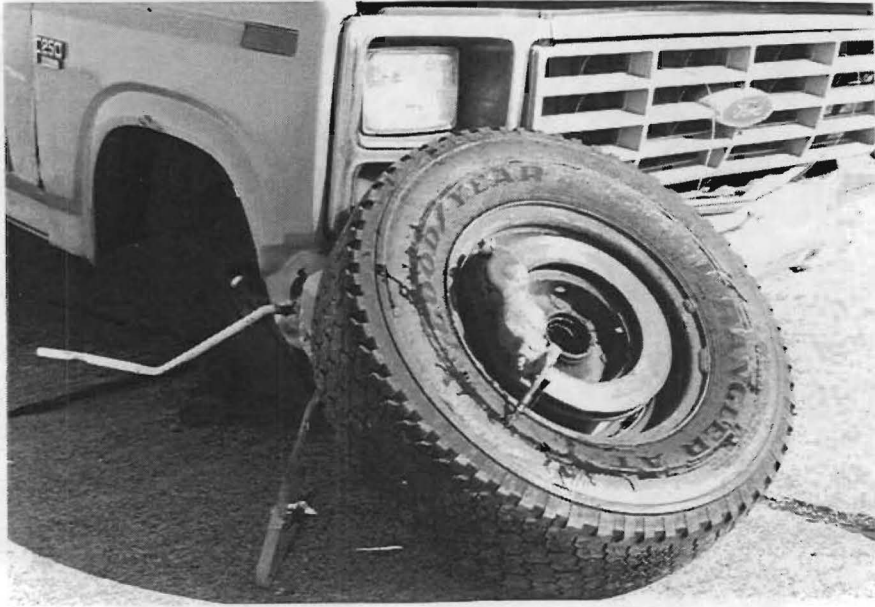
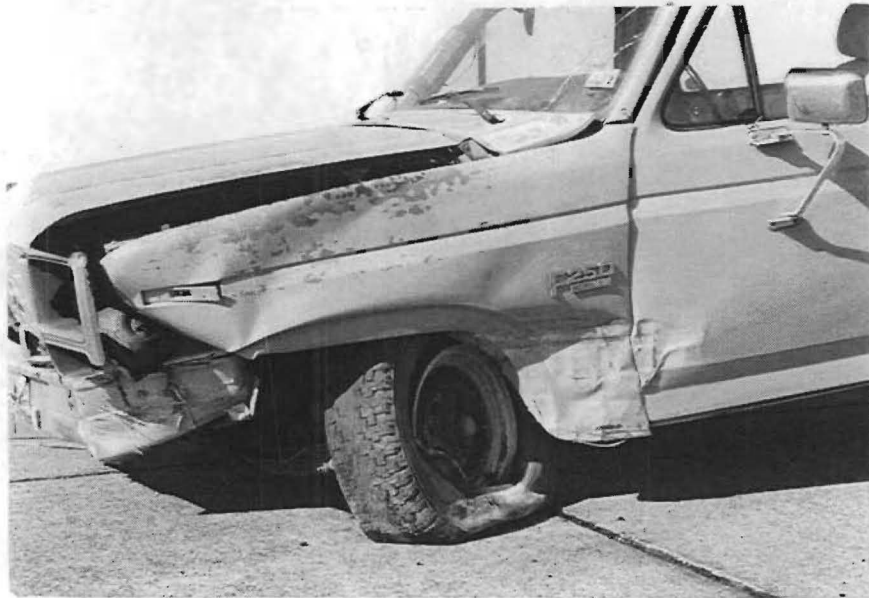
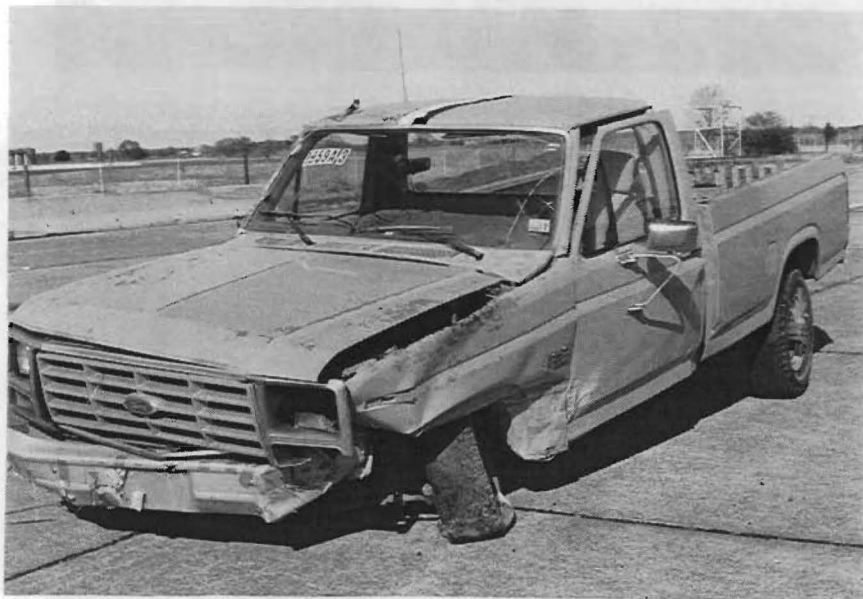
Figure 30. Post test damage to vehicle (test 1959A-3).

The entire vehicle sustained moderate damage as shown in Figure 30. Maximum crush at the left front corner of the vehicle was 15.7 in. (40.0 cm). The right front wheel was displaced from the spindle, and the entire front end shifted 7.9 in. (20 cm) to the right. The floor pan was deformed on the left side of the occupant compartment. In addition, damage was sustained to the front bumper, grill, hood, radiator, windshield, and left front axle beam. Most of the body panels were scraped or bent.

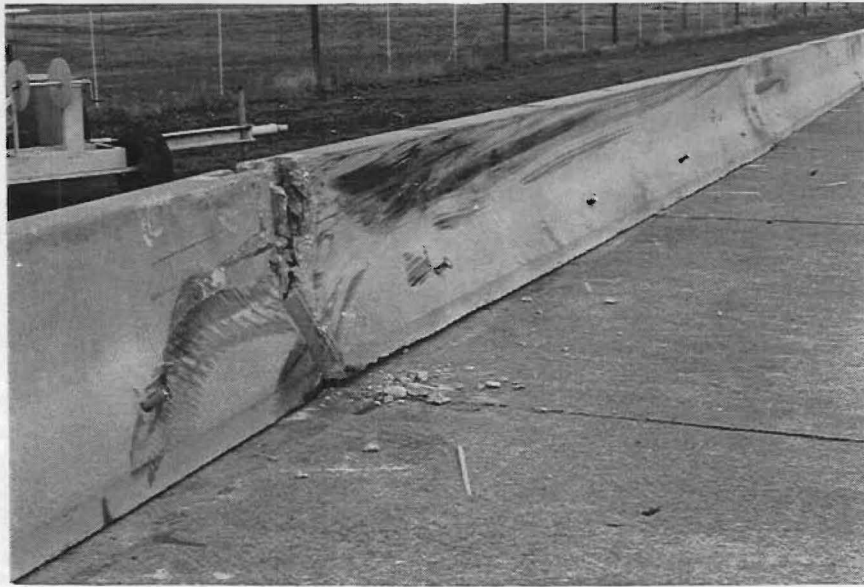
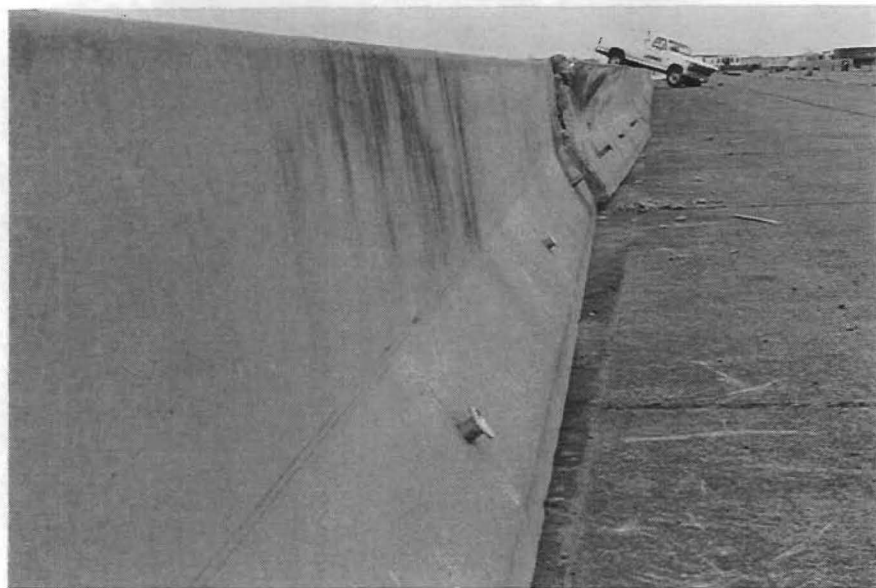
Figure 35. Post test damage to installation 1959A-4.

As can be seen in Figures 35 and 36, the barrier received moderate damage at the grid slot ends of the barrier. Other damage was cosmetic (i.e., tire marks and gouges) and was limited to the face of the barrier. Maximum permanent movement of the barrier was 9 in. (22.9 cm). The vehicle was in contact with the barrier for 174.0 ft (53.0 m).

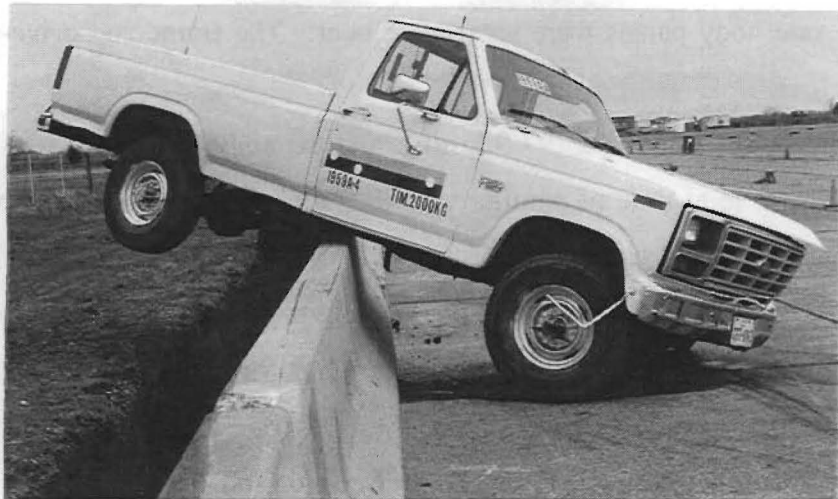
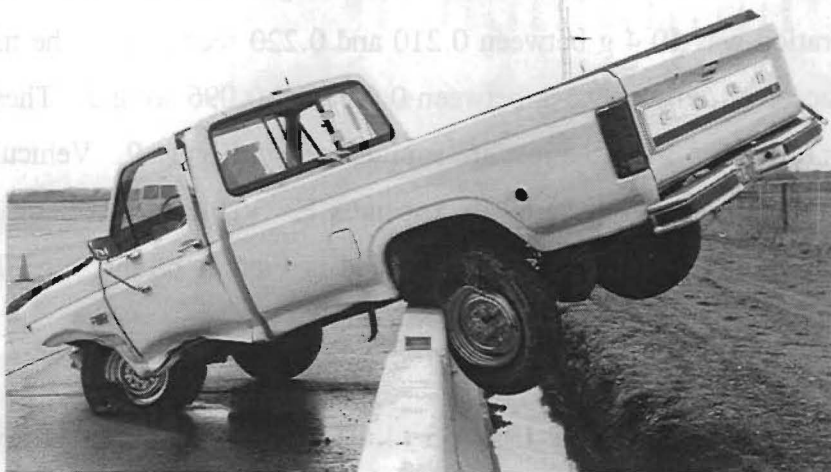
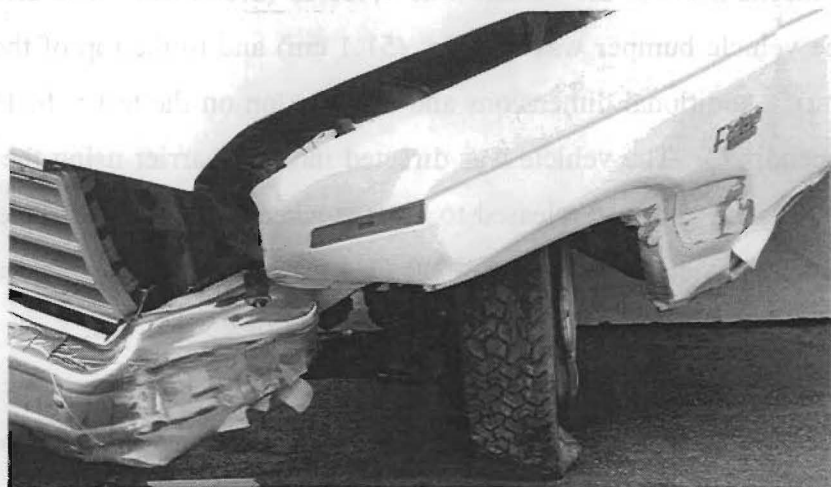
Figure 37. Post test damage to vehicle (1959A-4).

The vehicle sustained moderate damage as shown in Figure 37. Maximum crush at the left front corner of the vehicle was 15.7 in. (40.0 cm). The floor pan was deformed 5.5 in. (14.0 cm) into the occupant compartment on the left side. In addition, damage was sustained to the front bumper, grill, hood, radiator, windshield, and left front axle beam.

Most of the left side body panels were scraped or bent. The frame and drive-shaft were bent.

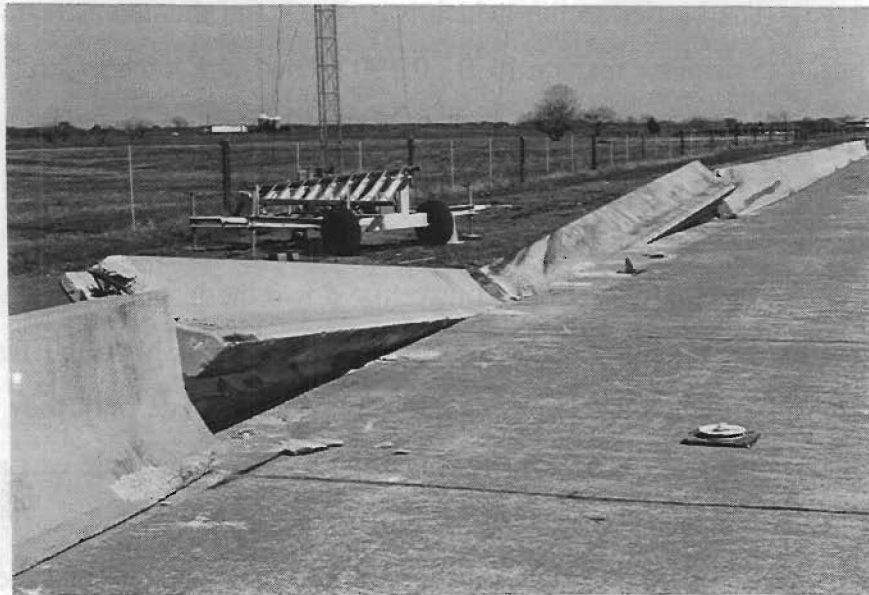
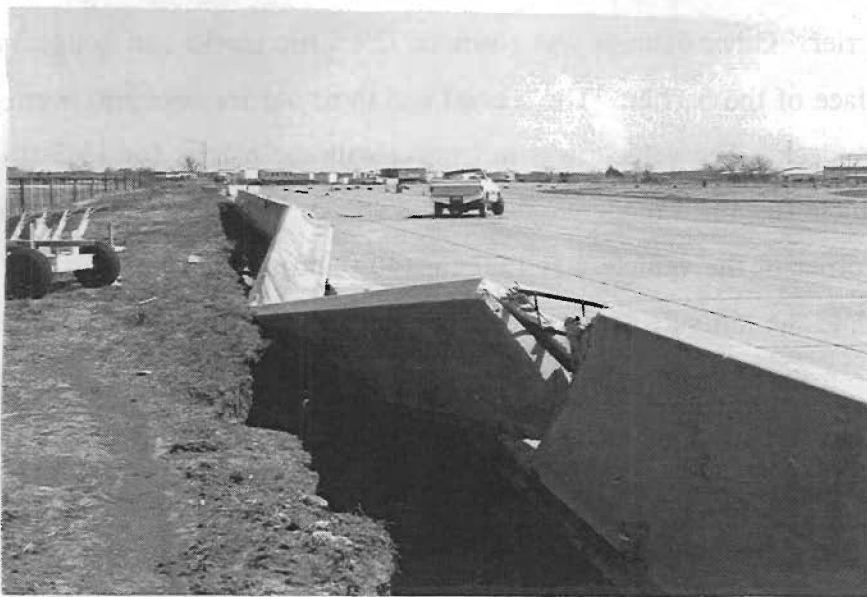
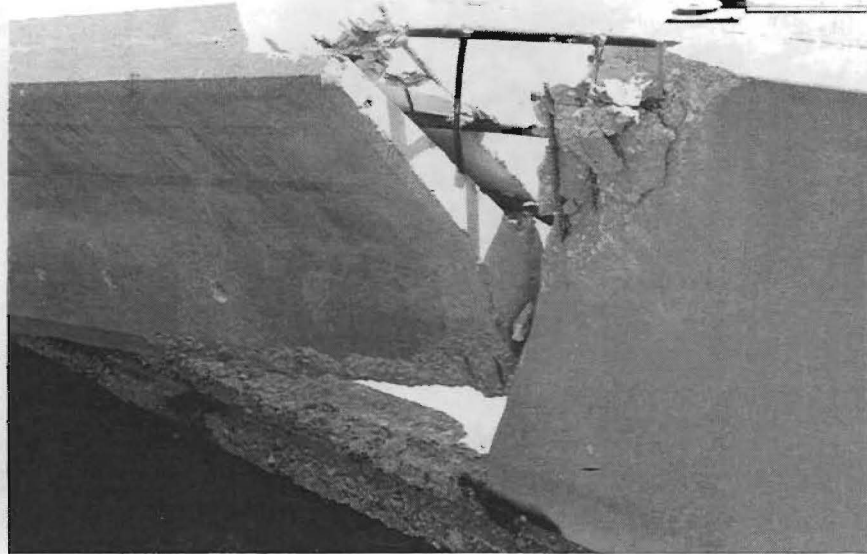
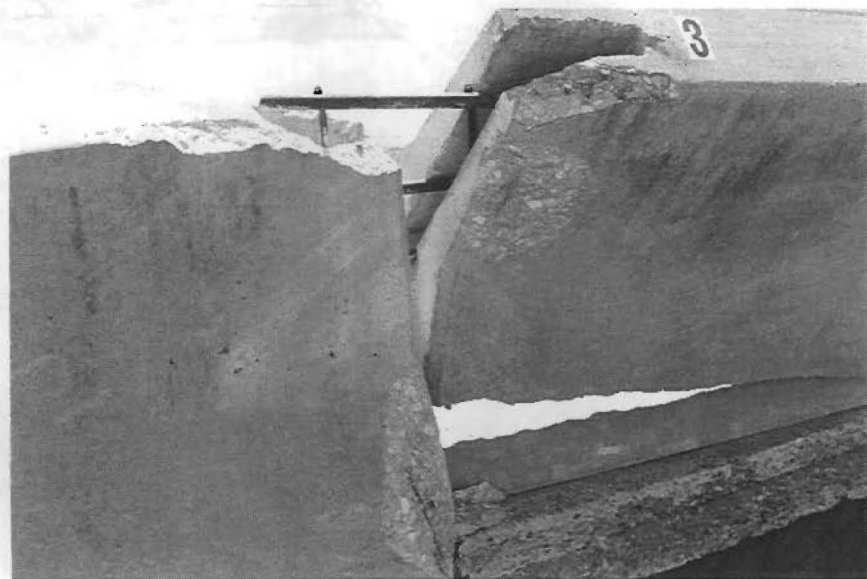
Figure 42. Post test damage to installation 1959A-5.

As can be seen in Figure 42, the barrier received moderate damage at the grid slot ends of the barrier. Other damage was cosmetic (i.e., tire marks and gouges) and was limited to the face of the barrier. The second and third barrier segments were displaced from the bridge deck. The vehicle was in contact with the barrier for 13.5 ft (4.1 m).

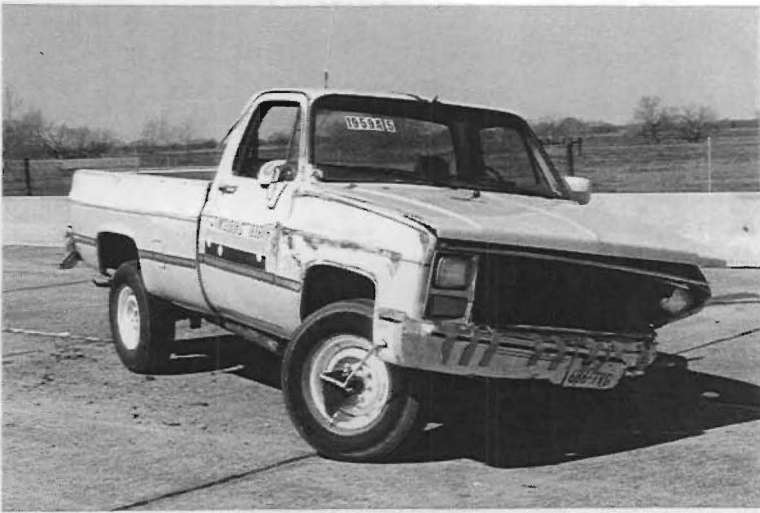
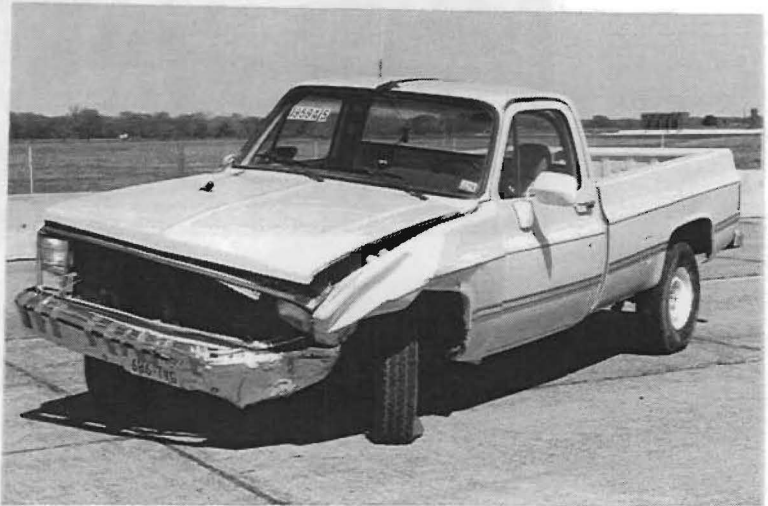
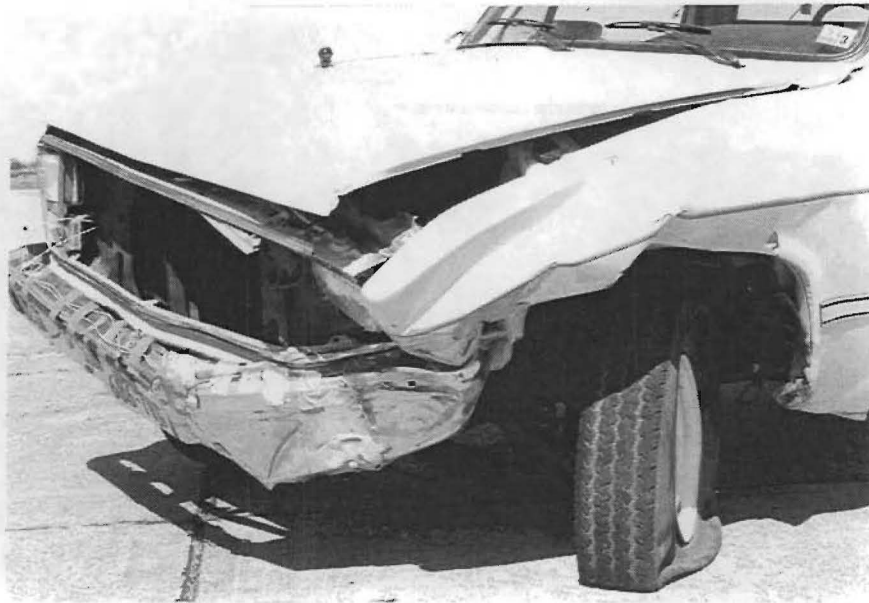
Figure 43. Post test damage to vehicle (1959A-5).

The vehicle sustained moderate damage as shown in Figure 43. Maximum crush at the left front corner of the vehicle was 15.7 in. (40.0 cm). The floor pan was deformed 4.3 in. (11.0 cm) into the left side of the occupant compartment. In addition, damage was sustained to the front bumper, grill, hood, radiator, and all of the left front suspension components. Most of the right side body panels were scraped and/or bent. The frame was bent on the right side.
