EVALUATION OF THE HIGH LOAD DETECTION
AND WARNING SYSTEM ON I.H. 45
IN HOUSTON

Research Report Number 202-1

Research Study Number 2-18-75-202

March 1976

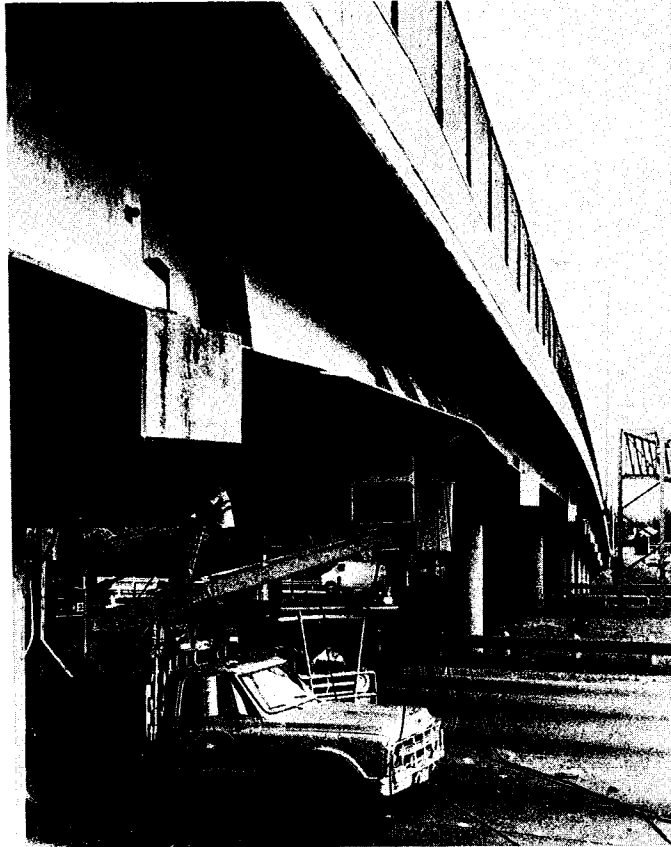
FIGURE 2. HOUSTON AVENUE OVERPASS ON
I.H. 10 EASTBOUND

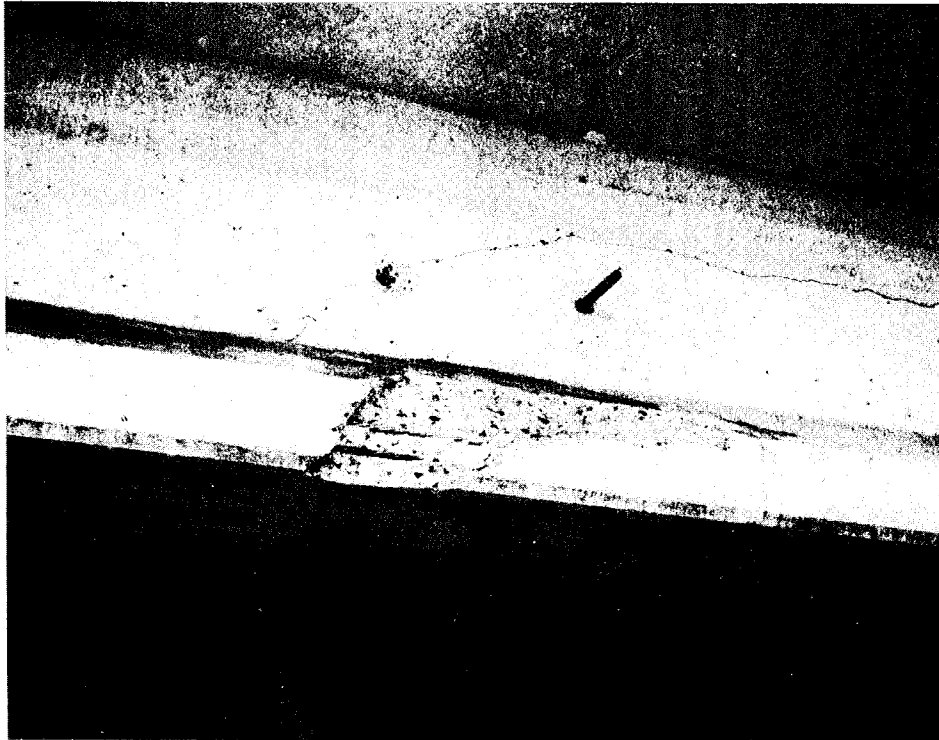
FIGURE 3. ROBINSON ROAD OVERPASS ON I.H. 45
NORTHBOUND IN MONTGOMERY COUNTY

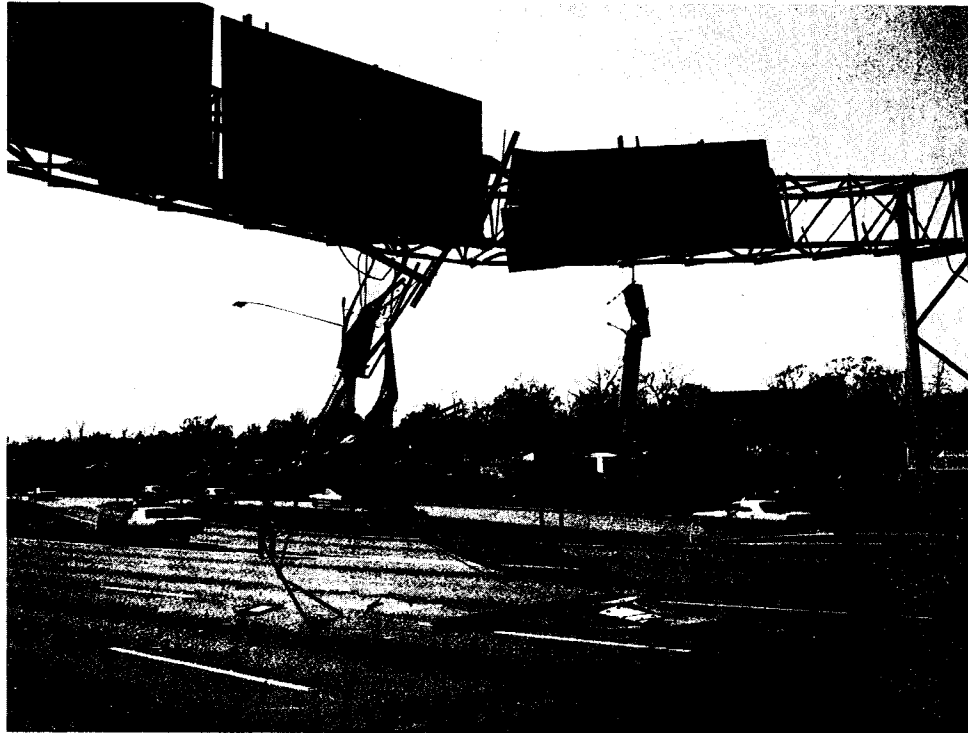
Figure 4 indicates the damage sustained by an overheight sign bridge structure on I.H. 45 southbound at the Cavalcade exit near the Houston CBD. Although the sign structures are not damaged as frequently as bridge superstructures, repairs are likely to be more costly. The road clearance was 17 feet 6 inches. A truck pulling a dump trailer with a malfunctioning dump mechanism which in turn was raising the trailer struck the sign structure. Replacement cost for the sign structure was \$35,000. Figure 4, along with the previous 3 figures, indicates the general damages sustained by the structures in District 12.

FIGURE 4. OVERHEAD SIGN BRIDGE STRUCTURE
ON I.H. 45 SOUTHBOUND AT THE CAVALCADE STREET EXIT

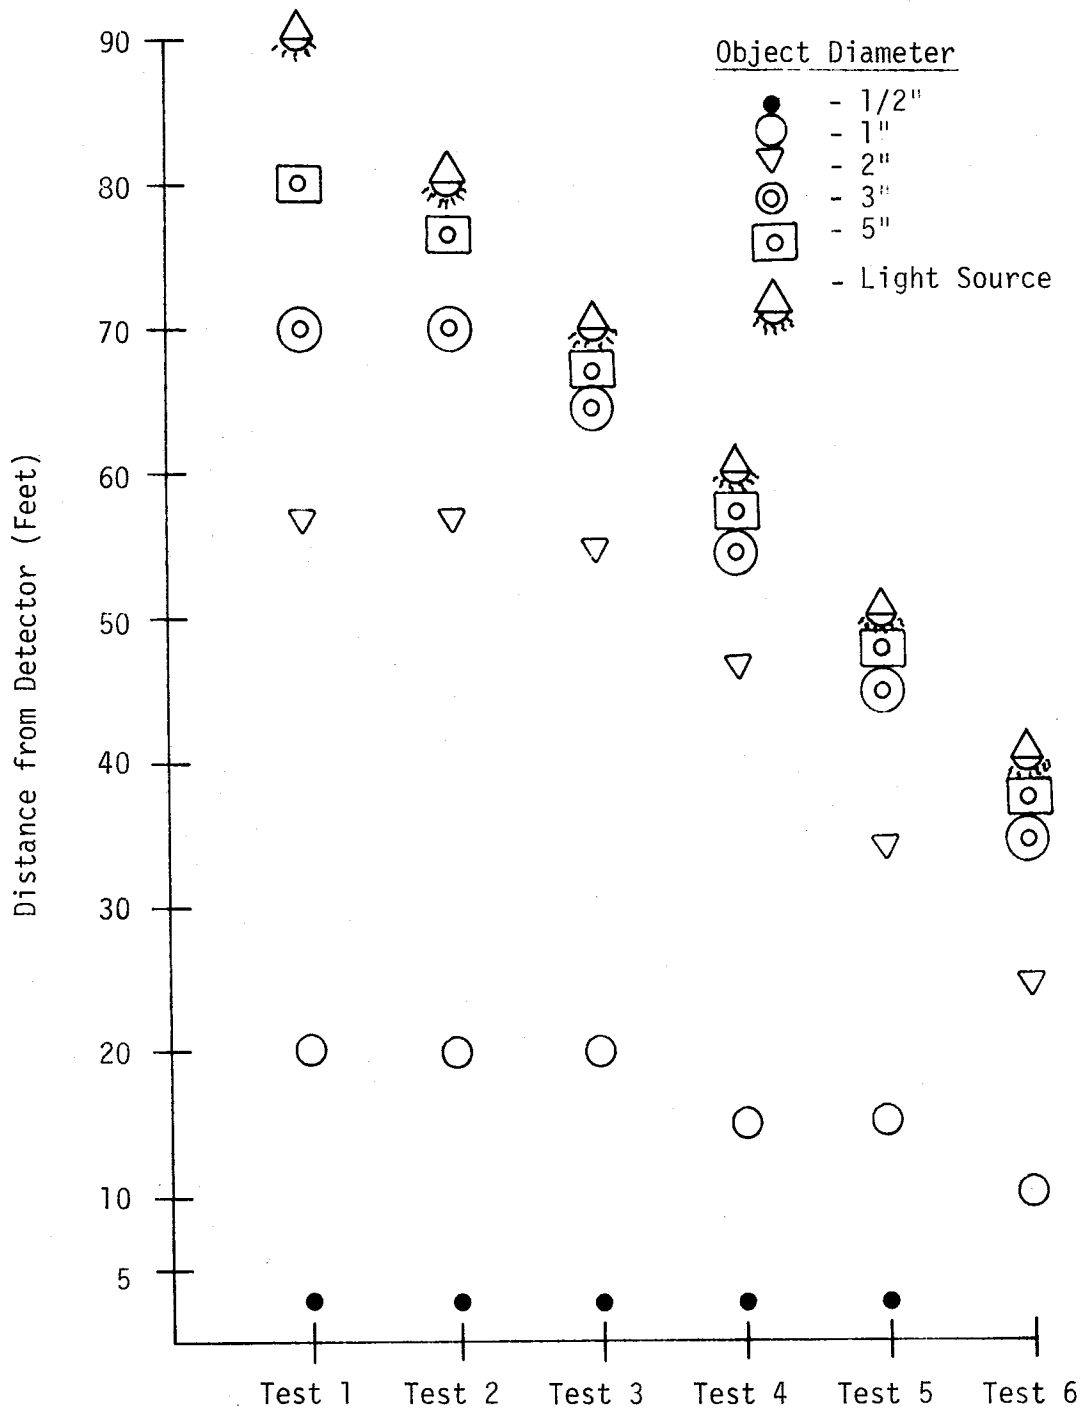
in Figure 13. A one-half-inch object will be detected only if it passes within 3 feet of the detector, an one-inch object would be detected at approximately 20 feet. The sensors cannot detect a sufficient light intensity reduction past these distances due to the diffraction of light around the objects regardless of the objects' speeds.

FIGURE 13 Maximum Distances for Object Detection with Different Light Source - Detector Distances

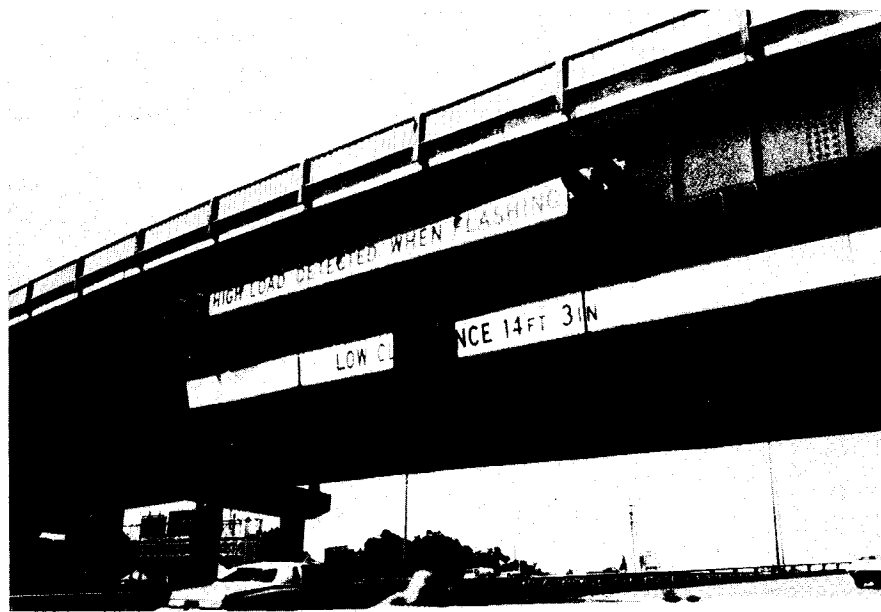
FIGURE 15. LOW CLEARANCE SIGN DAMAGE
