EVALUATION OF FABRIC INTERLAYERS

Research Report 261-2

TEXAS TRANSPORTATION INSTITUTE

November, 1982

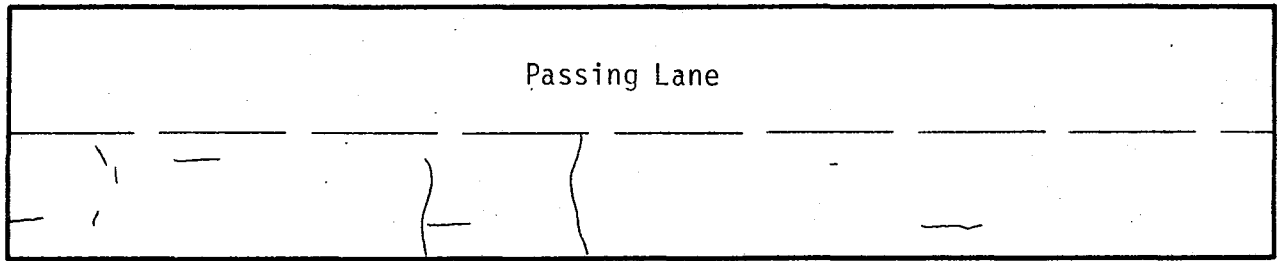
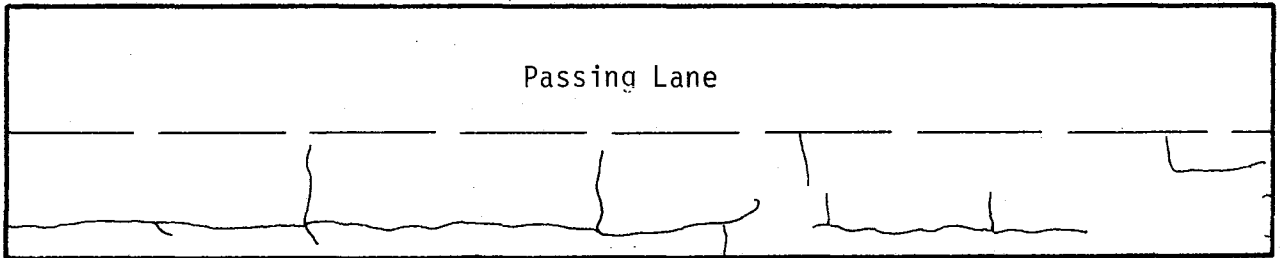
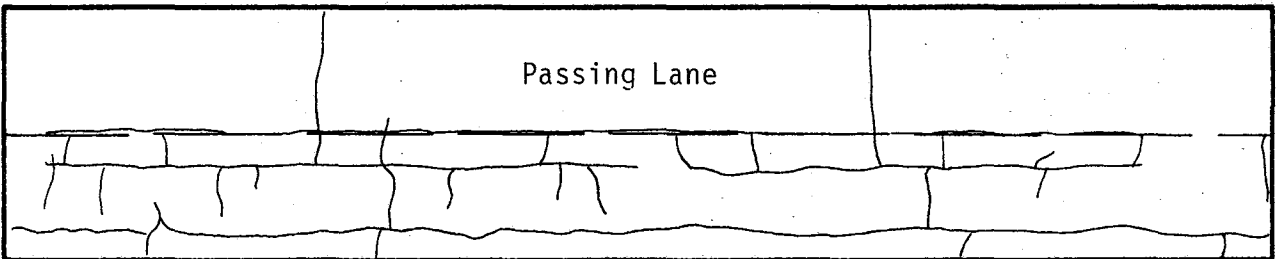
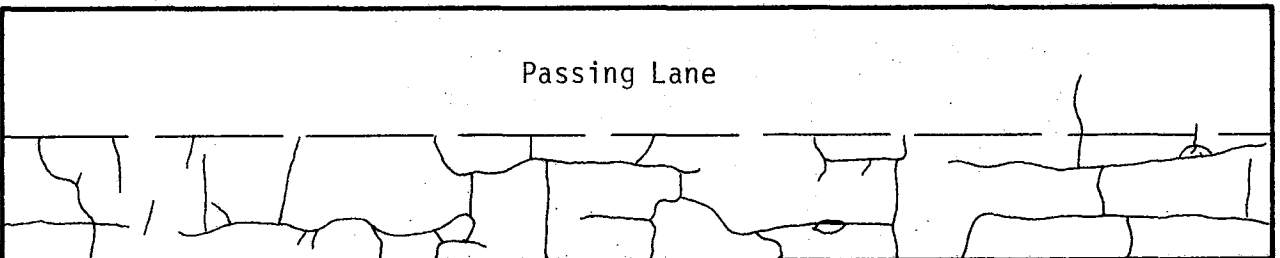
Figure B2. Typical Cracking Patterns on IH 10 West of Sonora (District 7) Prior to Overlaying (Maps are typically 100 ft. x 24 ft.).

The existing asphalt concrete pavement structure prior to overlaying is briefly described in Table 1. It consisted of 15-inches of flexible base and 3-inches of HMAC (170 lb/yd<sup>2</sup> Type C plus 150 lb/yd<sup>2</sup> Type D) originally constructed in 1969. Transverse, longitudinal and alligator cracking was prevalent in the travel lane for the entire length of this project. The most severe cracking was in the right wheelpath which was

also rutted and exhibited evidence of pumping in certain areas. There was very little cracking in the passing lane. Typical cracking patterns are shown in Figures B2 in Appendix B.

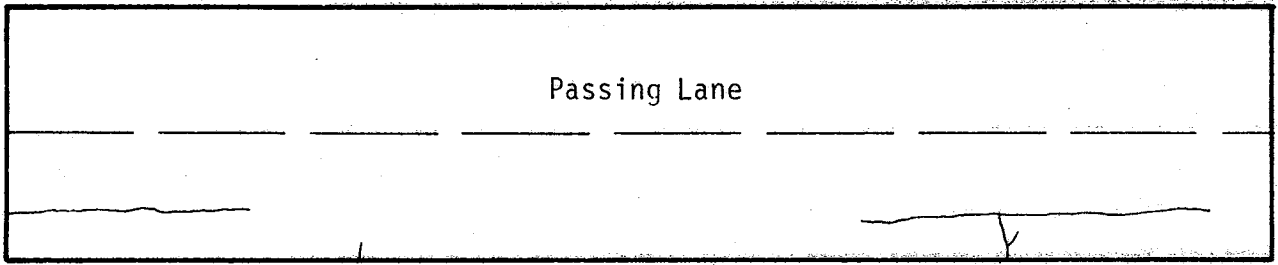
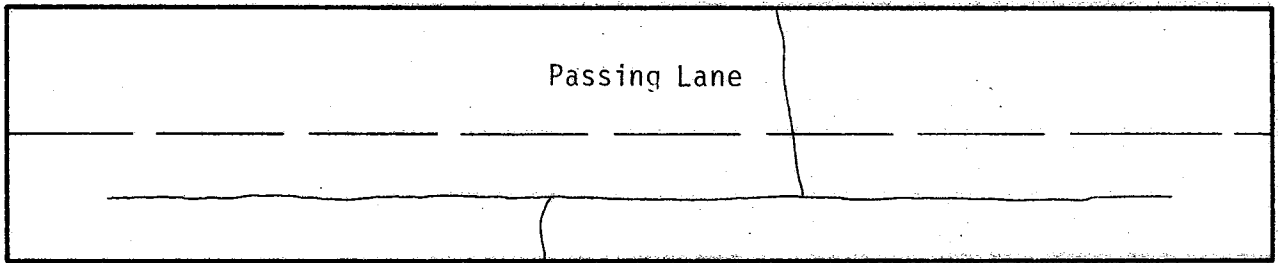
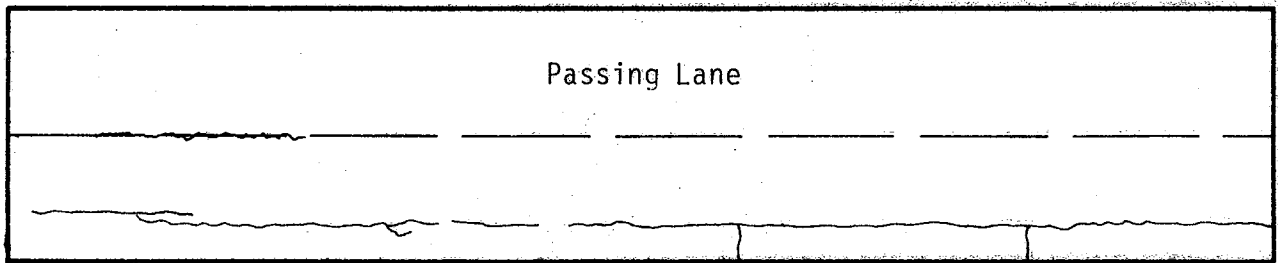
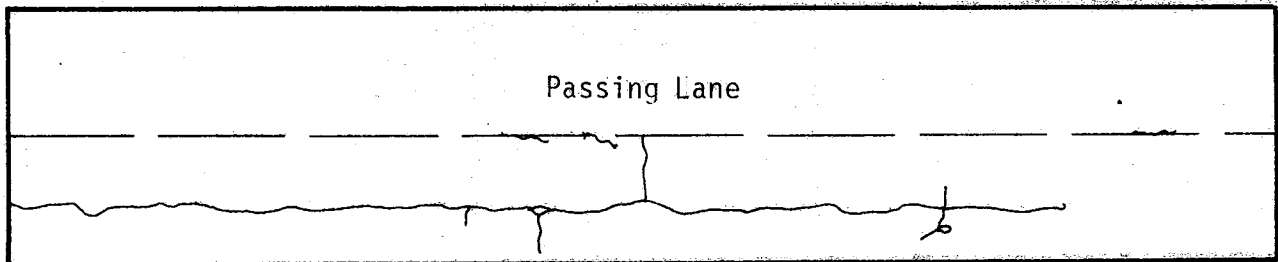
Figure C2. Typical Cracking Patterns on IH40 West of Amarillo (District 4) (These reflected through overlay during first winter). (Maps are typically 100 ft. x 24 ft.).

After seven months in service, following the severe winter of 1979-80, a visual evaluation (in April 1980) revealed a considerable quantity of cracks. Several transverse cracks had appeared at the pavement surface which spanned part or all of the roadway. An intermittent longitudinal crack just to the right of the center of the travel lane was visible along approximately 90 percent of each test section. Typical cracking patterns are presented in Figures C2a through C2d in Appendix C. Although it has not been verified, it is assumed that most, if not all, of these are reflection cracks. At the time of the evaluation, the majority of these cracks had been filled with an asphalt crack sealing material.

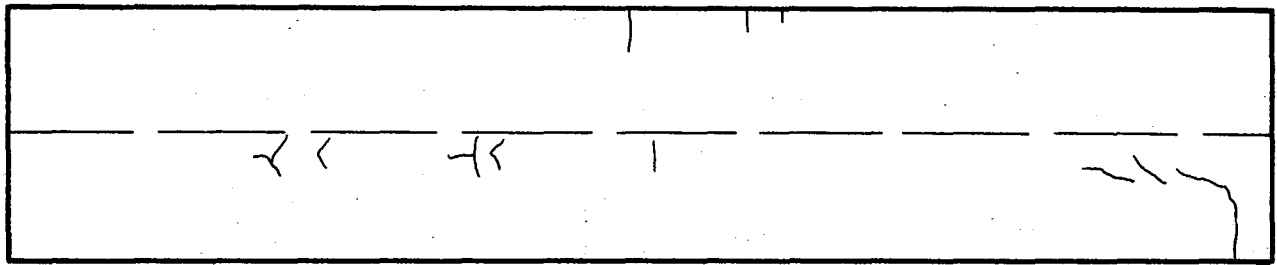
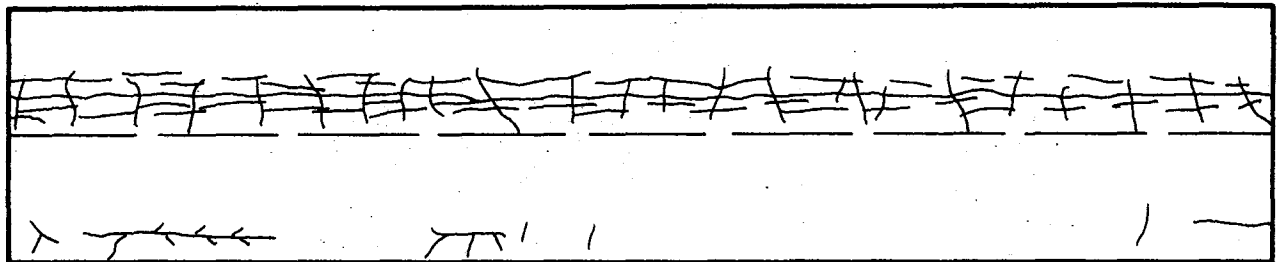
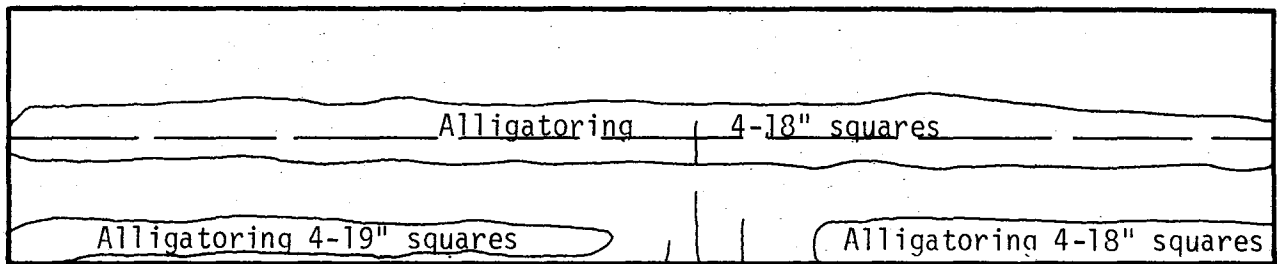
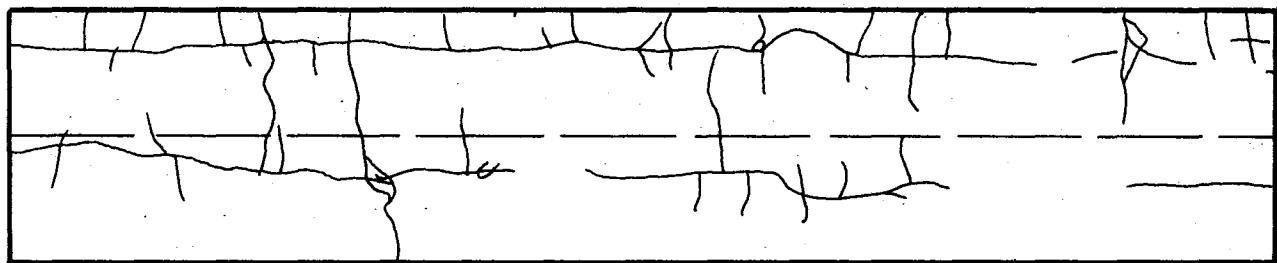
Figure D3. Typical Cracking Patterns on US 281 in Edinburg (District 21) Prior to Overlaying. (Maps are typically 100 ft. x 24 ft.).

Cracking patterns visible at the pavement surface prior to milling were mostly of the fatigue variety with some transverse cracks in isolated areas (Figure D2, Appendix D). Cracking patterns were quite variable from one location to another and ranged in intensity from almost none in a 100 foot length to continuous, severe alligator cracking in one or both wheelpaths. There was evidence of rutting and pumping in isolated areas. Cracking patterns were no longer visible after the milling procedure.
