DEVELOPMENT OF A SAFE END TREATMENT FOR W-BEAM-ON-BARRELS BARRIER

Research Report 262-6F

Research Study No. 2-18-79-262 Safety Devices for Highway Work Zones

November 1984

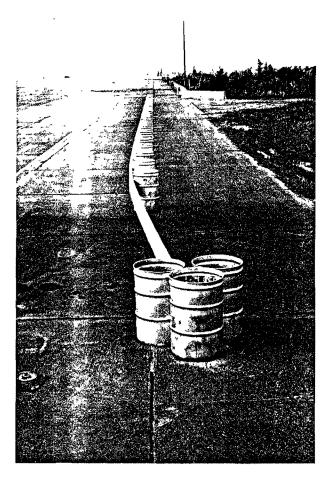
Figure 2. Existing W-Beam on Barrel End Treatment

The WBBB end treatment currently used in Texas is essentially a tapered terminal where the end of the W-beam rail is bent down to the ground. In addition to the taper, the rail end is flared away from the travelway approximately 4 ft (1.2 m) over a distance of approximately 50 ft (15.1 m). The end of the W-beam is held in place by three steel drums at the nose containing 4 in. (10.2 cm) of sand. A 25 ft (7.7 m) section of unsupported rail separates the three steel drums at the nose of the treatment and the beginning of the length of need for the barrier. Figure 1 shows drawings of the existing WBBB terminal design and Figure 2 shows photographs of the constructed end treatment. Note that steel barrels at the beginning of the length of need of the barrier are full of sand as shown in Figure 3. Preliminary analysis of the impact performance of the existing end treatment for WBBB was inconclusive. Therefore, full-scale crash testing of the design was undertaken to accurately determine the crashworthiness of the terminal.

Flared Offset

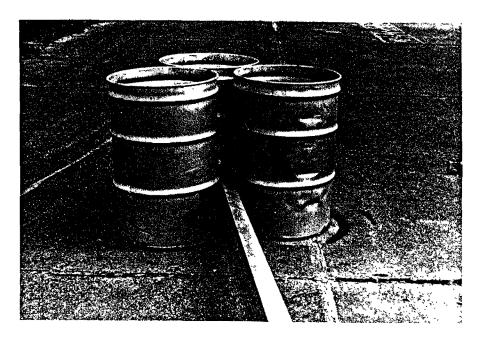
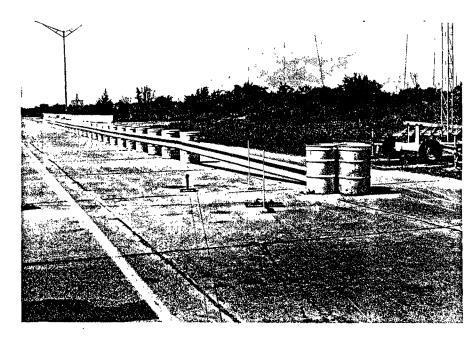
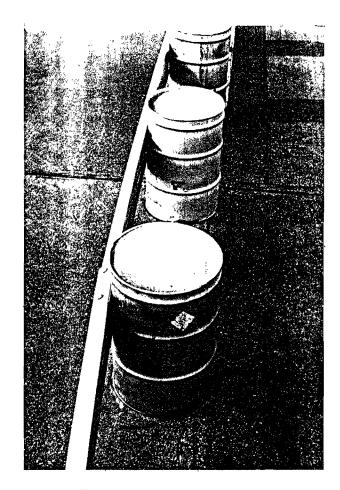
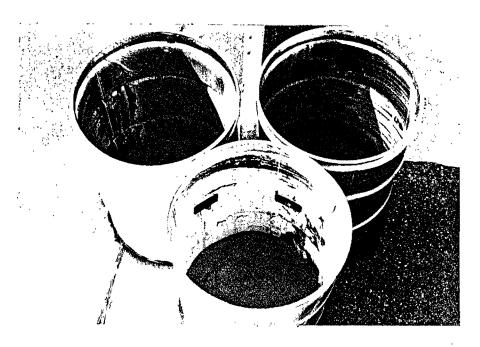
Figure 3. Sand Level in Barrels Existing End Treatment

3-Barrel Nose Terminal

W-Beam Drop From 27" to 12.75"

Typical Level-Full

Nose Terminal Level-4 inches

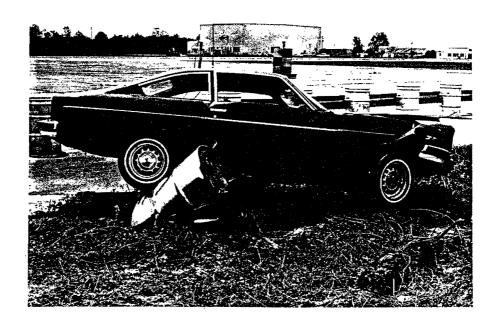
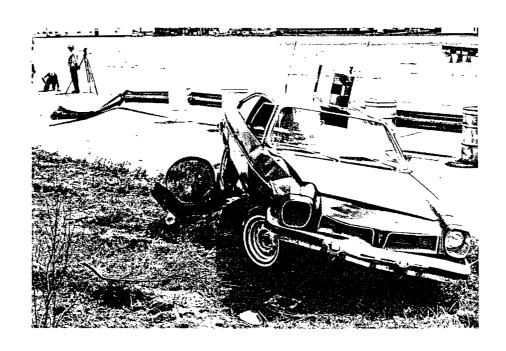
Figure 6. Test Vehicle After Test 12

The longitudinal occupant impact velocity measured during the test was $31 \, \text{ft/sec}$ (9.6 m/sec). This value is only slightly higher than the recommended maximum longitudinal impact velocity of $30 \, \text{ft/sec}$ (9.3 m/sec) and is much lower than the maximum allowable limit of $40 \, \text{ft/sec}$ (12.3 m/sec) (2). The measured lateral occupant impact velocity was $6 \, \text{ft/sec}$ (1.9 m/sec), which is much lower than the recommended limits (2). Longitudinal and lateral ridedown accelerations of $3.8 \, \text{and} \, 2.1 \, \text{g's}$, respectively, were also well below recommended limits (2). Figures $5 \, \text{and} \, 6 \, \text{show}$ the test vehicle before and after the test. Figure $7 \, \text{shows}$ the damage to the test

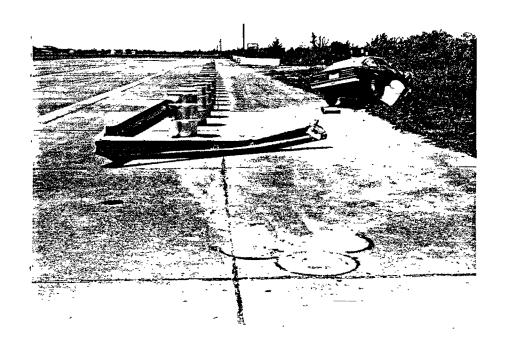
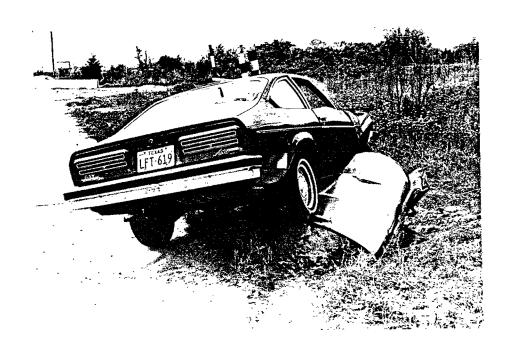
Figure 7. Existing WBBB After Test 12

Test 12*. In the first test a 2410 lb (1095 kg) vehicle impacted the three-barrel end cluster at 48 mph (77 km/h) and an impact angle of 0°. The centerline of the impacting vehicle was offset 15 in. (38 cm) from the center nose of the end treatment. Upon impact the 25 ft (7.7 m) section of unsupported W-beam buckled through the bolt holes midway between the end of the terminal and the beginning of the length of need. The vehicle then rode up onto the clustered barrels and dragged them along as the test vehicle continued to travel behind the barrier. The test vehicle came to rest approximately 55 ft (17 m) from the point of impact. Figure 4 summarizes the results of test 12.

installation. This test was considered to be a success since impact severity measures were within acceptable limits and the test passed normal structural adequacy and post impact vehicle trajectory criteria.

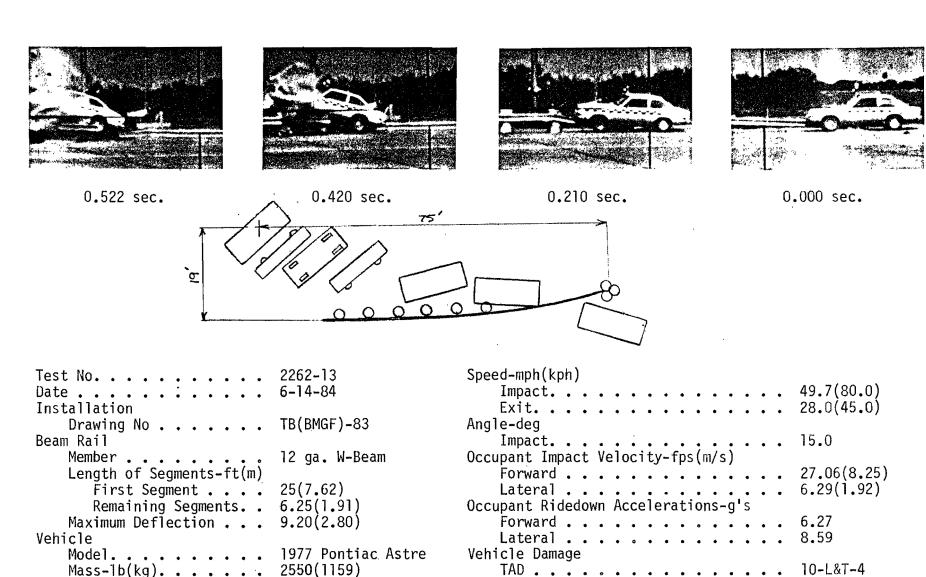
Figure 8. Summary of Test 13

Figure 8 summarizes the results of test 13. Although, as shown in Figure 8, impact severity evaluation criteria were within recommended limits, the test was considered to be a failure since the vehicle rolled over. Figures 9 and 10 show the test vehicle before and after the test, and Figure 11 shows test installation damage.

Note: Vehicle Rolled Over

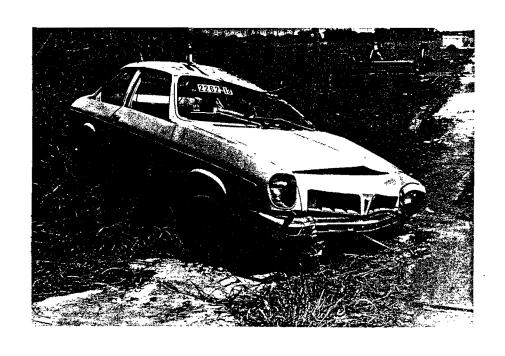
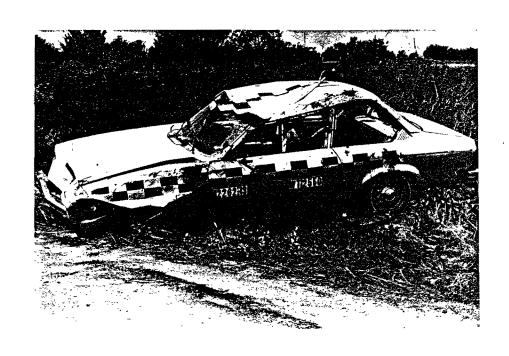
Figure 10. Test Vehicle After Test 13

Test 13. The second test involved a 2250 lb (1021 kg) vehicle impacting the end treatment midway between the nose and the beginning of the length of need. The test vehicle impacted the terminal at 49.7 mph (80 km/h) and an angle of 15 deg. relative to the longitudinal barrier. Upon impact, the W-beam at the point of contact was pushed down to the ground where it remained in an upright position. The test vehicle's left front tire then climbed over the guardrail and the rail lifted the front of the vehicle off the ground. As the vehicle approached the beginning of the length of need, the front bumper was raised to a height of approximately 27 in. (69 cm). The test vehicle's front bumper struck the first barrel full of sand near the top of the steel drum. The vehicle then ramped over the barrier and rolled a complete revolution before coming to rest on its tires approximately 75 ft (23 m) from the point of impact.

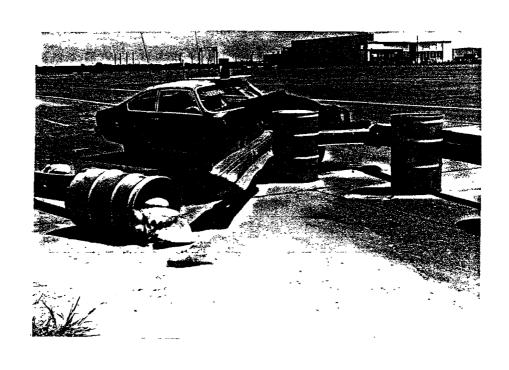
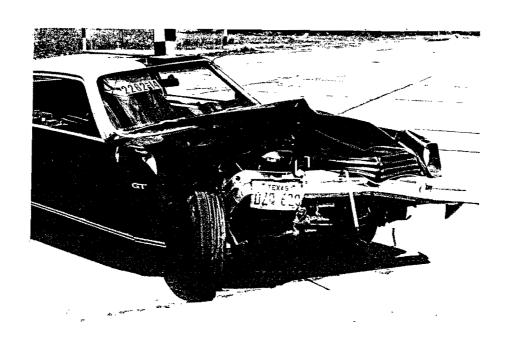
Figure 16, Test Vehicle After Test 14

The forward and lateral occupant impact velocities were 16.7 and 8.4 ft/sec (5.2 and 2.6 m/sec), respectively, while the forward and lateral ridedown velocities were 11.4 and 9.2 g's, respectively. These values are well below the recommended values cited in NCHRP Report 230. Figures 15 and 16 show the test vehicle before and after testing. As illustrated, the

vehicle suffered extensive damage to the front and was not operable. Figure 17 shows photos of the test installation before and after impact. This test was determined to be successful because all measures of impact severity were within acceptable limits, the modified terminal exhibited no structural inadequacy, and vehicle post impact trajectory was acceptable.

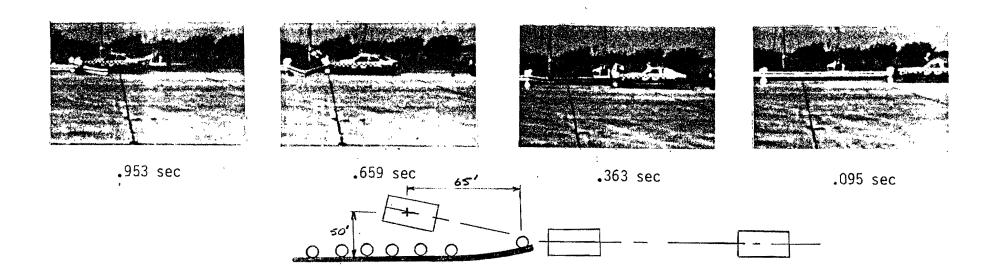
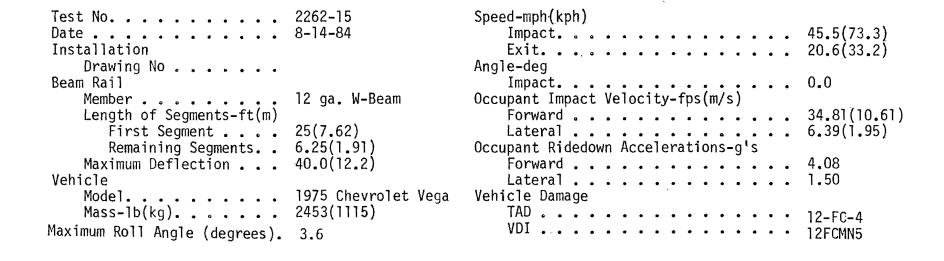
Figure 18. Summary of Test 15

Figure 18 shows a summary of test 15. As shown in this figure the longitudinal occupant impact velocity was 35 ft/sec (10.8 m/sec), which is above the recommended limit of 30 ft/sec (9.3 m/sec) but below the maximum allowable limit of 0 ft/sec (12.3 m/sec) ($\underline{2}$). All other measures of impact severity shown in Figure 18 were well below the recommended values. Figures 19 and 20 show the damage incurred by the test vehicle, and Figure 21 shows the damage sustained by the test installation. Although the longitudinal occupant impact velocity was above recommended limits for this test, the test was considered to be a success because the impact velocity was within maximum acceptable limits and the test passed all other methods of evaluation.
