BRIDGE SLAB CONCRETE PLACED ADJACENT
TO MOVING LIVE LOADS

Research Report Number 266-1F
Bridge Slab Concrete Placed Adjacent to
Moving Live Loads
Research Study Number 2-5-79-266

Texas Transportation Institute
The Texas A&M University System
College Station, Texas

January 1981

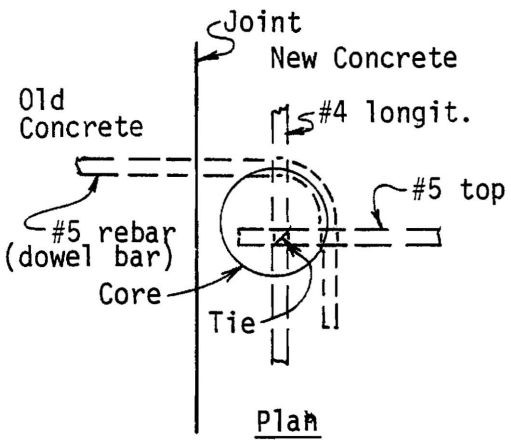
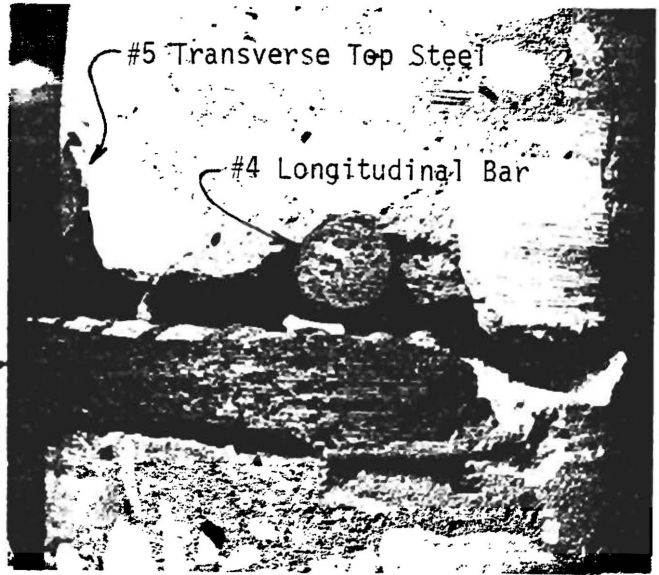
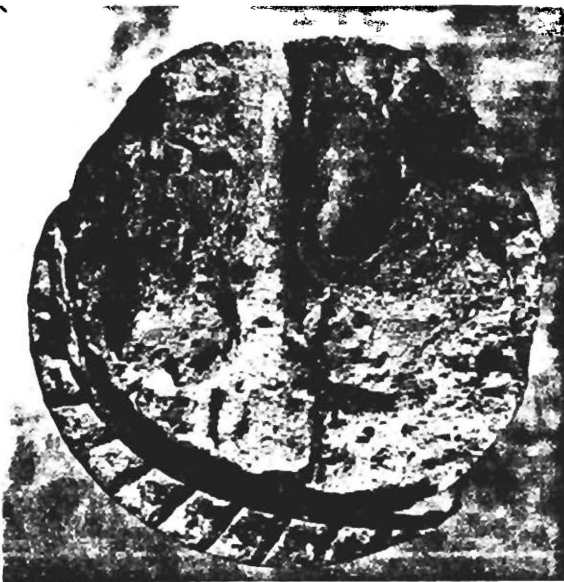
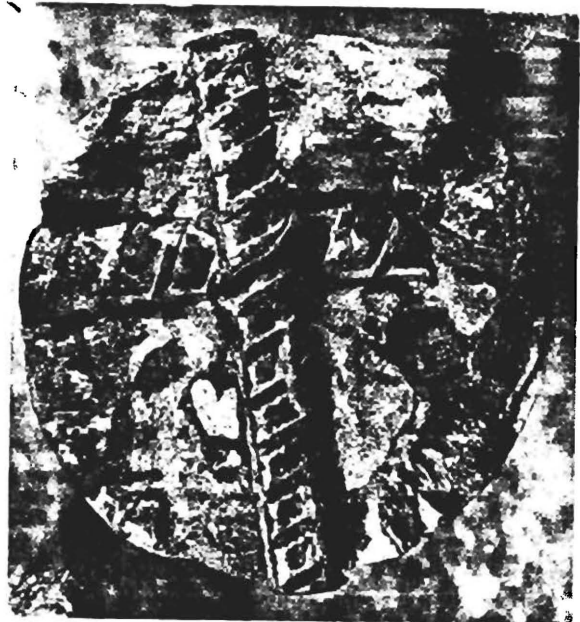
Figure 16. Core WRDD10F from Southbound Traffic Bridge, US 75 & White Rock Creek.

It is believed that the intermittent deflections caused by traffic on the old deck caused the fresh concrete to puddle at the level of top steel. This

Horizontal bend, #5 bar from old concrete crossing joint to new concrete.

WRDD10F	8 1/4	None	Steel	Top of core is cracked parallel to traffic; concrete in upper part appears to have broken after set began. Core is separated horizontally at level of #5 new rebar (the end 3 in. is in the core), the #4 longitudinal bar tied to and just below the #5 new rebar, and the #5 rebar dowel from the old concrete (this bar is split by the core bit at its horizontal bend) which is just beneath the #4 bar. The two parts, separated in coring, leave an open crack, see photo to right, about 1/4 in. wide when they are carefully fitted together. The imprint of the #4 bar has no bar

CORE MARK	LENGTH (in.)	TREATMENT	CONTINUOUS REINF.	REMARKS
				deformation marks, and its surface appears to have been puddled when the concrete was plastic. Clearly, the relative movements of the old and new decks caused this.
				Northbound traffic, 90 ft span (10 cores)
WRDLU1F	8 1/2	TPF	Steel	Random hairline cracks, top and bottom.
WRDLU2	6	None	Steel	No visible defects; bar impression contains mill scale indicating good bond.
WRDLU3F	8 3/4	TPF US	Steel	Random hairline cracks, bottom only.
WRDL1F	8 1/2	TPF	Steel	The #5 dowel bar from existing deck to new deck was cut in coring across the joint between new and old concrete. A definite void around the dowel in the new concrete exists. This indicates relative vertical movement between the dowel and the new concrete. No other distress is visible.
WRDL2F	8	TPF Dye	Steel	Cored across joint between new and existing deck cutting #5 dowel. A #4 longitudinal bar, and the end of a #5 transverse bar, are wired together in the core. The concrete around the bars is not compact; it contains voids and cracks which are probably caused by relative movement between the dowel (and the other steel wired to it), and the fresh concrete. Random hairline cracks, top and bottom.

Localized potential trouble areas exist at rebar dowels that are bent horizontally 90 degrees upon emergence from the old concrete. A wallowed out area was found in five cores from bridges using that detail for the dowel. The trouble was not found around dowels that extended straight, without bending, into the new concrete.

It is recommended that the dowel be treated as follows in order to avoid future void areas in concrete around the dowels at the joint between the old and new concretes:

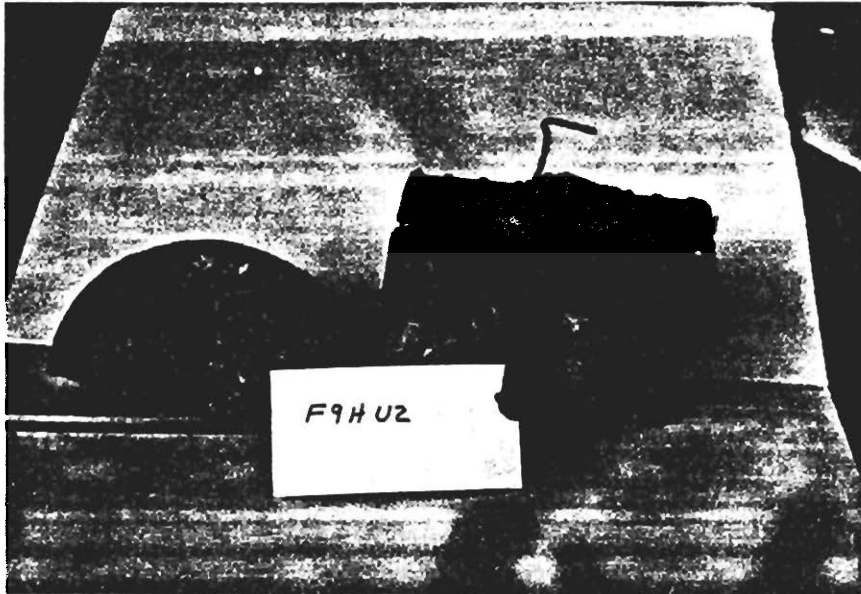
concrete 1/2 in. from the end of the two #5 bars lying side by side. This core is shown in Figure 18. The core F9HD2 contained two #4 bars side by side, and one #5 bar. The dye penetrated 1/4 in., at the most, from the ends of these bars. There was no evidence of debonding of steel in these cores -- neither from dye penetration nor from the condition of the material in the bar imprint area.

Figure 18. Core F9HU2 After Dye Treatment.

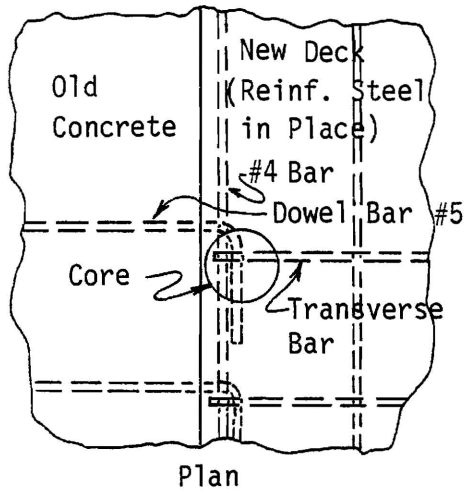
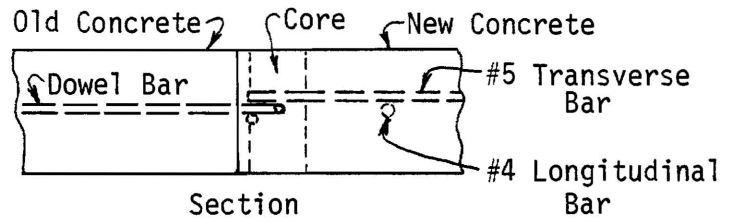
The dowel bar is a reinforcing bar in the old concrete.

Figure 19. Core WRDD4; Location and Photograph.

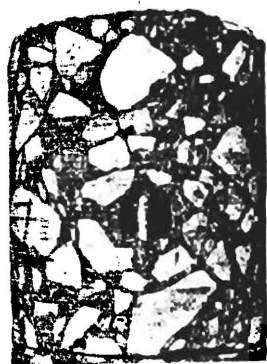
Cores WRDD7 and WRDD3F were taken from the 50 ft span southbound US 75-White Rock Creek bridge. There was some dye penetration along some of the steel in these cores, but the full bar imprint was never completely colored.

The imprint of the bars in the mortar was sharp and clear in both of these cores, and there appears no good evidence that there was debonding in either case. Core WRDD7 is shown in Figure 20.

Figure 20. Core WRDD7 Before and After Dye Treatment.

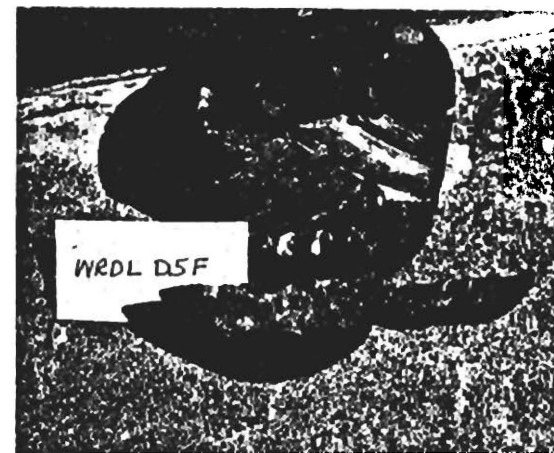
Core WRDL5F

WRDL5F	Dye penetrated the mortar to a depth of about 1/4 in. The #5 top bar, parallel to traffic, was very close to the vertical face of the core. It had only 1/8 in. cover on the outside, and there was a void space visible at the top of this bar. Dye around this bar was complete, coloring the entire embedded area. When the bar was lifted from its embedment it was coated with a film of colored paste. The imprint was not sharply defined and there were numerous small voids and air pockets in that imprint. This condition was probably caused by movement of the bar with respect to the plastic concrete.

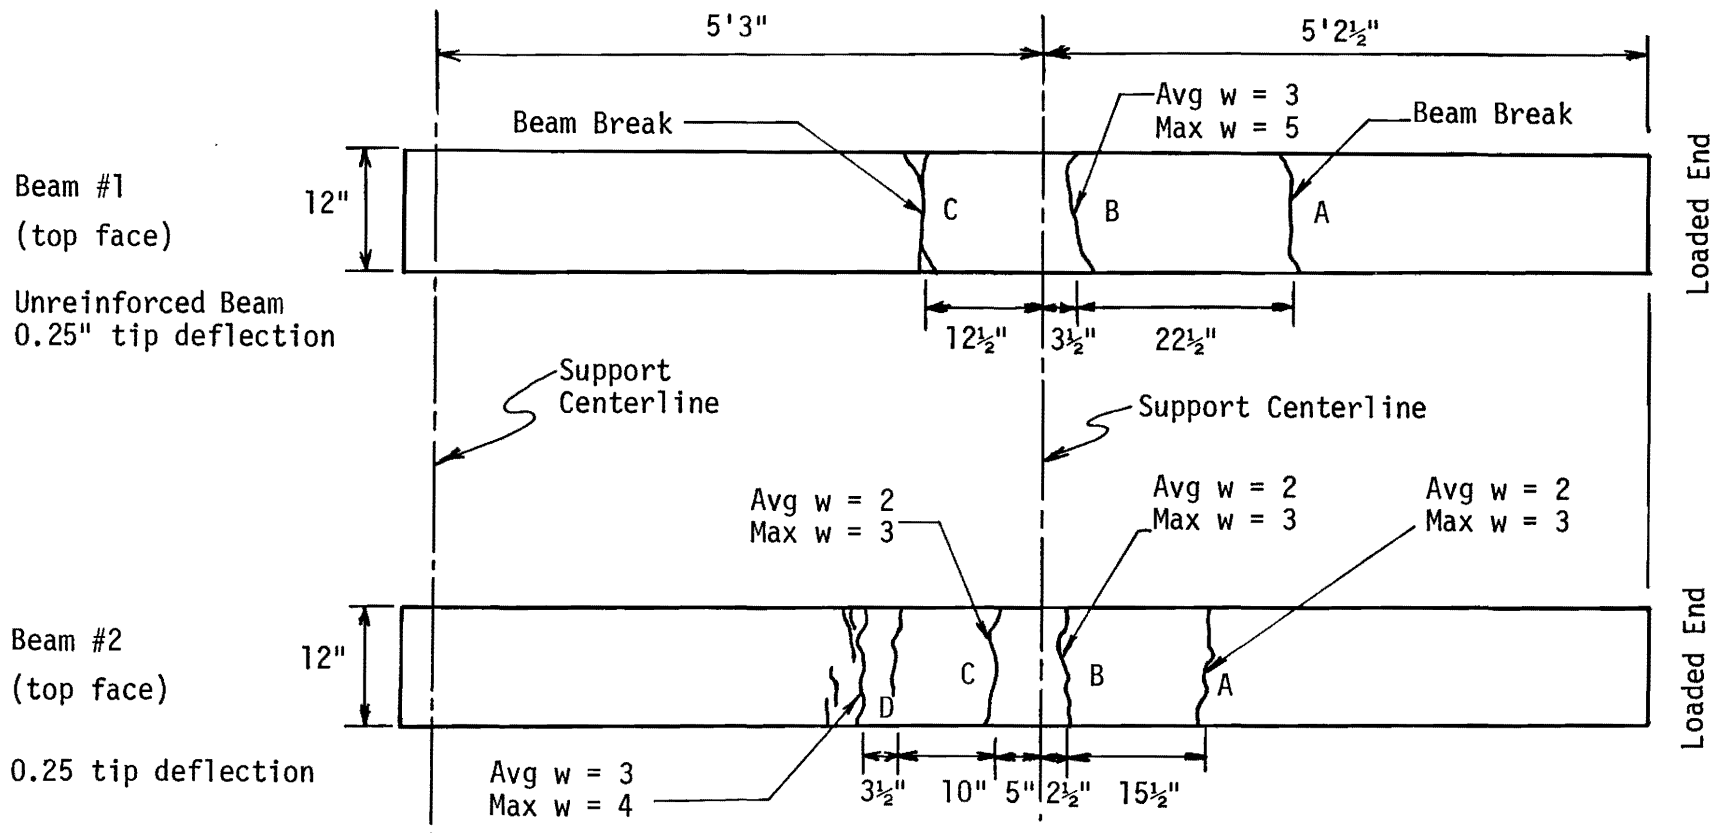
Figure 36. Beam Crack Pattern at End of Test.
Beams #1 & #2

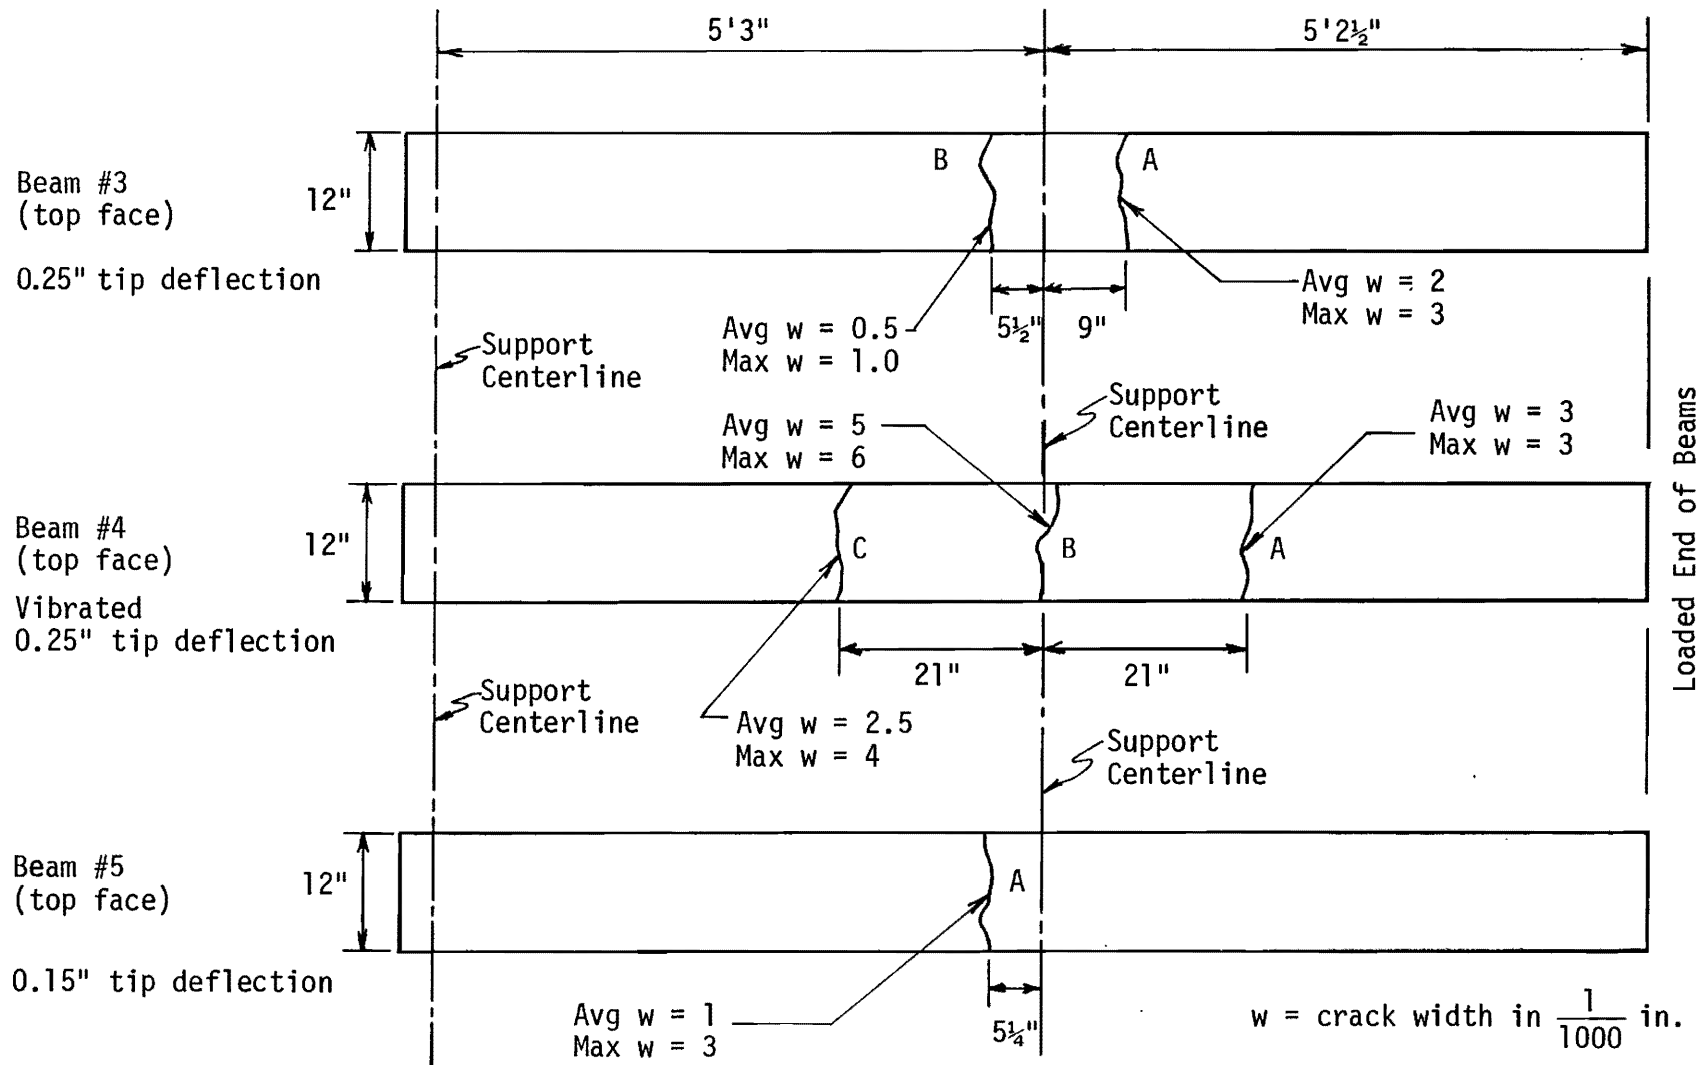
Test beam #5, with 0.15 in. end deflection as compared to 0.25 in. for the other test beams, had the smallest surface curvature as shown in Table 10. Only one crack formed in the vicinity of the center support as compared to

Figure 37. Beam Crack Pattern at End of Test
Beams #3, #4, & #5.
