1. Report No. TX-96/2919-2		2. Government Accession No.		3. Recipient's Catalog No.	
4. Title and Subtitle FORENSIC EVALUATION OF THE CEMENT TREATED BASE FAILURE ON SH 36 IN HOUSTON				5. Report Date October 1995

**FORENSIC EVALUATION OF THE CEMENT TREATED
BASE FAILURE ON SH 36 IN HOUSTON**

Research Report 2919-2
Research Study Number 7-2919
Research Study Title: Spall Repair, Base and Subgrade Stabilization,
and Non Destructive Test Service (NDT) for the Houston District, Phase II

October 1995

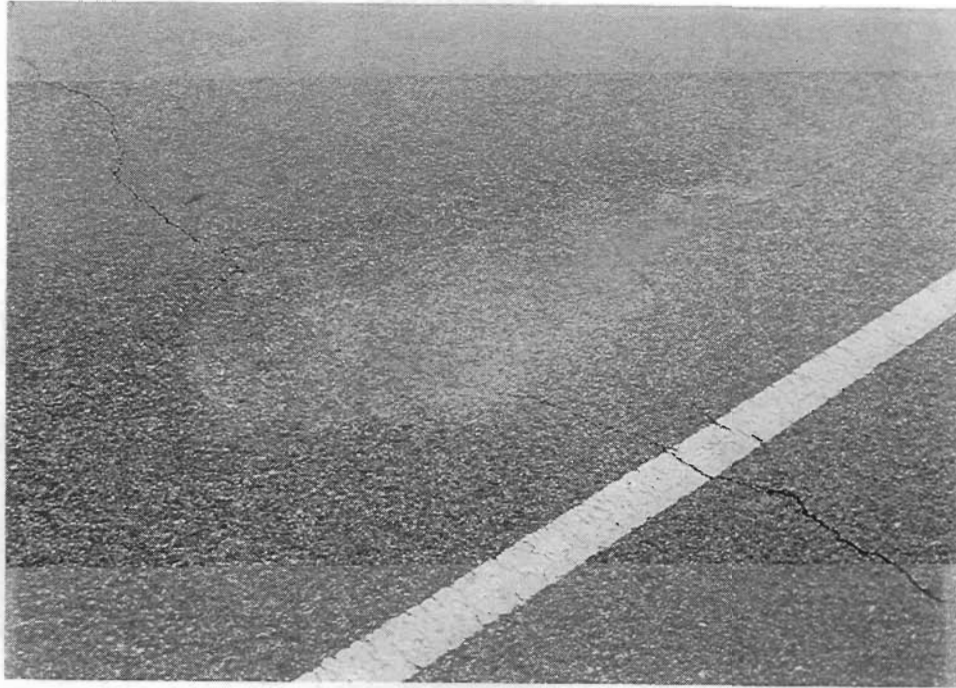
After three years in service, several sections on this highway were showing significant distress. The distress took the form of transverse depressions in the wheel paths. Figure 1 shows a typical transverse crack on this highway; evidence of pumping is clearly present. In the worst areas, the depressions were at about 6 meter spacings and about 0.3 m wide with depths ranging from 10 to 20 mm. The depressions were found initially in the wheel paths but eventually extended to cover the entire lane; they were centered around existing transverse reflection cracks. The depressions did not extend into the shoulder. The riding quality of the section was noticeably reduced in these areas. The section had a riding quality similar to that of a faulted jointed concrete pavement.

Figure 1. Transverse Depressions in the Wheel Path (Note Pumping of Fine Material).

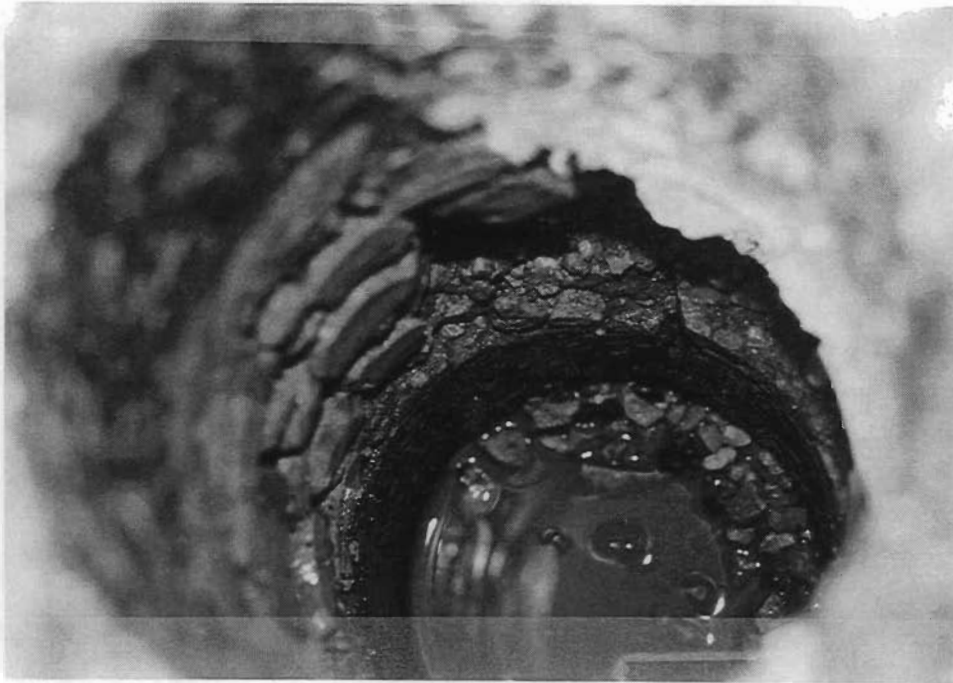
Figure 3. Core Hole with Disintegration of the Top 150 mm of the CTB Layer.

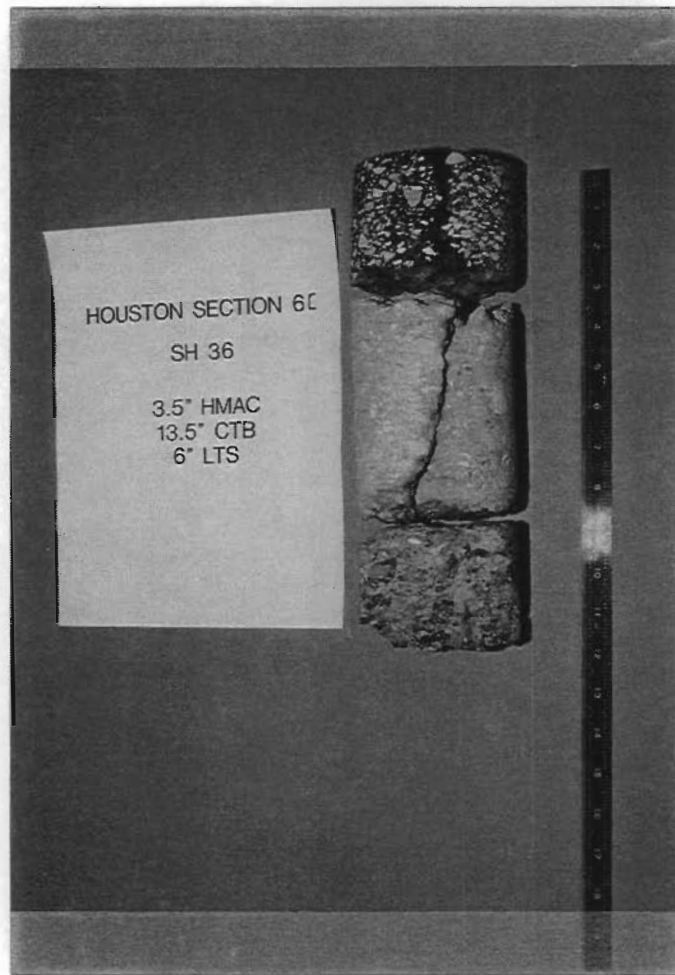
Figure 4a. Core Sample Taken through Crack in the Pavement.

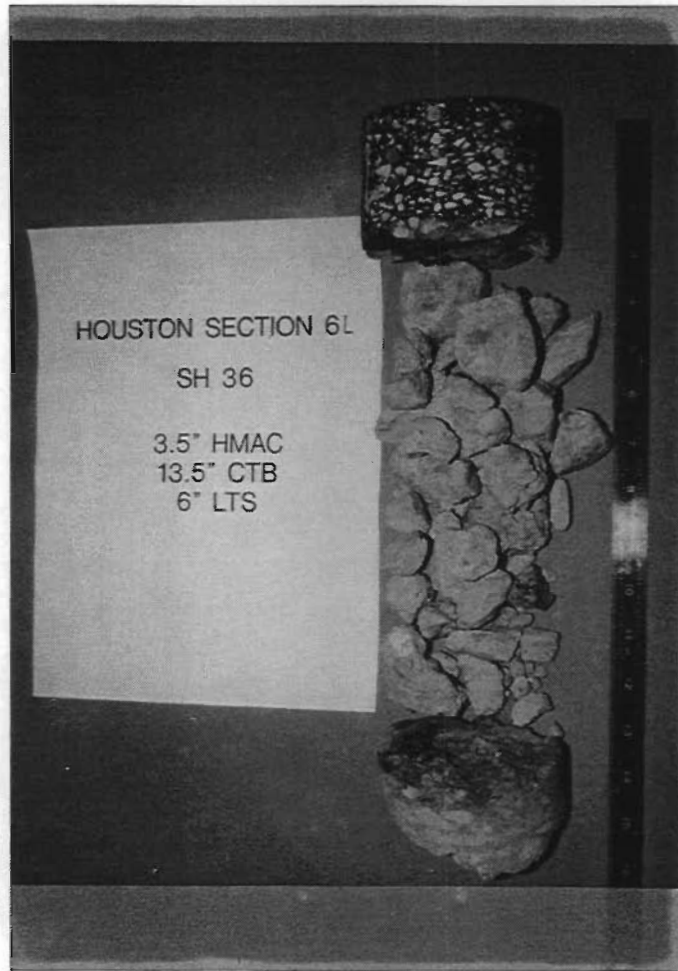
Figure 4b. Top 150 mm of the CTB Completely Disintegrated.

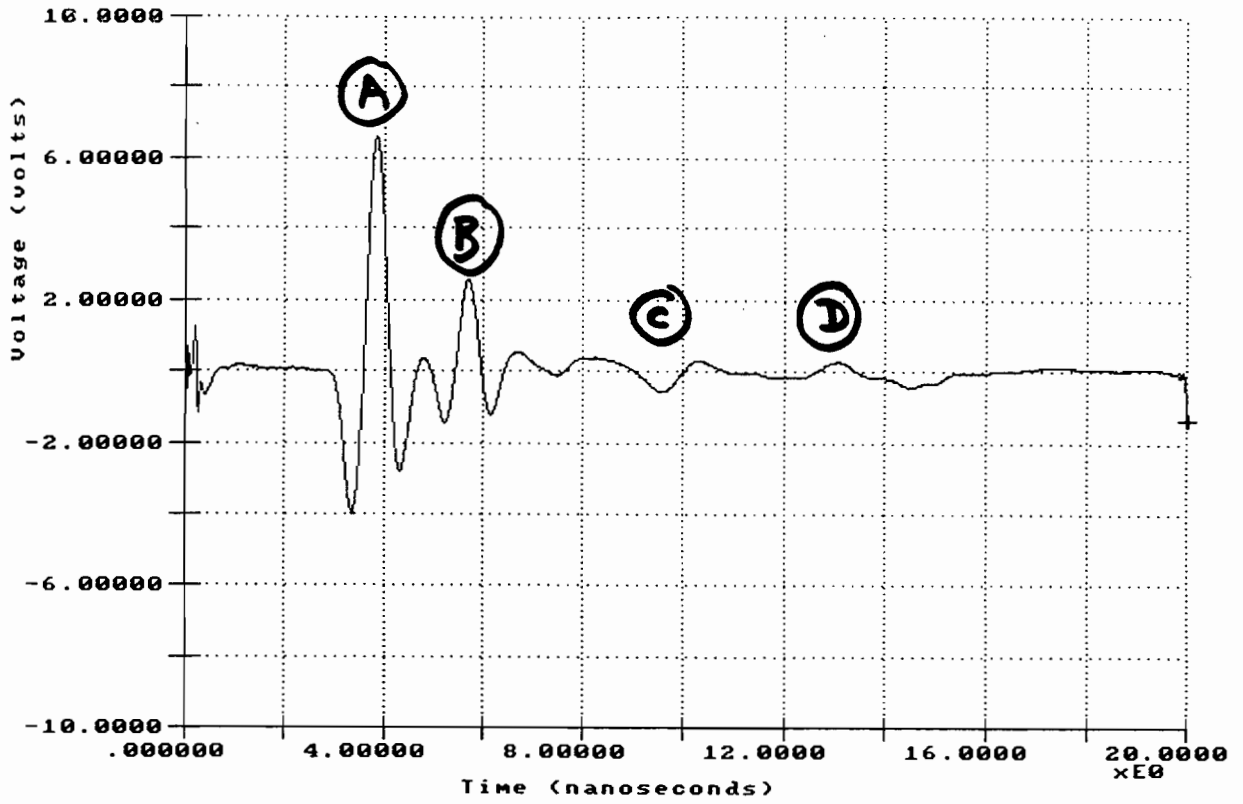
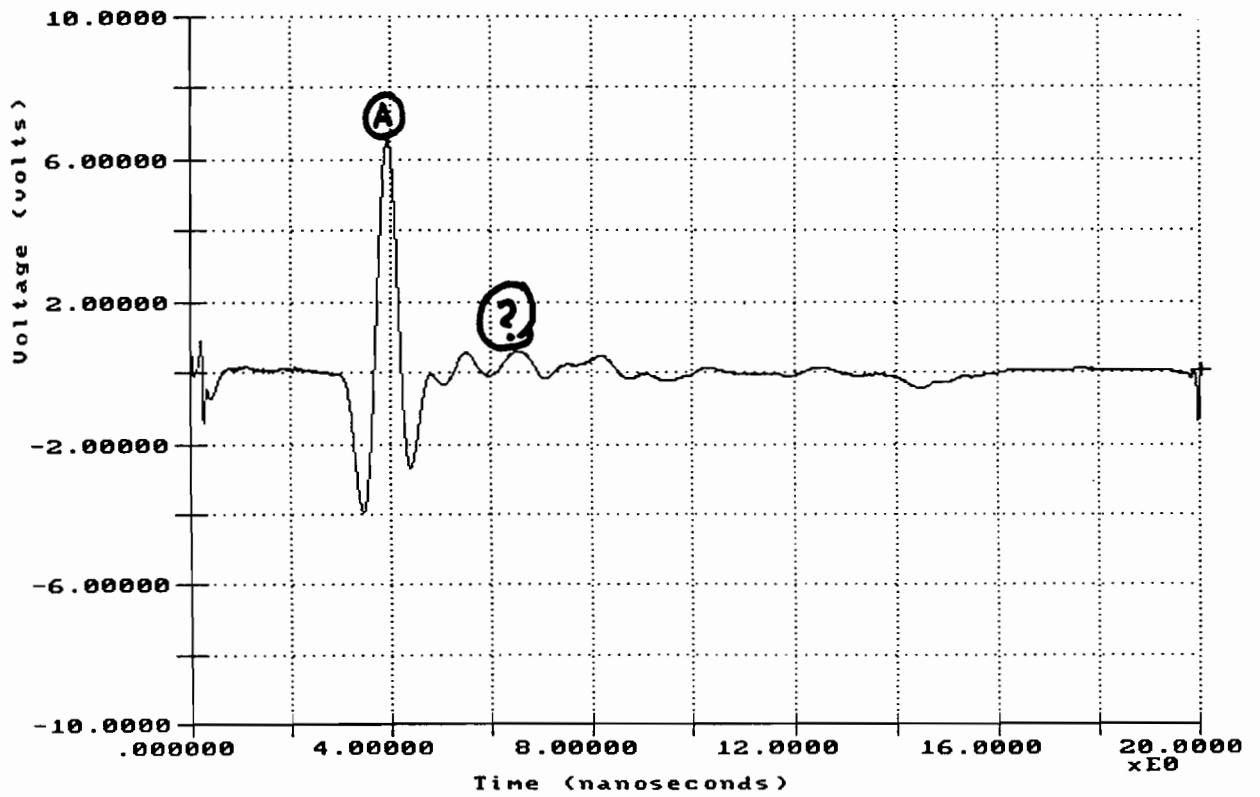
Figure 7. GPR Waveforms from SH 36.

GPR traces from an undistressed “good” and “bad” area of SH 36 are shown in Figure 7. The good area has three distinct peaks, A, B, and C being reflections from the

top of the AC, top of the upper CTB layer, and top of second CTB layer. Peaks A and B are positive peaks, and peak C is a negative peak. The negative peak indicates that the lower CTB has a lower dielectric than the upper CTB layer. The trace from the distressed area only has one clear peak, that being the surface reflection A. The major difference between these traces is the decrease in amplitude of peak B. This decrease is associated with a change in moisture content and density of the top CTB layer. The lower peak in the distressed area is associated with a low density location. It appears that GPR may be used to discriminate good from bad areas, although more GPR testing and coring should be performed to confirm this.

One other point of some interest from the GPR traces is the calculated dielectric of the top CTB layer. The value in the sound area was calculated to be in the 11 to 13 range; this is substantially higher than previously measured on other CTB sections in Houston. Normally, a value in the range 8 to 9 is found. This high value on SH 36 can only be attributed to the presence of moisture in the top layer of CTB. It rained the day before testing, and it is apparent that some of this moisture was trapped within the top CTB layer. The dielectric value of the asphalt was 6 which is in the expected range. How the moisture enters the CTB is unknown. One possibility is that moisture enters surface cracks and through internal suction saturates the upper CTB layer.

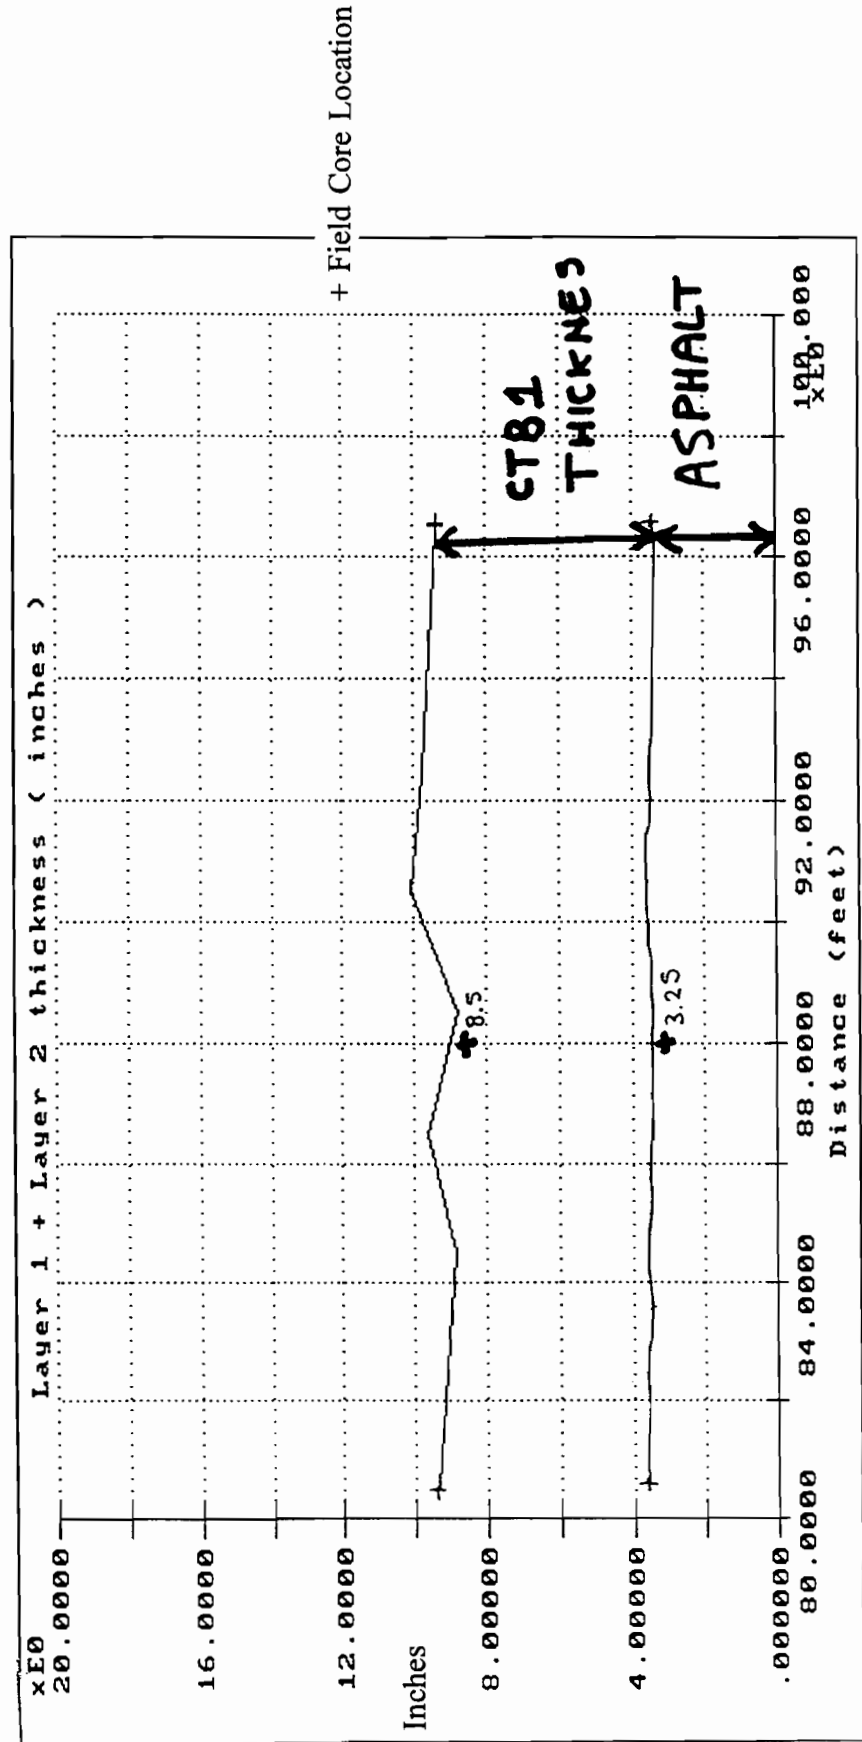
The amplitudes and time separation between peaks A, B, and C can be used to estimate the thicknesses of the asphalt and top CTB layer. A plot of calculated layer thickness for a short section around the core location is given in Figure 8. The core was taken at 27 m from the start of the section; the actual core thicknesses are marked with a + at this location. The actual thicknesses compare well with the predicted thicknesses.

Figure 8. GPR Layer Thickness Estimates for SH 36. (1 inch = 25.4 mm, 1 foot = 0.305 m)

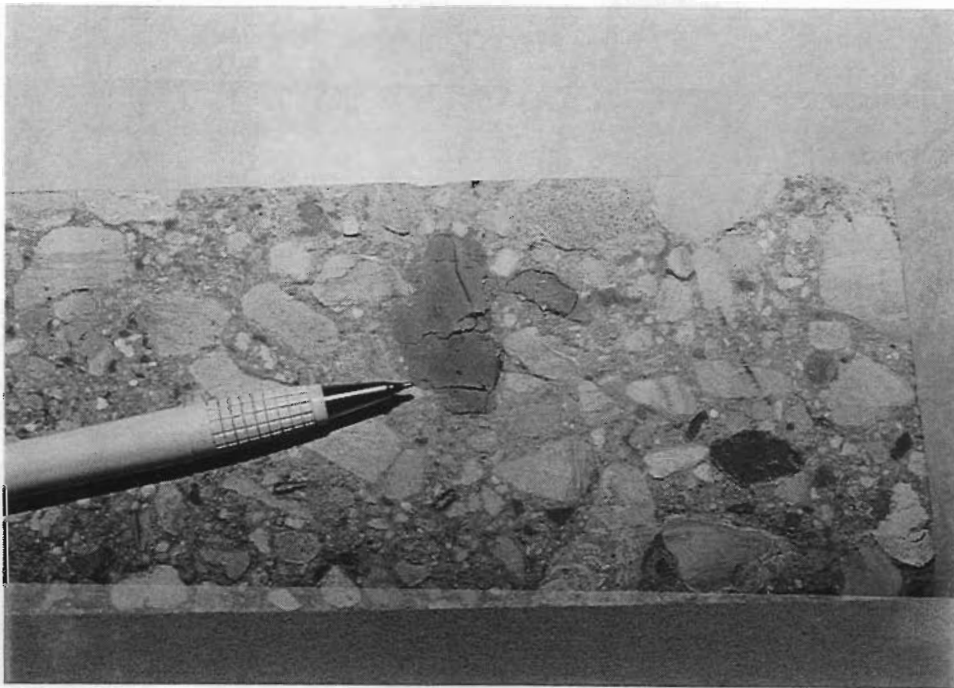
A sieve and subsequent hydrometer analysis were performed on the base material to determine the amount of clay present in the base. From the hydrometer analysis, it was found that the base contained as much as 15% clay. The clay lumps found in the base can be seen in Figure 9. It is believed that apart from the clay seen with the naked eye, the base material is dispersed with microscopic sized clay particles. Even with some severe clay contamination, the base material had a PI of 9 which passes TxDOT specifications for base materials ($PI < 10$).

The large amount of clay in the base causes a high suction value in this layer, which means the material is water susceptible and will soak up any free water. A proof for the excess amount of water in the CTB layer is the high dielectric constant values found during radar analysis (discussed in the previous section).

Figure 9. Clay Ball Found in the Top 150 mm of the Cement Treated Base.

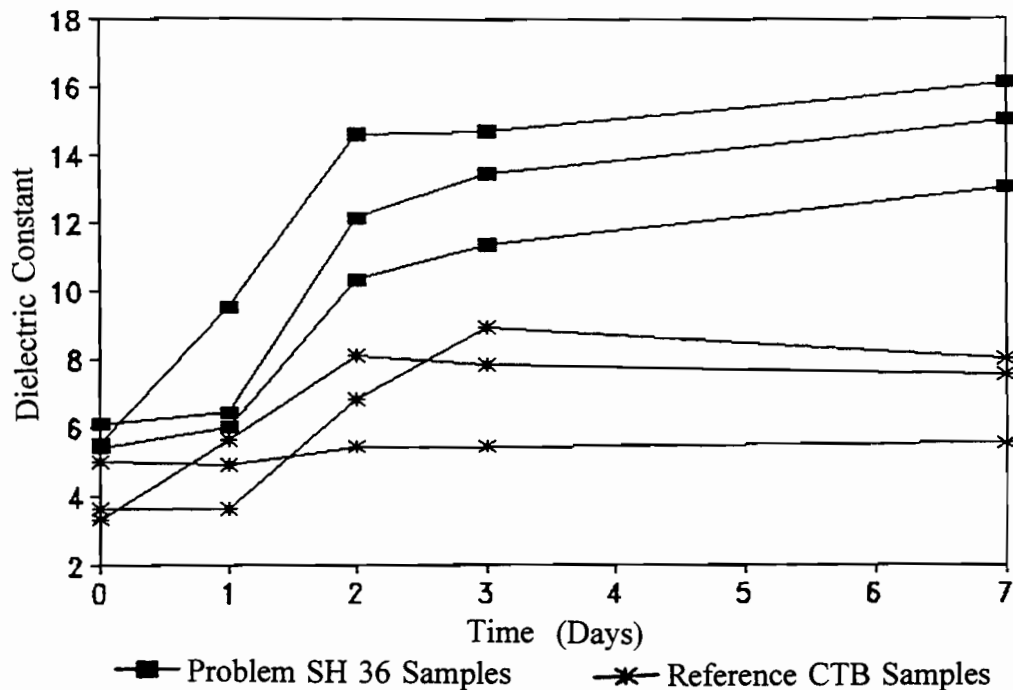
Figure 11. Dielectric Values vs. Time of Samples During Soak Test.

apparent from visual observation that the SH 36 cores were saturated after two days. The moisture reached the surface through internal suction forces. Even after two weeks of soaking, none of the other cores reached saturation. This indicates that the rate water is absorbed by the samples containing clay lumps is much higher than the rate water is soaked up by the sound samples.

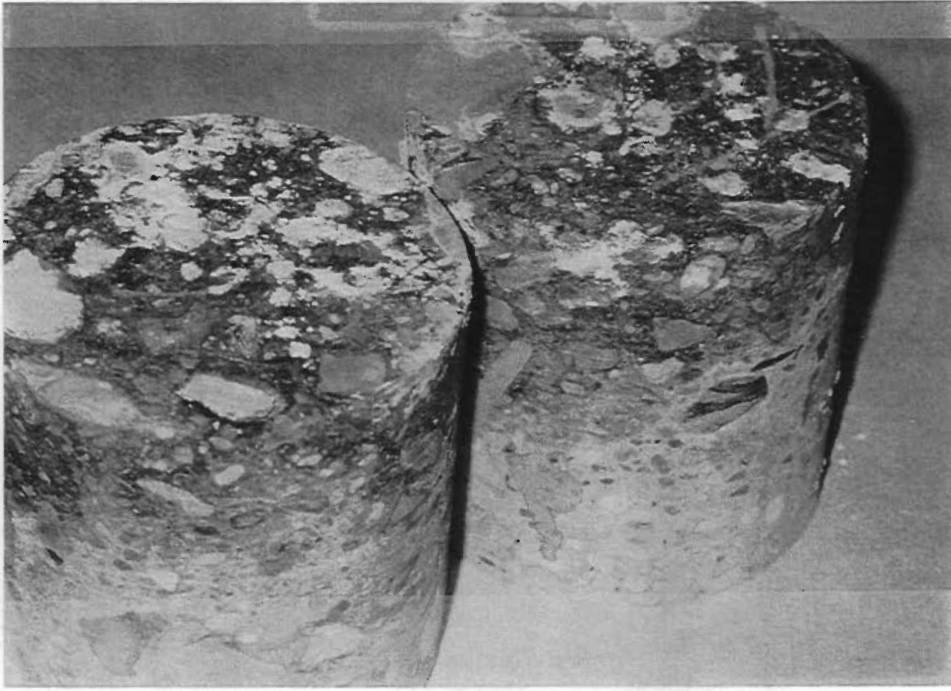
After about the fifth day of conducting the soak test, another phenomenon became apparent. The samples from SH 36 had white crystals forming on all the evaporation surfaces, especially at the top of the core samples. This phenomenon is known as efflorescence in concrete and carbonation in stabilized layers; this commonly occurs when air or water leaches through these materials. The white crystal residue is calcium carbonate that forms when calcium hydroxide leaches from the stabilized base and reacts with carbon dioxide from the air. The reduction of available calcium hydroxide in the stabilized material is accompanied by a dramatic strength loss and can lead to complete chemical decomposition. Efflorescence only occurred on the core samples from SH 36 with a high clay content. Two samples showing evidence of efflorescence are shown in Figure 12.

Figure 12. Signs of Efflorescence on Core Samples from SH 36.

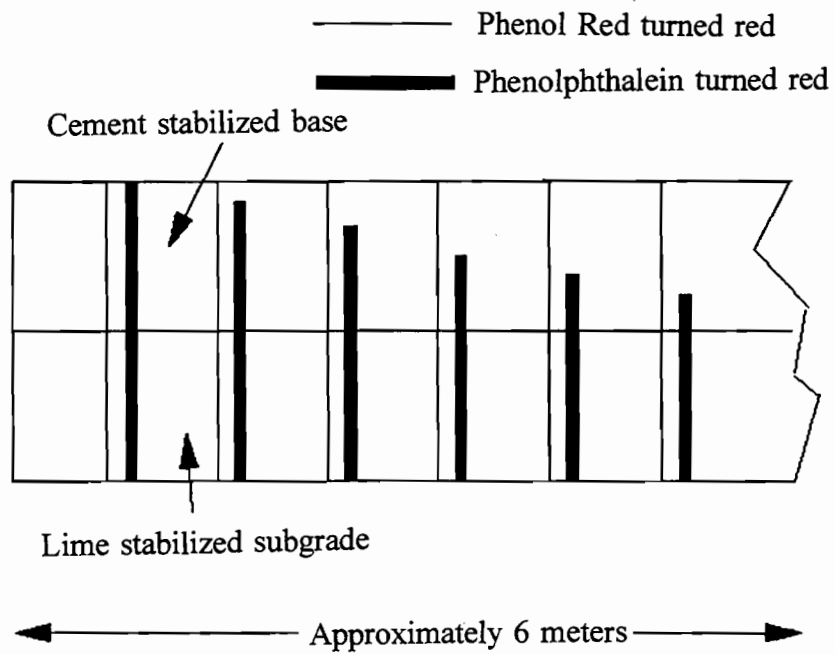
- The phenol red turned red throughout the length of the cross section of both layers.
- The phenolphthalein turned red through the lime and cement stabilized layers on the eastern-most side of the pavement. However, when moving to the inside of the pavement, the length of the red strip decreased. This is indicated in Figure 14 which is a schematic representation of the cross section of the pavement. At the pavement edge, the pH of both base and subgrade is high, indicating adequate stabilization. Moving towards the middle of the section, a layer of low pH is observed in the CTB. This carbonated layer increased in thickness when moving to the middle of the section.

The following are proposed as contributing factors on the failure of US 59:

- a) No mix design specifies the percentage stabilizer to be used.
- b) Inadequate curing of the surface.
- c) Overwetting of sections of the base to achieve compaction.

Figure 14. Carbonation Test Performed on the Eastern End of a Freshly Cut Trench Through the Cross Section of US 59.
