1. Report No. TX-98/2919-3	2. Government Accession No.	3. Recipient's Catalog No.	
4. Title and Subtitle INVESTIGATION OF SPALL REPAIR FOR CONCRETE PAVEMENT		5. Report Date July 1996 Resubmitted: July 1997

**INVESTIGATION OF SPALL REPAIR
FOR CONCRETE PAVEMENT**

Research Report 2919-3
Research Study Number 7-2919
Study Title: Spall Repair, Base and Subgrade Stabilization, and
Non Destructive Test (NDT) Services for the Houston District, Phase II

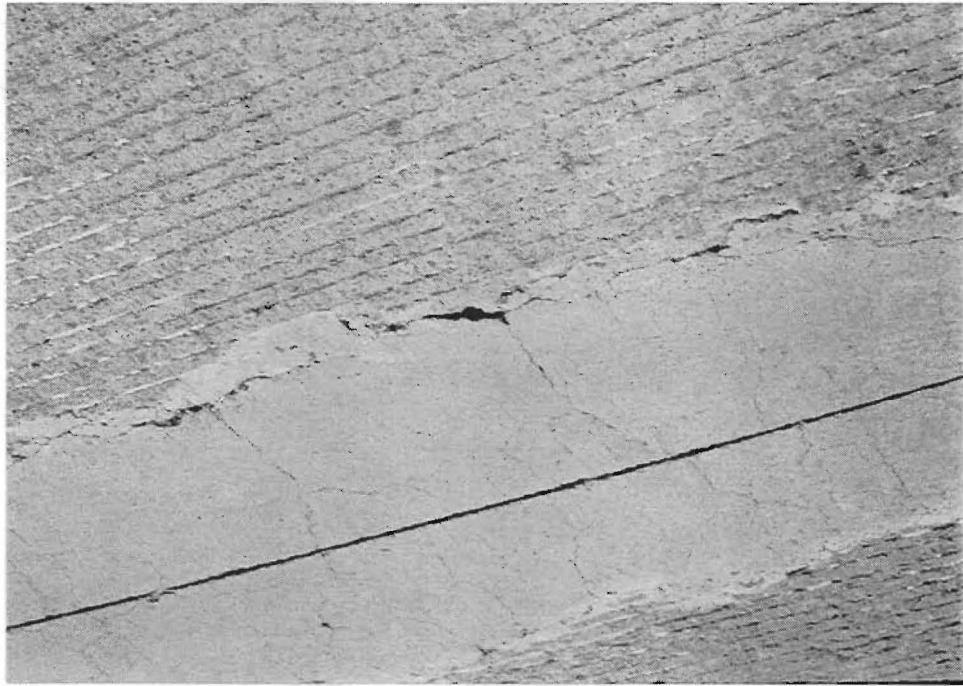
The pavement section repaired with Pyramid in BW 8 North was revisited in October 20, 1993, June 16, 1994, and January 20, 1995, to observe the performance of the repairs. The distresses observed included: (1) cracking around the edge of the patch, which may indicate debonding of the repair material from the base concrete along the circumference of the patch (Fig. 3.6); (2) spalling of the repair material; (3) transverse cracking across the patch, which may be a reflection from the crack in the base concrete (Figs 3.7 and 3.8); and (4) map cracking (Fig. 3.6). On the surface of most of the sawcut patches, transverse cracks did not occur, as observed in the survey (Fig. 3.7) done January 20, 1995. A slanting sawcut, as shown in Fig. 3.8, apparently did not control cracking. These transverse cracks in the patch were usually connected with the cracks in the pavement (Figs. 3.7 and 3.8). When the saw cuts were placed along the orientation of the original crack, a zigzag crack still occurred in the surface near the sawcut and basically parallel to the sawcut.

Fig. 3.6. Debonding and Map Cracking Observed on October 20, 1993.

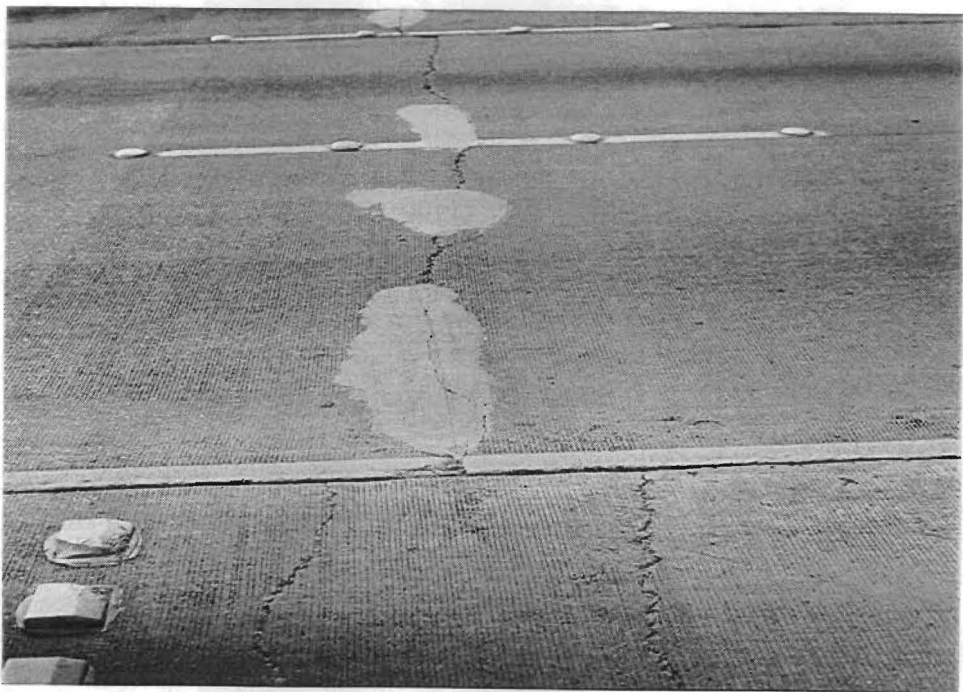
Fig. 3.7. Transverse Cracking and Minor Spalling (January 20, 1995).

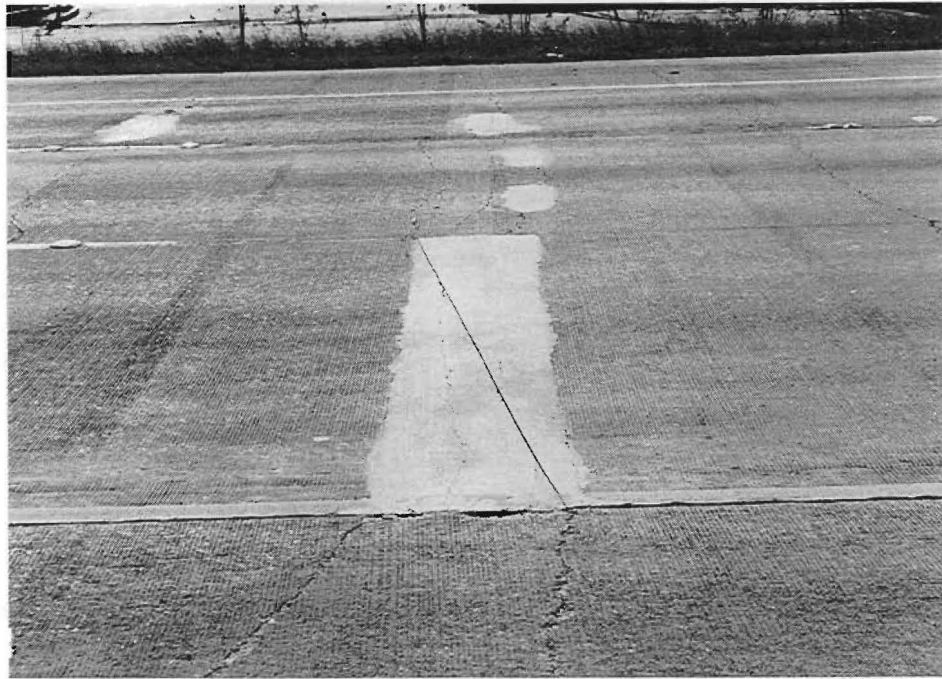
Fig. 3.8. Transverse Cracking and Minor Spalling in a Block Repair (January 20, 1995).

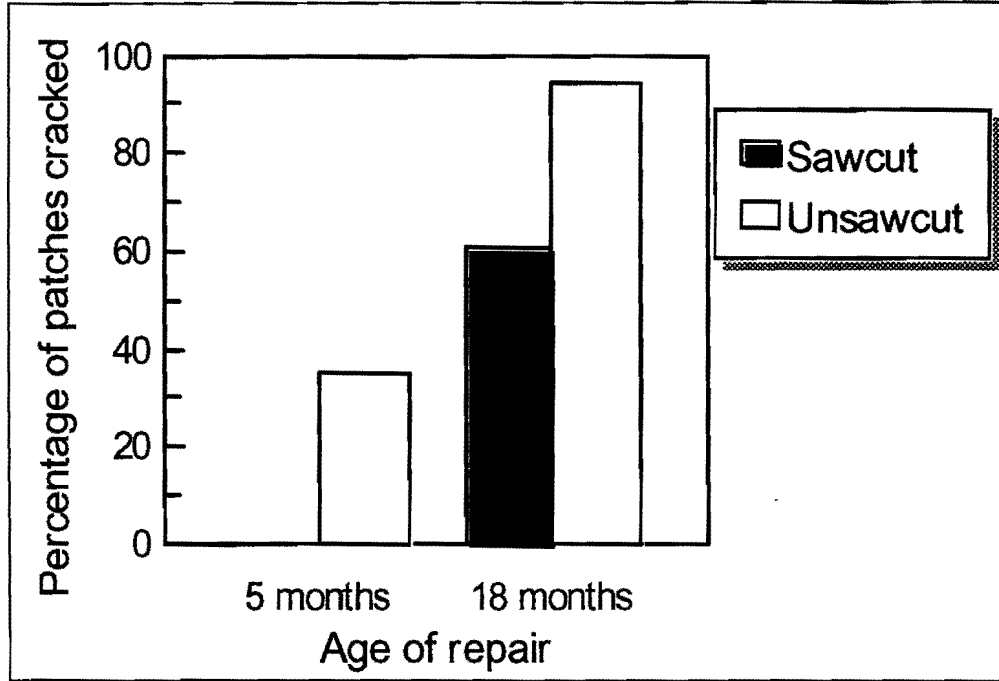
Data for the Pyramid patches where transverse cracks and spalls were observed on October 20, 1993, and January 20, 1995, are summarized in Fig. 3.9 and 3.10, respectively. These figures show the rate of the development of the distresses in the spall repair. The

Fig. 3.9. Percentage of the Pyramid Patches Where Cracks Were Observed.

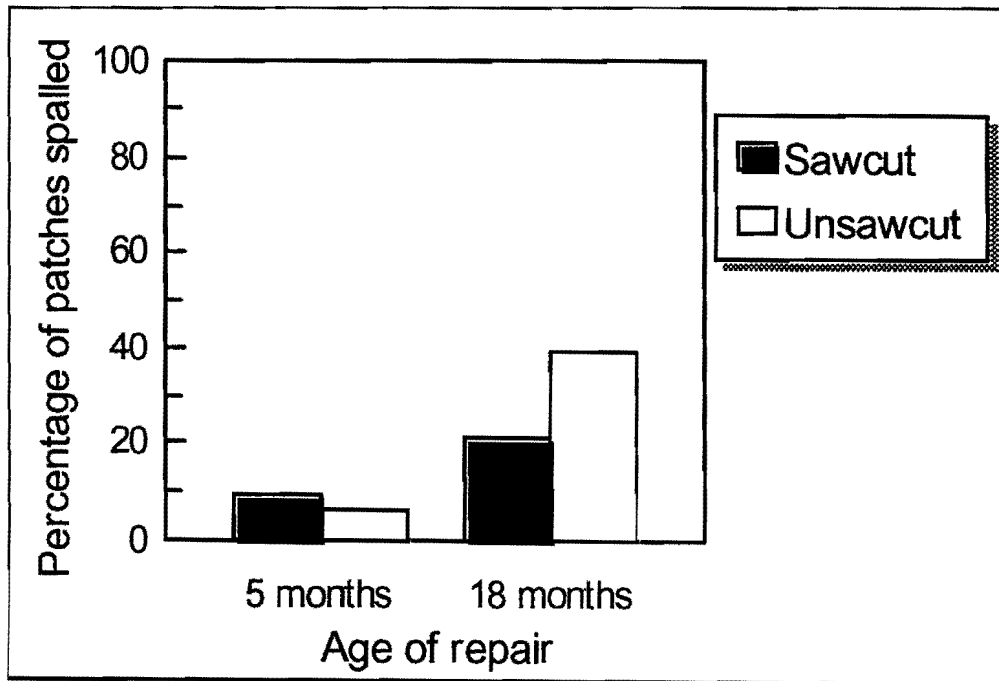
Fig. 3.10. Percentage of the Pyramid Patches Where Spalls Were Observed.

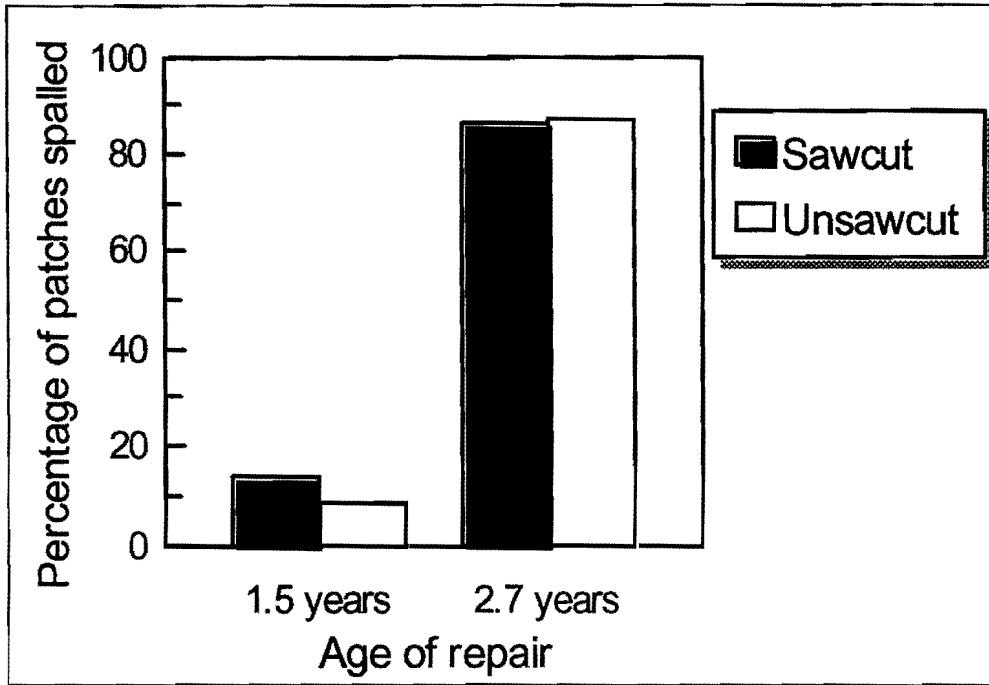
increase in the percentage of spalling in the Rapid Set patches, sawcut and unsawcut, is summarized in Fig. 3.11. The ages of repair shown in the figure are estimated, since the date of the Rapid Set repair in 1993 is not known. It seems that, after two and half years, the percentage of sawcut and unsawcut patches where spalls occurred is similar.

Fig. 3.11. Percentage of the Rapid Set Patches Where Spalls Were Observed.

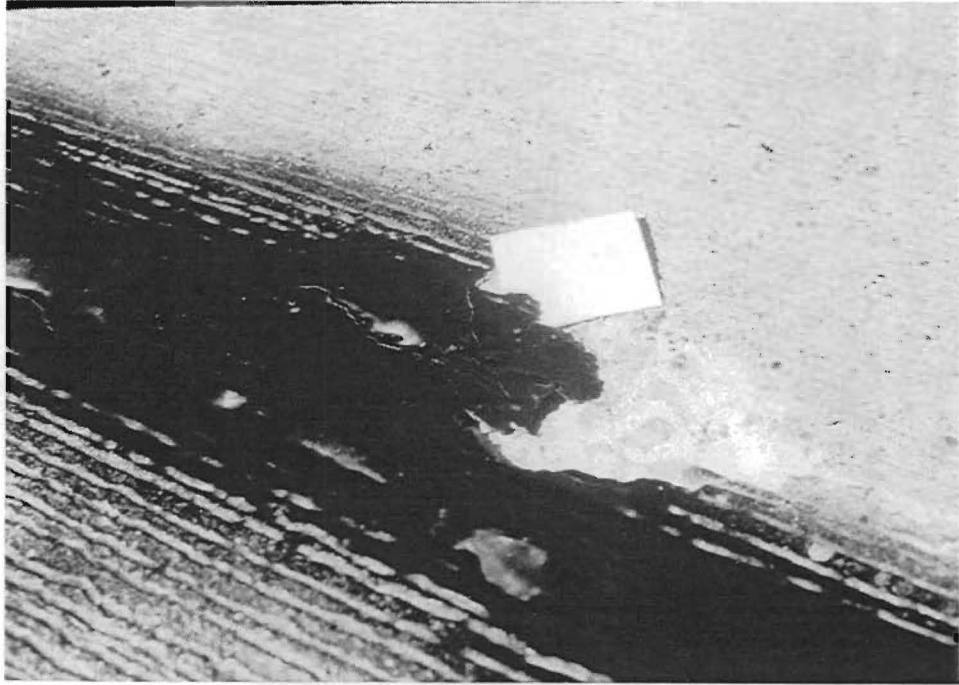
Fig. 3.12. Repair No.6 with Flamecoat PF113-H101 Observed on October 20, 1993.

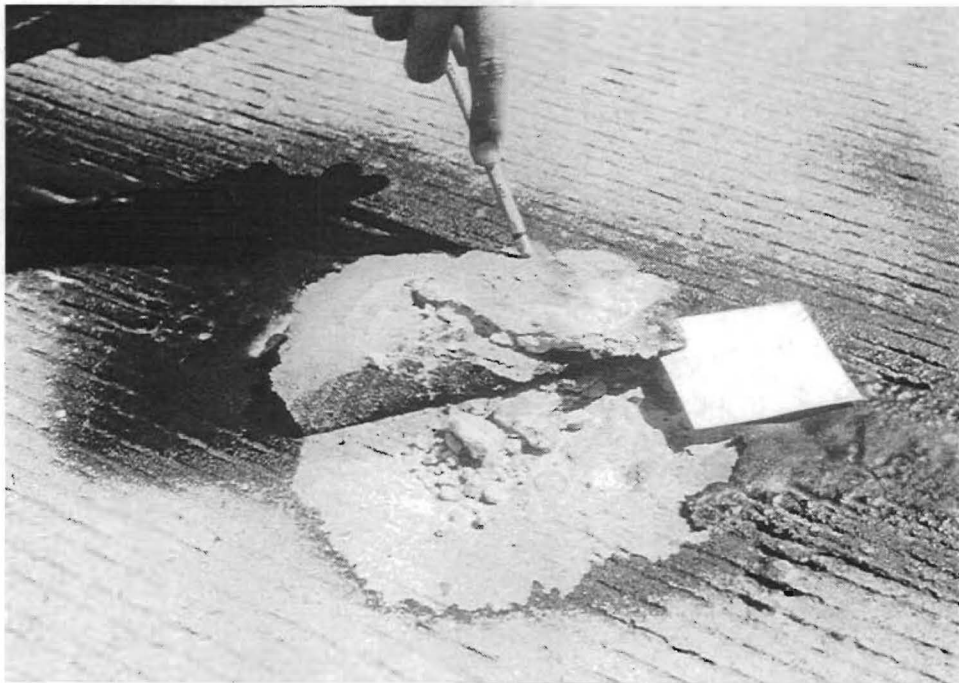
Fig. 3.13. Repair No.16 with Flamecoat PH101 Observed on October 20, 1993.

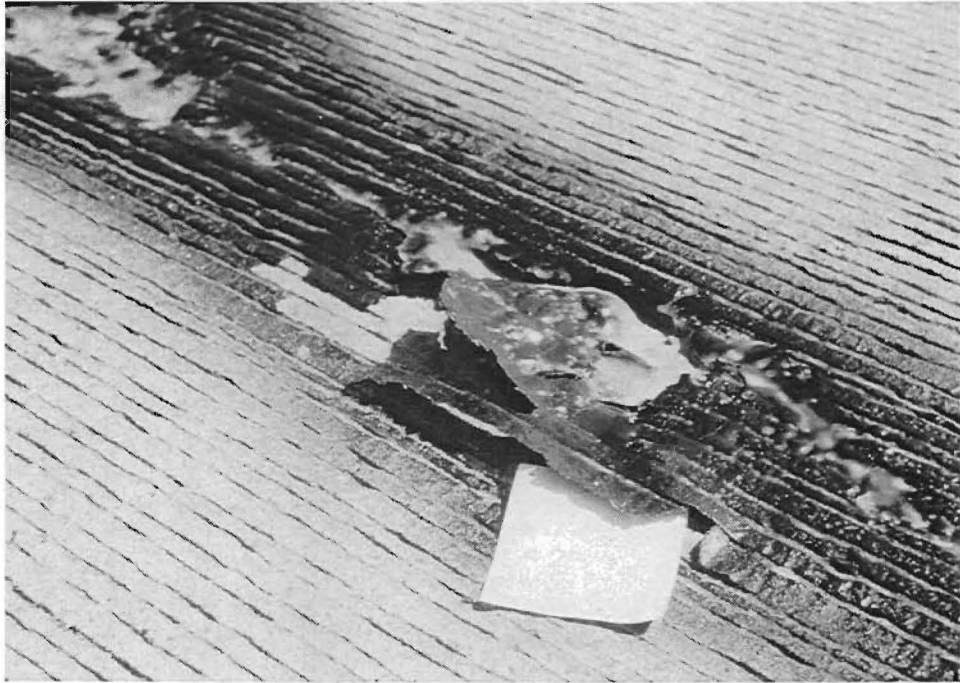
Fig. 3.14. Repair No.28 with Flamecoat PR111-H101 Observed on October 20, 1993.

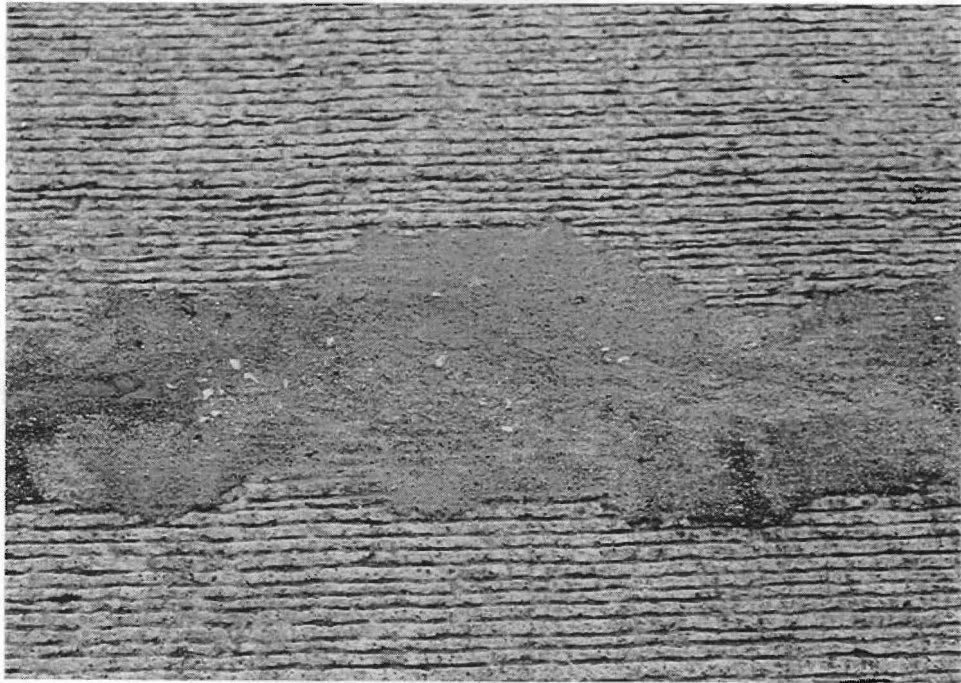
surface finish was caused by improper finishing. Fig. 3.15 shows a Sylcrete product repair with no visible damage. It is worthwhile to note here that the spall repairs using Sylcrete mender on I-59 in the Rosenberg area had completely failed shortly after the repair was complete. Sylcrete flexible cement appears to be a better pavement material because of its lower modulus, although the material manufacturer recommends the mender for concrete repair. Pavement around these Sylcrete product repairs was sounded by hammering. Some hollowed areas were found and are noted in Table 3.3.

Fig. 3.15. Sylcrete Repair with No Distress Observed on January 20, 1995.

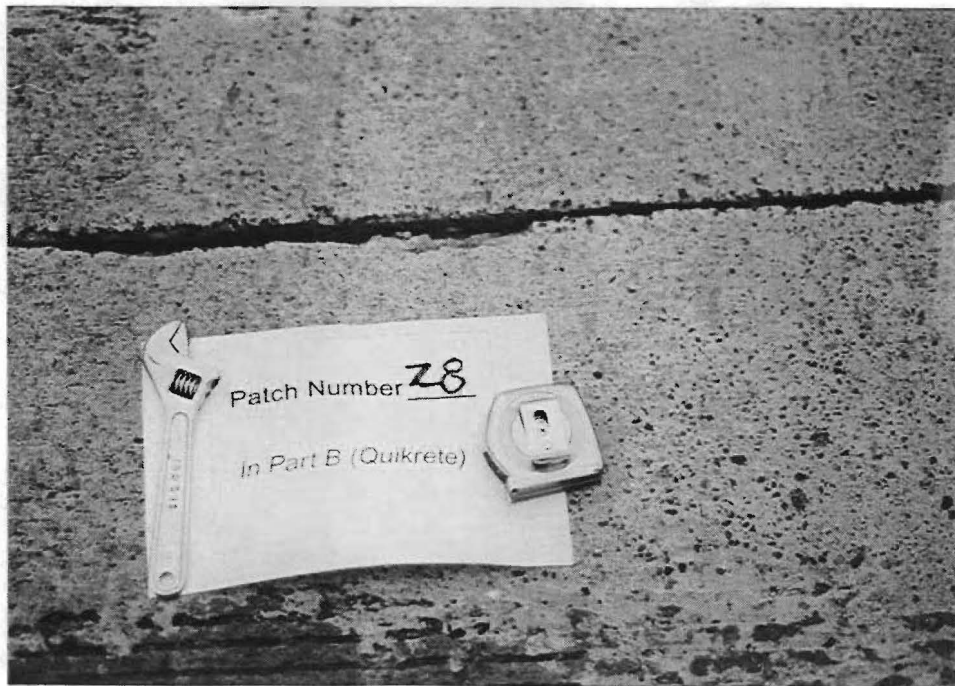
Fig. 4.8. Repair No. 28: Minor Spalling Along The Saw Cut (January 4, 1995).

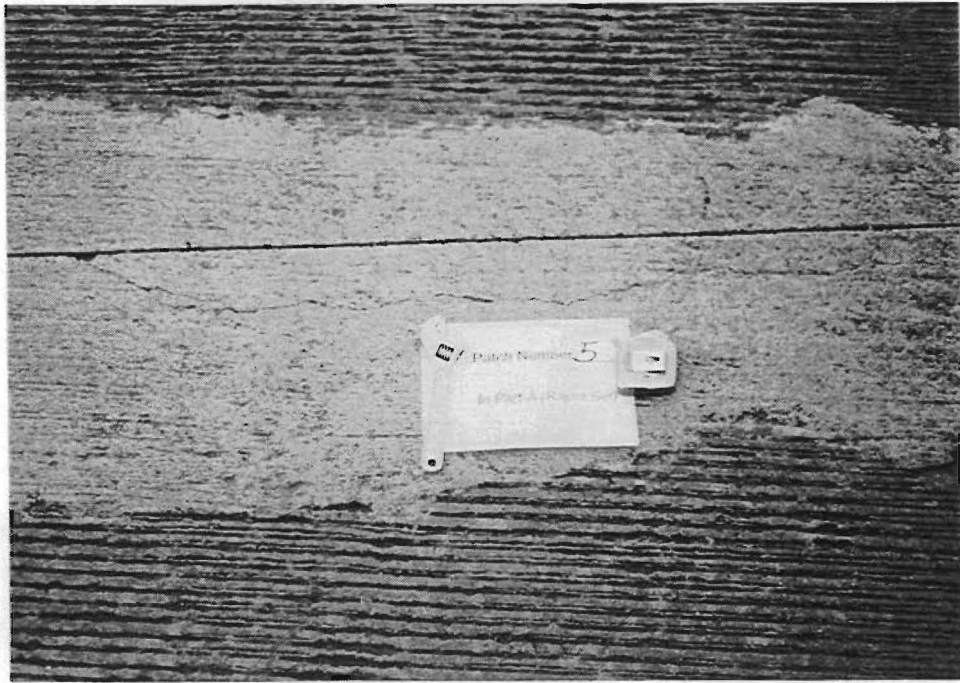
Fig. 4.9. Repair No. 5: A Transverse Crack Near the Saw Cut (January 4, 1995).

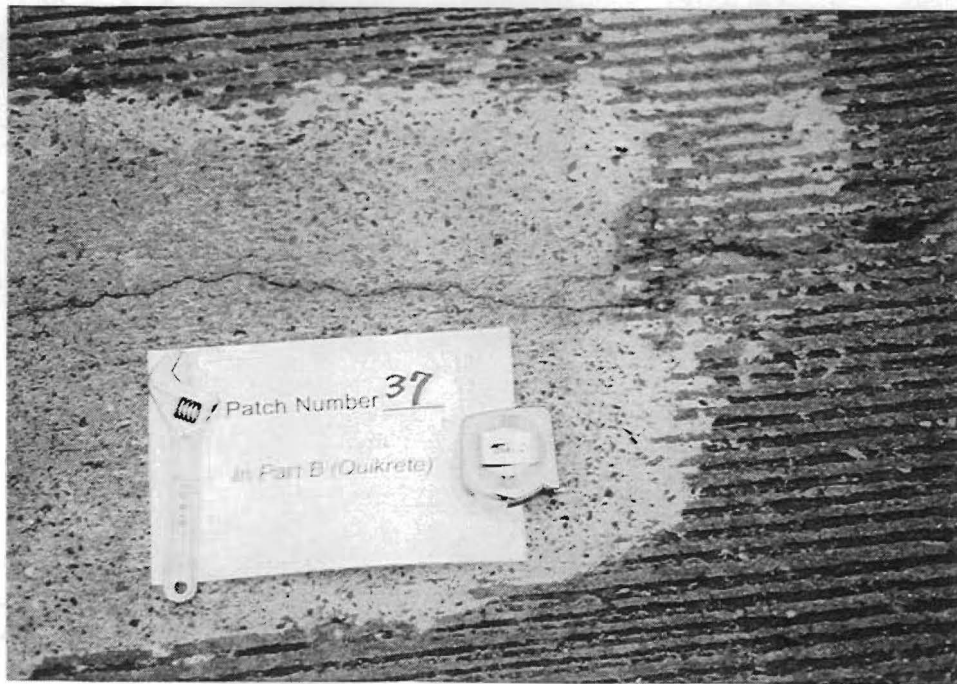
Fig. 4.10. Repair No. 37: A Transverse Crack on the Uncut Patch (January 4, 1995).

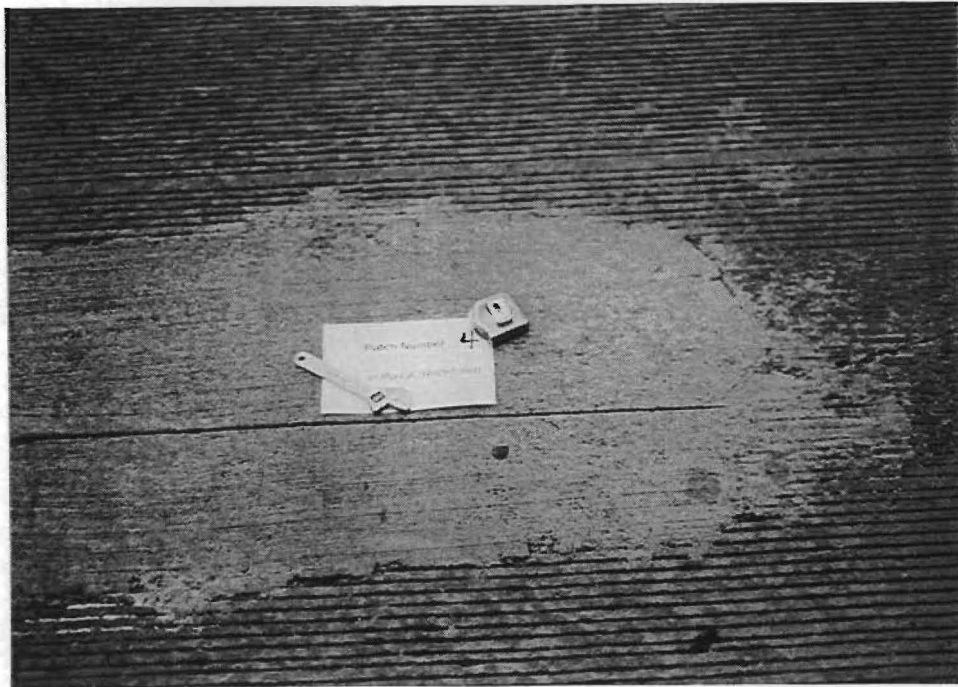
Fig. 4.11. Repair No. 4: No Random Crack on a Saw Cut Patch (January 4, 1995).

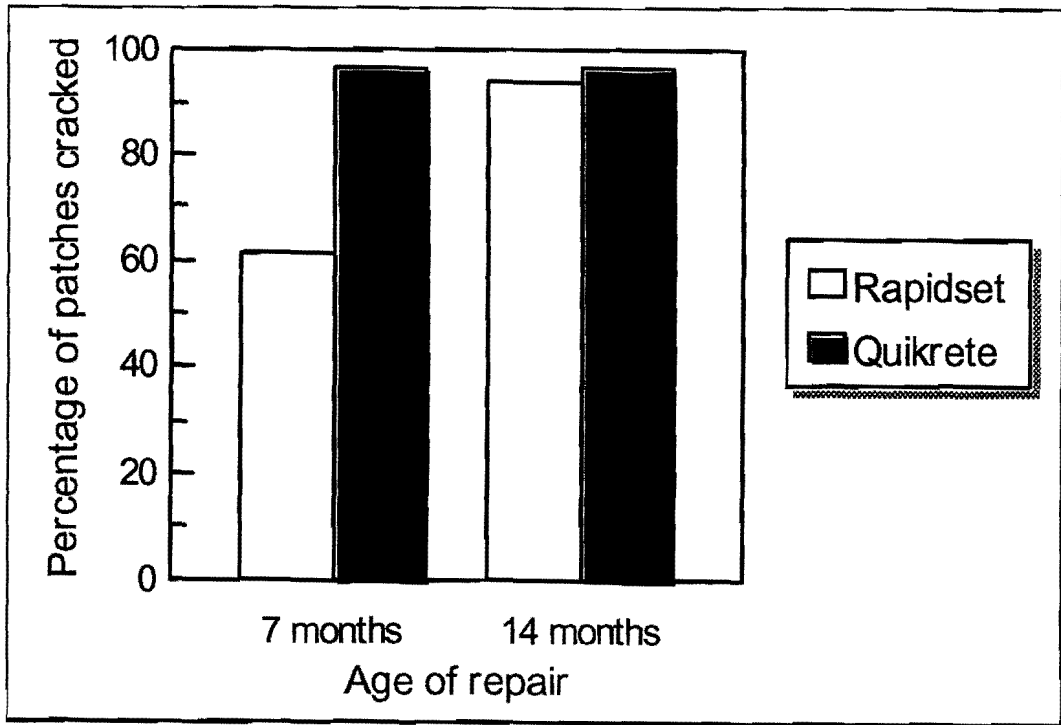
Fig. 4.12. Percentage of Uncut Patches Where Transverse Cracks Occurred.

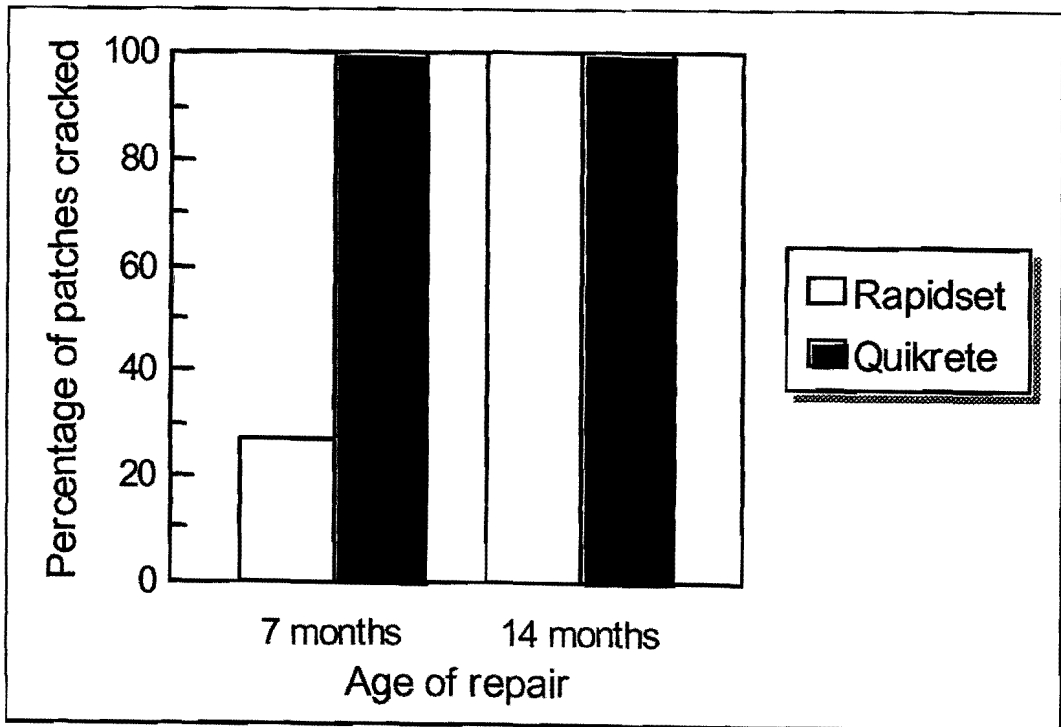
Fig. 4.13. Percentage of Saw Cut Patches Where Cracks Occurred Parallel to the Saw Cut.
