1. Report No. TX-98/2947-S		2. Government Accession No.		3. Recipient's Catalog No.	
4. Title and Subtitle APPLICATIONS OF GROUND-COUPLED GPR TO PAVEMENT EVALUATION				5. Report Date November 1997

APPLICATIONS OF GROUND-COUPLED GPR TO PAVEMENT EVALUATION

Research Report 2947-S
Research Study Number 7-2947
Research Study Title: Using Ground-Coupled and Air-Launched
Radar Systems for Pavement Evaluation

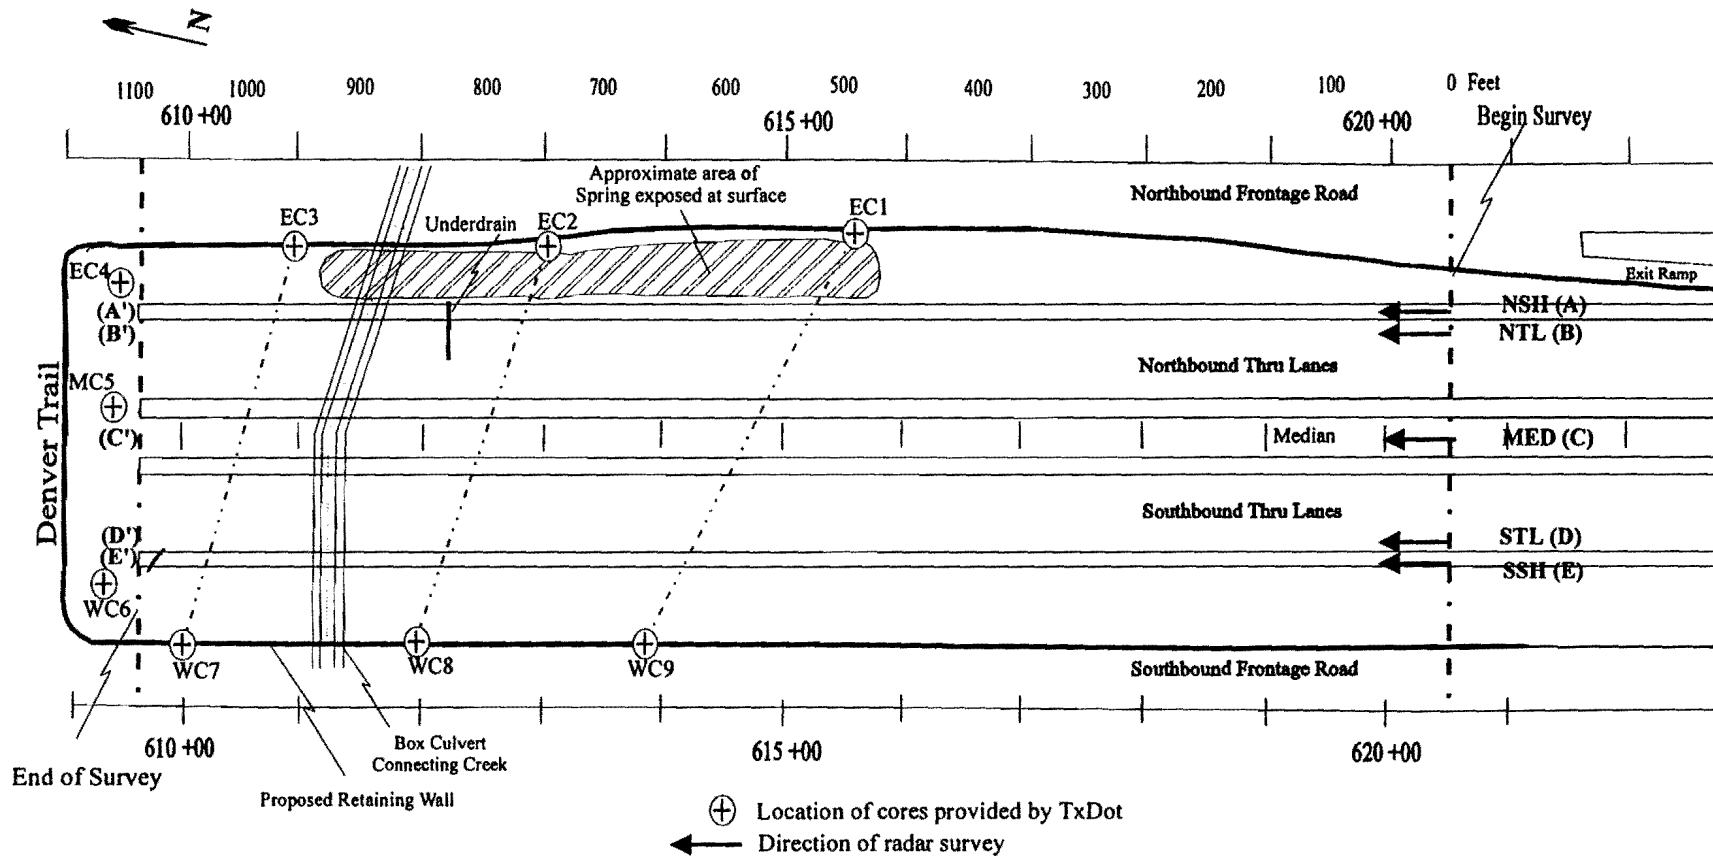
On December 13, 1996, TTI conducted a ground penetrating radar survey along State Highway 199 to determine the lateral extent of a local aquifer. Figure 1 shows a schematic of the area. Water was seen flowing from a sand formation downhill, toward Denver Trail, within a drainage ditch on the east side of SH 199. An under drain, or slotted PVC pipe, was installed beneath the northbound lanes at Station 612 +25 to alleviate water buildup and damage from beneath the road surface. The driving lanes of SH 199 are constructed of 150 mm (6 ins) of select material overlain by 250 mm (10 ins) of jointed concrete and 50 mm (2 ins) of asphalt. The shoulders are constructed of 150 mm (6 ins) of roadbed material, quite possible area material, overlain by 250 mm (10 ins) of base and 50 mm (2 ins) of asphalt.

Core records were acquired through TxDOT, whereby cross-sections were then inferred. The locations of the cores are shown in Figure 1. It can be seen from the cross-sections, Figure 2, Figure 3, and Figure 4 a, b, and c, that the surface of the site dips from both the north and south towards the creek located at Station 611 +00 on the west side of SH 199 to 612 +00 on the east side. The largest topographic high is to the south. Probable groundwater flow is toward the creek from both sides.

Figure 1. State Highway 199, Azle, Texas, Illustrating Location of Cores, Survey Lines and Station Numbers.
 (1 ft = 0.3 m)

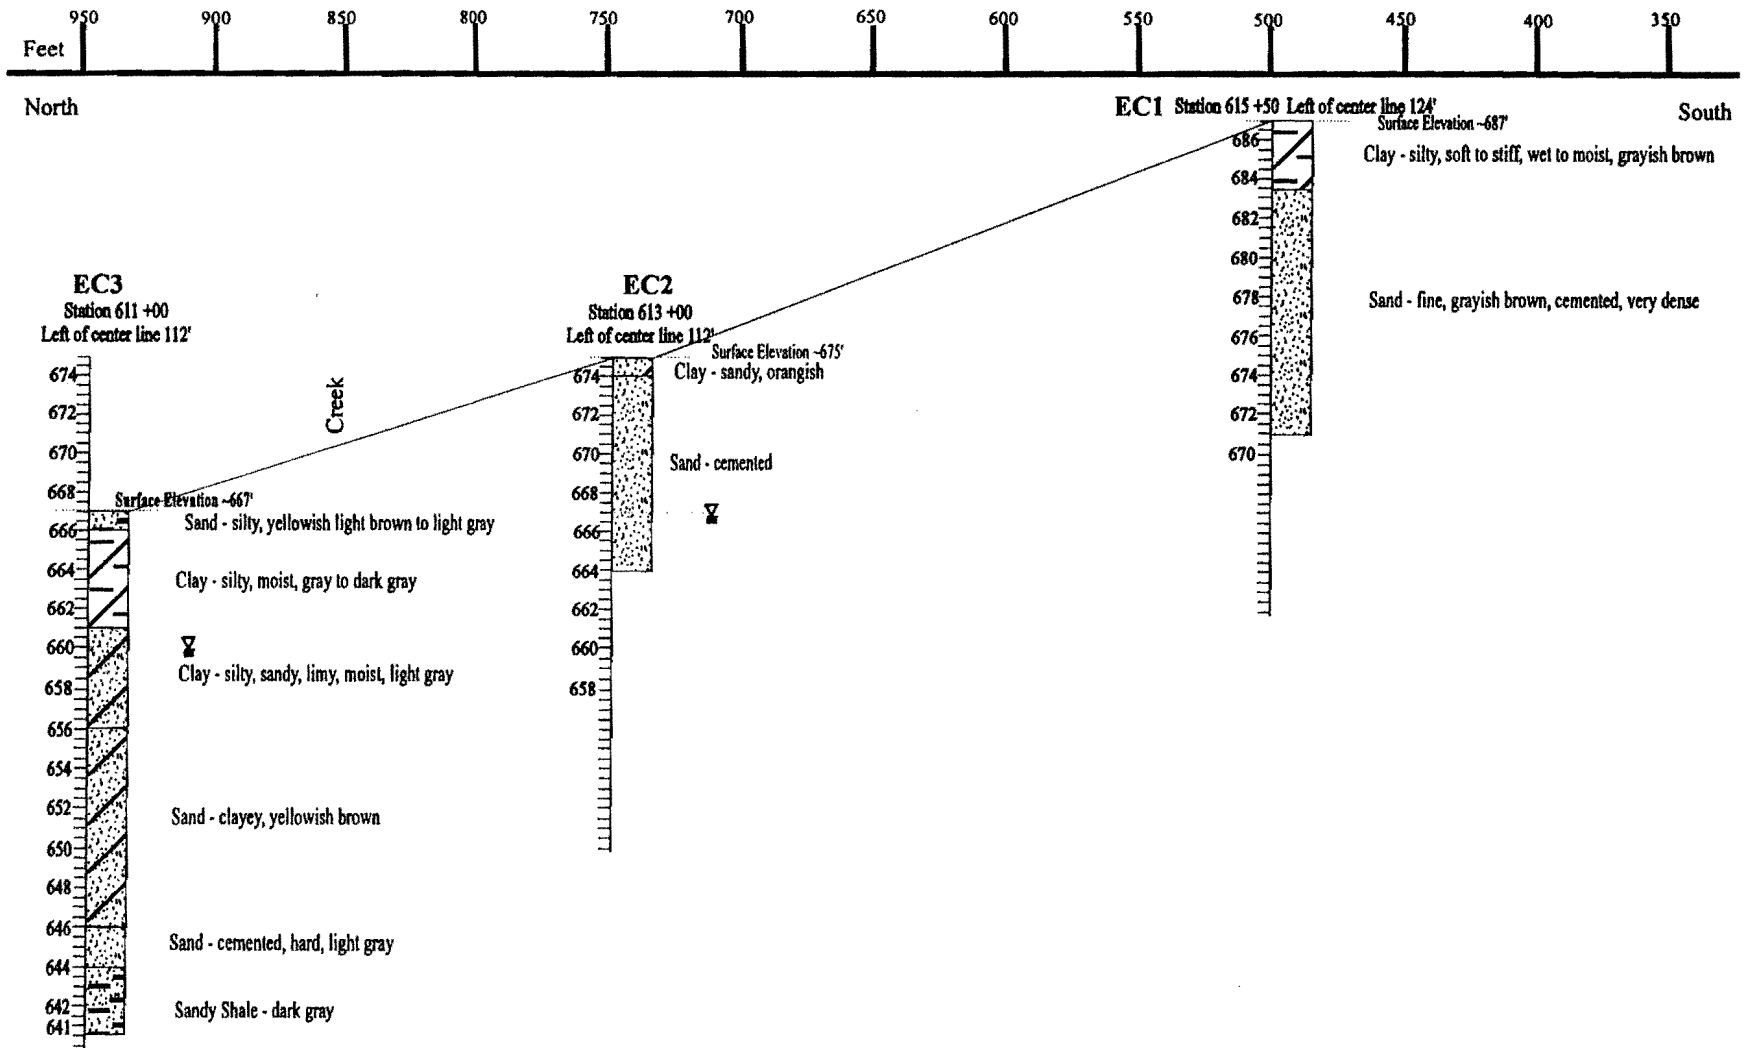
Observation of the cross-section from south to north, beginning with the cores from the east side of SH 199 (Figure 2), revealed 1.4 m (4.6 ft) of a silty clay overlies a dense, cemented sand, in core EC1, the southern most core on the east side of SH 199. As one travels downhill, or to the north, the clay grades into 0.3 m (1.0 ft) of sandy clay overlying the same cemented sand, in core EC2. Core EC3 reveals 0.3 m (1.0 ft) of silty sand overlying 1.5 m (5 ft) of silty clay which grades into a sandy, silty clay. Ground water surfaces were measured at elevation 660 in core EC3 (near bottom of hill) and at elevation 667 in core EC2. There was no mention of existing groundwater in the core log for EC1.

Figure 2. Cross-Section Along the East Side of State Highway 199, Azle, Texas. Refer to Figure 1 for Core Locations.
 (1 ft = 0.3 m)

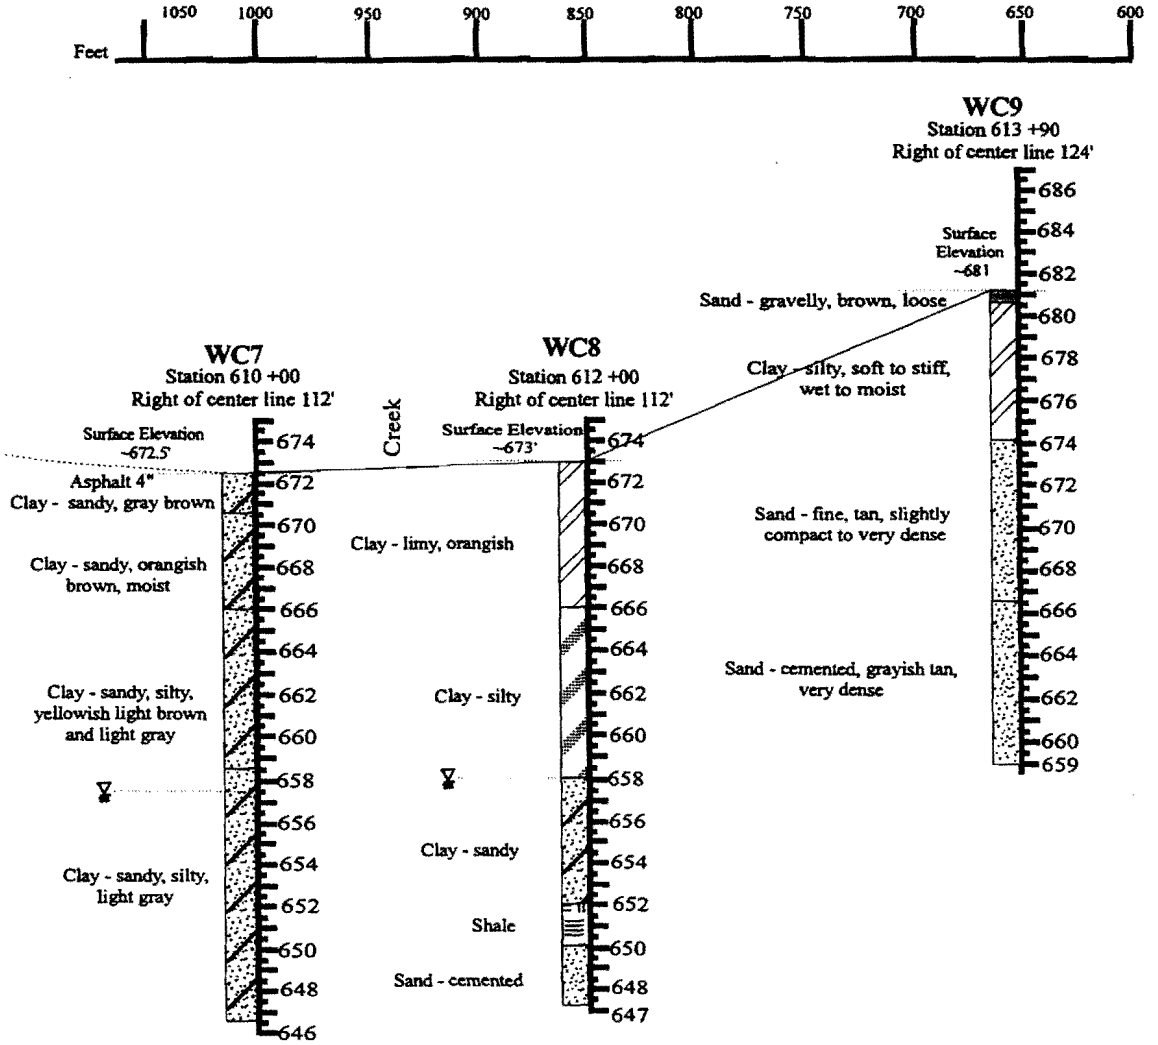
Figure 3. Cross-Section Along West Side of State Highway 199, Azle, Texas. Refer to Figure 1 for Core Locations. (1 ft = 0.3 m)

The cross-section of the cores on the west side of SH 199 is shown in Figure 3. Core WC9 consists of a 150 mm (6 ins) of gravelly sand overlying a silty clay. The clay, 2.1 m thick, found at the surface of core WC8 overlies a silty clay, 2.4 m (8 ft) thick. Core WC7 consists mainly of sandy clay grading into a silty, sandy clay. According to the drillers groundwater was found in cores WC7 and WC8 within the sandy/silty clay, at nearly the same depth (elevation 658).

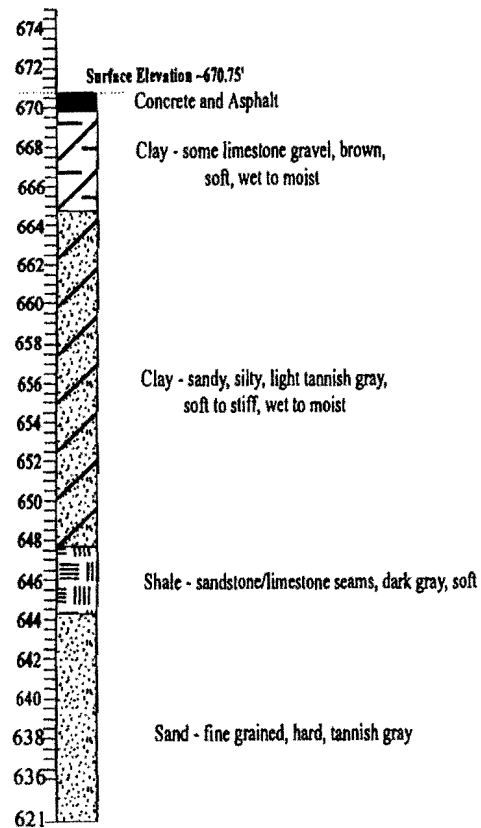
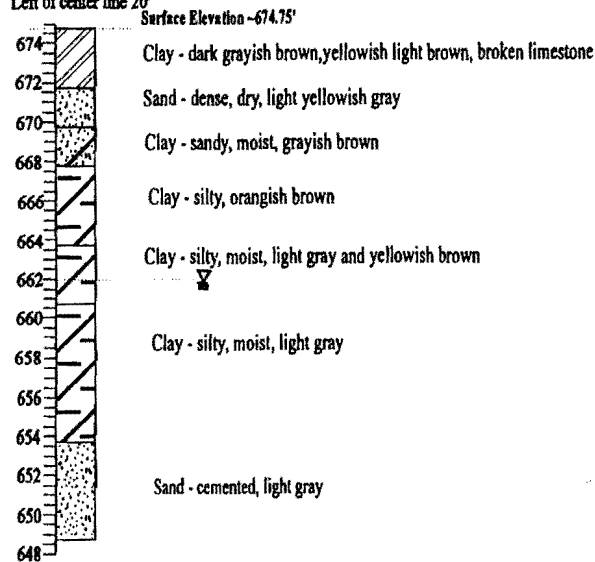
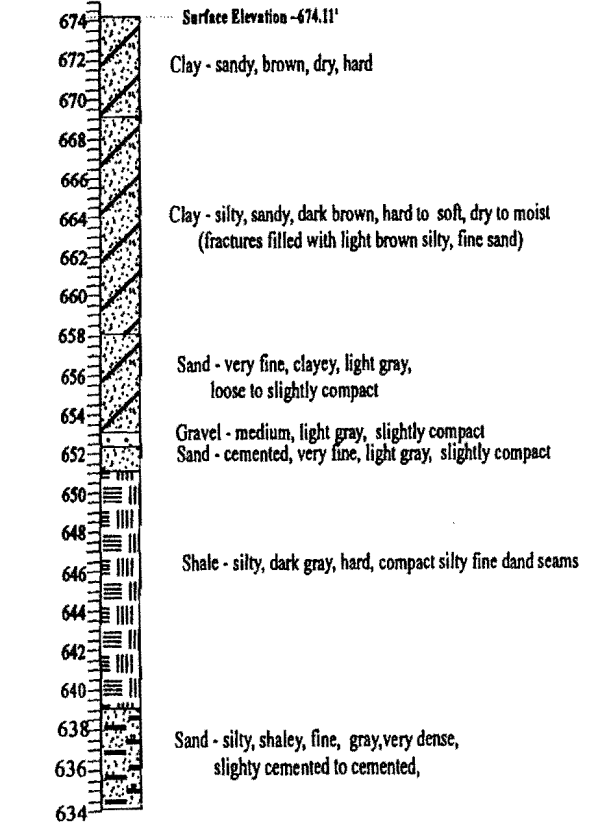
Figure 4. Cross-Sections Perpendicular to State Highway 199, Azle, Texas (East to West). Refer to Figure for Location of Cores. (Continued) (1 ft = 0.3 m)

Cores EC4, MC5, WC6, run east to west across SH 199 near to Station 609 +50 (Figure 4c). Two meters of clay, either sandy or containing broken limestone, exist at the surface of these cores. Sand is only seen relatively near to the surface in core MC5.

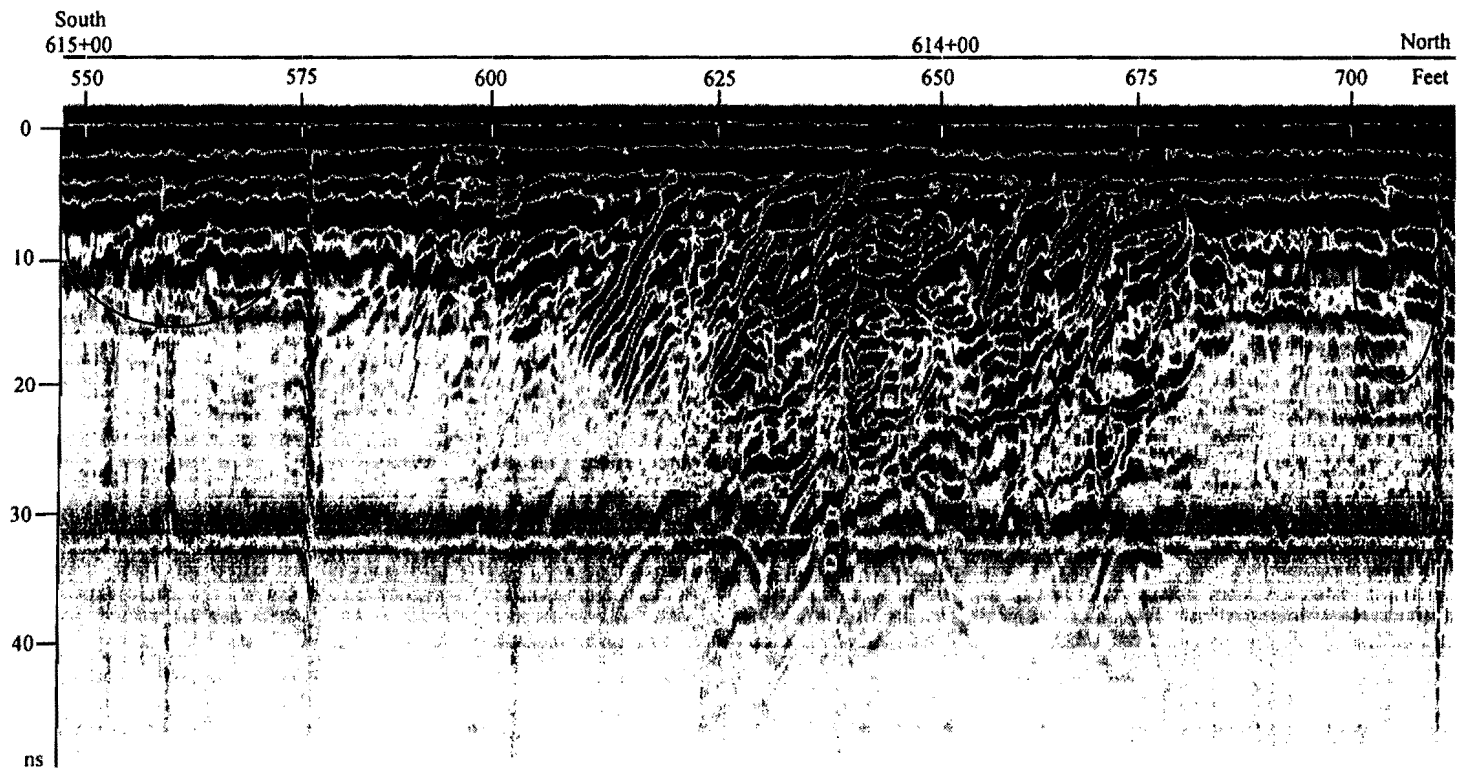
The radar survey in the median separating the north and southbound lanes produced a strong, distinctive reflection pattern within the subsurface beginning around the 150 m (500 ft) mark and tapering off around the 210 m (700 ft) mark. (See Figure 5 for radar profile and Figure 6 - for location). This reflection pattern was then used to help distinguish the same sort of pattern from the surveys completed atop the roadway. It appears that around 165 m (540 ft) a layer tapers out then reappears around 210 m (700 ft). This survey in the median also exhibits some unclear areas starting around 260 m (850 ft) and just before the end of the survey it appears as if another layer joins in. The distinctive reflection pattern was also found in survey NSH (northbound shoulder) from 145 - 180 m (470 - 590 ft) (Figure 7) and from 230 - 250 m (750 - 820 ft) (Figure 8). It appears that around the 150 m (490 ft) mark, the bottom of the vase in the main lane is affected by water, as is the roadbed material and probably the base material in the shoulder. The contacts between the base material, the roadbed material and the natural geology taper in and out along the survey on the northbound shoulder. The characteristic reflection is more noticeable in the shoulder survey than the main lane, however, it can be seen in survey NTL (northbound thru lane) from 150 - 160 m (490 - 520 ft) and 210 - 250 m (700 - 820 ft) (See Figures 9 and 10, respectively). Data from the main lane entail interference as seen by the spikes approximately every 4 m (13 ft), due to the joints between the concrete slabs. It is also assumed the materials making up the shoulder are of a lower dielectric and are less compacted than the main lane. The area around the 230 m (750 ft) mark distinguished by the radar, in both the northbound shoulder and main lane, is where sand is seen close to the surface within core EC2 and might be saturated with water and/or clay layers are grading into the area.

Figure 5. A Portion of the Radar Data Taken from the Median Along State Highway 199 in Azle, Texas. The Survey is Running South to North and Shows an Area of Possible Sandy Saturated Deposits. Tapering Out of Layers Can Be Seen in Between 550 ft and 575 ft as Well as After 700 ft. (1 ft = 0.3 m)

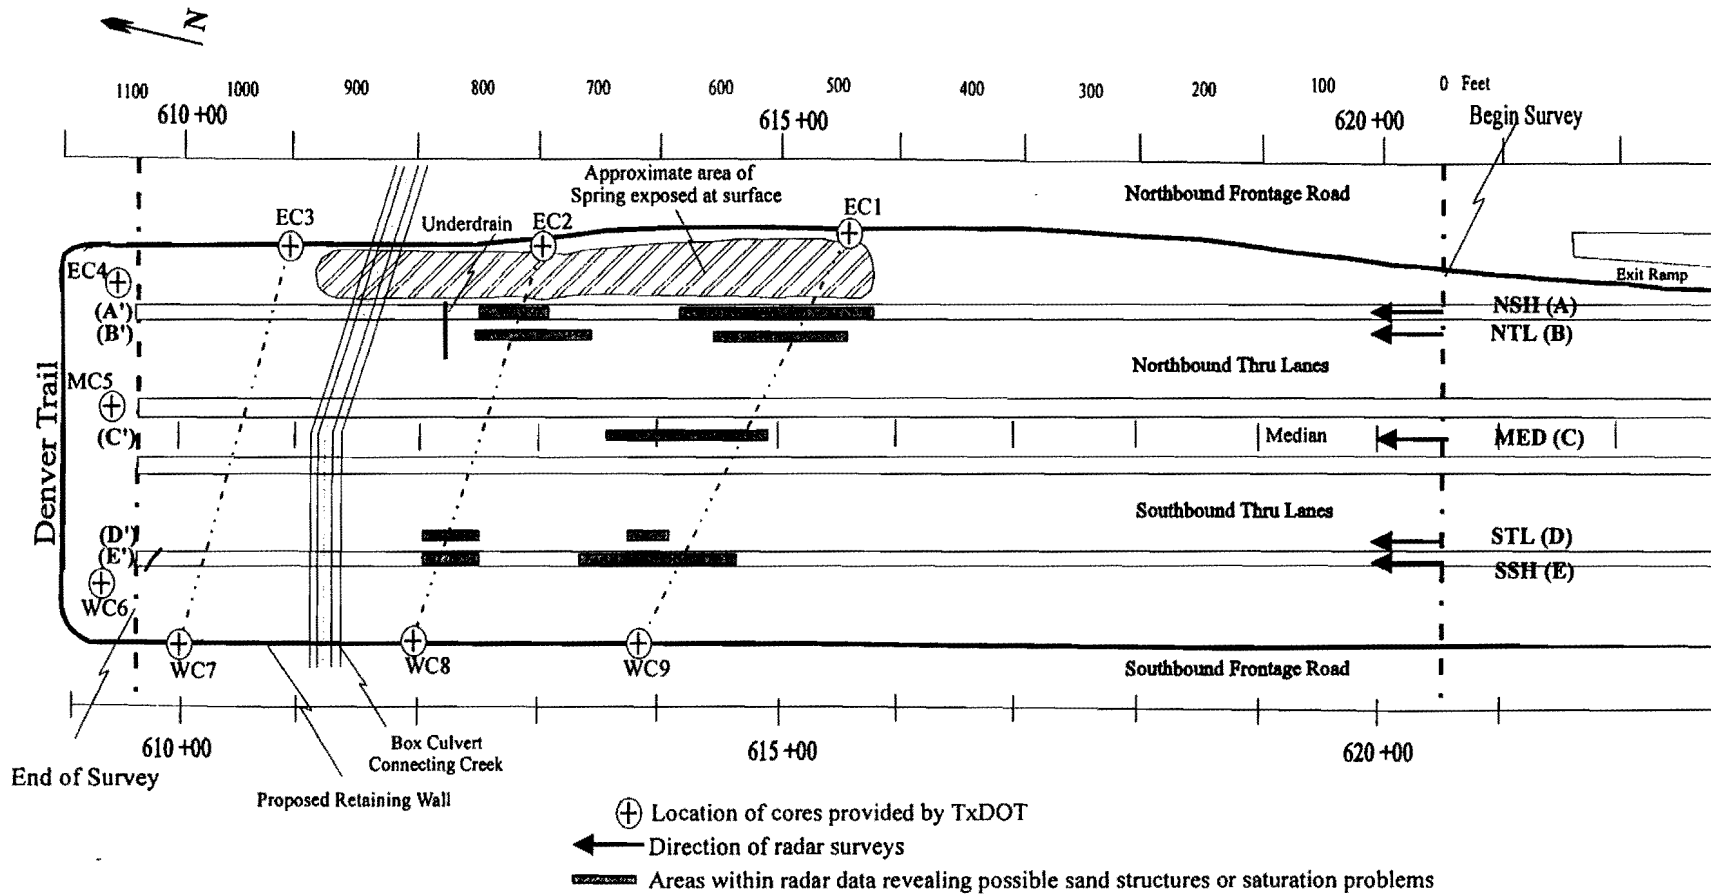
Figure 6. State Highway 199, Azle, Texas, Illustrating Locations of Possible Concern Resulting from GPR Survey.
 (1 ft = 0.3 m)

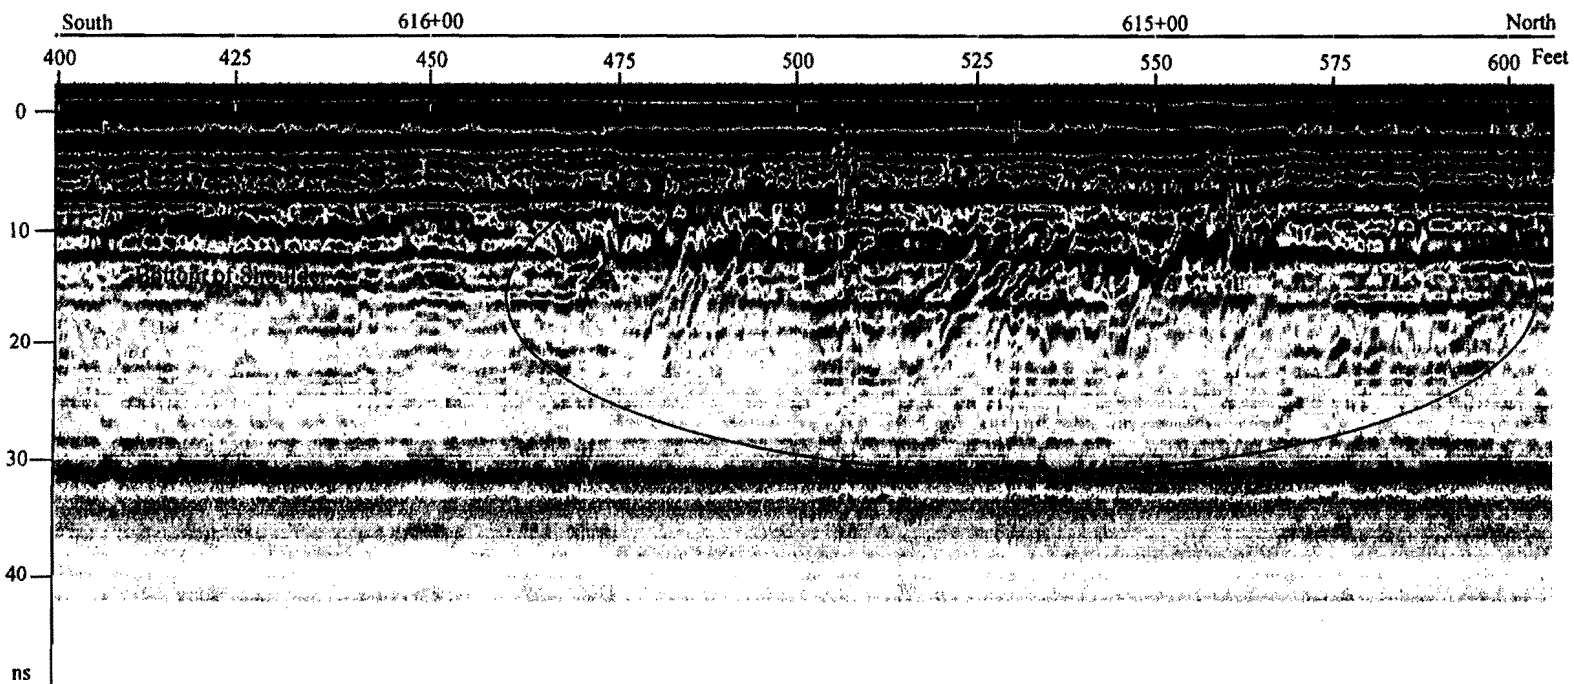
Figure 7. A Portion of the Radar Data Taken from the Northbound Shoulder (NSH) Along State Highway 199 in Azle, Texas. The Survey is Running South to North and Shows an Area of Possible Sandy Saturated Deposits Beginning at 475 ft. (1 ft = 0.3 m)

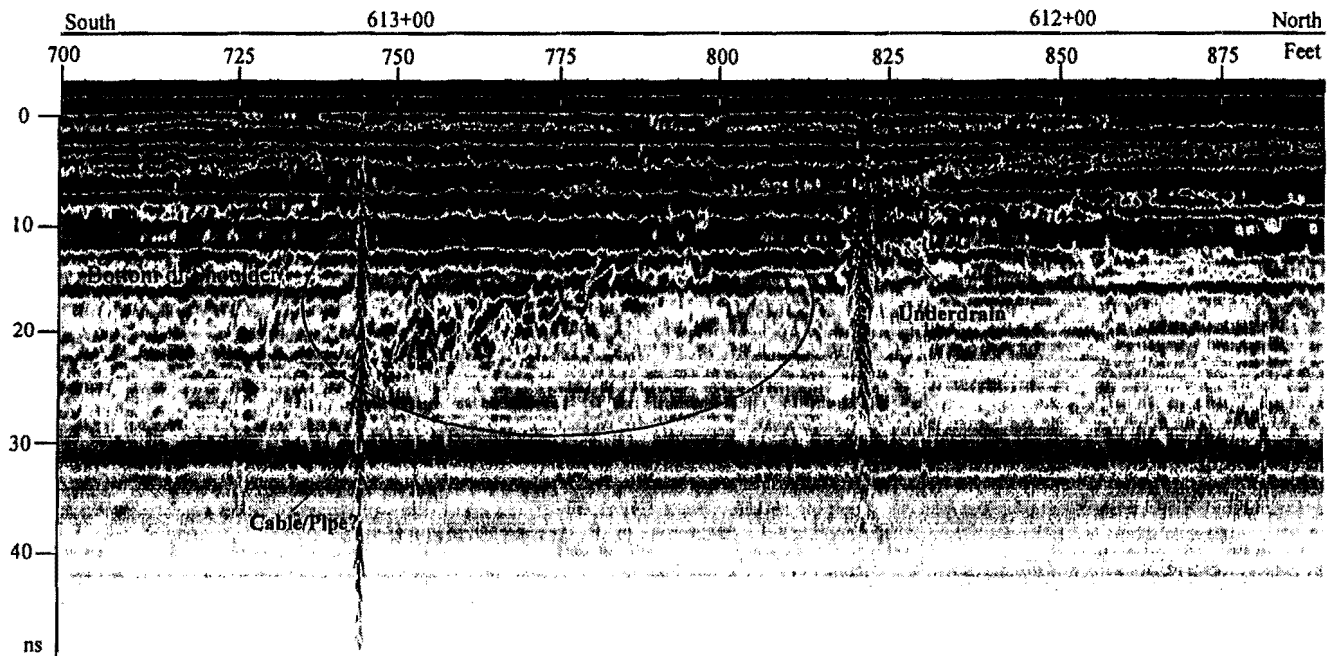
Figure 8. A Portion of the Radar Taken from the Northbound Shoulder (NSH) Along State Highway 199 in Azle, Texas. The Survey is Running South to North and Shows a Distinctive Reflector Between 750 and 800 ft Markers. The Underdrain Placed on the Northbound Side is Also Visible. (1 ft = 0.3 m)

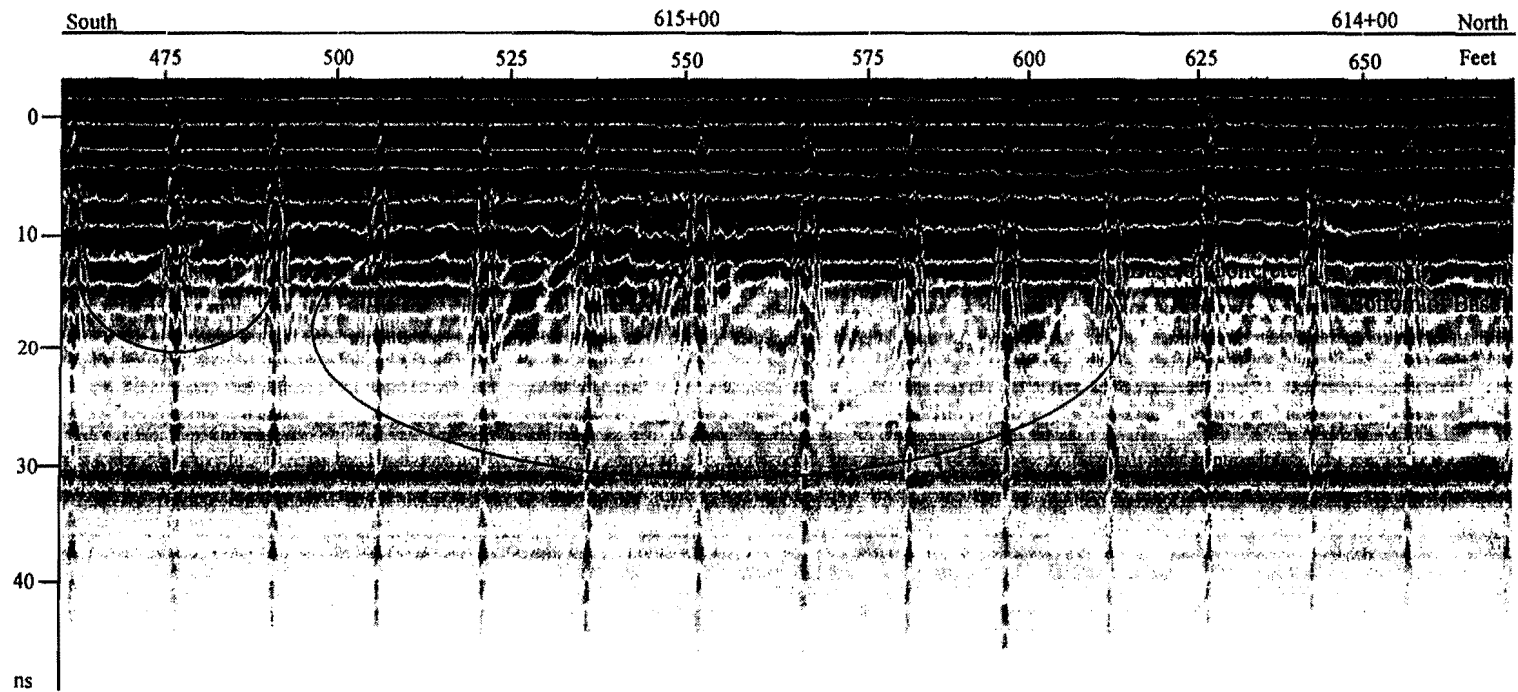
Figure 9. A Portion of the Radar Data Taken from the Northbound Main Lane (NTL) Along State Highway 199 in Azle, Texas. The survey is Running South to North and Shows an Area of Possible Sandy Saturated Deposits Between 500 and 600 ft. Possible Taping bed at 475 ft mark. Spiking Produced by Joints in Concrete.
(1 ft = 0.3 m)

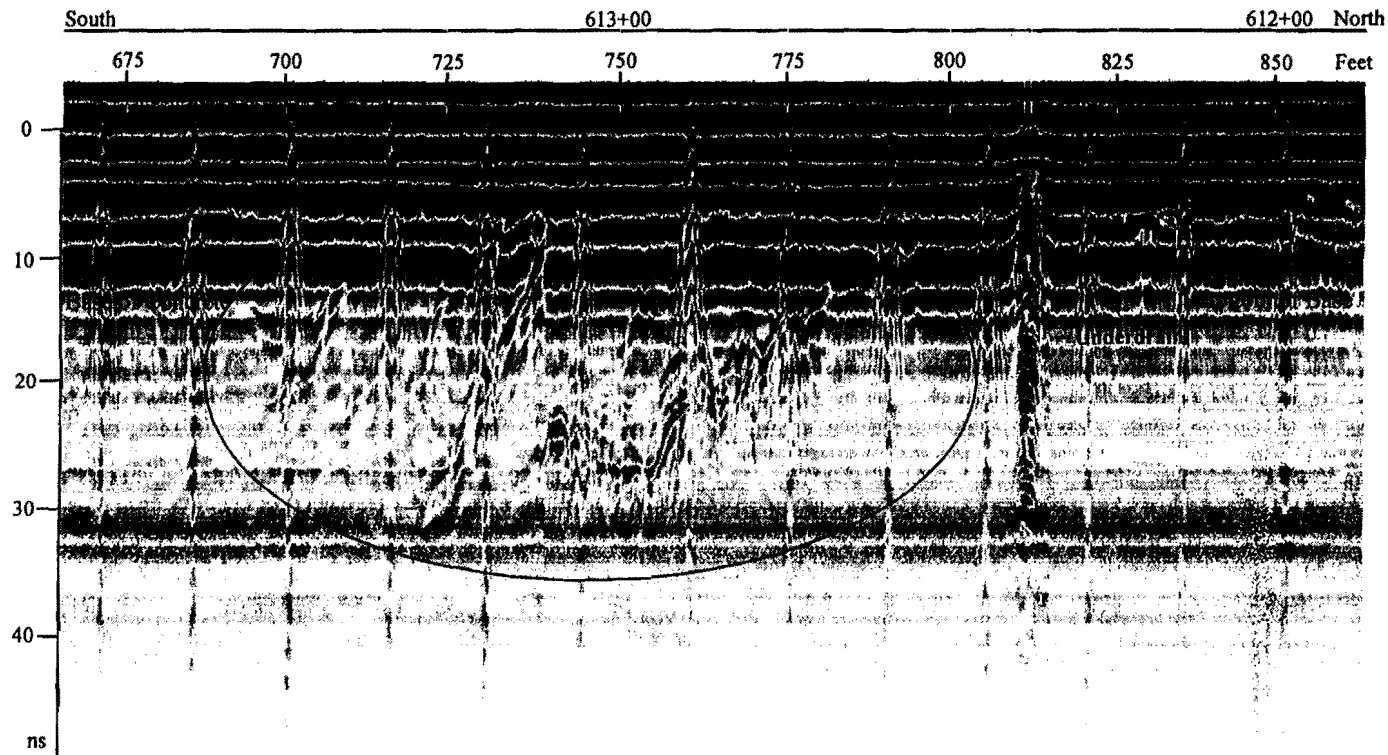
Figure 10. A Portion of the Radar Data Taken from the Northbound Main Lane (NTL) Along State Highway 199 in Azle, Texas. The survey is Running South to North and Shows a Distinctive Reflector Between 700 and 800 ft. The Underdrain Placed is also Visible. (1 ft = 0.3 m)

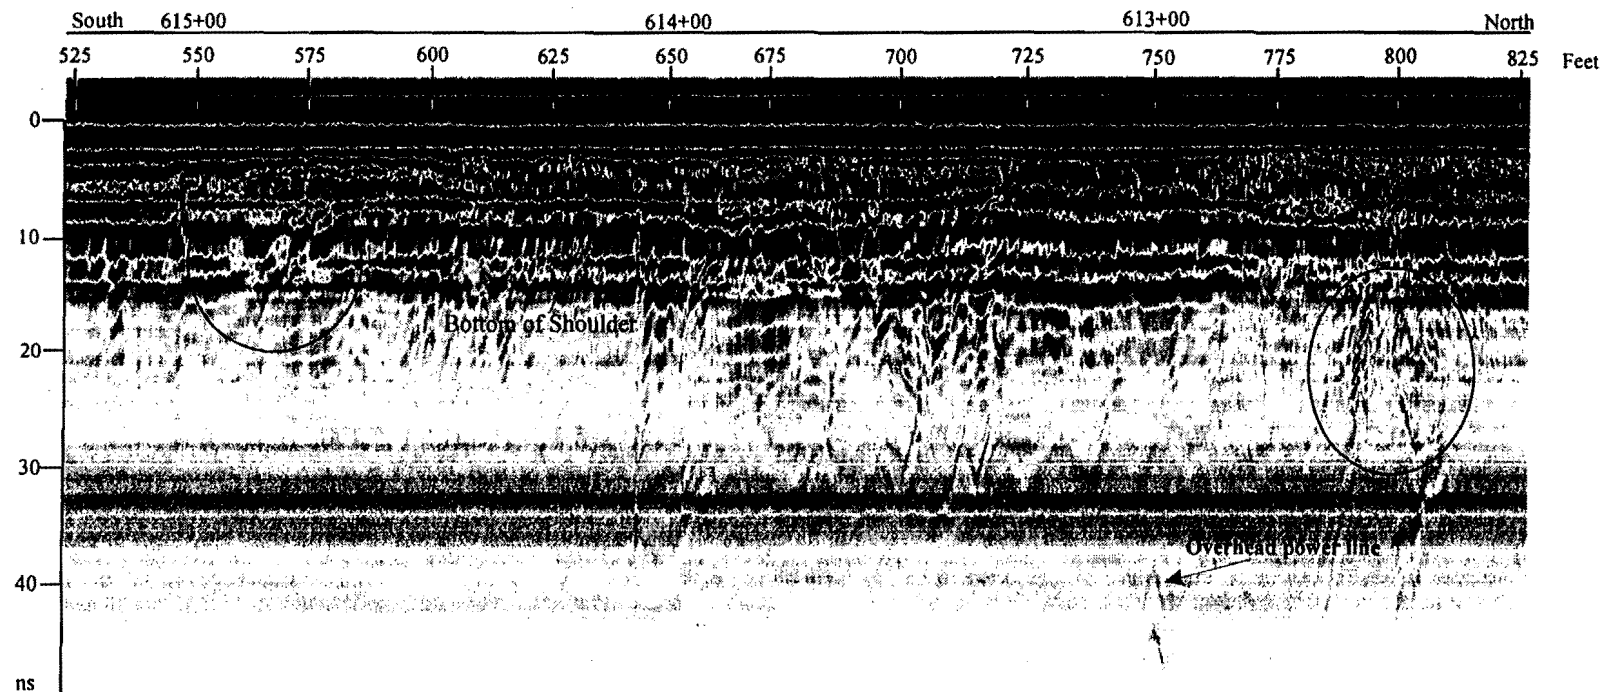
The reflection pattern could also be seen in survey STL (southbound thru lane) from 180 - 230 m (590 - 750 ft) and 240 - 260 m (820 - 850 ft) and in SSH (southbound shoulder) from the 175 - 240 m (570 - 790 ft) mark (Figure 11). The data from the southbound main lane exhibited weak reflections, however their locations could be correlated with the other surveys.

Figure 11. A Portion of the Radar Data Taken from the Southbound Shoulder (SSH) Along State Highway 199 in Azle, Texas. The survey is Running south to North and Shows a Reflection Pattern, Similar to that from the Median, Between the 525 and 825 ft Markers. Possible Tapering Bed at 575 ft and a Distinctive Reflector at 800 ft. (1 ft = 0.3 m)

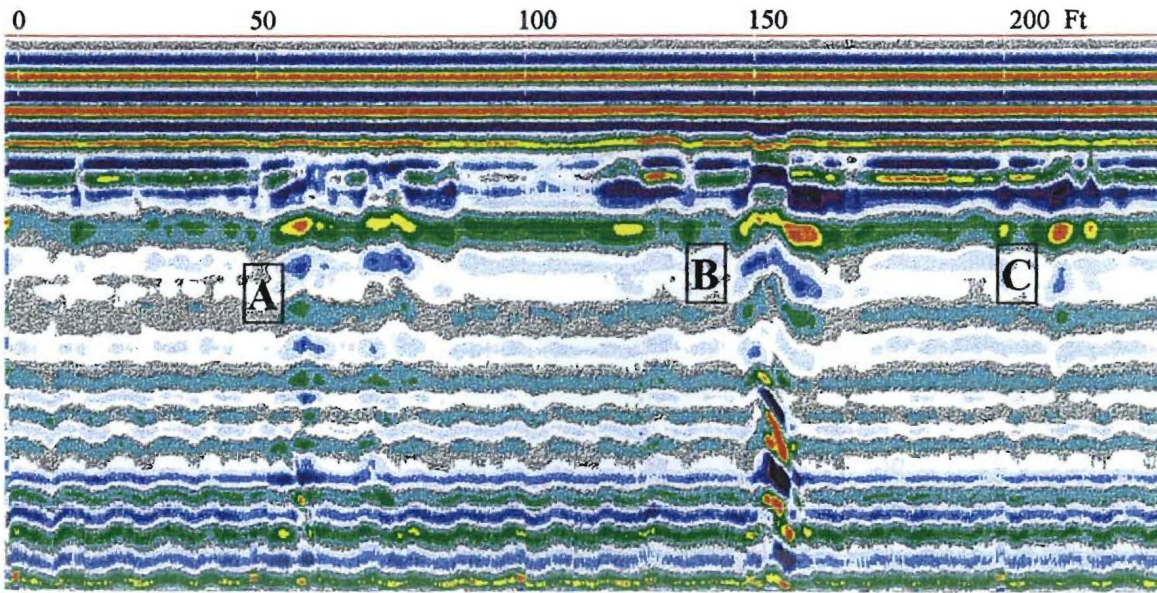
Figure 17. 100 MHz Data from Frontage Road 2 Adjacent to Grassy Median with Known Sinkholes. (1 ft = 0.3 m)

Areas of potential sinkholes are readily visible in the radar data from the frontage roads. TTI recommends the coring of both frontage roads in order to better support the findings from the ground penetrating radar data, along with providing precise depths to the sinkholes. We recommend that cores be taken from sinkholes D and/or E on Frontage Road 1, as well as sinkhole B and/or A on Frontage Road 2. The estimated depths to the problems are given

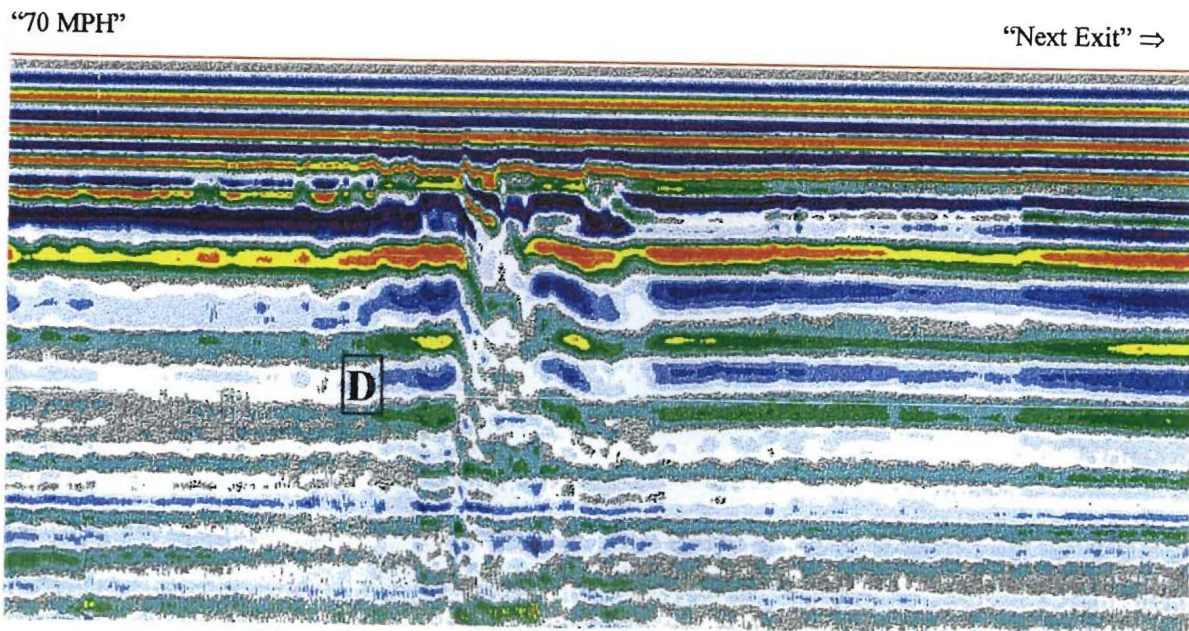
Figure 18. 100 MHz Data from Frontage 2.

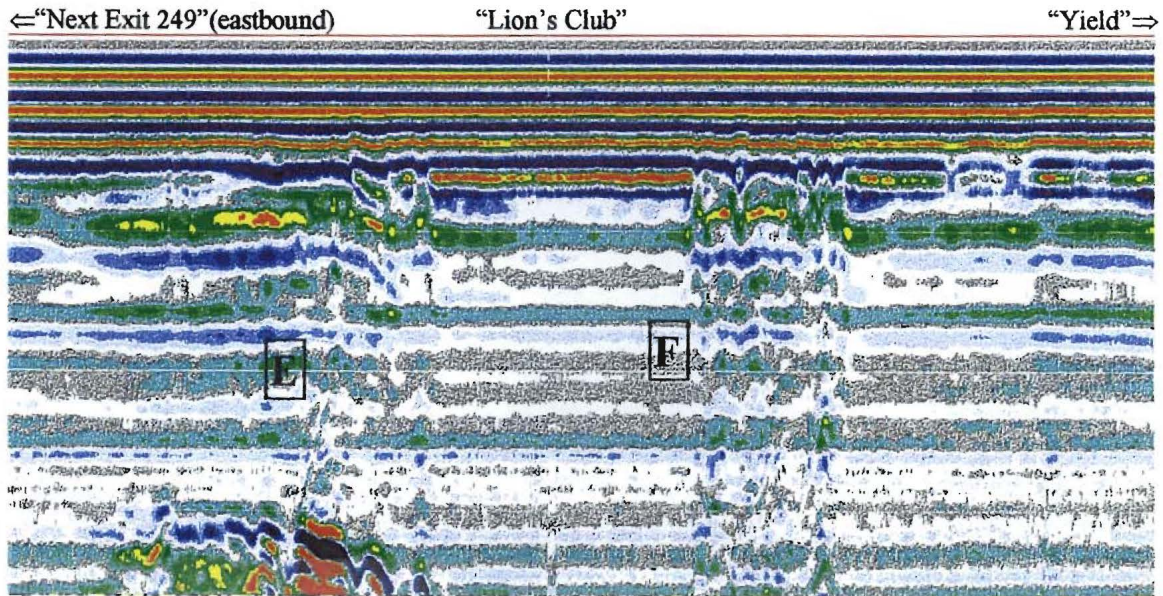
Figure 19. 100 MHz Data from Frontage 1.

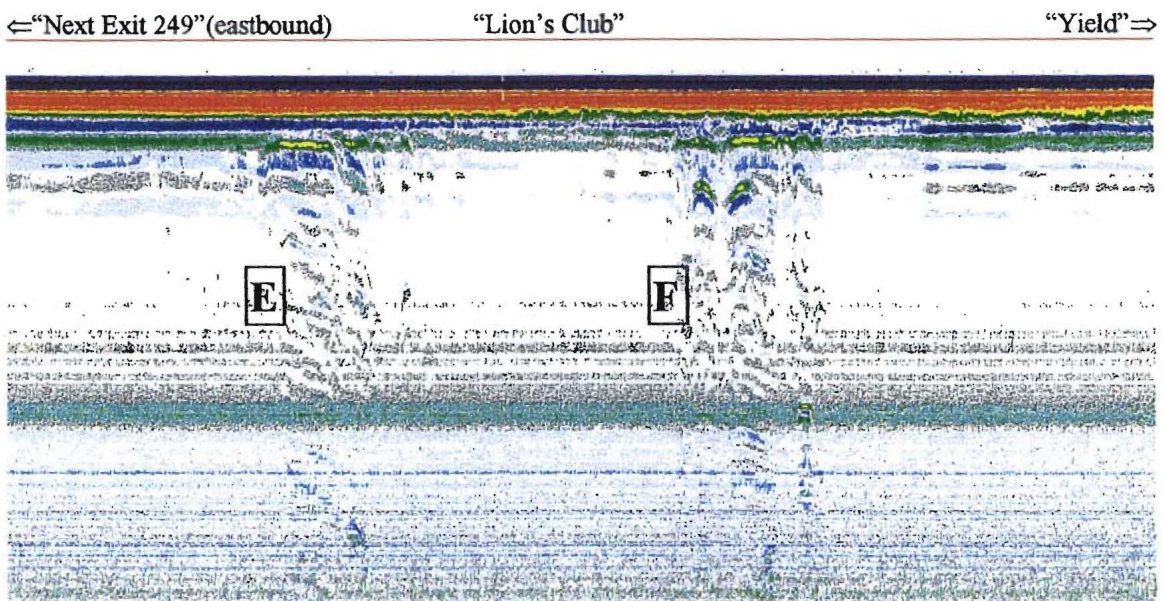
Figure 20. 500 MHz Data from Frontage 1.

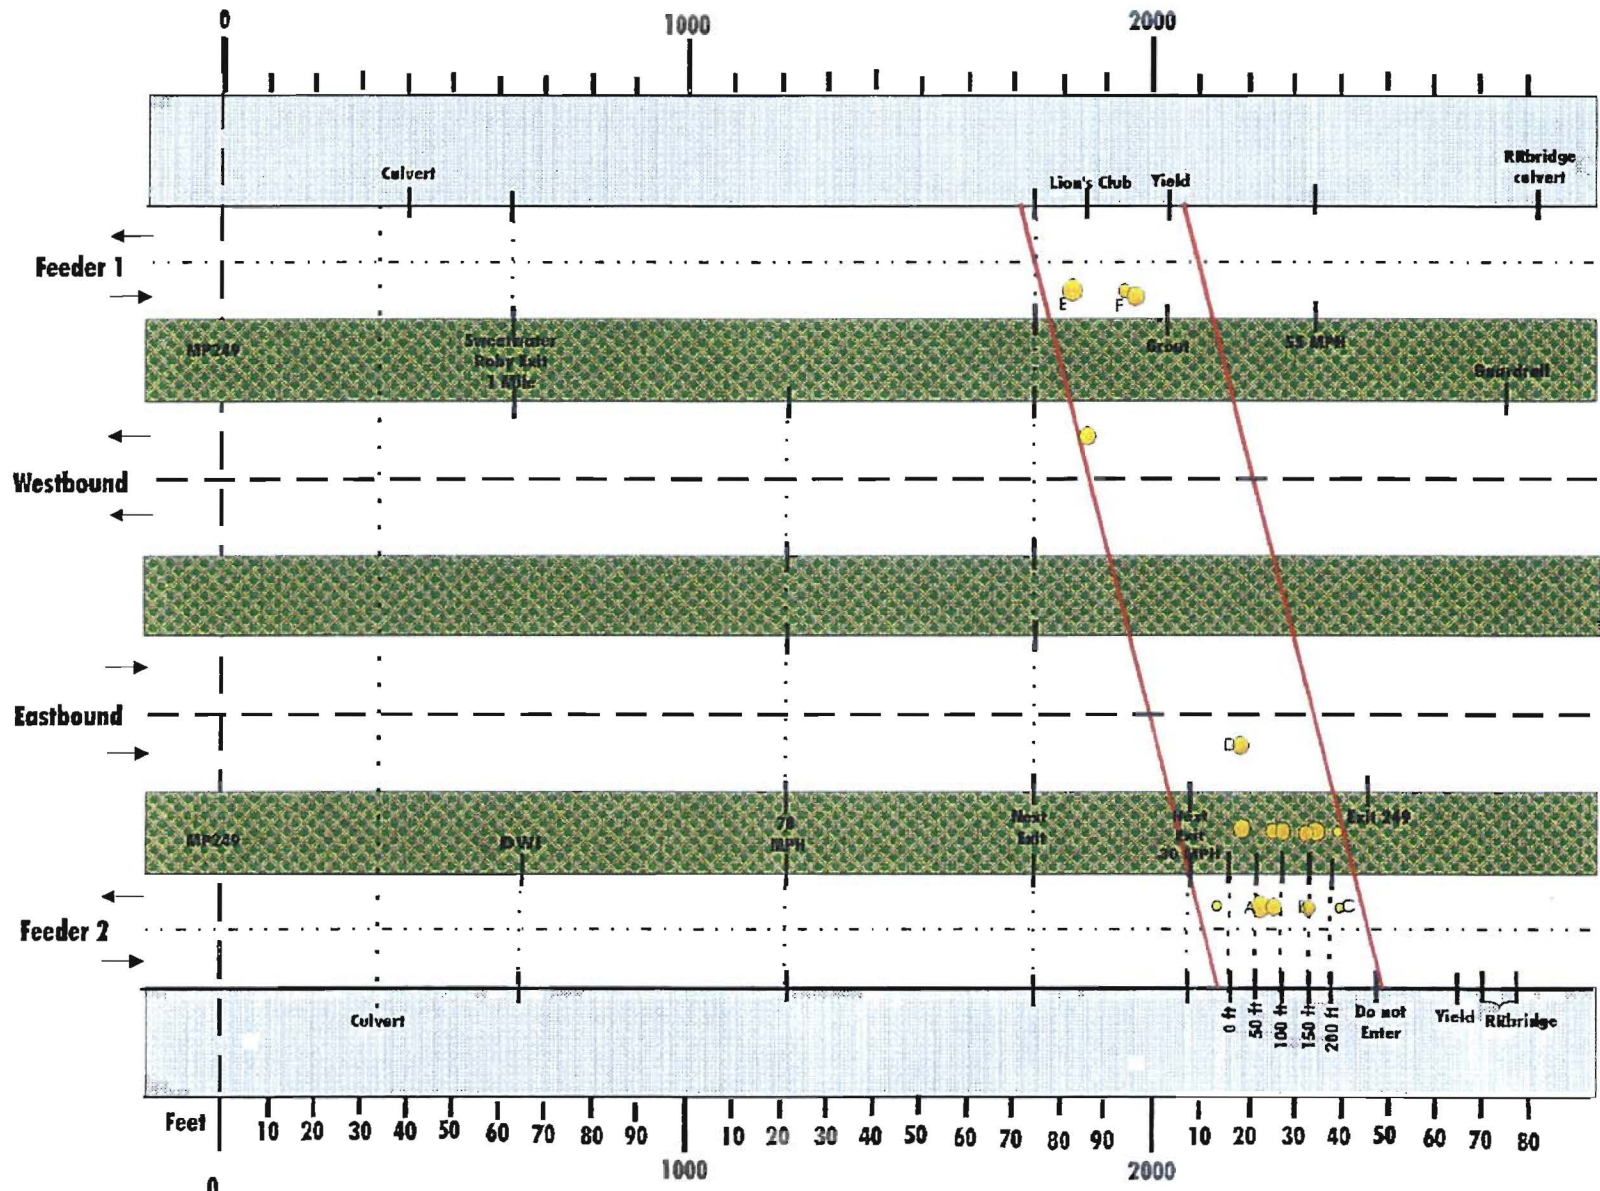
One small area of possible concern is located on the I-20 eastbound driving lane between the zero mark and 15 m (50 ft) mark found on the southern frontage road Frontage 2 (Figure 21). An overall review of the potential areas of concern can be seen in Figure 22.

Figure 22. Sweetwater Interstate 20.

above and should be used as a guideline for coring. We also recommend examination of the premises surrounding all sites with assessed sinkholes to insure that objects on or above the surface are not affecting the radar. The main highway lanes should be monitored for any deterioration, possibly due to the existence of sinkholes beneath the road. Future monitoring should include detail radar surveys in all main highway lanes and medians.

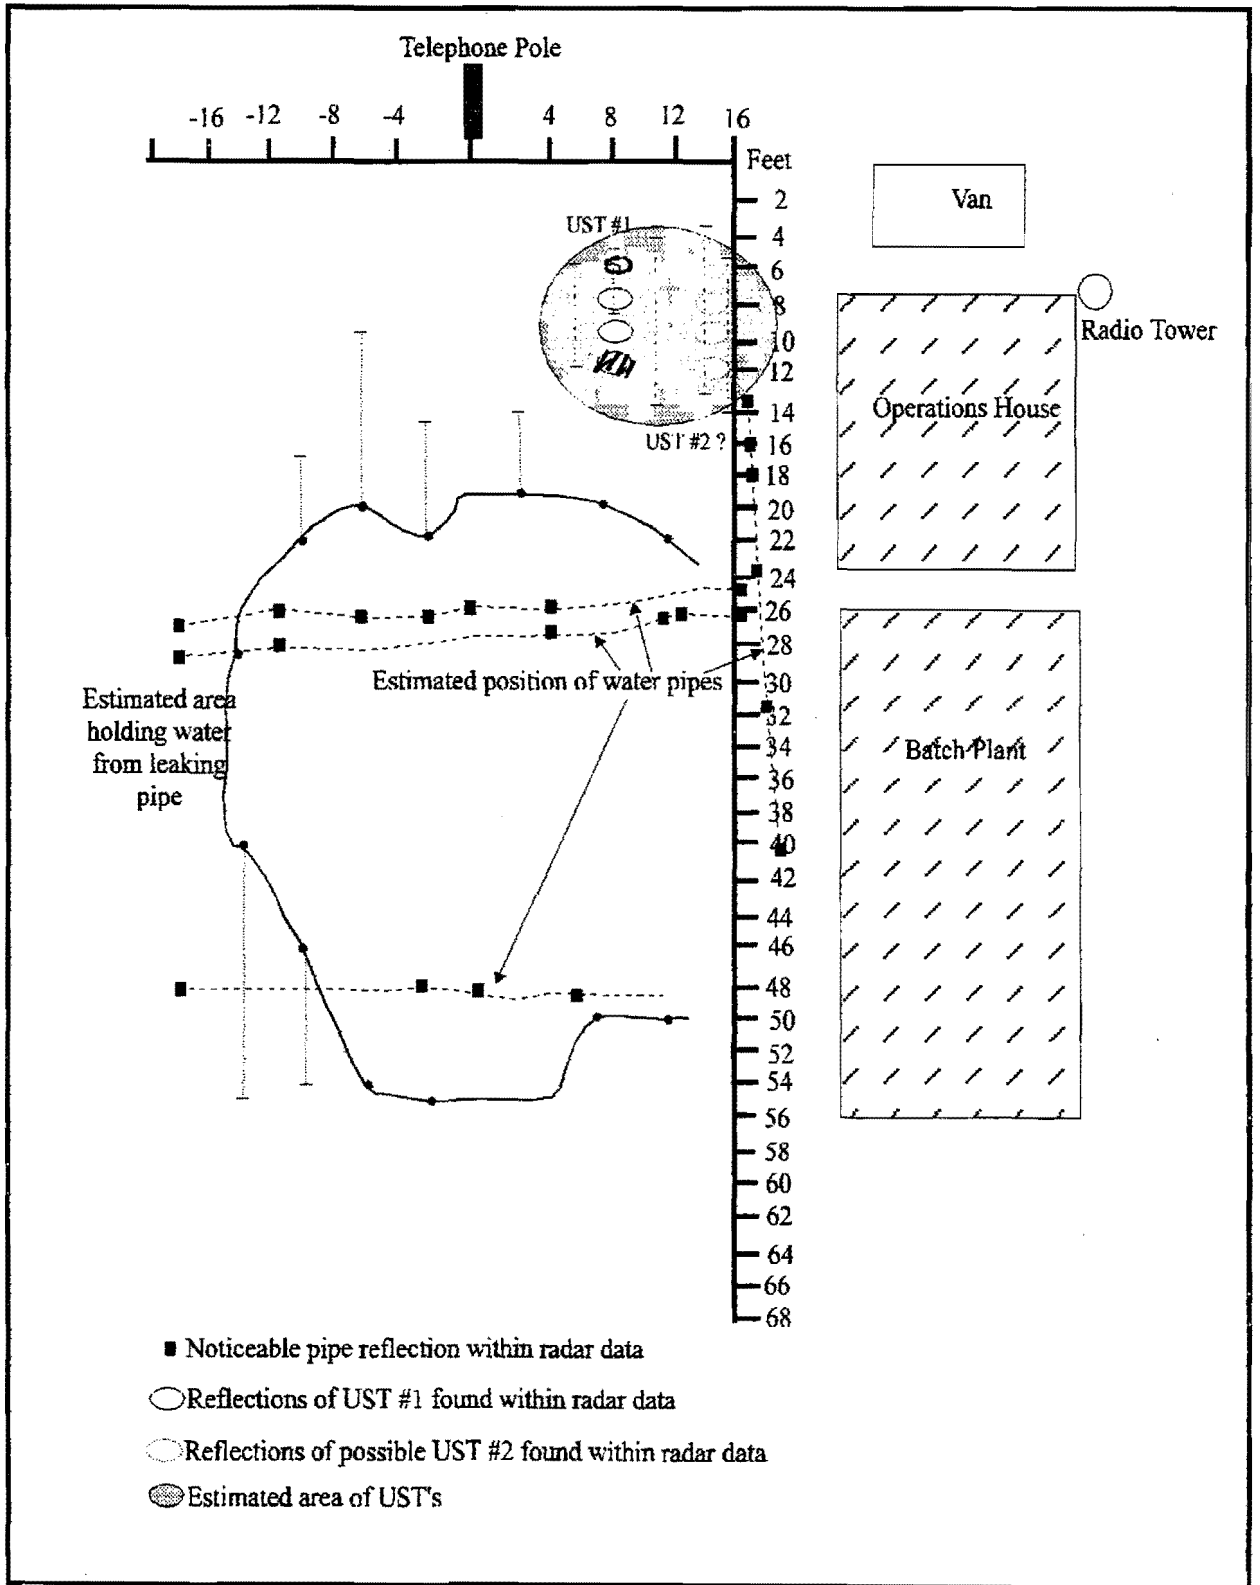
UST #1 was found within the quadrant of (8, 6) to (12, 6) to (8, 12) to (12, 12), however it is located closer to the $x = 8$ than to $x = 12$. The depth of UST #1 is approximately .52-.6 m (1.70-2 ft). This depth was calculated using a common dielectric constant for concrete, 7. If the exact dielectric constant of the concrete at the site was known, a more accurate depth could be calculated.

The estimated location of UST #2 is in the quadrant of (12, 8) to (16, 8) to (12, 12) to (16, 12), yet being located closer to the $x = 16$ line. A depth to UST #2 could not be calculated, but it is assumed to be at a similar depth as that of UST #1.

Figure 23. Site Layout at Beall Concrete Plant with GPR Results.

As shown in Figure 23 the GPR survey also predicted the presence of some buried water pipes which appeared from the GPR traces to be leaking. An estimation of the extent of the leakage was also given.
