1. Report No. TX-98/2947-S		2. Government Accession No.		3. Recipient's Catalog No.	
4. Title and Subtitle APPLICATIONS OF GROUND-COUPLED GPR TO PAVEMENT EVALUATION				5. Report Date November 1997

APPLICATIONS OF GROUND-COUPLED GPR TO PAVEMENT EVALUATION

Research Report 2947-S
Research Study Number 7-2947
Research Study Title: Using Ground-Coupled and Air-Launched
Radar Systems for Pavement Evaluation

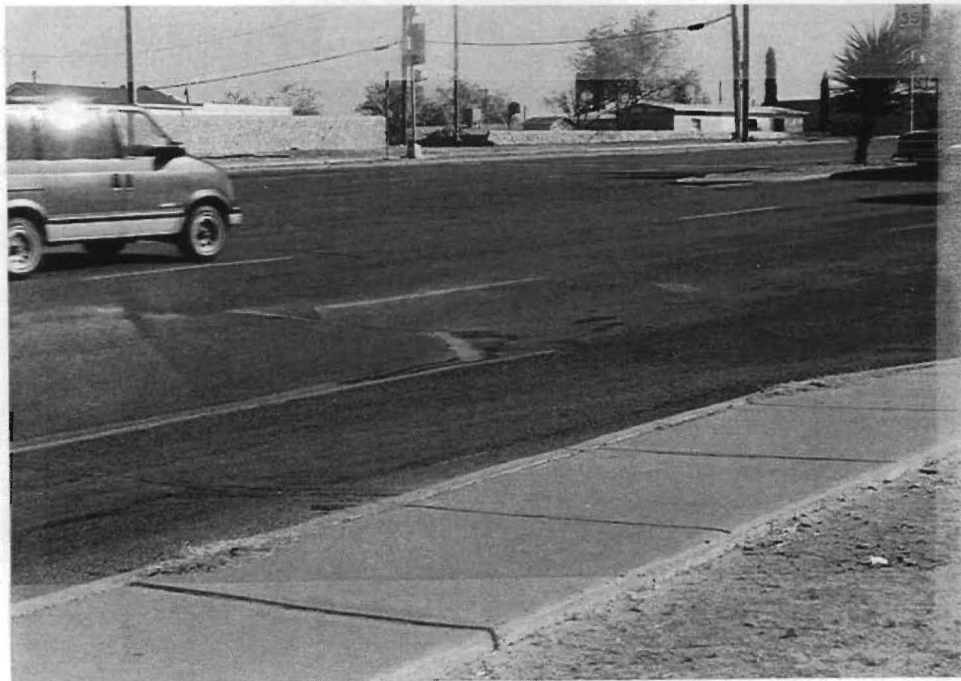
Figure 27. Water Seeping from Pavement Near the Intersection with Kern Street.

The water seeping from the pavement on Mesa Road in the southbound lane near the intersection with Kern appears to be coming from a leaking utility line. A major line runs longitudinally along the center median and a smaller line runs transversely across the pavement at approximately 236 m (775 ft) from the start of the section. Our best guess is that the transverse pipe is leaking. It was noted that a repair has recently been made to the longitudinal pipe in this area and it may well be that this pipe is also leaking.

At the moment we do not see any major voids or sinkholes occurring, however, continuing seepage and pumping will eventually lead to a pavement failure. These results should be forwarded to the responsible utility company.

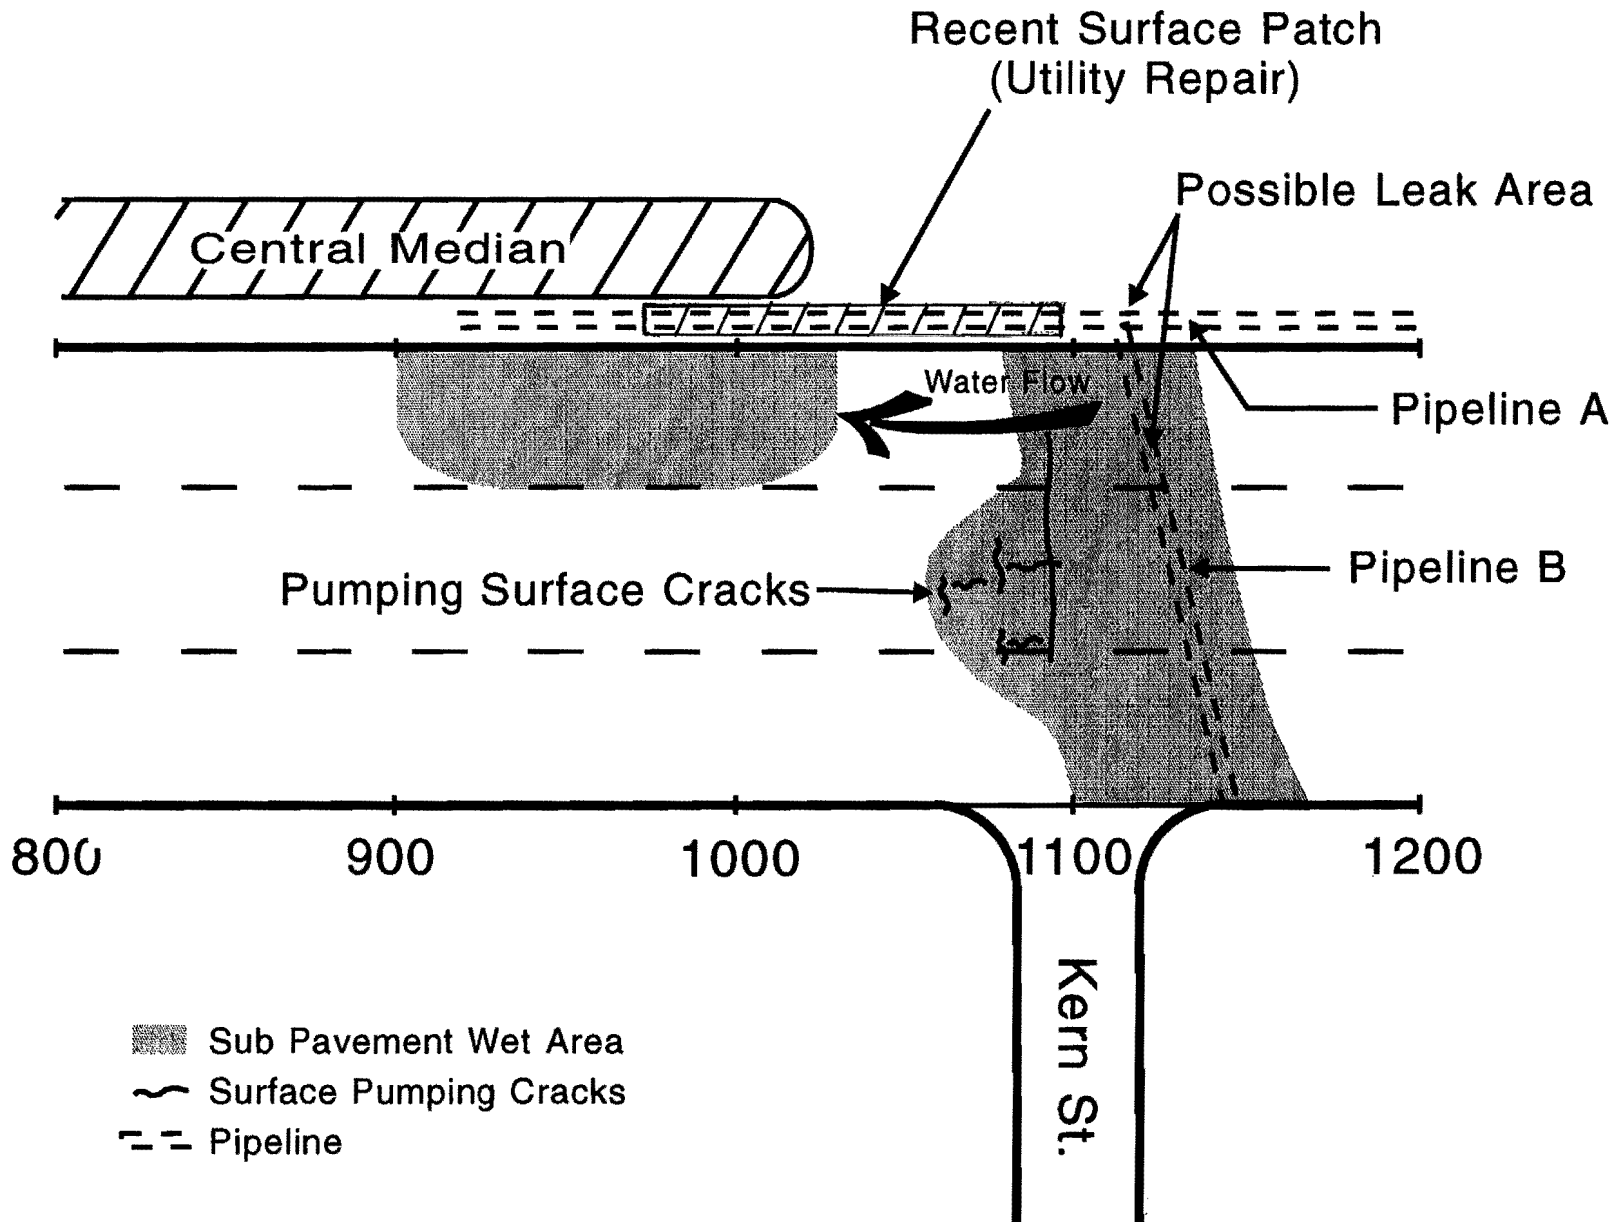
The first moisture anomaly which was located between 60 and 90 m (200-300 ft) was located in the low spot of the section. It is clear that the drainage system of the road is not working and the structure is trapping water. The consequences of this trapped moisture were also apparent on the surface of the road, where the pavement has been repeatedly repaired. From the GPR profile it is apparent that there have been several attempts to repair the problem but they have not been successful.

The second moisture anomaly is located on a sloping hillside between marks 900 and 1150 (Figure 28). The area of the moisture varies under each lane. In the right (outer) lane the moisture area is between 300 and 352 m (985 and 1155 ft), in the center lane the moisture area is narrowest and only from 306 to 342 m (1000 to 1120 ft) and in the left (inner) lane the moisture was observed to be from 290 to 358 m (950 to 1175 ft). All of these moisture anomalies were in close proximity to an underground water pipeline. The water appears to be flowing downhill from the pipe and ponding below the surface then leaching out of surface cracks. The water flow mechanism can be seen especially in the center lane radar profiles where a part of the water starts to flow down to the subgrade soil while part of the water finds its way up to the surface through the pavement structure (see arrows). In the left (inner lane) the water appears to flow around the pipe and then flow down above the bedrock. The only reflection that might indicate that there is also moisture in the bedrock can be found under this lane between 330 and 360 m (1080 and 1180 ft). It is clear that at this location the water is not coming up to the surface but flowing down through cracks.

As a conclusion it is proposed that the water is coming from leaking water or sewer pipes. This interpretation is also supported by the fact that the amount of leaking water varied during the day. The greatest amount of water was coming to the surface a couple of hours after the morning water consumption peaks.

Figure 29. Summary of GPR Results Showing Trapped Moisture and Possible Leak Locations.
