1. Report No. TX-98/2966-1		2. Government Accession No.		3. Recipient's Catalog No.	
4. Title and Subtitle FIELD PERFORMANCE EVALUATION OF HYDRATED, FLY ASH BASES IN THE ATLANTA DISTRICT - YEAR 1				5. Report Date November 1997

**FIELD PERFORMANCE EVALUATION OF HYDRATED,
FLY ASH BASES IN THE ATLANTA DISTRICT - YEAR 1**

Research Report 2966-1
Research Study Number 7-2966
Research Study Title:
Durability of Surface Treatments as the Wearing Course
Placed on Crushed Fly Ash and Long-Term Performance
of Crushed Fly Ash for Flexible Base

November 1997

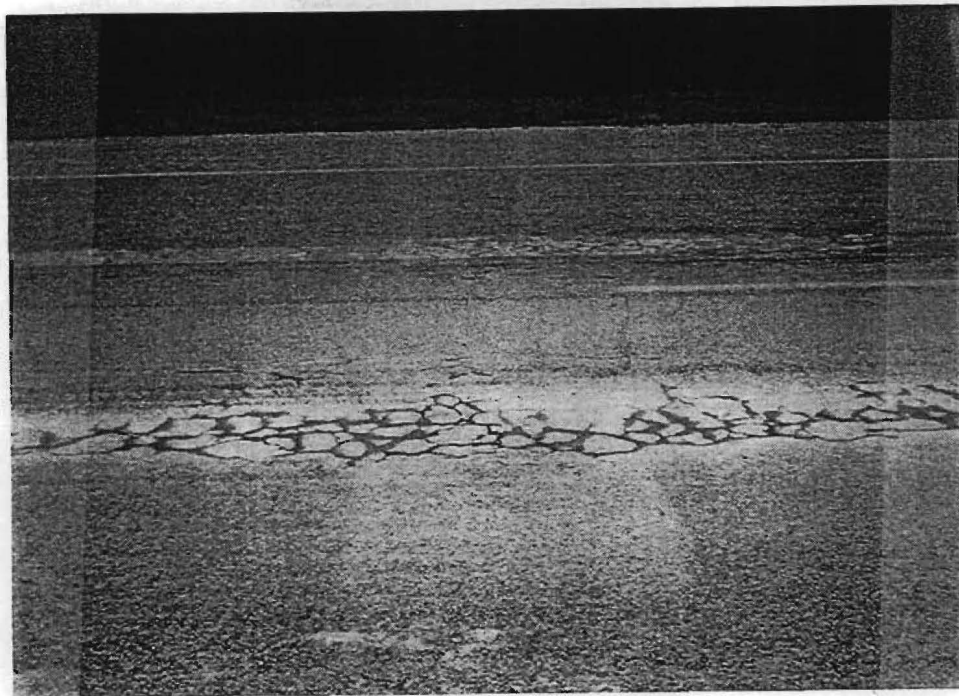
Figure 2. Alligator Cracking on Loop 390

This project begins at US 59 in Marshall and extends to 0.5 km south of SH 43. The total length of the project is about 4.0 km. For visual condition surveys, the project was evaluated at 13 locations (60 m survey length per location) in the eastbound lane. There were three types of distress beginning to be evident on Loop 390: alligator cracking, a slight flushing of the seal coat surface, and rutting. Quantities of distress at each survey location are shown below in Table 2. A typical photograph of the alligator cracking is shown in Figure 2.

FWD data shown in Table 8 and Figure 3 indicate that the base layer is weak in some areas which also happens to coincide with areas where alligator cracking is observed. Another concern here and on most of the other test pavements is the variability in moduli along the length of the pavement.

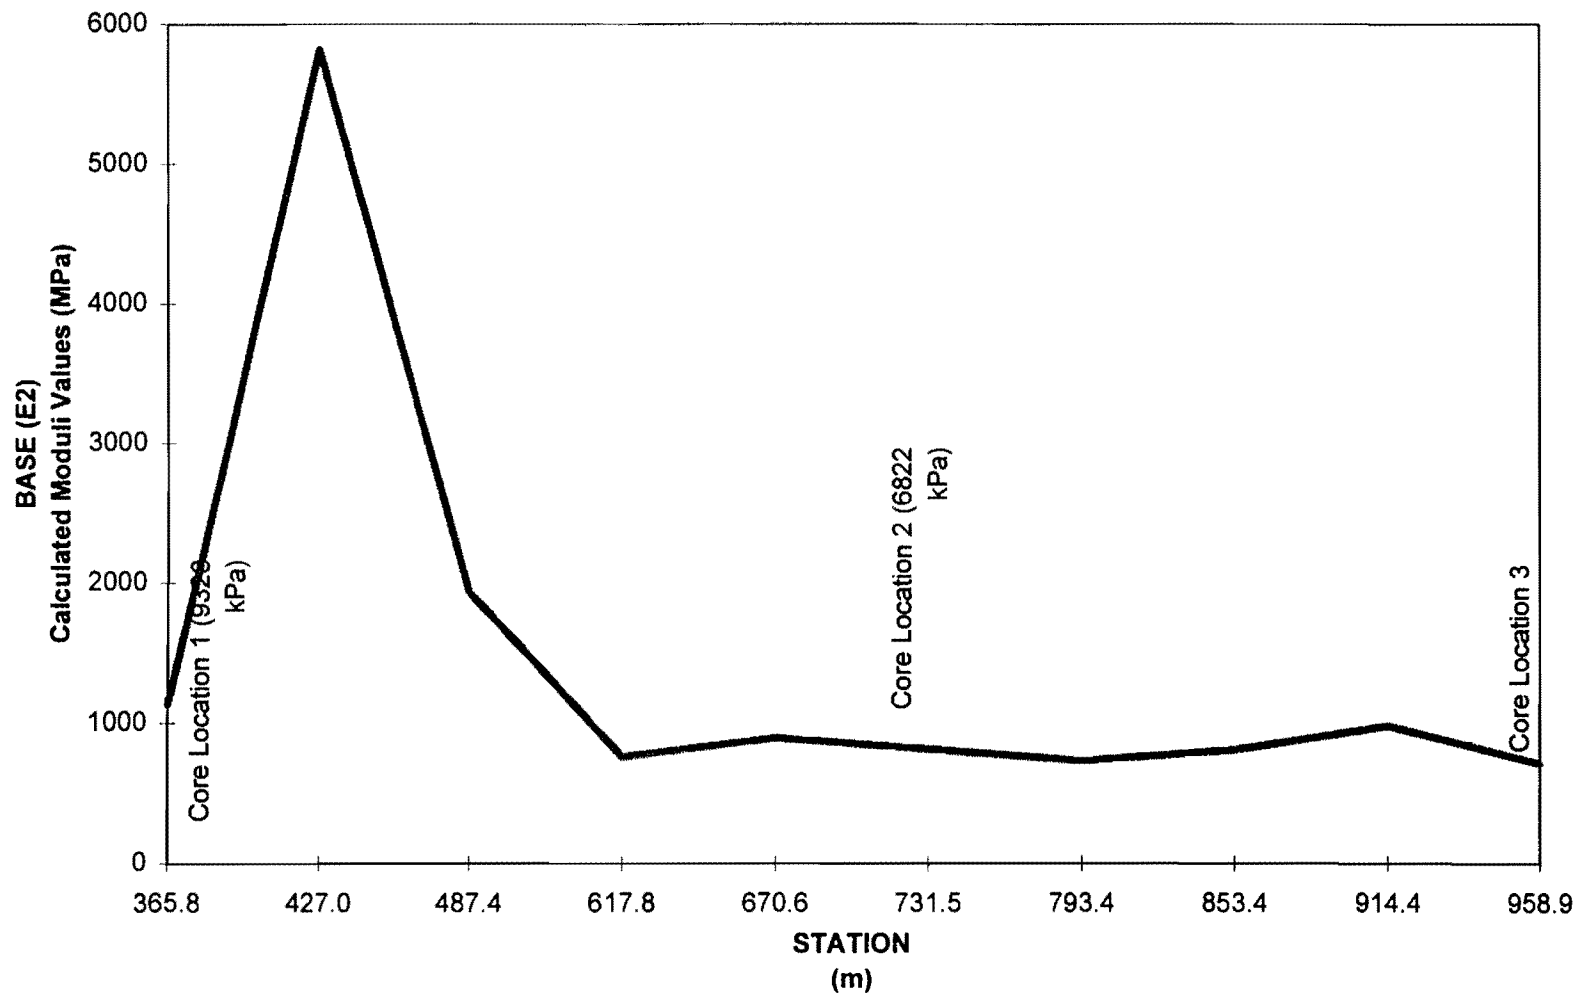
Figure 4. Base Moduli Values for IH 20 Frontage Road

The first four data points and last data point on the FWD (Table 9) show extremely high moduli values for the base material (seemingly uncharacteristic for this material). Therefore, researchers conclude that the data points at each end of the section are another type of pavement so these data points are excluded from Figure 4. The moduli values are not as variable on this pavement but are generally on the border or below that which is desired of at least 1000 MPa; however, this does not correlate with the high compressive strengths of the cores.

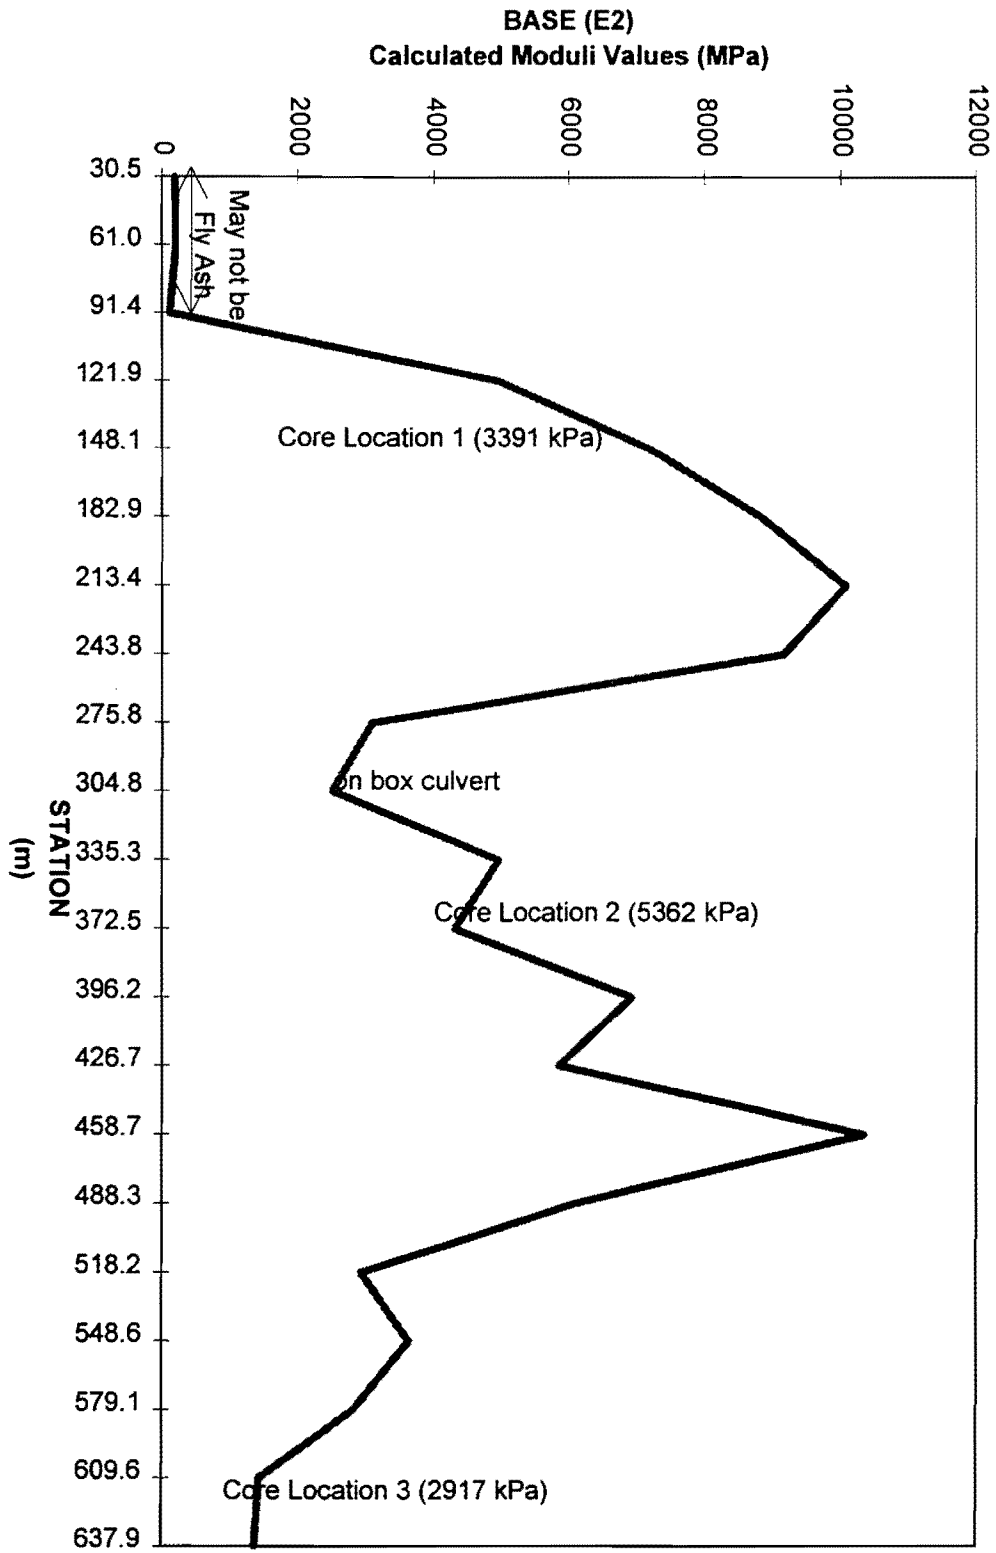
Figure 5. Base Moduli Values for SH 154

With indications of what appears to be shrinkage cracking, one would expect this pavement to be the stiffest of the six. This is true in terms of FWD data (Table 10). Base moduli values along the pavement exceed 7000 MPa in some locations. Also note the variability in the moduli values as shown in Figure 5. Average compressive strength of the three field cores was 4090 kPa.

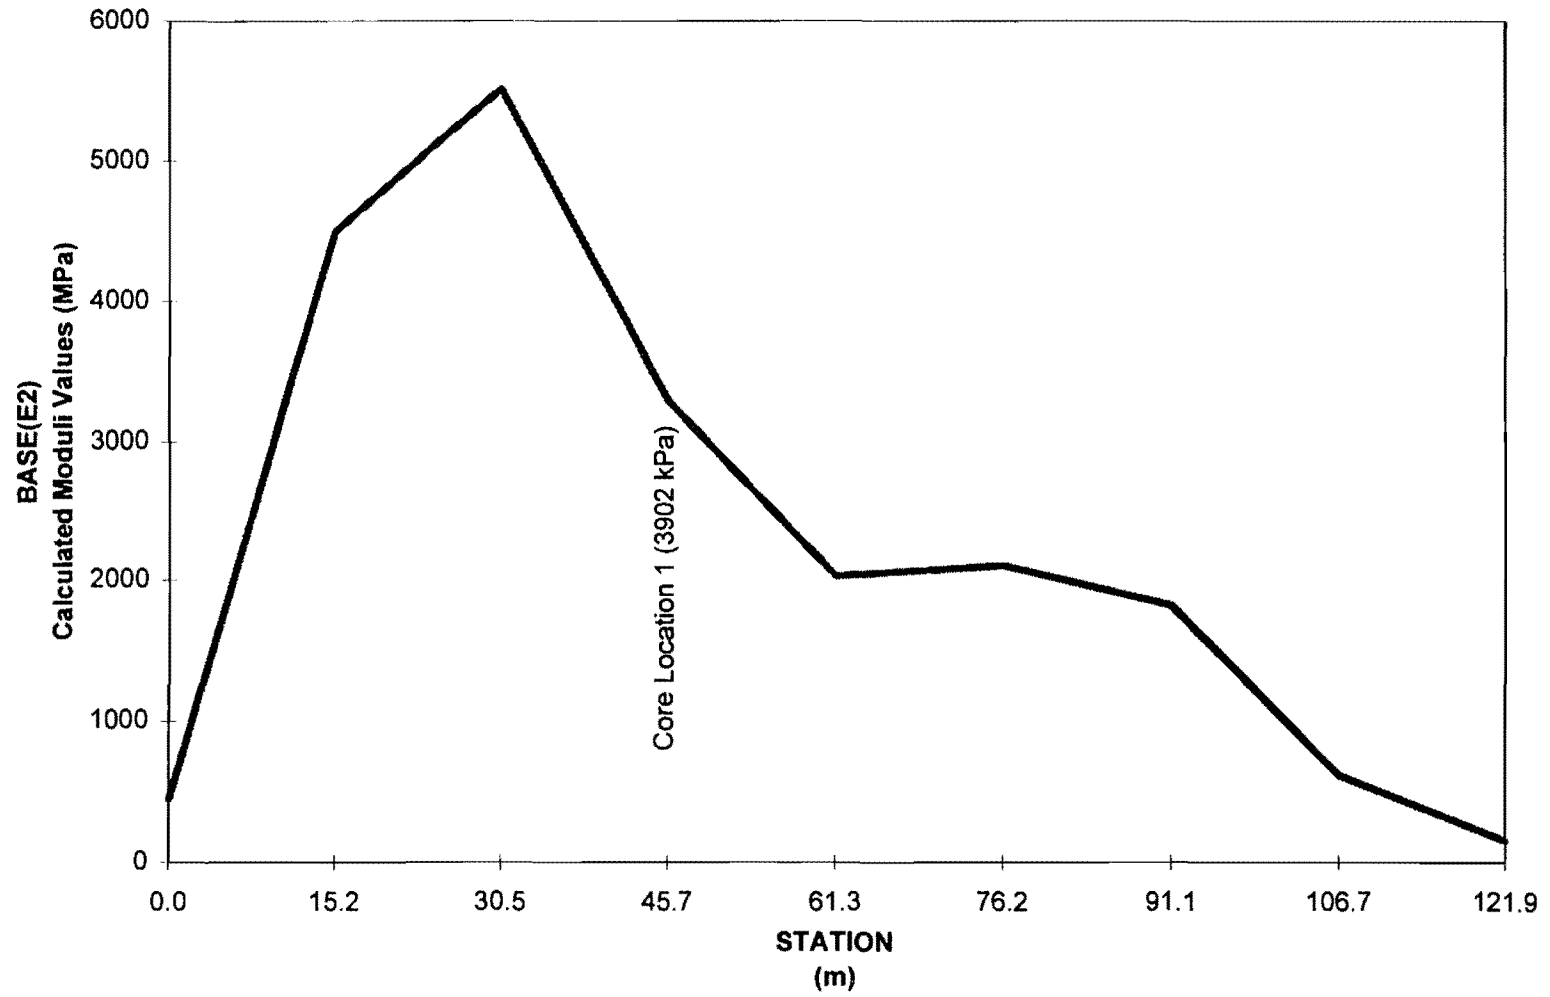
Figure 6. Base Moduli Values for FM 1326

One core was obtained from FM 1326 which could be tested and its compressive strength was 3902 kPa. FWD data (Table 11 and Figure 6) indicate some weak spots in the base layer but also some variability.

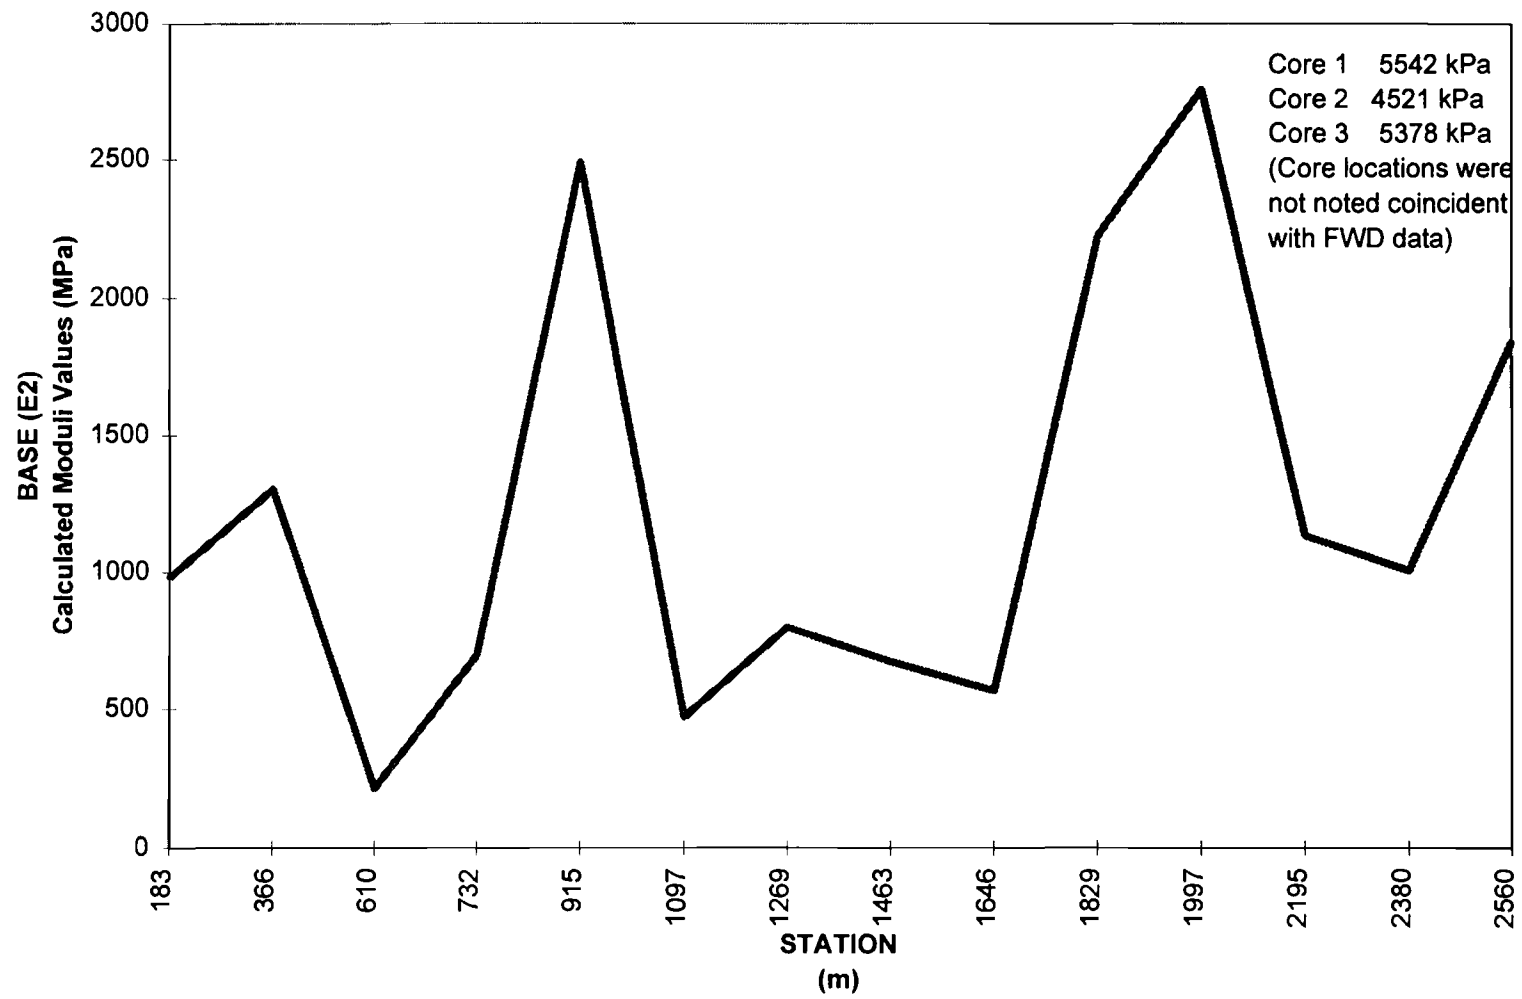
Figure 7. Base Moduli Values for FM 1520

Three cores were obtained from FM 1520 with an average compressive strength of 5147 kPa. FWD data on this pavement also indicates that there are some weak areas where the moduli values drop below the minimum desired value of 1000 MPa, and again, there is variability along the length of the pavement (Table 12 and Figure 7).

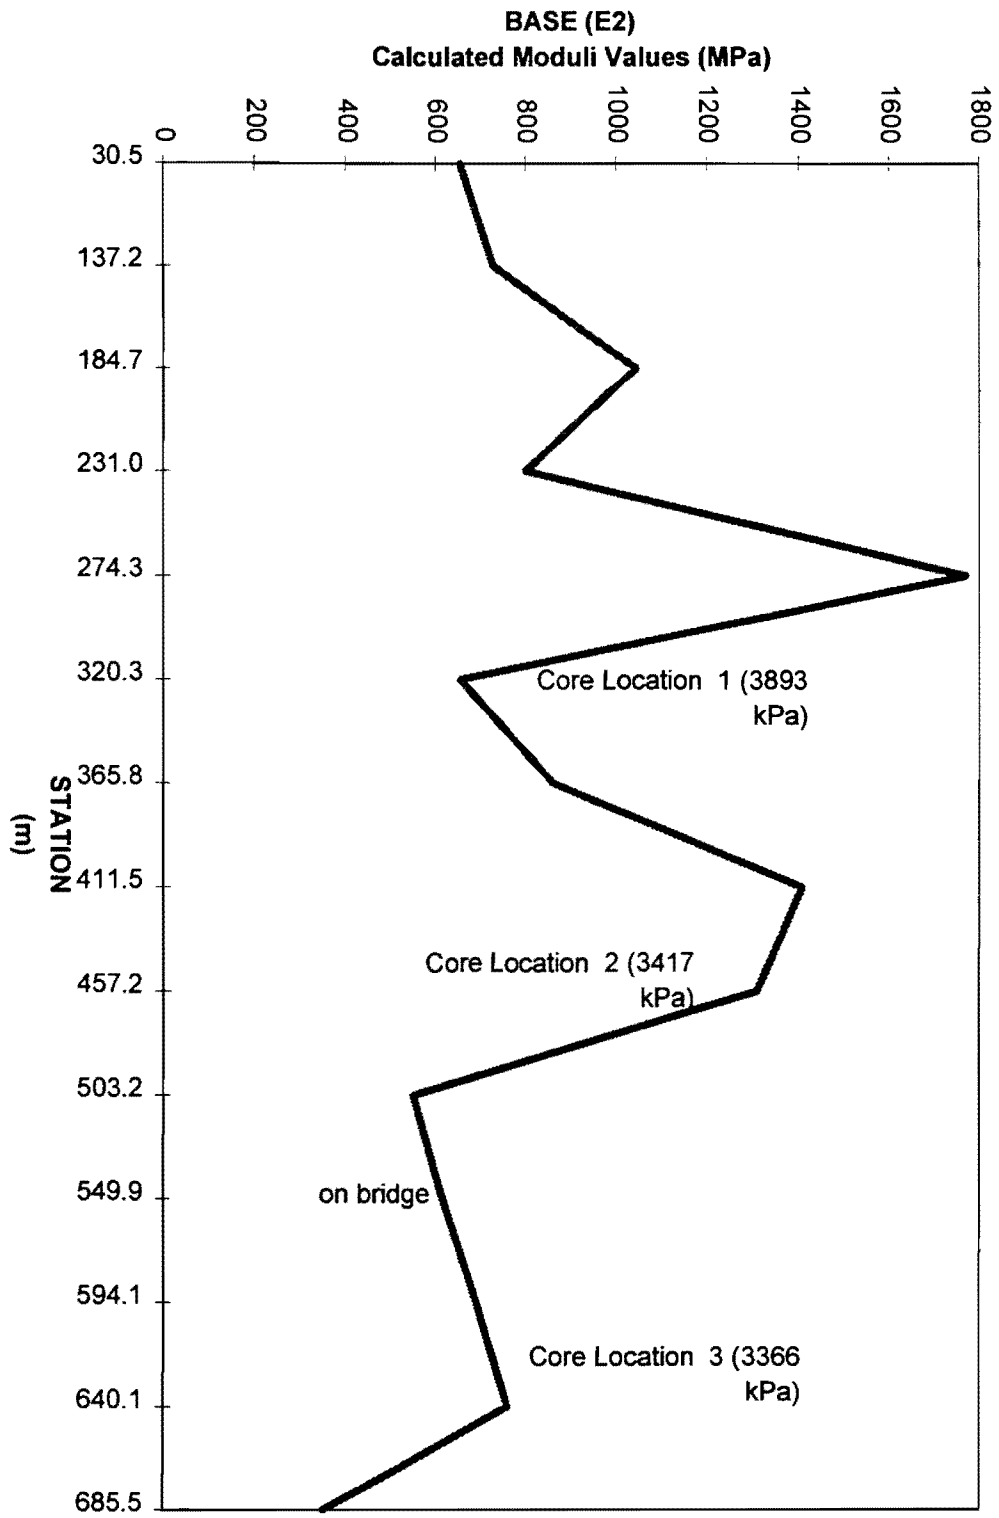
Figure 8. Base Moduli Values for FM 560

Three cores were obtained from FM 560 with an average compressive strength of 3359 kPa. The base on this pavement has two different thicknesses along its length: 24 cm and 16 cm. Because of the difference in thicknesses, two separate FWD analyses were performed as shown in Table 13. Results from both analyses, however, were combined for Figure 8. The data point at station 96.3 is not shown in Figure 8 because it appears that it may not be representative. Moduli values for this pavement do not appear to be as variable as on some of the others; however, the values are lower than the desired minimum of 1000 Mpa.

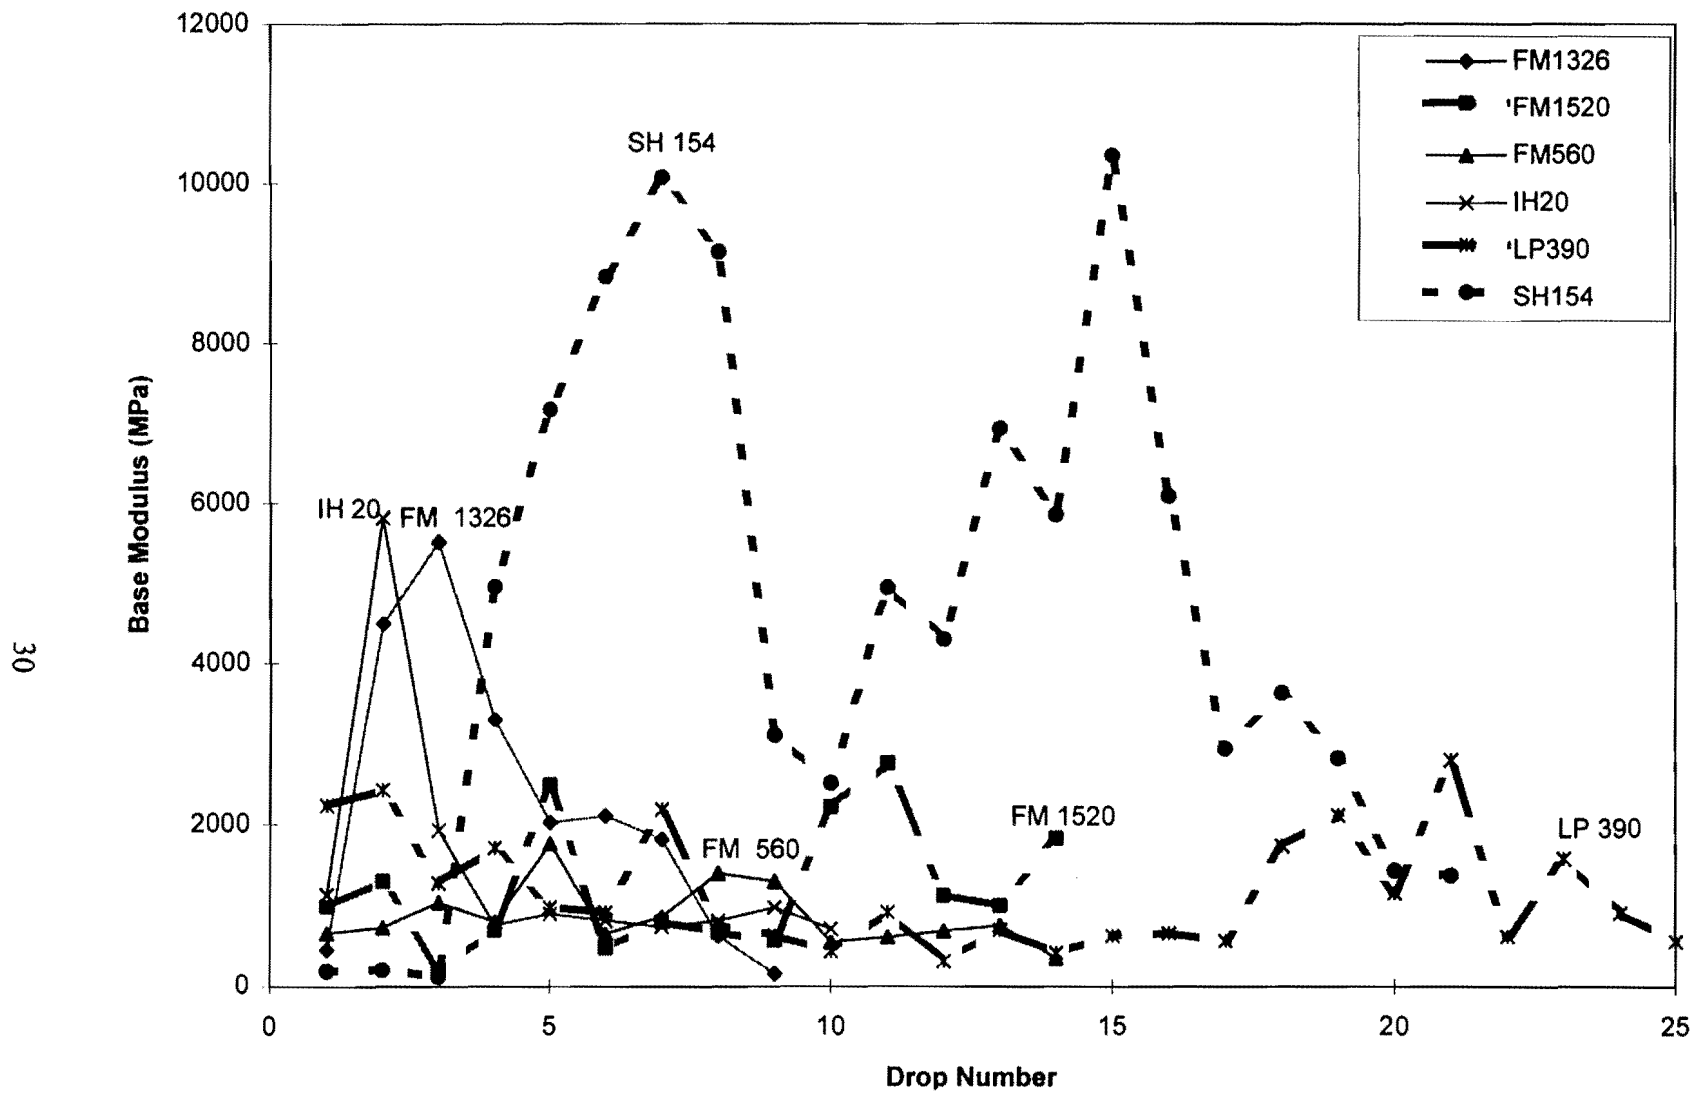
Figure 9. Base Moduli Values for All 6 Pavement Sections.

- Concern is warranted regarding the fly ash material variability as exhibited in moduli values from FWD data. There is variability along a single pavement length, as well as between different pavements (i.e., SH 154 is much stiffer overall than any other pavement). This variability is evident in Figure 9. Reasons for this variability are unknown but should be investigated. The material may have been inconsistent in its *as-received* condition, or the effect of the fly ash as a stabilizer may be deteriorating over time (perhaps due to water infiltrating the base in certain areas).

It is also recommended that this year's monitoring program employ the use of ground penetrating radar (GPR) on all six test pavements. It is possible that the reason for the moduli variation in the base materials is due to the presence of water in the base which is causing a *weakening* of that layer. If so, this will be revealed through GPR. This additional work will not require any new allocation of research funds.
