**FLY-ASH BASES IN THE ATLANTA DISTRICT:
EVALUATION OF SURFACE TREATMENT BOND
AND
YEAR-TWO FIELD PERFORMANCE EVALUATIONS**

Report 2966-2
Project Number 7-2966
Research Project:
Durability of Surface Treatments as the Wearing Course
Placed on Crushed Fly Ash and Long-Term Performance
of Crushed Fly Ash for Flexible Base

December 1998

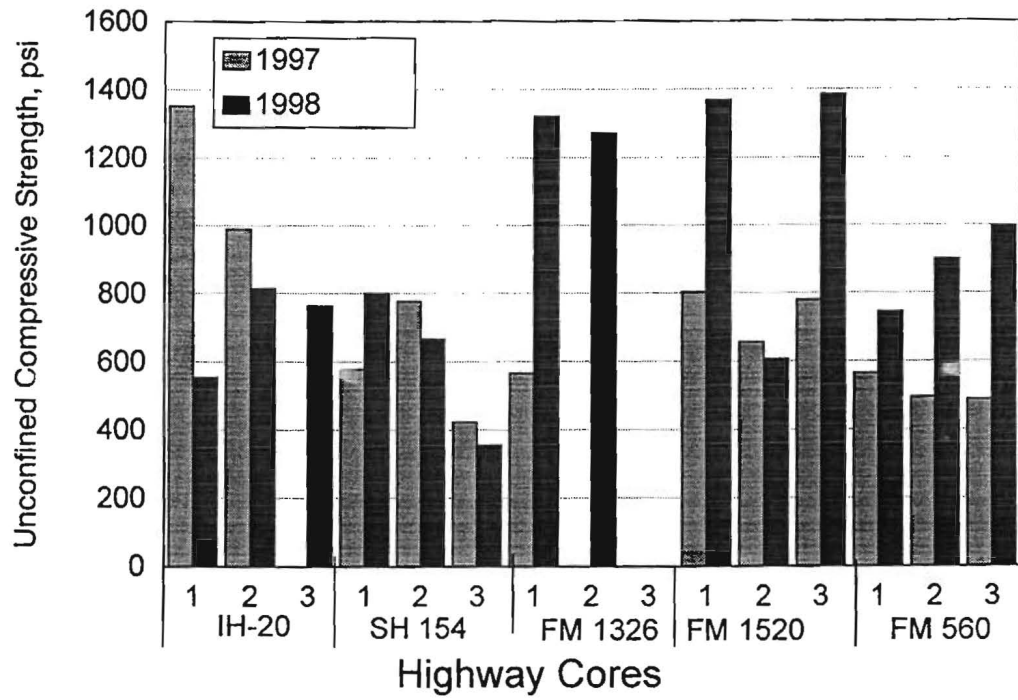
Figure 6. Unconfined Compressive Strength of Highway Cores

Three cores were obtained from this pavement as shown in Figure 6. Last year, this pavement exhibited the highest compressive strength but there was a loss in strength as noted with the cores taken in 1998. However, there doesn't seem to be an appreciable difference in the base moduli values from 1997 to 1998 (Figure 8). Note in Figure 8, that the last data point may coincide with the beginning of a different type of pavement section.

With indications of what appears to be shrinkage cracking, one would expect this pavement to be the stiffest of the six. This is true in terms of FWD data (Figure 9). Base moduli values along the pavement exceed 1,000,000 psi in some locations. Base moduli values in 1998 appear to be similar to that in 1997 with some places showing significantly higher moduli than the previous year. Compressive strength of the cores is also close to the values obtained the previous year (Figure 6).

Two cores were obtained from FM 1326 which could be tested and the compressive strength was significantly higher than the single core which was tested in 1997. FWD data (Table 12 and Figure 10) indicate that the base is not deteriorating but exhibits an overall similar or better modulus than the previous year.

All three cores obtained from FM 560 had a higher compressive strength than the cores obtained the previous year. The base on this pavement has two different thicknesses along its length: 9 inches and 16 inches. Because of the difference in thicknesses, two separate FWD analyses were performed as shown in Table 14. Results from both analyses, however, were combined for Figure 12. Moduli values for this pavement do not appear to be as variable as on some of the others; however, the values are lower than the desired minimum of 145,000 psi. Also, however, there seems to be little change in moduli values between 1997 and 1998.

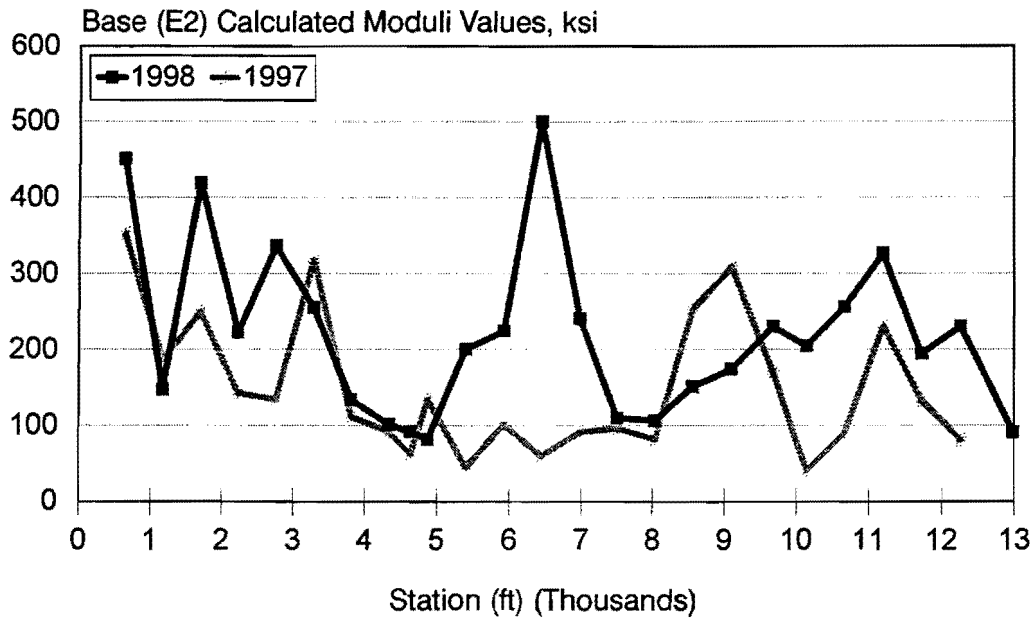
Figure 7. Base Moduli Values for Loop 390

FWD data shown in Table 8 and Figure 7 indicate that the base layer is weak in some areas which also coincided with areas where alligator cracking was observed in 1997. As shown in Figure 7, there is some variation in the moduli values between 1997 and 1998; however, the difference does not seem to warrant concern that the base is exhibiting a deteriorating strength.
