1. Report No. FHWA/TX-84/ 52 +343-2		2. Government Accession No.		3. Recipient's Catalog No.	
4. Title and Subtitle TEST AND EVALUATION OF NEIGHBORHOOD MAILBOX				5. Report Date March 1984

TEST AND EVALUATION OF NEIGHBORHOOD MAILBOX

Research Report No. 343-2

Improved Design of Lightpoles, Guardrails, and Other Appurtenances

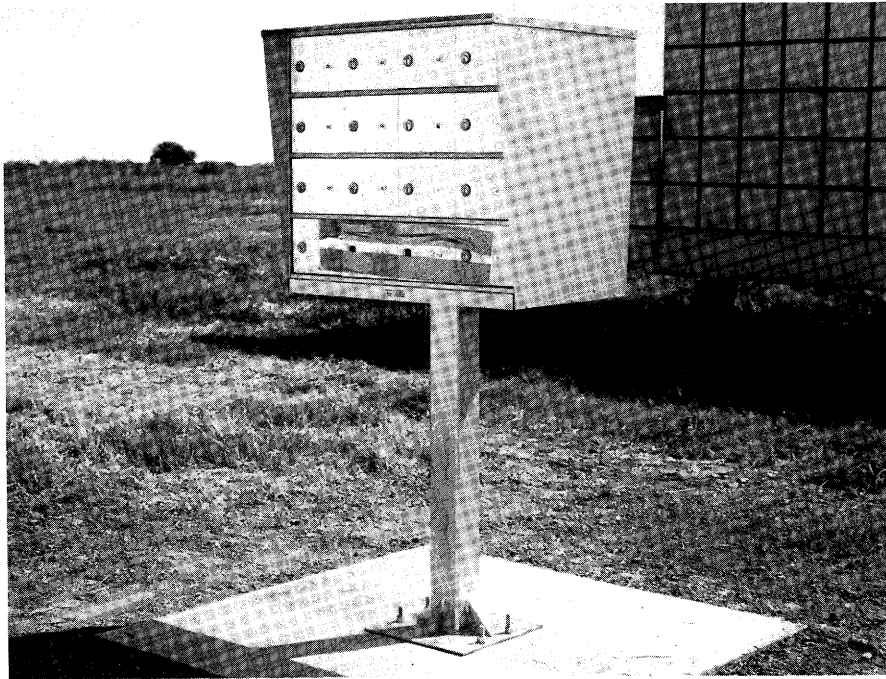
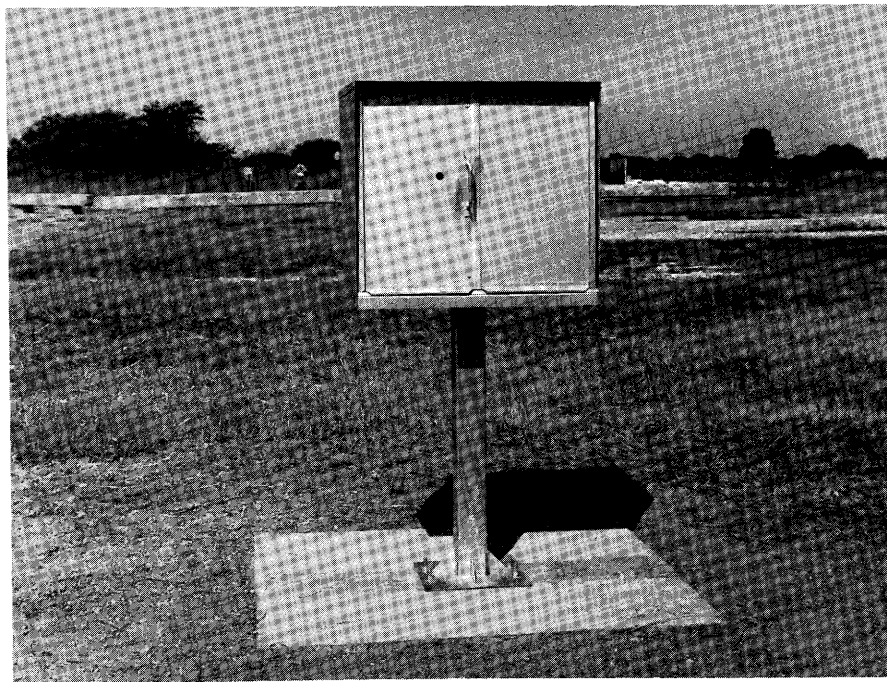
Figure 3 . Test Installation Before Test 2343-1.

An Auth No. 452 neighborhood mailbox, manufactured by Auth Electric Co., Deer Park, N. Y., was set up for Test 2343-1 according to typical field installation procedures. The sixteen compartment mailbox unit was supported by a 3-1/2" x 3-1/2" structural steel tube. Steel plates, 12" x 12" x 3/16", welded to the tube at the top and bottom, were used to attach the boxes to the tube and to anchor the tube to the concrete foundation. The lower anchor plate was connected to the concrete foundation with four 1/2" diameter J-bolts. Details of the mailbox and base are shown in Figures 1 and 2. Photographs of the test installation before testing are presented in Figures 3 and 4. Two of the lower compartments were taped closed because the locks were missing.

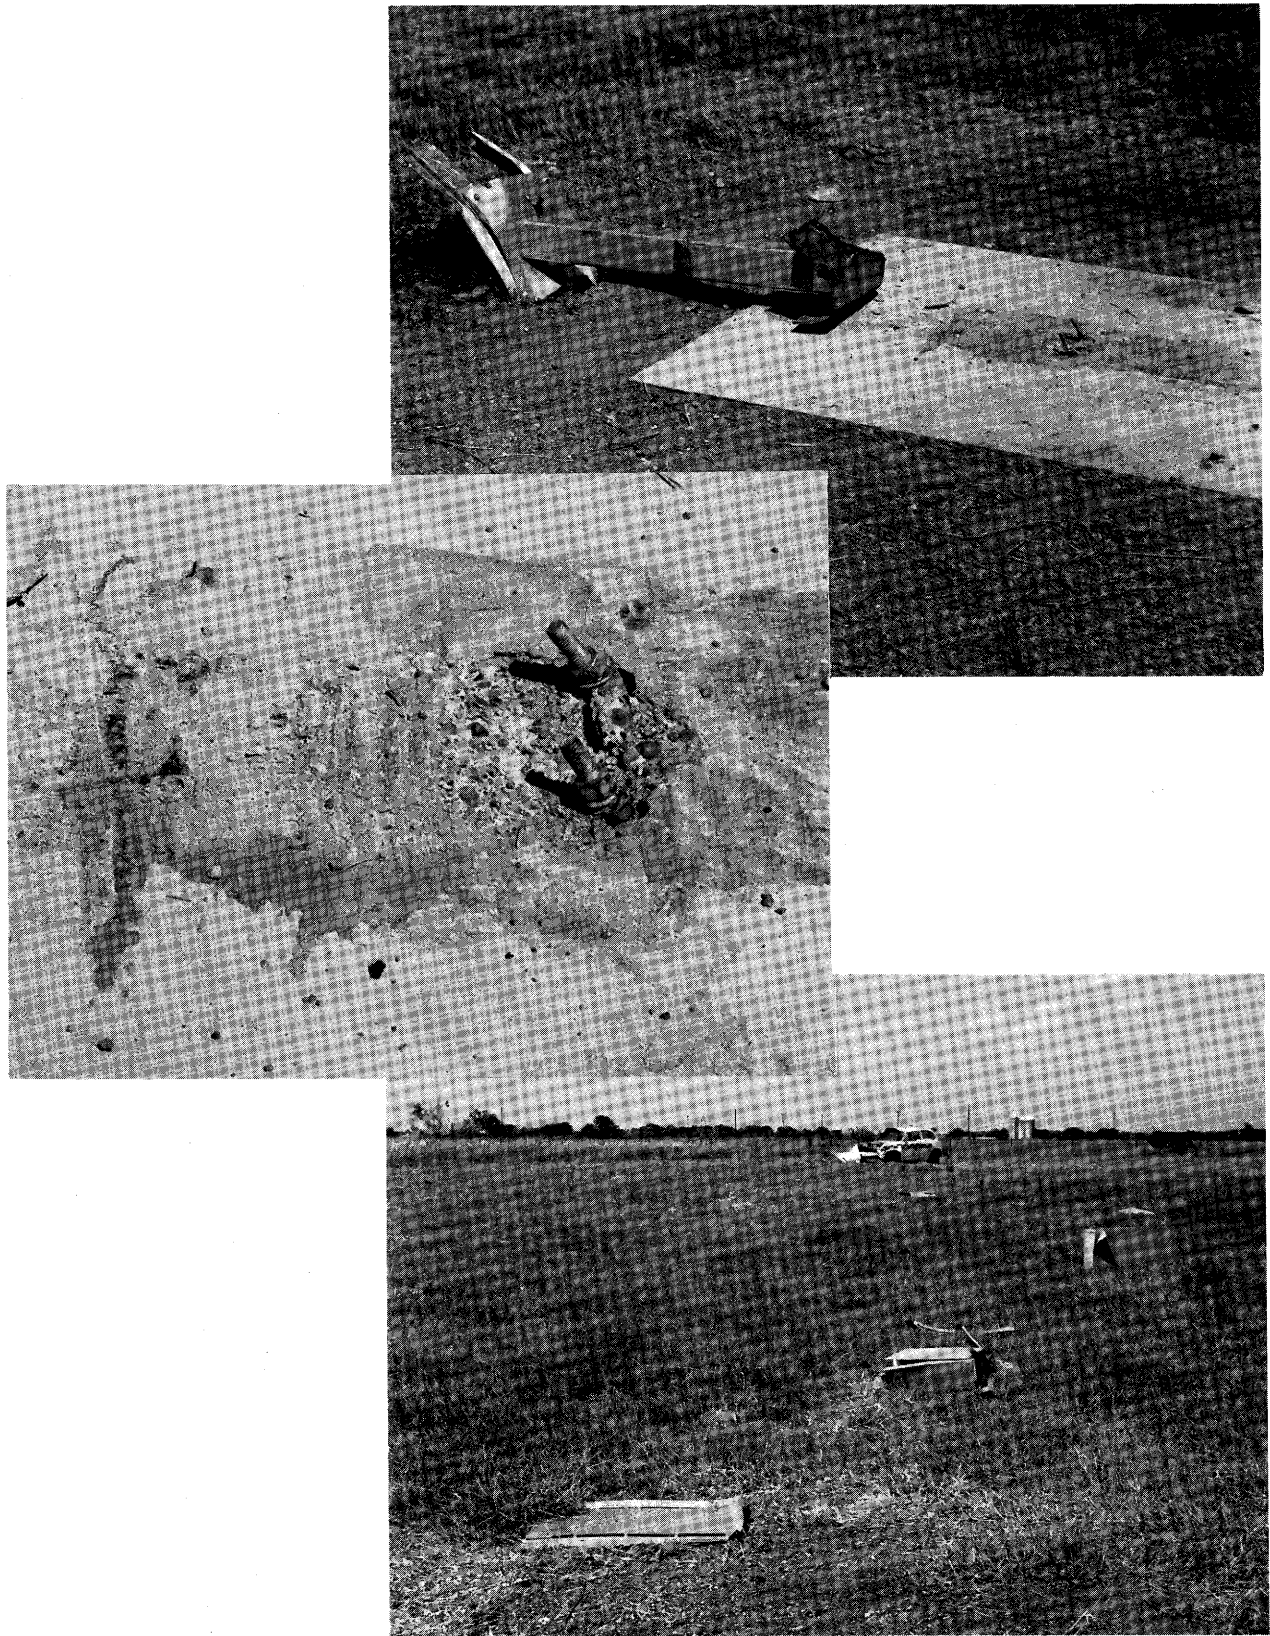
Figure 6. Test Site After Test 2343-1.

The mailbox compartments began to break away from the upper plate at 0.005 sec after impact. The anchor plate began pulling up at about 0.010 sec. As evidence in Figure 6 shows the downstream anchor bolts sheared off at the slab while the upstream anchor bolts pulled out of the anchor plate. The mailboxes hit the windshield at 0.046 sec after impact. The vehicle then rode over the post and lost contact at 0.195 sec with vehicle speed of 51.7 mph (83.2 kph). The vehicle subsequently rolled six complete revolutions.

The mailbox unit came completely apart during the test and was scattered as is shown in Figure 6. Damage to the vehicle was extensive due to rollover as depicted in Figure 7.

not meet the recommended performance criteria (5). It is therefore concluded that this mailbox installation and similar installations should not be permitted within the clear zone of high-speed roadways. Further testing and evaluation would be necessary to establish safe and acceptable operating conditions for the installation on other than high-speed roadways. Pending such investigation, these installations should also be considered undesirable within the clear zone of all roadways.

Impact performance of the installation can probably be improved by the inclusion of breakaway features such as a slipbase, breakaway welds at the post-to-base plate connection, a weakened support, etc. However, any such feature should be fully analyzed and crash tested prior to implementation.

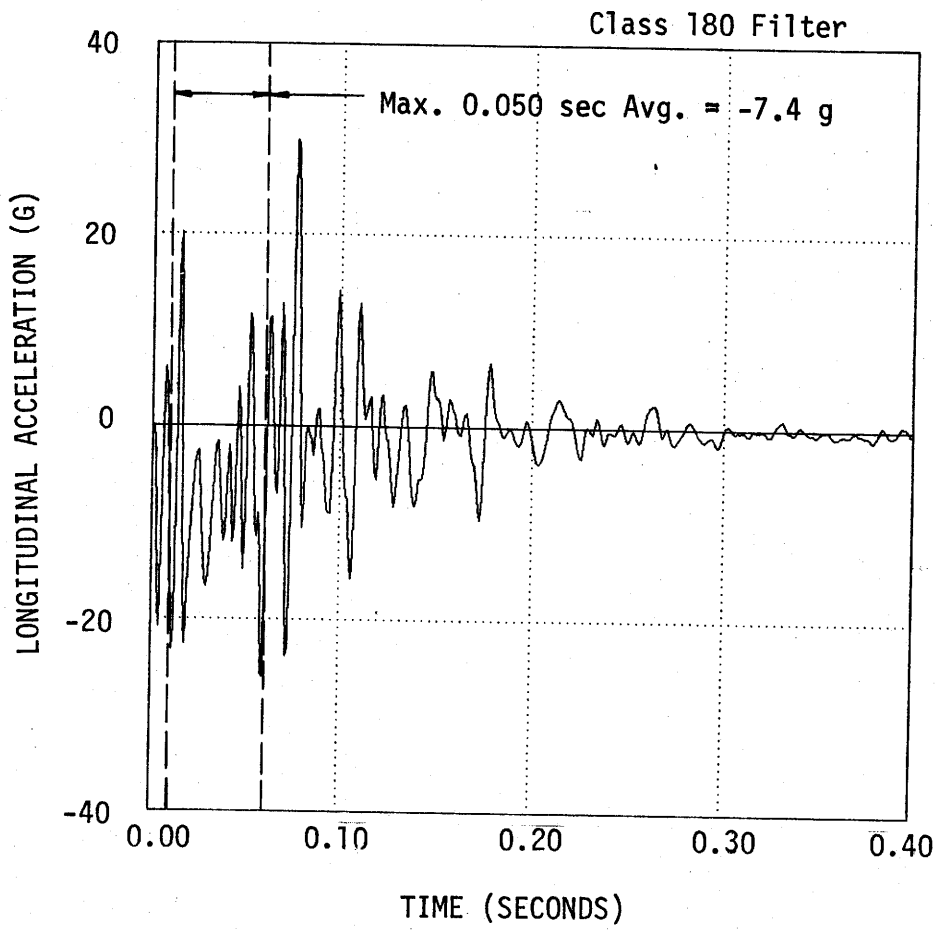
Figure 10. Vehicle Longitudinal Accelerometer Trace for Test 2343-1.

The maximum 50 msec longitudinal acceleration was -7.4 g. Change in vehicle velocity at 0.195 sec (loss of contact) was 10.6 mph (17.0 kph) and change in vehicle momentum was 938 lb-sec.
