1. Report No. TX-97/3910-S		2. Government Accession No.		3. Recipient's Catalog No.	
4. Title and Subtitle EVALUATION OF WORK ZONE BARRICADES				5. Report Date November 1997

# **EVALUATION OF WORK ZONE BARRICADES**

Research Report 3910-S  
Research Study Number 7-3910  
Research Study Title: Design, Evaluate, and Test  
Work Zone Sign Supports and Barricades

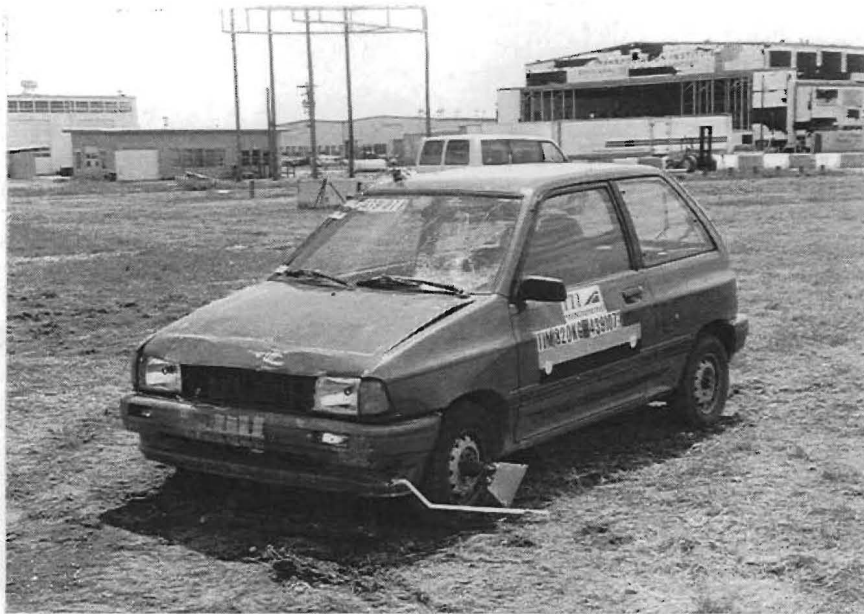
**Figure 16. Vehicle after test 439107-1.**

The vehicle received minor superficial damage as shown in Figure 16. The bumper, hood, and grill were dented and scraped, and the headlights were broken. The windshield was shattered on the driver's side from contact with the warning light.

A summary of the test results is shown in Figure 17. This test is judged to be unsatisfactory due to shattering of the windshield by the warning light attachment. Thus, it is recommended that warning lights should not be used with barricades. However, it is the opinion of the project staff that the barricade would have performed satisfactorily, meeting all evaluation criteria set forth in NCHRP Report 350, if there were no warning light attached to the barricade.

- The attachment of warning lights to Type III barricades is not recommended.
- The use of vertical braces for the horizontal rail elements of Type III barricades fabricated from either hollow core plastic or steel perforated tubing is recommended for field implementation. However, the size for the center vertical brace should be as small as practical.
- The modified connection design of welding a short stub to the skid and inserting and bolting the vertical supports to the stubs for steel perforated tubing Type III barricades is recommended for field implementation.
- The two proprietary prototype barricades with fiberglass vertical supports are recommended for field applications. However, since these are prototype units, the final designs for these fiberglass Type III barricades should be evaluated to make sure the production units would perform similarly to the prototype units.

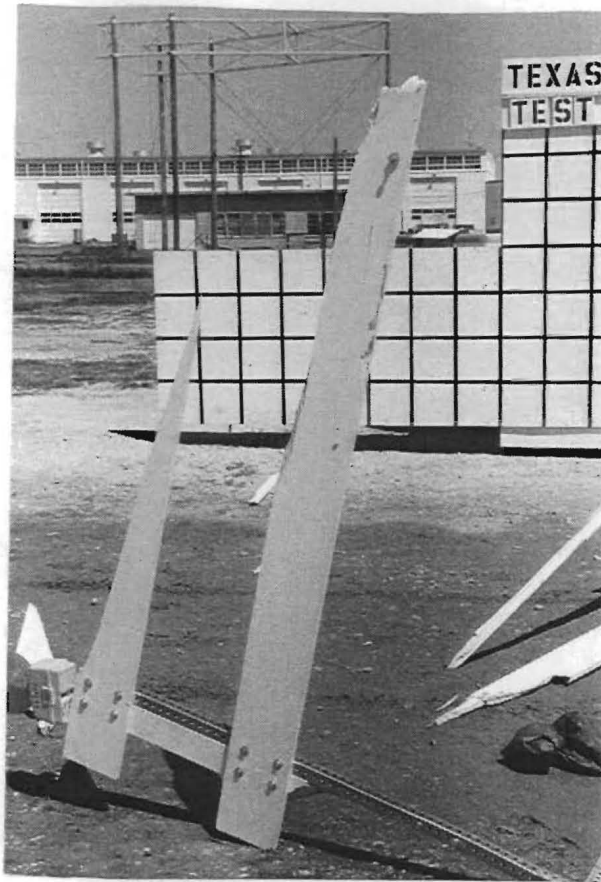
**Figure 21. Installation After Test 439107-2.**

The vehicle impacted the barricade head-on at a speed of 98.04 km/h. At 0.011 s after impact, the lower and center horizontal panels fractured near the center vertical support. The center vertical support fractured near the center at 0.015 s, and a section of the center support contacted the windshield at 0.072 s. By 0.103 s, the barricade had shattered into multiple pieces. The vehicle was traveling at 94.52 km/h as it lost contact with the barricade. Brakes on the vehicle were applied as the vehicle exited the test site, and the vehicle came to rest 71.6 m down and 5.9 m to the right of the impact point. Sequential photographs can be found in Appendix B, Figure 87.

The modification to the connection design between the vertical supports and the skids, i.e., welding a stub to the skid and inserting and bolting the vertical supports to the stubs, does not appear to have any apparent effect on the impact performance of the barricade under this set of impact conditions.

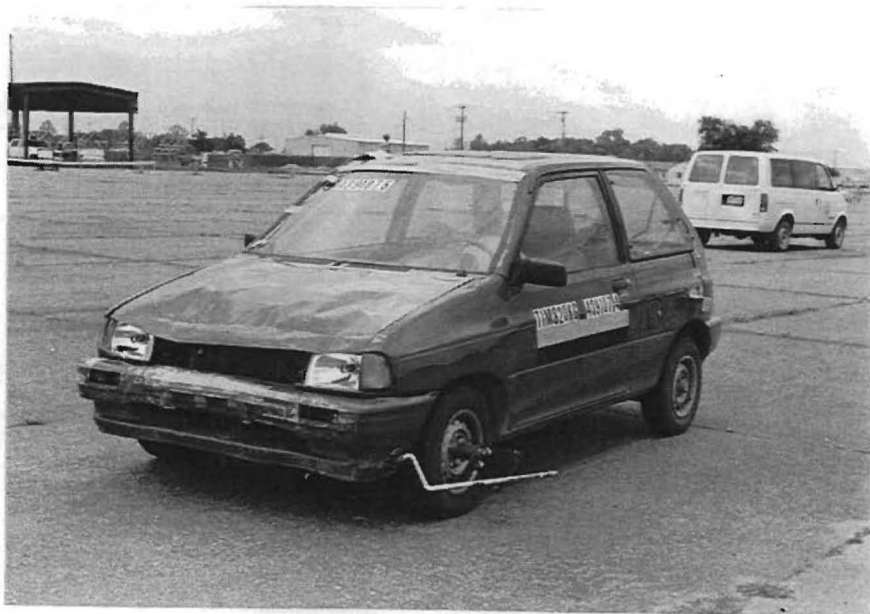
**Figure 34. Vehicle After Test 439107-5.**

The vehicle received minor scrapes and dents as shown in Figure 34. Only the bumper and hood were damaged.

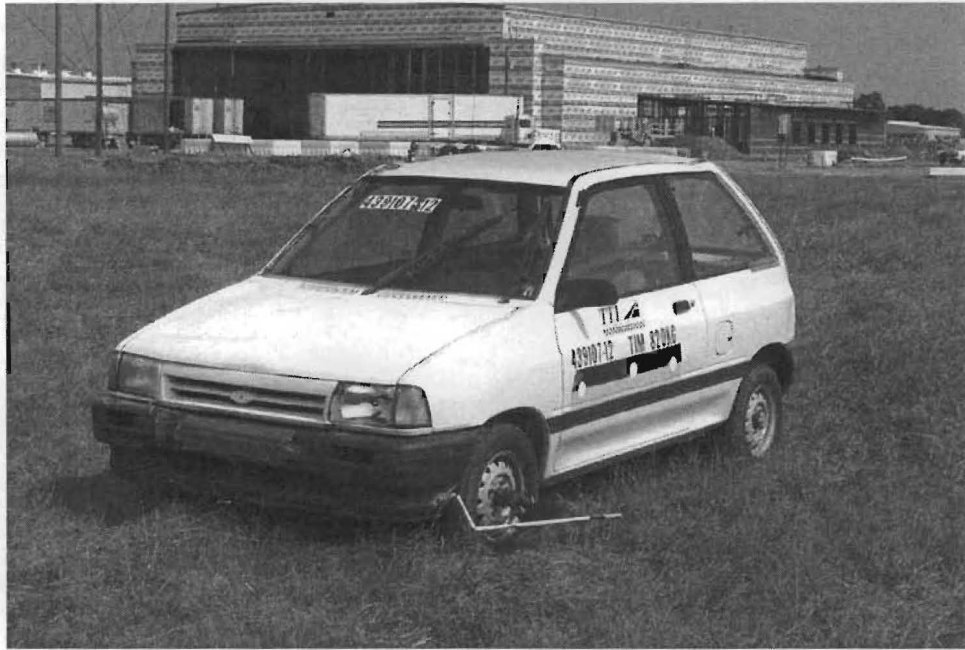
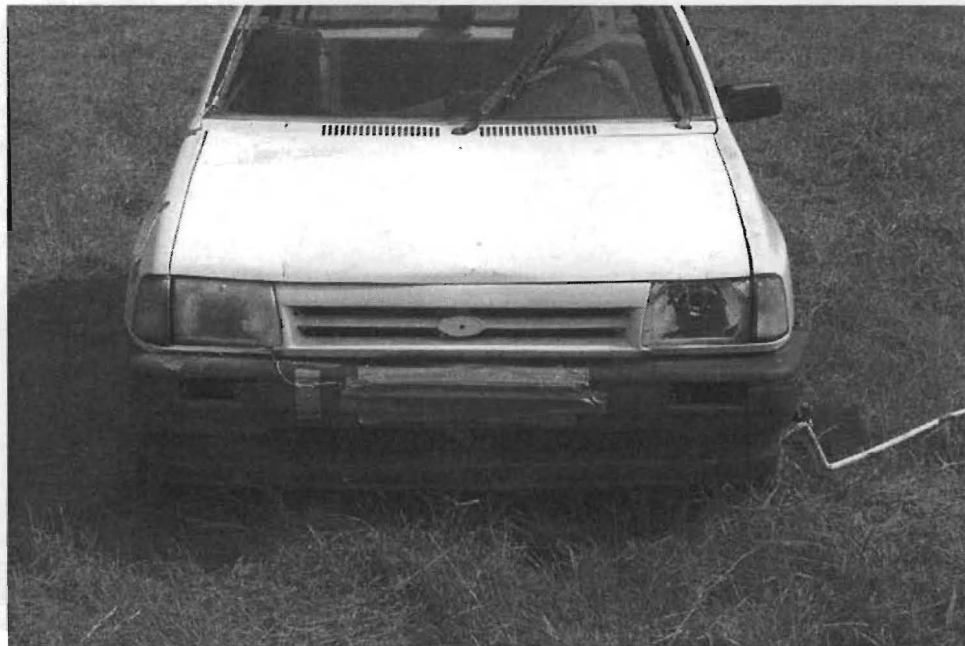
**Figure 40. Vehicle After Test 439107-12.**

The only damage the vehicle received was a dent in the hood and a broken headlight, as shown in Figure 40.

A summary of the test results is shown in Figure 41. This test with the Price fiberglass Type III barricade is judged to be successful, meeting all evaluation criteria set forth in NCHRP Report 350.

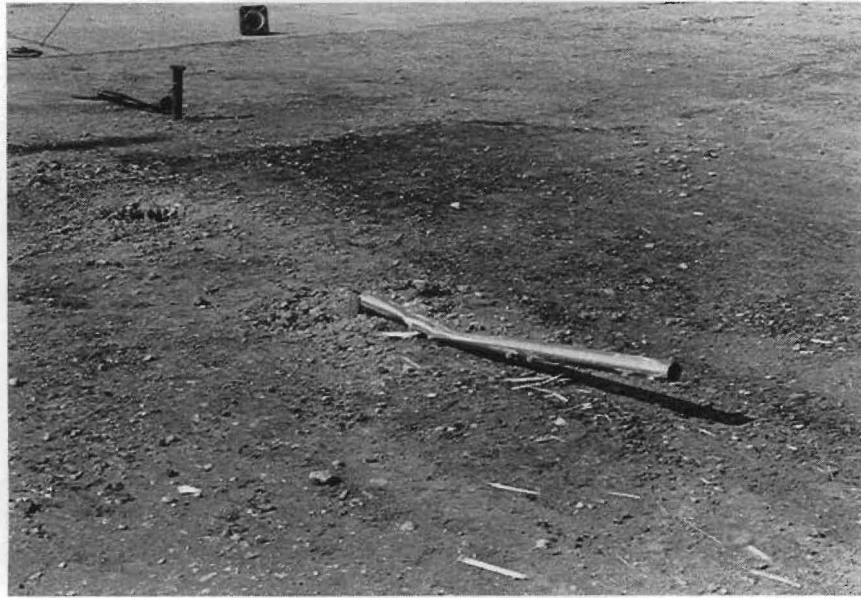
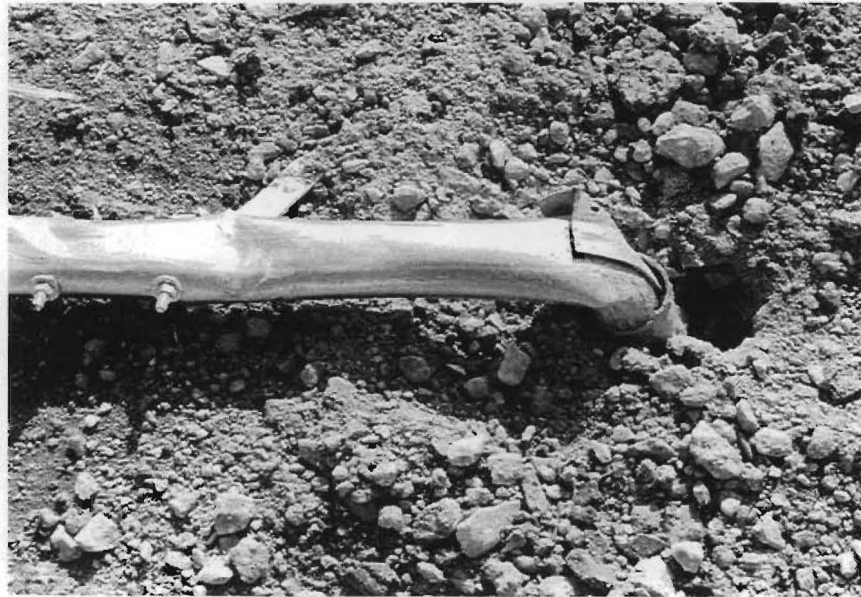
**Figure 56. Installation After Test 439107-7.**

The barricade separated into several pieces, as shown in Figures 55 and 56. The debris extended 42.1 m down, 8.5 m to the left, and 7.0 m to the right of the impact point. Sequential photographs of the test can be found in Appendix B, Figure 93.

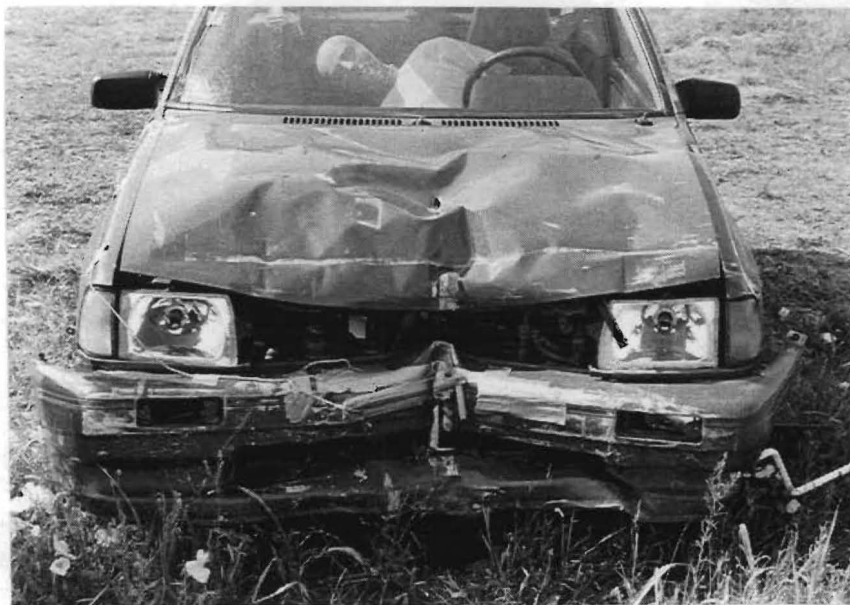
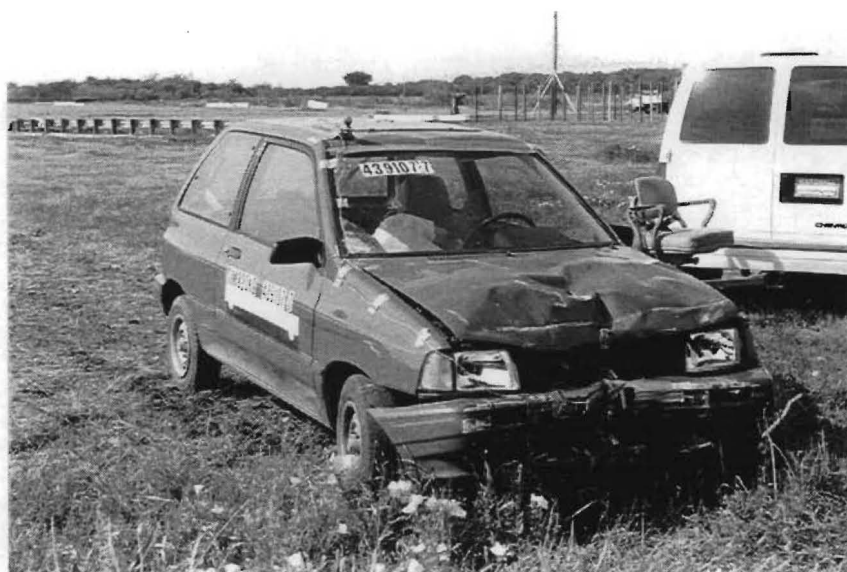
**Figure 57. Vehicle After Test 439107-7.**

The vehicle received moderate damage to the center front as shown in Figure 57. The front bumper, grill, and hood were dented a maximum of 51 mm. The hood received a tear, and the windshield was shattered in the lower right corner.

A summary of the test results is shown in Figure 58. This test is judged to be successful, meeting all evaluation criteria set forth in NCHRP Report 350. This test indicates that impact with the ground-mounted Type III barricade in an end-on configuration does not pose undue hazard to errant vehicles.

- The ground-mounted Type III barricade design using thin-wall steel tubing is recommended for field implementation.

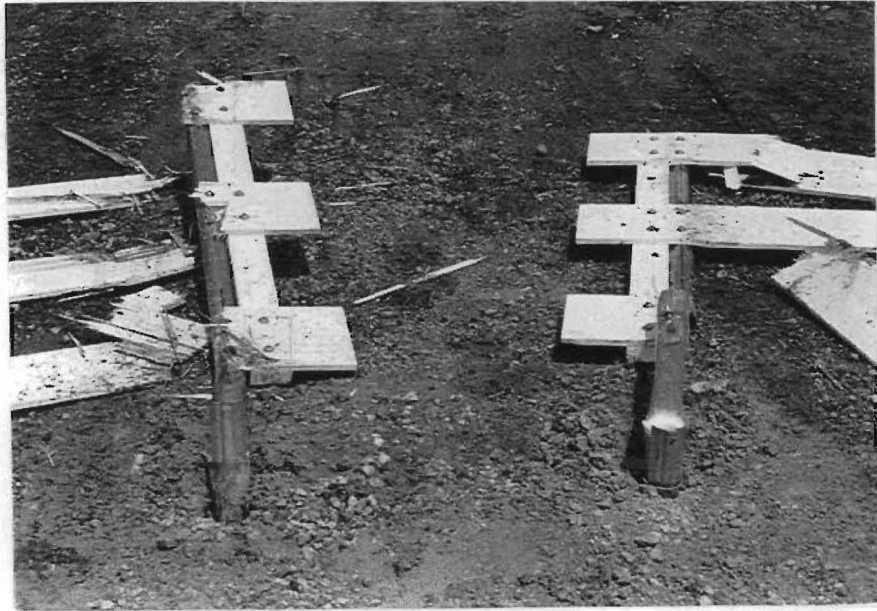
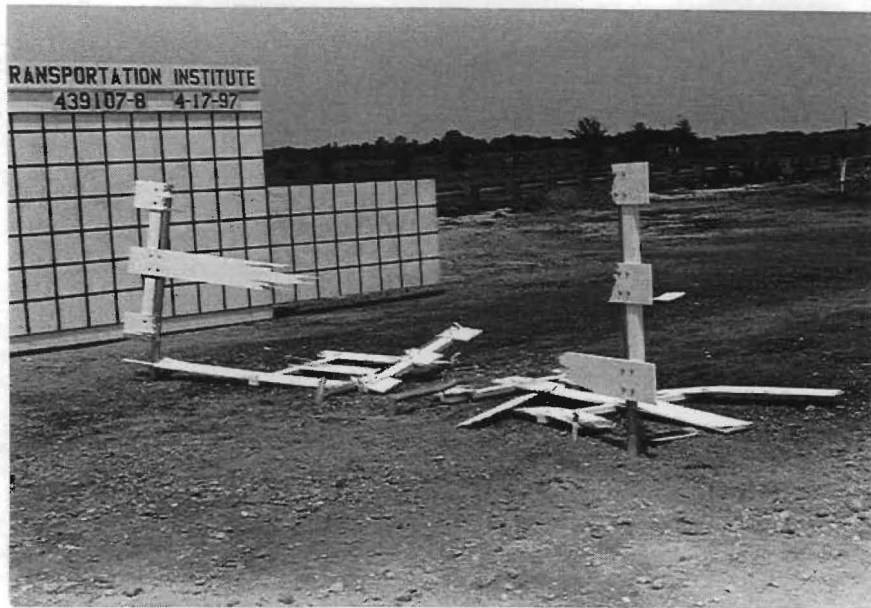
**Figure 62. Installation After Test 439107-8.**

Most of the debris remained at the impact point, as shown in Figures 61 and 62. The outer supports of the barricade remained upright, and the two supports impacted by the vehicle laid over on the ground. One small fragment of the support was 4.3 m down and 1.8 m to the left of the impact point. Sequential photographs of the test can be found in Appendix B, Figure 94.

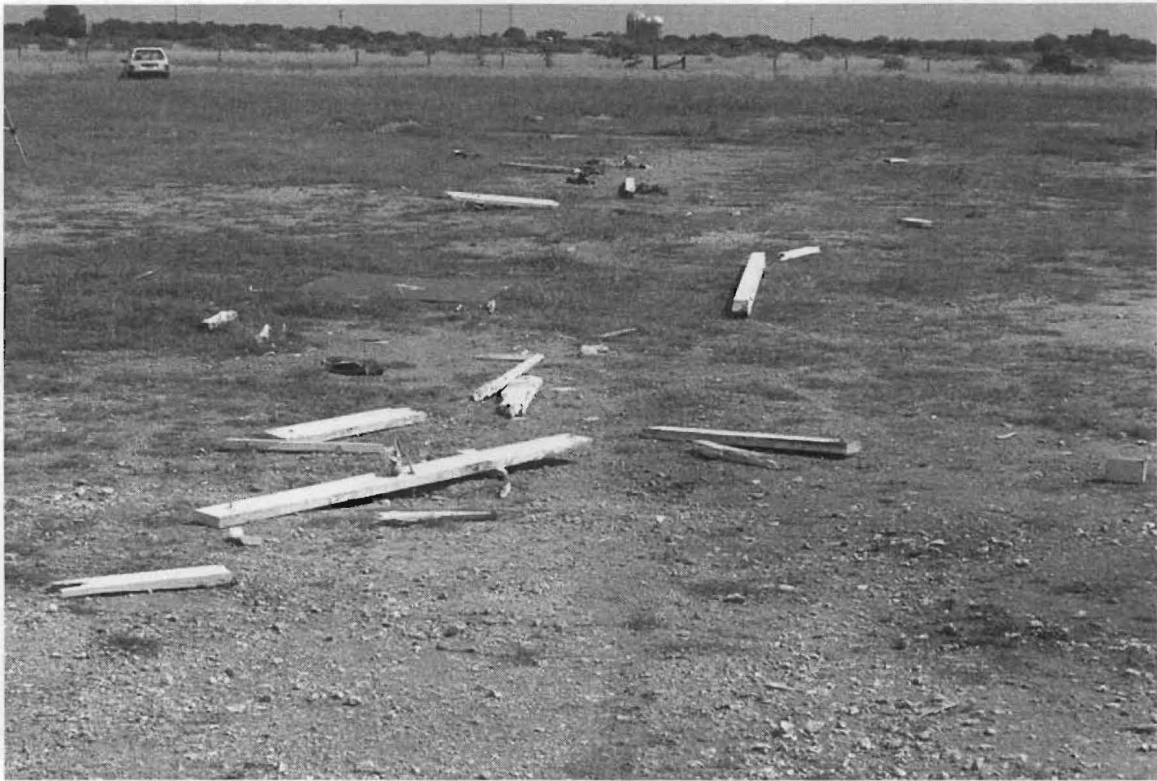
**Figure 74. Installation After Test 439107-10.**

The barricade separated into several pieces, as shown in Figures 73 and 74. The debris extended 33.8 m down and 1.8 m to either side of the impact point.

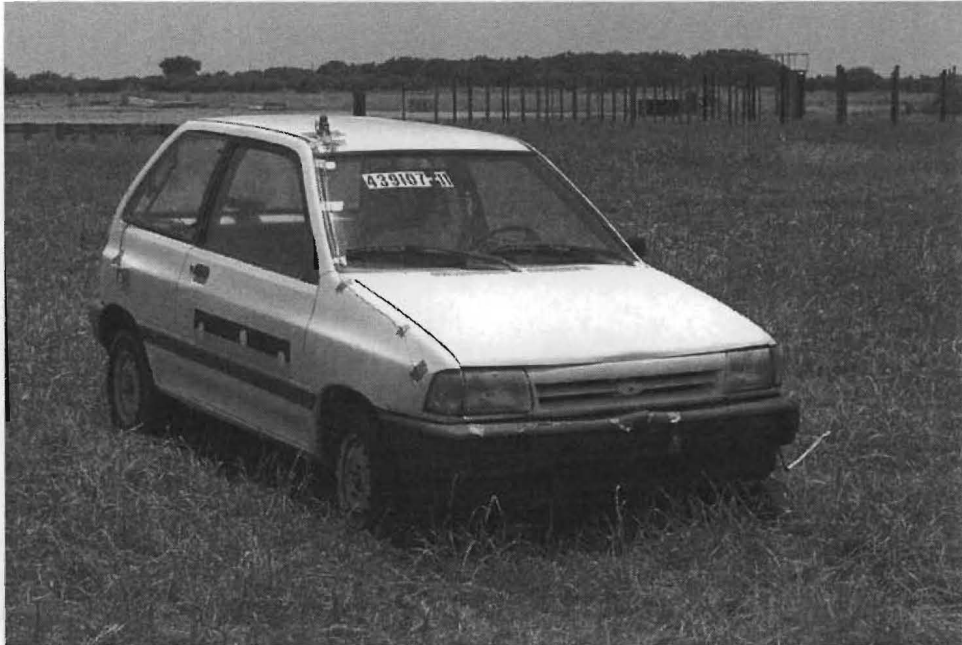
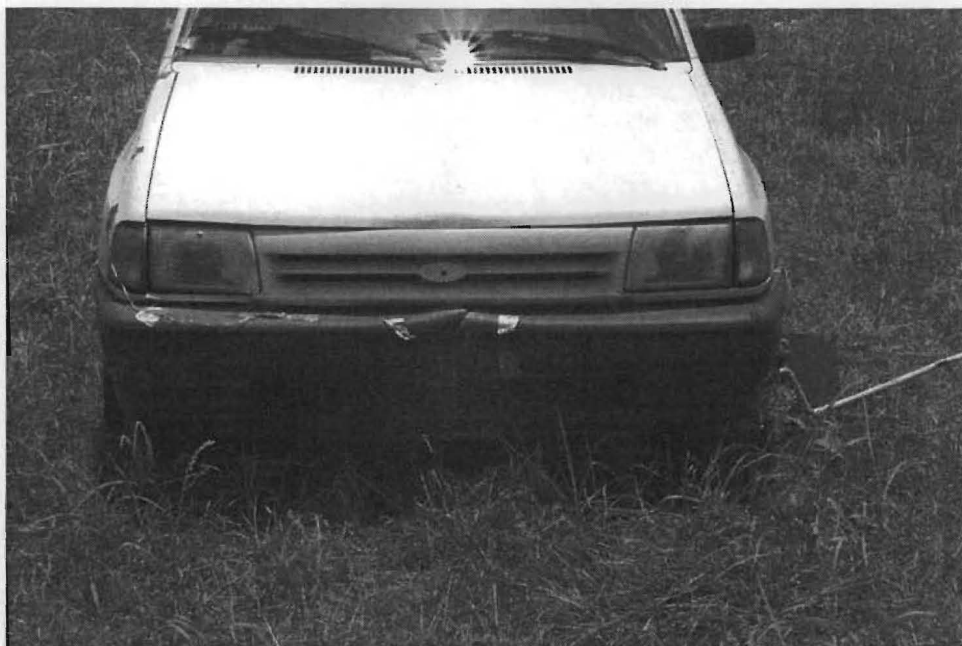
**Figure 80. Vehicle After Test 439107-11.**

The front bumper of the vehicle received minor scrapes only, as shown in Figure 80.

A summary of the test results is shown in Figure 81. This test is judged to be successful, meeting all evaluation criteria set forth in NCHRP Report 350. The test results indicate that all three support types for vertical panels performed satisfactorily and are acceptable for field implementation.
