1. Report No. <b>TX-98/3963-S</b>	2. Government Accession No.	3. Recipient's Catalog No.	
4. Title and Subtitle <b>EVALUATION OF A MODIFIED STEEL POST W-BEAM GUARDRAIL SYSTEM</b>		5. Report Date <b>November 1997</b>	6. Performing Organization Code

# **EVALUATION OF A MODIFIED STEEL POST W-BEAM GUARDRAIL SYSTEM**

**Report 3963-S**  
**Research Study Number 7-3963**  
**Research Study Title: Guardrail Testing to NCHRP Report 350 Criteria**

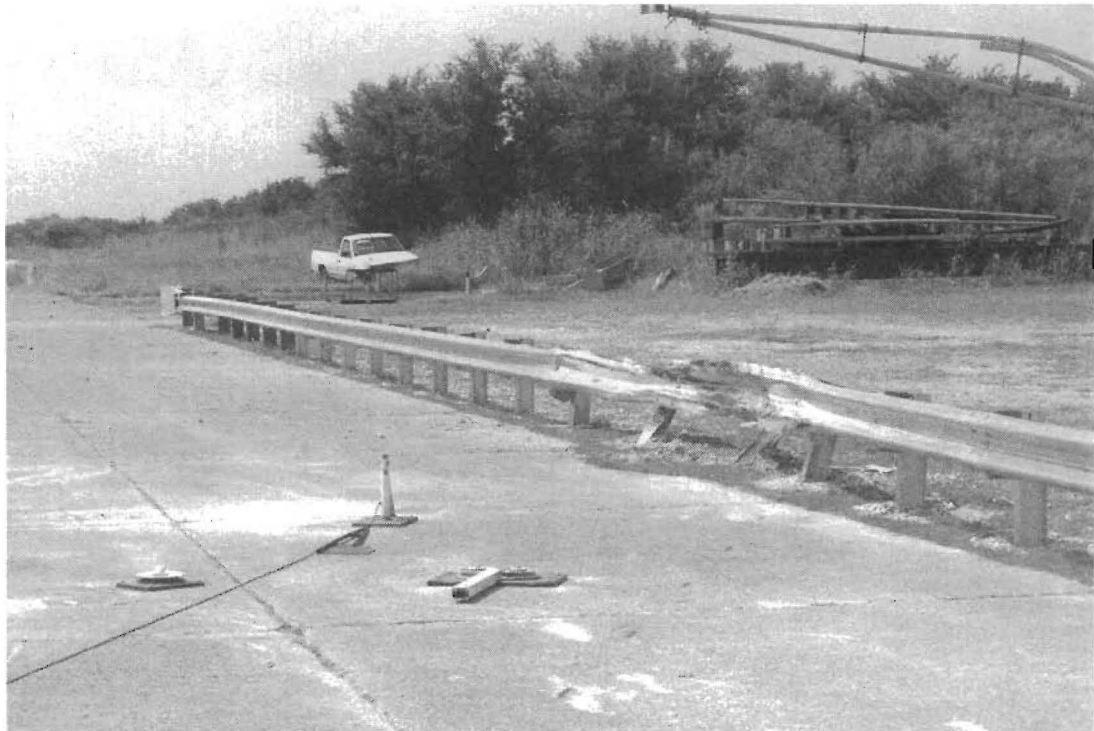
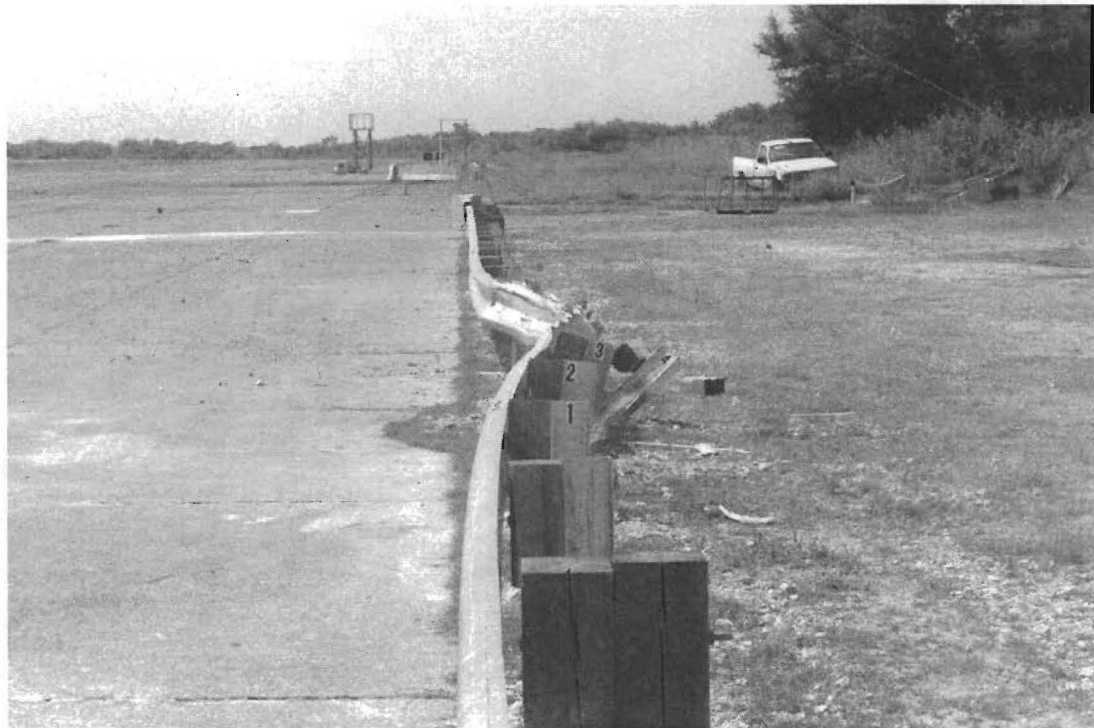
While airborne, the vehicle lost contact with the guardrail at 0.535 s, traveling at a speed of 62.35 km/h and an exit angle of 9.67 degrees. As it was exiting the system, the right rear tire briefly contacted the top of the rail. The left rear tire recontacted the ground at 1.079 s, followed shortly thereafter by the left front tire, the right front tire and, lastly, the right rear tire. The brakes on the vehicle were applied 3.05 s after impact and the vehicle subsequently came to rest 70.2 m down from the impact point and 7.3 m behind the guardrail. Sequential photographs of the test period are shown in Appendix B.

**Figure 8. After impact trajectory for test 439637-1.**

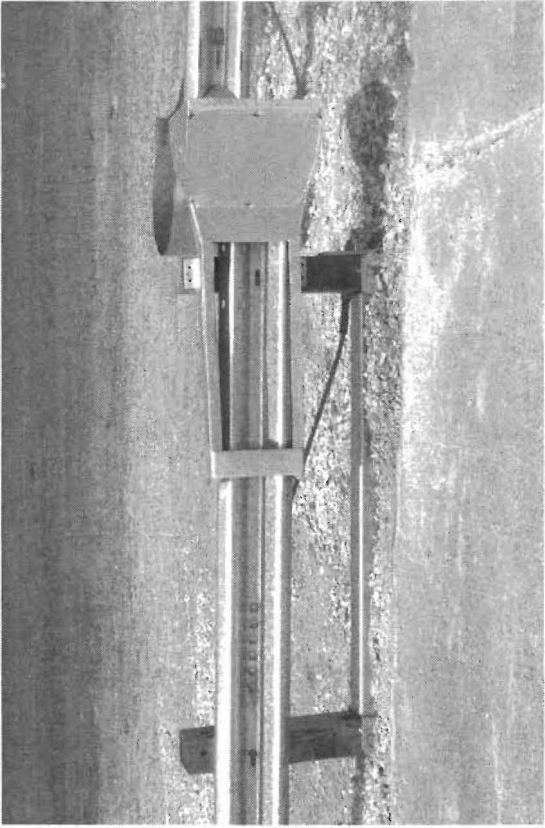
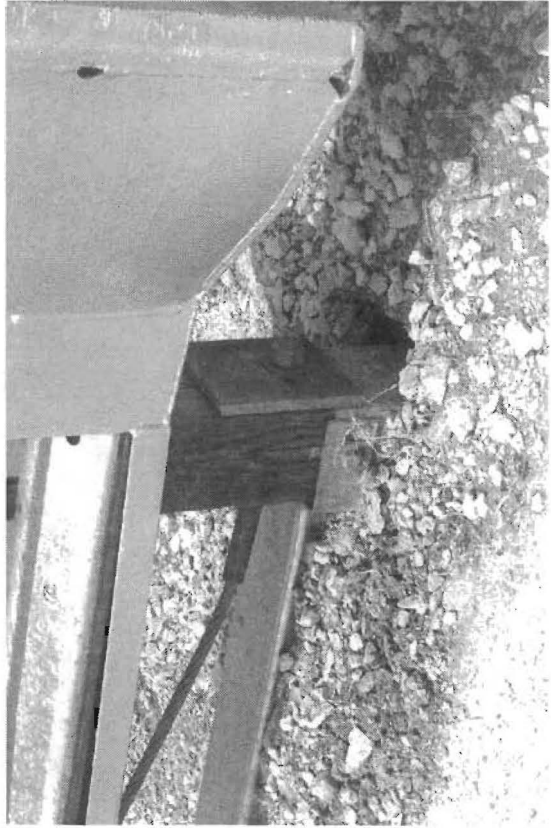
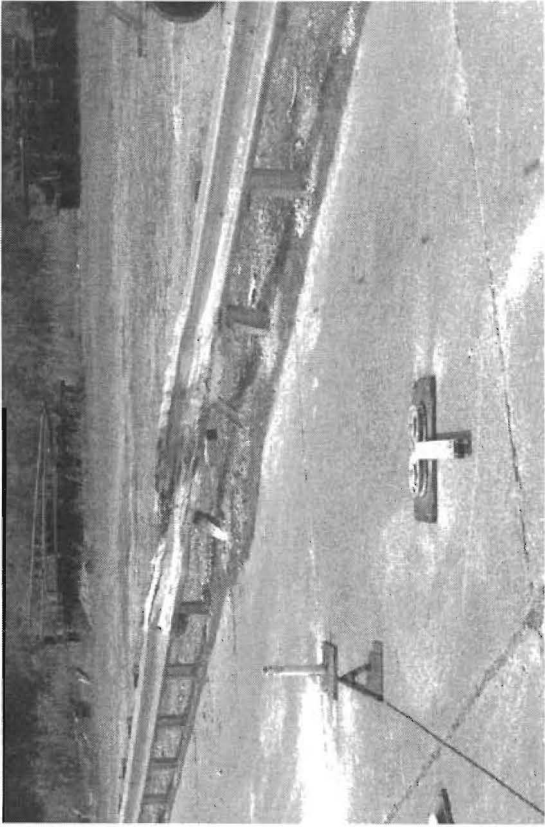
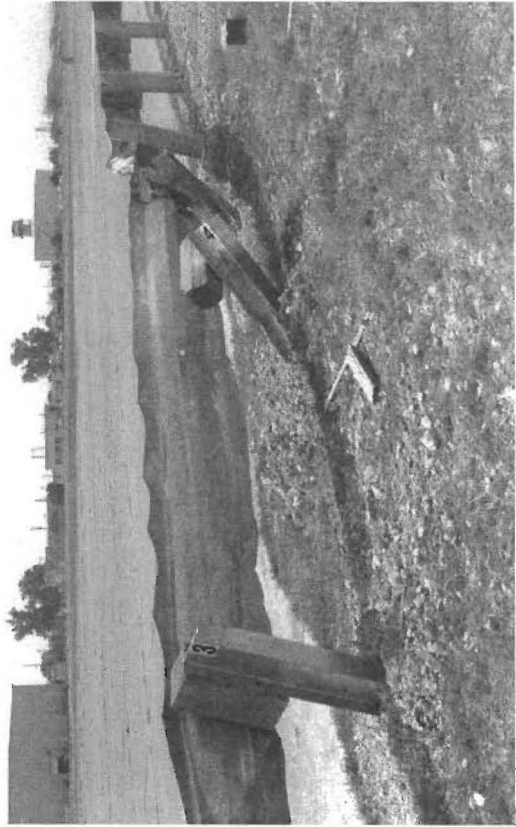
Damage to the guardrail is shown in Figures 8 and 9. Posts 10 through 16 were displaced laterally with maximum movement at the ground line measured to be 380 mm at post 13. Post 12 was separated from the guardrail but the rail remained attached to post 13, which was at a splice. The length of contact of the vehicle with the guardrail was 5.2 m.

Figure 9. Installation after test 439637-1.

Maximum dynamic deflection of the rail was 0.75 m and the maximum permanent deformation was 0.45 m.

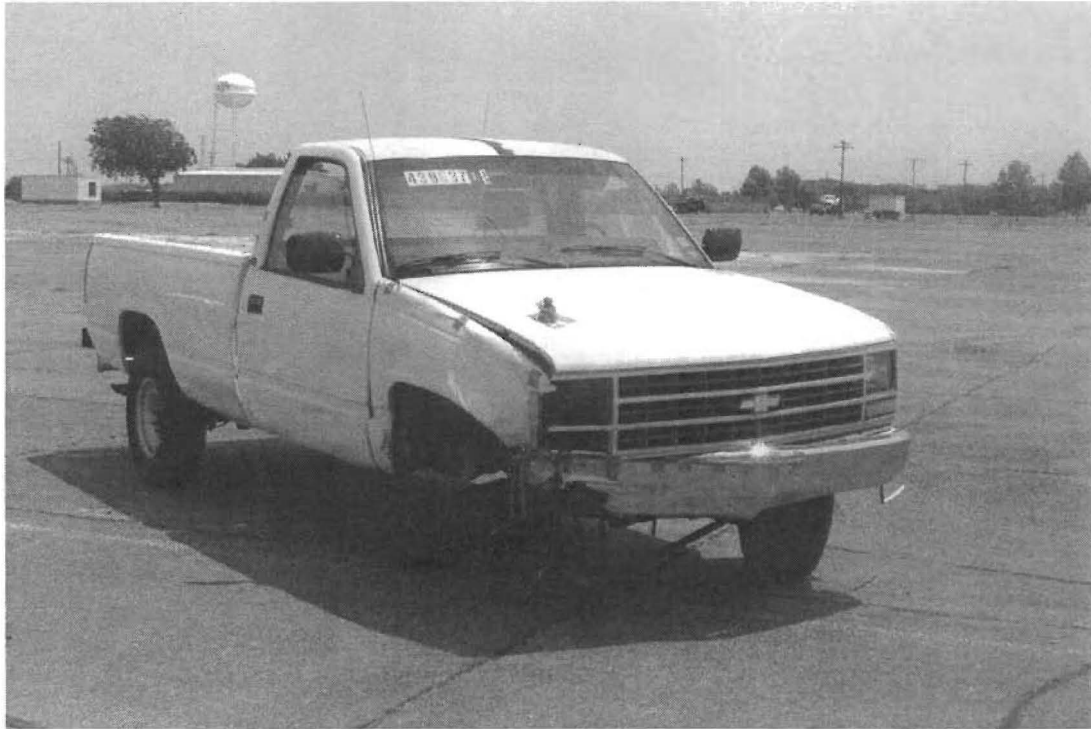
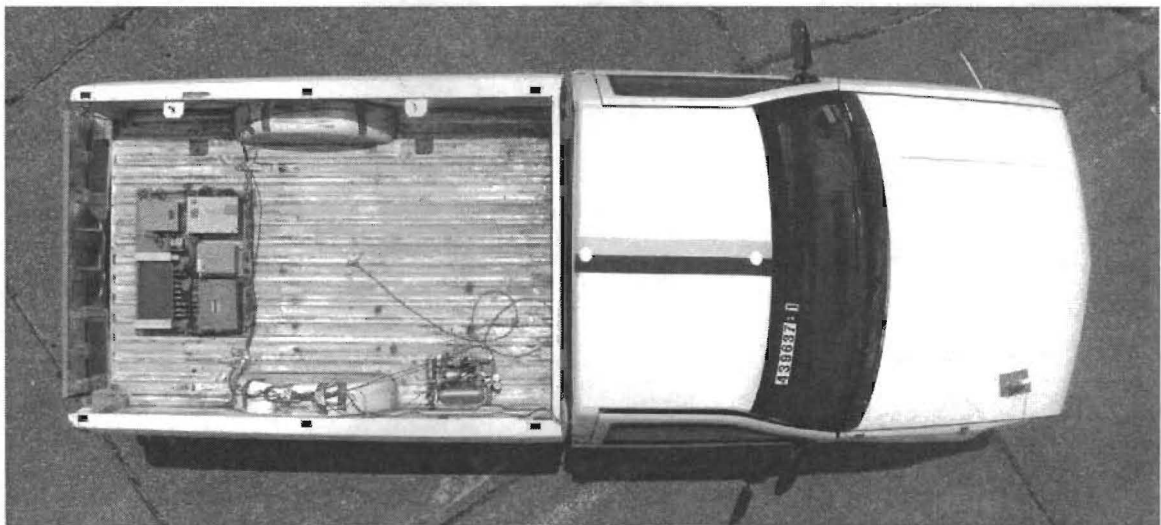
The vehicle sustained damage to the upper and lower A-arms, stabilizer bar, right front frame, and right front tie rods. Also damaged were the fan, radiator, the right side grill, right front quarter panel, and right front tire and rim. Maximum crush to the exterior of the vehicle at bumper height was 435 mm. Maximum deformation into the occupant compartment was 23 mm in the left floorpan area. Photographs of the vehicle damage are shown in Figure 10. Additional information on vehicle damage such as exterior crush measurements and occupant compartment deformation measurements are shown in Appendix C.

**Figure 10. Vehicle after test 439637-1.**
