CONDITION SURVEY OF CONTINUOUS BRIDGE DECKS

Research Report 403-1F  
Research Study Number 2-5-85-403  
Condition Survey of Continuous Bridge Decks

Texas State Department of Highways and Public Transportation  
in cooperation with  
U. S. Department of Transportation, Federal Highway Administration

TEXAS TRANSPORTATION INSTITUTE  
The Texas A&M University System  
College Station, Texas

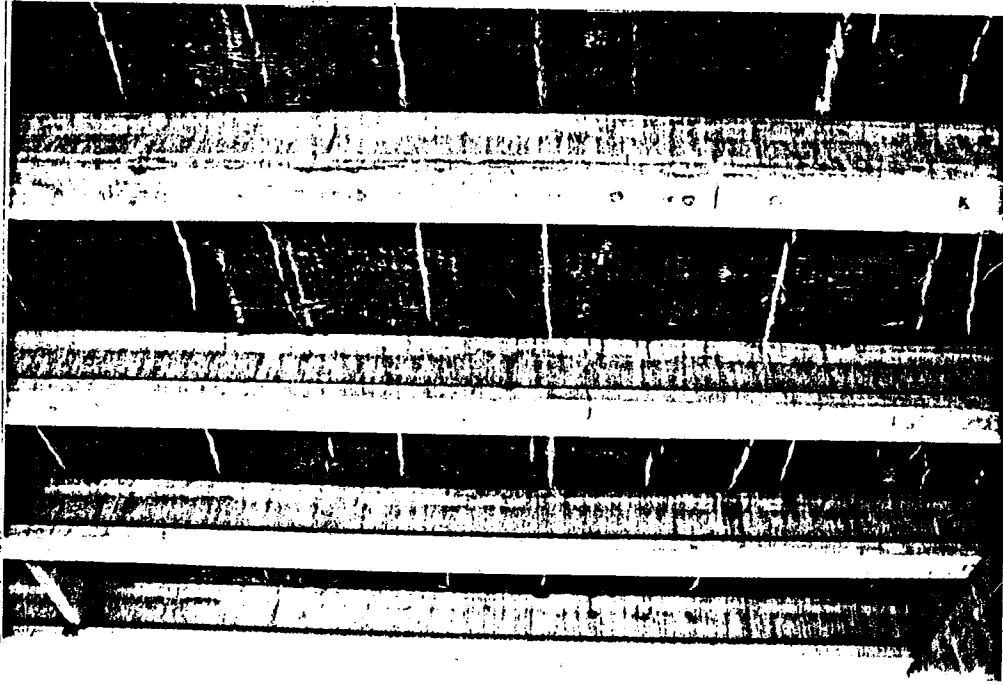
(3) Deck cracks, although minor in many cases, are found in most bridges. They are caused by plastic shrinkage, drying shrinkage, settlement of formwork, live load stresses, and corrosion of reinforcing steel (3). Roadway particles of soil and the like, surface texture, and surface overlays make it difficult or impossible to see most cracks on top of the deck because they are usually very narrow. If they are leaking cracks, efflorescence and exudation are deposited on the bottom of the slab where the presence of the crack is easily seen from the ground below. An example of this is shown in Figure 5.

Figure 5. Deck cracks marked by leakage.

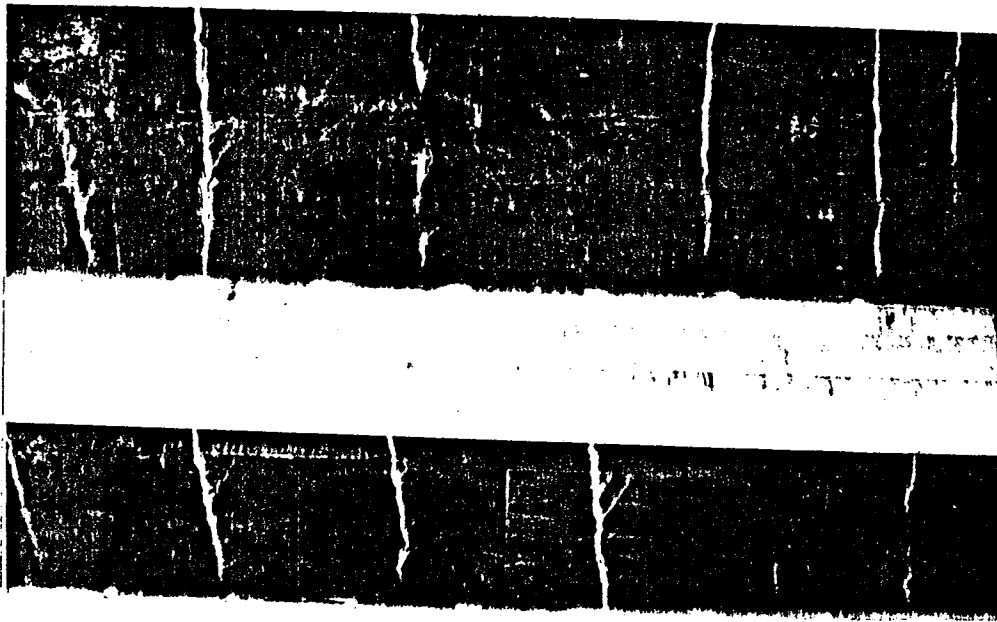
(a) Transverse cracks, perpendicular to the direction of traffic, are the most prevalent of the deck cracks. They sometimes run the full width of the roadway, but usually they are much shorter. The short runs characteristic of PC girder bridges are shown in Figure 6. In the PC girder type of bridge, the transverse crack does not usually cross over the girder as it does in steel girder bridges.

Figure 6. Transverse cracks in deck stopping short of girder.

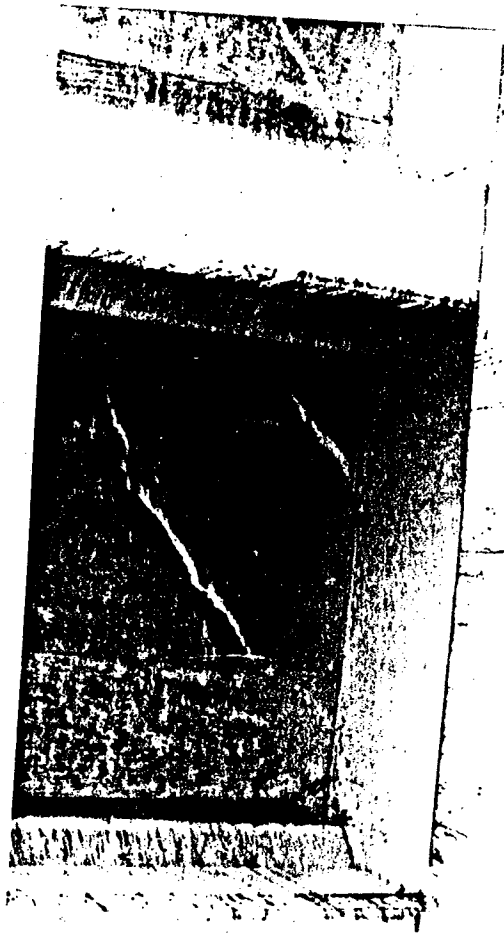
(c) Diagonal cracks, shown in Figure 7, are usually short and occur primarily at bents. In skewed bridges they form across the acute angle and are more transverse than diagonal.

Figure 7. Diagonal cracks in deck at bent.

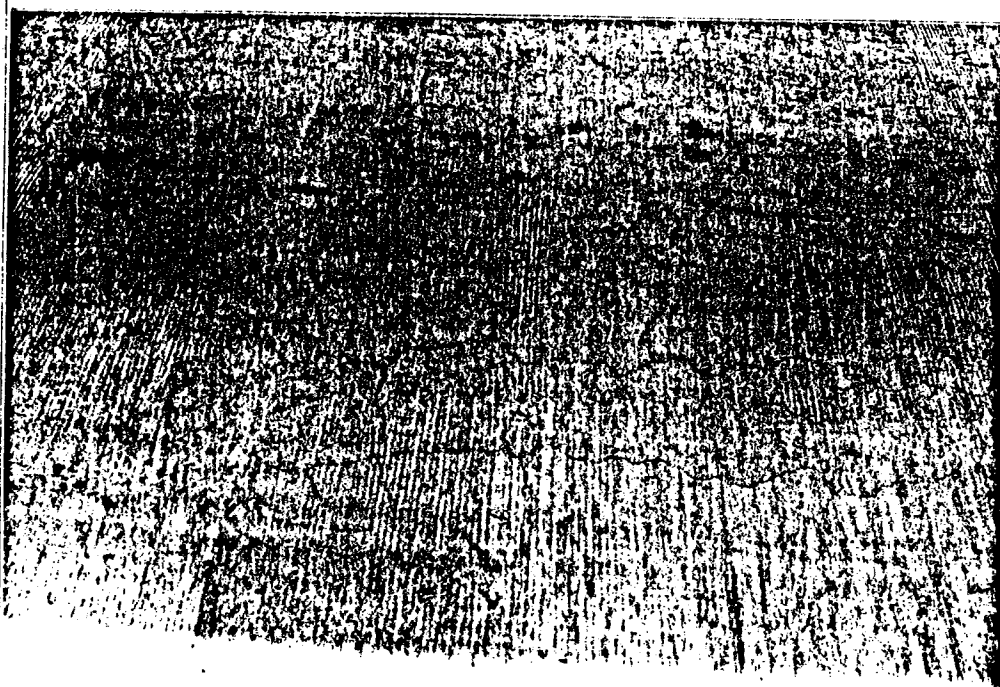
(d) Checkerboard cracks, shown on top of a slab in Figure 8, follow the pattern of slab reinforcing steel, and they usually indicate a condition of serious deterioration. Initially, these cracks might begin with subsidence of plastic concrete leaving a small crack over the reinforcing steel bar, or by steel corrosion, or a combination of these. Live load stresses, concrete shrinkage, and steel corrosion cause the initial cracks to spread. If the pattern is seen in the bottom as well as the top of the slab, the deck has become seriously weakened, and there is danger of rapid deterioration and complete local failure.

Figure 8. Checkerboard cracking on top of slab.

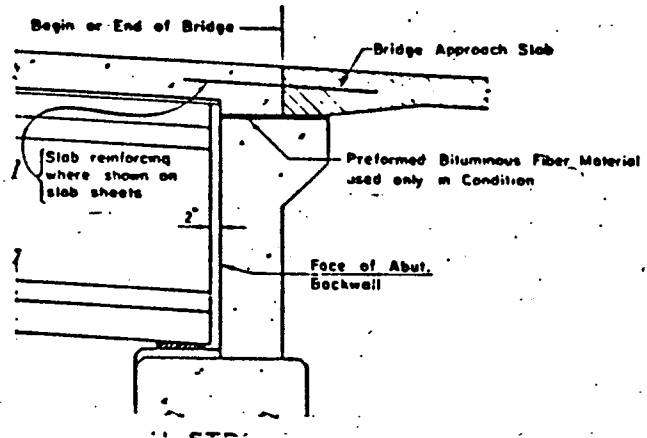
(e) A crack pattern on the bottom surface of slabs supported on top of the backwall was found in a number of PC girder bridges. The crack, very narrow and difficult to see in most cases, begins at the face of the top flange about one or two feet from the end of the girders. Although the pattern varies, the crack generally runs diagonally from the girder, gradually becoming transverse. About midway between girders, it meets a corresponding crack from the adjacent girder. Cracking occurs when the slab bends under live load entering or leaving the bridge. The load causes compression in the bearing pad at the end of the girder and also compression of the pad, if any, under the slab resting on the top of the backwall. The differences in these compressions produce bending in the slab, and, in some cases the slab cracks. Figure 9 shows structural details at the abutment and a photograph of one case of this type of cracking in which the crack outline has been marked for clarity.

(a) Details at abutment.

(b) Bottom of slab cracks at abutment.

Figure 9. Deck cracking and details at abutment.

The crack type discussed in section 3A(3)e and shown in Figure 9, was found in some of these bridges, but they did not appear to be wearing. Since the crack is caused by live loads, it should be monitored for further deterioration.

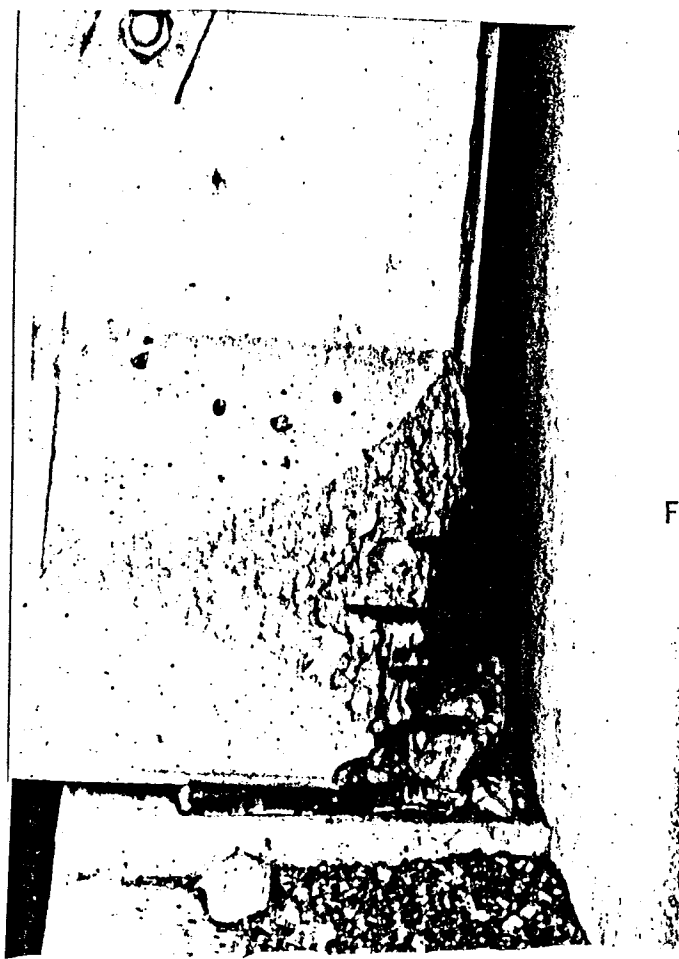
End spalls at girder bearings sometimes occur from the restraint to longitudinal movement combined with heavy bearing at the support. The bearing area of the beam is reduced by the spall, and in PC girders, ends of prestressing steel strands are exposed as shown in Figure 10.

Figure 10. Spalled PC girder end.

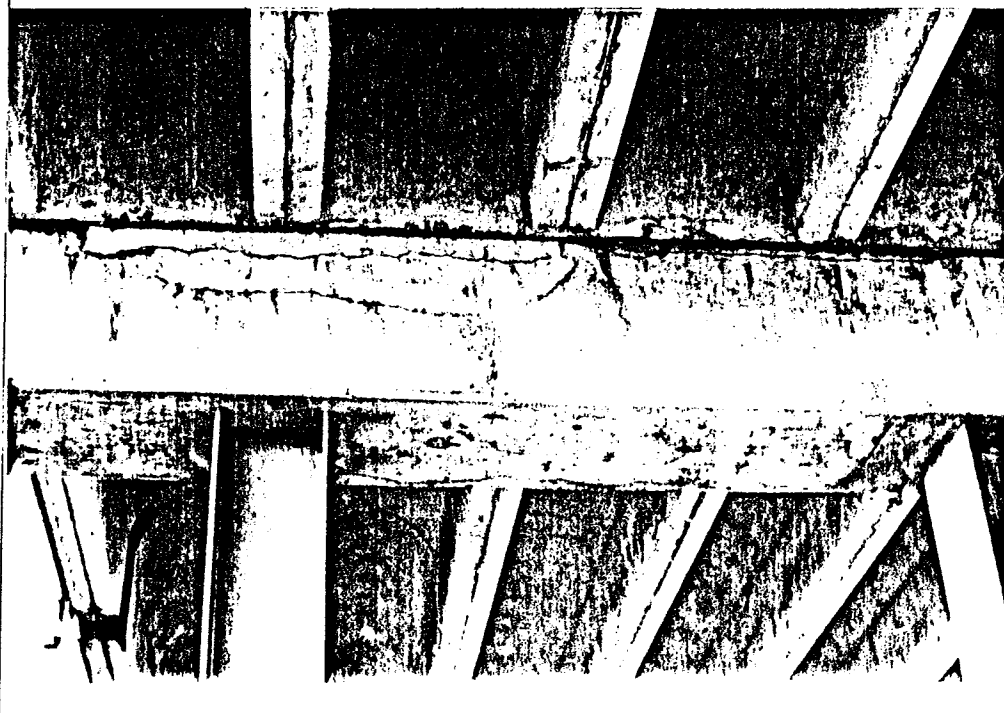
Bent cap spalls occur at girder bearings when longitudinal shortening of the girder is restrained by friction or by dowels. It is rarely a problem with PC girders resting on elastomeric pads. Figure 11 shows this type of spall in an older pan girder bridge.

Figure 11. Spalled bent cap, PFS bridge.

Spalled faces of bent caps, shown in Figure 11, were found in two of the six PFS bridges, and one of these had spalled beam ends as well. One end of each girder is doweled to the cap. Road debris that accumulates in the joint at the end of the span exerts pressure to open the joint. This is resisted by the vertical dowel until the pressure becomes so great that spalling occurs. This can cause spalling of the ends of the girders, too. This condition has been corrected in a late design, the PFT type, by tying the adjacent spans together by longitudinal dowels across the joint. The detail is shown in Figure A-1. It prevents the joint from opening, the debris cannot enter, and the spalling does not occur. Other damage reported at this joint, but not seen in the inspection, is corrosion damage in diaphragms, girders, and bent caps caused by drainage of deicing salt water through the joint.

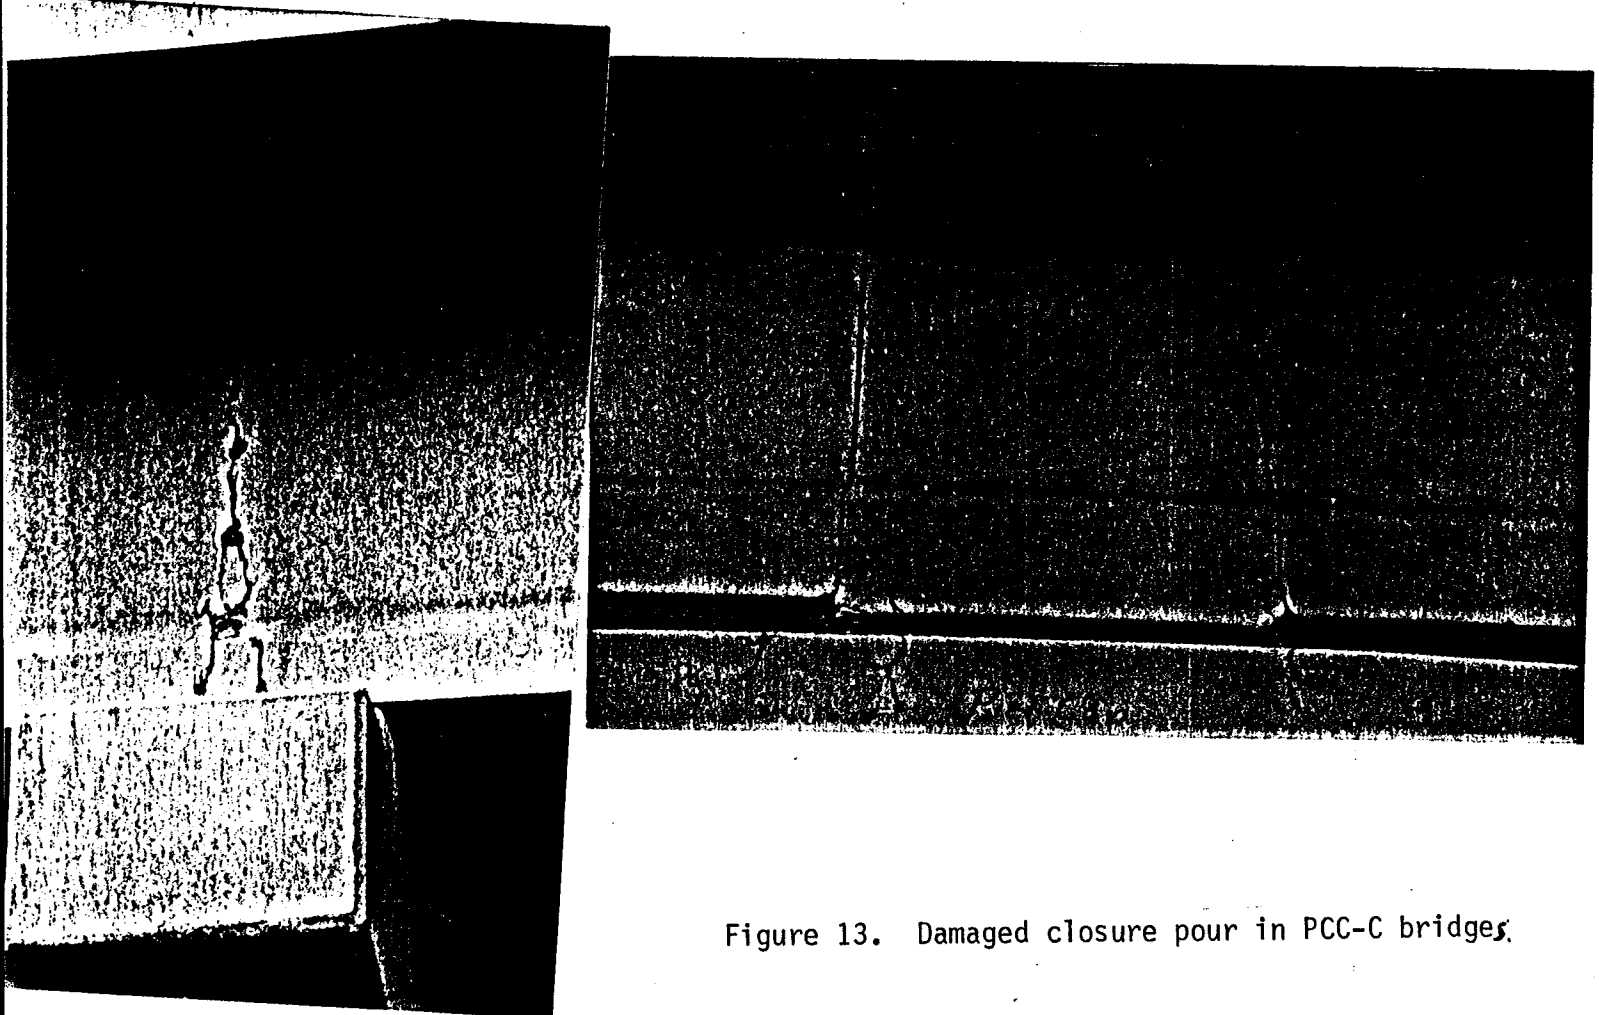
(6) Cracked and spalled beam end closure pours (diaphragms or bent cap stems) are found only in the PCC-C type bridge. The pour joins the ends of PC girders of adjacent spans of a continuous unit. Structural details are shown in Figure A-1, and a photograph of the cracks is shown in Figure 13. The defect occurs at the ends of the pour near bent cap ends.

Figure 13. Damaged closure pour in PCC-C bridges.

The cause of the damage in the closure pours is not known, but it probably results from a combination of shrinkage and creep of the girders, thermal movements, and live load stresses. There is no evidence that it is detrimental to the serviceability of the bridge, but it does provide access to contaminants that might initiate corrosion of reinforcing steel.

spalling at ends of the diaphragms. Make corrections in design or construction, or both, to eliminate the problem.

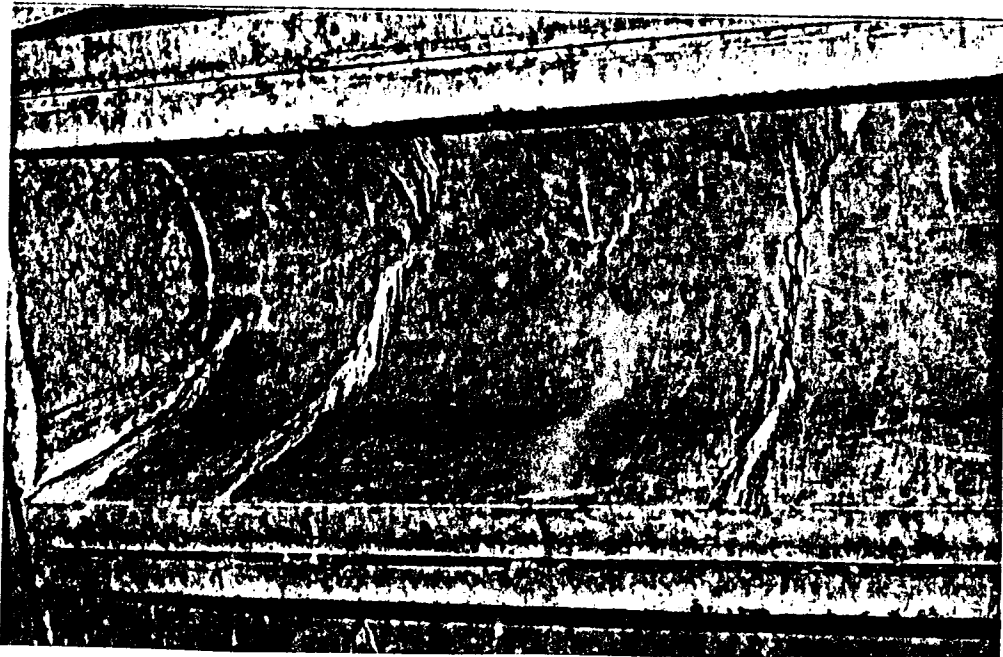
Figure 15. Transverse cracks from bottom of deck - PFT bridge (item 265).

- (3) Make changes in design details, or construction procedures, or both, to eliminate transverse cracking in PFT bridges.

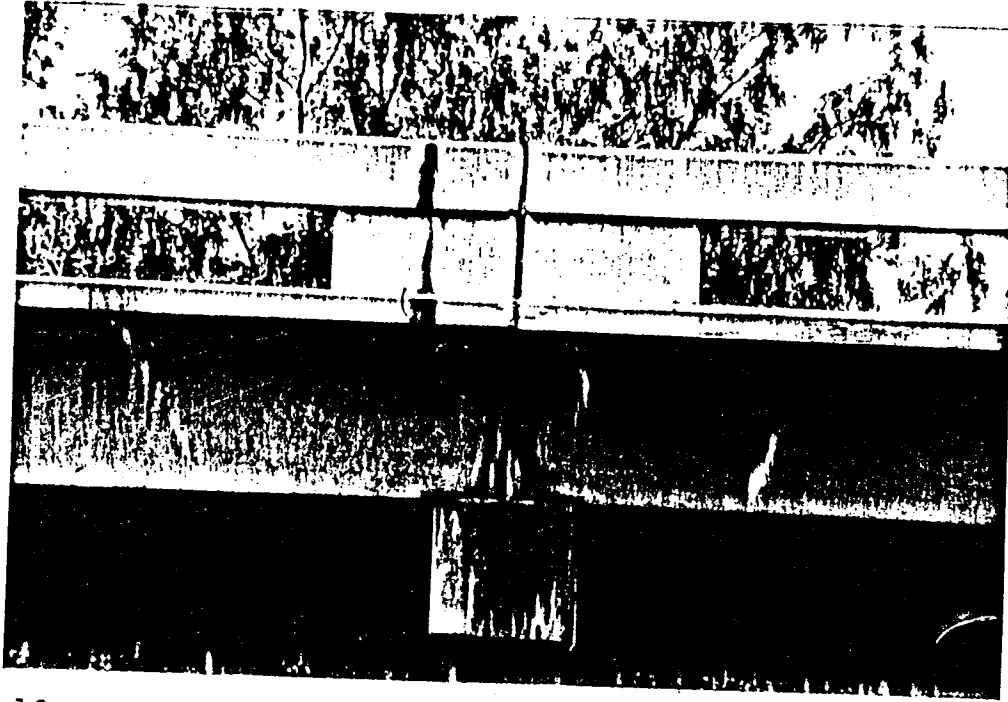
Figure 16. Transverse crack extending into the outside girder as a diagonal tensile type crack - PFT bridge (item 265).

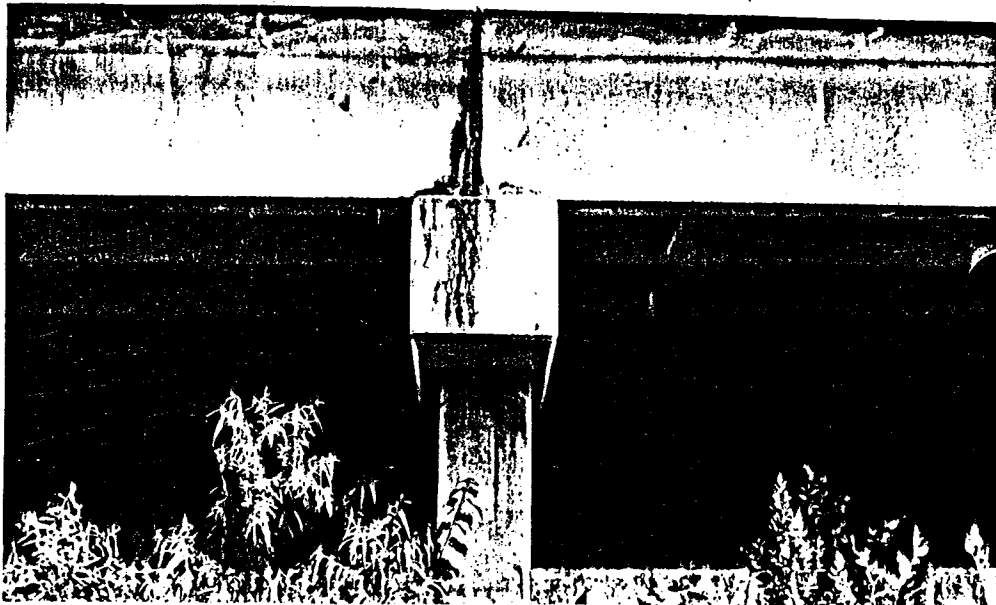
Figure 17. Transverse crack extending into the outside girder as a flexural crack - PFT bridge (item 266).

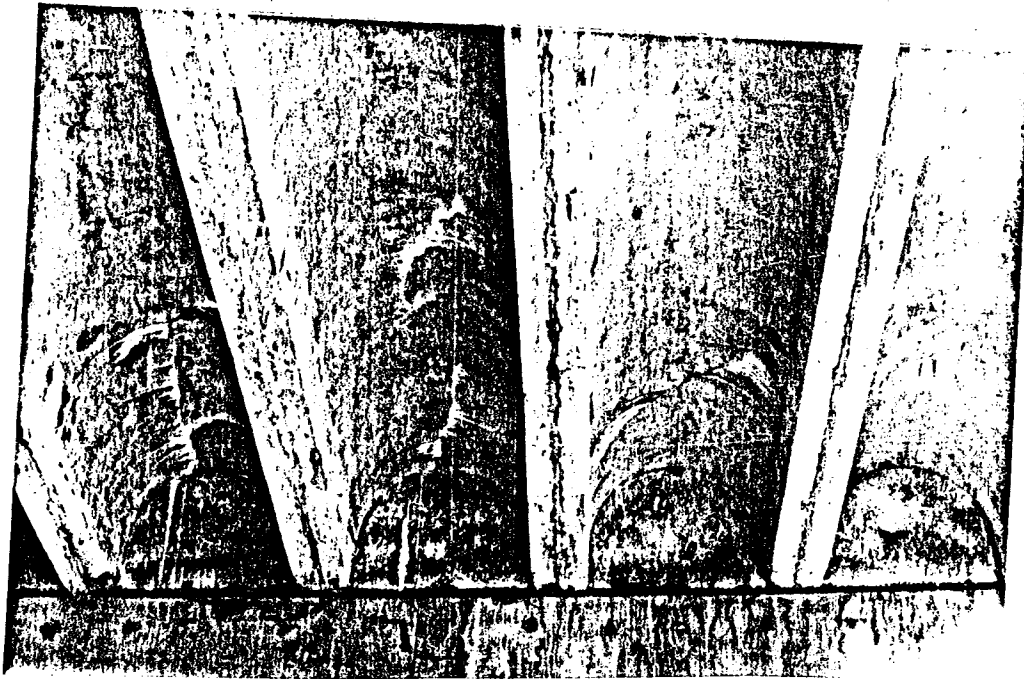
Transverse deck cracks were found on each side of the tied joints in four of the 11 PFT bridges. The cracks are about 5 ft from the joint at the edge of the overhang. They run at a slight diagonal until they reach some 3 ft from the joint then they parallel the joint in the central region of the roadway. This is shown in Figure 14. They sometimes appear in pairs, and they are always somewhat irregular instead of running uniformly straight. In the 40 ft spans, the crack varies from very narrow to about 0.04 in. wide, extending sometimes up to 6 in. into the web of the girder, as seen in Figure 15. In the outside girder of some 40 ft spans, the crack appears as a diagonal tensile crack, Figure 16, whereas in others it appears as a flexural crack, Figure 17. Corresponding cracks in the 30 ft span bridge are shown below the slab in Figure 18, and in the overhang in Figure 19.

Figure 18. Transverse cracks below the deck of a 30.3 ft span - PFT bridge (item 268).

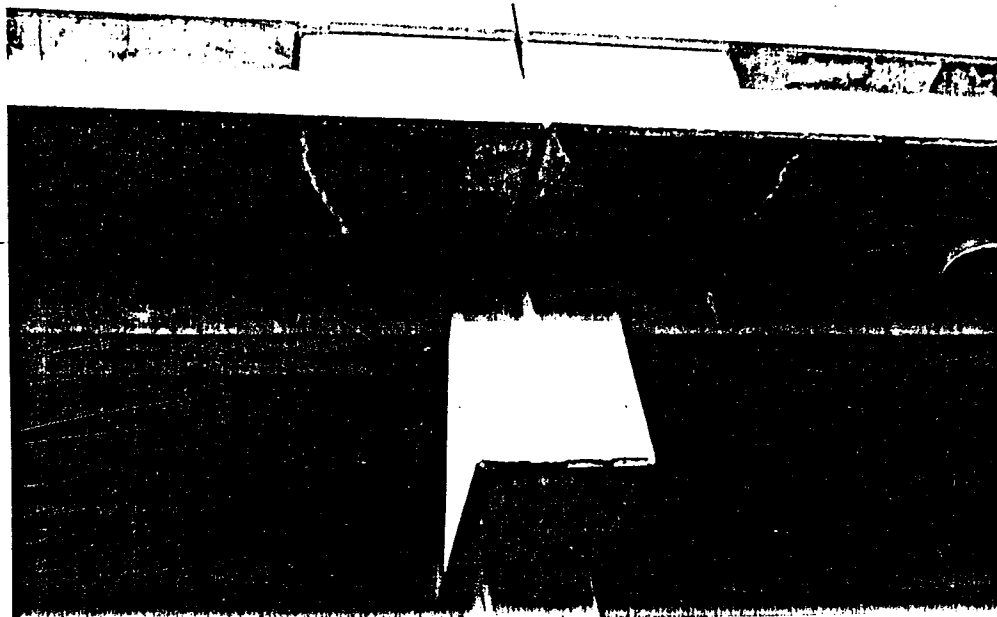
Figure 19. Transverse deck cracks seen in overhang of 30.3 ft span PFT bridge (item 268). Note that no crack is visible in the girder.

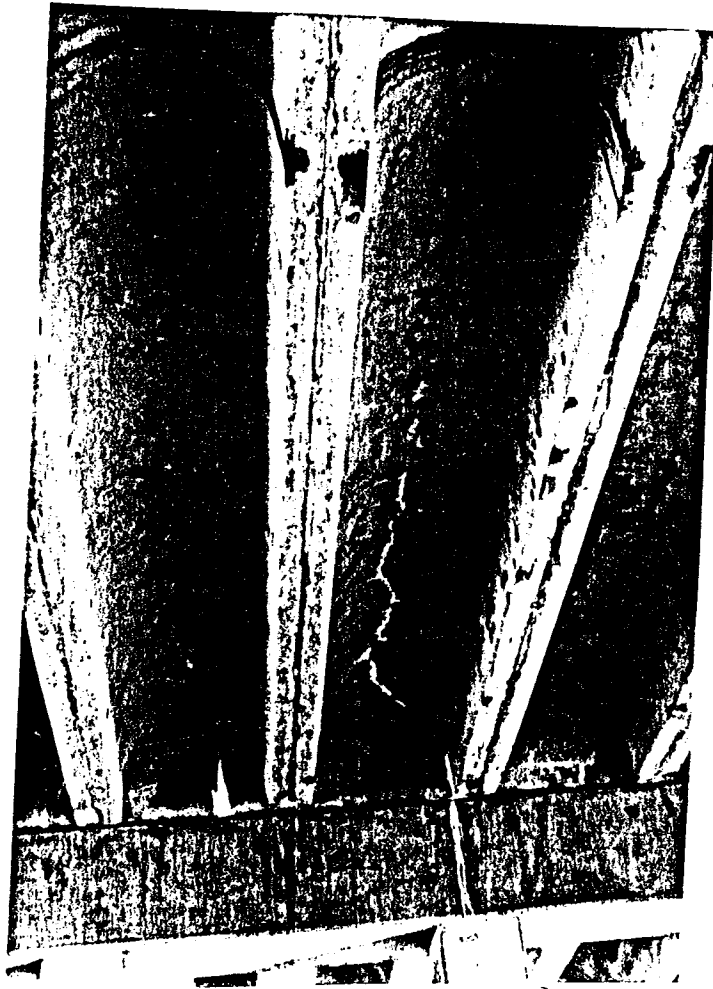
(1) Pan Girder Bridges - The most common defect found in this bridge type is a longitudinal crack at the top of the crown of the curved recessed soffit. The crack, seen from the bottom of the bridge, runs the length of the span, and measurements show it to be some 0.01 in. wide. It was not seen from the top, possibly because of texturing or because it was hidden by an overlay. Figure 20 shows leakage marks on the bottom side of one PFT bridge. These cracks show no wear, and they should cause no problems unless deicing salt runoff penetrates them.

Figure 20. Leakage marking a longitudinal crack in a PFT bridge (item 268).

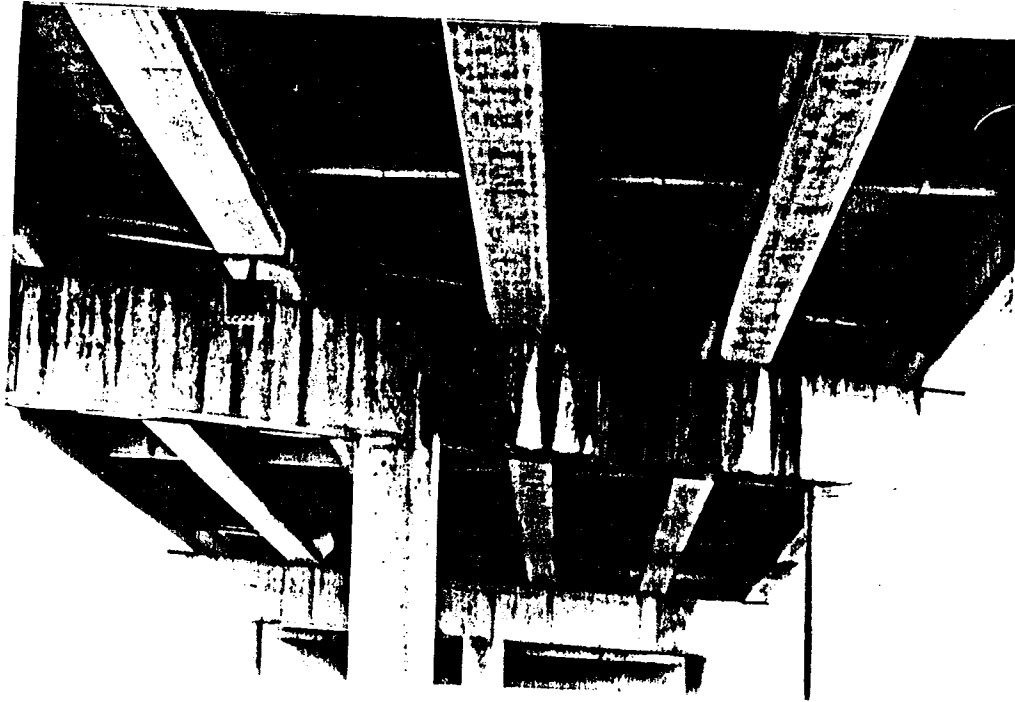
runoff water stains resulting from open joints or damaged seals, seen in Figure 21, are common.

Figure 21. Deck runoff stains.

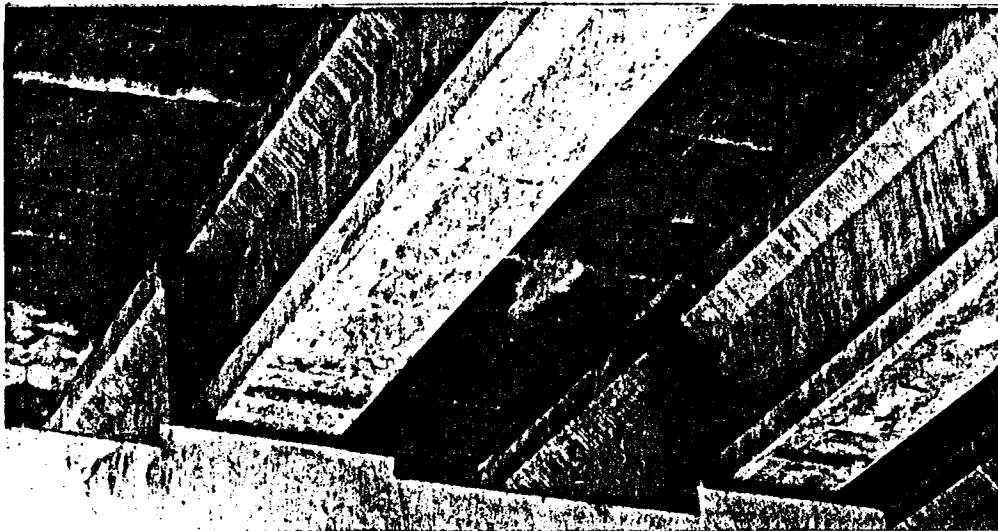
Third interior bent from S end

Figure 22. Beam end closure pour not continuous along bent cap.

Continuity for live load is attained in girders through a closure pour, seen in Figure A-1, made to join ends of girders longitudinally after they are in place. In all bridges except item 220, Table A-1 and Figure 22, that pour is continuous across the bent. The ends of the pour at the outside faces of edge girders in 22 percent of these bridges are cracked or spalled similar to that shown in Figure 13. It is not known if this defect is only superficial, but it appears to be because no evidence of damage was found except at the ends. The pour is finished off flush with the outside surface of the PC girders in all except two bridges. Those two exceptions had the pour extending beyond the faces of the girders, and no deterioration was found in the closure pours in these.
