1. Report No. FHWA/TX-87/408-2	2. Government Accession No.	3. Recipient's Catalog No.	
4. Title and Subtitle Delineation of Urban Freeway Gore Area Crash Cushions		5. Report Date April 1988

DELINEATION OF URBAN FREEWAY GORE AREA CRASH CUSHIONS

Research Report 408-2
Research Study Number 2-18-86-408

TEXAS TRANSPORTATION INSTITUTE
The Texas A&M University System
College Station, Texas 77843

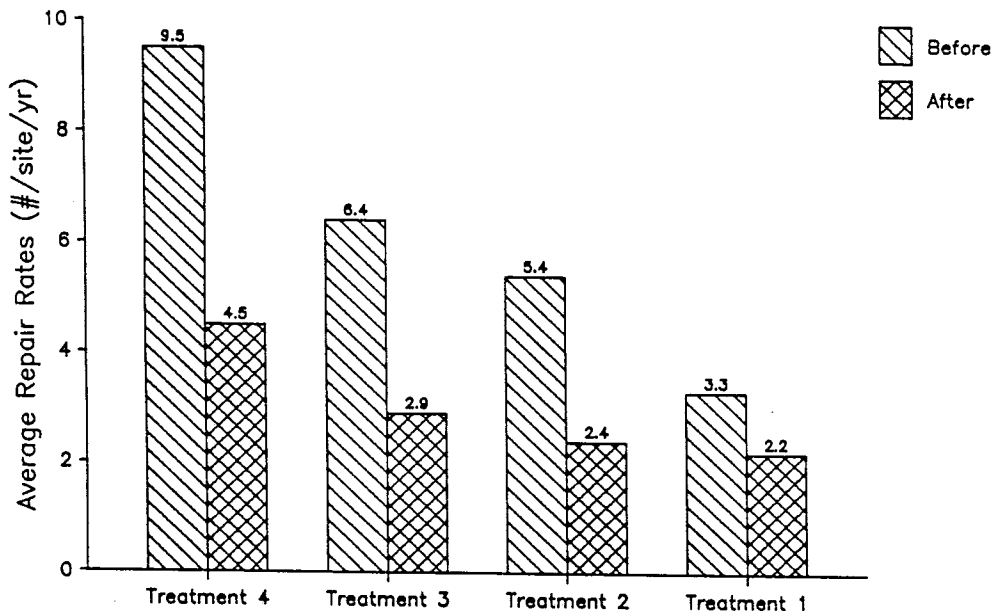
Figure 3-5 summarizes the average effect each delineation treatment has had on crash cushion repairs, presenting the average repair rates (by sites with identical treatments) per year before and after installation of crash cushion delineation. Over the four-year period, yearly repair rates were reduced (on the average) 33% at Treatment 1 sites, and 53-55% at sites where Treatments 2, 3, and 4 were installed.

Figure 3-5. Average Annual Crash Cushion Repair Rates for Four Years Before and Four Years After Treatments were Installed at Houston Sites.

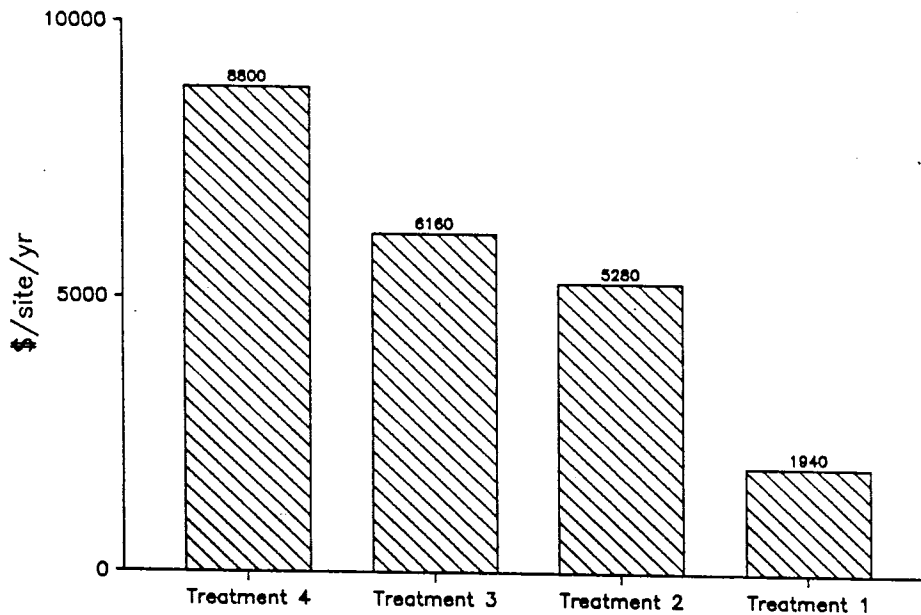
Using a recent cost estimate (7) of \$1,760 per repair of the steel drum crash cushions, the average annual savings in repair costs for the various treatments ranged from \$1,940 to \$8,800 per year (Figure 3-6). This cost estimate per repair includes both the labor and material costs for the actual repair of the cushion as well as an estimate of an average accident cost to motorists who collide with a steel drum cushion.

The values in Figure 3-6 are presented to show that all treatments did result in some yearly cost savings. These values should not be used to compare the relative effectiveness between treatments. The crash cushion repair rates before delineation was installed varied dramatically from site to site. The treatments were not evaluated across sites with similar repair rates (the sites where Treatment 4 was used had much higher repair rates initially) and so a relative comparison between treatments is not appropriate.

Figure 3-6. Average Yearly Savings in Crash Cushion Repair Costs at Houston Study Sites.

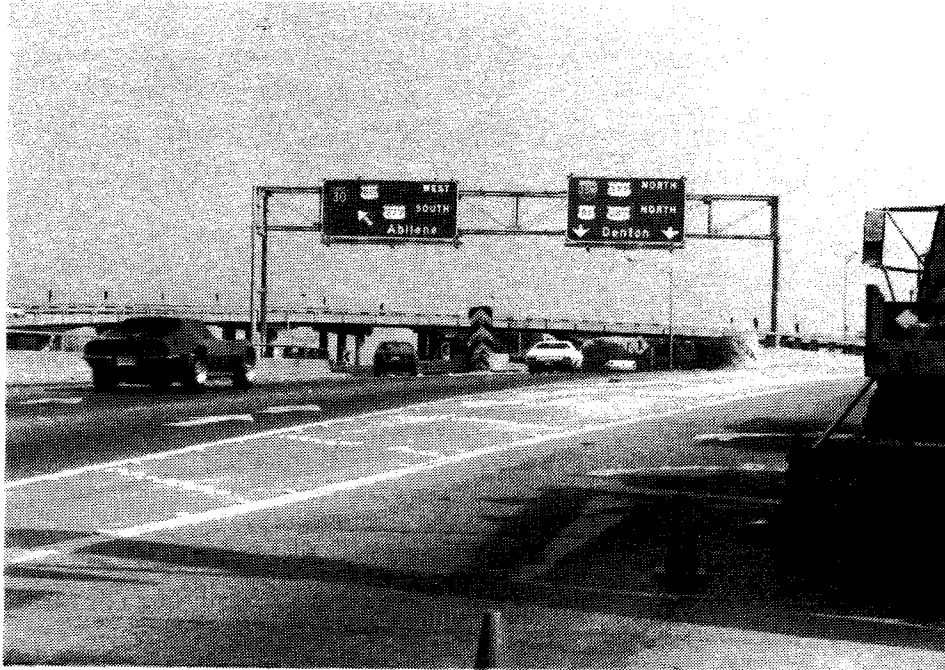
The study site gore, located at the Interstate (IH) 35W North -- IH-30 East-West Interchange in Ft. Worth, is the left-hand exit to IH-30 West. This is the site where long-term encroachment rate data (discussed previously) were collected. A schematic diagram of Site 1 and its sign locations with respect to the gore area is shown in Figure 4-2. Approaching the interchange are two through lanes and a left-hand exit lane. The crash cushions at the gore area are delineated with yellow and black chevron-patterned nose and back panels, supplemented by a pair of alternately flashing yellow beacons, vertically positioned on the back panel (see Figure 4-3). Because of vertical highway curvature and an overpass that limits the effective sight distance to the gore area, this site was classified as a Type IIa (left) Gore Area by the researchers.

Figure 4-3. Crash Cushion and Pavement Delineation - Site 1 (Ft. Worth).

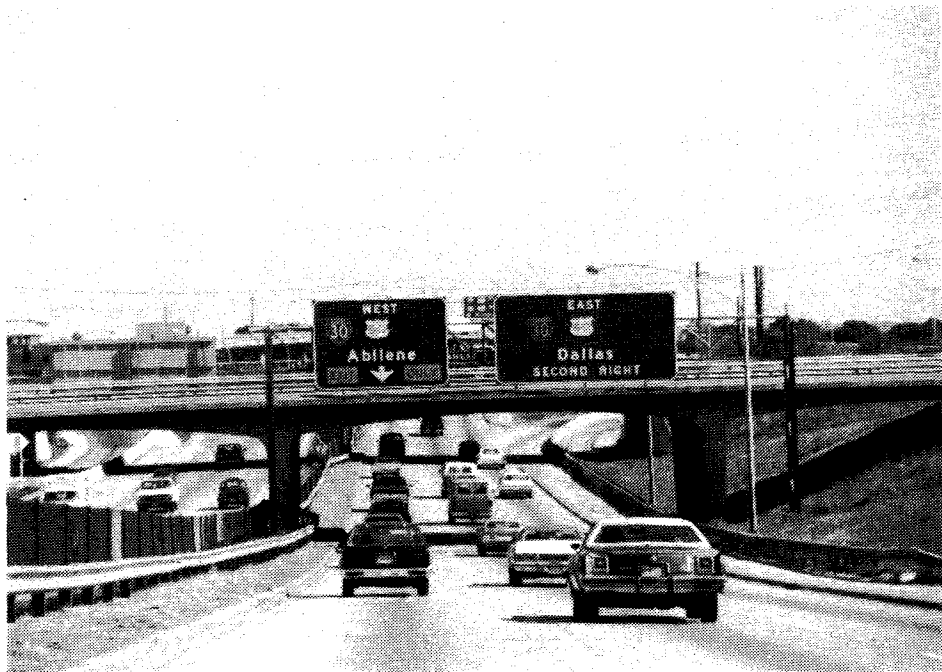
The second set of signs, located on the Vickery Blvd. overpass, has two sign panels and is approximately 1250 feet from the gore tip (Figure 4-5). The left panel contains the information, "IH-30 -- US 80 WEST, ABILENE, EXIT ONLY," while the panel on the right displays, "IH-30 -- US 80 EAST, DALLAS, SECOND RIGHT."

Figure 4-5. Vickery Blvd. Overpass Sign Location - Site 1 (1250 Ft. From Gore Area).

2. A diagrammatic sign suggested for use at this interchange is shown in Figure 4-9. It is recommended that the sign be installed at the Vickery Blvd. overpass (see Figure 4-2) and that the two existing panels be removed. This would give motorists more time to receive and process the information on the sign than if it were placed on the railroad overpass closer to the interchange. Installing the sign at the suggested location would give drivers up to 1800 feet to receive and process the information and navigate the interchange.

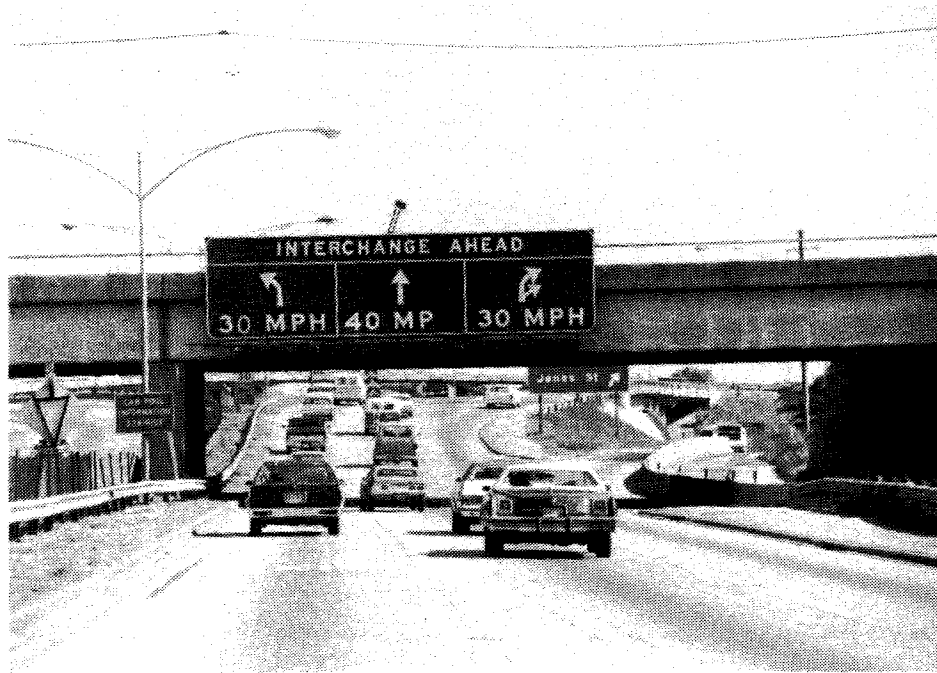
The third set of signs, located on the railroad overpass, is approximately 800 feet from the gore area (Figure 4-6). Above all three panels lies a strip which reads "INTERCHANGE AHEAD." The three panels, from left to right, give advisory speeds for the legs of the interchange and contain the following information: "↖ 30 MPH" (left), "40 ↑ MP" (middle - the "H" in MPH is missing), and "↗ 30 MPH" (right). Just beyond this location,

Figure 4-6. Railroad Overpass Sign Location - Site 1
(800 Ft. From Gore Area).

3. It is recommended that the advisory speed panels mounted on the railroad overpass (Figure 4-6) be removed and be replaced with the two panels taken from the Vickery Blvd. overpass (those presently seen in Figure 4-5). The bottom line of the right panel, which currently reads "SECOND RIGHT", should be changed to read "EXIT 1/10 MI. ". This refers to the exit ramp to Interstate 30 East to Dallas (Figure 4-8). While this ramp is still the "second right" as indicated by the existing sign, the closeness of the exit ramp to Lancaster Avenue and Jones Street (Figure 4-7) may cause confusion for some drivers. The arrow pointing upward and to the right is consistent with the thought process that the eastbound exit for Interstate 30 is "up ahead" and to the right.

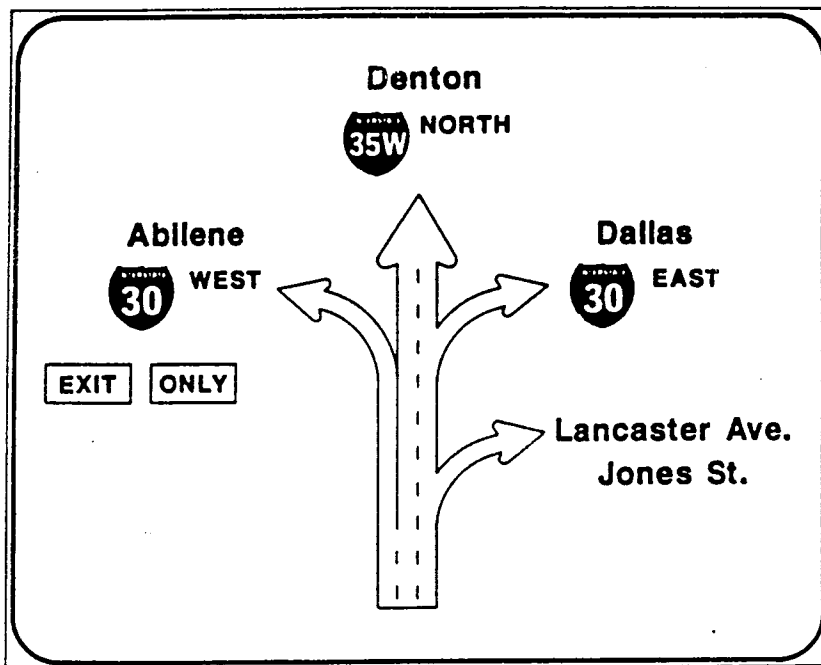
Figure 4-9. Proposed Diagrammatic Sign - Site 1 (Ft. Worth).

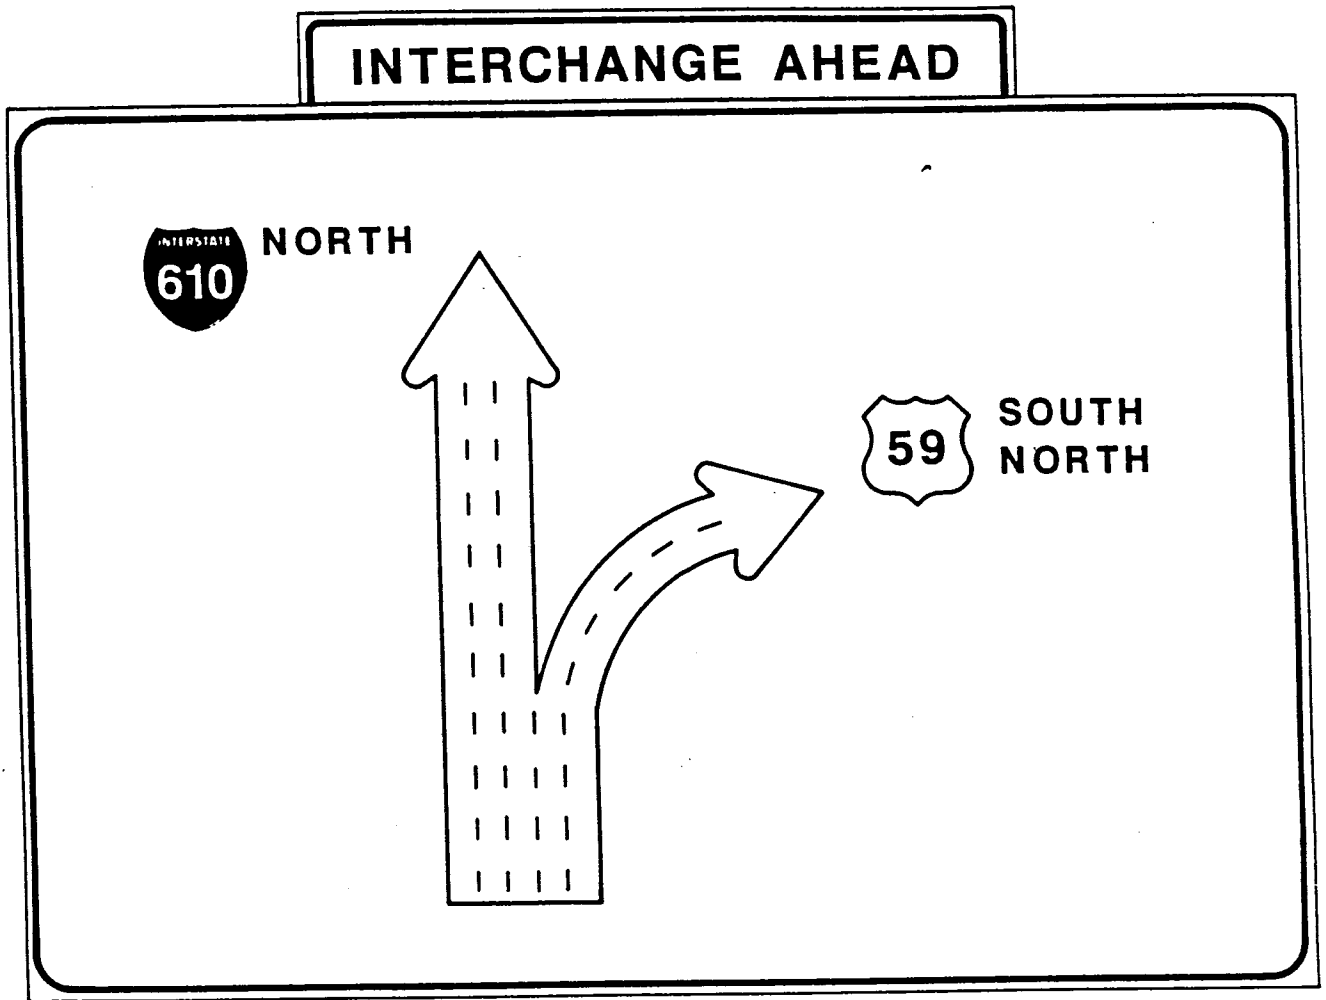
Figure 4-17. Proposed Diagrammatic Sign - Site 2 (Houston).

1. A diagrammatic sign, like the one in Figure 4-17, could be constructed and placed on an overhead sign bridge far enough upstream to inform drivers of the upcoming interchange (at least 1500 feet). However, it should not be so close to the sign location in Figure 4-14 that it interferes with the sign. It would even be suitable to combine the two signs (diagrammatic and "RIGHT 2 LANES MUST EXIT") on the same sign bridge.
2. An additional diagrammatic sign like the existing one shown in Figure 4-15 could be placed on the right side of the road at that location in order to insure that all drivers in all five lanes are able to see this information at this location.

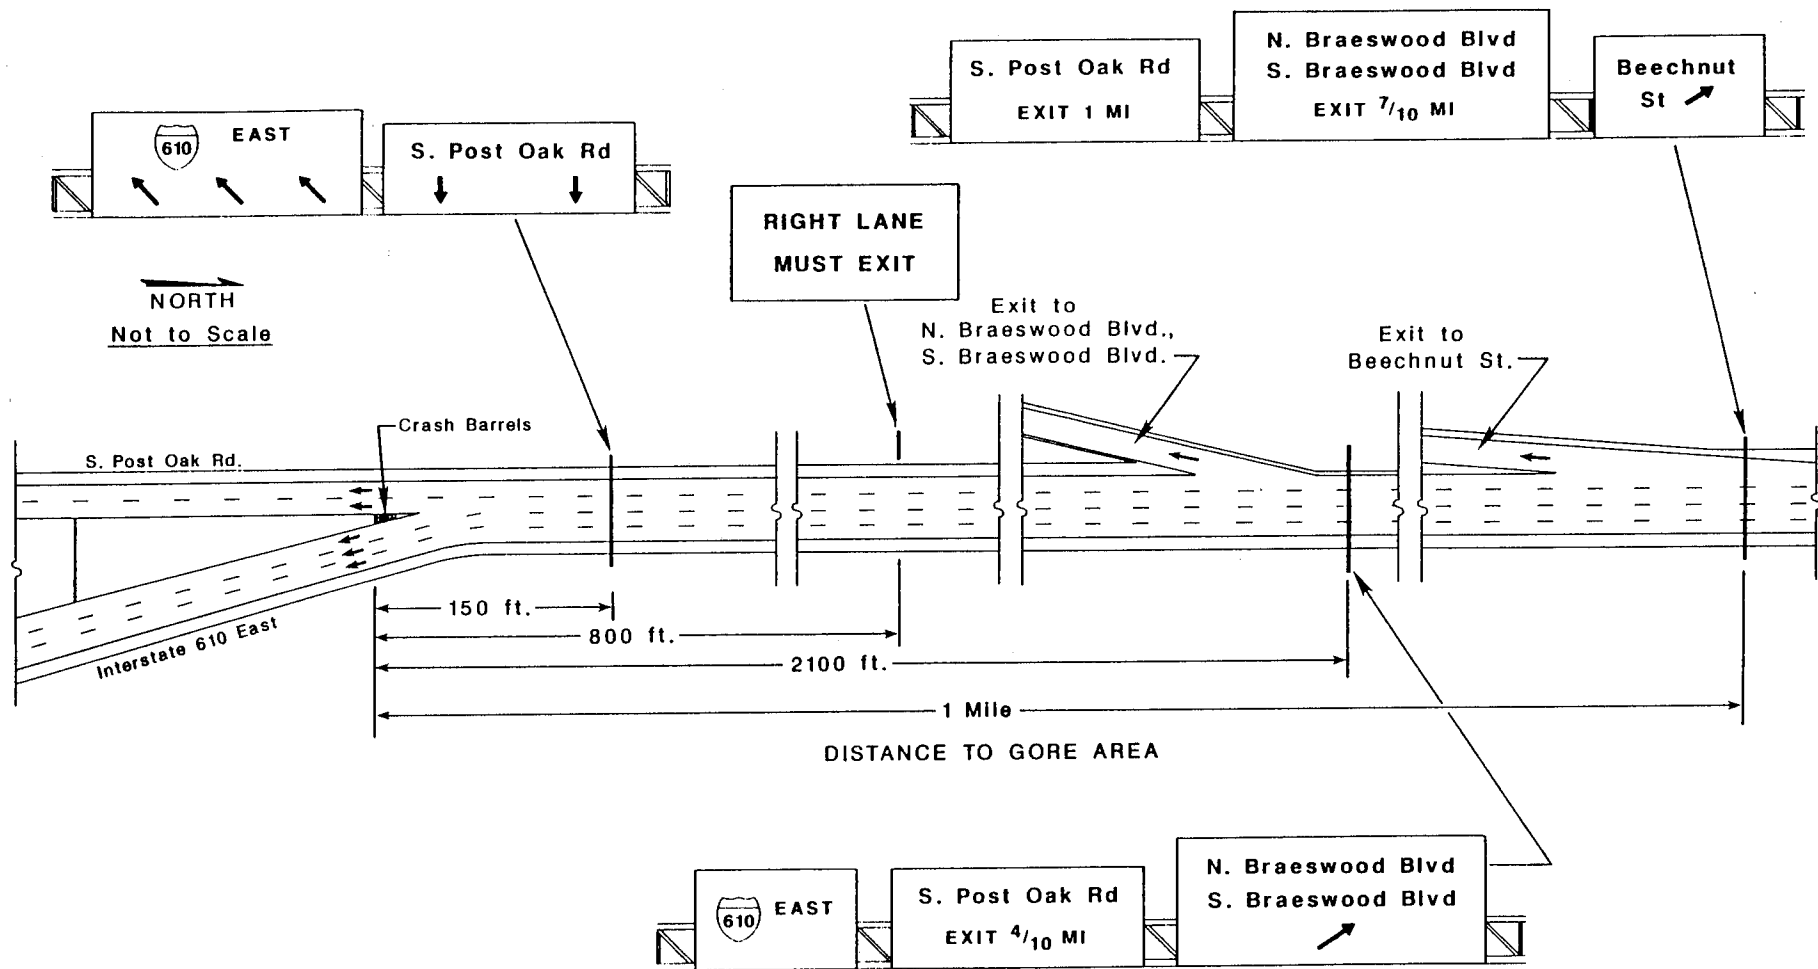
Site 3 is located at the S. Post Oak Road Exit from IH-610 (West Loop) South. A diagram of the site conditions (including signing) is shown in Figure 4-18. Existing crash cushion delineation includes orange and white chevron-patterned back panels supplemented by three yellow Type 1 TMUTCD (6) diamond-shaped object markers beneath the back panel (Figure 4-19). As with Site 2, this site was classified as a Type IIIa gore area due to geometric factors which direct a driver's visual perception of his travel path into the gore area.

Figure 4-18. Site 3 Schematic Diagram, IH-610 Southbound to S. Post Oak Rd. (Houston)

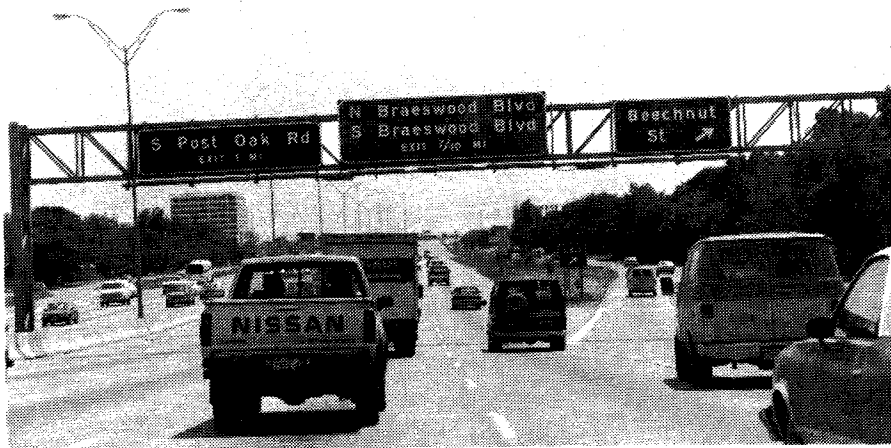
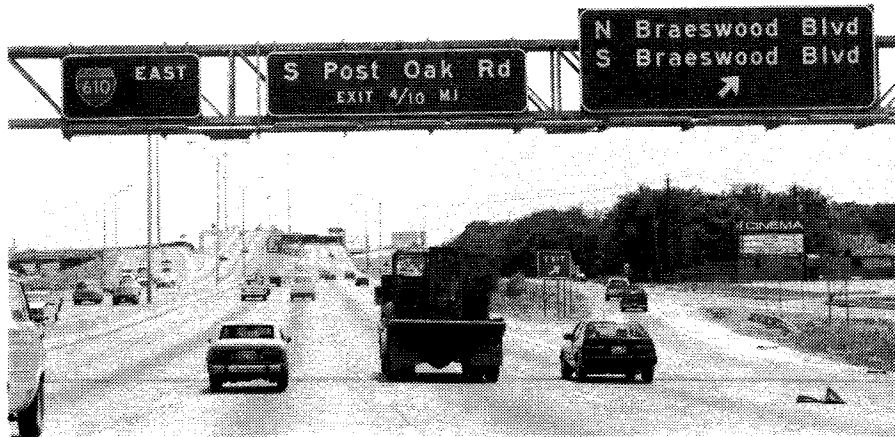
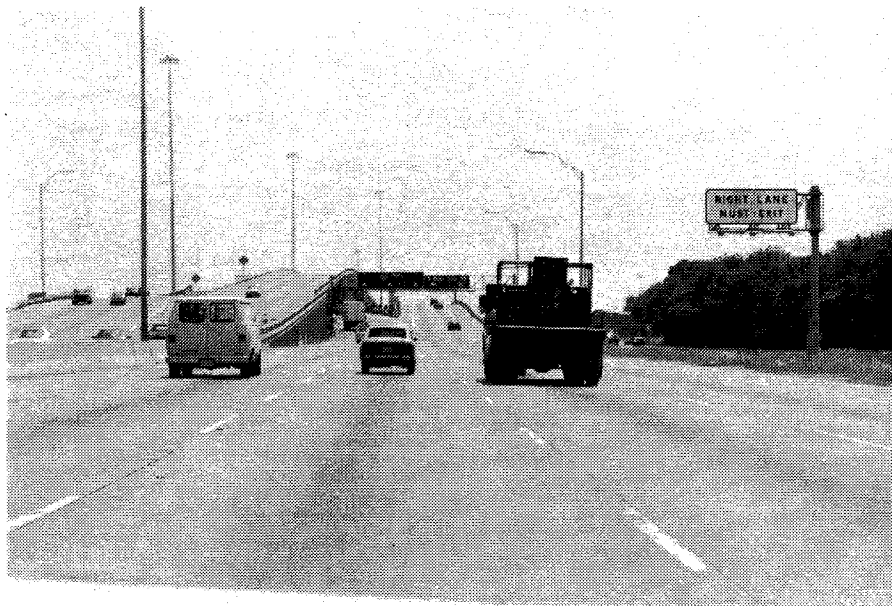
The geometric design of the freeway and exit ramp at this location may give drivers a misconception of the actual roadway ahead. Figures 4-20 to 4-22 illustrate the situation. A long tangent section of roadway begins to curve to the left at the gore area while the exit ramp continues on a tangent. The mainlanes to the left are somewhat hidden by a flyover left-hand entrance ramp to the opposing northbound lanes of IH-610 (see Figure 4-20), and drivers approaching the gore area may not realize in time that it is necessary to veer to the left to remain on the freeway.

1. A diagrammatic sign like that shown in Figure 4-24 is suggested to better illustrate the roadway features. The proximity of the Braeswood Blvd. Exit (Figure 4-21) limits where the diagrammatic sign could be placed. The sign should be located on an overhead sign bridge somewhere between 1500 to 2100 feet from the gore area, but should not be placed so close to the Braeswood Blvd. Exit that it would be in competition with the existing signs. The best solution would be to locate the diagrammatic sign 1500 feet from the gore and move the existing sign shown in Figure 4-22 ("RIGHT LANE MUST EXIT") to this new location. It would be more desirable to have two panels on one sign bridge than to have individual signs spaced only a few hundred feet apart.

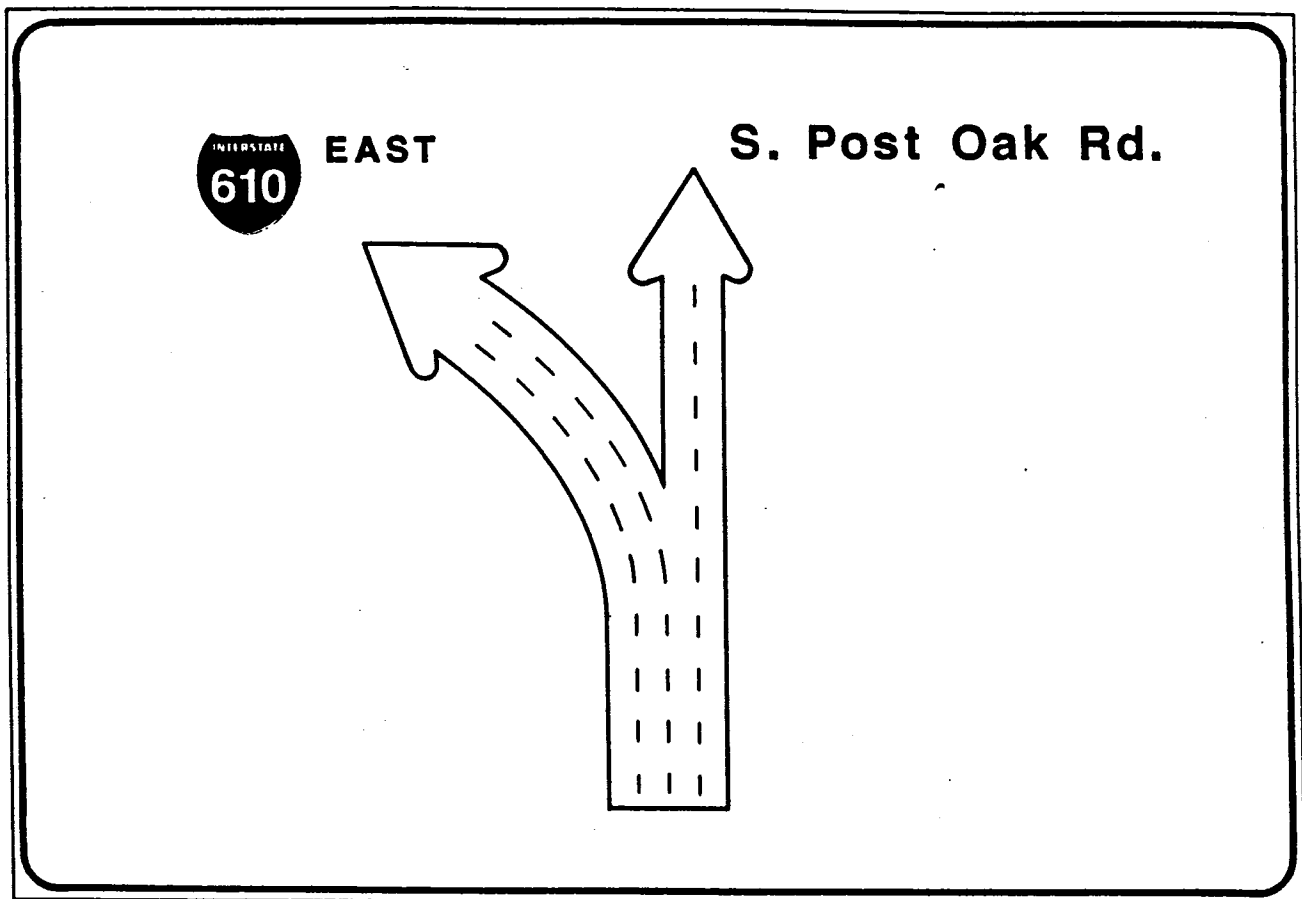
Figure 4-24. Proposed Diagrammatic Sign - Site 3 (Houston).
