Technical R	eport Documentation Page
1. Report No. FHWA/TX-03/4288-1	2. Government Accessio	n No.	3. Recipient's Catalog N	0.
4. Title and Subtitle		5. Report Date		
DESIGN AND EVALUATION OF THE TXDOT F41		1 AND 177	October 2002	
AESTHETIC BRIDGE RAILS			6. Performing Organizat	ion Code

DESIGN AND EVALUATION OF THE TXDOT F411 AND T77 AESTHETIC BRIDGE RAILS

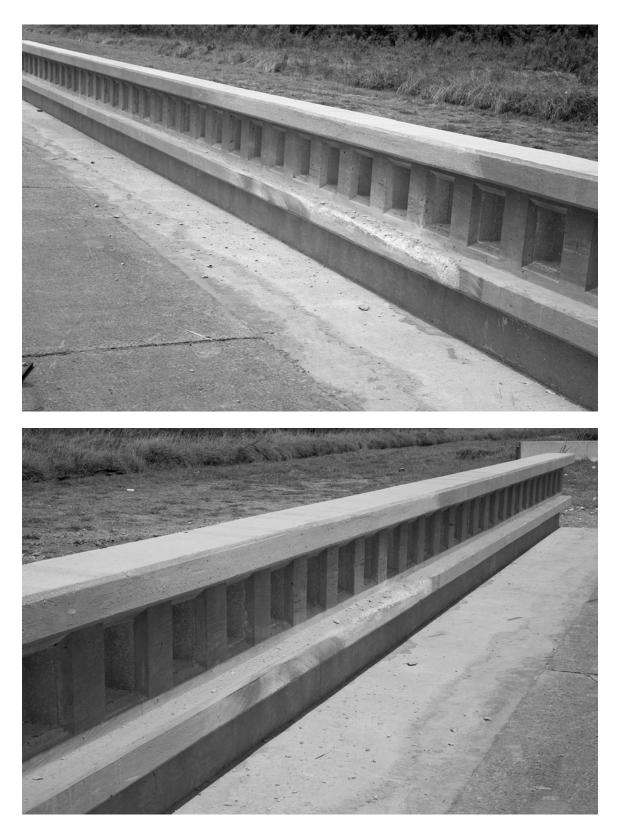
Figure 9. Installation after Test 442882-1.

The TxDOT F411 bridge rail sustained minimal cosmetic damage as shown in Figures 8 and 9. There were tire marks and scrapes along the face of the bridge rail for a distance of 11.4 ft (3.5 m). No cracks were noted in the beam rail, window frames, or deck. No measurable deformation occurred, and the working width was 1.4 ft. (0.4 m).

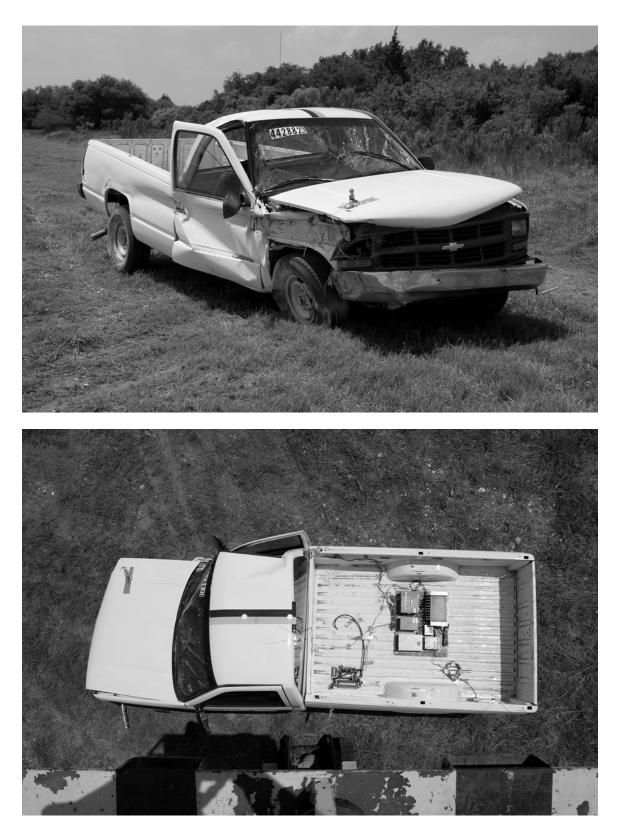
Figure 10. Vehicle after Test 442882-1.

Figure 10 shows damage imparted to the vehicle. Structural damage included deformation of the right upper and lower A-arms, right spindle and tie rod ends, stabilizer bar, right front of the frame, A and B pillars, floor pan, and firewall. Also damaged were the front bumper, hood, radiator and fan, right front tire and wheel, right front quarter panel, right door and window glass, and right side bed. The roof was deformed and the windshield was cracked. Maximum exterior crush to the vehicle was 25.6 inches (650 mm) in the front plane at the right front corner near bumper height. The vehicle was also crushed 20.9 inches (530 mm) in the side plane at the right front corner near bumper height. Maximum occupant compartment deformation was 8.3 inches (210 mm) in the right side door area. The right side floor pan area was deformed inward 7.3 inches (186 mm), and the right side firewall area was deformed inward 6.9 inches (175 mm). Figure 11 shows photographs of the interior of the vehicle. Exterior vehicle crush and occupant compartment deformation are shown in Appendix D, Tables 5 and 6.

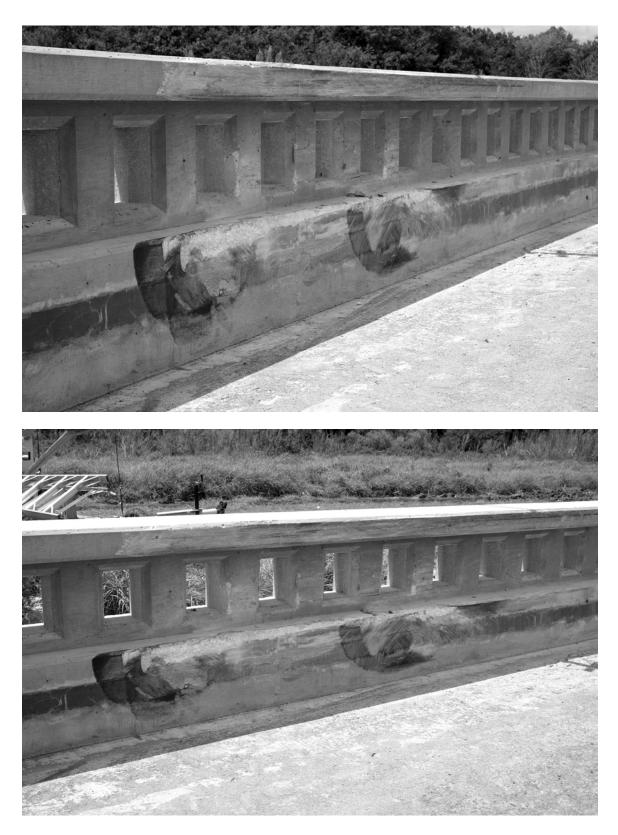
Figure 16. Installation after Test 442882-2.

The modified TxDOT F411 bridge rail sustained minimal cosmetic damage as shown in Figures 15 and 16. There were tire marks and scrapes along the face of the lower beam of the bridge rail for a distance of 9.8 ft (3.0 m). No cracks were noted in the beam rail, window frames, or deck. No measurable deformation occurred, and the working width was 1.7 ft (0.5 m).

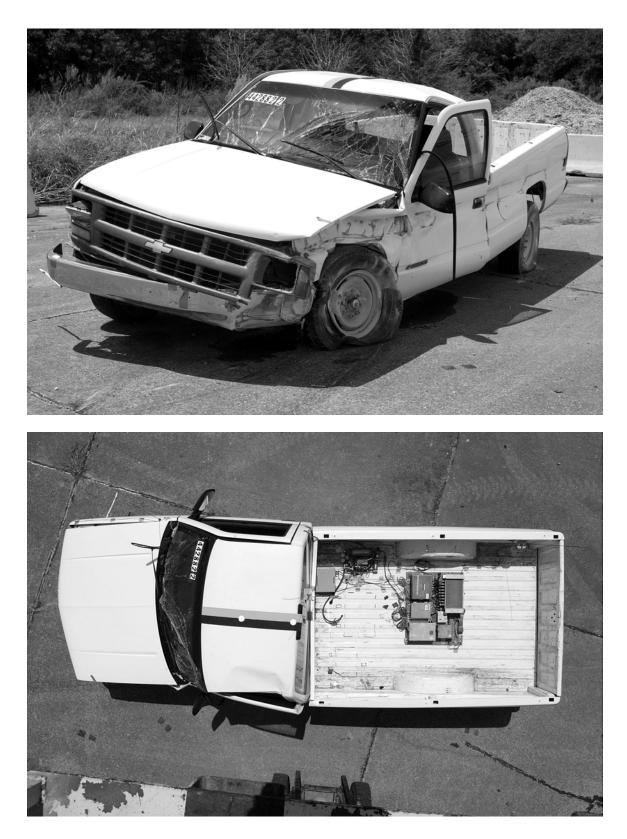
Figure 17. Vehicle after Test 442882-2.

Figure 17 shows damage imparted to the vehicle. Structural damage included deformation of the left upper and lower A-arms, left rod ends, sway bar, left A- and B-pillars, floor pan, and firewall. Also damaged were the front bumper, grill, hood, radiator and fan, left front tire and wheel, left front quarter panel, left door, and left side bed. The roof was deformed, and the windshield was cracked. Maximum exterior crush to the vehicle was 26.4 inches (670 mm) in the side plane at the left front corner 31.9 inches (810 mm) above ground level. The vehicle was also crushed 21.7 inches (550 mm) in the frontal plane at the left corner near bumper height. Maximum occupant compartment deformation was 4.6 inches (118 mm) in the instrument panel area. The factory-installed opening, which accommodates the manual transmission floor shift, tore at the forward and rear corners, increasing the opening to 7.1 inches (180 mm) long and 6.3 inches (160 mm) wide. (The dimensions of the factory-installed opening for the floor shift was originally 5.6 inches [143 m] by 5.6 inches [143 mm]). No other separation in the floor pan or toe pan was noted. Figure 18 shows photographs of the interior of the vehicle. Exterior vehicle crush and occupant compartment deformations are shown in Appendix D, Tables 7 and 8.

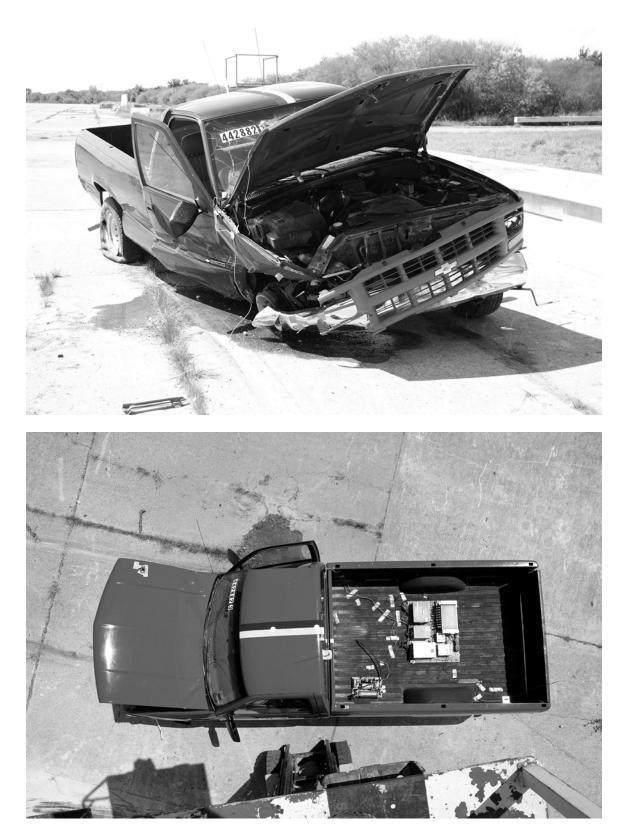
Figure 24. Vehicle after Test 442882-3.

The vehicle sustained damage as shown in Figure 24. The right side A-arms, sway bar, and right front of the frame rail were deformed. The A-pillar was deformed, there was a crease in the top right side of the cab, and the top of the right door was pulled away from the cab 11.4 inches (290 mm). Also damaged were the front bumper, hood, grill, radiator, fan, right front and left front quarter panel, right side bed, rear bumper, and right rear tire and wheel. The right front tire and exterior part of the wheel rim separated from the center part of the wheel rim (at the pop rivets). Small pieces of sheet metal were torn from the lower section of the cab and the right rear side of the bed (2.4 inches \times 5.9 inches [60 mm \times 150 mm]). Maximum exterior crush to the vehicle was 30.7 inches (780 mm) in the front plane at the right front corner at bumper height. Maximum occupant compartment deformation was 8.7 inches (222 mm) in the right front firewall. Photographs of the interior of the vehicle are shown in Figure 25. Exterior vehicle crush and occupant compartment deformations are shown in Appendix D, Tables 9 and 10.
