**CONSTRUCTION DETAILS AND INITIAL PERFORMANCE OF TWO
HIGH-PERFORMANCE BASE SECTIONS**

Tom Scullion, P.E.
Research Engineer
Texas Transportation Institute

Report 5-4358-01-1
Project 5-4358-01
Project Title:
Pilot Implementation of High Performance Flexible Base Specifications

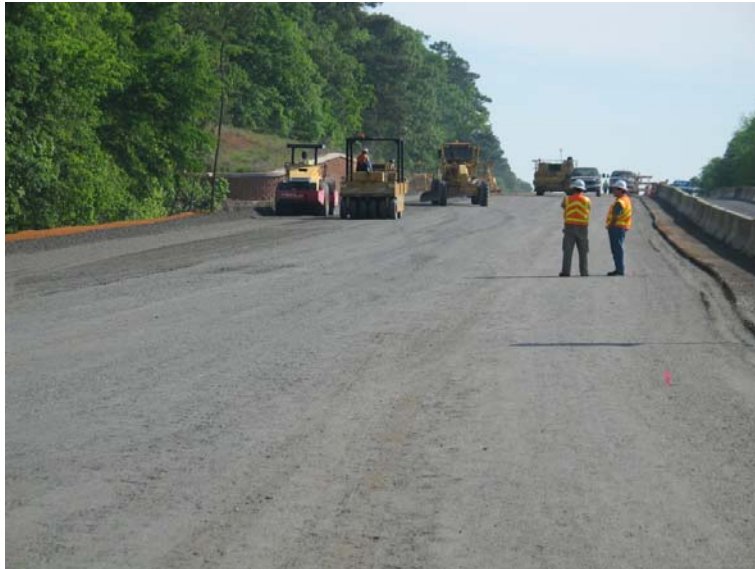
Figure 1. Granite Mountain Base Being Placed on SH 31.

In April 2005 the Tyler District constructed a short section on SH 31 using the Granite Mountain flexible base. Granite Mountain base is from Arkansas and is not commonly used by TxDOT although it is used extensively for oilfield gravel road construction in east Texas. The reported advantage is that it performs much better as an unsurfaced gravel road than traditional Texas limestone materials. Granite Mountain material is hauled by train from Arkansas and it is stockpiled in Longview. As shown in [Figure 1](#), a field change was executed on SH 31 and a short section (700 ft) of Granite Mountain base was included in this project. The material properties for the Granite Mountain base are shown in [Table 2](#). The base used in the remainder of the project was a Type A, Grade 2 base supplied by Armor Material from a pit near Terrell, Texas. The triaxial strength on that base were measured to be 42 psi (unconfined) and 194 psi @ 15 psi confining.

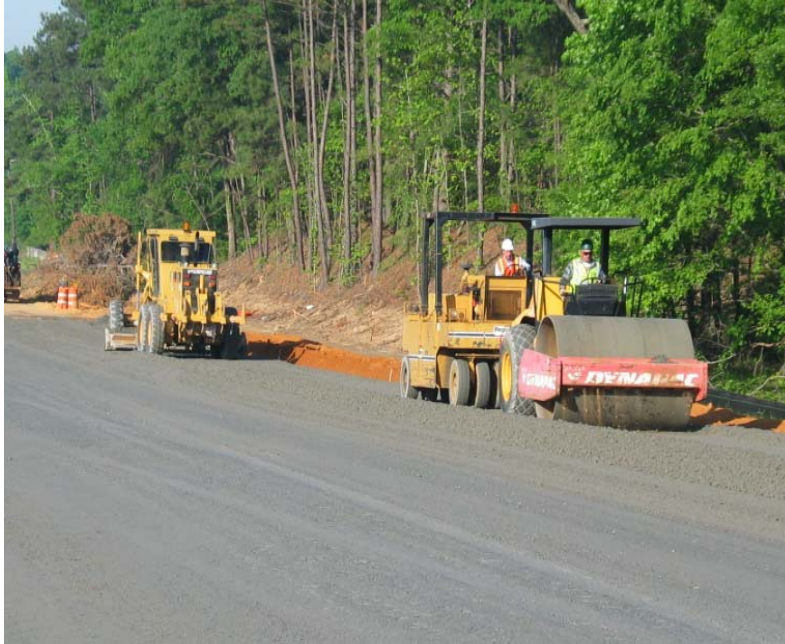
Figure 2. Compaction Sequence on SH 31.

The section was placed by the local contractor using the sequence shown in [Figure 2](#). The pneumatic compactor and vibratory steel wheel worked in tandem. The first pass was immediately behind the grader. In the early passes the steel wheel was in vibratory mode. The final pass was in non-vibratory mode. The local contractor was very concerned about compacting this base because of his experience working with similar materials using the Federal Aviation Administration (FAA) airfield specification (P-154 base), which calls for less than 3 percent passing the No. 200 sieve. However, on SH 31 no problems were encountered with handling or compaction. The specifications for this job called for 100 percent of laboratory density achieved with Tex-113-E procedure. This density was achieved with three passes of the tandem configuration and one finishing pass with the steel wheel in static mode.

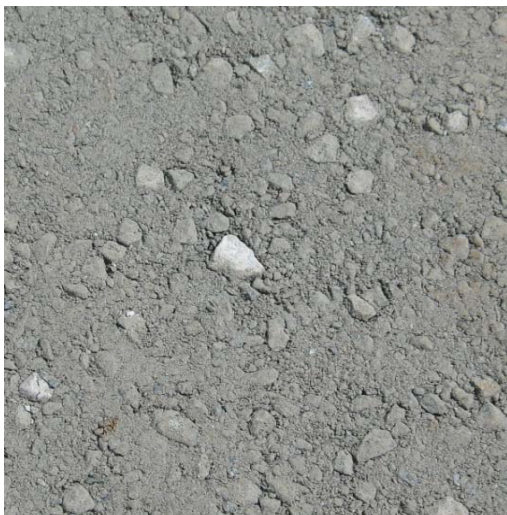
a) finished base

A close-up of the completed base is shown in [Figure 3](#). The surface of the base is tight with a smooth finish. Densities were checked with a standard nuclear device. One comment heard with all of these bases, is that the nuclear test could be problematic with these granular low-fines bases, particularly as they do not retain moisture. When driving the rod for the nuclear gauge cracks appear in the base, and when removing the rod some disturbance (uplift) of the base is sometimes observed. This result was not a problem on the SH 31 base, but it was a large concern with the section constructed on US 287.

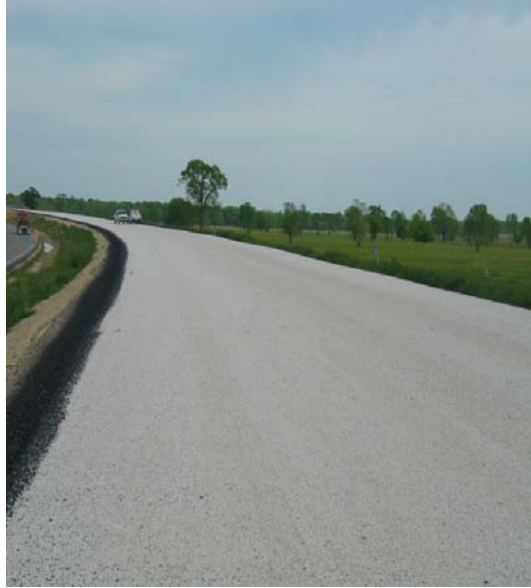
a) underseal prior to HMA placement

Photographs of the flexible base during and after construction are shown in [Figure 4](#). [Figure 4b](#) illustrates some of the non-base-related construction issues with this section. The contractor had problems achieving density in the asphalt layer, and the right lane in this figure was totally replaced very early after construction.

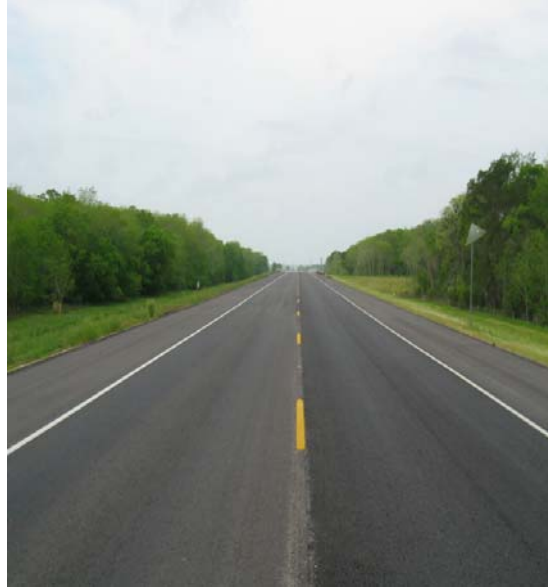
b) after placement of HMA

The district reported that there were several problems with the HMA layer placed on this project. As seen in [Figure 4b](#) the right lane was completely milled and replaced.

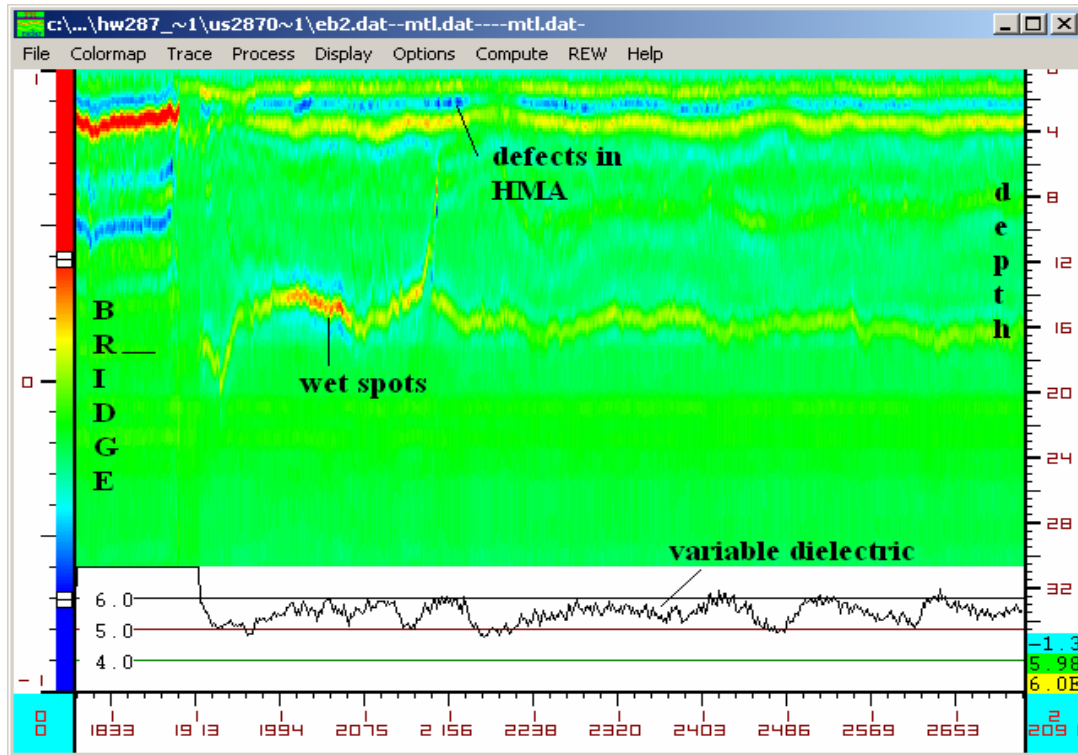
Figure 5. GPR Data from Mill Creek Base Section on US 287, Bryan District.

This section was tested with the FWD and Ground Penetrating Radar (GPR) in April 2006. The average moduli value for this base is close to 60 ksi. However, for these data there is one weak area; the deflection under the 9000 lb load at one location is 24 mils (0.024 inches), well above the average for this section (13 mils). The increase appears to be related to a weakening or lack of support in the stabilized layer. The GPR also indicated moisture at the bottom of the base at the high deflection location; this is shown in [Figure 5](#) and labeled as a wet spot. [Figure 5](#) shows about 1000 ft of GPR data from one location next to a bridge. The top of the base is the yellow line at a depth of 4 inches, whereas the top of the lime-treated layer is at a depth of approximately 16 inches. The red areas in the reflection from the top of the lime layer indicate a build up in moisture. From the GPR data there is also some concern about the asphalt layer on this project. The surface dielectric varies, which is an indication of variable surface density, and there is an interface in the middle of the 4 inch mat. This is possibly an indication of moisture build up at the bottom of the top lift of asphalt. The GPR data did not indicate any problem with the Mill Creek base. The dielectric values for the base were all less than 10.

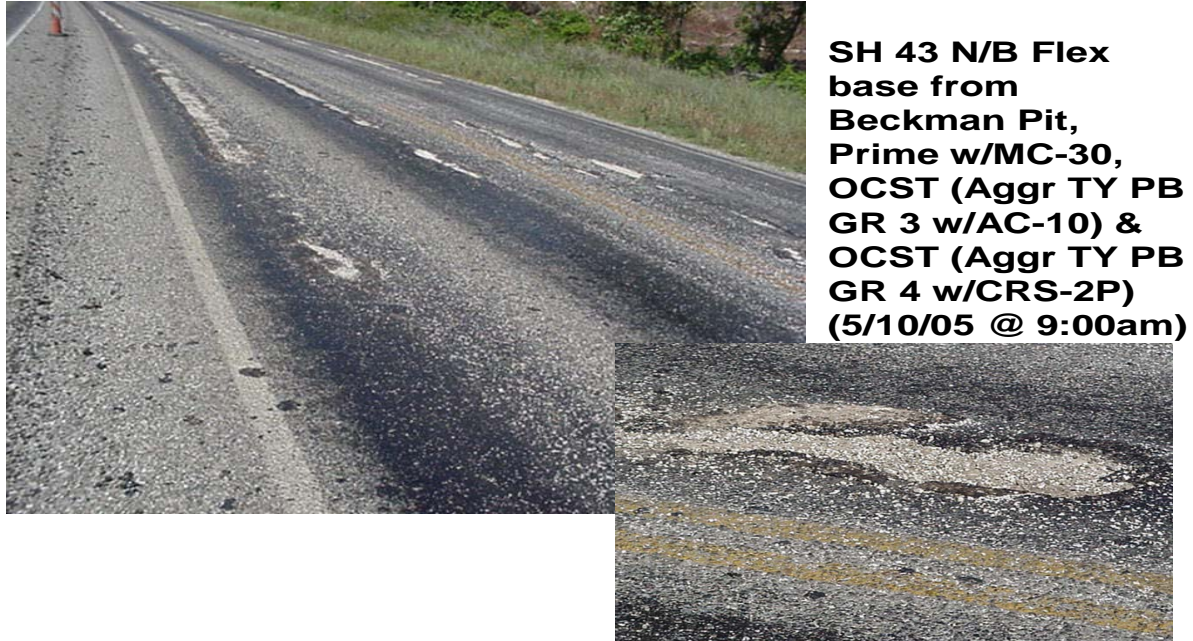
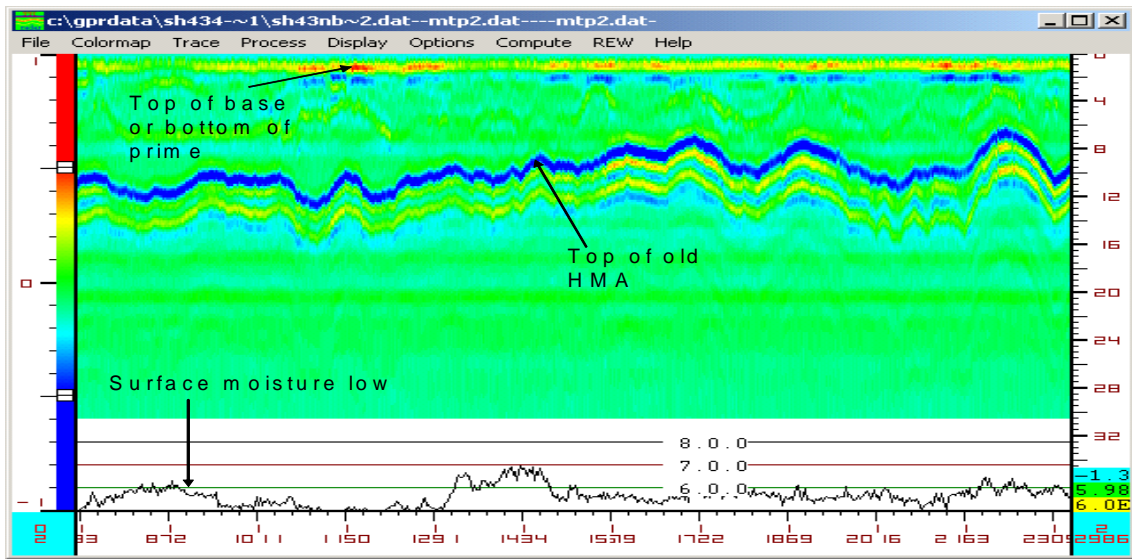
Figure 6. Seal Damage on the SH 43 Limestone Section Together with GPR Data.

A surface treatment was placed and the initial performance of both sections was good. However problems were observed when the hot weather arrived in late spring of 2005. In both cases shelling of the surface seal occurred and the top of the flexible base was exposed. Substantial rainfall then occurred and additional stability problems (rutting) were noted in the SB lanes containing the Jones Mill base.

The surface condition and the corresponding GPR data for both sections are shown in [Figures 6 and 7](#). The surface condition in both sections initially looked similar. In the GPR data the depth scale in inches is on the far right of the figure, the solid blue line at a depth of approximately 8 inches is the reflection from the bottom of the existing HMA layer. The most significant feature of the GPR data is the surface dielectric data which is plotted at the bottom of the figure. This data was collected several weeks after any significant rainfall but surprisingly the surface dielectric was higher in the Jones Mill section (average above 8) than in the high fines crushed limestone section (below 6). Because of their superior drainage capabilities it is normally anticipated that the Jones Mill would have a lower more uniform dielectric than the limestone material. In this case it appears moisture is being retained in the Jones Mill material.

- The initial loss of the surface seal was not base related as it occurred on both bases.
- The cause of the stability problems in the Jones Mill bases was attributed to the bases permeability (as compared to the limestone) and more importantly that the base was placed directly on an existing asphalt surface and the base was not “day-lighted” at the edges. As is normal practice in Texas the existing material was bladed up against edge of the base. The existing shoulder material was clay. This in-fact caused a bath tub effect trapping water, where moisture entering the base through the surface became trapped.
- Typically Texas limestone base particularly with slush rolling which causes the fines to rise to the surface are practically impermeable
- The clay contamination of the Jones Mill base certainly contributed to the eventual failure.

Bases designed according to the Item 245 specification, which was developed as a deliverable of this study, will be more permeable than traditional high fines limestone bases. Therefore it is important ensure that they are “day-lighted” at the edge, hopefully minimizing the risk of a bath tub situation. On SH 43 the Jones Mill base was eventually treated with 3% cement and it is now performing well.

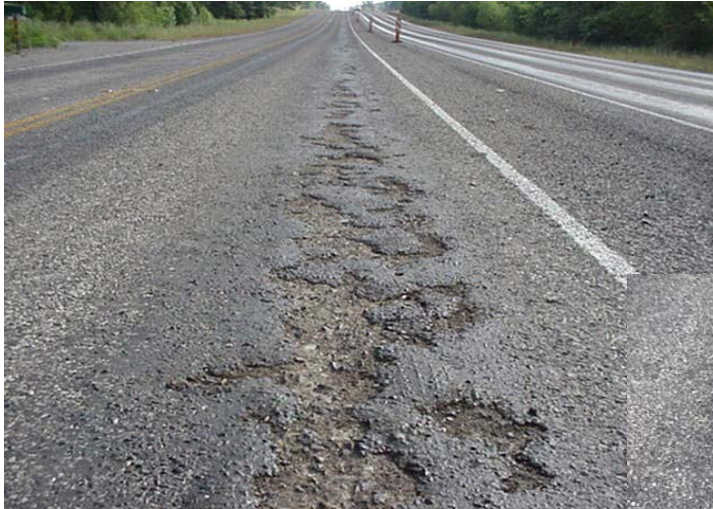
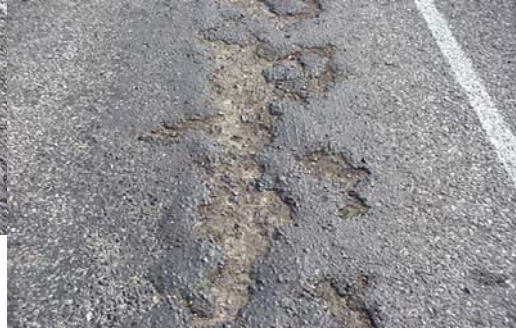
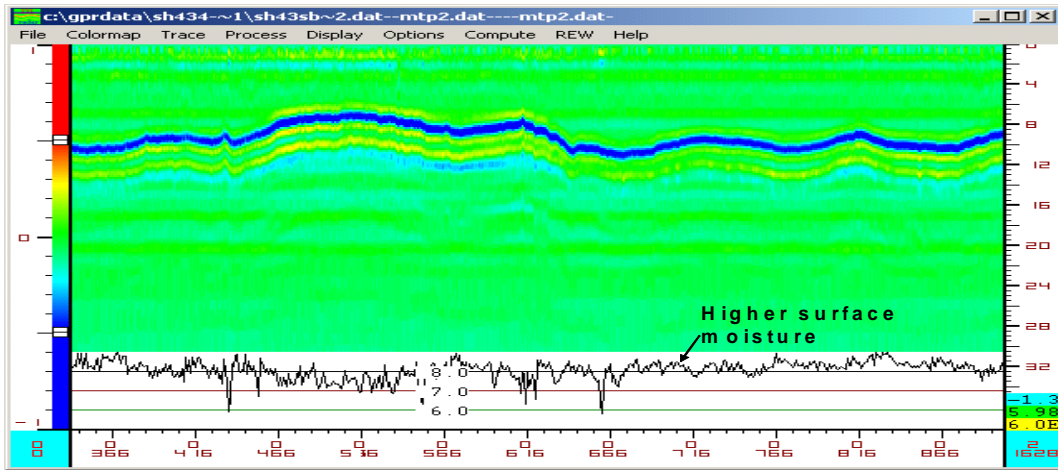
Figure 7. Seal Damage on the SH 43 Jones Mill Base Section and GPR Data.

In the mineralogical investigation conducted by [Harris \(2005\)](#) samples of the Jones Mill material from an available stockpile and from a failed section of the highway were evaluated using advanced mineralogical techniques including X-Ray Diffraction. Harris evaluated the silt and clay fraction (passing the 325 mesh sieve) of both samples of the Jones Mill base and found them to be different. The sample from the roadway contained substantially more silts and clay. From the fines fraction he calculated that the roadway samples contained 10% more clay than the stockpile sample. Potential causes of the differences could have been attributed to sampling

SH 43 S/B Flex base
from Jones Mill, AR.
Prime w/MC-30 &
OCST (TY PB GR3)
w/CRS-2p
(5/10/05 @ (9:00 am))

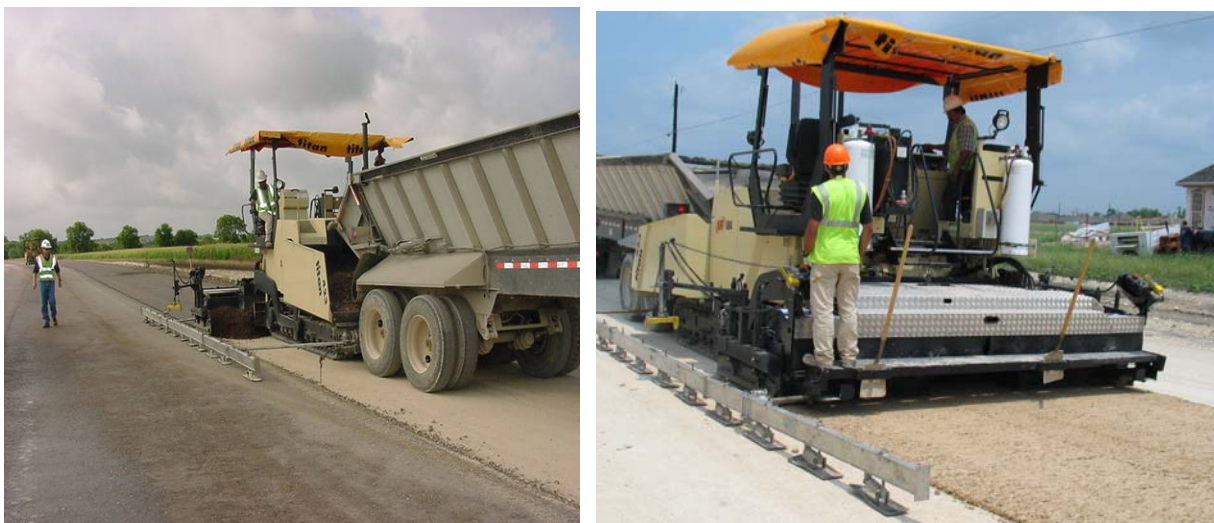
Figure 8. Base Paver Operations in the Waco District.

Late in Project 0-4358 new base paving materials were introduced to Texas. The base paver shown in Figure 8 was operated by Big Creek Construction Inc. on a new construction project in the Waco District. Placing base using pavers such as these is routine in other states, but has not been done in Texas (Hefer and Scullion, 2002).

The construction operation consisted of a pugmill for blending and adding moisture to the base (two-person operation), the base paver shown (two-person operation), and one steel wheel vibratory roller (one-person). The contractor commented that the operation was economically viable because of the reduction in labor and equipment over standard operations.

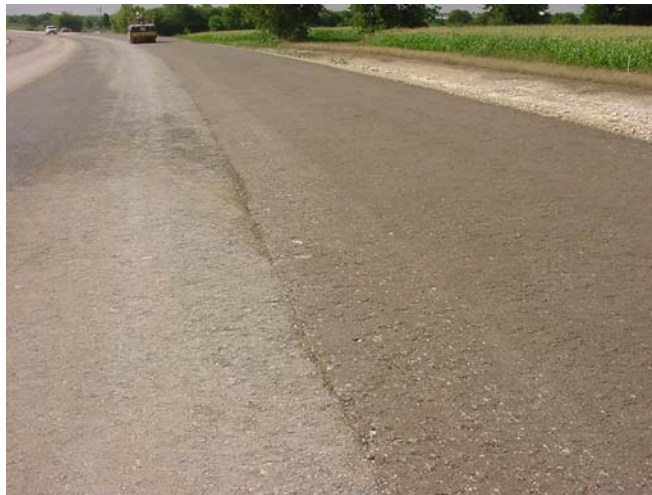
Figure 9. Smooth Ride and Excellent Joints in Paver-Placed Base Layer.

To achieve compaction the base was placed at 2 percent above optimum moisture content. The TxDOT inspector reported that the base was measured to be at 92 percent of required density before rolling. The base was left for about 30 minutes before rolling commenced. No problems were reported in obtaining the 100 percent density required in the current specification. To obtain a desired lift thickness a 1 inch roll down was anticipated, so if the design thickness was 6 inches then 7 inches was placed directly out of the paver. As shown in [Figure 9](#) the completed section looked excellent and offered a smooth ride. Handling and working of the base was minimal; no evidence of any segregation was found with this operation.

All indications are that the base paver operation provides a more uniform base than that obtained by traditional operations. This seems particularly true with the low-fines bases promoted in this project. For that reason the pugmill and paver operation has been included in the draft Item 245 specification.
