**MIX DESIGN, CONSTRUCTION, AND PERFORMANCE OF A THIN
HMA OVERLAY ON PUMPHREY DRIVE, FORT WORTH, TX**

Report 5-5123-01-2

Project Title: Implementation of Thin Lift Type F HMAC Mix Design

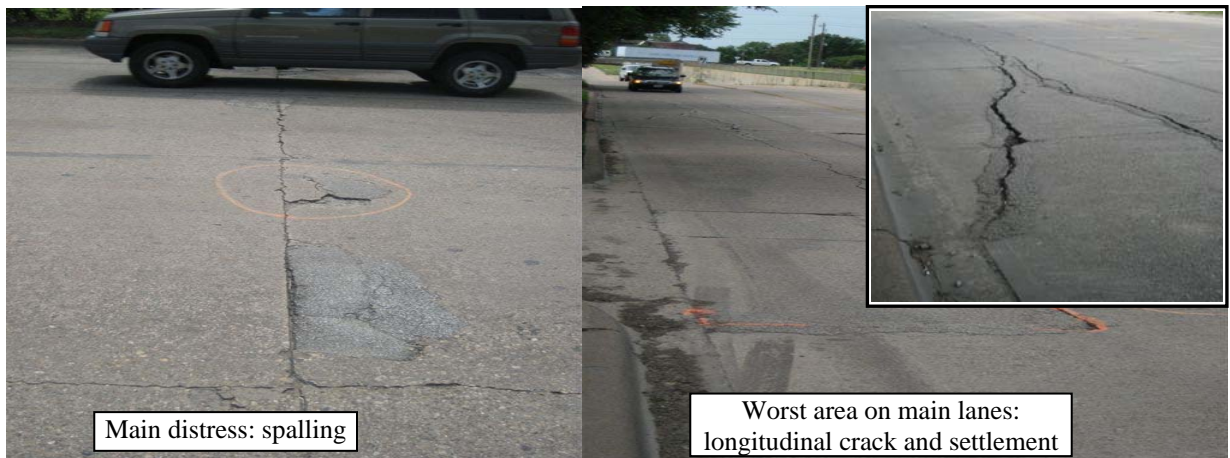
Both Richard Williammee, P.E., Fort Worth District Materials Engineer and the TTI researchers evaluated the existing PCC pavement conditions on June 14, 2007, and made recommendations on the areas that needed to be repaired before the thin HMA overlay. The main distress observed was spalling at the joints. The overall conditions of the main traffic lanes were acceptable except in two large areas with longitudinal cracks, settlements, and block cracking. [Figure 4](#) shows examples of the existing conditions of the main traffic lanes before the HMA overlay. The general conditions of the PCC pavement on the ramps were worse than those of the main traffic lanes as shown in [Figure 5](#). [Figure 6](#) presents some areas after full depth repairs were made.

Figure 4. Observed Distresses on the Main Traffic Lanes, Pumphrey Drive, FTW.

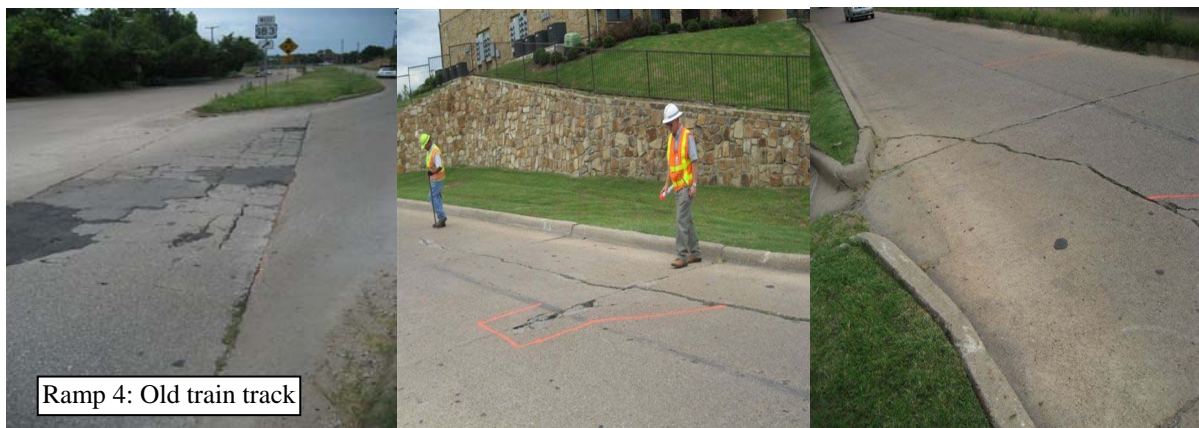
Figure 5. Observed Distresses on the Ramps, Pumphrey Drive, FTW.

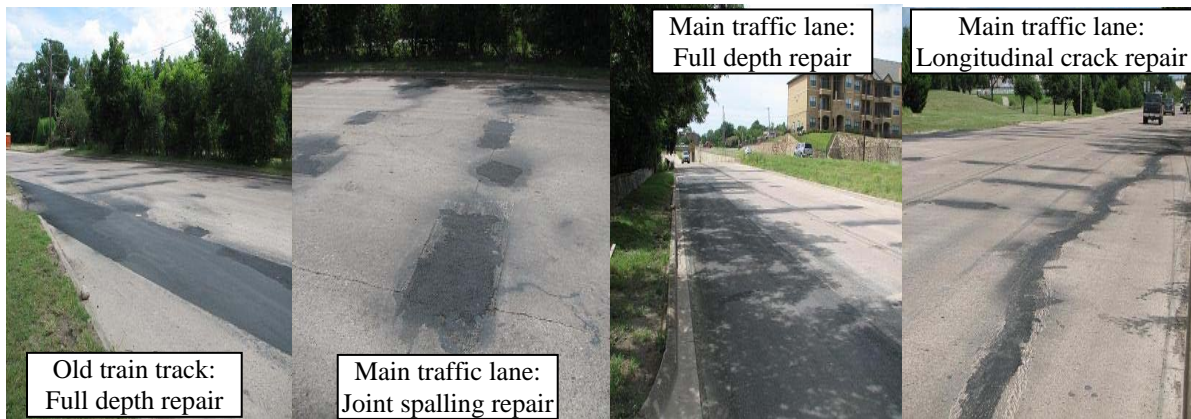
Figure 6. Repairs of Existing Distresses before the HMA Overlay.

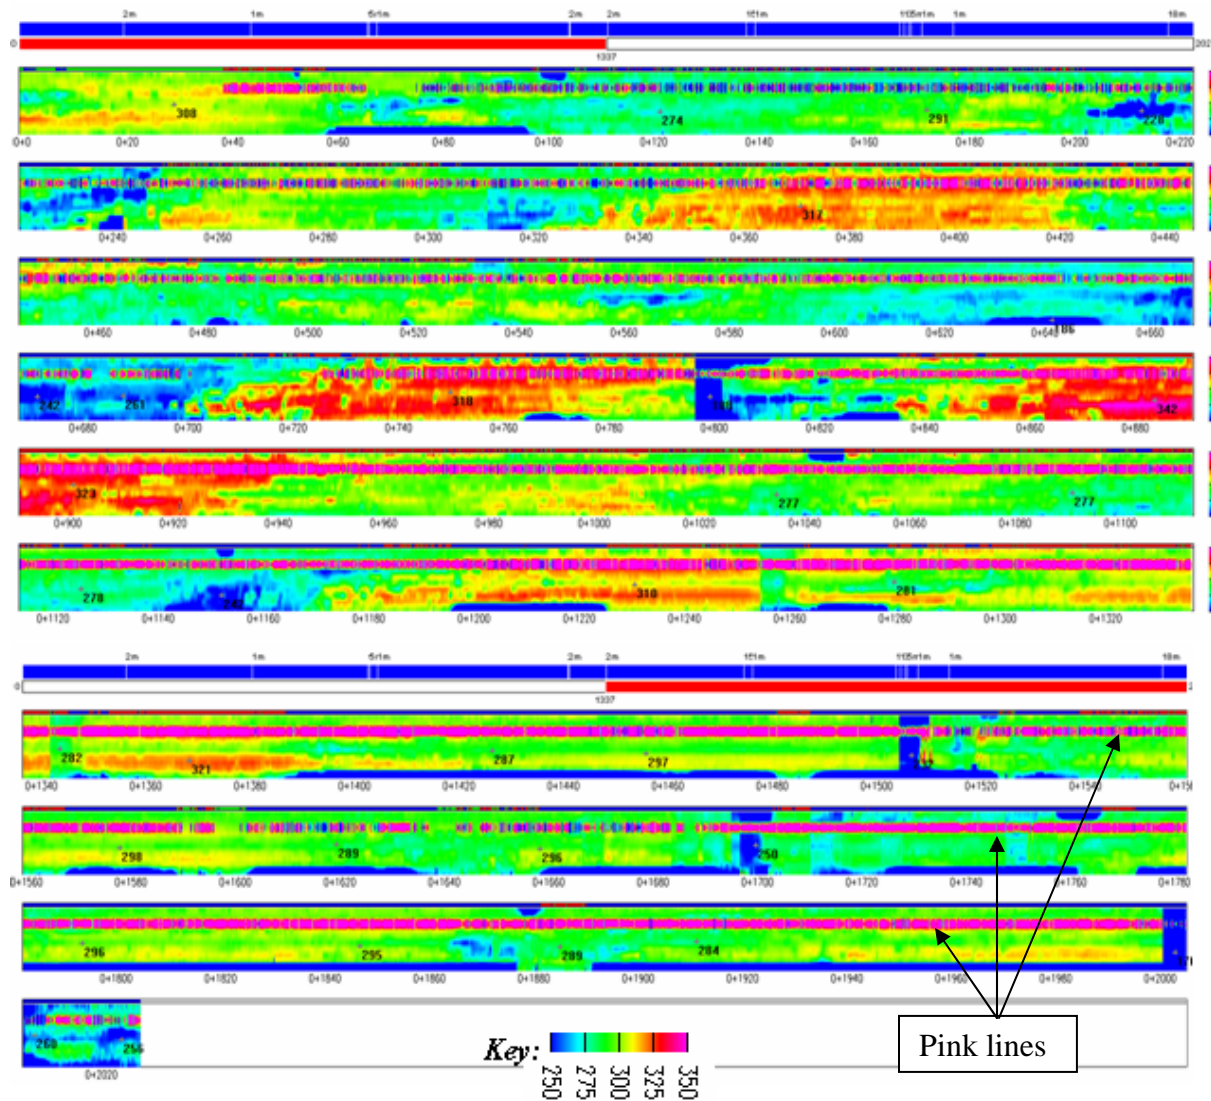
Figure 9. IR Thermal Profiles Measured on Pumphrey Drive (Crumb Rubber Mix).

The average mat temperature was about 290 °F. But, as shown in [Figure 9](#), the mat temperature was hardly uniform. There are some intermittent sections of green (about 290 °F) and red (about 318 °F) IR thermal color readings which could be a cause for concern with respect to uniformity in the compaction operation. There is clear visual evidence of intermittent cold spots (bluish) indicating potential thermal segregation in the mat. These cold spots were predominantly caused by paver stops and most often coincided with the end of every truckload of HMA caused by irregular mix delivery due to an inadequate number available for hauling. In more than two instances, the paver was stopped for over 20 minutes while waiting for the truckloads of HMA. Furthermore, as can be seen from [Figure 9](#), there was a significant variation in the HMA temperature of the truckloads; some were hotter, while some were colder. Additionally during this period, daily afternoon thunderstorms formed and, on at least 3 different days, moderate to heavy amounts of rain hit the laydown operation. The crew leader would normally continue to pave with the mix from the trucks that were already on the jobsite or on their way from the plant. Then they would quit for the day.

These thermal variations may have an impact on the compaction operation, which could lead to non-uniformity in the target compaction thickness and having other defects such as bumps in the completed mat. In particular, researchers observed that more compaction rolling passes were applied on the cold sections to attain the target 1 inch thickness. The planned comparative performance monitoring program of this project will allow an opportunity to monitor the effect of these thermal variations and cold spots on performance.

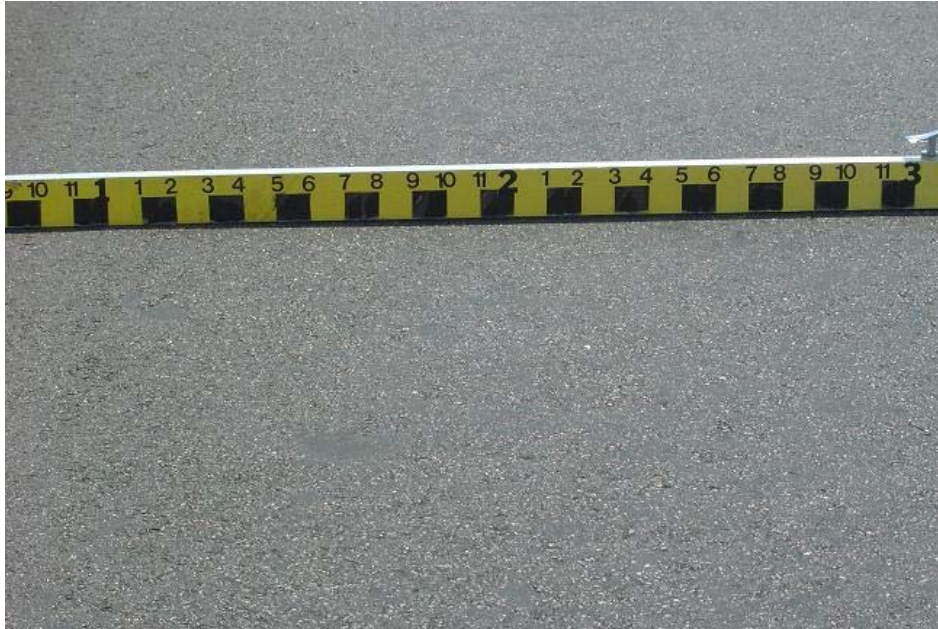
Generally, no rutting was observed on both the main traffic lanes and the ramps (Figure 12). The only area with rutting was in the SBR latex southbound lane at the Stop sign at the intersection with Roaring Springs Road (Figure 13). This is not unexpected due to slow and stopped traffic loading and higher binder content (7.2 percent) than the design binder content (6.8 percent).

Figure 12. No Rut on the Main Traffic Lanes and Ramps.

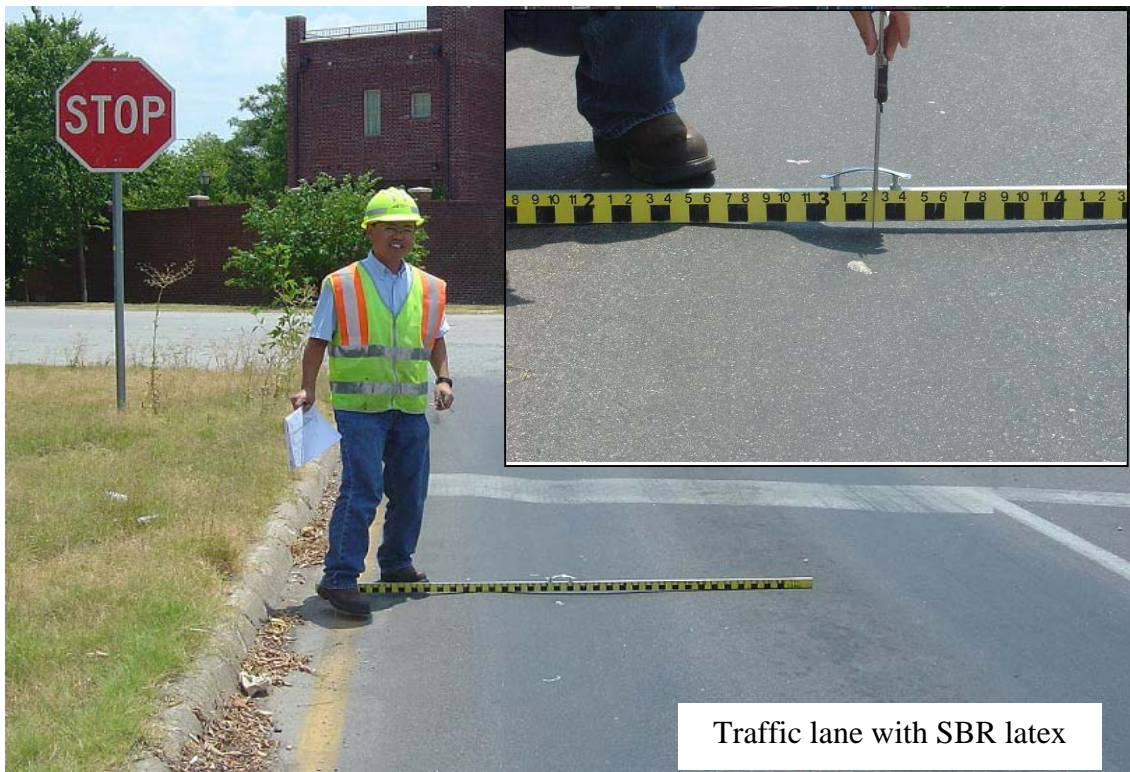
Figure 13. Observed Rut at the Stop Sign at Roaring Springs Road.

Some rutting did appear at a spot close to a traffic Stop sign where the traffic moves very slowly while decelerating and followed by a full stop at any Stop sign. It is well known that slow and stopped traffic can make the mix "soft" and consequently lead to rutting. Therefore, these 1 inch thick fine mixes may not be good for locations with slow and/or stopped traffic, thereby requiring more stiff mixes or thicker mats for these areas.

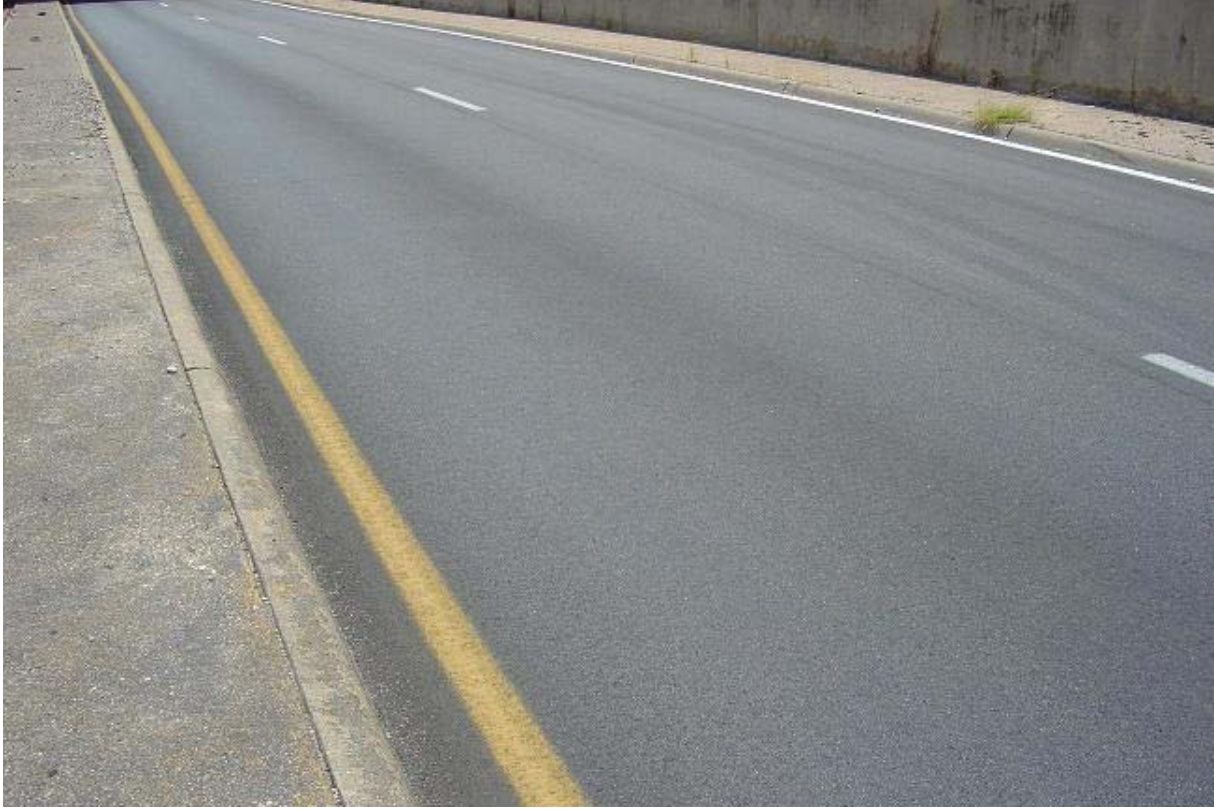
As shown in all four views of [Figure 14](#), the overall performance of this experimental test section is very good. Almost no transverse reflective cracking was observed anytime during the first year's performance.

(14d). No Transverse Reflective Cracking: A Closer Look
Figure 14. Field Observations of the Main Traffic Lanes.

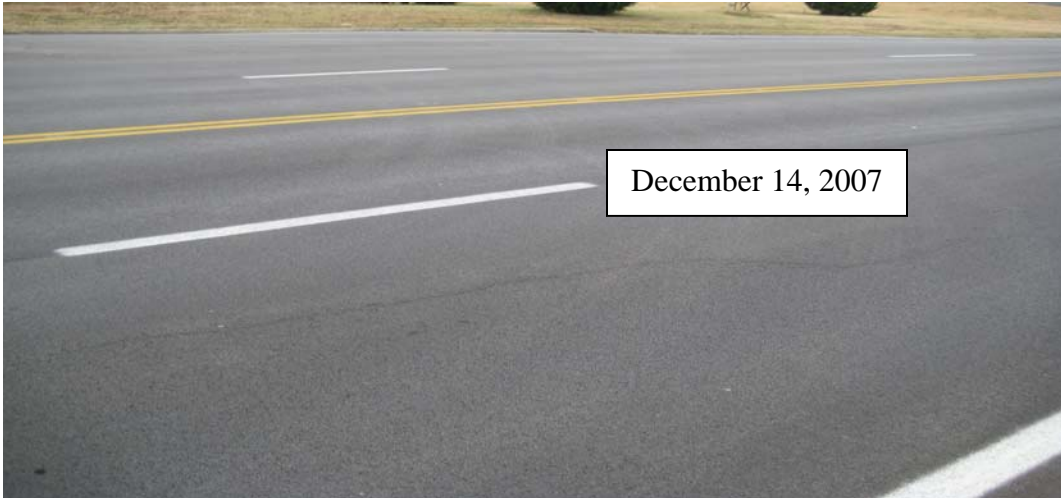
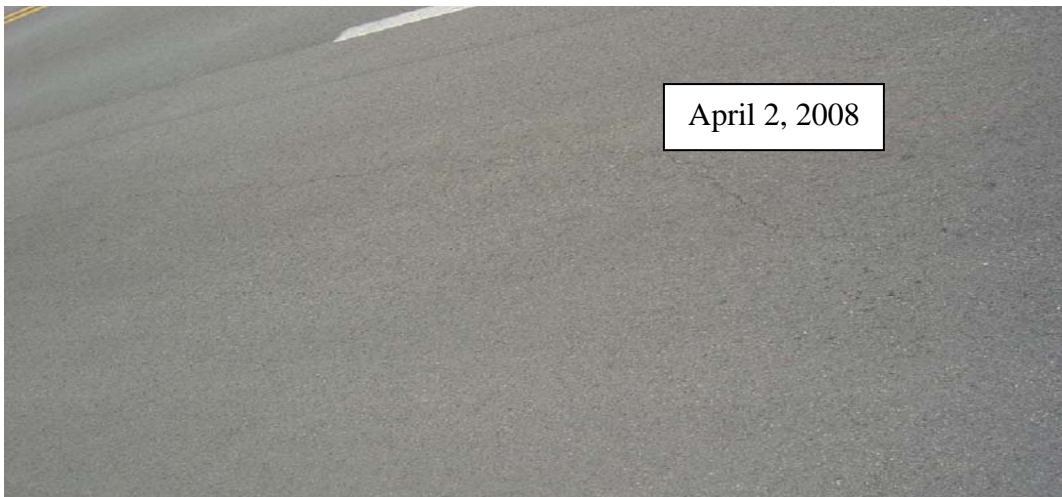
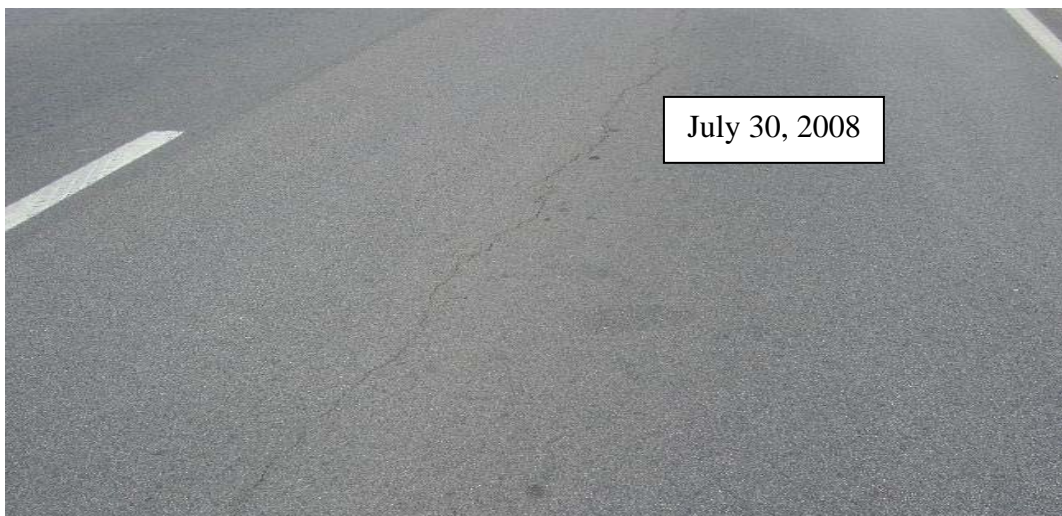
There was visual evidence of longitudinal cracking in the outside northbound lane in two locations of the section toward the Naval Air Base entrance as shown in [Figure 15](#). These two longitudinal cracks are considered to be caused by continual differential settlement of the foundation ([Figures 4 and 6](#)) which was also earlier observed on December 14, 2007. They still look the same as when observed the first time in July 2007 before the overlay placement.

Figure 15. Longitudinal Cracking Manifesting in the Outside Northbound Main Lane toward the Naval Air Base Entrance.

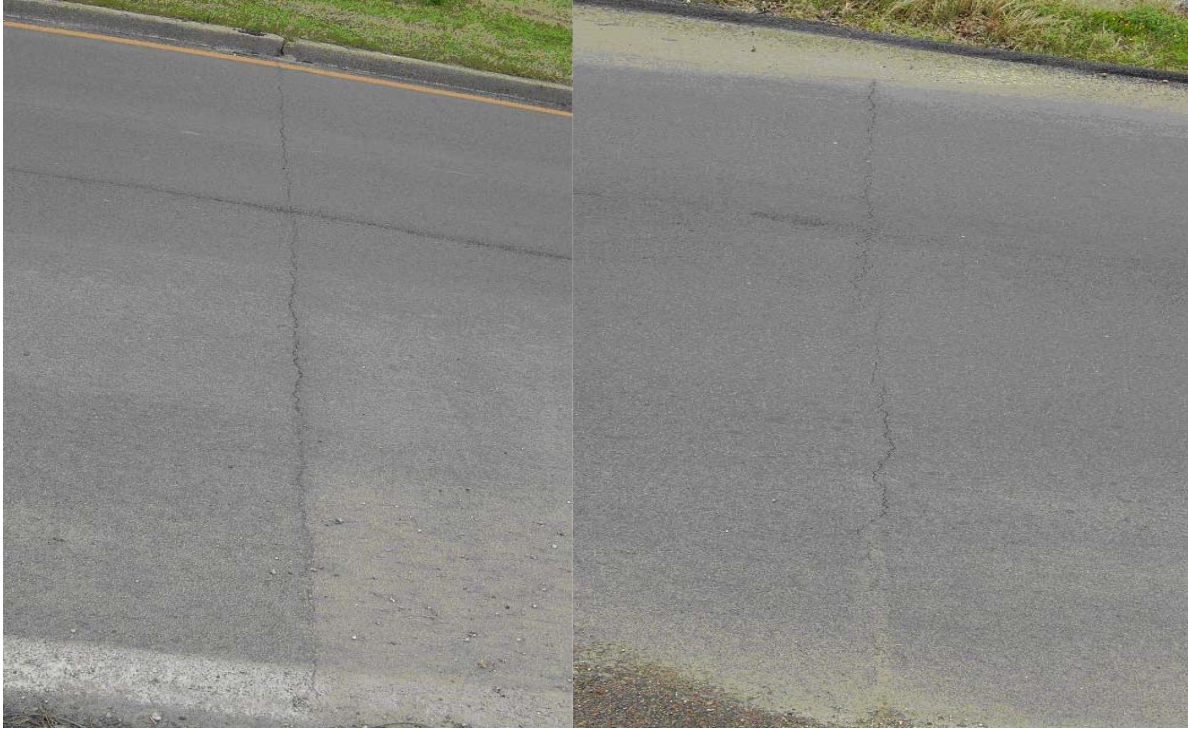
Transverse cracking reflecting through the thin overlay from the underlying jointed concrete pavement structure was the predominant surface distress that was visually observed on the ramps. [Figure 16](#) shows examples of typical transverse cracks that appeared on the ramps within the project mix overlay. Again, these transverse reflective cracks were observed during the first visit on December 14, 2007, and did not worsen when seen again during the visit on April 2, 2008. During the last visit on July 30, 2008, some of the reflected cracks were found to be healed. Engineering opinion as to the reasons were: 1) hot summer temperatures softening the asphalt binder, and 2) kneading under the traffic loading.

Figure 16. Examples of Transverse Reflective Cracking on Ramp R4.

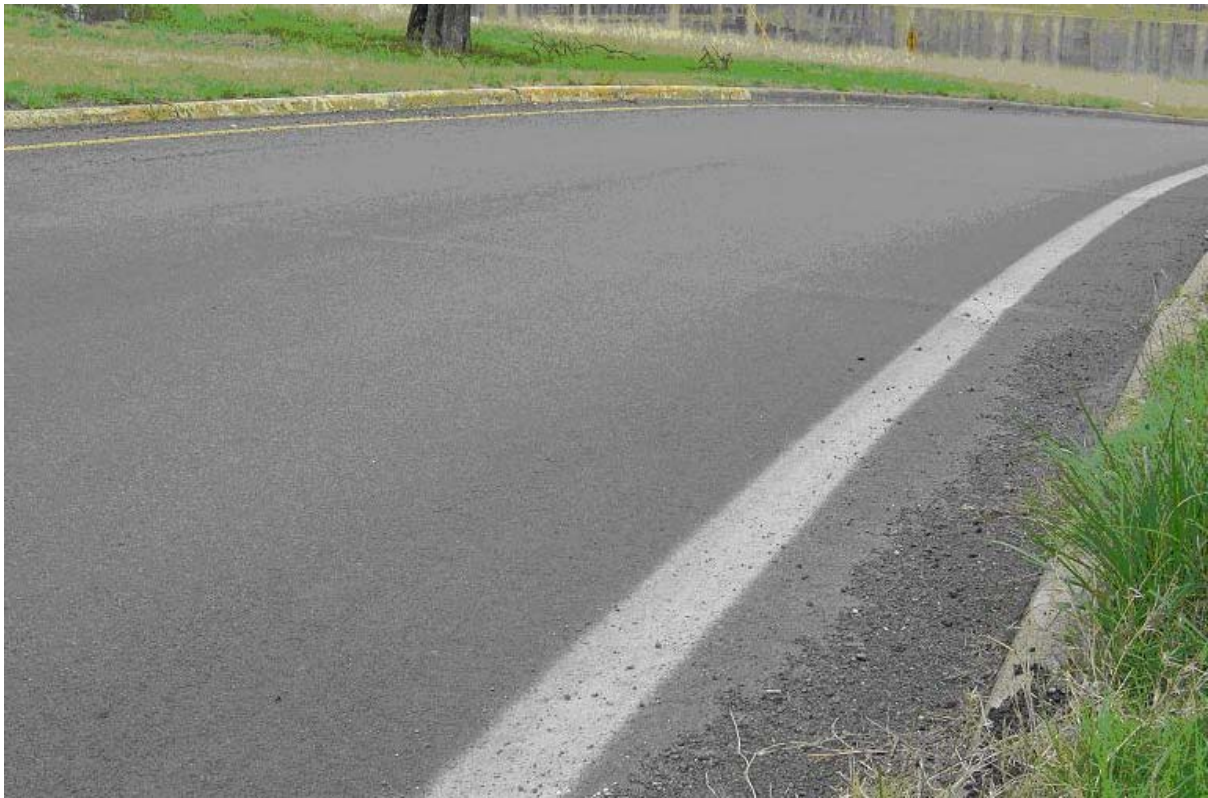
In addition to normal transverse cracking, bumps/humps transversely manifested during the initial compaction process along the underlying concrete joints on off-ramp R3 which was not tack coated at the time of the crumb rubber mix placement. In total, up to five regularly interspaced bump/humps, consistent with the concrete joints, were visually counted. These bumps/humps are considered to have been caused by the liquification and expansion of the crack sealant material at the time of the overlay placement. During placement, the laydown crew reported some compaction problems on this section citing expansion of the crack sealant under the hot-mix as the probable cause. Ramp R3 is the only section manifesting this problem. [Figure 17](#) shows an example of the bumps/humps on Ramp R3.

Figure 17. Example of Humps on Off-Ramp R3.
