**DESIGN, CONSTRUCTION, AND PERFORMANCE MONITORING OF
THE VERY THIN OVERLAY PLACED ON BUS 59 IN THE LUFKIN
DISTRICT**

Report 5-5598-01-2

Project Title: Implementation of Very Thin Overlay (<1 inch) in the Lufkin District

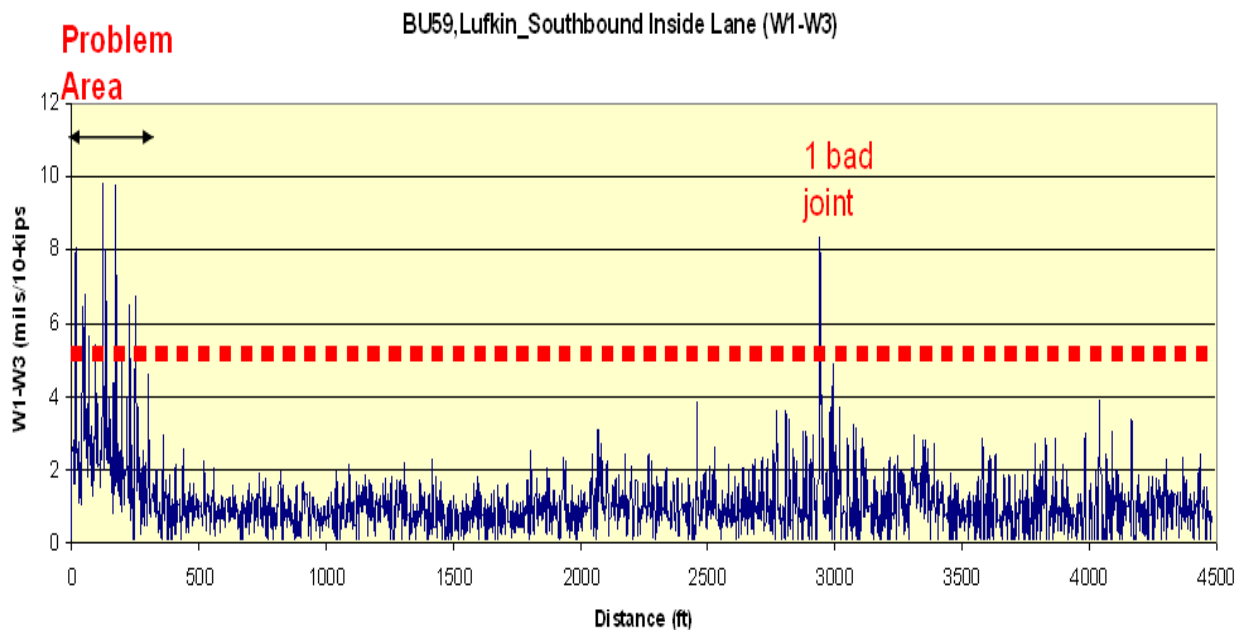
Figure 6. RDD Data (W1 – W3) for the CAM Project in Lufkin.

The data shown in Figure 5 are the difference in deflections between two sensors under the RDD. Sensor W1 is directly between the loading wheels and W3, which is 38 inches away. As the RDD rolls over a joint or crack the value of W1-W3 is an indication of the vertical movement or load transfer efficiency (LTE) of the joint. Studies have found that if this value is greater than 5 mils then there will be a potential for a reflection cracking problem with overlays placed over that joint (5). The red line in Figure 5 marks the 5 mils level. However, overall the load transfer efficiency for this highway looks good. There is one small area at the beginning of

the project about 250 ft long where the deflections are high, and there is one bad joint near 3000 ft from the beginning. The remainder of the section looks very good. This indicates that the section is a very good candidate for a thin overlay and that the design should be based on cracking caused by thermal movements of the underlying slabs. This is exactly the failure mode that is modeled in the Overlay Tester.

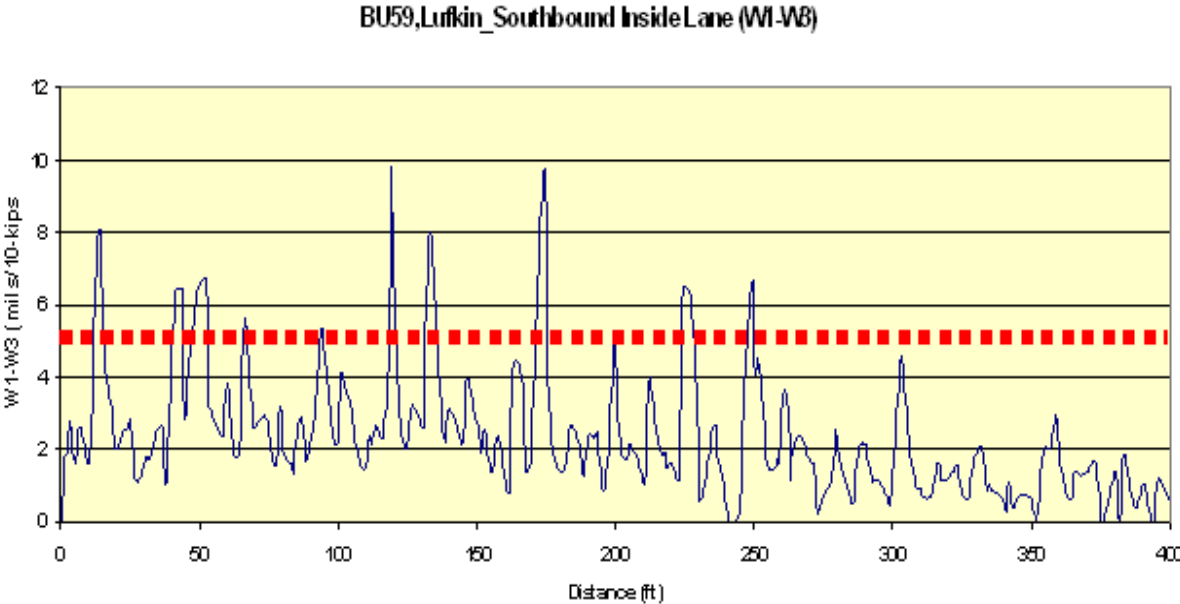
Figure 7. Problem Area Identified by the RDD on US 59.

The problem area at the start of this project is expanded below in [Figure 7](#). The large peaks in these data are recorded when the RDD runs over joints with poor load transfer. This plot shows that the eight problem joints are located in the first 250 ft of the project. It is anticipated that overlays placed over these joints would be prone to reflection cracking because of the high vertical movement occurring at these joints.

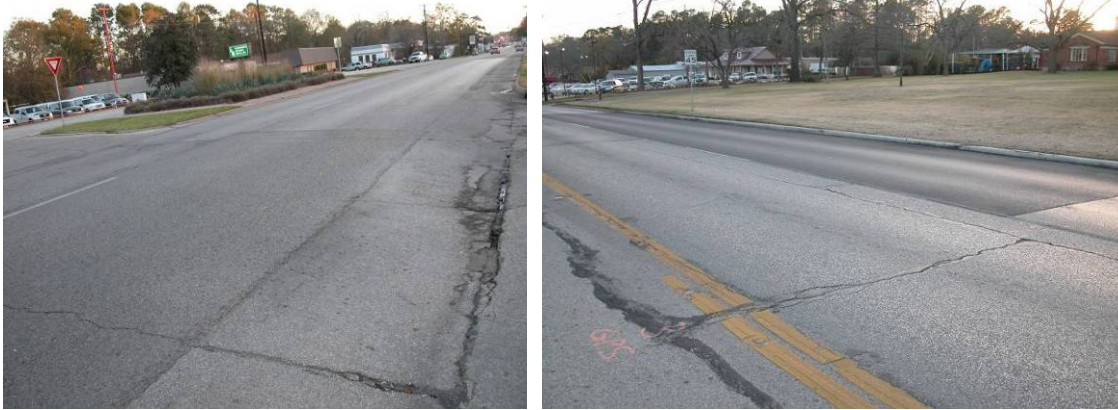
Figure 8. Location of Poor LTE on US 59 Prior to CAM Placement.

The problem area is shown in [Figure 8](#). At this location it was proposed that the contractor perform joint repair before the placement of the CAM mix. The areas requiring repair were identified before the project was let and incorporated into the plan sheets for this project. In subsequent discussions with TxDOT personnel not all of these joints were treated prior to placing the thin overlay.

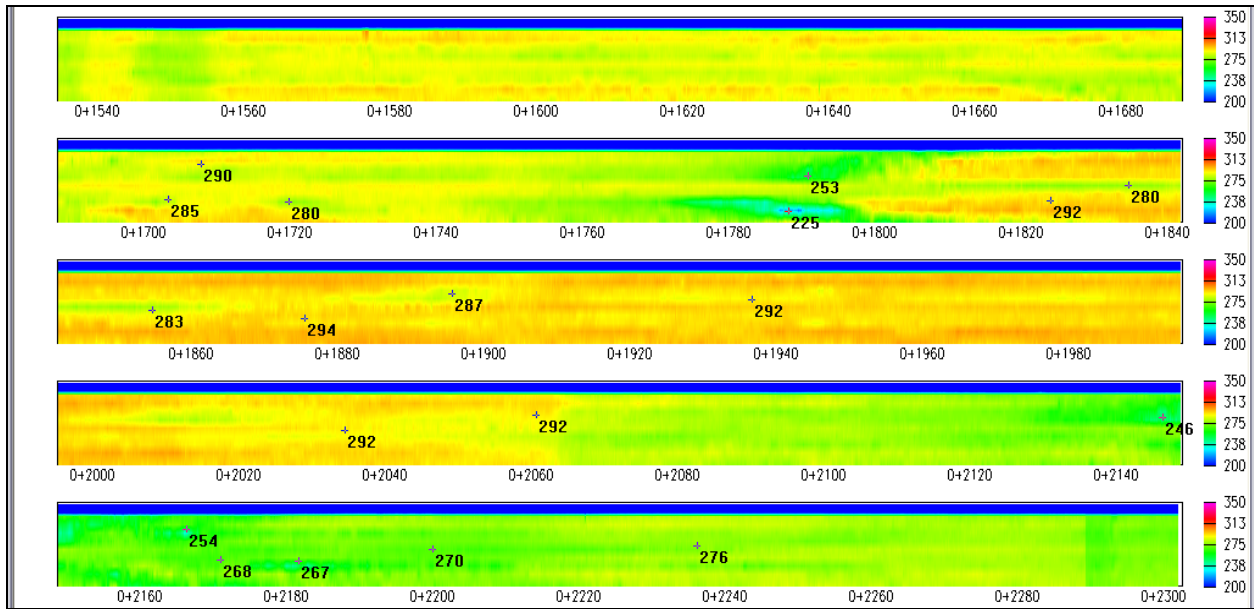
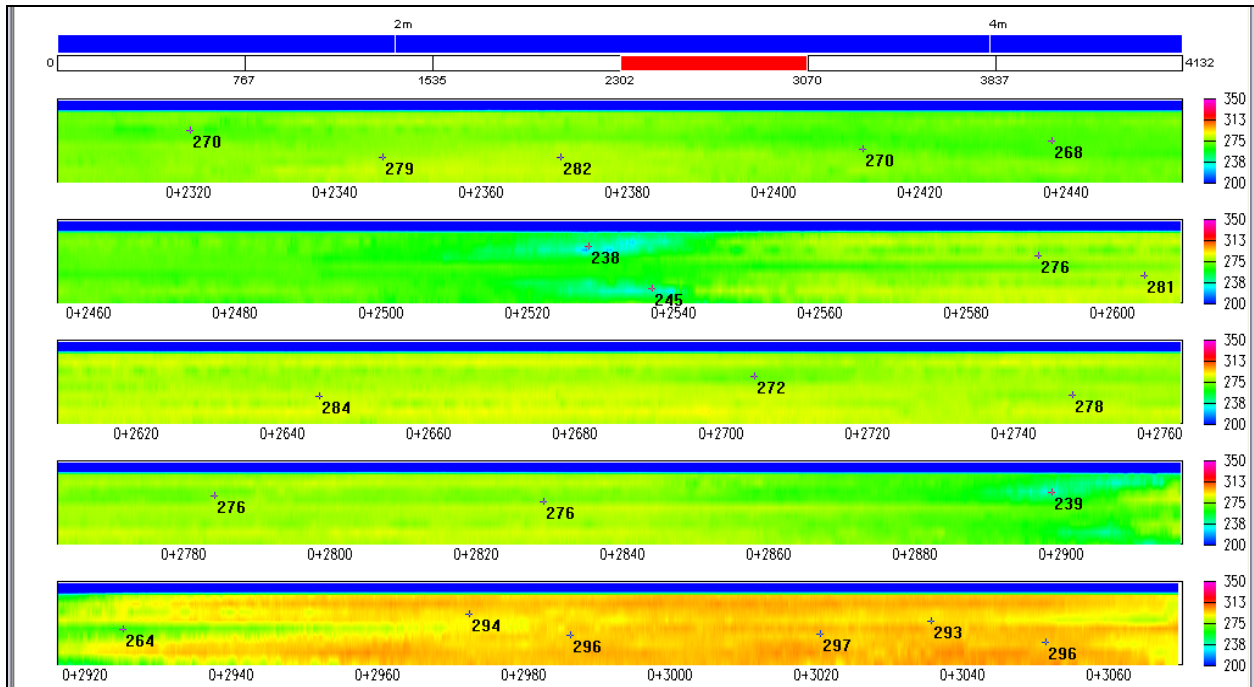
Figure 12. Thermal Profile at Start of US 75 Paving on 12-3-08.

[Figure 12](#) shows excerpts from the thermal profile of the turning lane. The profiles show good uniformity within truckloads. The temperature anomalies that occur are due to truck ends, with thermal differentials between 30 and 60 °F, and changes in the arrival temperature of trucks, which tended to result in mean placement temperatures of individual truckloads varying between approximately 275 and 300 °F. The cold location shown by sensor 1 in the thermal profile resulted because that sensor was off the mat.

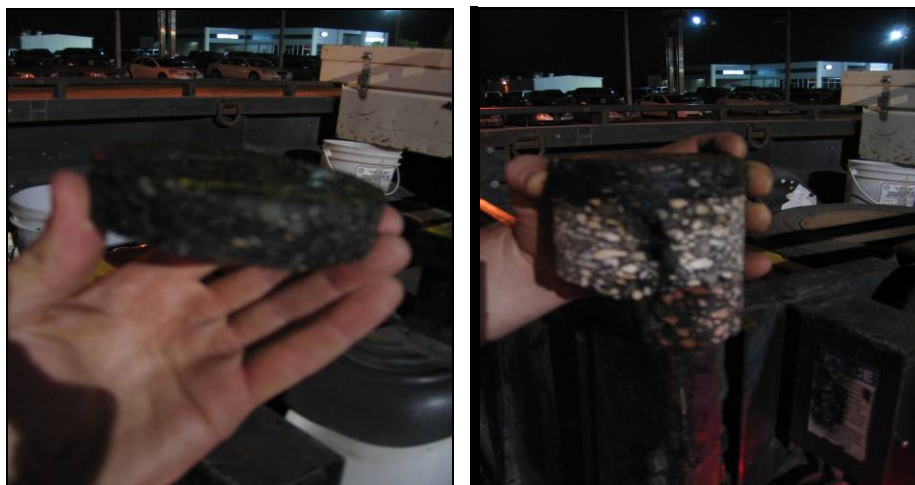
Figure 16. CAM Cores 1 (Left) and 2 (Right).

During TTI's visit the contractor obtained density results for two cores. These core densities were 93.6 and 91.8 percent. [Figure 16](#) shows the cores.

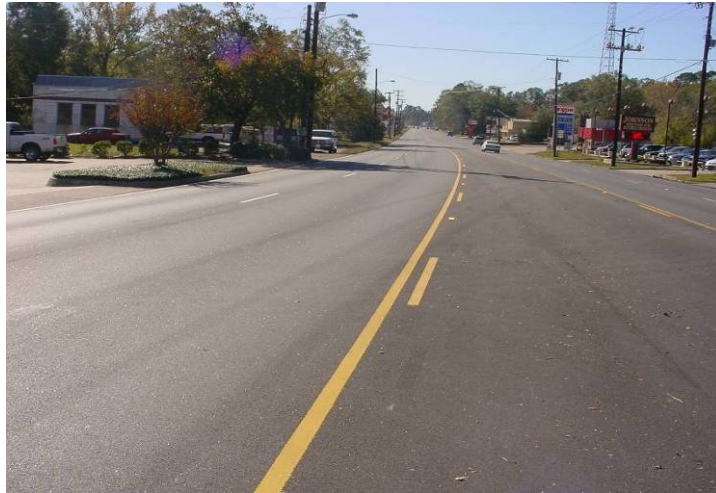
Figure 17. CAM Mix on US 59 Three Months after Placement.

Several inspections were made on this project; after three months in service a visual inspection and skid data were collected on this project. A photo of the CAM mix is shown in [Figure 17](#).

No performance problems were reported and no reflection cracks were found during this inspection. TxDOT also performed skid testing on this section, and the results are shown in [Figure 18](#) as the blue line. This is with a bald tire locked wheel trailer traveling at 40 mph. The average value is reasonable at 23.5, but this section does have some low values with three values below 20. There are no standards for acceptable skid numbers but values for new pavements are normally above 20. These measurements were repeated after one year, and the results are shown as the pink line in [Figure 18](#). The skid values continue to drop and the average value is now less than 20. The CAM mix is not flushing, the surface has a dense finish with very low macro-texture, and there is no explanation for these low skid numbers at this time.

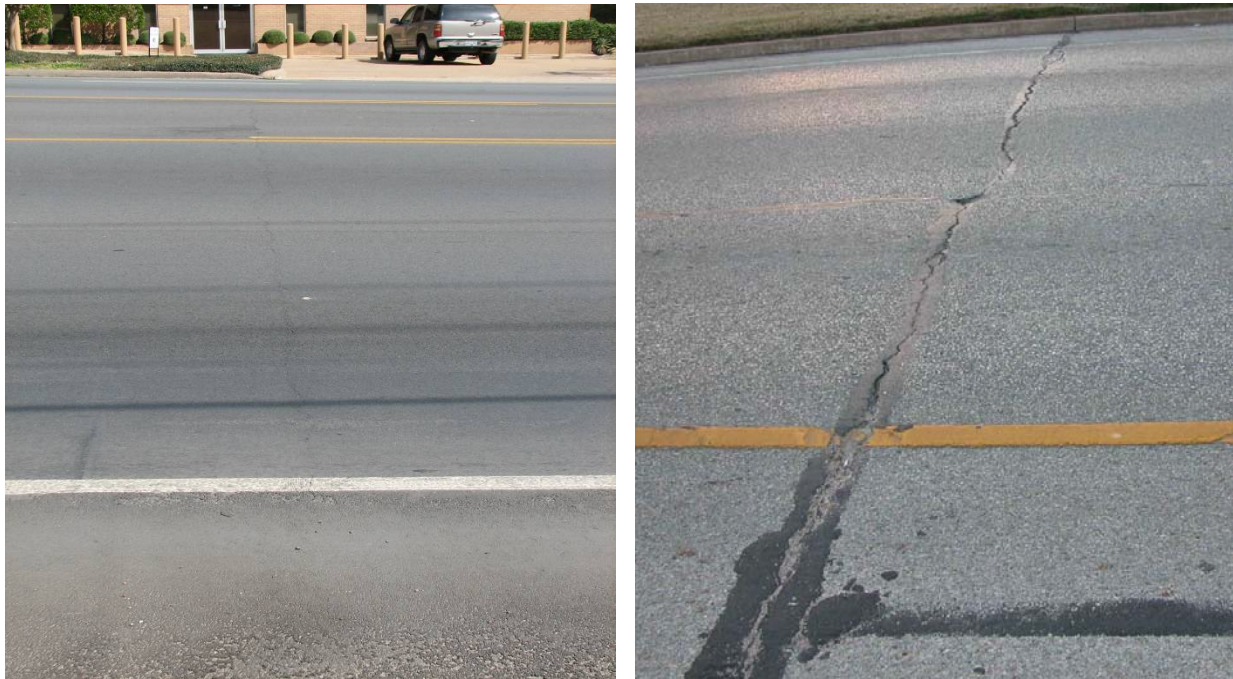
In a re-inspection a few very fine reflection cracks were found after one year in service. These are primarily at the beginning of the project where the RDD indicated load transfer problems. [Figure 19](#) shows an example of these cracks.

Figure 19. Low Severity Reflection Cracking after 1 Year – Original Condition on Right.

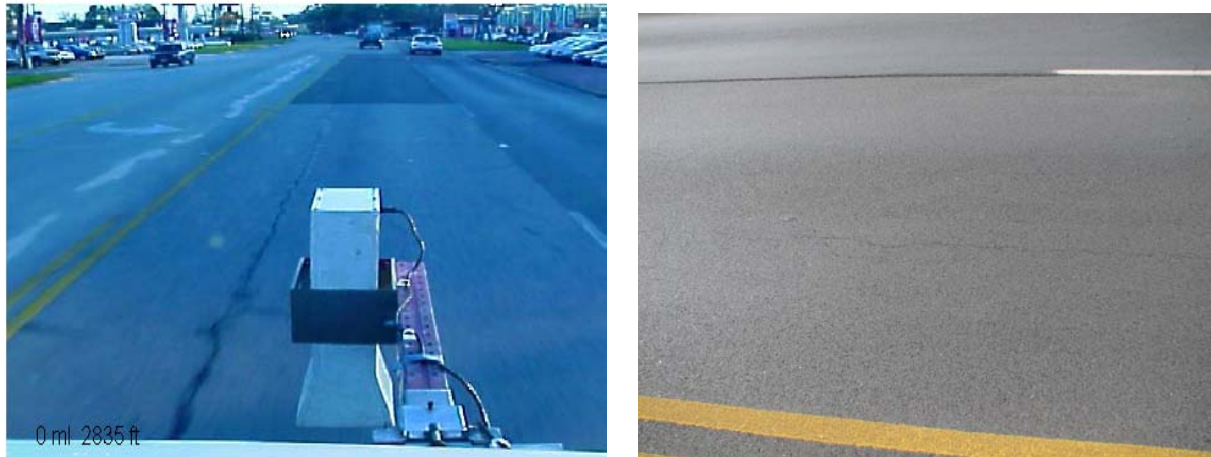
A short section of low severity longitudinal cracking (about 60 ft long) is also apparent in the inside lane in the south bound direct. The before and after photos of this are shown below in [Figure 20](#). At this location there is a longitudinal joint directly in the wheel path.

Figure 20. Before and After Photos of an Area Showing Fine Longitudinal Cracking.

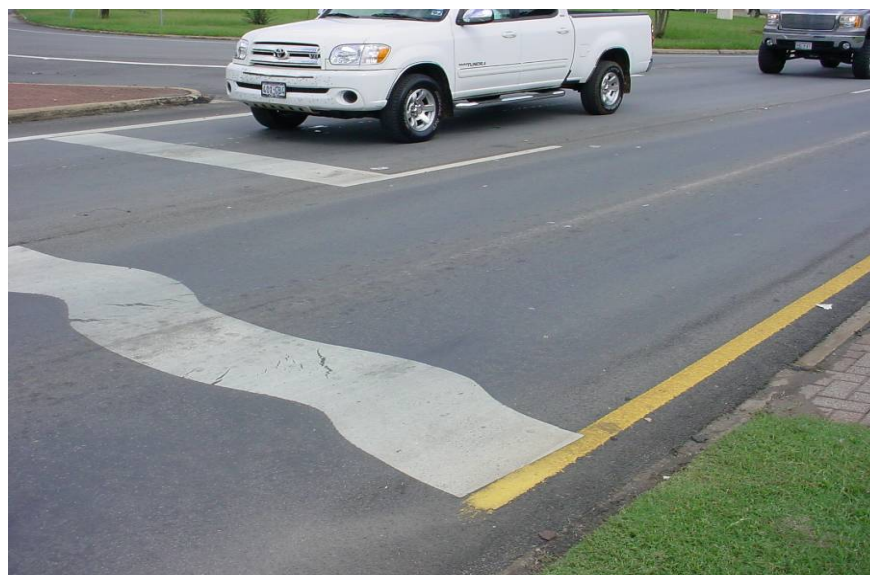
TTI was not present during the final day of paving on this project. But temperature problems were reported by Mr. Kip Smith from the Lufkin lab. These were related to mechanical problems with the breakdown roller. The mix was placed at the correct temperature but no compaction was performed for more than 1 hour. This 1000-ft section was replaced.

No areas of mix instability reported except for the location shown in [Figure 21](#). There are two major sets of lights on this project and one stop sign. In one lane there is evidence of pushing of the mix. In [Figure 21](#) the outside lane is fine but the inside lane has problems. This was discussed with TxDOT inspectors and this was the very first placement of the CAM material. After this stop sign there is a major 90 degree turn to the left. The inspector said the turn was too tight for the paver and that this area was basically too cold to be adequately compacted.

Figure 21. Mix Instability at One Stop Sign Associated with Construction Problems.
