IMPLEMENTATION OF TRANSVERSE VARIABLE ASPHALT RATE SEAL COAT PRACTICES IN TEXAS

Report 5-5833-01-1
Project 5-5833-01
Project Title: Statewide Implementation of TVAR Seal Coat Methods

TEXAS TRANSPORTATION INSTITUTE
The Texas A&M University System
College Station, Texas 77843-3135

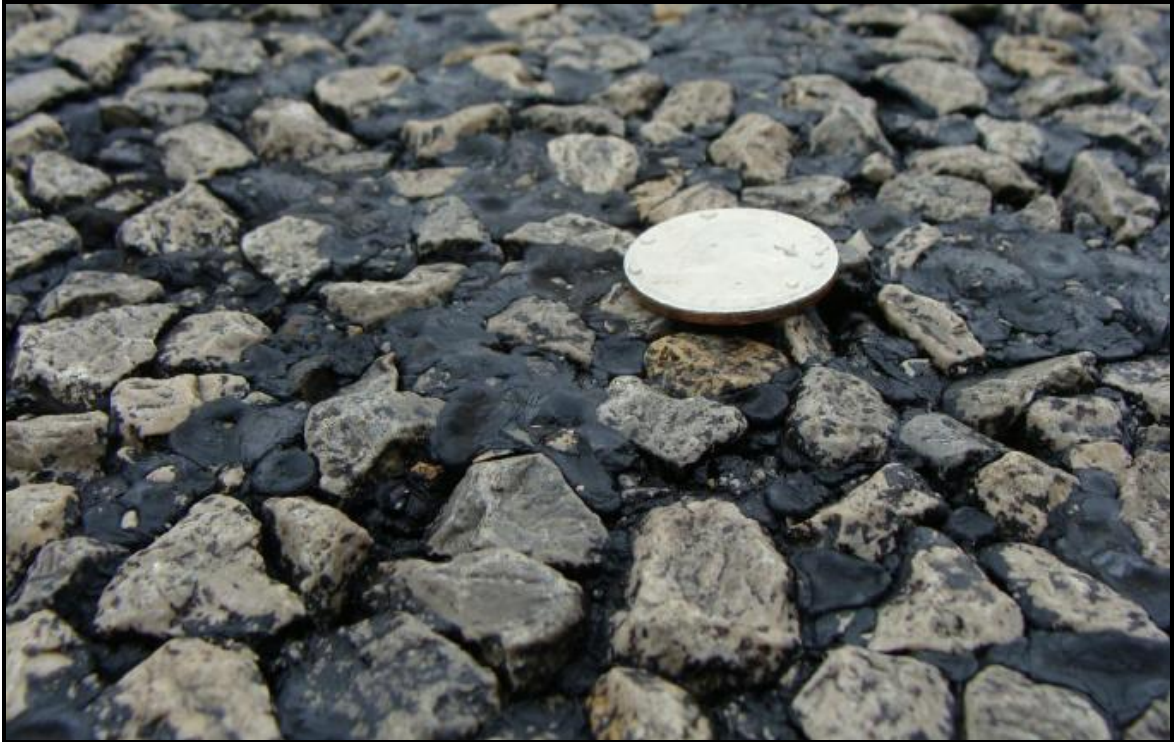
In 2009 and again in 2010, photographs of each location were taken similarly to the photography taken prior to placement of the seal coats in 2008. Photography included close-ups of pavement textures both in the outside wheel path and between the wheel paths. [Figures 7](#) and [8](#) are a pair of close-up photographs of the seal coat textures on US 283 in the Brownwood District after two years of traffic. Note the welling up of asphalt between the aggregates in the wheel path photograph.

Figure 7. Wheel Path Texture Close-up on US 283 Two Years after Seal Coat Placement.

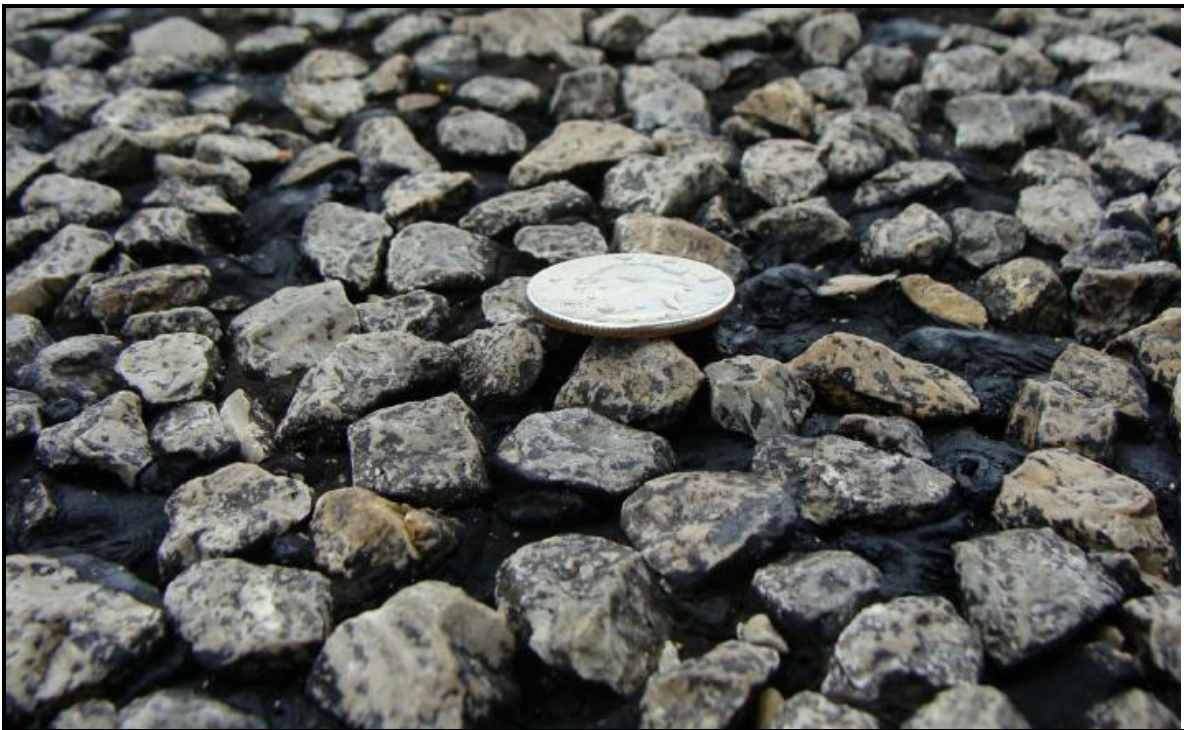
Figure 8. Between Wheel Path Texture Close-up on US 283 Two Years after Seal Coat Placement.

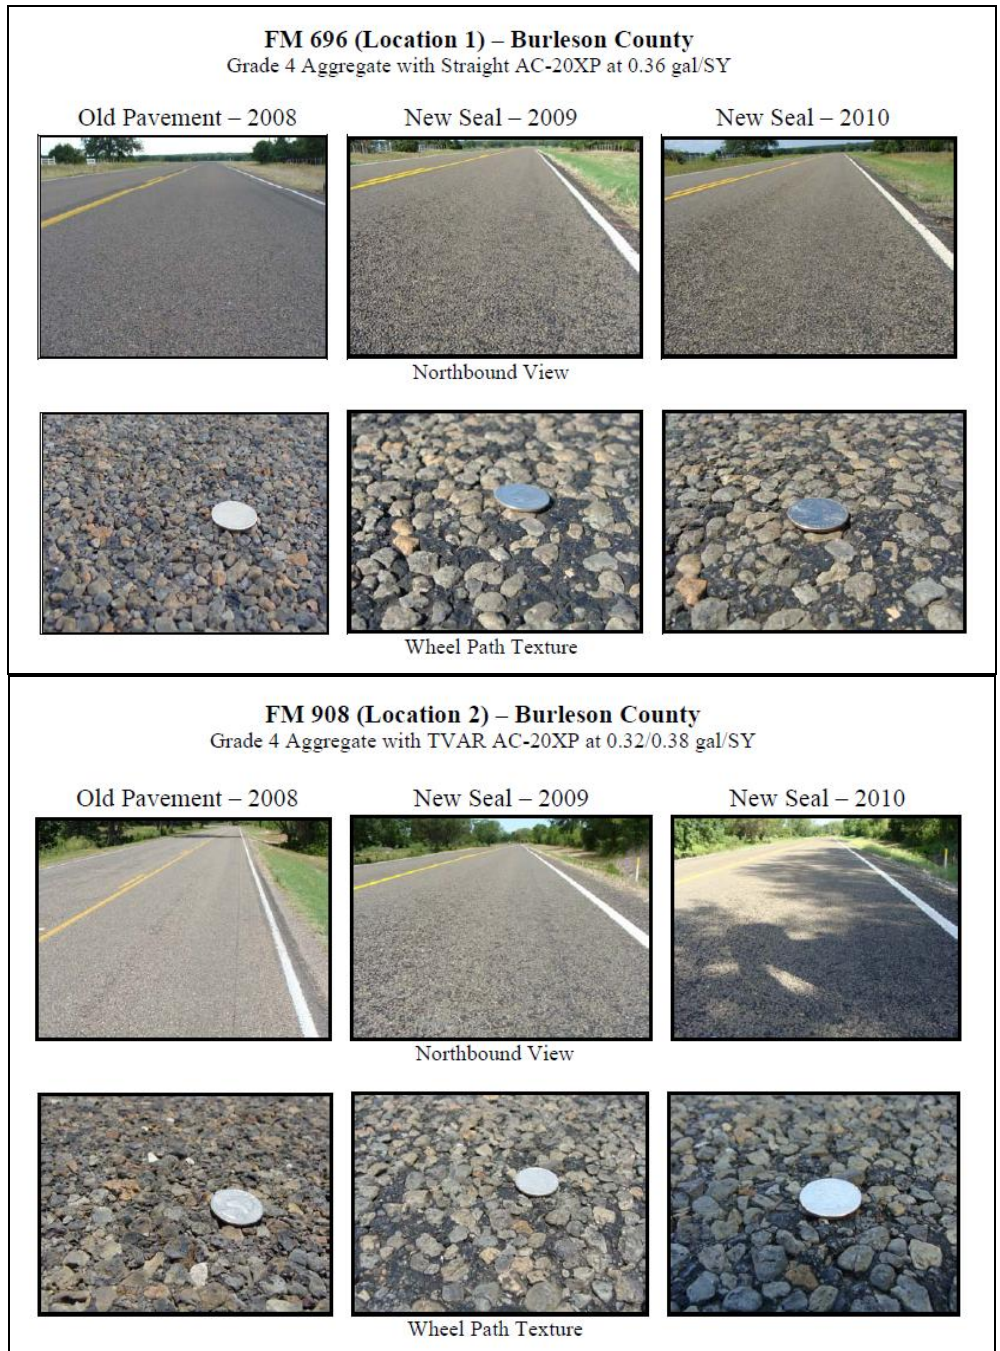
Several pairs of pavements merit individual comparison. The first is a pair of pavement locations in Burleson County. FM 696 and FM 908 are parallel north-south roads which carry similar traffic. FM 696 location 1 and FM 908 location 2 had both been sealed by maintenance the prior year with a fine Grade 4 seal coat. These maintenance seals were short in length, leaving the majority of these pavement surfaces to be sealed in 2008 in an aged condition. The appearance and texture depth test results in 2008 for these two test locations were virtually identical, as seen in [Table 11](#) and [Figure 16](#). However, since the textures of these two pavements otherwise differed, FM 908 location 2 received a TVAR seal coat, with asphalt rates at 0.32 and

Figure 16. Photographs of FM 908 and FM 696 Textures.

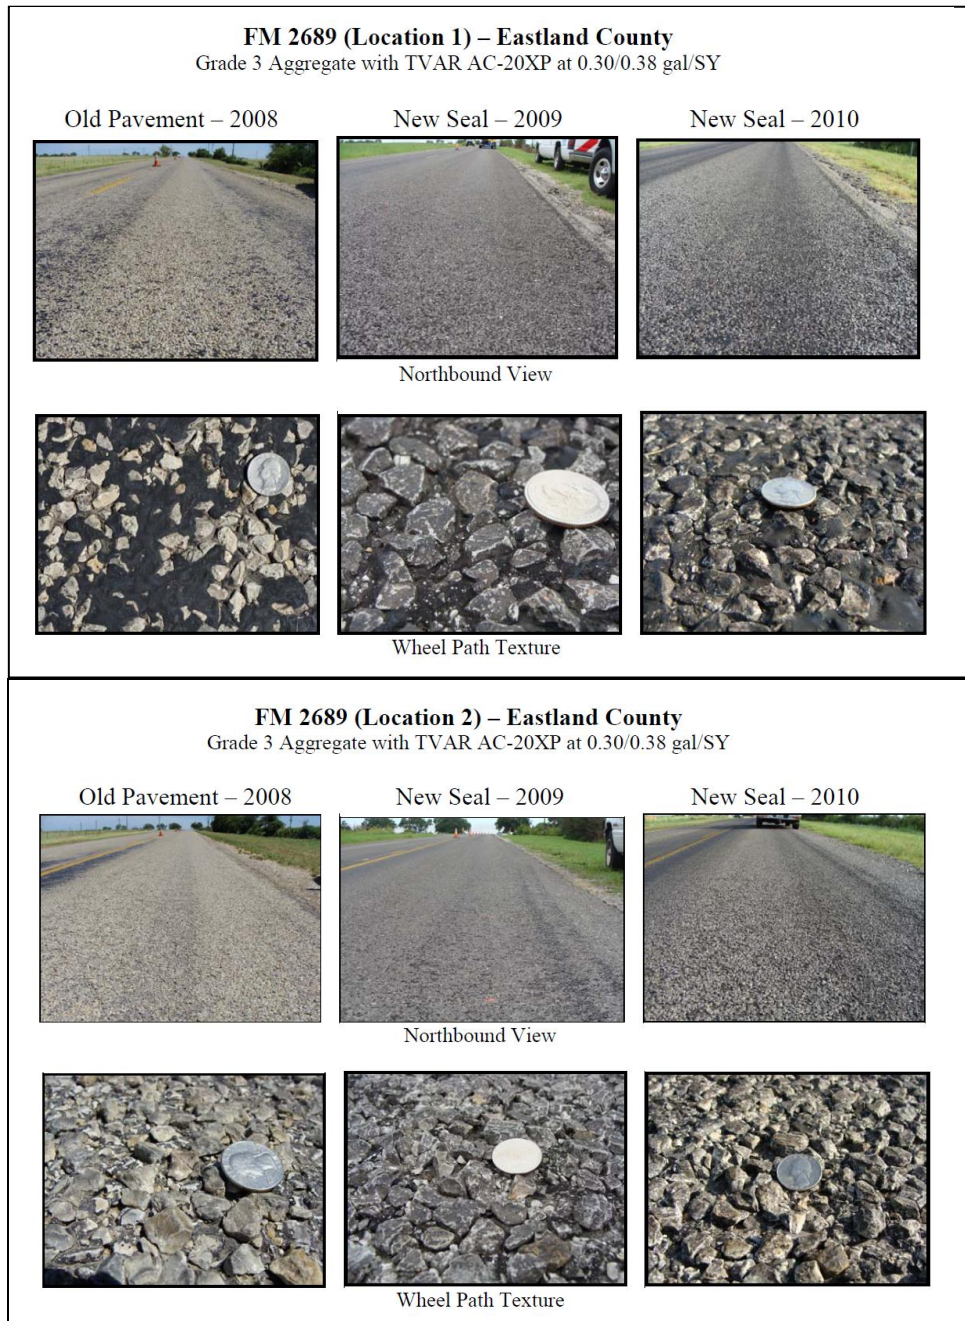
The second pair of pavement locations was on FM 2689 in Eastland County. They were located in the same lane, within approximately 600 ft of each other, and may be seen in [Figure 17](#). Yet, location 1 had limited pre-existing wheel path texture depth, 1.35 mm, compared to the pre-existing wheel path texture depth of 3.48 mm at location 2. These wheel path texture depths and those found after one year and two years of traffic are shown in [Table 12](#). Both locations received a TVAR seal coat, at asphalt application rates of 0.30 and 0.38 gal/SY, as the bulk of the pavement length called for a TVAR seal coat. Both locations have retained excellent textures over the two-year period of the study. Location 2, which did not require a TVAR method seal coat, has not lost aggregate from the wheel path even though a relatively low asphalt rate was applied.

Figure 17. Photographs of FM 2689 Textures.

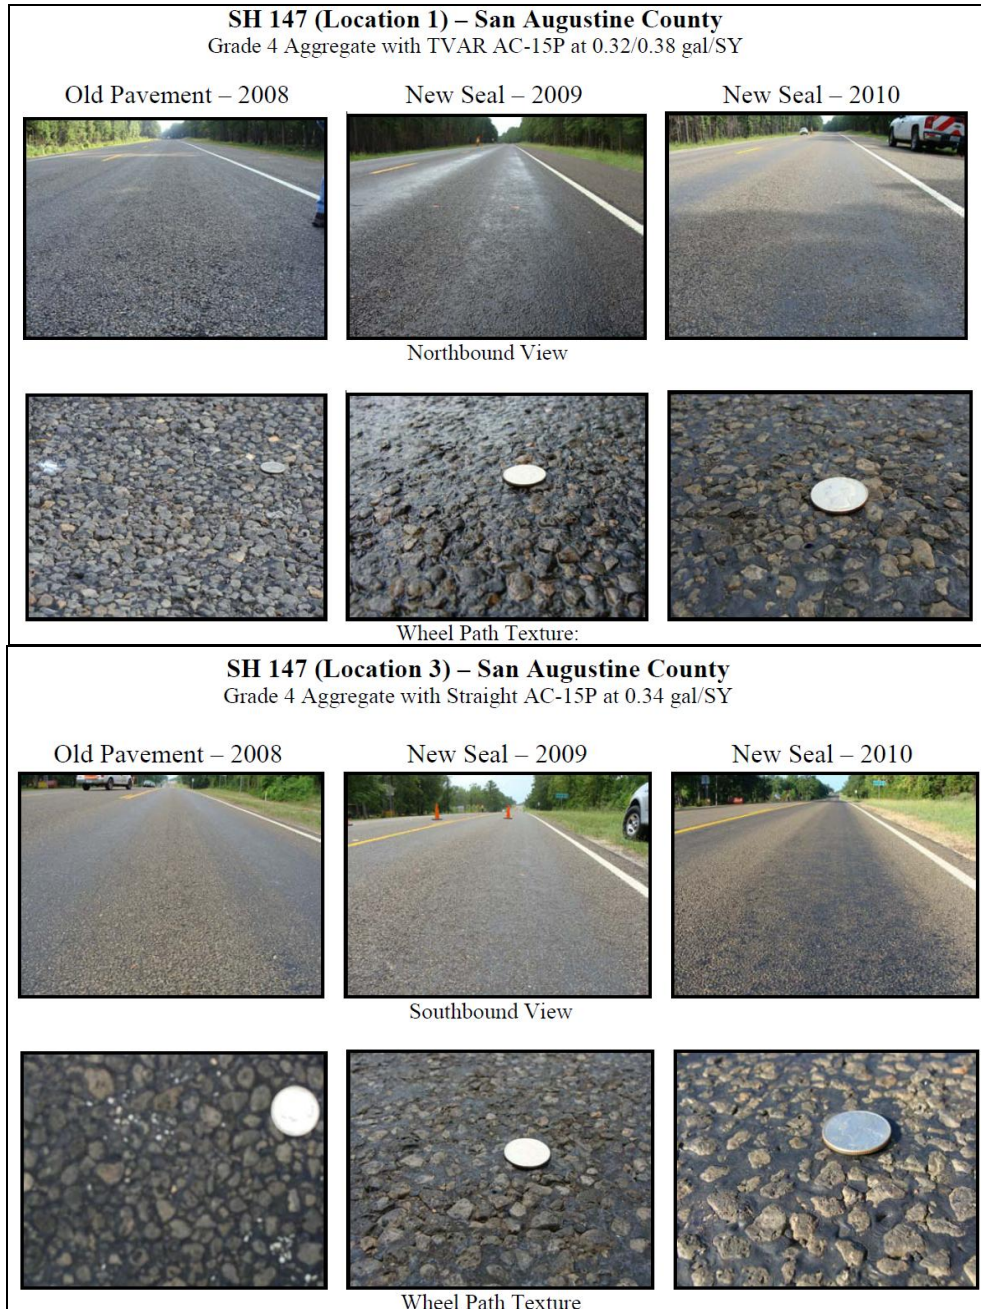
The third pair of locations is on SH 147 in San Augustine County. Location 1 is in the northbound lane and location 3 is in the southbound lane, approximately three miles apart. Because of predominantly differing texture conditions around these test locations, location 1 with reasonably good pre-existing wheel path textures received a TVAR seal coat at 0.32 and 0.38 gal/SY and location 3, which was a considerably flushed wheel path location, received a uniform asphalt application at 0.34 gal/SY. The visual appearances of these locations may be seen in [Figure 18](#), and [Table 13](#) contains pre-existing and post-seal coat wheel path texture depths. Location 3 has lost virtually all texture improvement provided by the new seal coat within two years of construction. Location 1 now has *less* wheel path texture than existed prior to seal coat construction two years prior, although the texture depth is superior to that in location 3. The appearance is that both of these locations still have an excess of asphalt at the surface and both would have benefited from a lesser asphalt application in the wheel paths provided that the lesser asphalt amount would have held the aggregate over the first winter.

Figure 18. Photographs of SH 147 Textures.

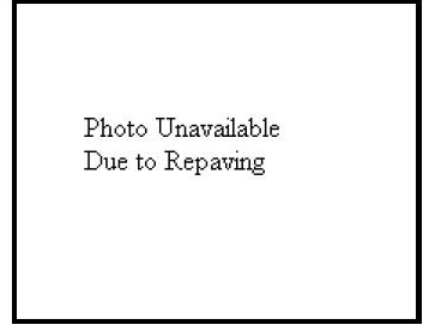
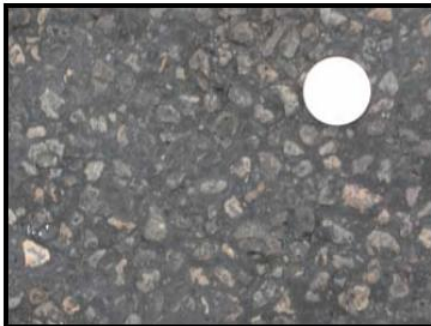
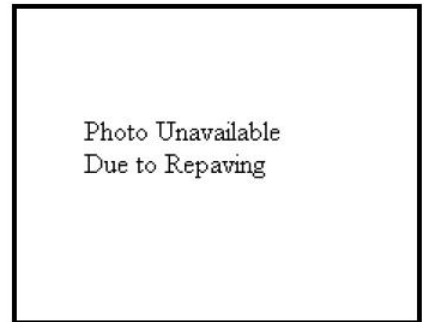
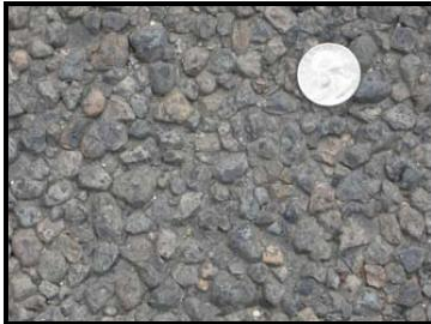
FM 819 (SB) – Angelina County
Grade 4 Aggregate with AC-20-5TR

Sand Patch Mean Texture Depth, mm			
	Old Pavement in 2008	New Seal in 2009	New Seal in 2010
Wheel Path	1.19	Data Unavailable Due to Repaving	
Between WP	1.97		
Difference	0.78
