1. Report No. FHWA/TX-12/5-9043-01-1		2. Government Accession No.		3. Recipient's Catalog No.	
4. Title and Subtitle HEATWURX PATCHING AT TWO LOCATIONS IN SAN ANTONIO				5. Report Date March 2012 Published: June 2012

HEATWURX PATCHING AT TWO LOCATIONS IN SAN ANTONIO

Project 5-9043-01
Report 5-9043-01-1
Project Title: Evaluation of Asphalt Pavement Patching Using Infrared Heat

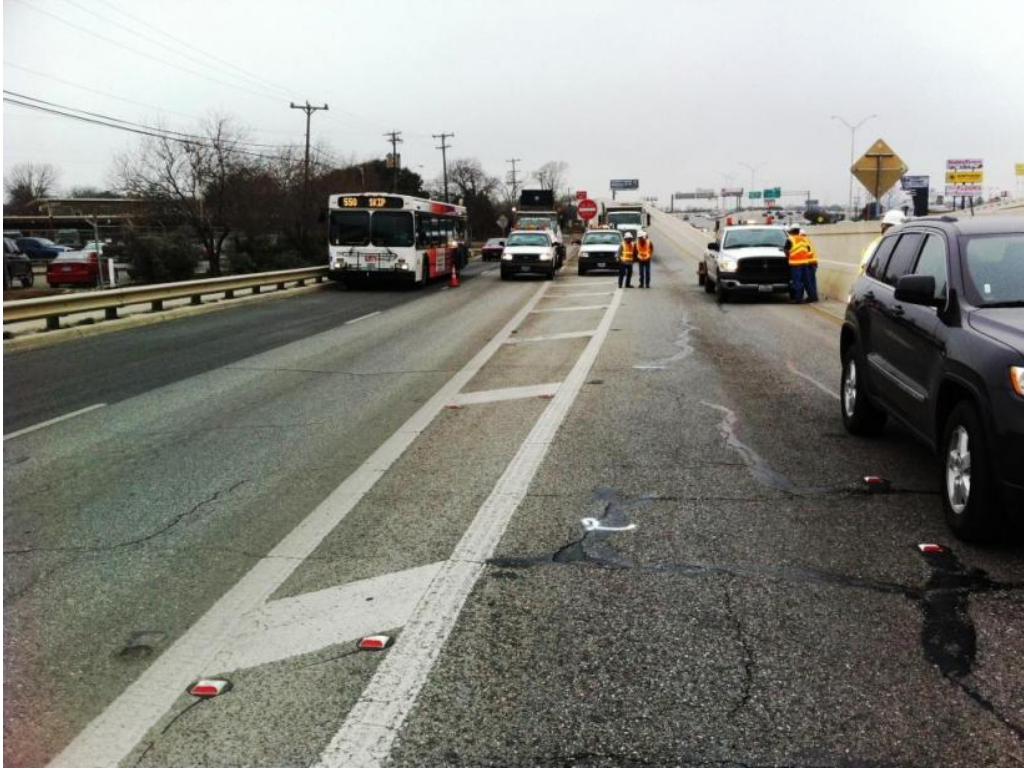
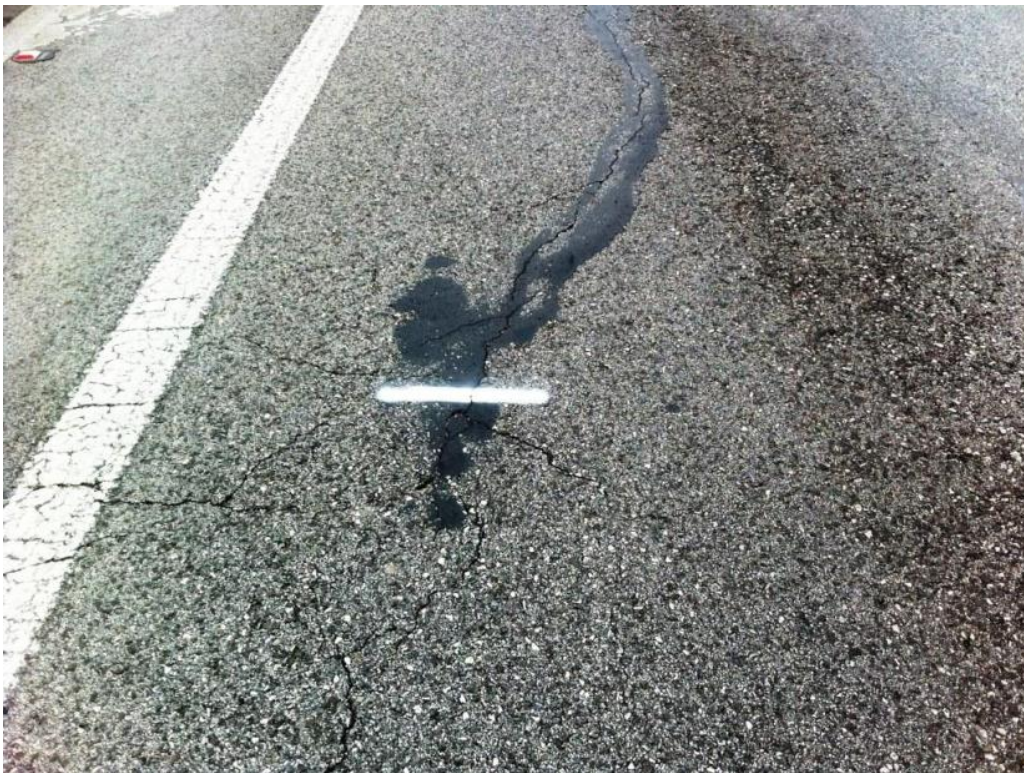
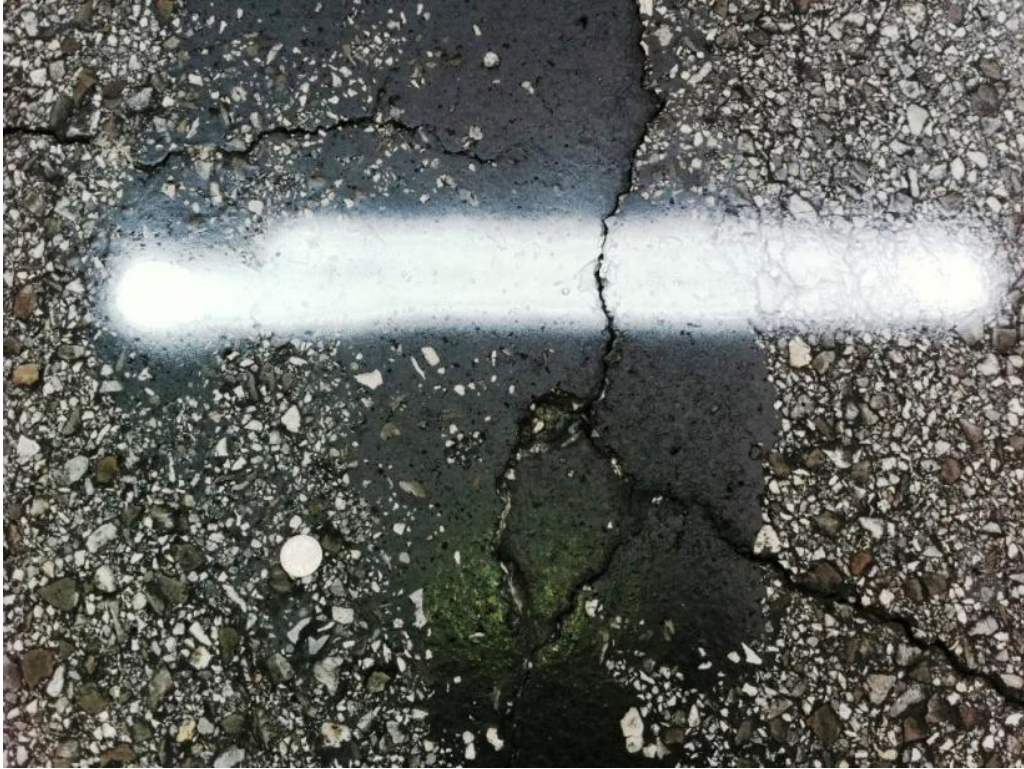
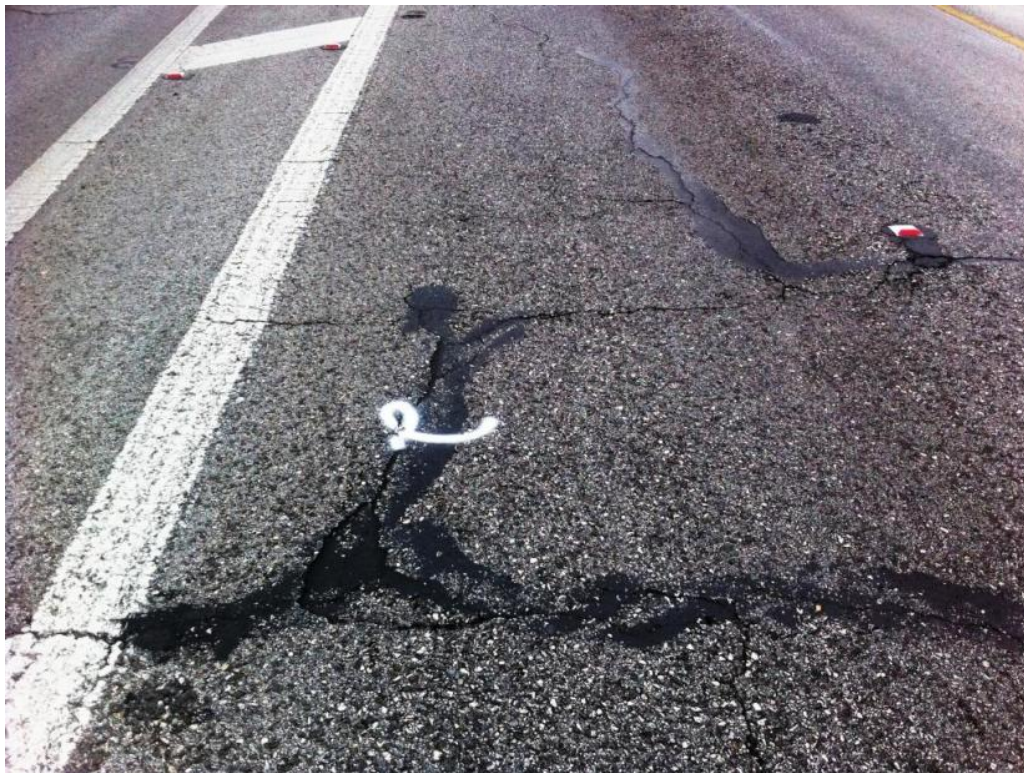
This site had block cracking and raveling. Cracks were as wide as 0.5 inches and the raveling was extensive and severe (see [Figures 24 through 27](#)). Deterioration of the cracks resulted in considerable roughness. This site has lower volumes of high speed traffic as compared to IH410Fr-2, which has higher volumes of slower traffic near an intersection. Two patches were placed at this site.

Figure 24. General Location of IH410Fr-1.

Figure 25. Location of Patch 1 on Site IH410Fr-1.

Figure 26. Close-up of Location of Patch 1 on IH410Fr-1.

Figure 27. Location of Patch 2 on IH410Fr-1.

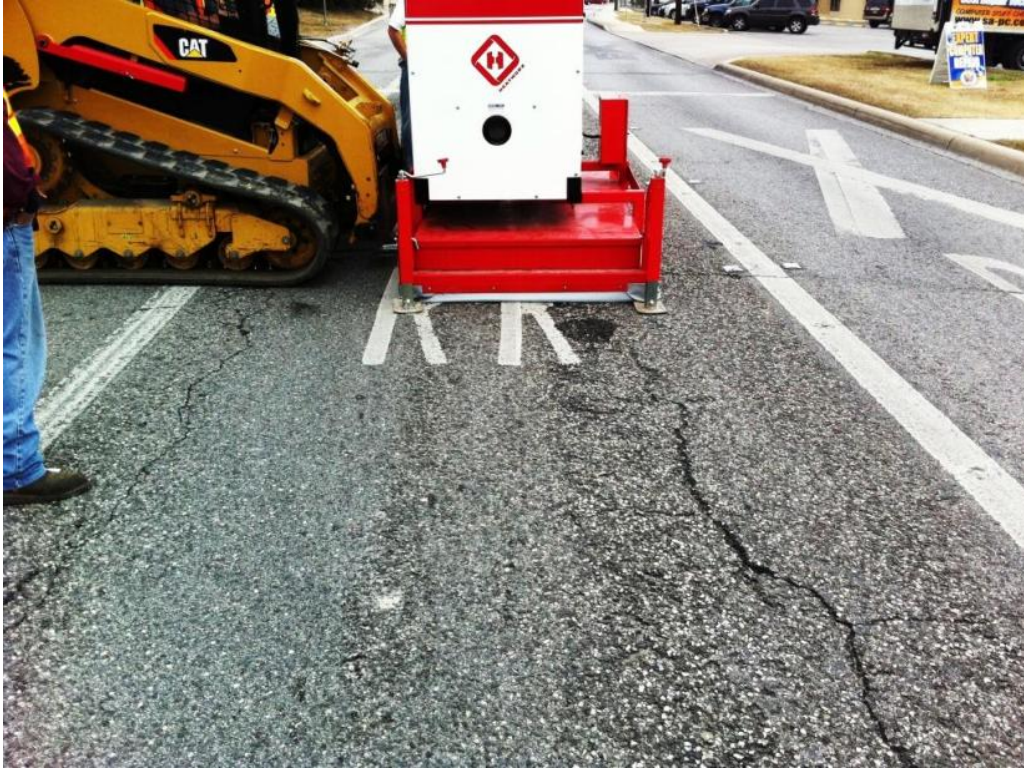
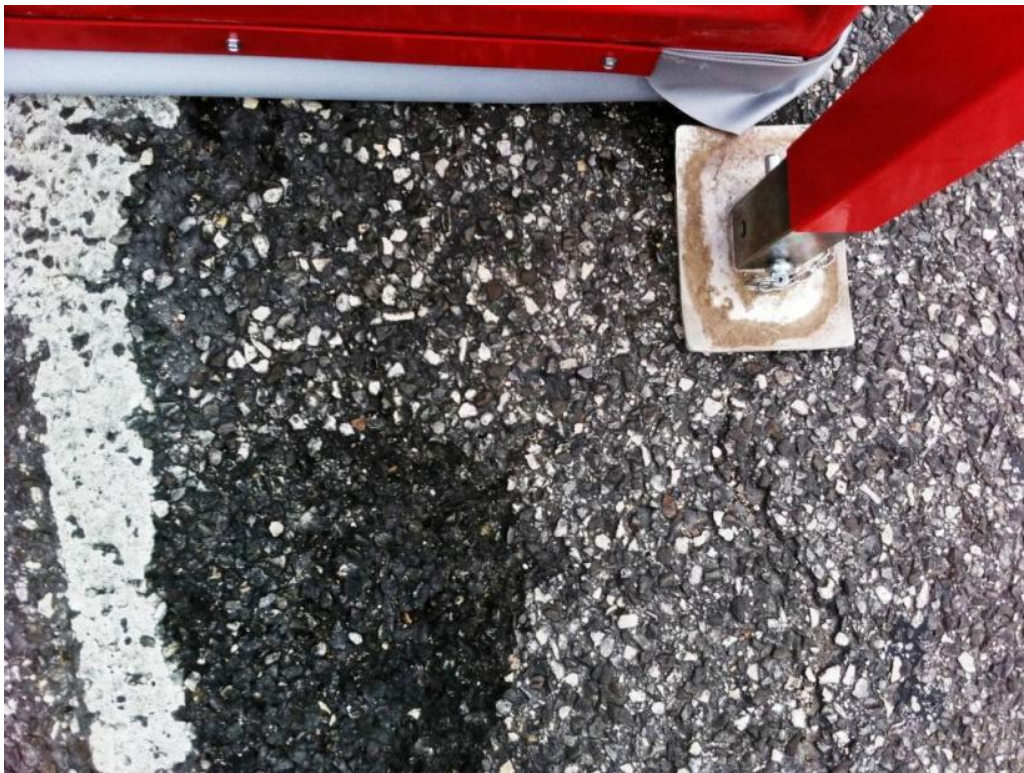
This site had less cracking, but more raveling than Site 1 (see [Figures 28 and 29](#)). Existing cracks were raveled and widened. Six patches were placed at this site.

Figure 28. Location of Patch 4 on IH410Fr-2.

Figure 29. Close-up of Location of Patch 4 on IH410Fr-2.

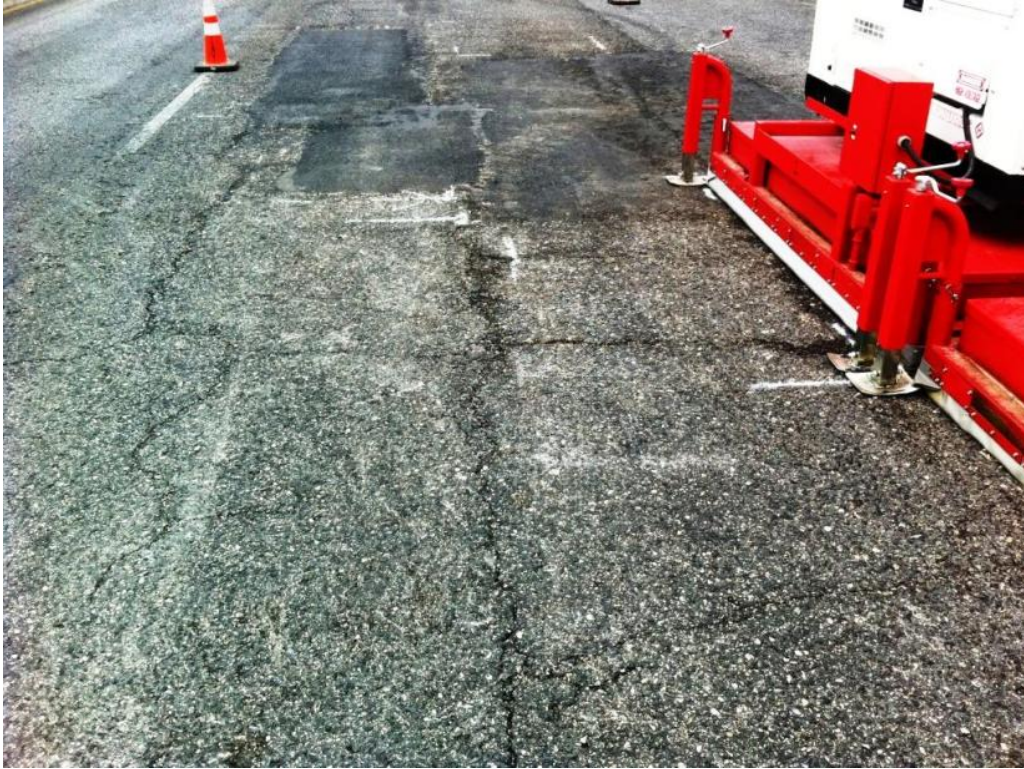
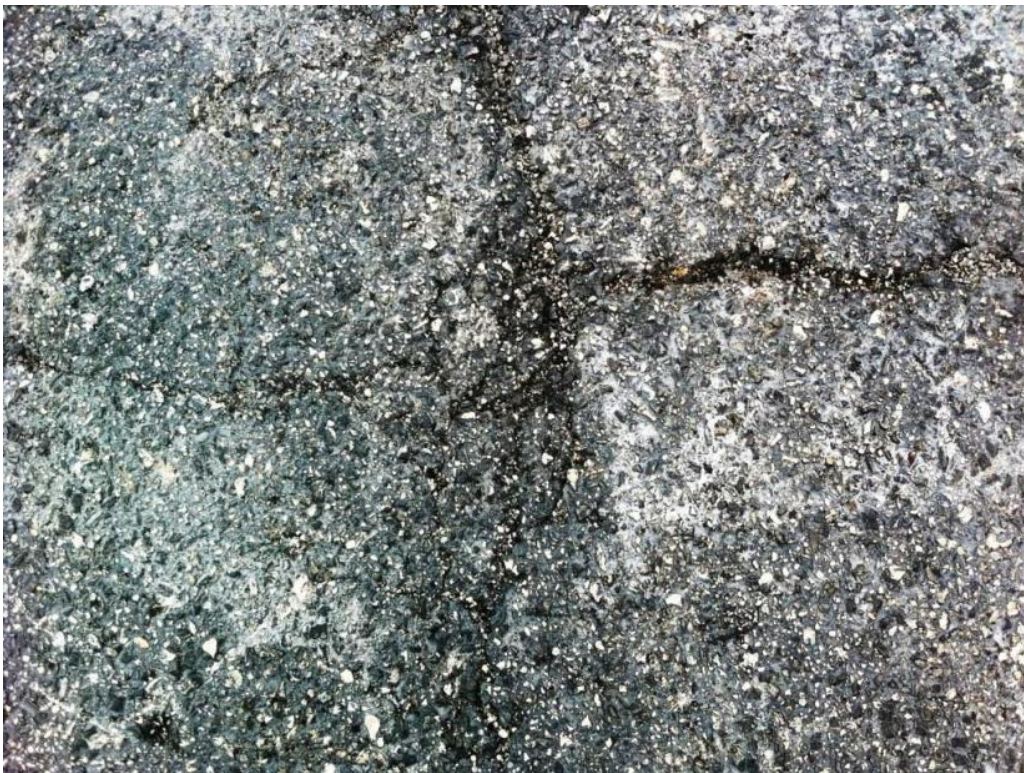
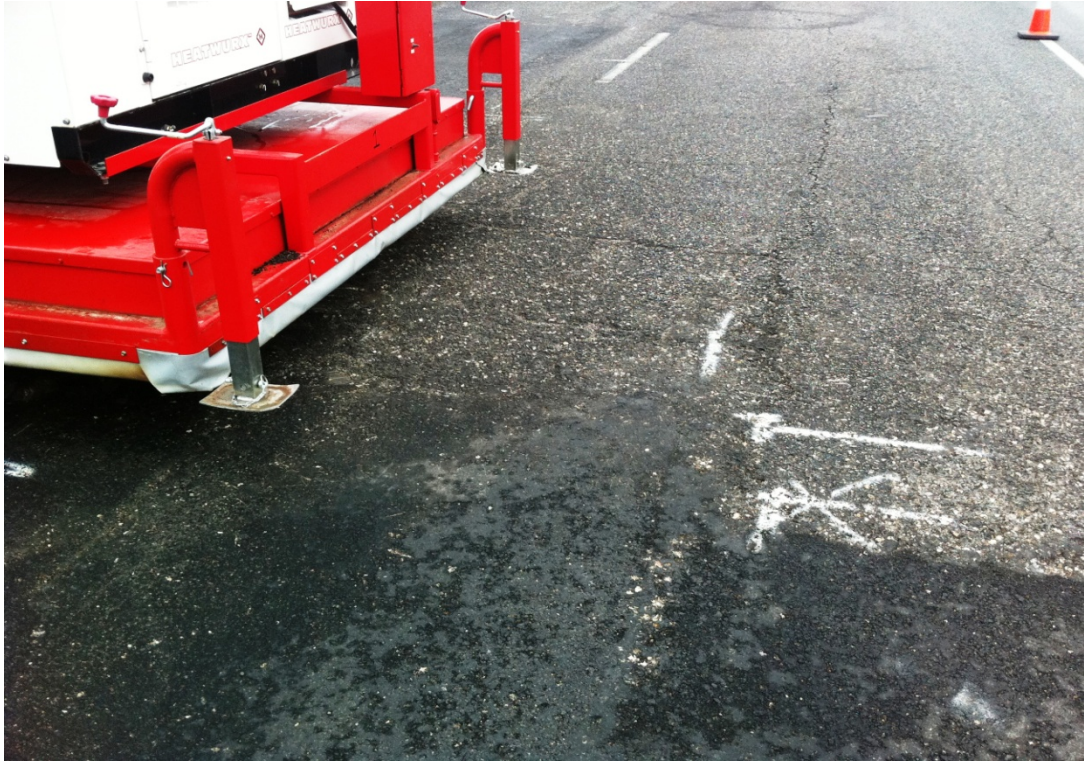
This site had block cracking and raveling (see [Figures 30 through 32](#)). Some of the cracks had begun to deteriorate, resulting in considerable roughness. Seventy-five patches were placed at this site.

Figure 30. Location of Patch 2/14-8 on IH10Fr.

Figure 31. Close-up of Location of Patch 2/14-8 on IH10Fr-1.

Figure 32. Location of Patch 2/15-2 on IH10Fr-1.

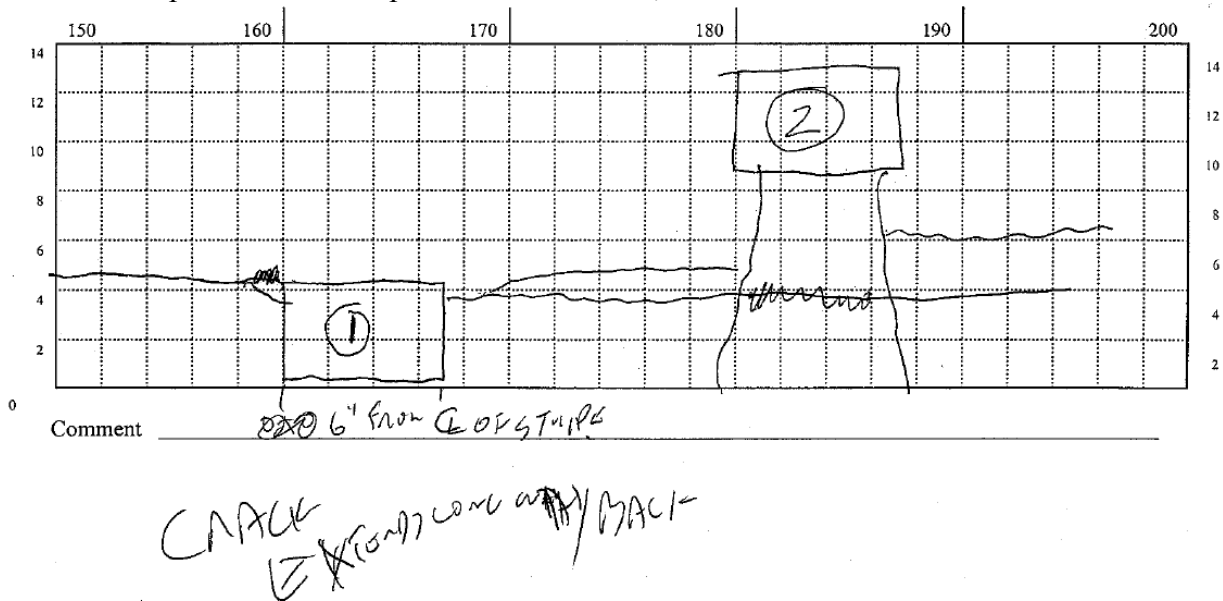
Figure 43. Crack Map of Site IH410Fr-1, Patch 1 and 2.

As noted earlier, the pavement at all three sites prior to patching was oxidized and cracked, with the cracks beginning to deteriorate. No alligator cracked areas were patched and most patches were placed on longitudinal cracks, with some intersecting cracks. Figure 43 shows an example of a crack map for Site IH410Fr-1, Patch 1 and 2.

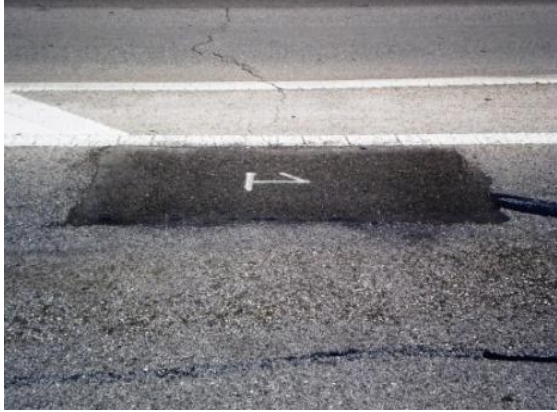
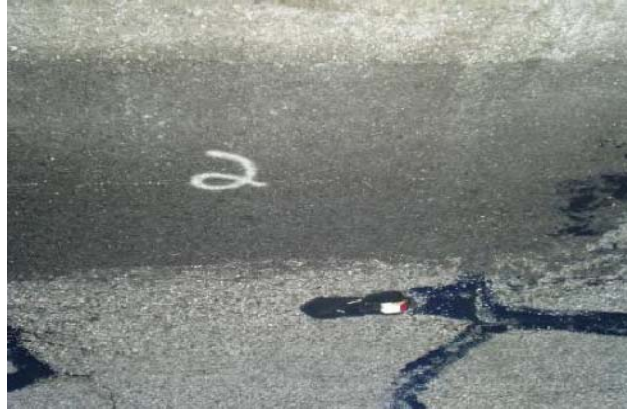
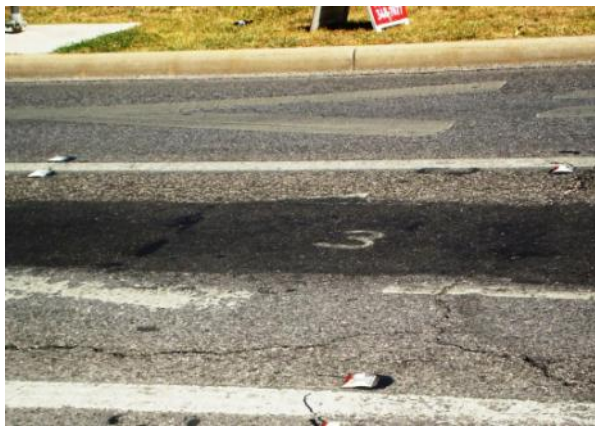
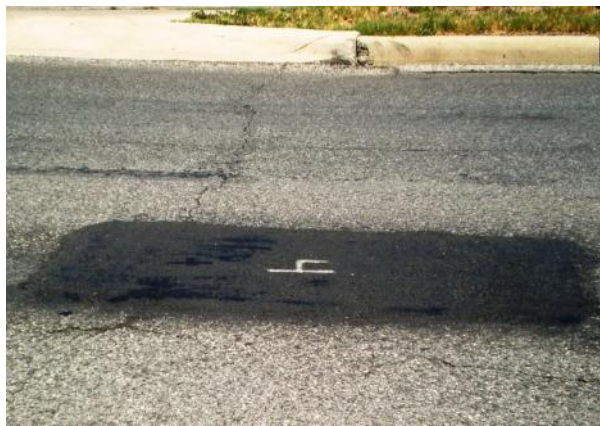
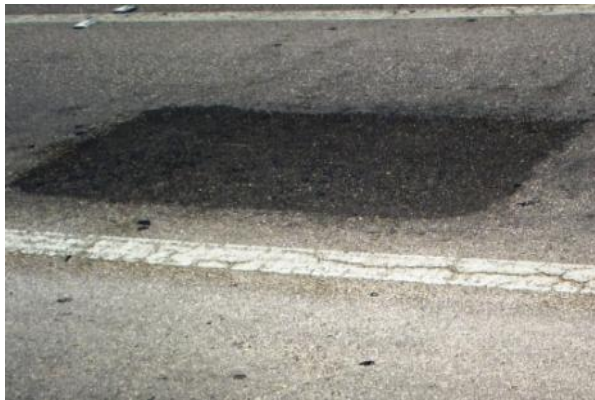
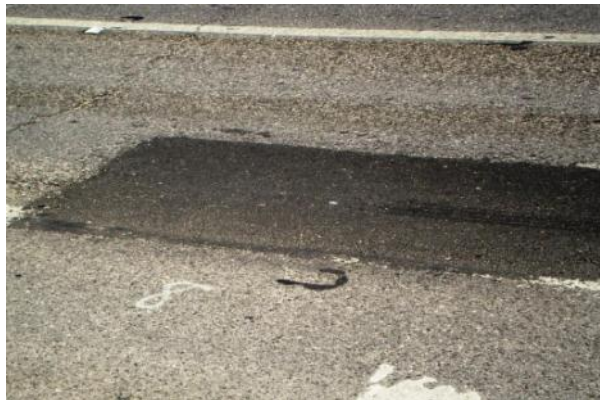
Immediately after repair, all patches were tight, flat, and level with the surrounding area. There were no cracks and every patch was performing well. At the July inspection, approximately five months after placement, the patches at the first two sites (IH410Fr-1 and -2) were still performing well and no distress was noted. Figures 44-49 illustrate the patches at Site IH410Fr-1 and IH410-2.

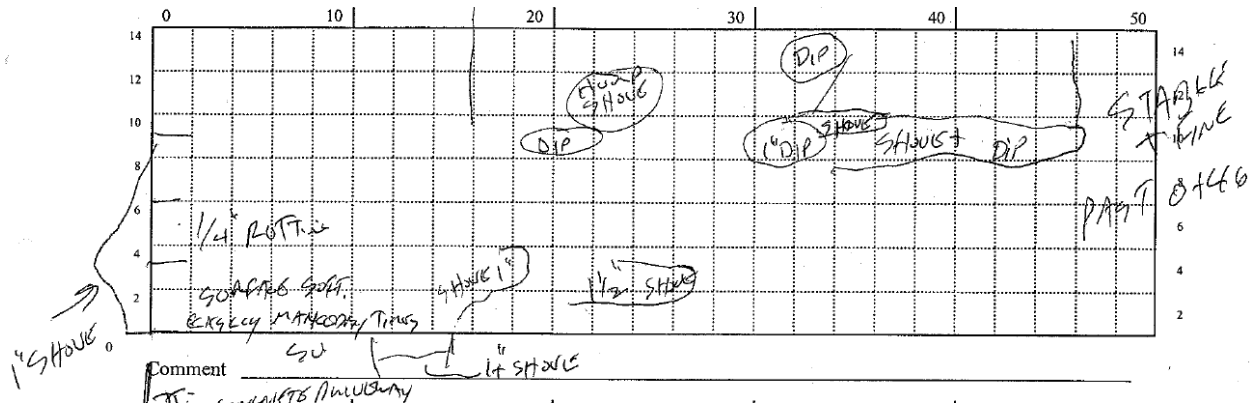
Figure 50. Distress Map of Site IH10Fr.

However, at the IH10Fr site, patches did not perform well. Patch 2/11-3 had 0.25 inches of rutting, patch 2/10-4 was soft and had 1-inch high shoving, as did patches 2/10-7 and 2/10-9. Patch 2/14-10 had a dip and a hump, as did patches 2/14-1 and 2/14-2. [Figure 50](#) shows the crack map diagram. [Figures 51](#) through [58](#) document the performance.

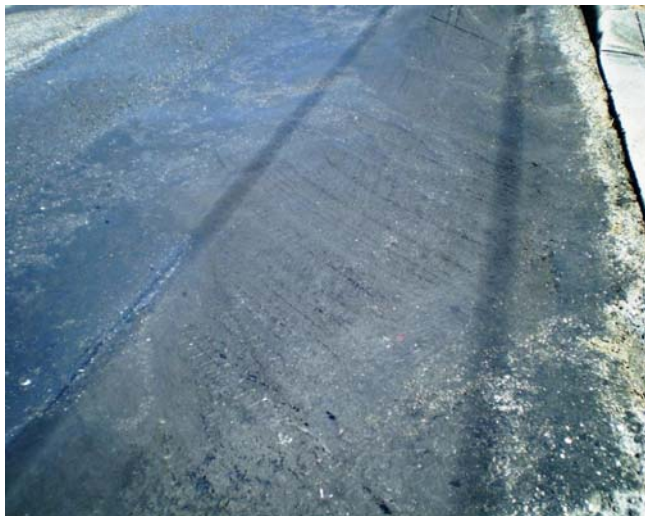
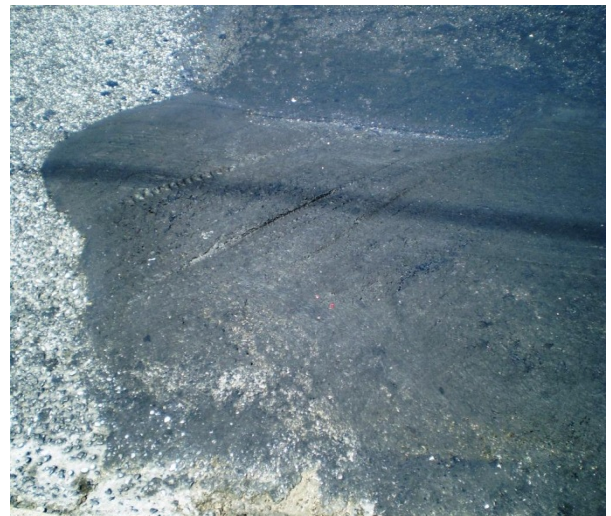
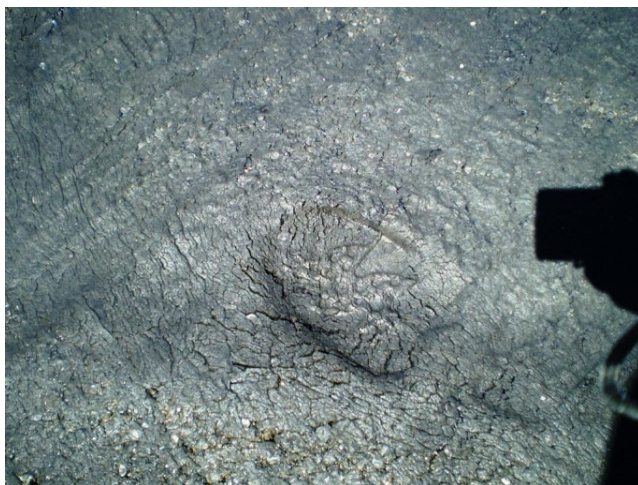
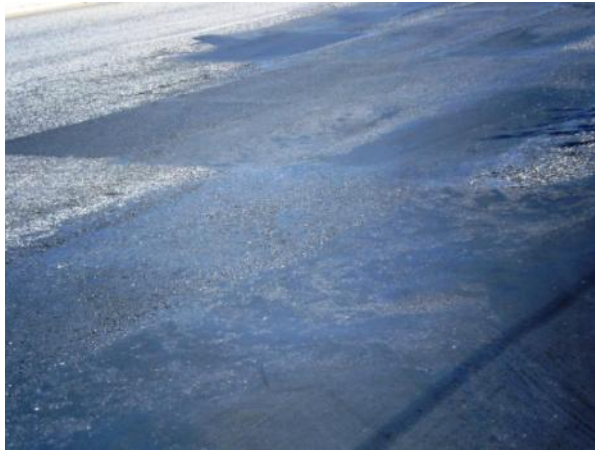
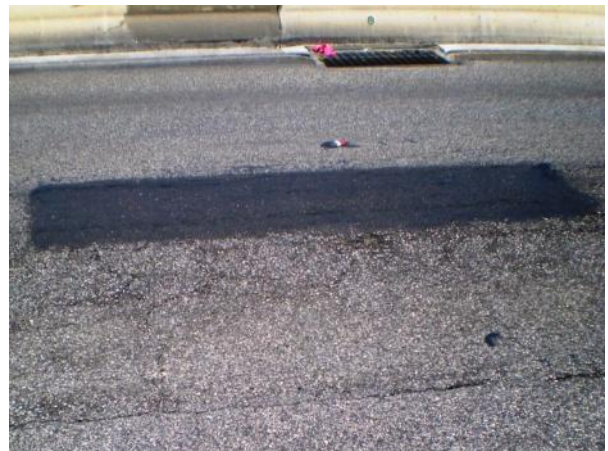
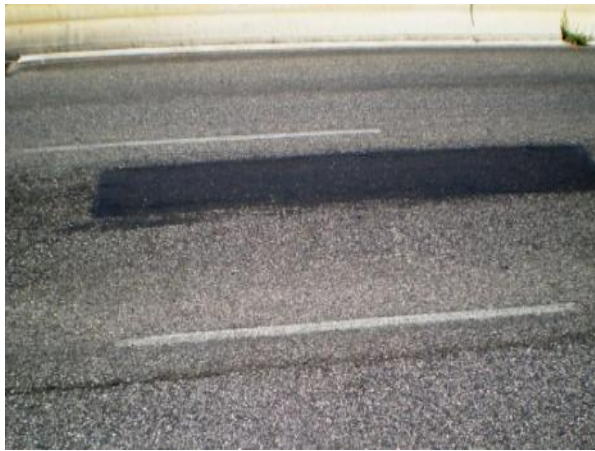
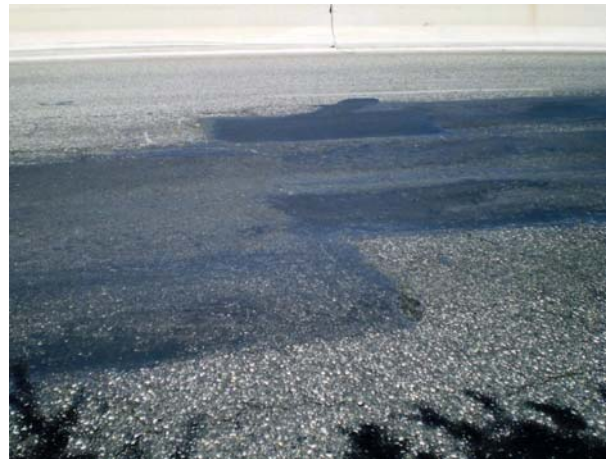
Figure 51. Patches 2/10-4 and 7 on Site IH10Fr.

Figure 52. Patch 2/10-4 on Site IH10Fr.

Figure 53. Patch 2/10-4 on Site IH10Fr.

Figure 55. Various 2/10 Patches on Site IH10Fr.

Figure 56. Patch 2/14-15 and 17 on Site IH10Fr.

Figure 57. Patch 2/14-16 and 18 on Site IH10Fr.

Figure 58. Various 2/14 Patches on Site IH10Fr.

These figures, especially [Figure 54](#), demonstrate that many of the patches were failing by shoving and settling. Due to the overall condition of this area, the entire area was milled and replaced. In the outside lane, 18 of the first 26 patches showed signs of significant distress. Patches in the middle lane and those further from the beginning performed better, but were replaced.

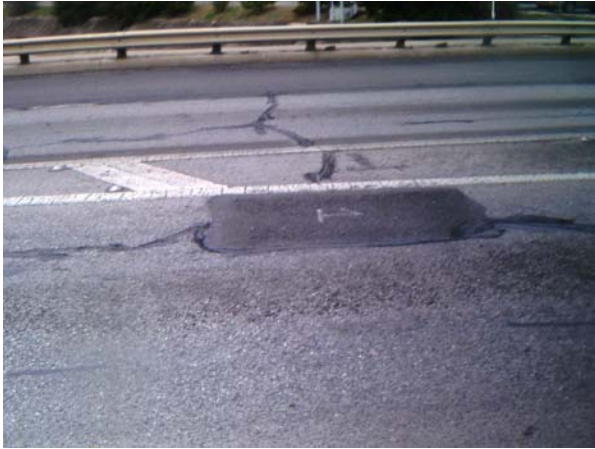
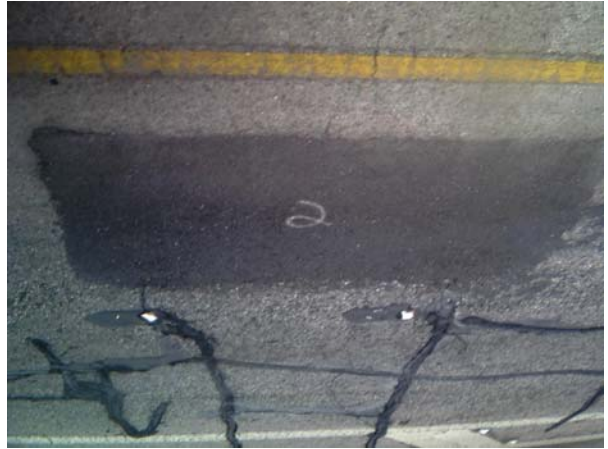
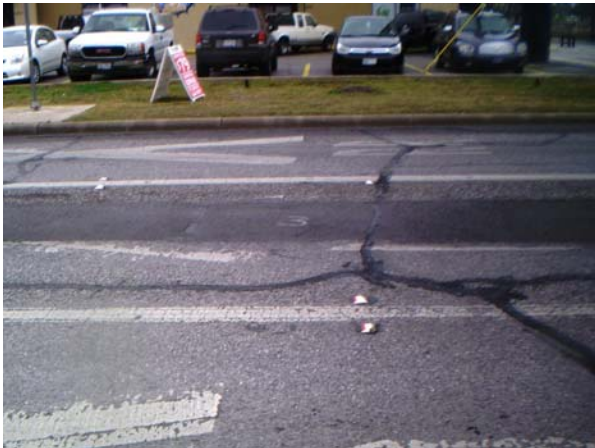
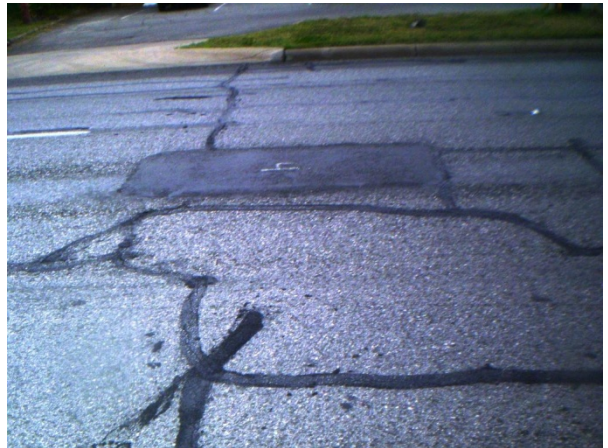
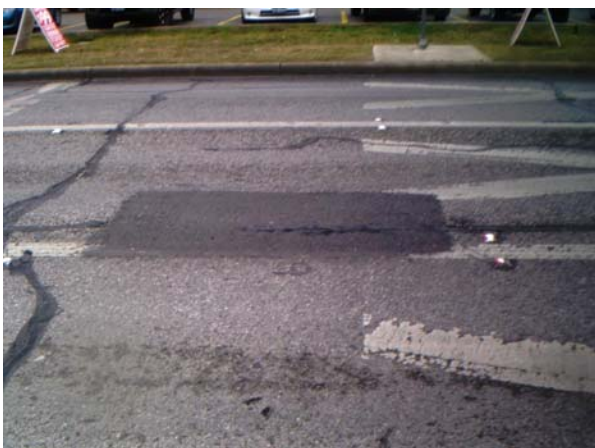
The sites were reinspected on January 20, 2012, after approximately 12 months of service. At the IH410Fr-1 and -2 sites location, patches were performing well, but patches 1, 2, 3, and 9 were settled approximately ½ inch.

Figure 59. Patch 1 on Site IH410Fr-1.

Figure 60. Patch 2 on Site IH410Fr-1.

Figure 61. Patch 3 on Site IH410Fr-2.

Figure 62. Patch 4 on Site IH410Fr-2.

Figure 63. Patch 9 on Site IH410Fr-2.

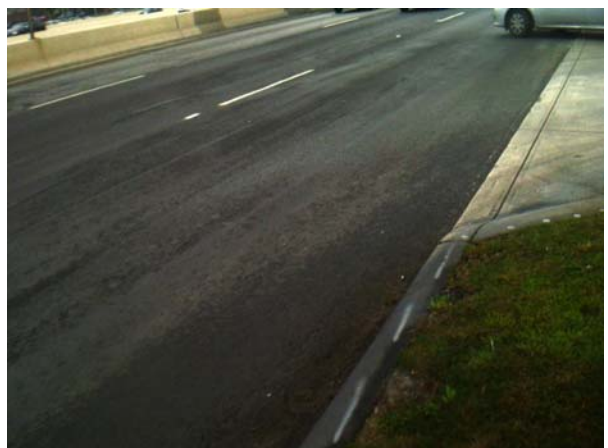
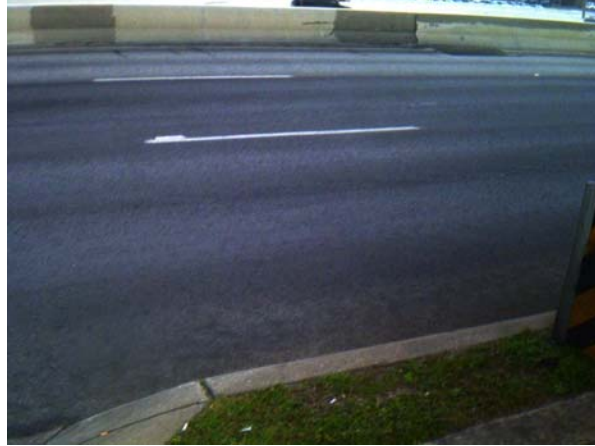
Figure 64. View of Replaced Site IH10Fr.

Figure 65. Replaced Site IH10Fr.

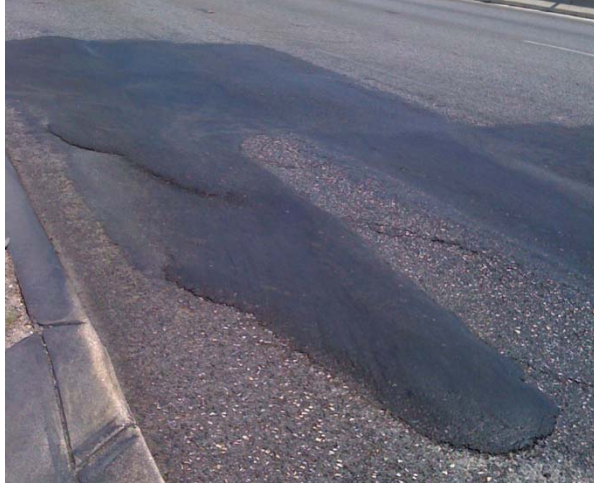
There was a failure of many of the patches at site IH10Fr, probably due to an excess of rejuvenator and possibly low air voids. [Figures 68](#) and [69](#) document these problems.

Figure 68. Shoving Failure at Site IH10Fr.

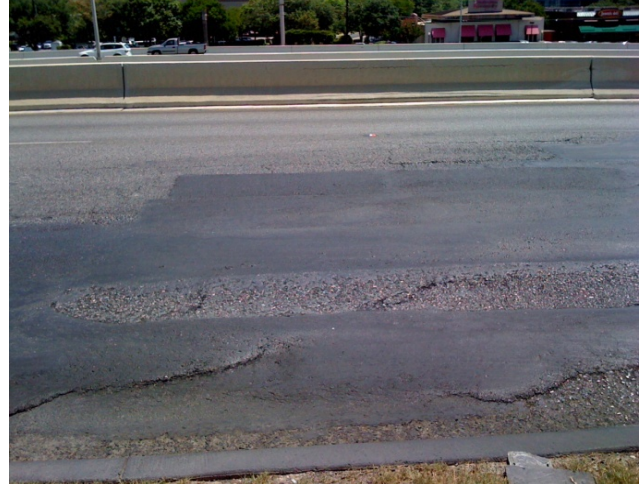
Figure 69. Shoving and Rutting Failure on Site IH10Fr.
