1. Report No. TX-96/5388-1F		2. Government Accession No.		3. Recipient's Catalog No.	
4. Title and Subtitle EVALUATION OF WORK ZONE BARRICADES AND TEMPORARY SIGN SUPPORTS				5. Report Date February 1996

EVALUATION OF WORK ZONE BARRICADES AND TEMPORARY SIGN SUPPORTS

Report No. 5388-1F
Research Study No. 585xxA3014
Research Study Title: Development of New Designs for Barricades
and Sign Supports in Work Zones

February 1996

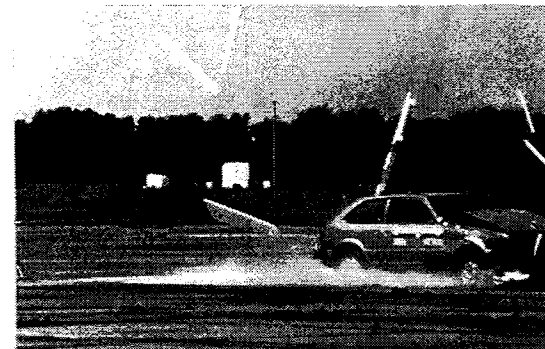
Figure 3. Sequential Photographs for Test No. 453360-1 (continued)

At 10 msec after initial impact, the sign panel broke loose from the barricade, and the vertical supports began to break loose from the bases. The sign panel struck the roof just above the windshield at 62 msec. The top of the vertical supports, which had broken off at the base, impacted and penetrated the windshield at 74 msec. As the vehicle continued forward, the sign panel rotated up and over the vehicle, striking the telemetry antenna resulting in loss of data transmission at about 93 msec. The time at loss of contact with the barricade, i.e., when the support ended contact with the vehicle, was 209 msec and the vehicle had slowed to 84.5 km/h. The support rotated as it went over the vehicle, and one leg momentarily contacted the rear portion of the roof just above the rear hatch at about 307 msec. Brakes on the vehicle were applied at 1.05 seconds after impact, which was after the vehicle cleared the immediate test site. Prior to brake application, the test vehicle was traveling on a relatively straight-forward path. However, one brake did not actuate upon application, causing the vehicle to yaw in a clockwise rotation. The vehicle subsequently came to rest 137 m down and 37 m to the right of the point of impact. Figure 3 shows sequential photographs of the test period.

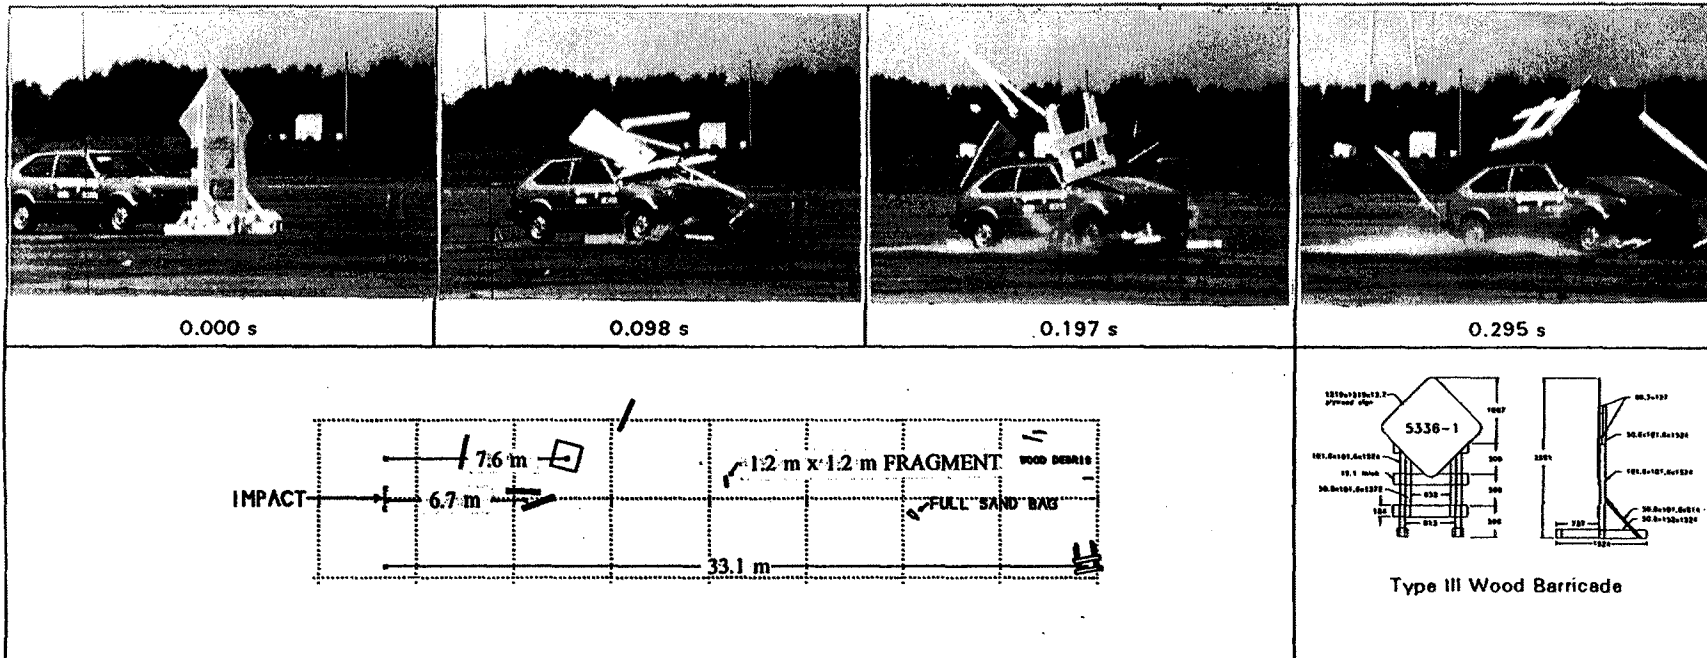
Figure 4. Summary of Results for Test No. 453360-1

Figure 4 presents a brief summary of the results of this test. The barricade shattered upon impact. The vertical supports broke from the bases and impacted and penetrated the windshield, resulting in broken glass entering the occupant compartment. The sign panel was detached from the barricade and impacted the roof of the vehicle. Debris from the barricade was thrown along an area 11 m wide by 37 m long. Some fragments were fairly large, which could pose potential hazard to oncoming traffic in adjacent lanes and to workers in the area. Sand was also scattered on the pavement, which could lead to loss of control of other vehicles. The vehicle sustained damage to the front bumper, hood, windshield and roof. There was no occupant contact during the test period. The maximum 50-msec average accelerations were -5.9 g in the longitudinal direction and 1.1 g in the lateral direction. The vehicle exited the immediate test site in a relatively smooth, stable manner and showed no potential for intrusion into adjacent traffic lanes.

In summary, the performance of the barricade was judged to be unsatisfactory due to penetration of the windshield and the occupant compartment by the fractured vertical supports of the barricade.

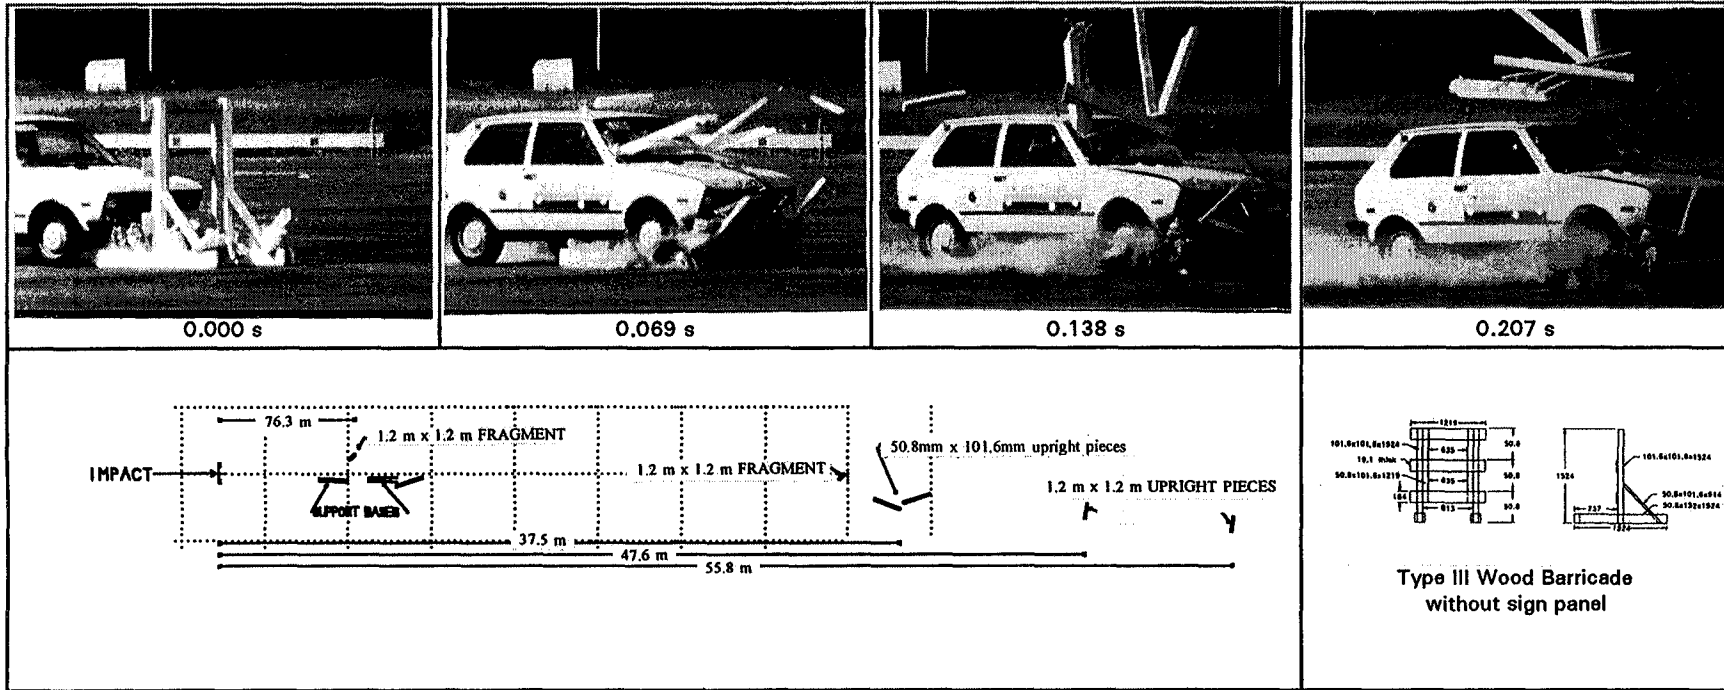
The barricade separated from the base upon impact, as can be seen in Figure 10. Debris and sand were strewn along the path of the vehicle in an area 4.3 m wide by 58.8 m long. Figure 10 shows damage to the vehicle. Maximum crush to the exterior of the vehicle was 190 mm to the center front bumper. The right front door was jammed, and there was damage to the bumper, grill, and hood. The right front tire was flat.

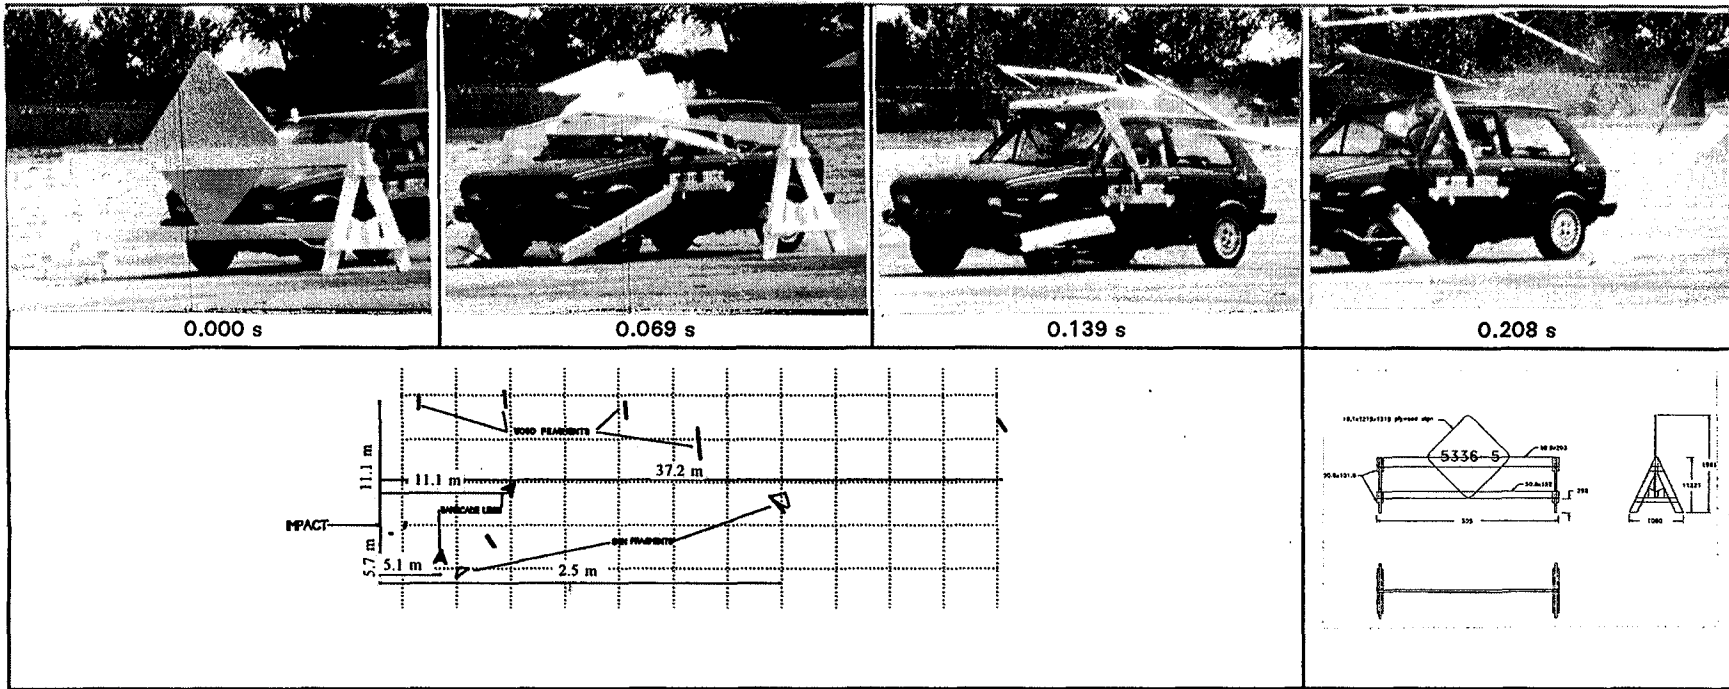
Figure 16 presents a brief summary of the results of this test. The barricade shattered upon impact, and a segment of the barricade impacted the windshield, penetrating and intruding into the occupant compartment, showing potential risk to occupants of the vehicle. Sand and many

In summary, the performance of the barricade was judged to be unsatisfactory due to penetration of the windshield and the occupant compartment by the fractured vertical supports of the barricade.

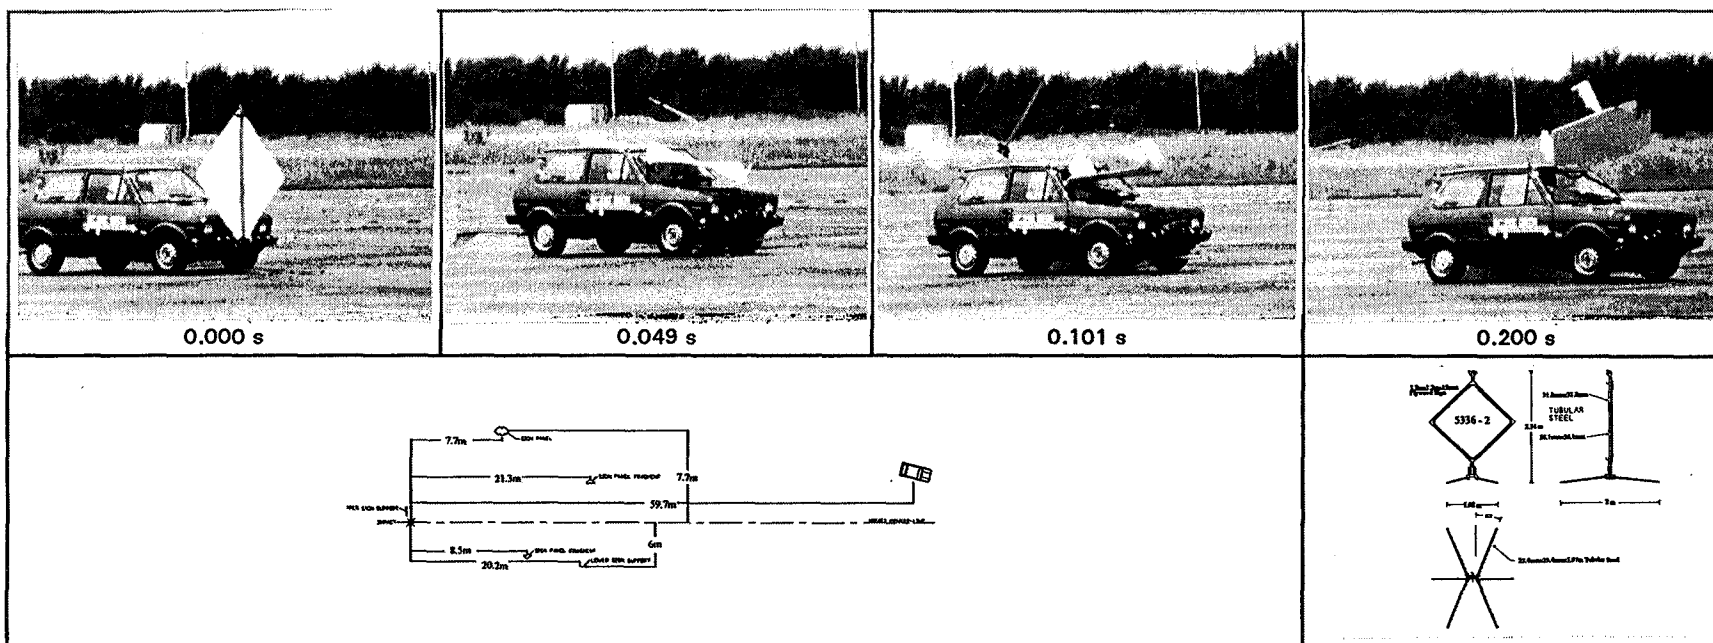
In summary, the performance of the spring-mounted portable sign support with a wooden sign panel was judged to be unsatisfactory due to penetration of the windshield and the occupant compartment by the sign panel and a portion of the sign support.

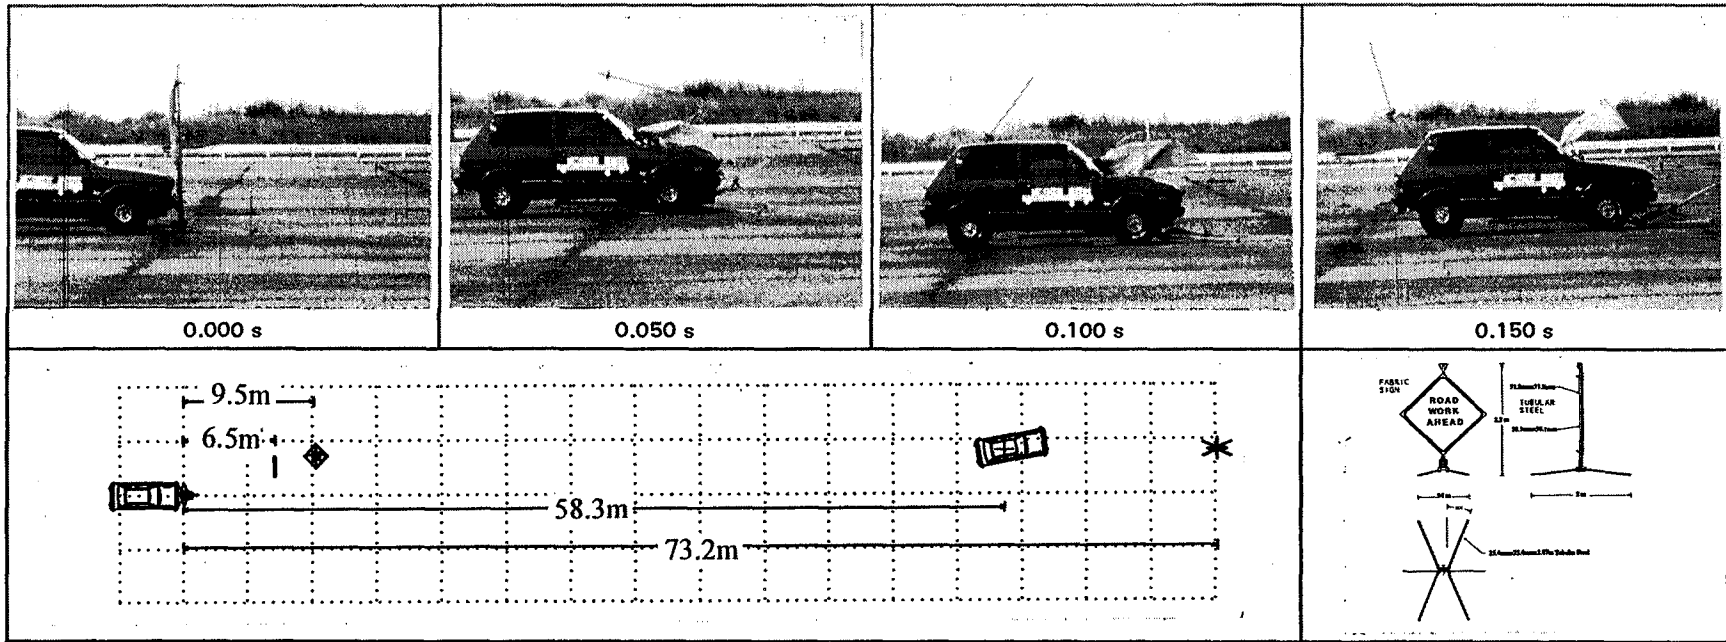
In summary, the spring-mounted portable sign support with plastic/fabric sign panel was judged to have met all evaluation criteria set forth in NCHRP Report 350.

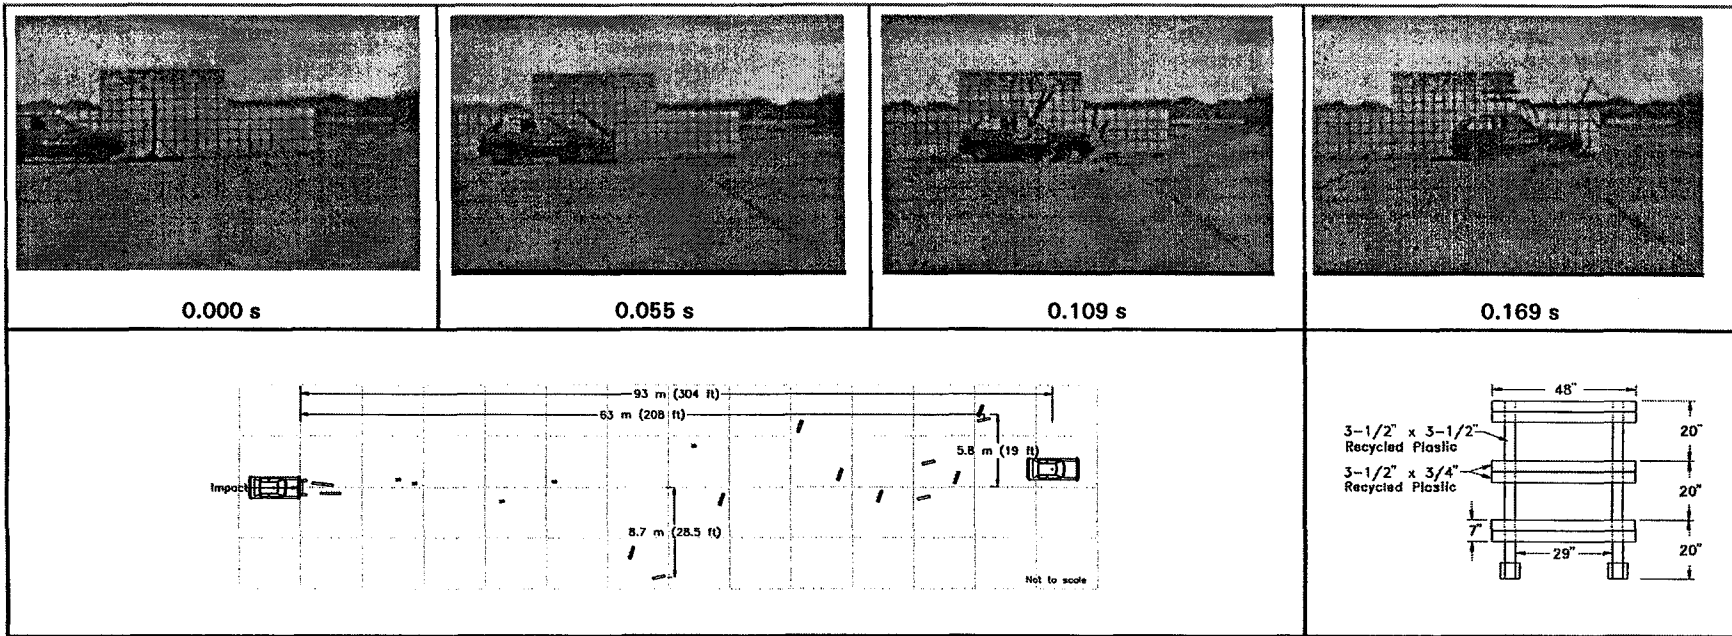
Figure 72. Summary of Results for Test No. 453790-5

As Figure 70 shows, the solid recycled plastic barricade shattered upon impact. Debris and sand were strewn along the path of the vehicle in an area 14.5 m wide by 63 m long. Figure 70 also shows damage to the vehicle. The bumper, grill, and hood of the vehicle were dented and scratched. The left side A-post was dented, the windshield was broken, and the roof was dented. Maximum exterior crush to the front of the vehicle at bumper height was 80 mm. Maximum intrusion into the occupant compartment (measured from high-speed film) was 259 mm near the head area of the driver. The maximum residual deformation into the occupant compartment was 61 mm.

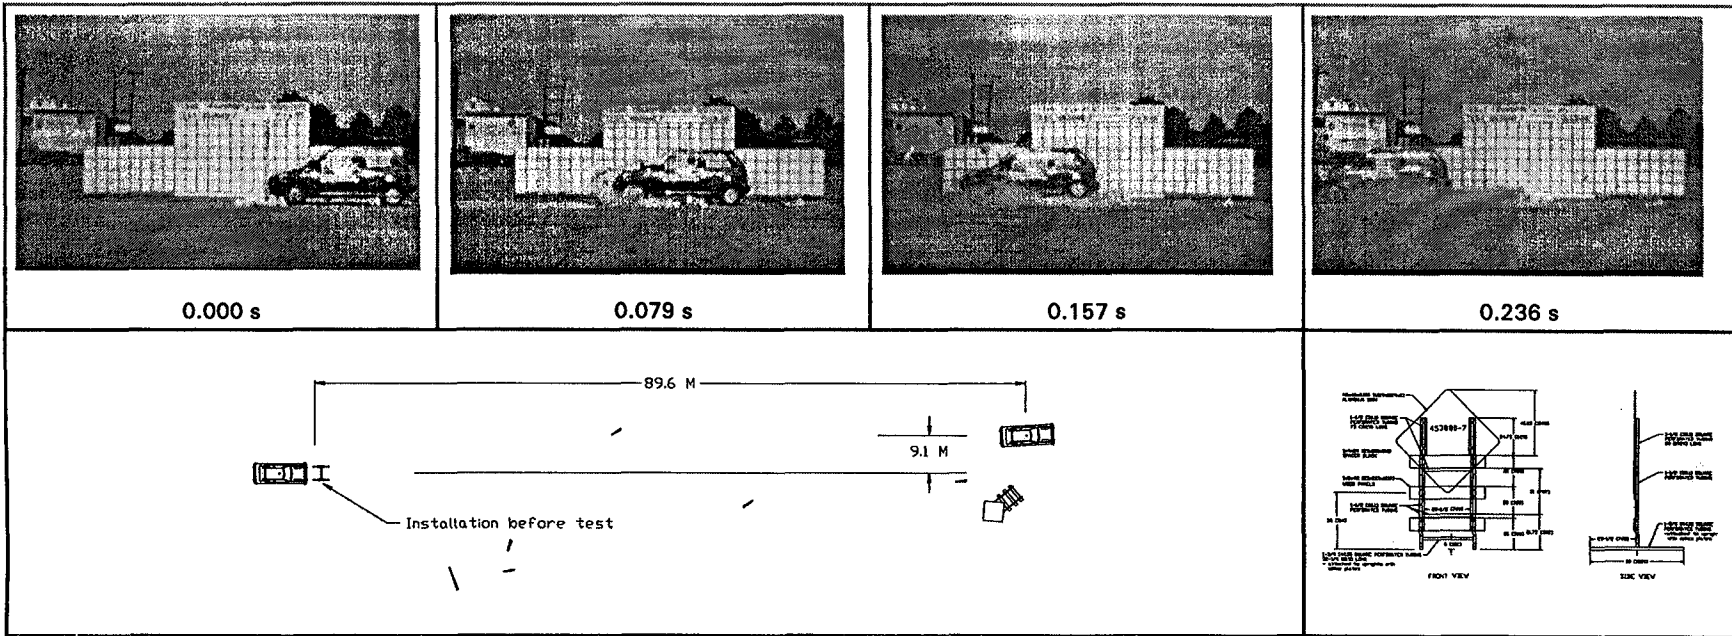
Figure 83. Summary of Results for Test No. 453880-7

The crash test with the second sign attachment alternative (test no. 453880-7) was successful. However, the fractured vertical supports, the rail elements and the sign panel stayed as a single unit and was thrown forward by the impacting vehicle, raising concern that this may pose a hazard to adjacent traffic and workers in the area. After consultation with TxDOT, it was decided that this sign attachment mechanism is not desirable and should not be considered for implementation.
