IMPACT BEHAVIOR OF SIGN SUPPORTS

A PROGRESS REPORT

Research Report Number 68-1

Sign Support Structures
Research Project Number 2-5-63-68

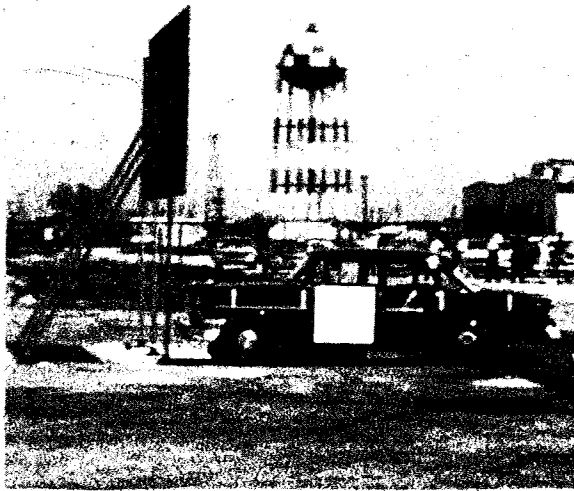
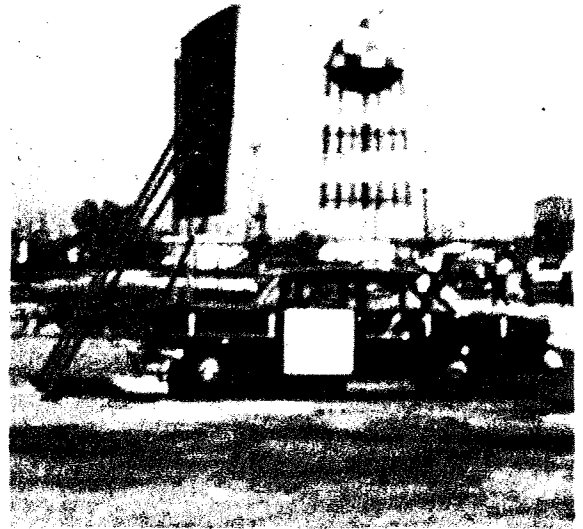
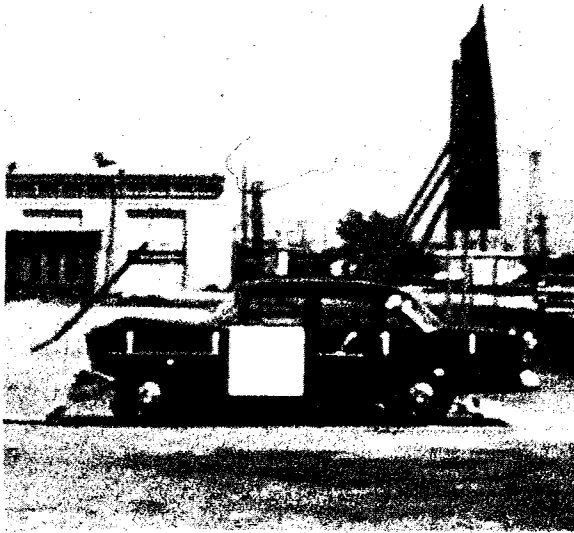
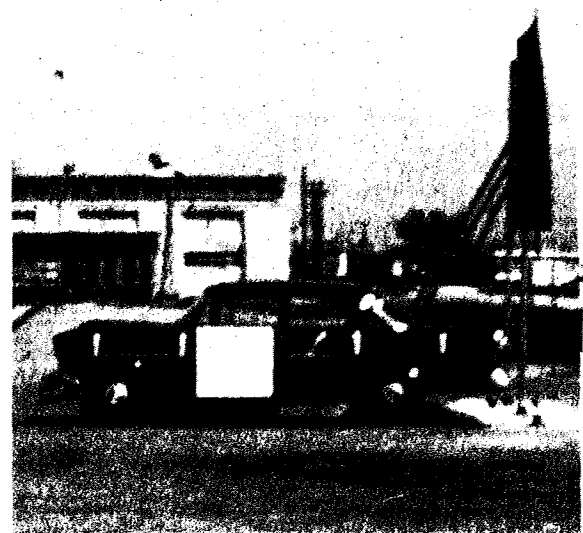
FIGURE 3 — SEQUENCE PHOTOGRAPHS TEST NO. 1

A careful study of the high-speed motion picture film of the crash indicated that the vertical leg failed first due to excessive deformation. Next the tubular leg was torn from its base plate, and finally failure occurred at the fracture joint. When failure of the fracture joint occurred it appeared that energy stored in the leg and in the sheet metal of the automobile caused the lower portion of the leg to proceed ahead of the automobile, striking the brace member causing a failure at the fracture joint of the brace prior to impact by the vehicle with the brace. When the vehicle made contact with the brace, the tubing failed due to excessive deformation, and there was a slight tendency for the tube to wrap around the bumper of the vehicle which, in turn, caused a failure at the weld holding the base plate to the lower end of the brace. Both pieces of the support removed by the vehicle were thrown forward in front of the vehicle some distance and were then struck repeatedly by the vehicle. They finally came to rest approximately 250 feet beyond the sign. Sequence photographs of this crash are shown in Figure 3.

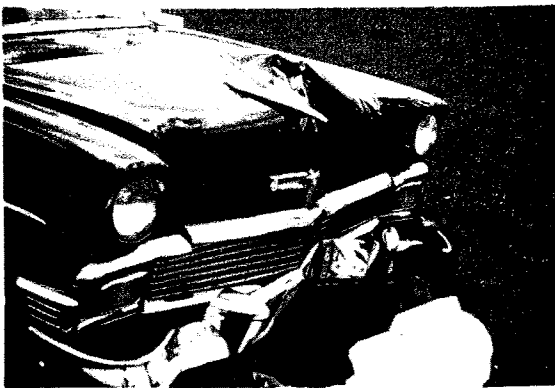
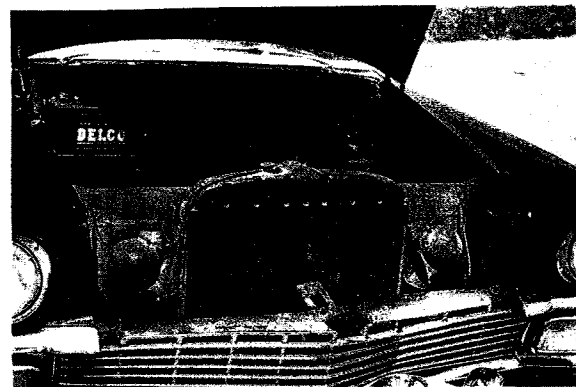
FIGURE 4 — VIEWS OF VEHICLE TEST NO. 1

Pictorial illustrations of the vehicle before and after impact are shown in Figure 4. From these photographs it is readily evident that the damage resulting from the collision

was negligible, especially when considered in terms of personal injury. There was no detectable deceleration of the vehicle due to the impact. Damage was limited to the bumper, gravel shield, grill and hood. The radiator was not damaged nor was it displaced in its harness. It was the general opinion of those observing the crash and the films that the driver possibly could have regained control of the automobile after the crash occurred. The vehicle traveled more than 350 feet following impact.

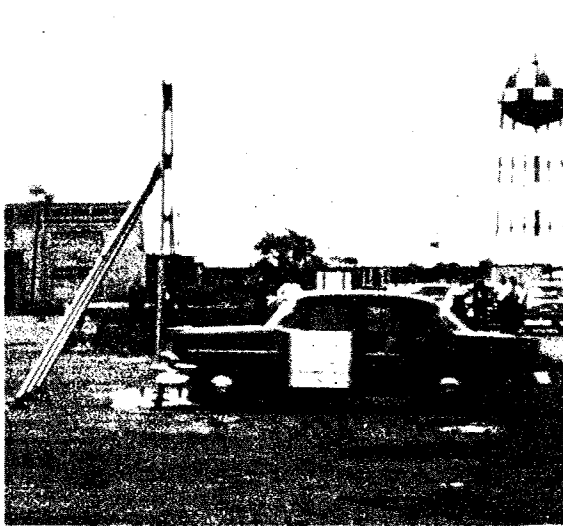
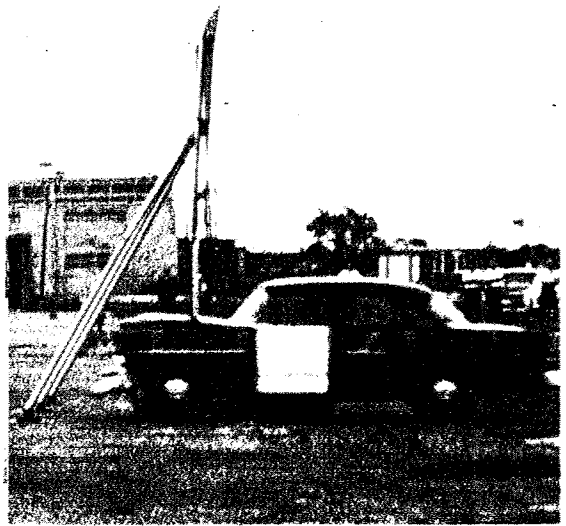
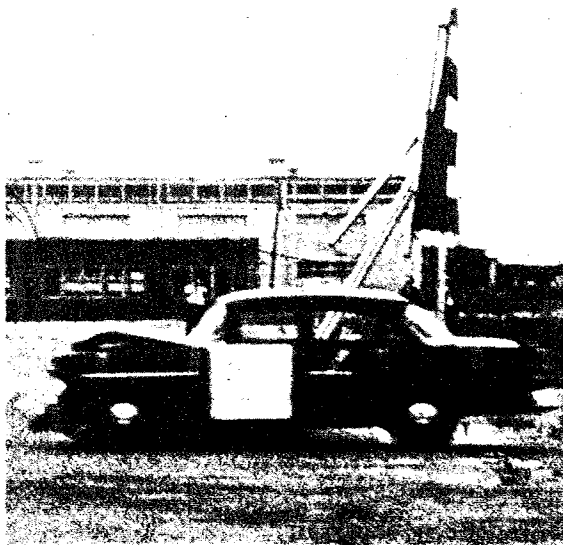
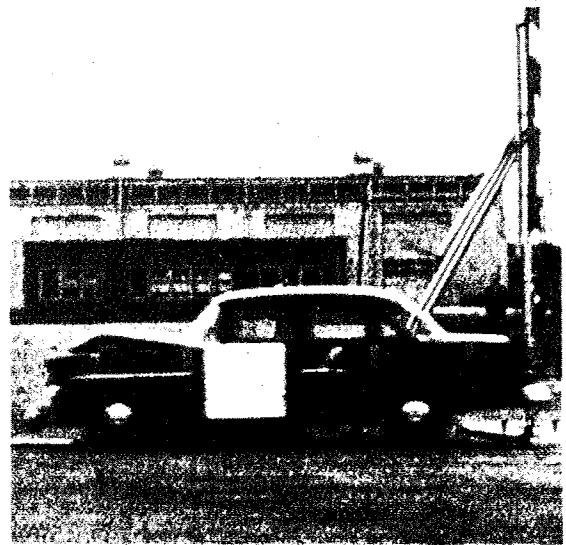
FIGURE 6 — SEQUENCE PHOTOGRAPHS TEST NO. 2

A study of the high speed motion picture film of this test revealed that the vertical leg failed by excessive deformation due to impact. (Sequence photographs of the crash are shown in Figure 6.) As this failure progressed the aluminum fracture joint insert was pulled out of the upper portion of the vertical leg. There was evidence that the cast aluminum insert used to form the fracture joint was not completely bonded to the inside wall of the tubing. Apparently the amount of epoxy used in bonding the insert was not sufficient to completely fill the space between the cast insert and the inside wall of the tubing. Finally, the brace was torn loose from the foundation due to shearing of the bolt which pinned the brace to the foundation.

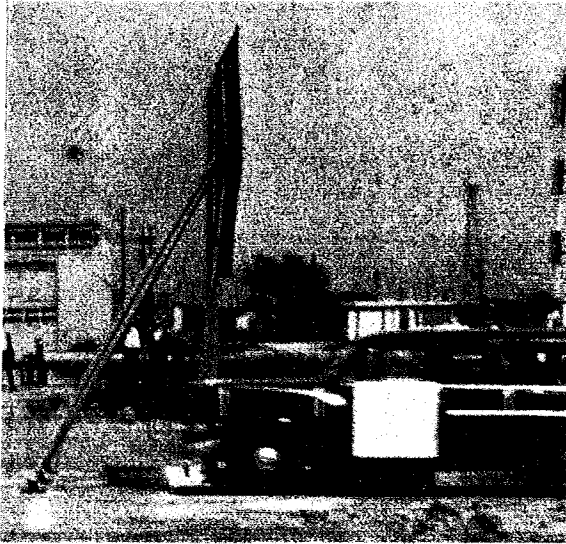
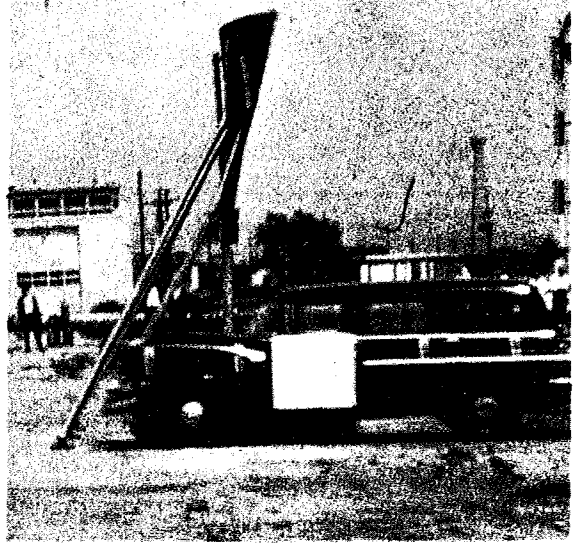
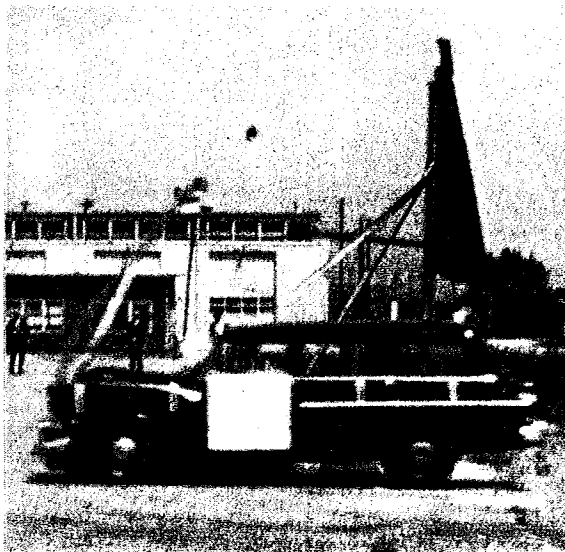
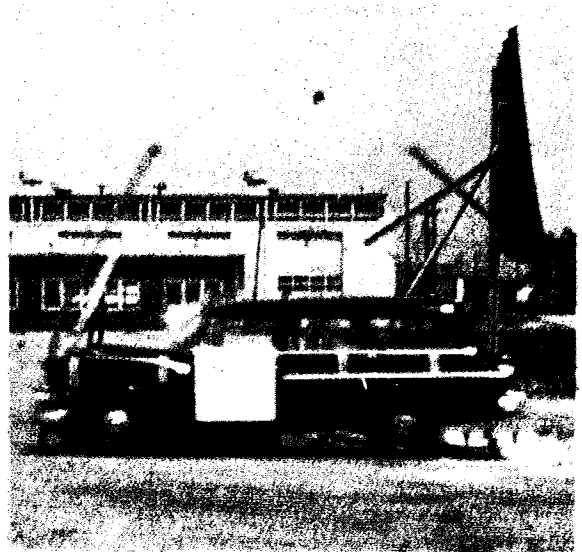
FIGURE 9 — SEQUENCE PHOTOGRAPHS TEST NO. 3

Observations of the high-speed film showed that the initial impact of the crash vehicle caused excessive deformation in the leg at bumper level. Sequence photographs of this test are shown in Figure 9. As the vehicle continued on through the support the front leg was pulled down causing failure of the bolt connecting the leg and the brace at the top. As the leg was pulled down the two lower cross beams were torn loose from the sign. The lower cross beam struck the windshield of the vehicle shattering the glass, but it did not break through the plastic lamination in the windshield. The front leg separated approximately six feet above ground level as it was being dragged under the vehicle. The brace member which had been freed at the top during the impact was torn loose at the base, and it and the upper portion of the front leg were carried along in front of the vehicle for a considerable distance. There was no perceptible deceleration of the automobile due to impact.

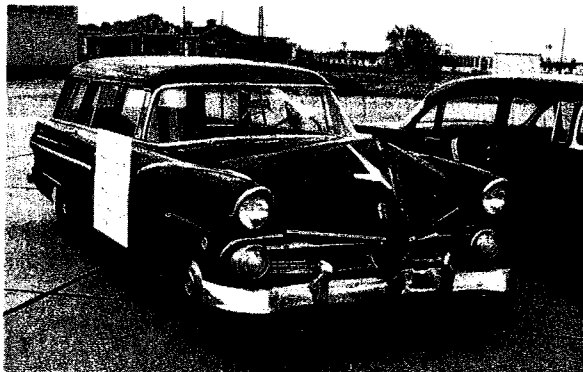
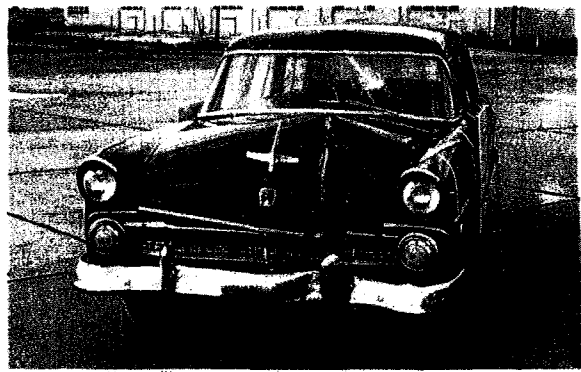
FIGURE 10 - VIEWS OF VEHICLES TEST NO. 3

As shown in Figure 10 damage to the vehicle was limited to the bumper, gravel shield, grill, hood, windshield, and top. The vehicle traveled more than 350 feet following impact.

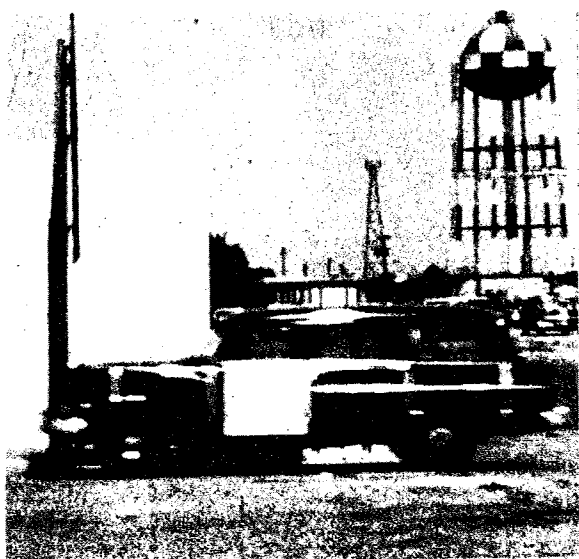
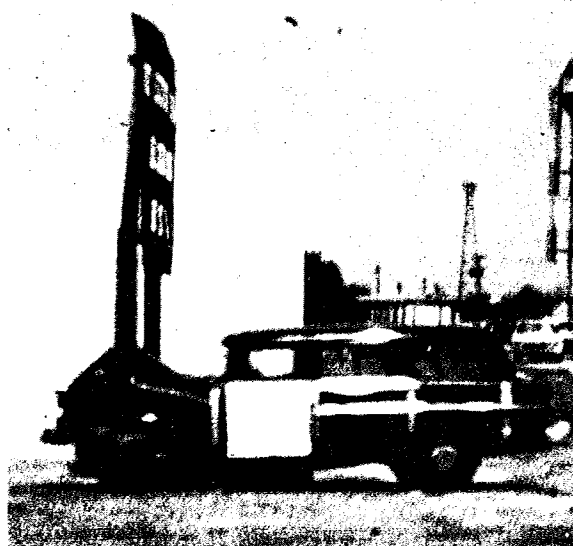
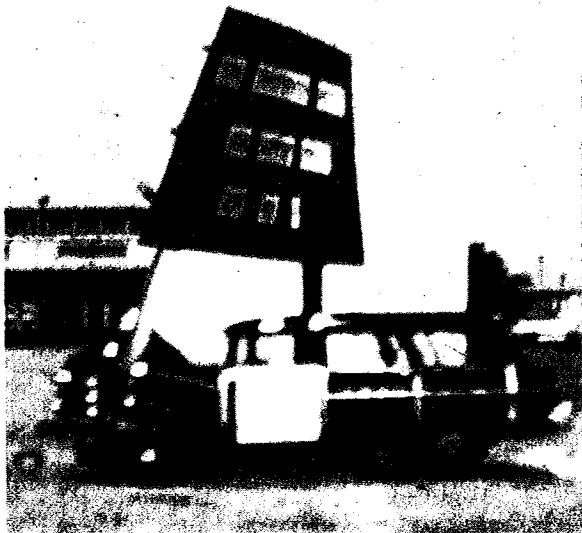
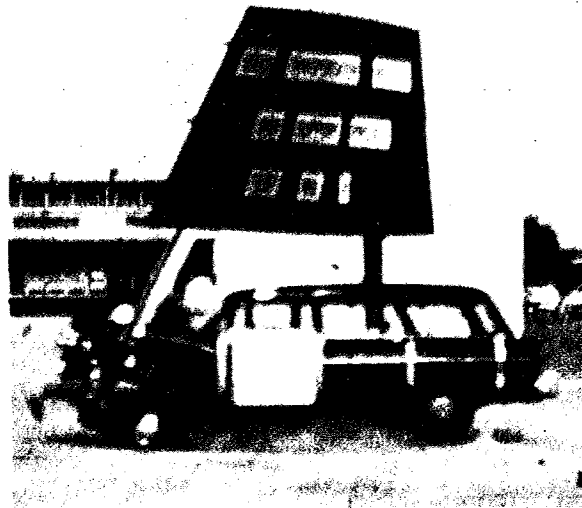
FIGURE 12 — SEQUENCE PHOTOGRAPHS TEST NO. 4

When impact occurred the slip joint behaved as expected but the plate extending alongside the web of the base served as a secondary restraint. The crash vehicle traveled 9 inches between initial impact and the time slippage occurred at the base. However, the vehicle traveled an additional 27 inches before the extension plate on the web of the post was raised above the foundation fitting. The inertia effects of the large mass above the bumper level and ambient air resistance on the sign were too great to allow forward rotation prior to movement of the extension plate. The upper portion of the post penetrated inside the left frame member of the vehicle to the left of the engine for a distance of approximately 3 feet. While this destruction was occurring the vehicle was decelerating rapidly and beginning to pitch and skid to the right. (Sequence photographs are shown in Figure 12). Finally the extension plate on the post was lifted above the foundation and the vehicle passed on under the post a distance of 63 feet beyond the sign. The front wheels were damaged to the extent that the left front wheel was restrained and the vehicle skidded to a stop. It should also be noted that the base plate of the foundation was not precisely horizontal and had to

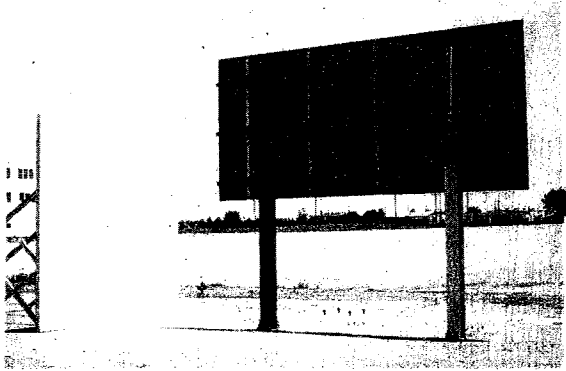
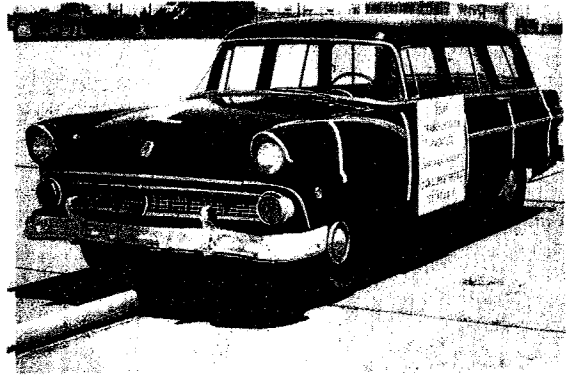
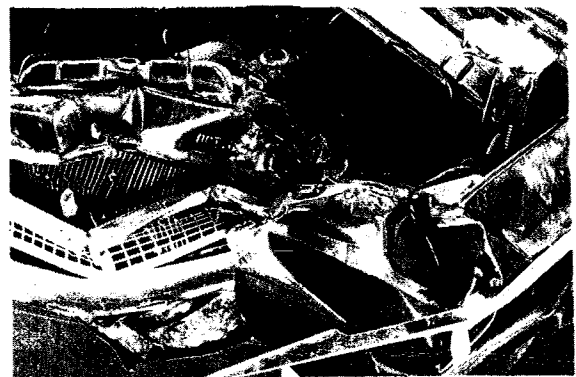
FIGURE 13 — VIEWS OF VEHICLE AND SIGN TEST NO. 4

be altered for a subsequent test. As the vehicle passed under the post, the base plate of the post tore the hood loose, penetrated the windshield in front of the driver's seat, and caused considerable damage to the front portion of the top of the vehicle. This particular variation was by no means satisfactory, and further modifications were proposed by engineers of the Bridge Division. Most observers conjectured that the severity of the impact and the damage due to the post striking the windshield and passenger area would probably have resulted in serious injury or possibly a fatality. Before and after views of the sign and the test vehicle are shown in Figure 13.

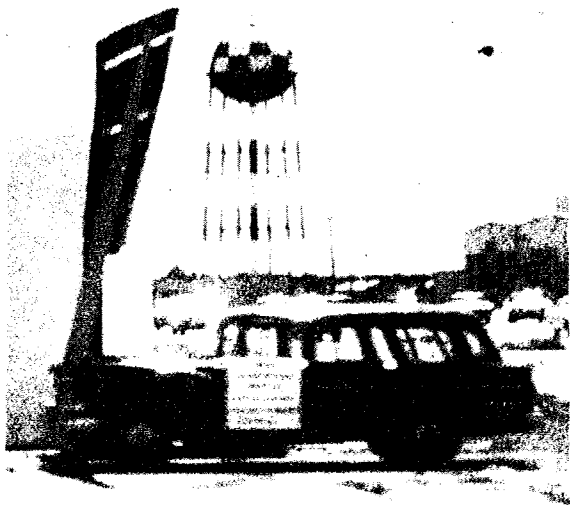
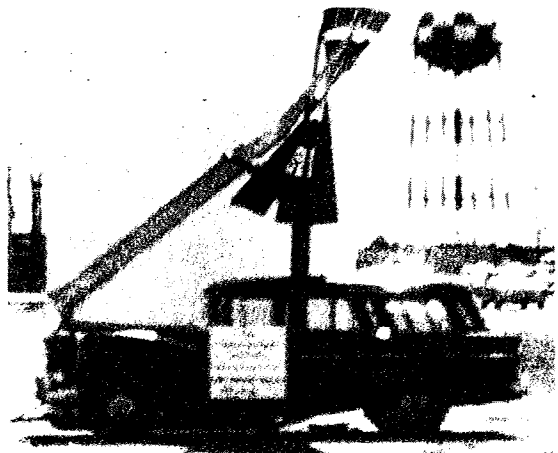
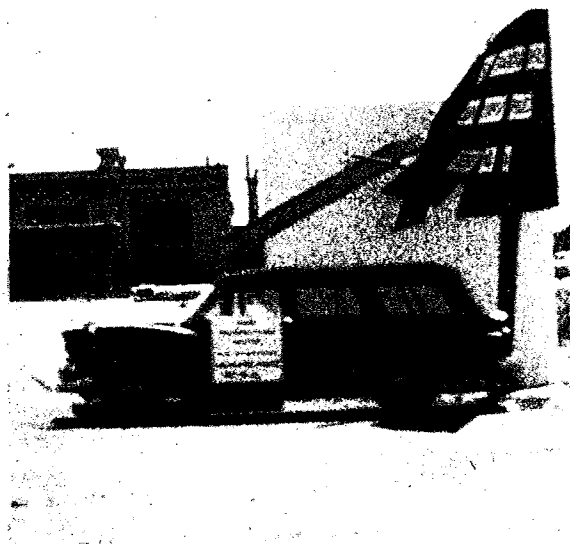
FIGURE 17 — SEQUENCE PHOTOGRAPH TEST NO. 6

When the vehicle struck the post (see Figure 17) the slip joint at the base functioned as expected and the post rotated upward clearing the vehicle. Several of the aluminum welds failed and the sign completely collapsed. It was apparent that the welds were of poor quality and observations drawn from the test could not be considered reliable. Before and after views of the impact, post, and vehicle are shown in Figure 18.

The posts were repaired and steps were taken to obtain high quality welds during fabrication. The test was re-run as Test 7 with very similar results. Only minor damage to the sheet metal on the front of the vehicle was incurred in causing the post to release at the base. And there was no perceptible deceleration of the vehicle due to impact. Once the post was released the base rotated upward clearing the vehicle as it passed under the sign. The impact caused the sign to rotate extensively about the right post but this was not sufficient to cause failure in the right post. In each of tests 6 and 7 the vehicle traveled more than 350 feet following impact.

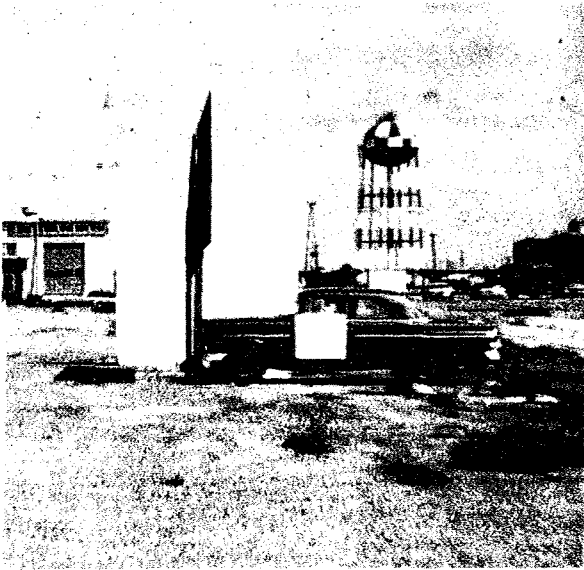
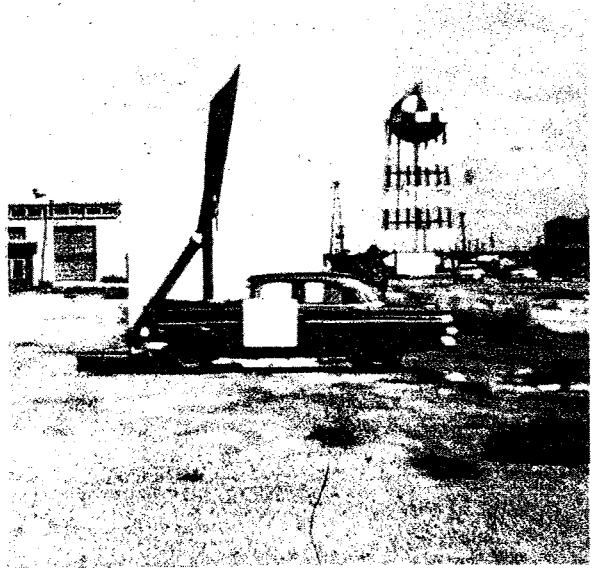
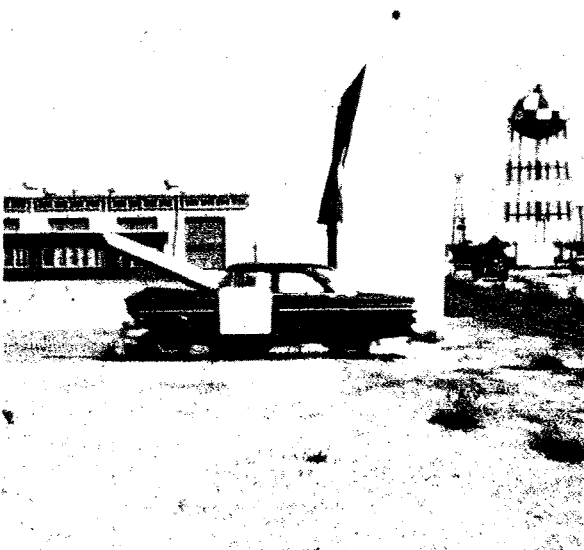
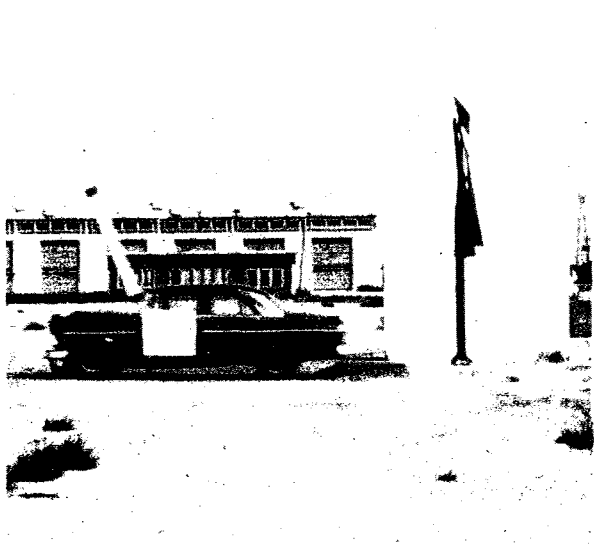
FIGURE 20 - SEQUENCE PHOTOGRAPHS TEST NO.8

From the high-speed film it was observed that the vehicle traveled approximately 9 inches, deforming the front bumper and related parts, between the time of initial impact and the time slippage occurred at the base of the post. Immediately after slippage occurred the fracture joint failed freeing the lower section of the post as shown in Figure 20. This lower section of the post then pierced the windshield, struck the dashboard, and vaulted over the top of the automobile, slightly puncturing the roof of the automobile near the left rear corner.

The before and after pictures in Figure 20A show that damage due to the initial impact was relatively minor when compared to photos of the vehicle used in Test 4 (see Figure 13). The vehicle traveled more than 350 feet after impact. Therefore, it was assumed that personal injury would probably be limited to minor cuts due to broken glass. However, the fact that the post penetrated the windshield is an indication that considerably greater injury could have resulted under other circumstances. As a result of these observations it was decided that the fracture joint was somewhat less than satisfactory. The fact that the lower section of the post could not be controlled after its release made it an extremely hazardous flying object.

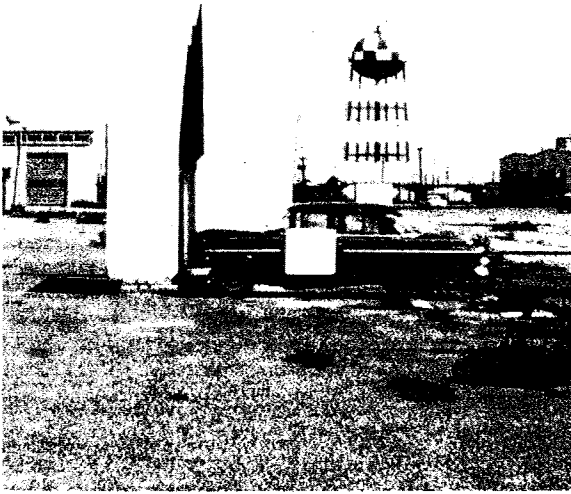
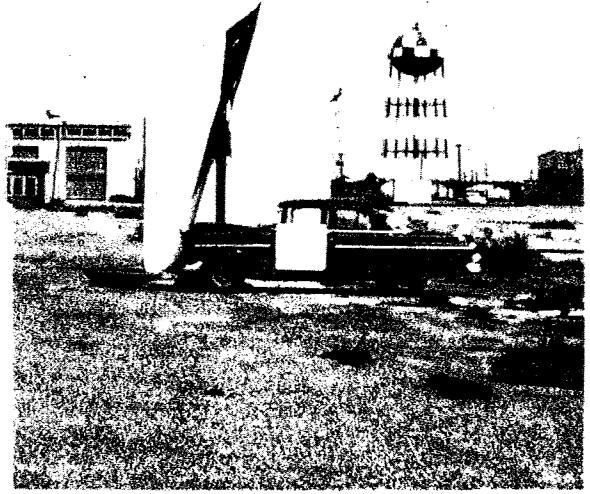
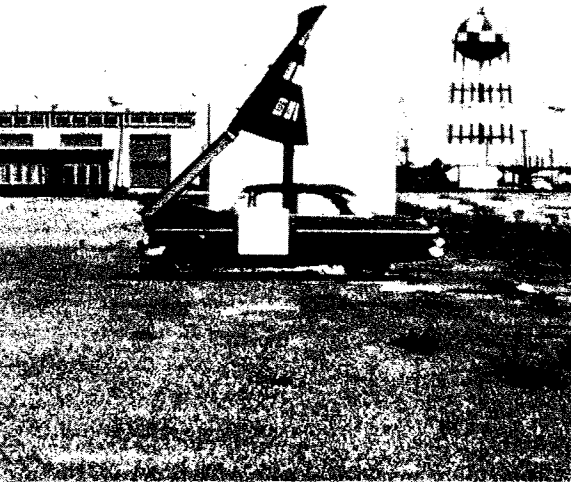
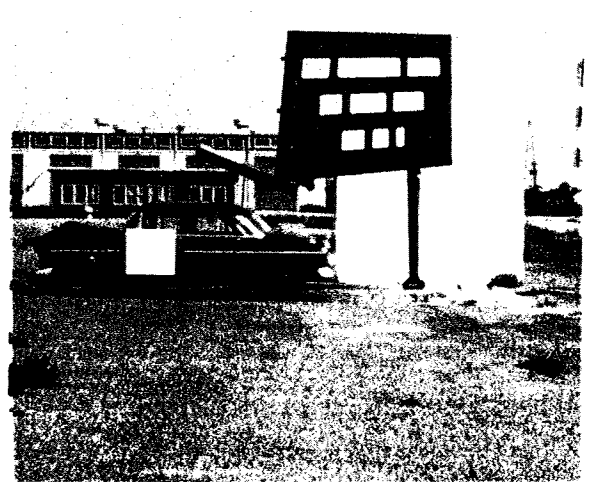
FIGURE 22 - SEQUENCE PHOTOGRAPHS TEST NO. 9

In the collision (see Figure 22) the vehicle traveled approximately 7 inches between the time of initial contact with the post and the time slippage occurred at the base. The bumper and sheet metal components were deformed in the process. Before and after pictures of the vehicle were not available for this test. The same unrepaired vehicle from Test 8 was used and some permanent deformation of the sheet metal parts was evident prior to the test as shown in Figure 20A. This permanent deformation changed the resiliency of the front of the vehicle, accounting for a reduction in deformation of vehicle on impact.

When the base had slipped free the post rotated through an angle of approximately 45 degrees before the fracture plate failed. At that point the plate failed across the bolt holes and the lower section of the beam rotated upward through an angle of roughly 120 degrees from its original position and completely cleared the top of the automobile.

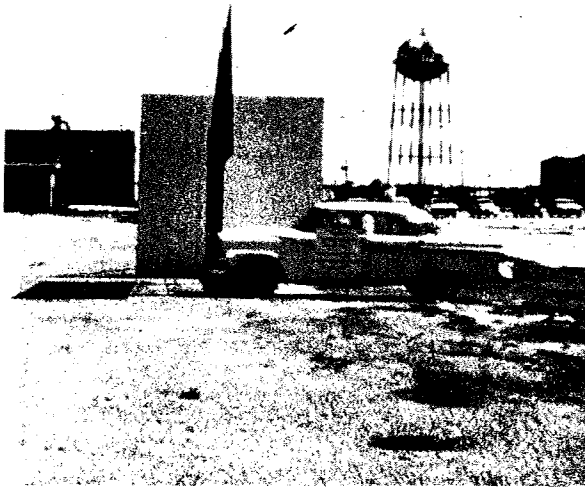
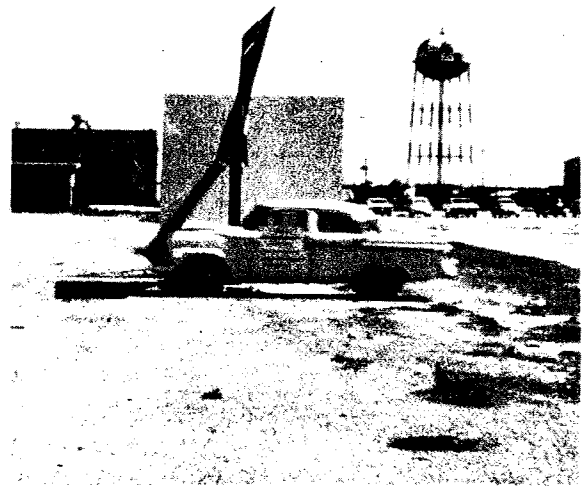
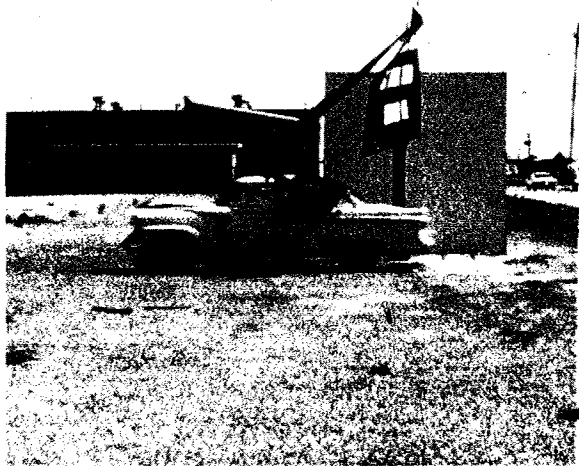
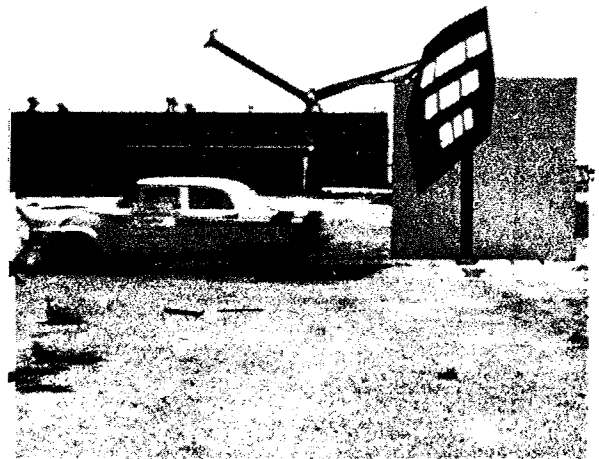
FIGURE 23 - SEQUENCE PHOTOGRAPHS TEST NO.10

Films of the crash showed that the vehicle traveled approximately 5 inches, deforming the front bumper and sheet metal, between the time of initial contact and the time slippage occurred at the base. Immediately after slippage occurred at the base the fracture plate on the front flange failed and the back flange performed as a hinge. The post rotated upward twisting the sign face through an angle of approximately 40 degrees from its original position. At that point the post pulled loose from the cross beams on the sign and the entire post rotated about its upper end. After the vehicle had passed under the sign the post came to rest on the ground immediately behind the sign. The reaction was considerably more violent than in the slow-speed test, but there was very little difference in damage sustained by the vehicle. The damage was limited to the bumper, grill, hood, and associated parts. (See before and after pictures in Figure 23A.)

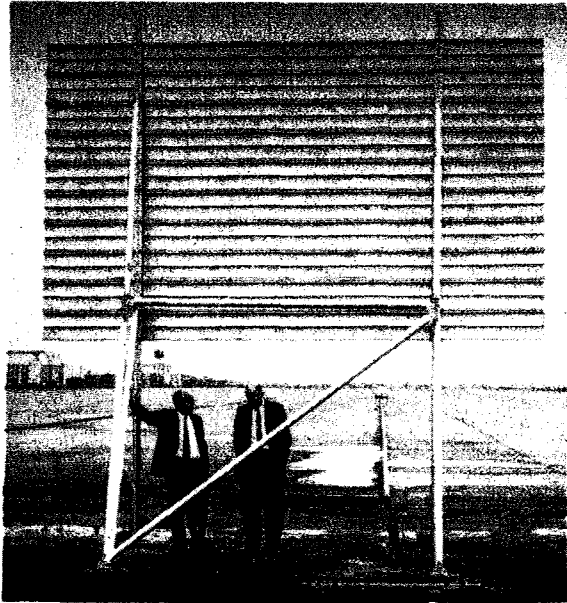
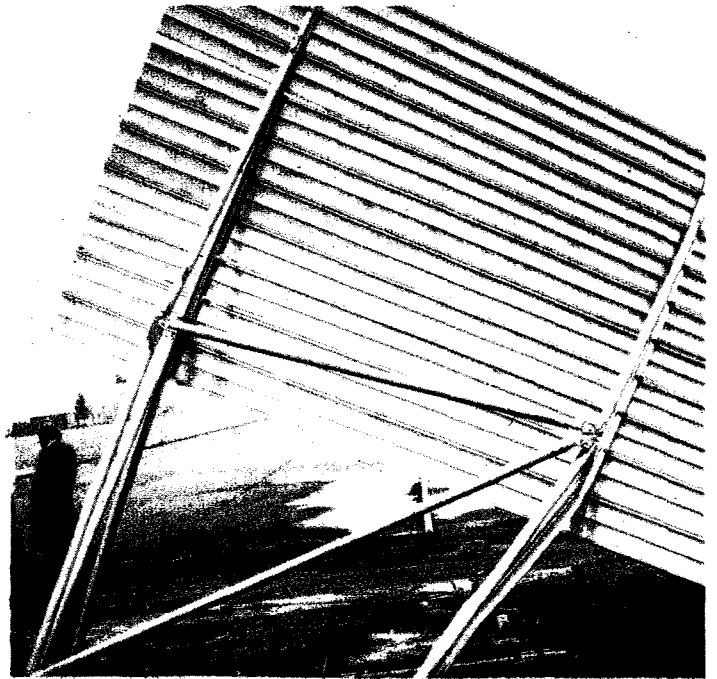
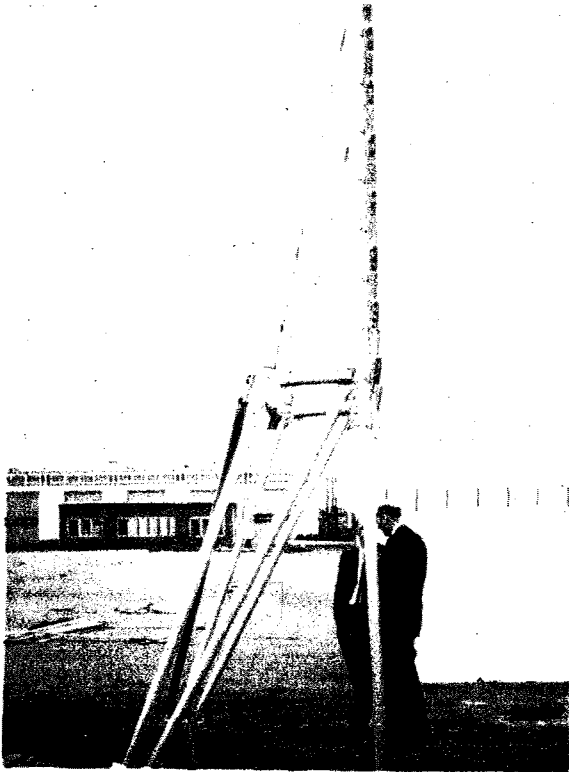
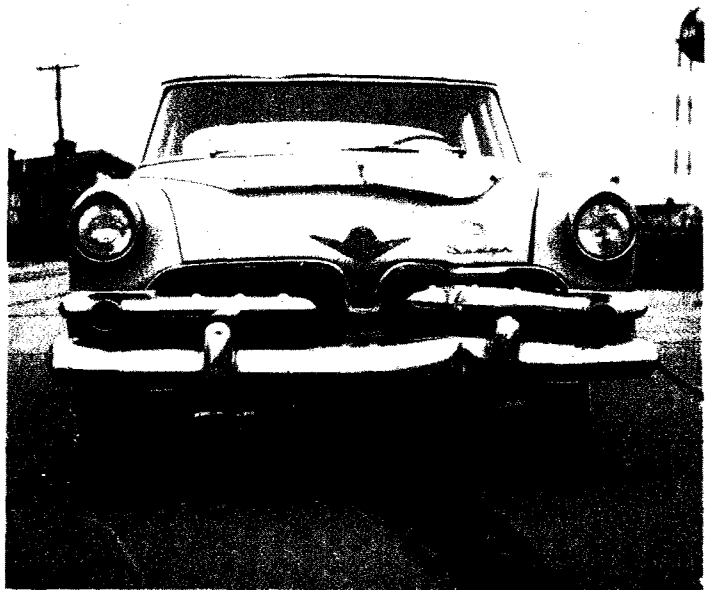
FIGURE 24 - DESIGN FEATURES, SIGN AND VEHICLE DAMAGE TEST NO. II

A power failure which occurred while the test was in progress stopped the high-speed camera, and consequently, that film was not available for detailed observation. Films from the other camera provided limited observation of the crash. Sequence photographs are shown in Figure 25. The front leg failed under the initial impact due to separation at the base plate. Later observation of the failure led the investigators to believe that the weld was inferior. The two members of the brace-leg were torn off immediately above welds reinforcing the connection of the members to the base plate.

There was very little damage to the vehicle, but the sign background and supports were damaged extensively. The vehicle traveled more than 350 feet after impact.

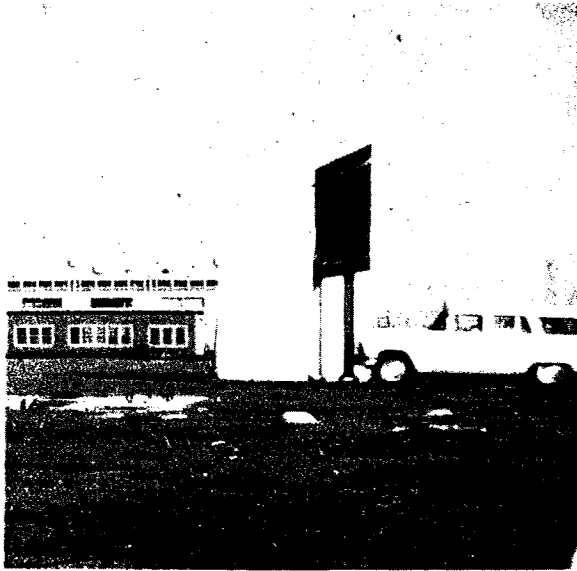
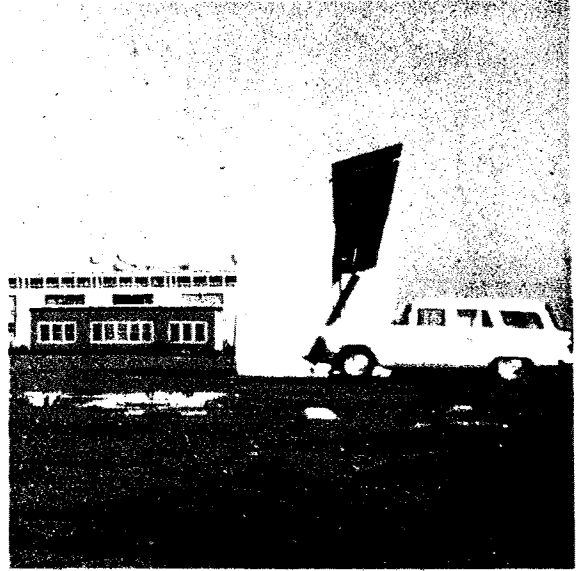
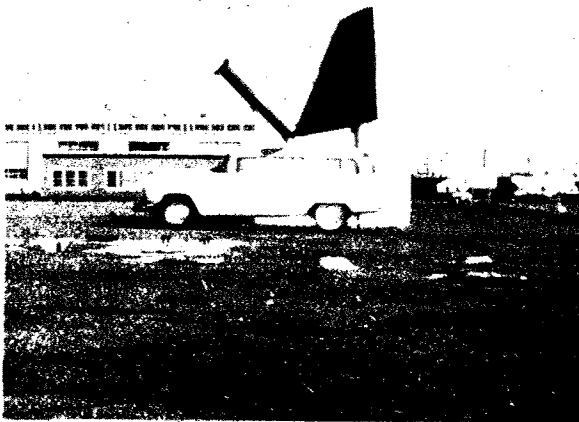
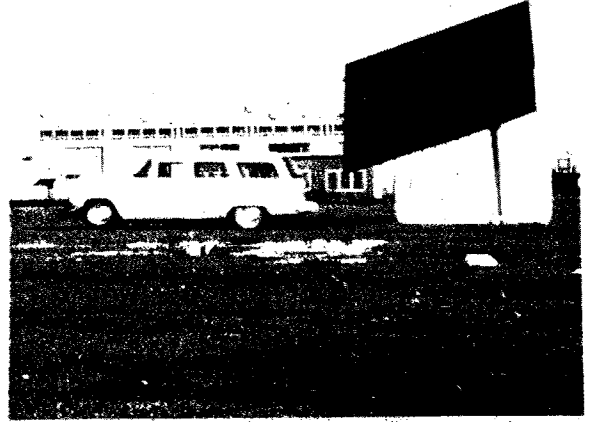
FIGURE 26 - SEQUENCE PHOTOGRAPHS TEST NO.13

There was little difference in the results of this test as compared to Tests 9 and 10. Sequence photographs from the high-speed film are shown in Figure 26. From the film it was observed that the vehicle traveled approximately 8 inches deforming the front bumper and associated parts between initial contact with the post and the time slippage occurred at the base. Immediately, the post twisted approximately 15 degrees to align itself with the vehicle and this twisting caused the fracture plate on the front flange to fail. Then, the lower section of the leg rotated about the hinge joint. The post was dragged across the grill section and released free of the vehicle at a point approximately 7 feet beyond where the vehicle had first encountered the post. The lower section of the post continued to rotate about the hinge until it struck the upper portion of the post. After the vehicle had passed on beyond the sign the entire sign rotated about the right support through an angle of approximately 75 degrees.
