IMPACT BEHAVIOR OF SIGN SUPPORTS-II

A STAFF PROGRESS REPORT

Research Report Number 68-2

Sign Support Structures  
Research Project Number 2-5-63-68

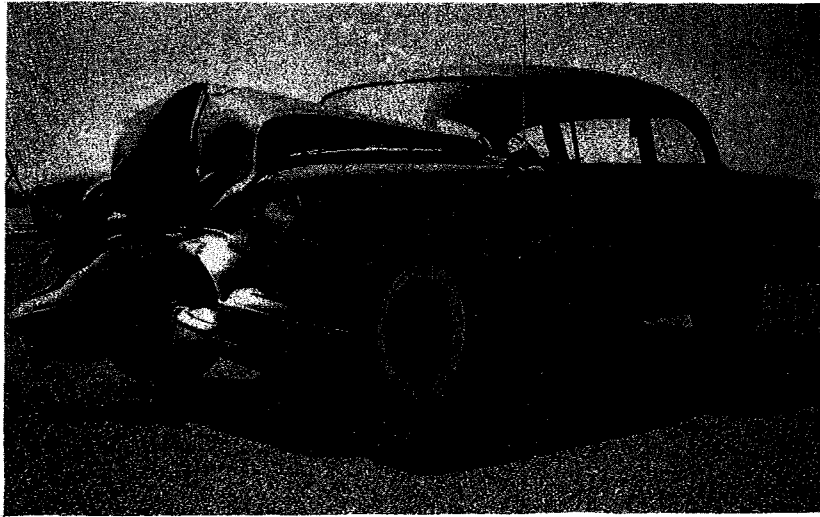
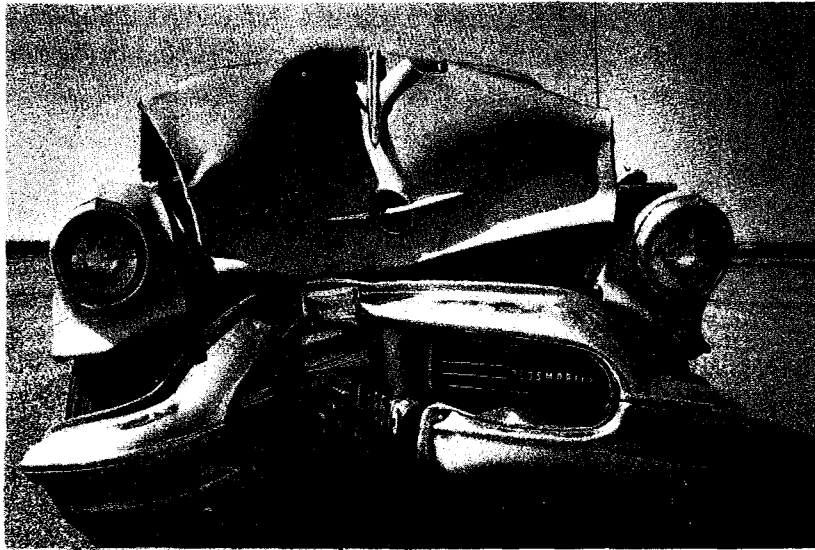
**FIGURE 2 – VEHICLE DAMAGE  
SLOW-SPEED FIXED POST TEST**

1955 Oldsmobile, was being towed along the rail the transmission was inadvertently engaged. The speed of the automobile was reduced and it veered to the left after it was released from the towing mechanism. As a result the vehicle struck the left leg of the sign at the approximate center of the hood. The crash speed was later calculated at 22 mph. The damage effects of this collision are illustrated in Figure 2. The sign installation was not damaged appreciably and the third test was conducted immediately. In this particular test the vehicle, a 1955 Pontiac, struck both posts simultaneously at a speed of approximately 45 mph. In the photographs in Figure 3, it is observed that the sign supports failed in the weld at the base plate, but failure occurred after much of the impact energy had been dissipated and the vehicle had stopped.

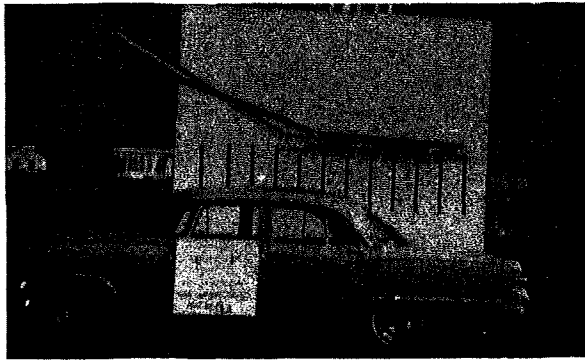
50 MPH TEST  
HORIZONTAL BASE PLATES

The variation in speed at which the crash vehicle struck the sign support did not materially affect the amount of damage done to the front of the vehicle. However, at slower speeds (25 mph) the sign struck the top of the automobile face down and caused considerable damage to the top of the automobile, Figure 6. Standard sedans were used in these tests and the steel top would have provided protection for occupants of the vehicle in practically every case. However, damage to convertibles would have been rather severe. The sign performed satisfactorily in its rotational movement over the top of the automobile at high speeds. The damage sustained in the slow speed tests however, necessitated some consideration of modifying the design to improve impact behavior at slow speeds.

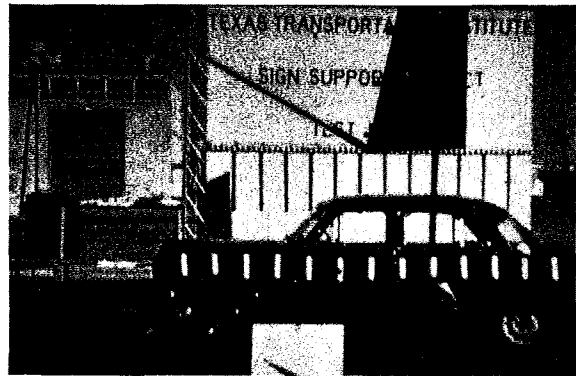
SINGLE LEG TEST

In the tests in which only the left leg of the sign was struck, the support was easily released at the base and the hinge joint functioned properly to permit the post to hinge up out of the way of the crash vehicle, (Figure 6). After the vehicle had passed on under the sign, the sign itself rotated horizontally causing the cast iron plate on the hinge of the right post to fail and as a result the sign collapsed.

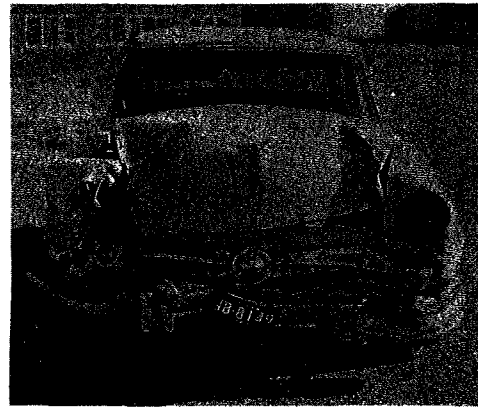
VEHICLE DAMAGE

The test results indicated that the left post deformed the front bumper and other parts approximately 8 to 10 inches before the cast iron fittings fractured. Approximately the same deformation was observed after the right front portion of the vehicle made contact with the right post. Additional deformation was caused by the inertia effects of the sign supports upon release of the base.

The sign supports rotated about the front of the hood so that the sign face struck the top of the automobile over the driver compartment, Figure 7. The sign produced 3 to 4 inches permanent deformation in the top of the automobile.

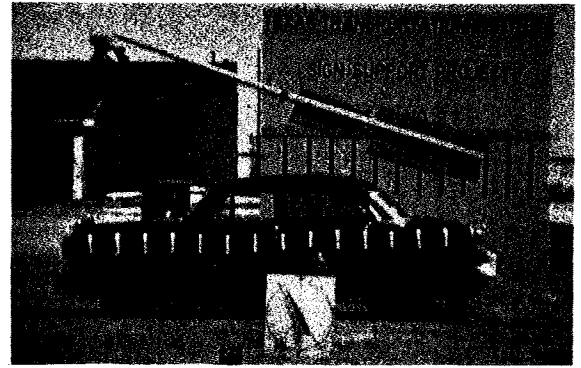
3" PIPE  
HORIZONTAL BASE

In the crash test on the 3-inch pipe support, the support deformed the front bumper approximately 4 inches before slippage occurred at the base. After the base slipped the ambient air resistance and inertia of the upper portion of the post which was 11 feet in length caused the post to bend through an angle of approximately 5 degrees above the hinge joint. The hinge joint did not fail in this test and the sign support went into a rotational pattern which carried it to a horizontal position approximately 2 1/2 feet directly above the automobile. The support continued in its rotational trajectory and the upper most portion of the post struck the rear of the vehicle (Figure 9).

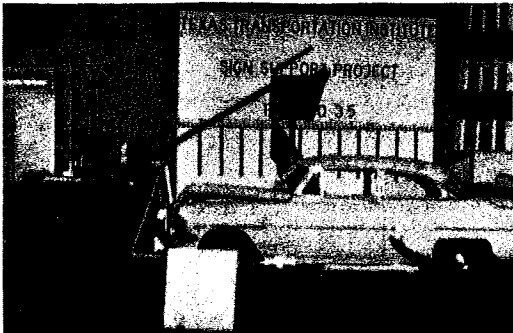
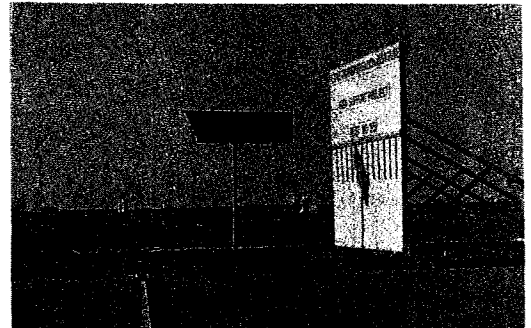
FIGURE 11 — VIEWS OF DUAL PIPE SUPPORT TEST

The sign was oriented at an angle of 15 degrees to simulate the most normal conditions of a vehicle leaving the roadway. In the test, the vehicle struck the left post at a speed of approximately 30 mph. Upon impact the bumper of the automobile and the grill and hood were deformed approximately 8 inches before slippage occurred at the base of the post. Once the base slipped the post rotated upward, swinging to the right, attempting to bend the sign around the right support (Figure 11). The upward rotation of the post partially pulled it loose from the sign and its horizontal rotation finally caused the sign to break in half and the left hand portion of the sign including the left hand support fell to the right of the vehicle. Since there was no hinge joint in the support the sign functioned as its own hinge in both the horizontal and the vertical direction.

On the basis of this test it was concluded that the dual pipe mounts would perform satisfactorily provided they employ a slip base. It is believed that the inclined base is beneficial because it aids the post in rotating clear of the automobile. No further tests were conducted on this particular design because experience from tests on two-legged signs

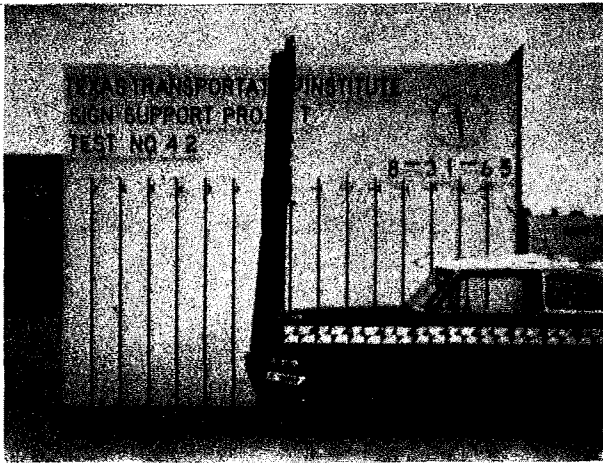
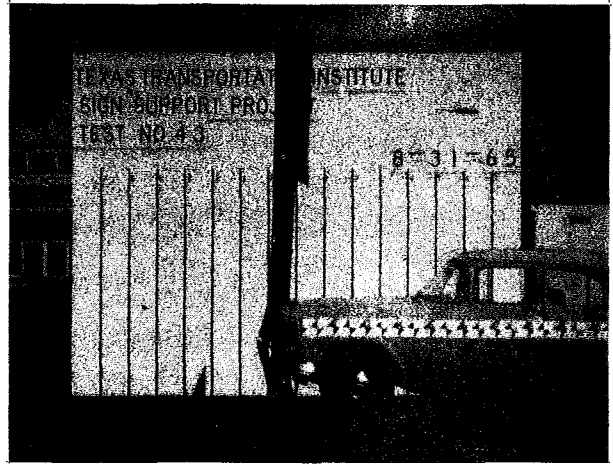
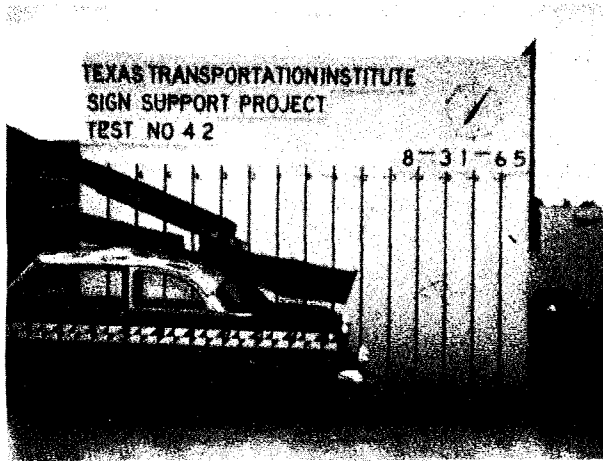
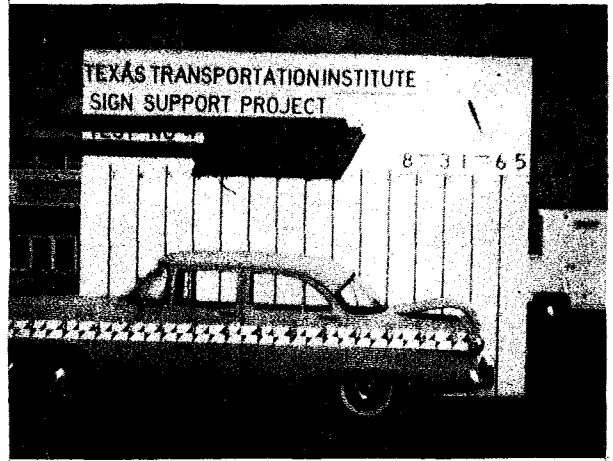
PENNSYLVANIA  
DESIGN

Pennsylvania Design--When the vehicle collided with both supports, ((Figure 12) the left support broke in two at the lower notch after the post had deformed the front bumper approximately 4 inches. The failure in the right post was delayed momentarily and then failed beginning at the lower notch which is on the front of the post and progressing to the back edge of the post at the foundation. The remaining lower portion of the post was broken off at the foundation.

After the posts were broken loose at the base, the supports were thrown clear of the front of the automobile, and the sign and supports started to rotate over the top of the automobile. During this rotation the sign slipped off the angles to which it was clamped, slipping upward and leaving the posts in free motion. The upper end of the right post struck the top of the vehicle over the rear seat, deforming the top approximately 4" to 5". The left post barely missed the rear bumper of the automobile as it continued to rotate over the top of the automobile.
