Project Summary Report 7-2966-S

Project 7-2966: Durability of Surface Treatments
as the Wearing Course Placed on Crushed Fly Ash
and Long-Term Performance of Crushed Fly Ash for Flexible Base

Performance of Fly Ash as a Base Material on Six Test Pavements in the Atlanta District

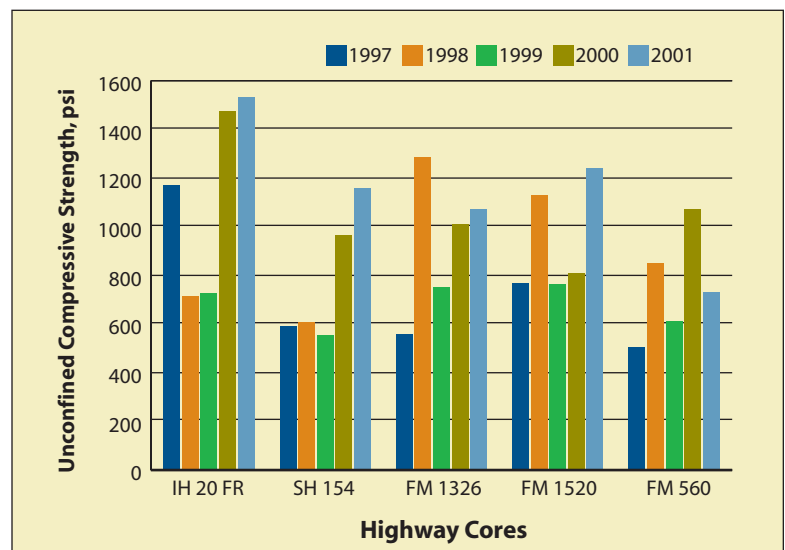
Figure 1. Compressive Strength of Highway Cores.

- Year 2001 FWD data were compared to those taken in 2000, 1999, 1998, and 1997. Moduli of the fly-ash base materials were back-calculated from the FWD data. There is no indication of any significant weakening of these base materials with time. In the past year, there appears to be some weakening exhibited in FM 560 and FM 1520.
- Cores were taken on all of the test pavements except Loop 390. No intact core could be obtained from Loop 390 throughout the five years of this project. Compressive strengths

for the cores from the other five test pavements were comparable to or greater than the strengths observed in the year 2000 and previous years as shown in [Figure 1](#).
