IMPACT BEHAVIOR OF LUMINAIRE SUPPORTS

Research Report Number 75-8

Supplementary Studies in Highway Illumination

TEXAS TRANSPORTATION INSTITUTE  
Texas A&M University  
College Station, Texas

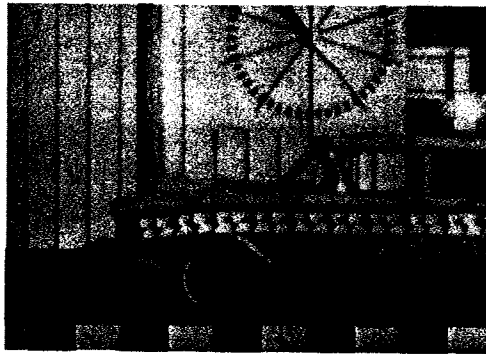
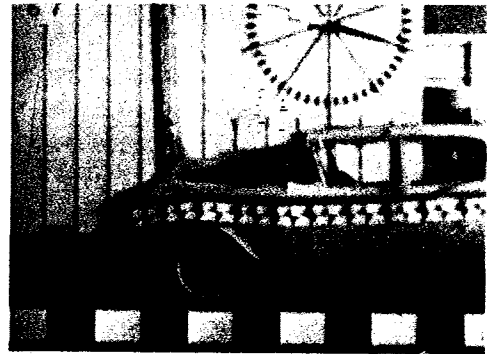
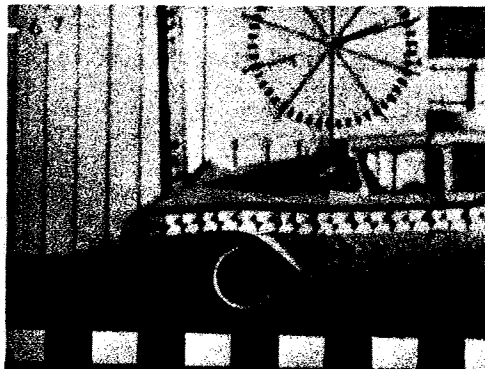
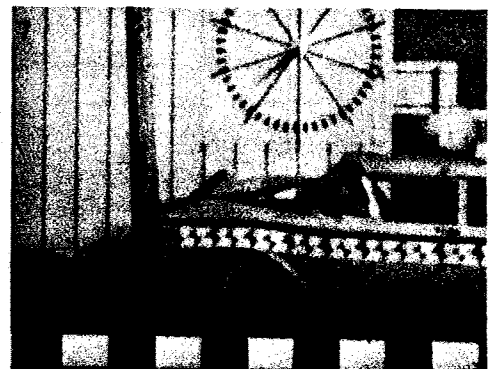
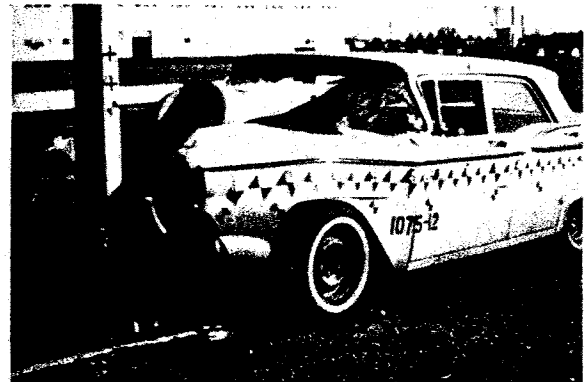
**FIGURE 4**  
**SEQUENCE PHOTOGRAPHS OF TEST OF STEEL**  
**POLE-STEEL TRANSFORMER BASE COMBINATION**

The fact that the steel pole with steel transformer base completely stopped the vehicle from an impact of 39.4 miles per hour is sufficient evidence that the design is unsatisfactory from the standpoint of safety. The front of the crash vehicle was deformed approximately 30 inches and the force of the impact actually caused the vehicle to bounce back approximately 24 inches. The severity of the collision is illustrated in the series of photographs in Figure 4. The pole remained in an upright position after the impact but considerable damage was done to the anchor bolts. This test is considered sufficient evidence to completely rule out this design.

1. The steel transformer base for luminaire supports is definitely an unsatisfactory design and should not be used in any case.
2. The cast aluminum transformer base for luminaire supports appears to be a satisfactory failure mechanism to reduce the impact severity of vehicular collisions with luminaire supports. However, this statement should be conditioned to apply only to head-on collisions at this time. No studies were conducted to determine the behavior of these designs under the conditions of skidding or side impact of the automobile. This is a very important consideration and further study is contemplated.

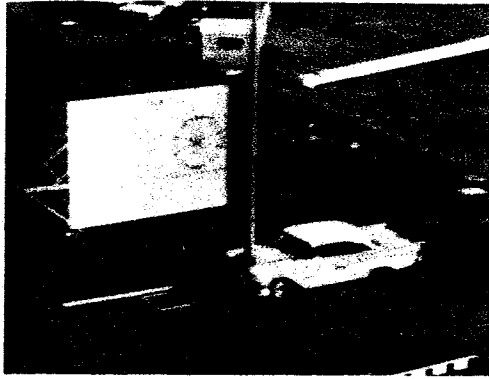
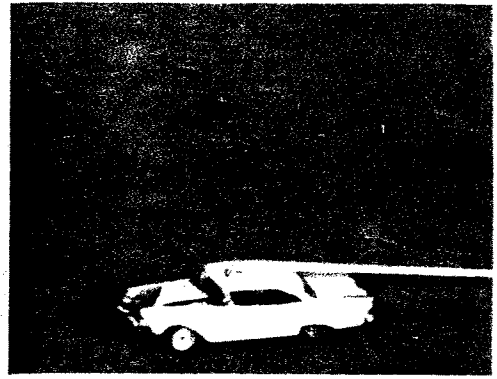
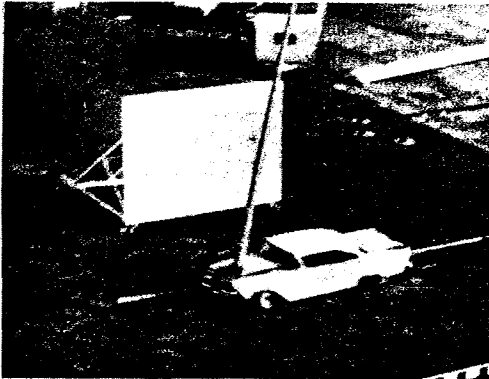
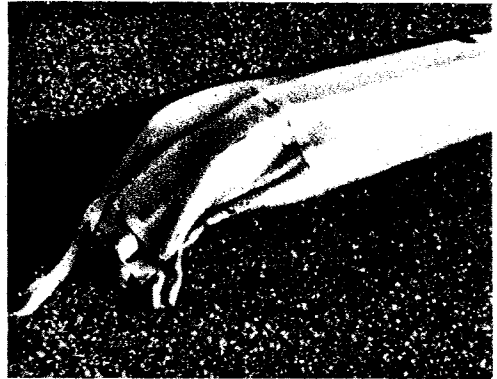
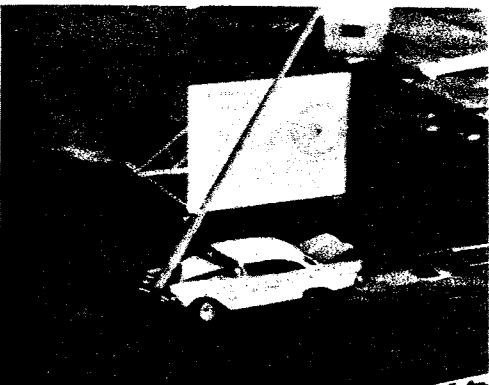
**FIGURE 5**  
**SEQUENCE PHOTOGRAPHS OF TEST OF**  
**FLANGE MOUNTED STEEL POLE**

The flange-mounted steel pole produced less severity than the steel-transformer base mounting, but it was still considered quite hazardous. The failure mechanism was the shaft itself. As the crash progressed (see Figure 5), the shaft crushed in the vehicle contact area and sheared across the weld at the flange. The impact force was sufficient to cause 27 inches of deformation before failure occurred. This particular pole was constructed of eleven gauge steel plate; some poles are made of thicker steel plate and they would naturally offer much greater resistance to impact.

As the vehicle crushed the pole and tore it loose from the flange, a hook was formed on the bottom of the pole which held the pole on the automobile momentarily. The pole finally cleared the automobile at approximately 40 feet beyond the point of impact. The fact that the pole was momentarily hooked to the automobile gave it a forward and downward acceleration and the pole struck the top of the automobile; however, this was comparatively minor damage. The pole finally came to rest with its top approximately 60 feet from the foundation.

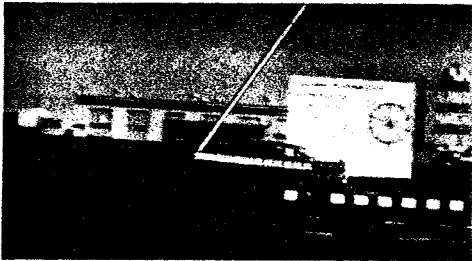
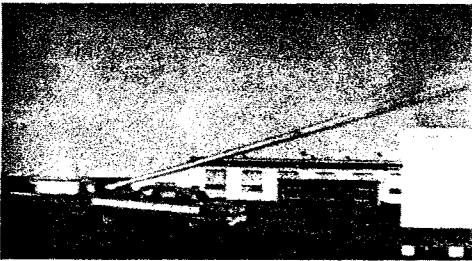
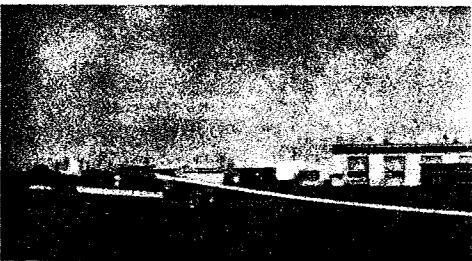
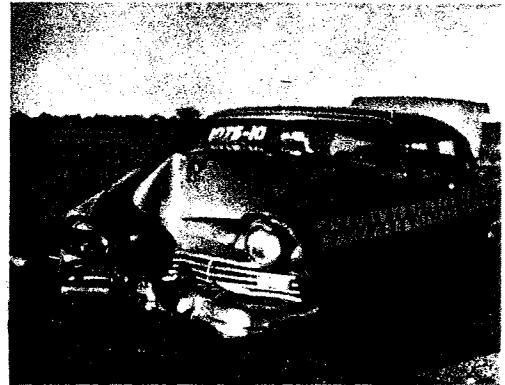
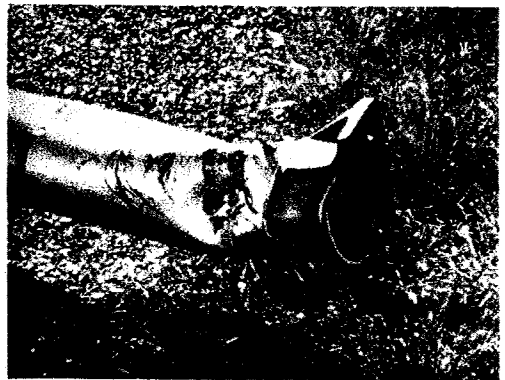
**FIGURE 6**  
**SEQUENCE PHOTOGRAPHS OF TEST OF**  
**FLANGE MOUNTED ALUMINUM POLE**

The flange-mounted aluminum pole offered almost as much resistance to impact as did the flange-mounted steel pole, based on observations of the physical damage to the automobile (see Figure 6). This is evidenced by the fact that the deformation of the frontal area of the automobile was 23 inches when the pole finally failed. Failure occurred by the vehicle crushing the impact side of the pole and breaking the cast aluminum flange on the pole. Since the pole was crimped or crushed, a hook was formed and caught on the front bumper of the vehicle momentarily as in the case of the steel pole. This gave the pole an appreciable forward and downward acceleration so that the pole struck the top of the automobile. The pole stayed in contact with the front of the automobile for approximately 45 feet beyond the point of impact. After striking the ground, the pole skidded forward until the top of the pole was approximately 40 feet from the foundation.

After the pole was torn loose at the base, the mast arm swung through approximately a half-circle before the top of the pole struck the ground.

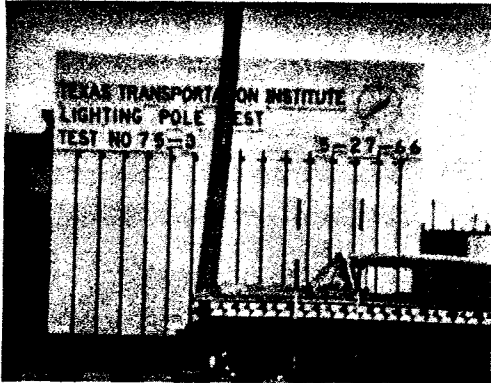
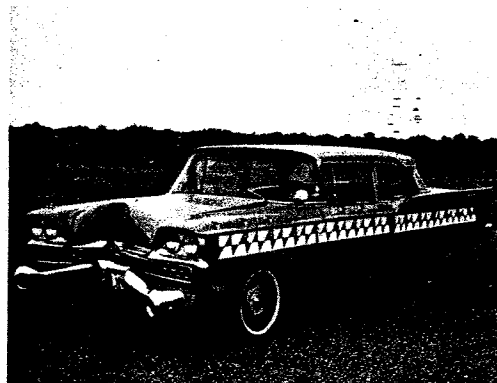
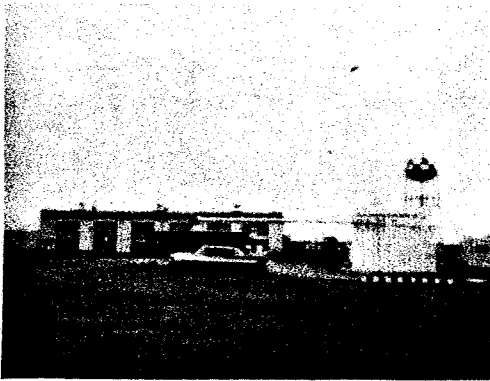
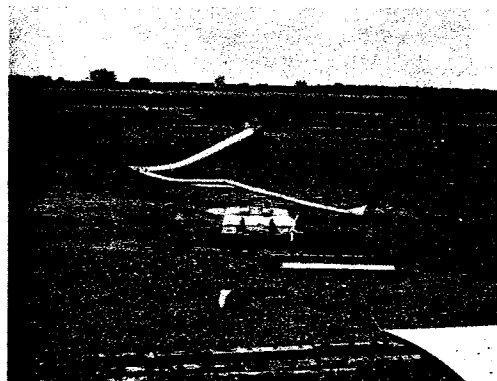
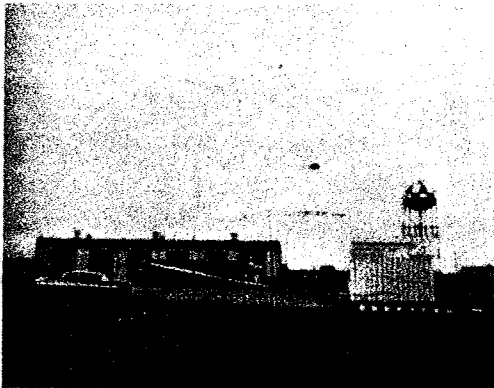
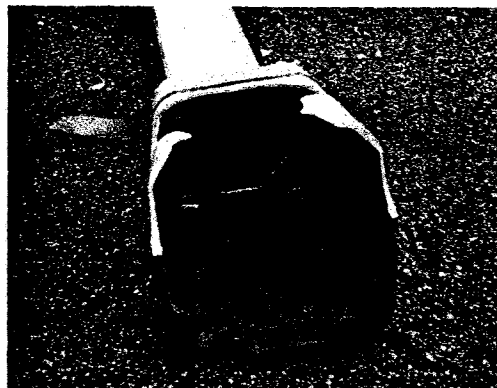
FIGURE 7  
SEQUENCE PHOTOGRAPHS OF TEST OF  
STEEL POLE-ALUMINUM TRANSFORMER  
BASE COMBINATION

In the 45-mile-per-hour test with the standard sedan, the vehicle caused failure in the transformer base after a maximum deformation of the frontal area of the vehicle of 15 1/2 inches, and the pole was thrown clear of the automobile (see Figure 7). As the crash vehicle struck the transformer base, failure occurred by breaking out the front lower portion of the transformer base held by the two anchor bolts on the impact side of the base (see Figure 7f). As this failure occurred, the anchor bolts on the backside actually functioned as a slip joint; the base simply slipped off the two back anchor bolts. It was noted that the pole remained in contact with the front of the automobile for a distance of approximately 15 feet beyond the point of impact. At that time it was thrown clear of the automobile and continued in an upward arc so that the lower end of the pole completely cleared the automobile and struck the ground behind it (see Figure 7c). It is significant to note that the pole continued in the same direction as the impact, and further, that the top of the pole struck the ground very near the foundation. It was observed, however, that the mast arm swung through an angle of approximately 210 degrees in a clockwise direction looking downward from the top of the pole.

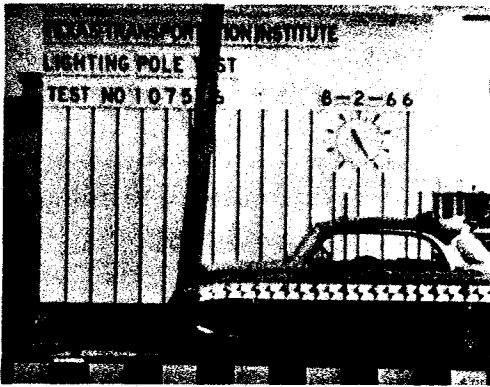
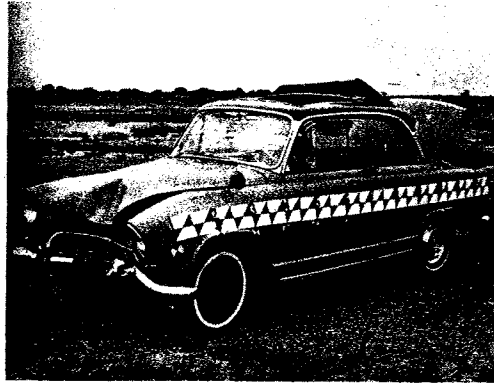
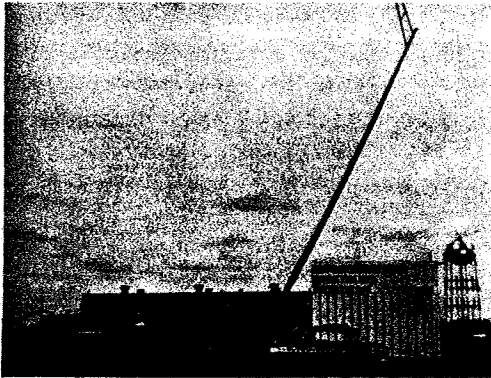
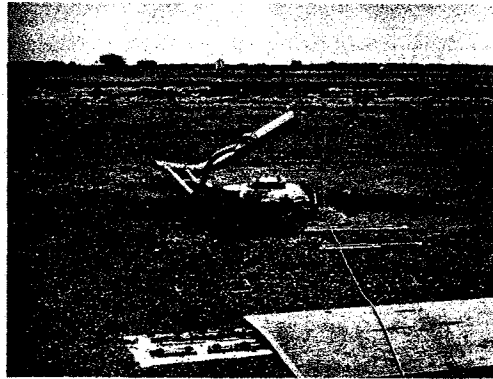
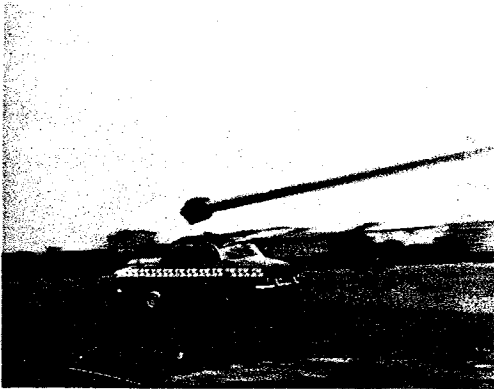
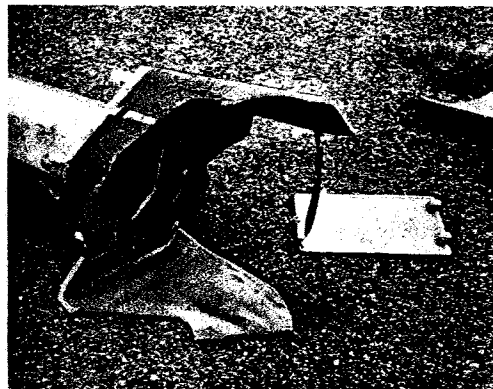
FIGURE 8  
SEQUENCE PHOTOGRAPHS OF TEST OF  
STEEL-POLE-ALUMINUM TRANSFORMER  
BASE COMBINATION

In the test with the compact sedan, the performance of the automobile and the pole appeared to be the same as that in the test described above (see Figure 8). Analysis of the film indicated that the deformation of the front of the vehicle was slightly less than that of the full-size sedan. This could be attributable to the design of the vehicle. A comparison of the change in speed during the impact shows that the compact sedan was reduced 7.7 miles per hour while the standard sedan was reduced in speed only 3.3 miles per hour. Otherwise, the tests appeared to produce the same results.

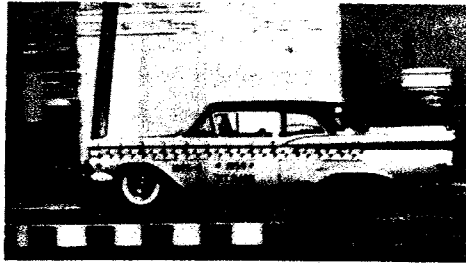
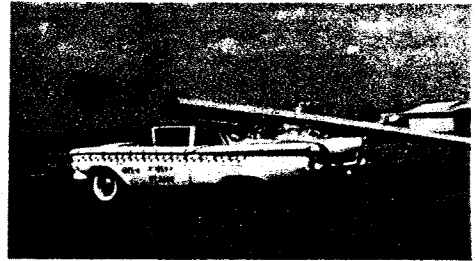
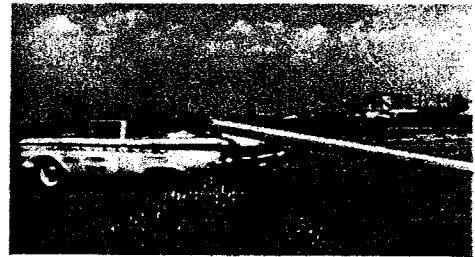
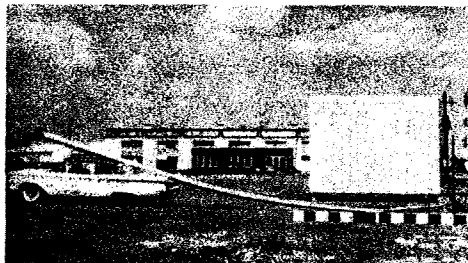
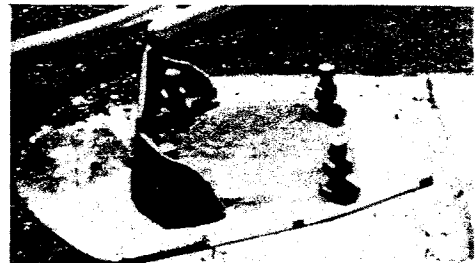
**FIGURE 9  
SEQUENCE PHOTOGRAPHS OF TEST OF  
STEEL-POLE-ALUMINUM TRANSFORMER  
BASE COMBINATION**

In the 20 mph test, the break-away action was the same as in the two previous tests. As the base was broken loose, it was carried forward approximately 20 feet where the pole slipped downward over the hood and the base became engaged with the paved surface and received a secondary impact by the automobile. This secondary impact caused only minor additional damage to the automobile, but in the following action the pole fell across the hood of the automobile, across the top and finally struck quite severely across the rear of the top breaking the rear glass in the automobile. This action is illustrated in the sequence photographs in Figure 9. It appears that the rear windshield was broken by the whiplash action of the pole when the top of the pole struck the ground. The base of the pole dragged across the top and trunk of the automobile as the vehicle cleared the area.

The fact that the pole strikes the top of the automobile in the slow speed collision is not a desirable feature; however, at the present it appears to be a characteristic that cannot be avoided. When considered in light of the possibility that the pole in any other mounting configuration may not have broken away it appears to be of secondary importance.

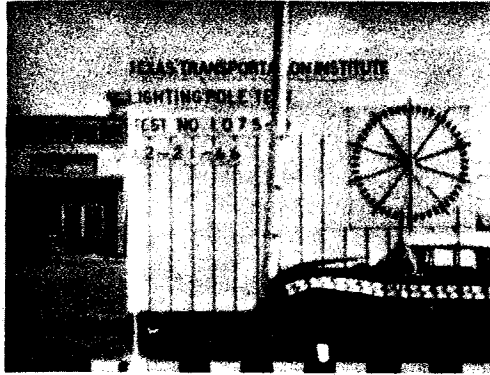
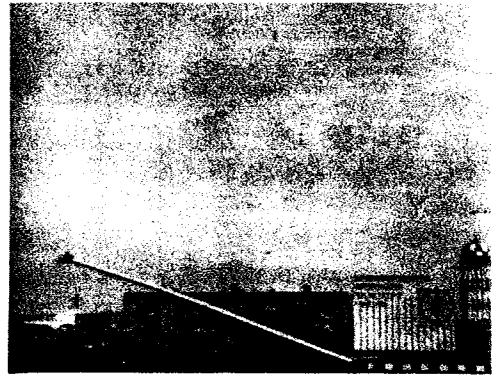
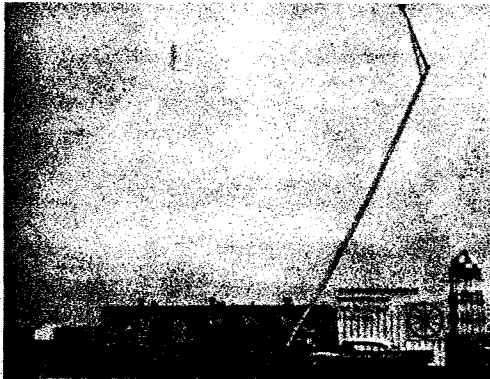
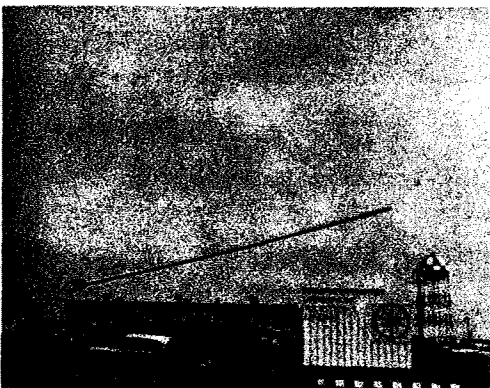
FIGURE 10  
SEQUENCE PHOTOGRAPHS OF TEST OF  
ALUMINUM-POLE-ALUMINUM TRANSFORMER  
BASE COMBINATION

In general, the impact behavior of this design was not greatly different from that of the steel pole with the larger aluminum transformer base. The failure mechanism, that is the fracture and the slippage of the base, was essentially the same as that experienced with the steel pole - aluminum transformer base design.

In the high-speed test it was observed that the pole was thrown clear of the automobile, approximately 6 feet beyond the point of impact, whereas the steel pole was not thrown clear until the vehicle had reached a point of approximately 15 feet beyond the point of impact. This difference is attributed primarily to the difference in the weight of the poles. As shown in the sequence photographs in Figure 10, the vehicle passed on through without a secondary impact and the pole fell with its top near the foundation. It was observed that the pole rotated through an angle of approximately 240 degrees during its descent to the ground.

In the slow-speed test, the vehicle veered to the left as it left the end of the guide rail and almost missed the pole. The vehicle struck the pole with its right bumper and right headlight section and forced the pole off at a small angle to the right. The failure mechanism, that is fracture of the base, occurred in the same way but the pole did not fall on the automobile. Quite likely if this had been a head-on collision, as in the other tests, the pole would have struck the top of the automobile.

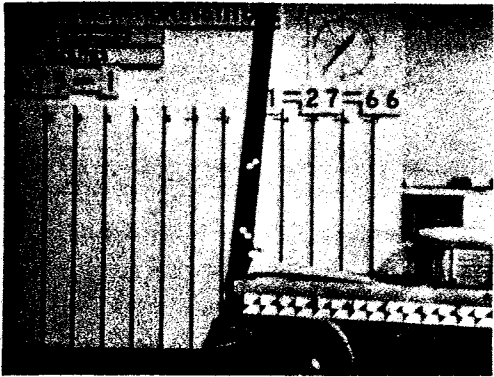
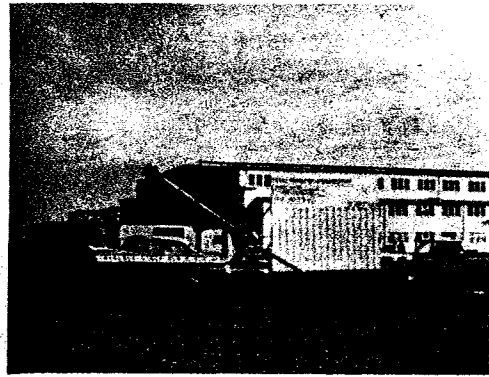
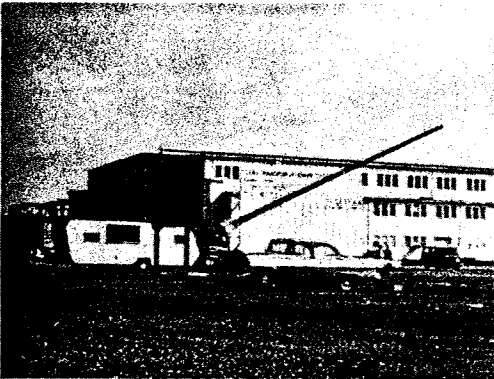
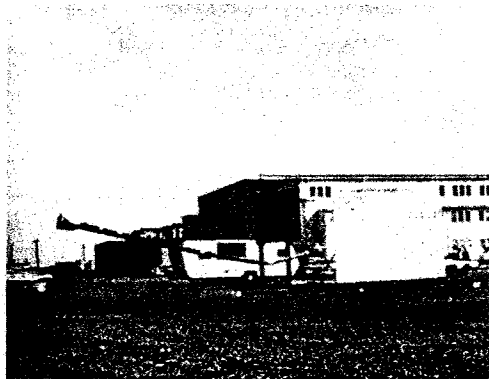
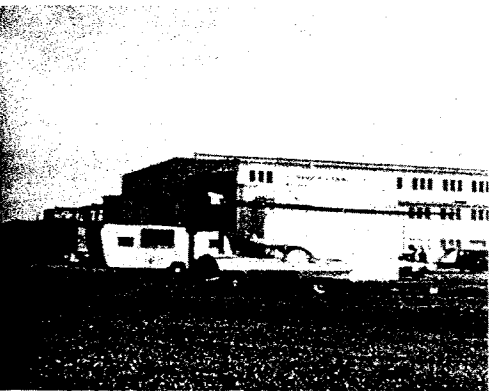
**FIGURE II  
SEQUENCE PHOTOGRAPHS OF TEST OF STEEL  
POLE - STEEL TRANSFORMER BASE WITH CAST  
ALUMINUM INSERT COMBINATION**

The two crash tests were conducted at nominal speeds of 50 and 30 miles per hour. In the 50 mph test, the performance of the failure mechanism was similar in many respects to the break-away signs (see Figure 11). Initial failure was due to slippage between the transformer base and the insert. After the base slipped the attaching bolts were caught between the front transformer base and the back side of the insert causing the damage to the insert as shown in Figure 11(f).

The front of the vehicle was deformed 15.8" during the impact. Part of this was due to the weight of the steel transformer base, 120 pounds, to be set into motion. Once the base was free, the mounting assembly traveled approximately 75 feet in the direction of the impact. The pole remained airborne long enough for the crash vehicle to clear the area without experiencing a secondary collision.

3. A cast aluminum insert placed between the foundation and a steel transformer base for luminaire supports appears to be satisfactory for remedial design measures. However, this does not appear to be a feasible consideration for new design.

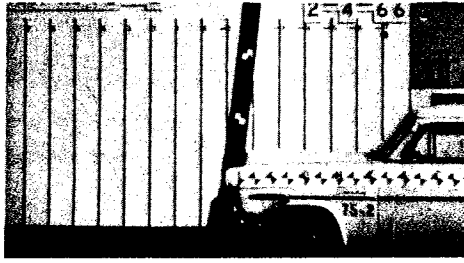
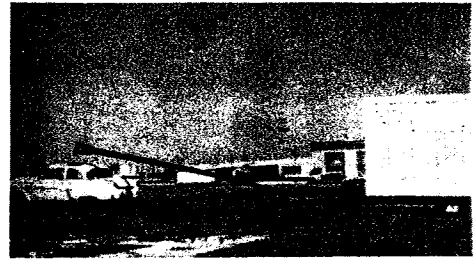
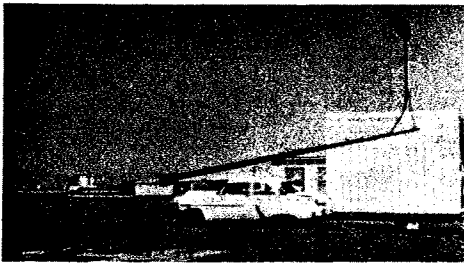
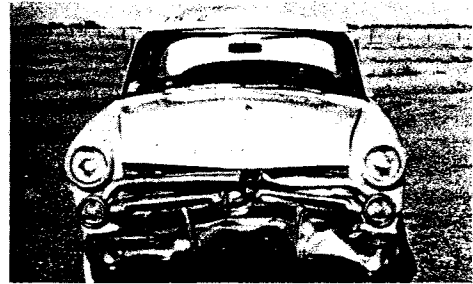
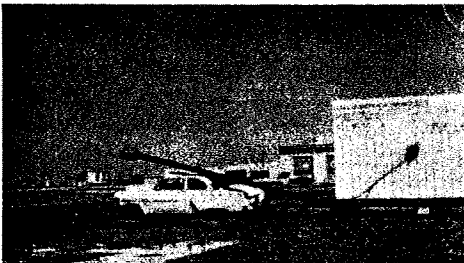
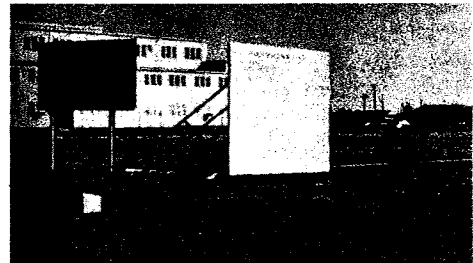
**FIGURE 12**  
**SEQUENCE PHOTOGRAPHS OF TEST OF STEEL**  
**POLE - STEEL TRANSFORMER BASE WITH CAST**  
**ALUMINUM INSERT COMBINATION**

In the slow-speed test, the performance of the mounting assembly was essentially the same except the pole struck the top of the vehicle in a secondary collision (see Figure 12). Once again, the mounting assembly was accelerated in the

direction of the impact. This was due primarily to the low mass center of the mounting assembly.

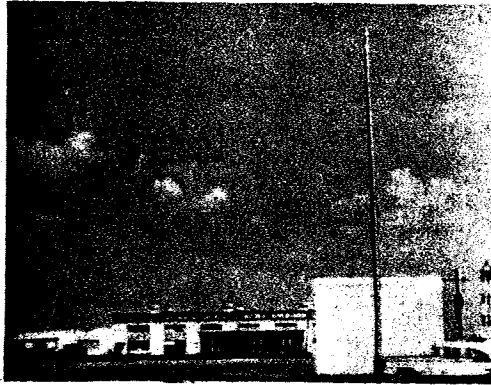
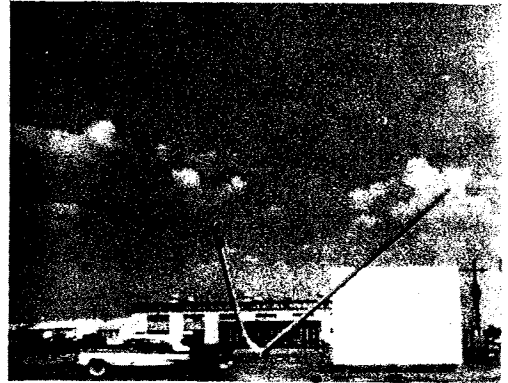
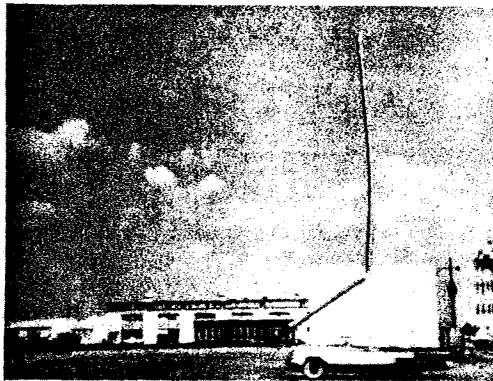
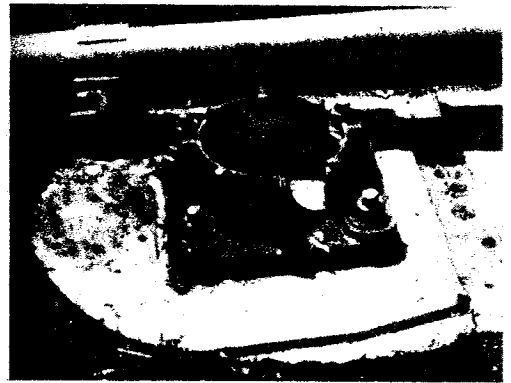
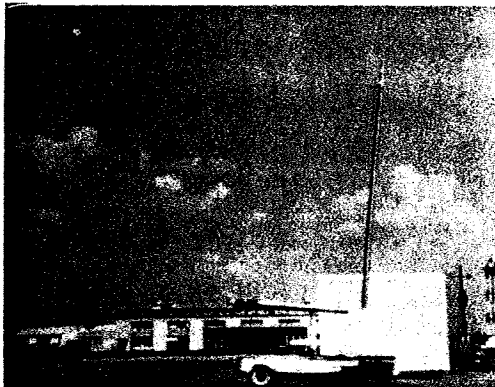
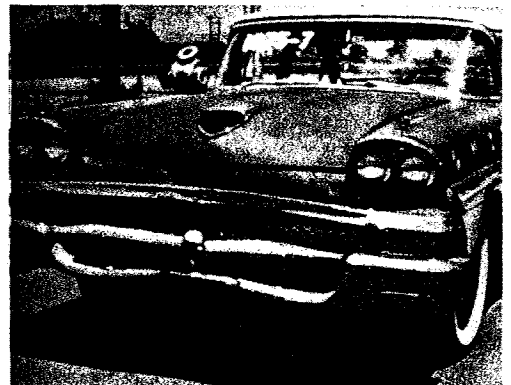
**FIGURE 13**  
**SEQUENCE PHOTOGRAPHS OF TEST OF**  
**FLANGE MOUNTED FIBERGLASS POLE**

The fiberglass pole was crash tested using a standard sedan in a head-on collision at approximately 55 miles per hour. The vehicle suffered very little damage in the collision, as shown in the sequence photographs in Figure 13. Deformation of the front of the vehicle was only 3 inches and its speed was reduced 2.5 miles per hour, from 55.8 to 53.3.
