PROGRESS REPORT ON THE RELATIONSHIP  
BETWEEN LABORATORY AND FIELD  
PERFORMANCE OF LIGHTWEIGHT  
AGGREGATE CONCRETE

Eugene Buth  
Research Associate  
and  
W. B. Ledbetter  
Assistant Research Engineer

Synthetic Aggregate Research  
Research Study Number 2-8-65-81

November, 1966

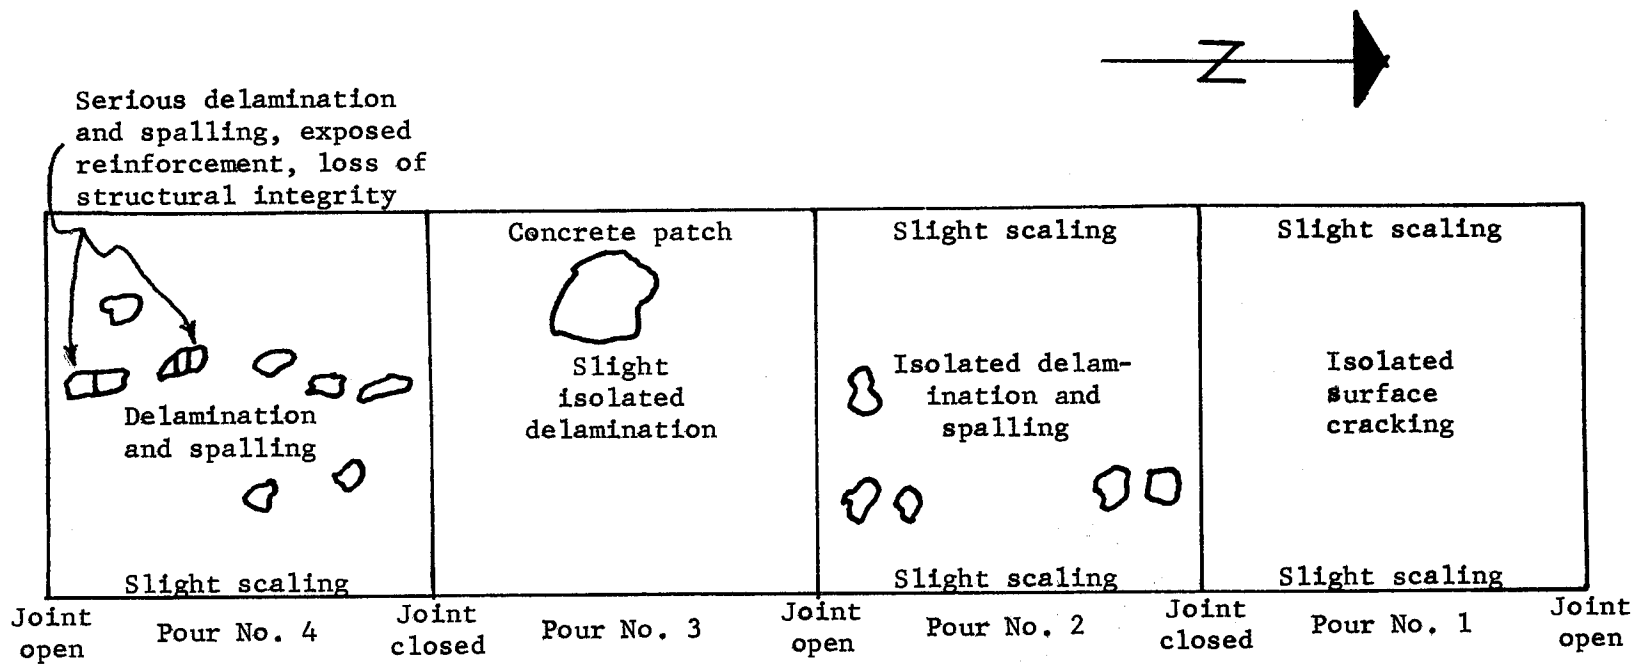
Fig. 2. Plan View of Deer Creek Bridge Deck Showing Deterioration.

As stated earlier, the quality of the concrete varied considerably from pour to pour--two being of relative good quality and two of relatively poor quality. A plan view showing the deterioration is given in Figure 2. It should be pointed out here that the pour numbers are arbitrary and do not represent construction sequence. Pour number one showed only slight surface scaling and minor random cracking and in general showed no serious distress. Pour number two had extensive scaling and moderate cracking with 15 percent of the area delaminated. Pour number three had minor random cracking and scaling and minor delamination. Pour number four was in the worst condition and showed minor cracking and severe scaling with several large areas of open delamination. One area of open delamination had severe cracks causing loss of structural integrity. Three months after the survey was made, the badly cracked and delaminated area failed completely leaving a two-foot hole in the deck. A 7- by 40-foot section of the slab has since been replaced.

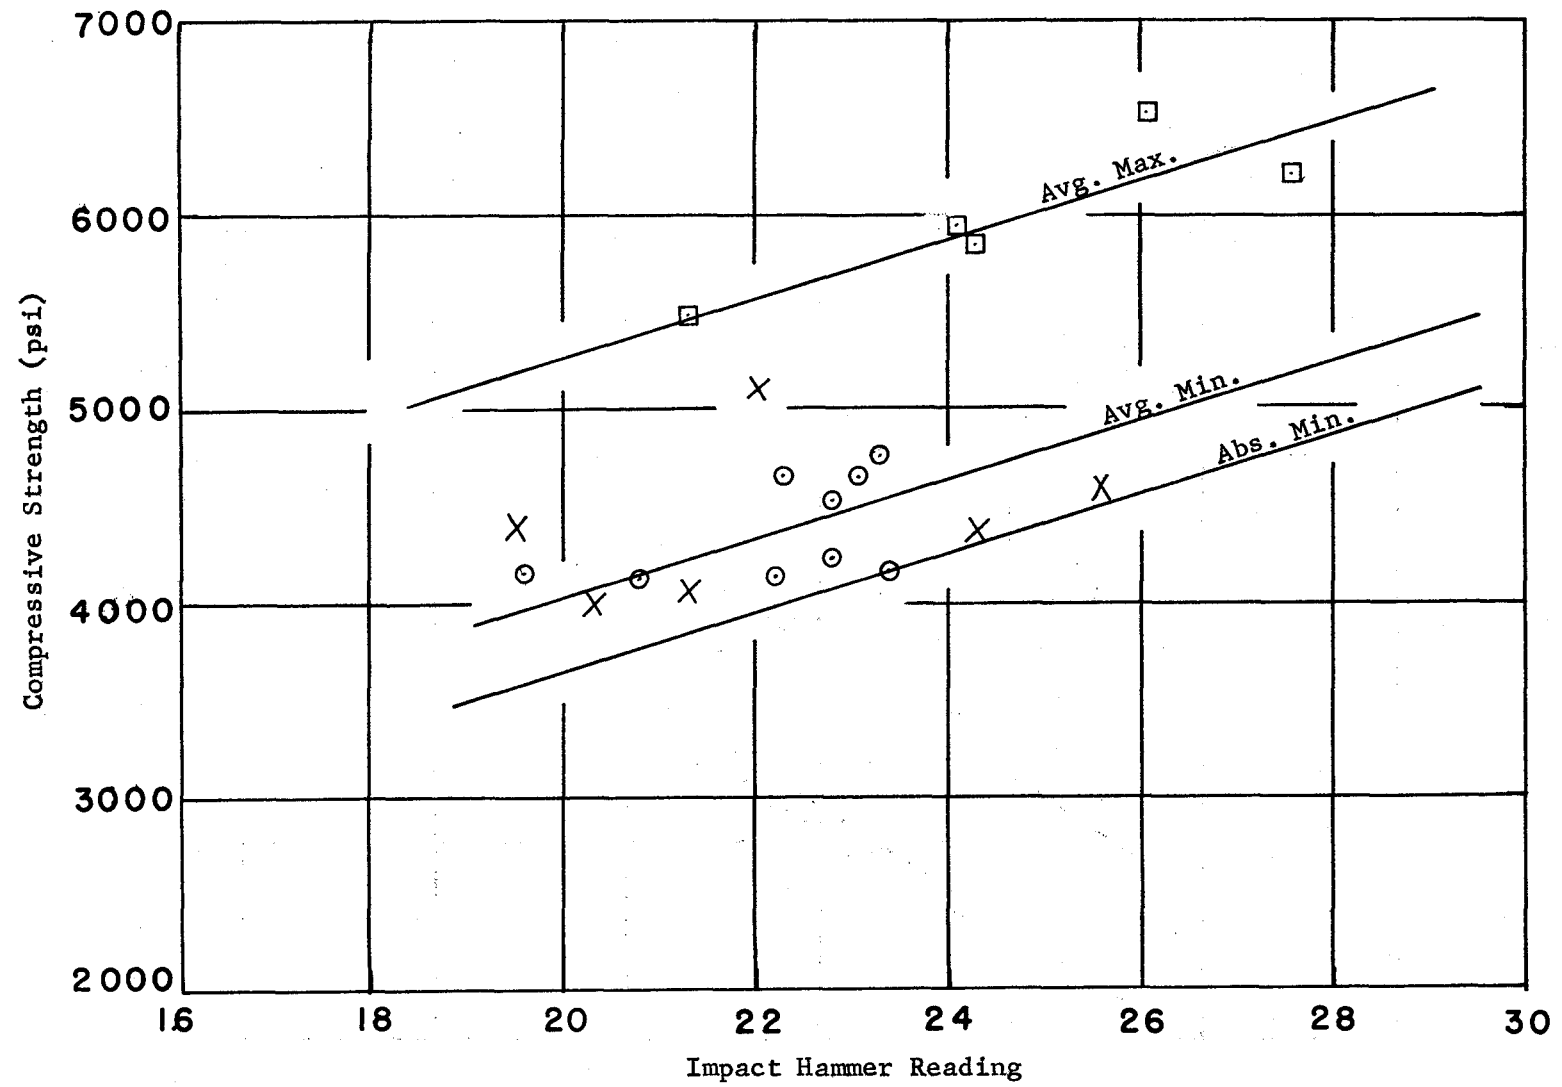
Fig. 3. Relationship Between Compressive Strength and Impact Hammer Reading.

Impact Hammer. Determinations of impact hammer readings were made on each of the cores and on specimens from the laboratory mixes. Comparisons of compressive strength with hammer reading and indicated modulus of elasticity with hammer readings are given in Figure 3 and 4. Using Figure 3 in conjunction with Table 1, it can be seen that these data indicate sufficient compressive strength was obtained in the deck.

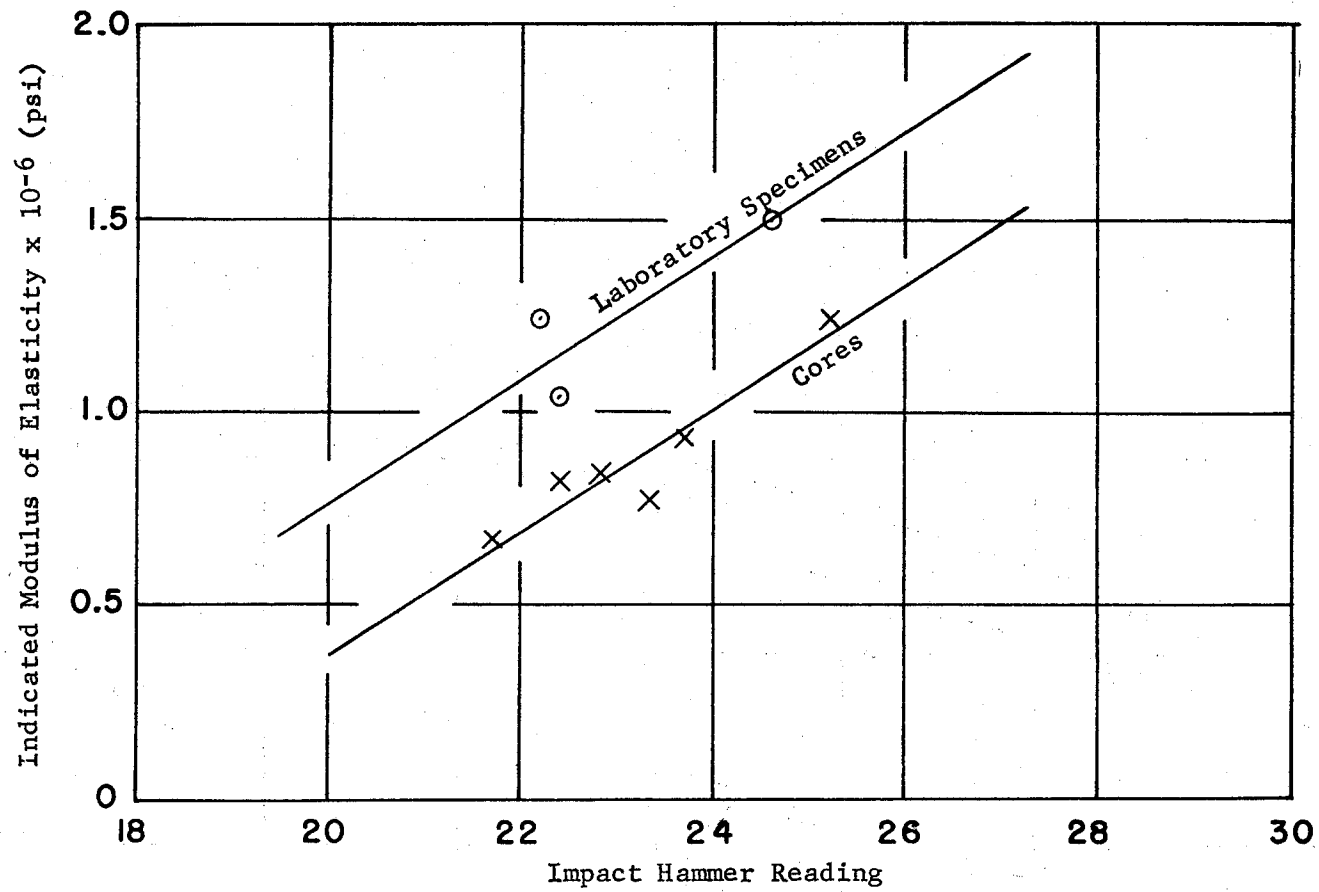
Fig. 4. Relationship Between Modulus of Elasticity and Impact Hammer Readings.

As indicated by Figure 4 or by Table 1, the cores were very flexible--an average indicated modulus of elasticity of only 0.92 million psi was obtained from the 11-year-old concrete while 28-day specimens from the laboratory mixes had an average indicated modulus of elasticity of 1.26 million psi. This tends to point out a significant difference between the materials used in the deck and those used in the laboratory mixes.
