**Development and *MASH* Full-Scale Crash  
Testing of a High-Mounting-Height  
Temporary Single Sign Support with  
Aluminum Sign**

**Test Report No. 9-1002-12-5**

**TEXAS A&M TRANSPORTATION INSTITUTE  
THE TEXAS A&M UNIVERSITY SYSTEM  
COLLEGE STATION, TEXAS**

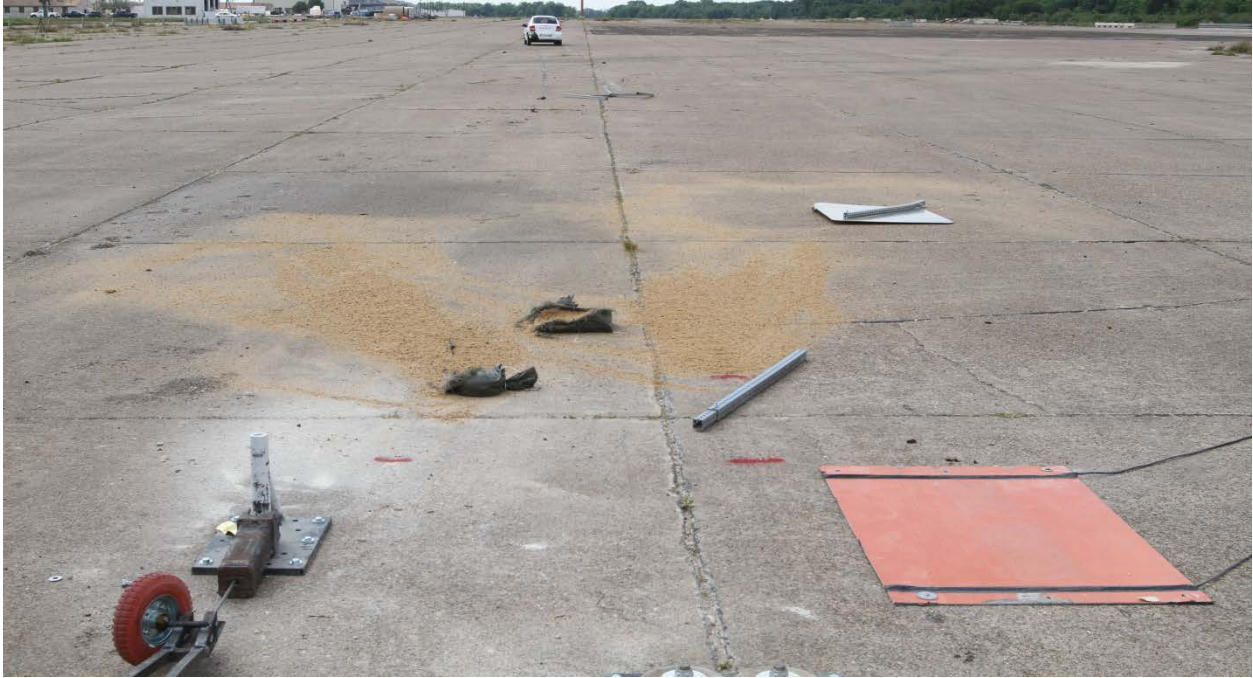
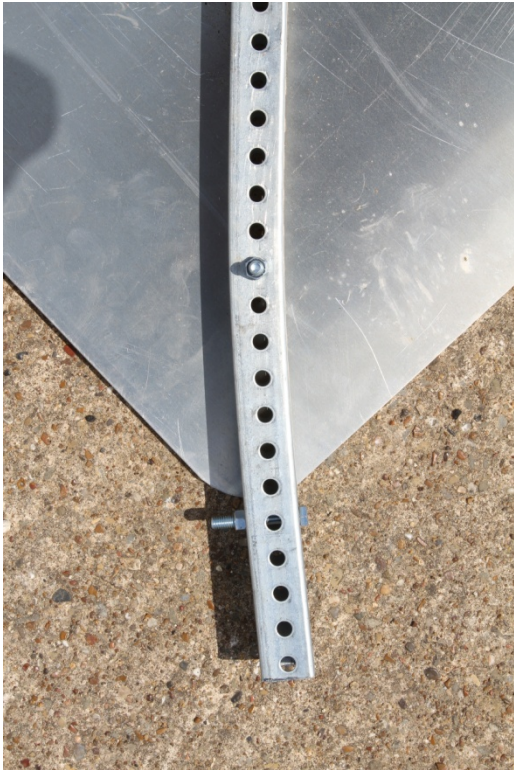
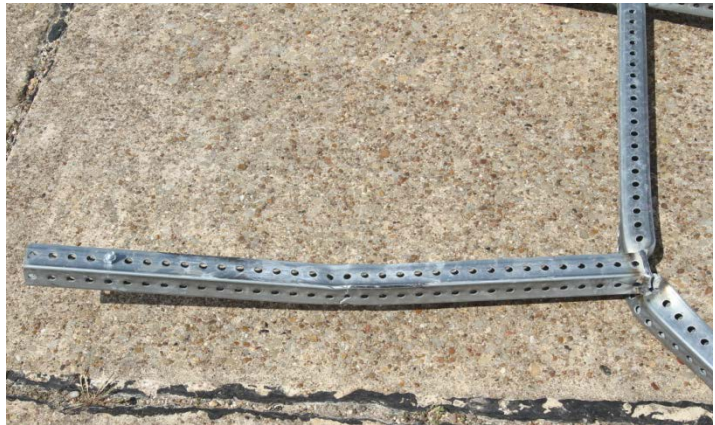
**Figure 4.8. Installation after Test No. 490022-7-1.**

Figure 4.8 shows damage to the sign support system. Both slip joints activated, but the upper slip joint only activated after significant rotation (almost 180 degrees) of the released vertical support. The vertical sign brace was deformed, and the sign assembly came to rest 20 ft downstream of the impact point. The base assembly was resting 77.5 ft downstream of the impact point.

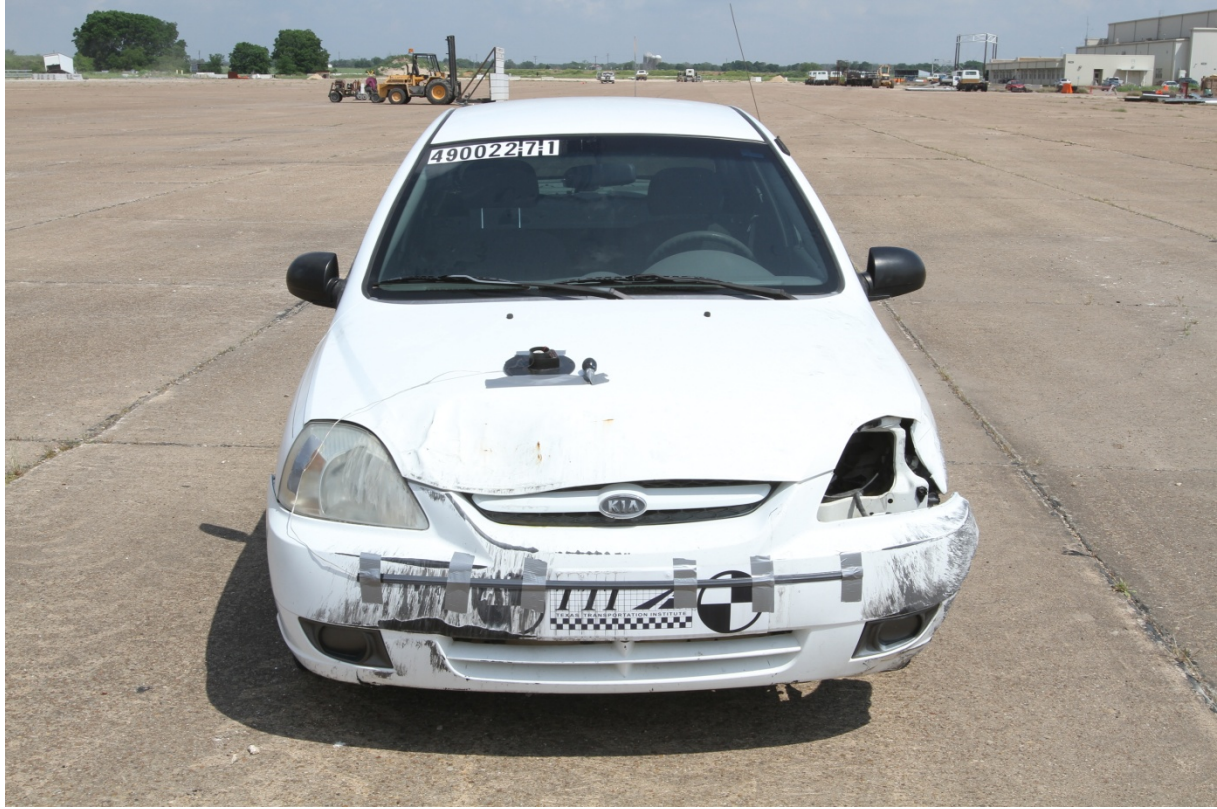
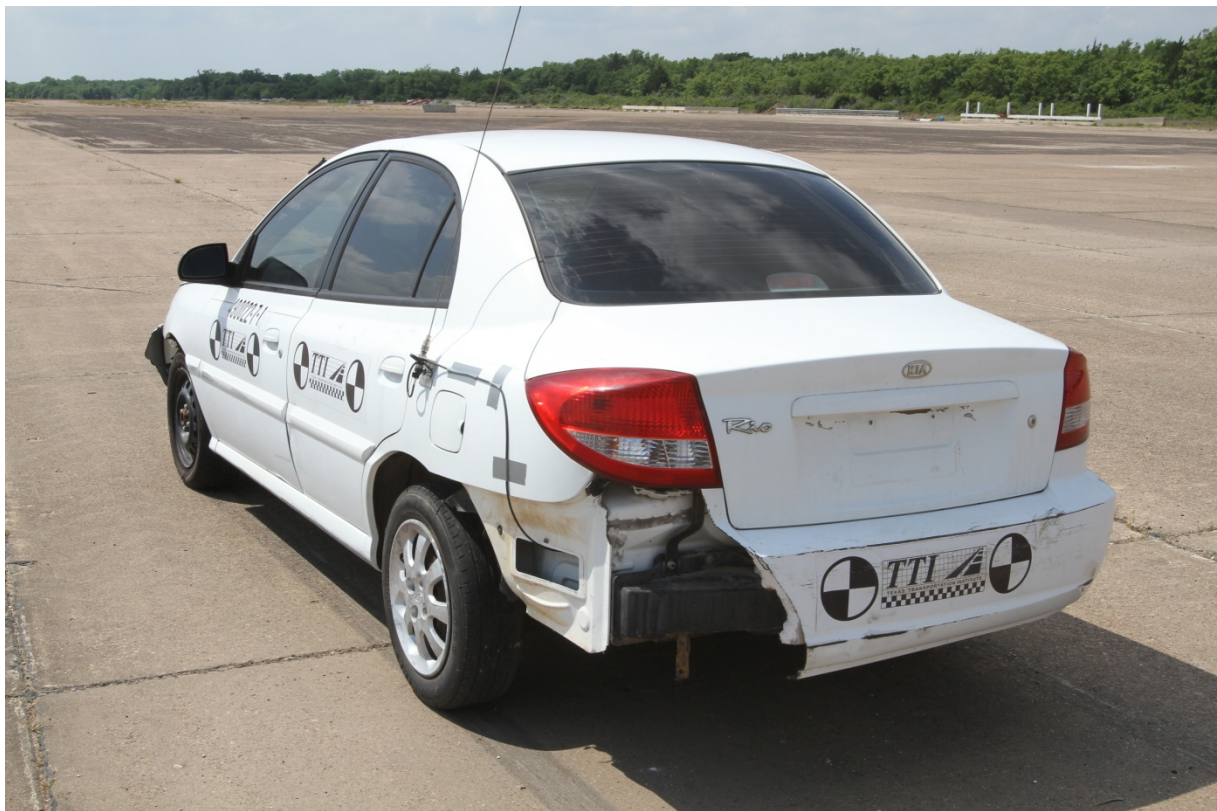
**Figure 4.9. Vehicle after Test No. 490022-7-1.**

The 1100C vehicle did not sustain any damage during the impact with the temporary single sign support. Figure 4.9 shows photographs of the exterior of the vehicle.

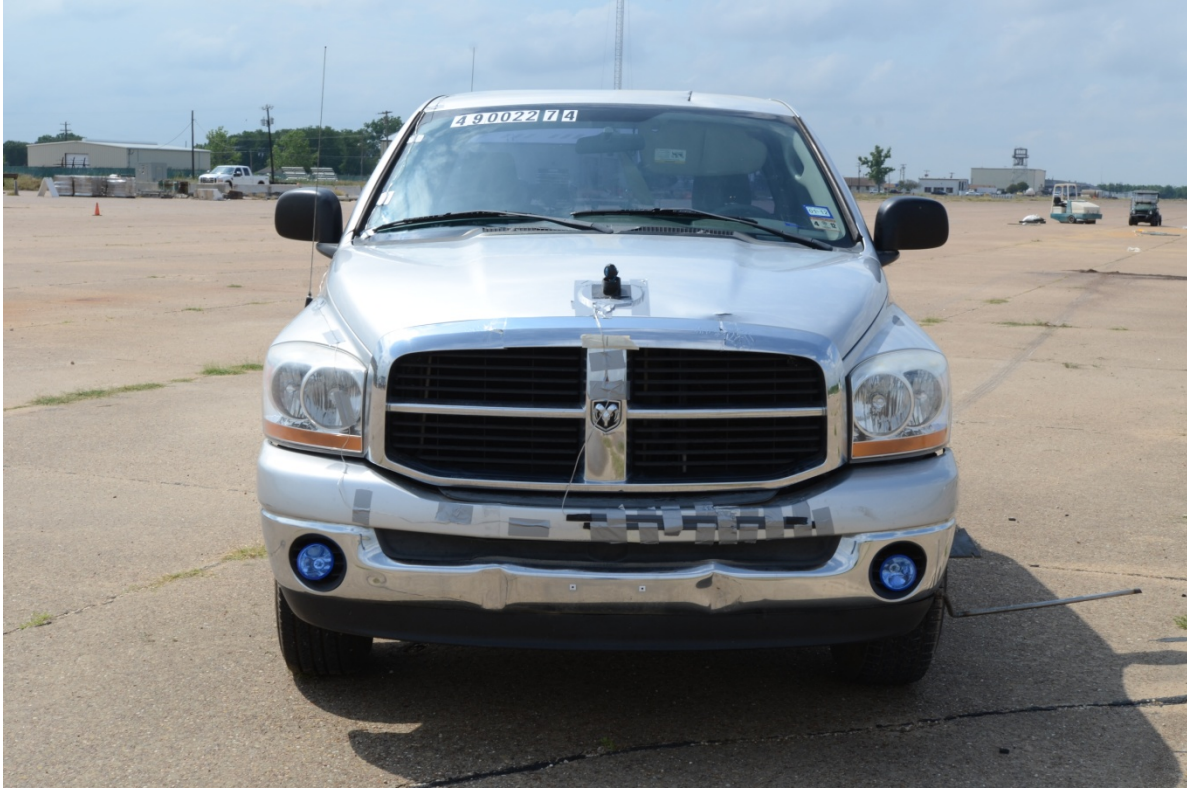
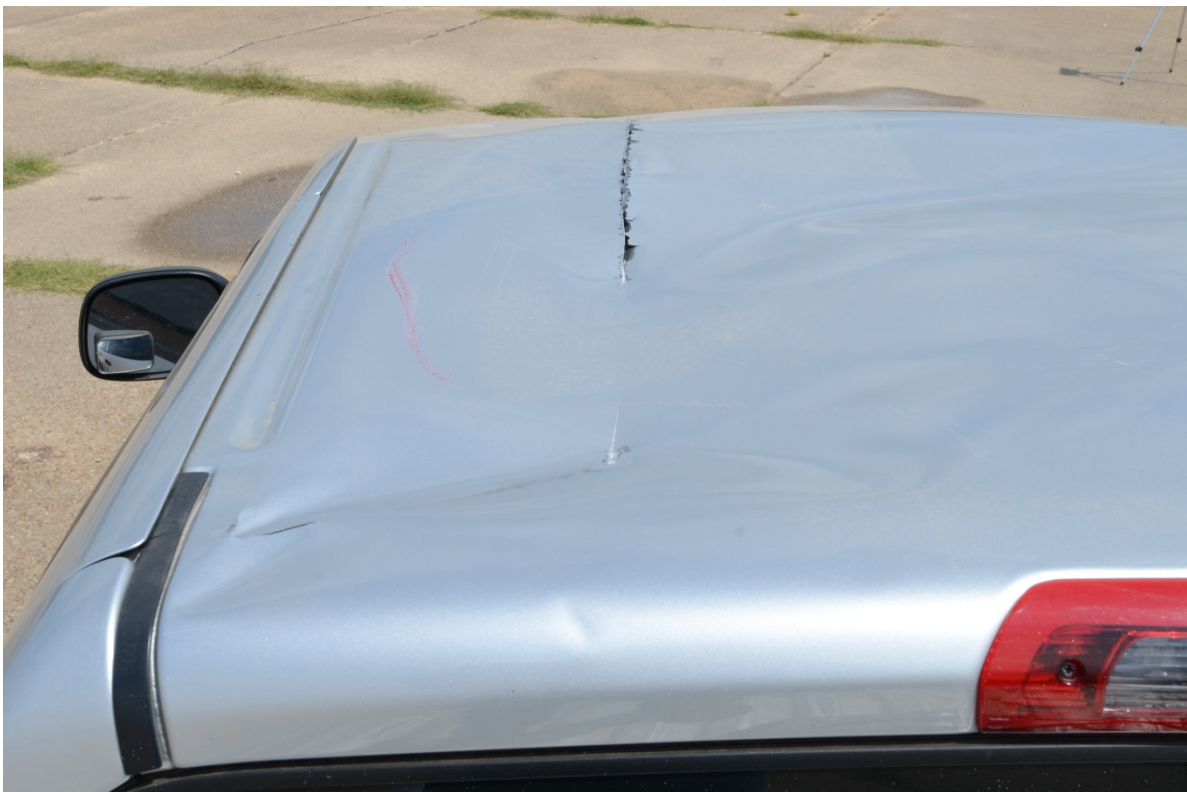
**Figure 6.8. Vehicle after Test No. 490022-7-4.**

The 2270P vehicle sustained a small dent in the bumper, hood, and grill, due to the initial impact with the 0-degree oriented sign support. There was no secondary impact between the 0-degree oriented sign assembly and the vehicle after release of the sign support assembly at the telescopic slip connection. [Figures 6.8](#) and [6.9](#) show photographs of the exterior and interior of the vehicle after the test.
