1. Report No. FHWA/TX-13/9-1002-12-6		2. Government Accession No.		3. Recipient's Catalog No.	
4. Title and Subtitle MASH Full-Scale Crash Testing of 4-ft Mounting Height, 24"×30" Chevron Sign Installed on 5.5H:1V Slope Ditch				5. Report Date Published: March 2013

***MASH* Full-Scale Crash Testing of 4-ft Mounting Height 24"×30" Chevron
Sign Installed on 5.5H:1V Slope Ditch**

Report 9-1002-12-6
Project 9-1002-12
Project Title: Roadside Safety Device Crash Testing Program

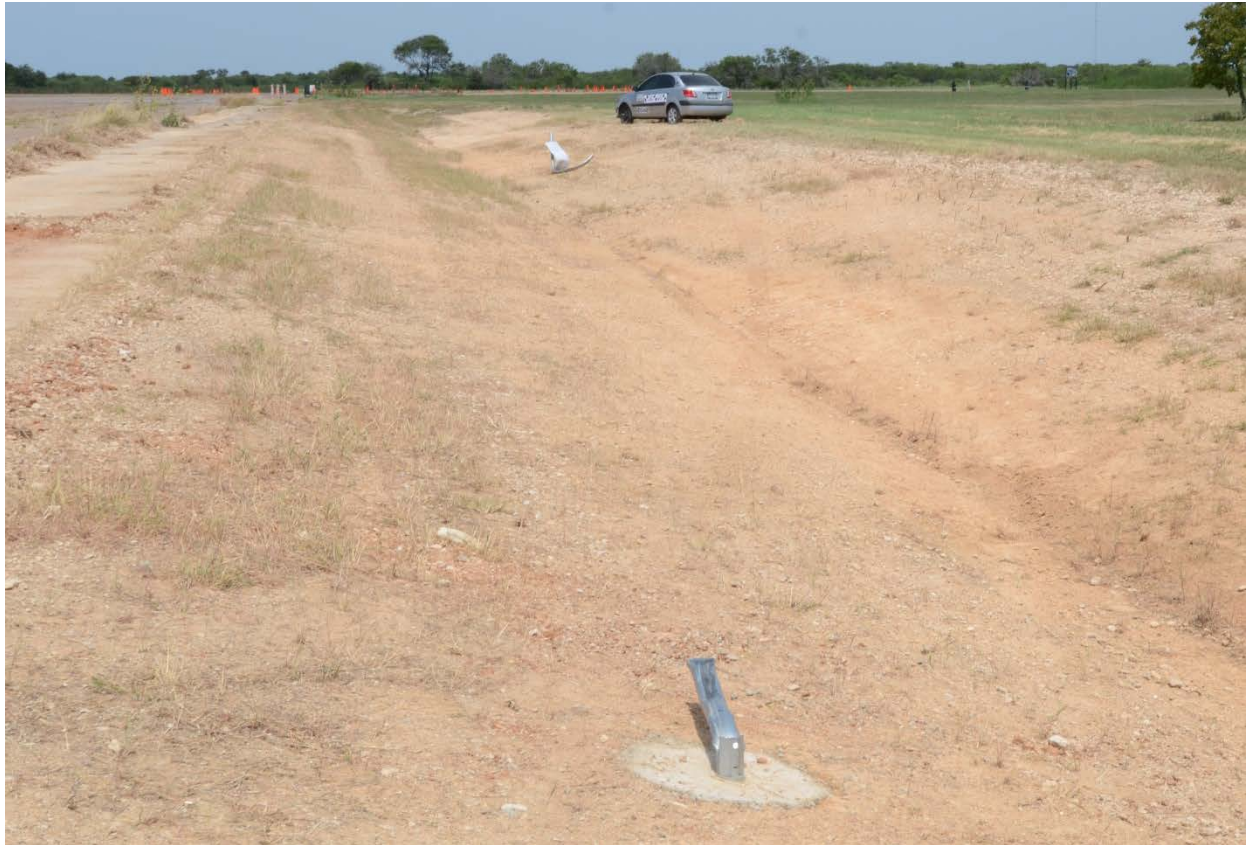
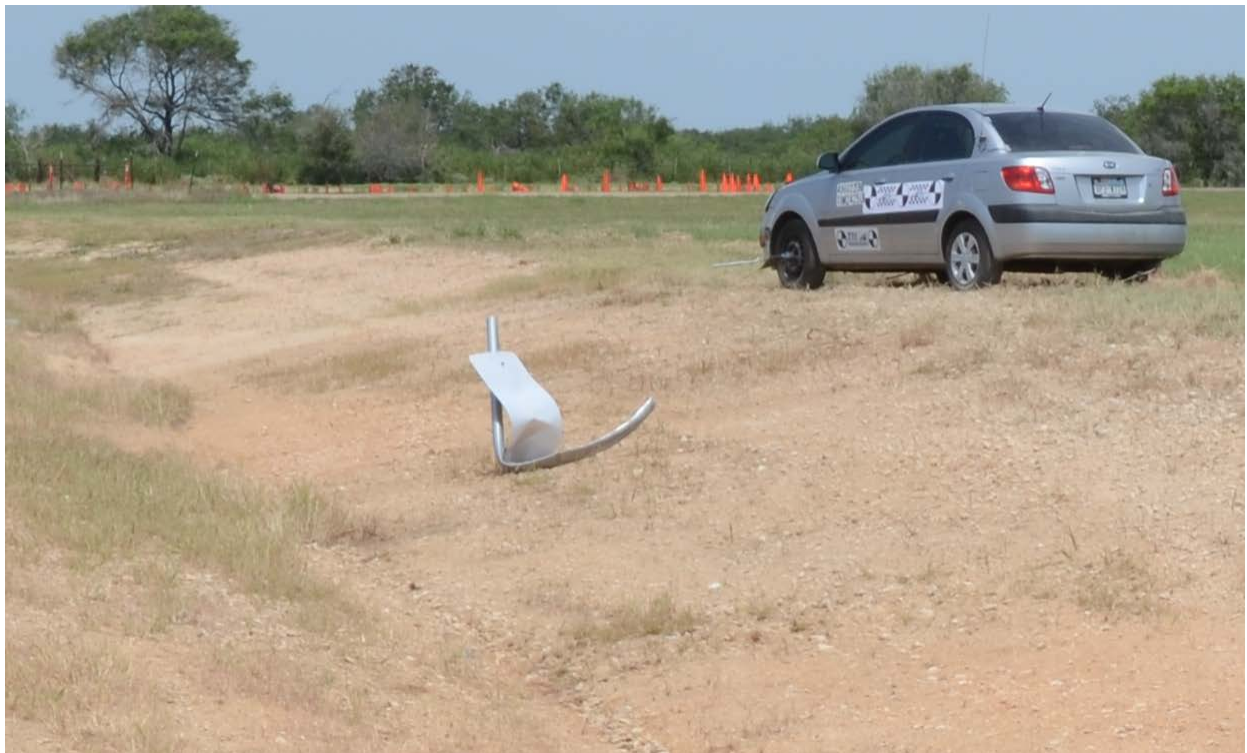
Figure 5.3. Vehicle/Installation after Test No. 490022-9.

As shown in [Figures 5.3](#) and [5.4](#), the sign support did not completely pull out of the socket. The support deformed at bumper height and ground level, and subsequently fractured near bumper height approximately 21 inches above ground. During impact, the support post wrapped around the front end of the vehicle and the sign impacted the hood. The sign panel slid up the support post, causing the upper sign bracket to slide off the top of the post while remaining connected to the sign. The support and the sign panel came to rest 126 ft downstream of the impact point.

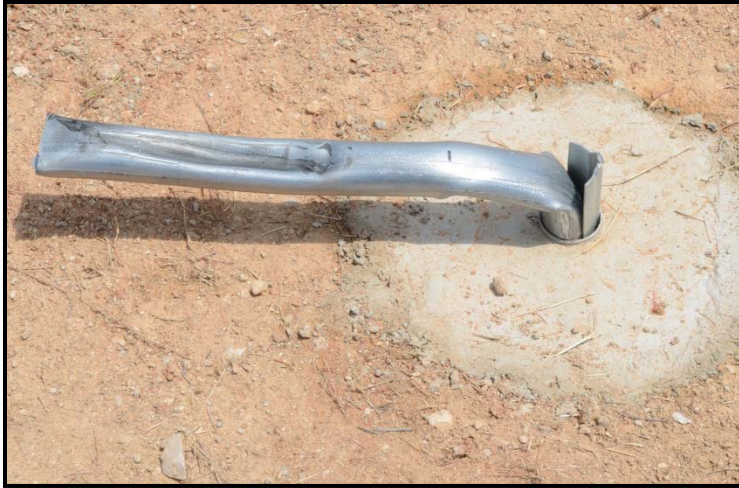
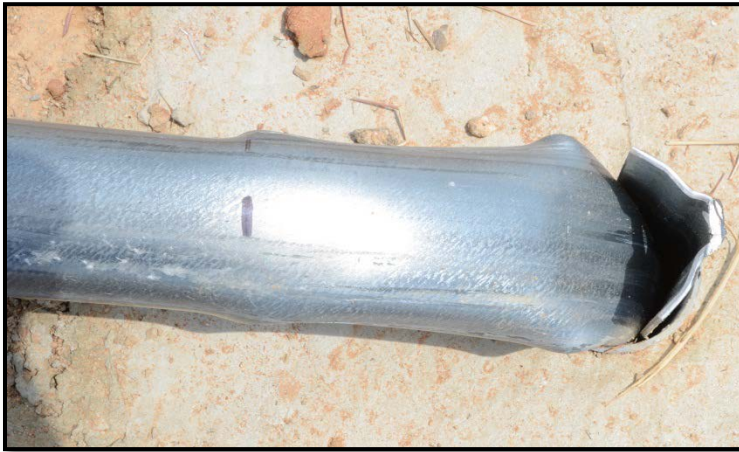
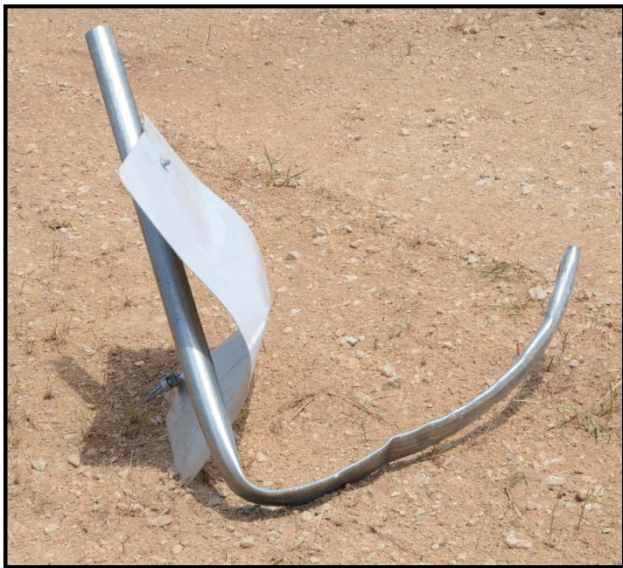
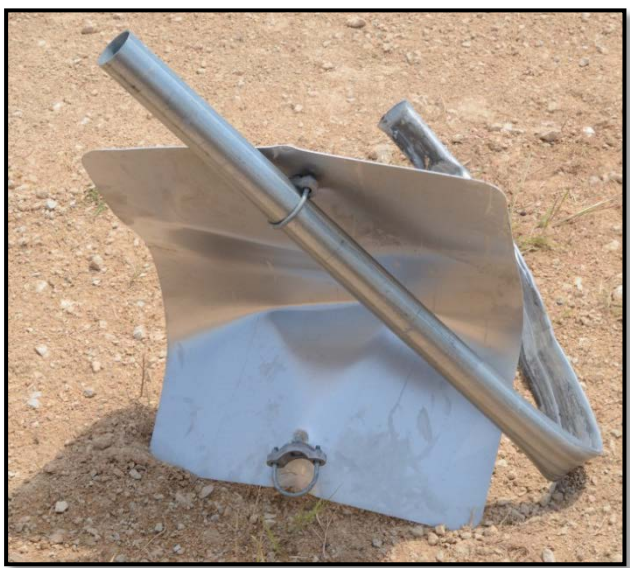
Figure 5.4. Installation after Test No. 490022-9.

Results: The sign support fractured at approximately 21 inches above wedge and socket system. (PASS)

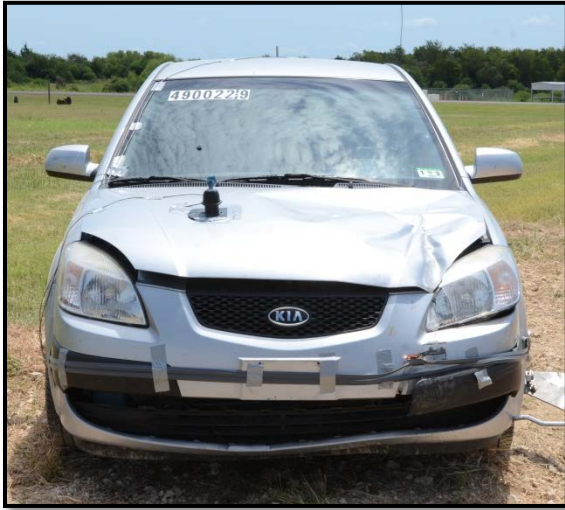
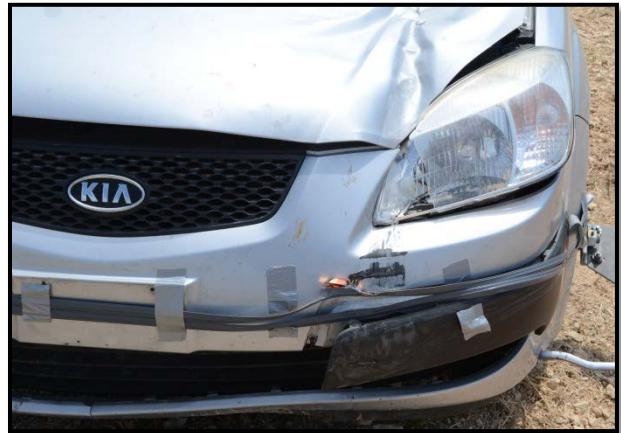
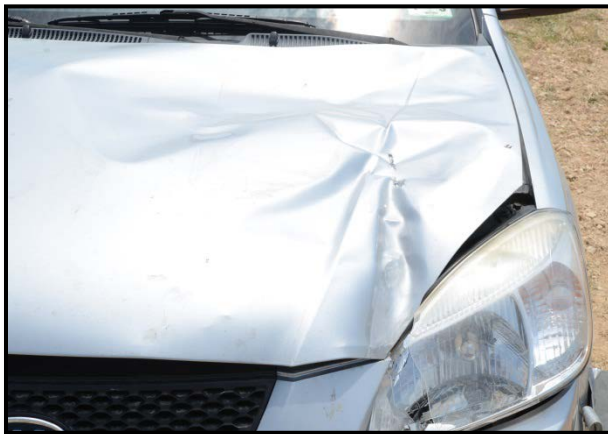
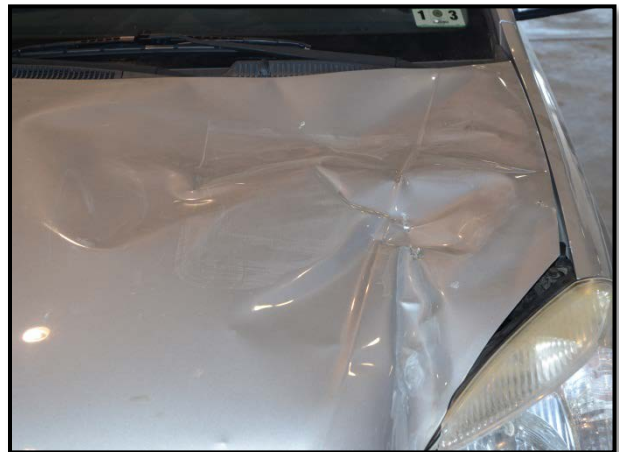
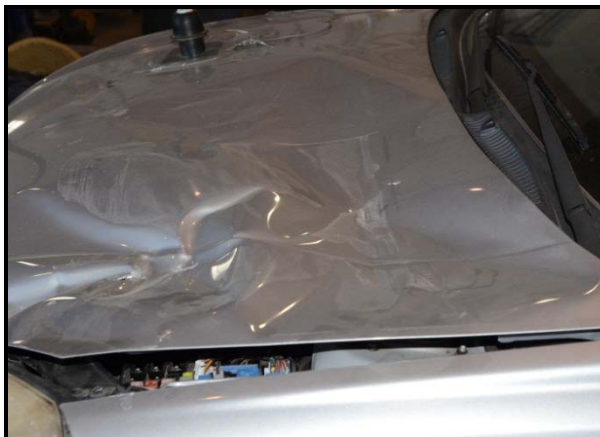
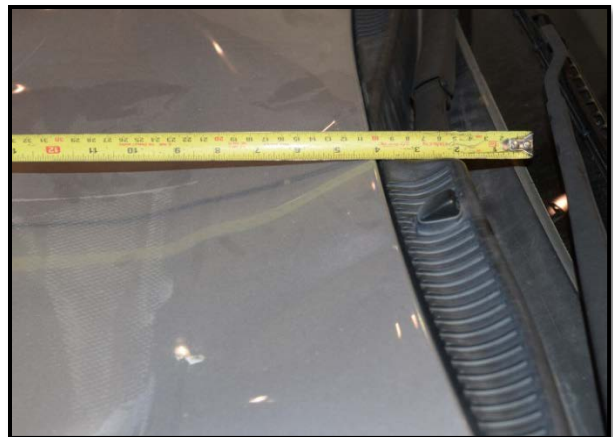
Figure 5.5. Vehicle after Test No. 490022-9.

[Figure 5.5](#) shows damage sustained by the 1100C vehicle. The front bumper, hood, and left head light were damaged. The impact of the chevron sign support system with the vehicle caused a 31-inch × 21-inch dent in the left-central portion of the hood. Maximum exterior crush to the vehicle was 1.75 inches on the hood. [Figure 5.5](#) shows deformation and striations left by the sign during impact with the vehicle's hood. The upper edge of the striations caused by contact with the sign panel was approximately 8.5 inches from the base of the windshield. There was no deformation to the occupant compartment. [Tables B2](#) and [B3](#) in [Appendix B](#) provide exterior crush and occupant compartment measurements, respectively.
