CRASH TEST AND EVALUATION OF LOCKING ARCHITECTURAL MAILBOXES

Test Report No. 9-1002-12-9

TEXAS A&M TRANSPORTATION INSTITUTE
COLLEGE STATION, TEXAS

TEXAS DEPARTMENT OF TRANSPORTATION

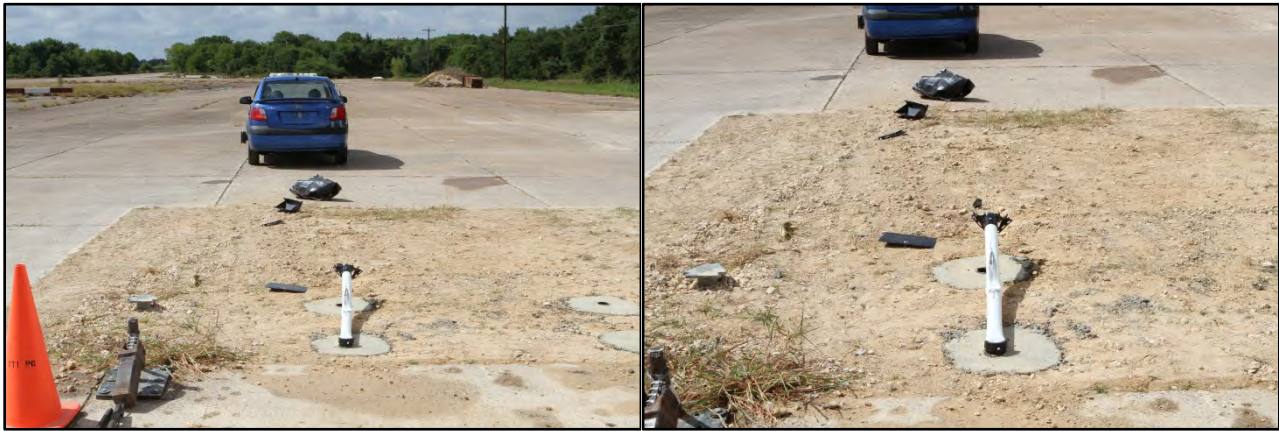
Figure 4.6. Vehicle/Installation Positions after Test No. 490023-9-1.

[Figure 4.6](#) and [4.7](#) show damage to the locking architectural mailbox installation. The post was deformed and bent over at ground line. The connection bracket was torn from the support and the mailbox came to rest 21 ft downstream of impact. Several pieces of the mailbox became detached and lay along the path of the vehicle.

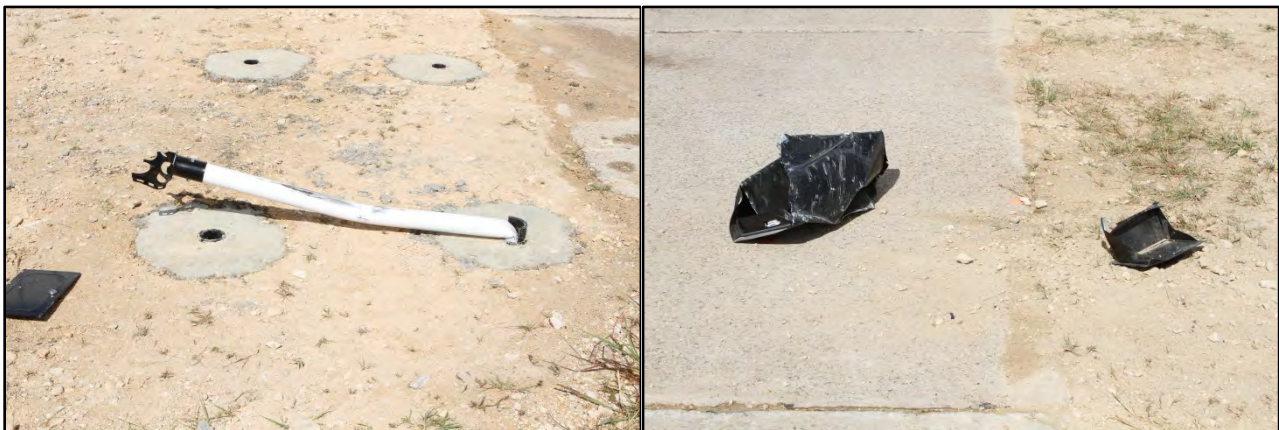
Figure 4.7. Installation after Test No. 490023-9-1.

Results: The locking architectural mailbox detached from the support post and separated into several pieces while being carried along beneath the vehicle. The detached pieces did not penetrate or show potential for penetrating the occupant compartment, nor present hazard to others in the area. (PASS)

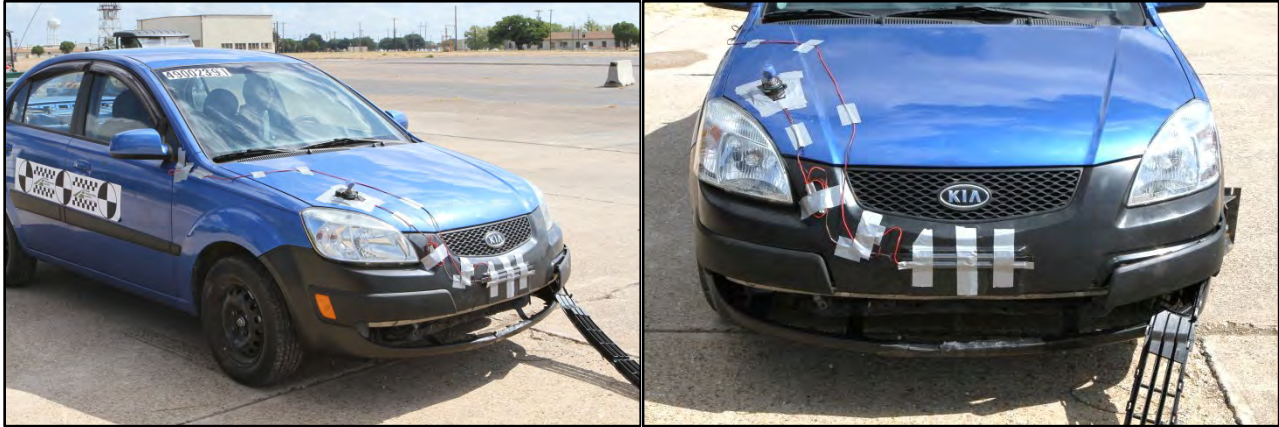
Figure 4.8. Vehicle after Test No. 490023-9-1.

Figure 4.8 shows damage to the exterior of the vehicle, and Figure 4.9 shows the interior of the vehicle. A very small dent was noted on the hood and bumper. There was no contact of any components of the mailbox system with the windshield. Tables A2 and A3 in Appendix A provide exterior crush and occupant compartment measurements for the vehicle.

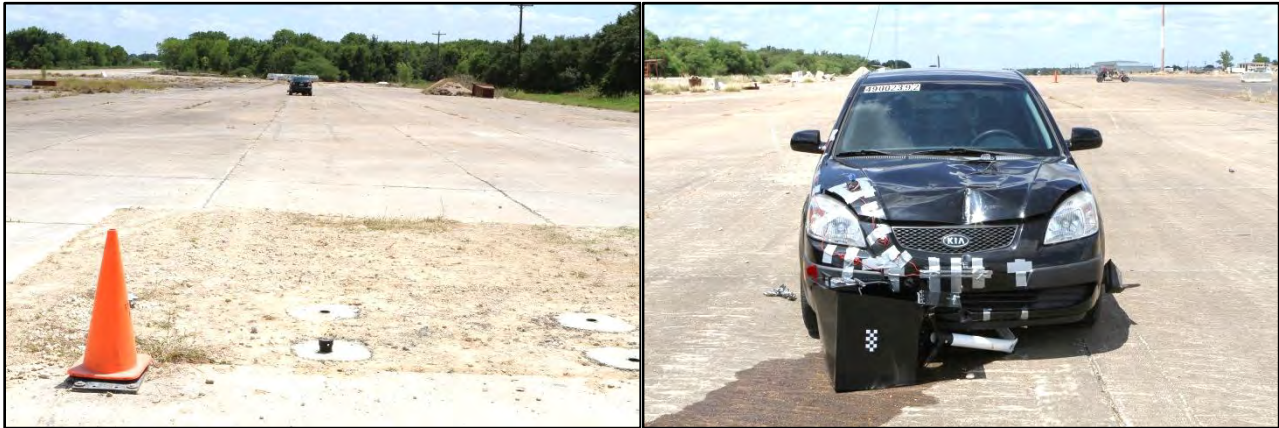
Figure 4.13. Vehicle/Installation Positions after Test No. 490023-9-2.

[Figures 4.13](#) and [4.14](#) show damage to the mailbox installation. The support post pulled out of the socket and was deformed. The mailbox came apart at several connection seams, but all the pieces remained together and the mailbox remained attached to the support post. The mailbox and support post came to rest in front of the vehicle 245 ft downstream of impact.

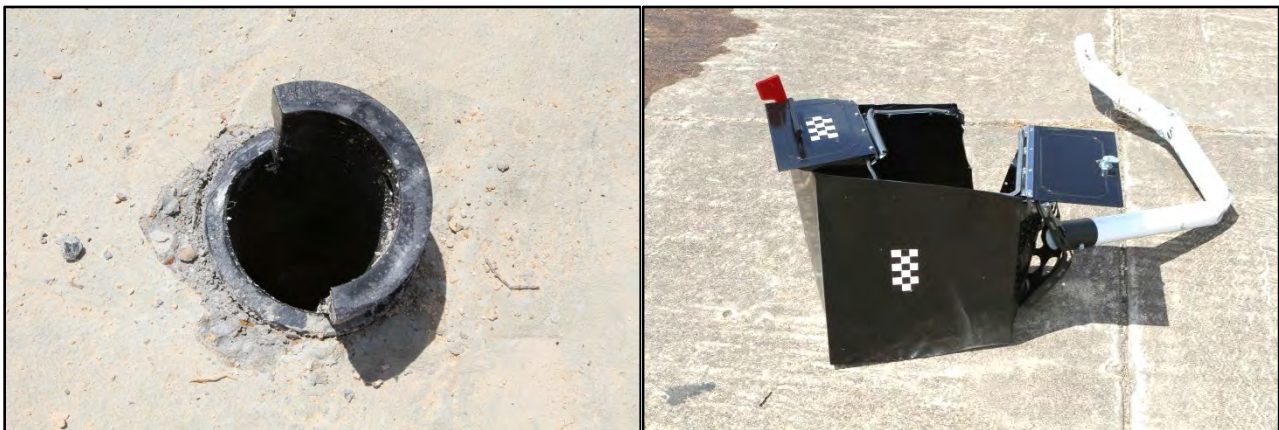
Figure 4.14. Installation after Test No. 490023-9-2.

Results: The locking architectural mailbox on the SHUR-TITE® single-mount post yielded to the vehicle and released from its foundation. (PASS)

Results: The locking architectural mailbox separated at several connection seams; however, the pieces remained connected and attached to the support post and traveled along the front of the vehicle. The mailbox installation did not penetrate or show potential for penetrating the occupant compartment, nor present hazard to others in the area. (PASS)

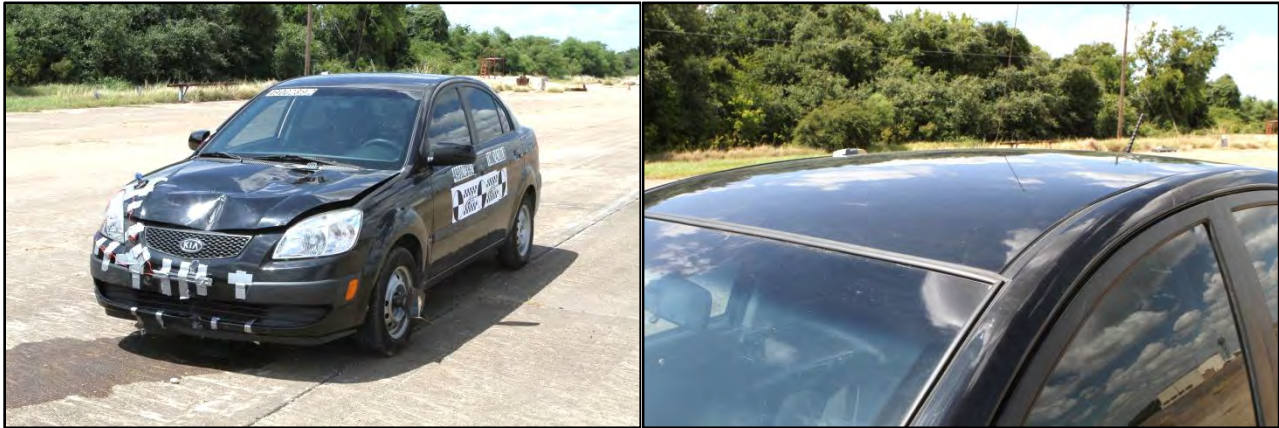
Figure 4.15. Vehicle after Test No. 490023-9-2.

[Figure 4.15](#) shows damage to the exterior of the vehicle, and [Figure 4.16](#) shows the interior of the vehicle. The vehicle sustained a small cut on the hood, and the hood was

deformed inward 1.25 inches. There was no contact of any components of the mailbox system with the windshield. [Tables B2](#) and [B3](#) in [Appendix B](#) provide exterior crush and occupant compartment measurements.

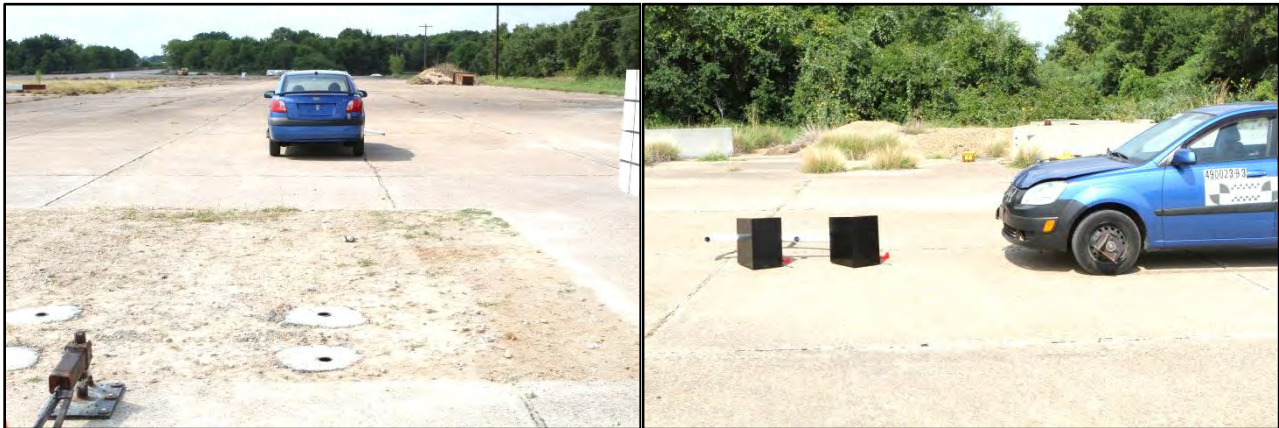
Figure 5.6. Vehicle/Installation Positions after Test No. 490023-9-3.

[Figures 5.6](#) and [5.7](#) show damage to the locking architectural mailbox installation. The support post lifted out of the socket and was carried in front of the vehicle. The support post was deformed as well as the bracket attaching the mailboxes to the support post. The mailboxes remained attached to the support post and the assembly came to rest in front of the vehicle 58 ft downstream of impact.

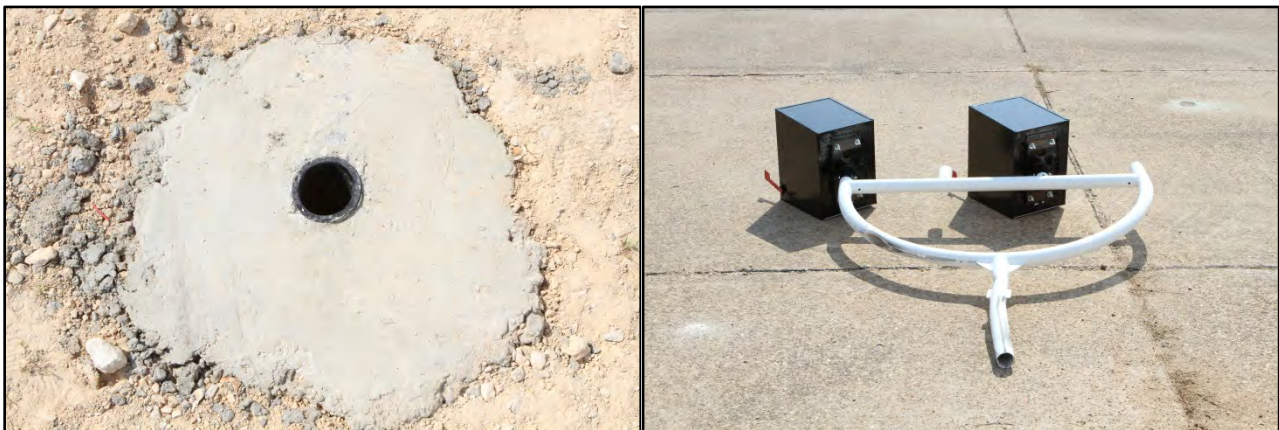
Figure 5.7. Installation after Test No. 490023-9-3.

Results: The locking architectural mailboxes on the SHUR-TITE® multiple-mount post activated by yielding to the vehicle and lifting out of the foundation socket. (PASS)

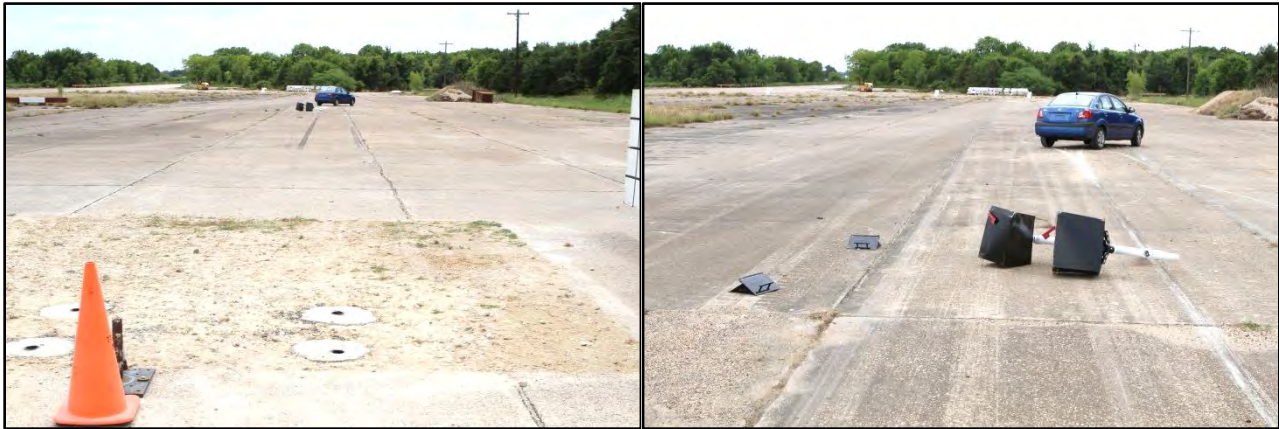
Figure 5.13. Vehicle/Installation Positions after Test No. 490023-9-4.

[Figures 5.13 and 5.14](#) show damage to the mailbox installation. The support post collapsed inward and was pulled out of the socket. The mailboxes remained attached to the support post, however, the doors separated from the mailboxes. The mailboxes and support post came to rest 110 ft downstream of impact.

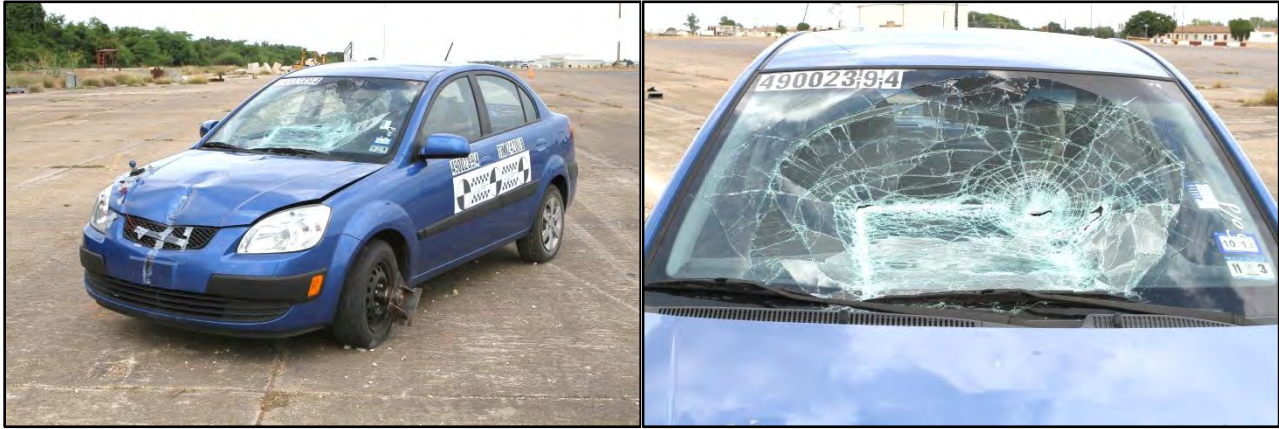
Figure 5.15. Vehicle after Test No. 490023-9-4.

The windshield sustained four cuts. One cut was 19 inches long, a second was 4.5 inches long, a third was 2 inches long, and the fourth was 3 inches long. The windshield was depressed 4.5 inches toward the occupant compartment over an area measuring 30 inches × 36 inches. [Figure 5.15](#) shows damage to the exterior of the vehicle, and [Figure 5.16](#) shows the interior of the vehicle. [Tables D2](#) and [D3](#) in [Appendix D](#) provide exterior crush and occupant compartment measurements.

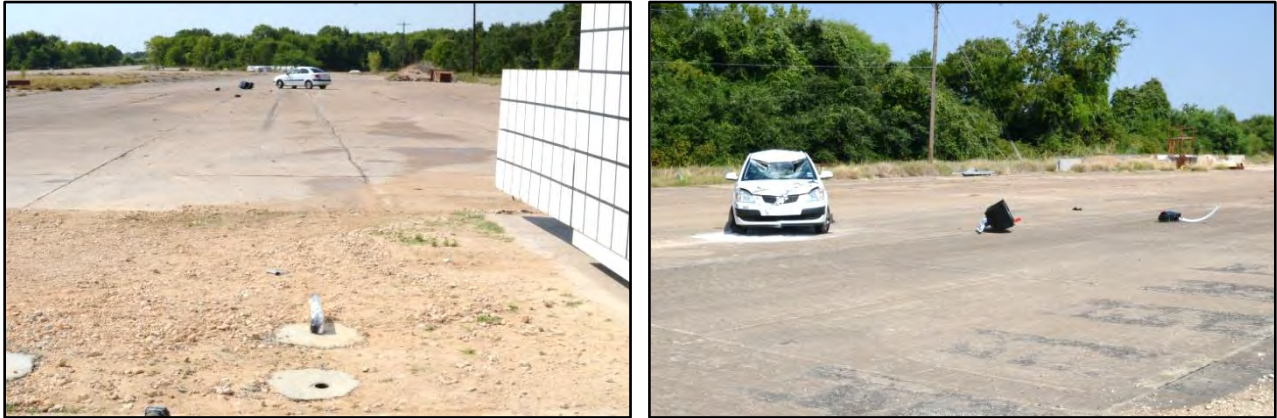
Figure 6.7. Vehicle/Installation Positions after Test No. 490023-9-5.

standard mailbox, and a section of the support post came to rest 192 ft downstream of impact and 10 ft to the left of centerline of the vehicle path.

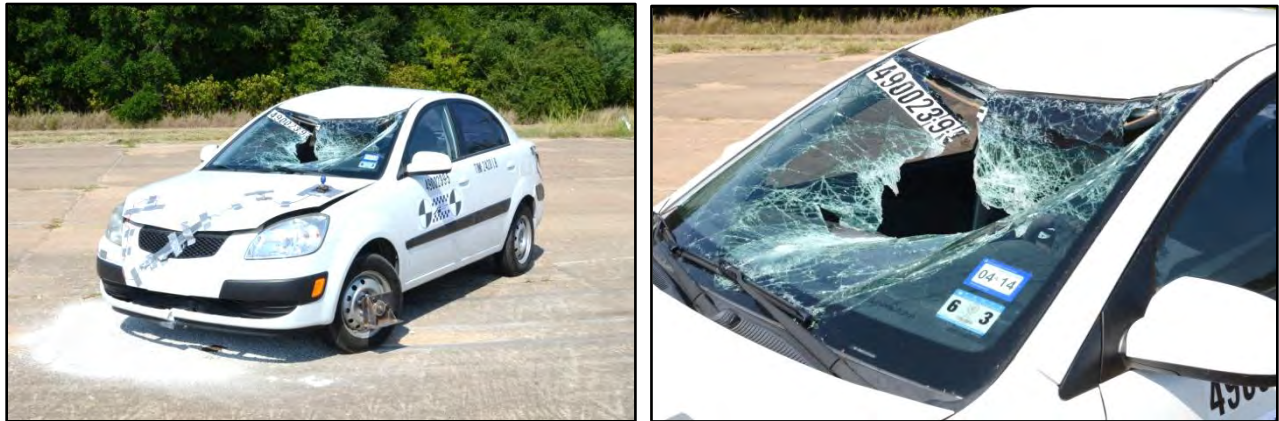
Figure 6.9. Vehicle after Test No. 490023-9-5.

The windshield of the vehicle sustained an open tear measuring 14 inches \times 24 inches. The roof of the vehicle was deformed downward into the occupant compartment 4.75 inches. Figure 6.9 shows damage to the exterior of the vehicle, and Figure 6.10 shows the interior of the vehicle. Tables E2 and E3 in Appendix E provide exterior crush and occupant compartment measurements.

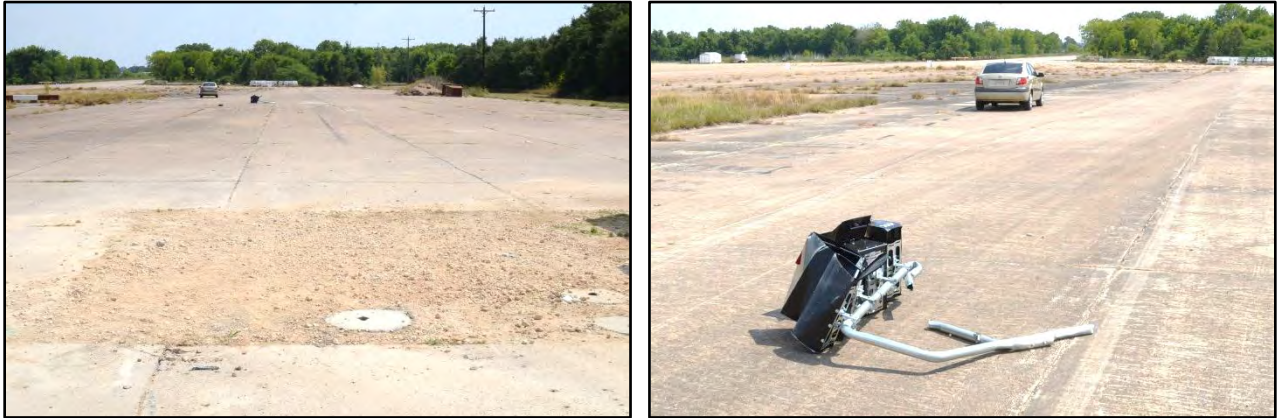
Figure 6.20. Vehicle/Installation Positions after Test No. 490023-9-6.

to the support post. The system came to rest 188 ft downstream of impact and 8 ft to the left of centerline of the vehicle path.

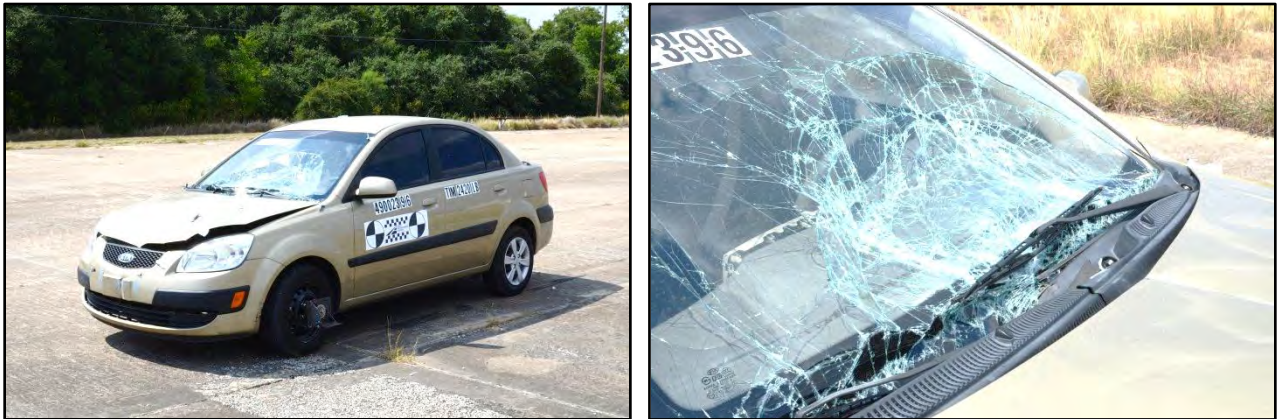
Figure 6.22. Vehicle after Test No. 490023-9-6.

The hood of the vehicle was dented and pushed downward. The windshield was shattered and pushed into the occupant compartment 3.5 inches and there were several small tears at the bottom edge of the windshield behind the dashboard. [Figure 6.22](#) shows damage to the exterior of the vehicle, and [Figure 6.23](#) shows the interior of the vehicle. [Tables F2](#) and [F3](#) in [Appendix F](#) provide exterior crush and occupant compartment measurements.
