CRASH TEST AND EVALUATION OF TEMPORARY WOOD SIGN SUPPORT SYSTEM FOR LARGE GUIDE SIGNS

Test Report 9-1002-15-4

TEXAS A&M TRANSPORTATION INSTITUTE
COLLEGE STATION, TEXAS

TEXAS DEPARTMENT OF TRANSPORTATION

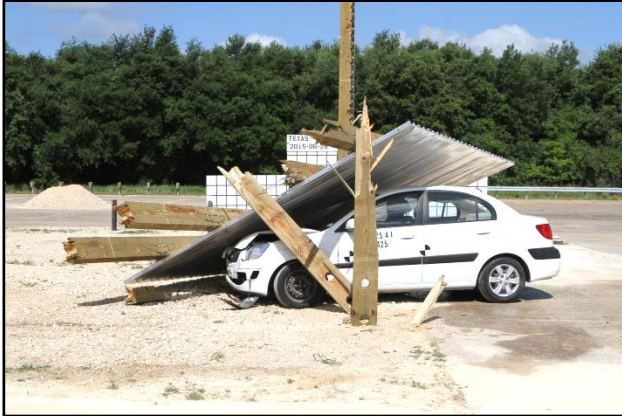
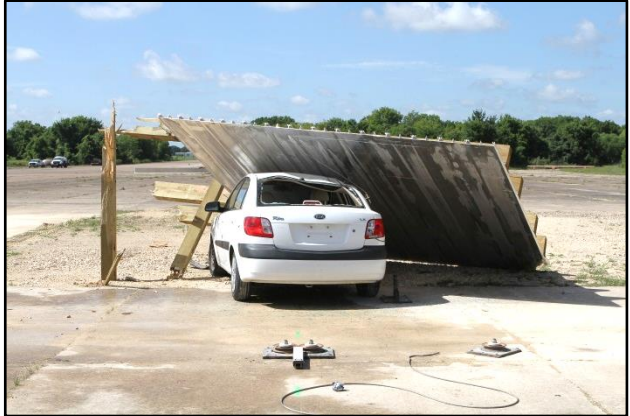
Figure 5.3. Vehicle/Installation Positions after Test No. 490025-4-1.

Figures 5.3 and 5.4 show damage to the sign support system after the test. Post 1 fractured at the hole just beneath the sign panel in a torsional manner. Post 2 fractured at all three weakening hole locations. Posts 3 and 4 both fractured at the holes near and above ground level. The sign panel remained intact and came to rest partially on top of the vehicle.

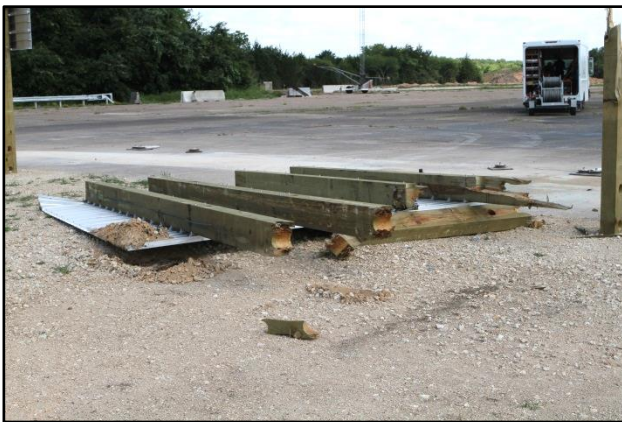
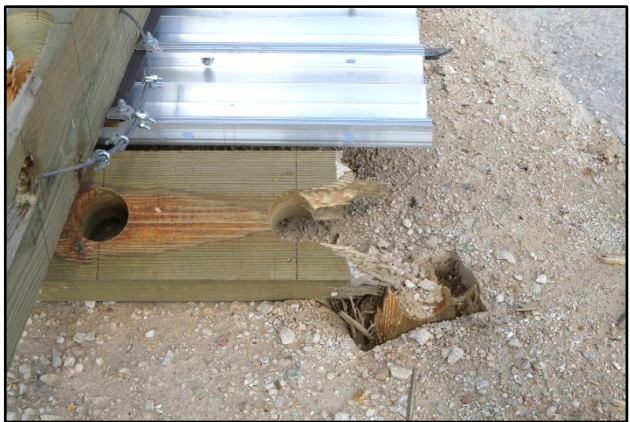
Figure 5.4. Installation after Test No. 490025-4-1.

Results: The Temporary Wood Sign Support for Large Guide Signs readily activated by fracturing in various design locations. (PASS)

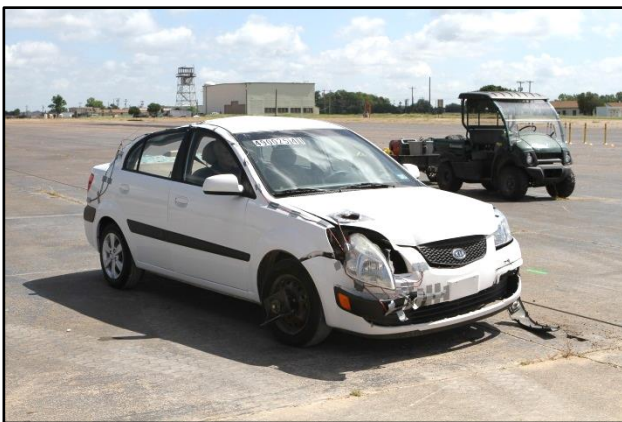
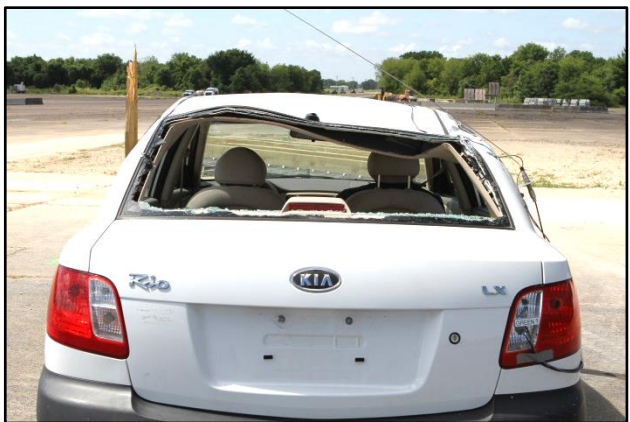
Figure 5.5. Vehicle after Test No. 490025-4-1.

Damage to the vehicle is shown in Figure 5.5. The front bumper, hood, roof, and right C-post were deformed. The windshield sustained stress cracks radiating from the right corner of the roof, and the rear glass was shattered. Maximum external crush to the vehicle was 2.5 inches in the roof and 2.0 inches in the front plane at the right front corner of the bumper at bumper height. Figure 5.6 shows the interior of the vehicle before and after the test. Maximum occupant compartment deformation was 2.5 inches in the roof. Exterior vehicle crush and occupant compartment measurements are shown in Appendix C2, Tables C.2 and C.3.

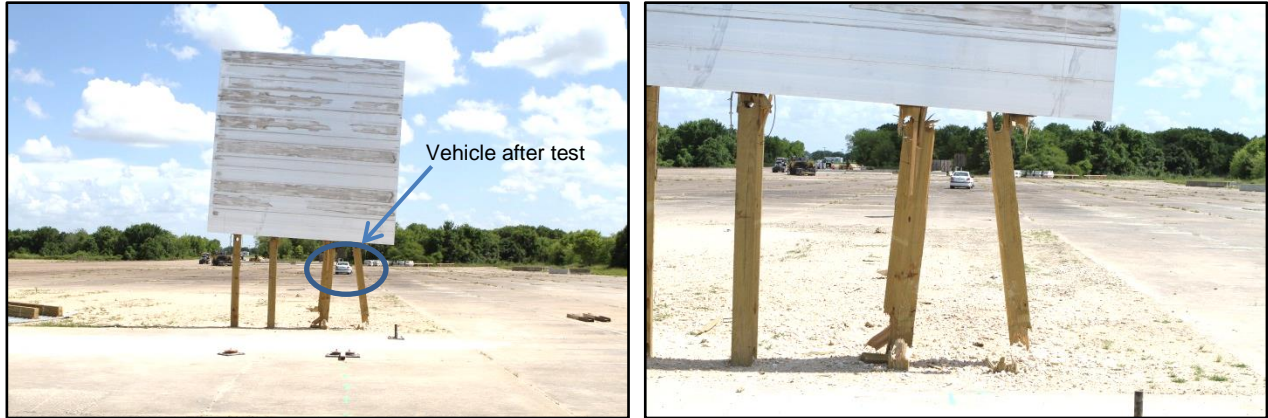
Figure 6.3. Vehicle/Installation Positions after Test No. 490025-4-2.

Figures 6.3 and 6.4 show damage to the sign support system after the test. Post 2 partially fractured at the hole just below sign panel. Posts 3 and 4 fractured at all three weakening holes as designed, and remained attached to the sign panel by the restraining cables.

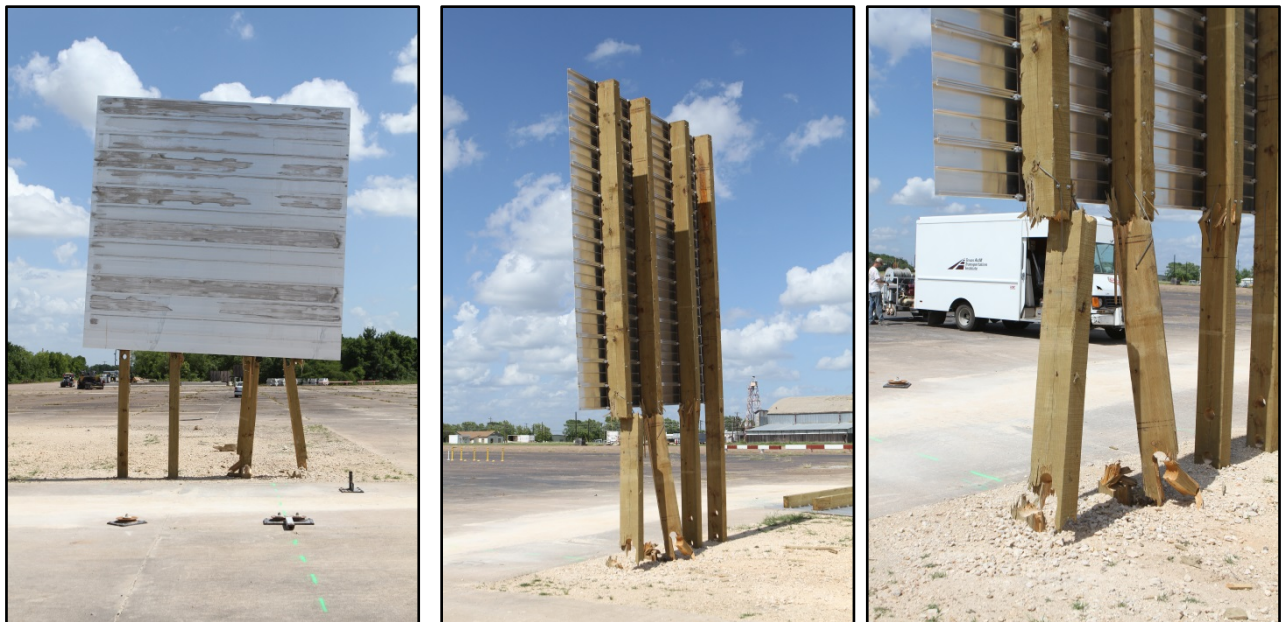
Figure 6.4. Installation after Test No. 490025-4-2.

Results: The Temporary Wood Sign Support for Large Guide Signs readily activated by fracturing in various designed locations. (PASS)

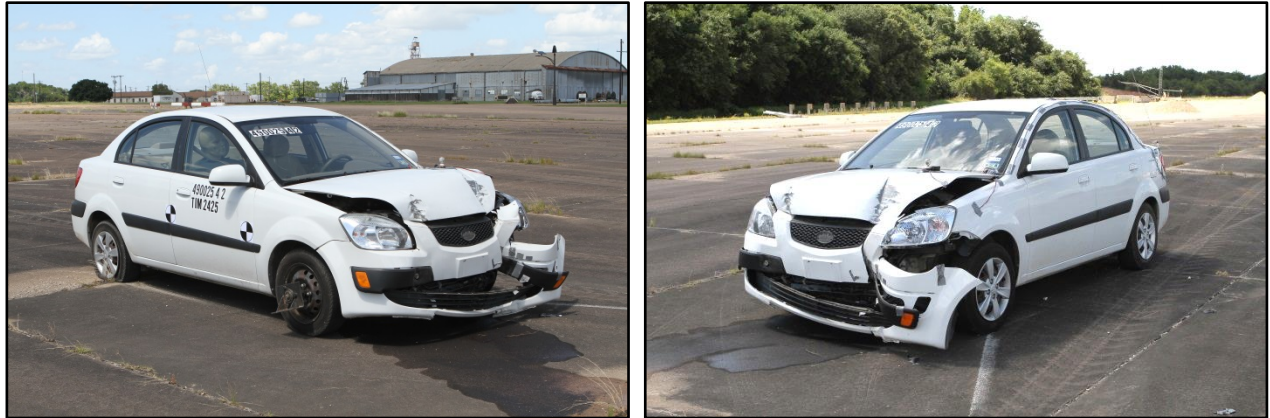
Figure 6.5. Vehicle after Test No. 490025-4-2.

Damage to the vehicle is shown in Figure 6.5. The front bumper, hood, and roof were deformed. The windshield sustained a crack radiating from the left front corner of the roof. Maximum external deformation of the vehicle was 3.26 inches in the front plane at the left quarter point of the bumper at bumper height. No occupant compartment deformation was noted. Figure 6.6 shows the interior of the vehicle. Exterior vehicle crush and occupant compartment measurements are shown in Appendix D2, Tables D.2 and D.3.
