CRASH TESTING AND EVALUATION OF MULTIPLE MAILBOX SUPPORTS FOR USE WITH LOCKING ARCHITECTURAL MAILBOXES

Test Report 9-1002-15-7

TEXAS A&M TRANSPORTATION INSTITUTE
COLLEGE STATION, TEXAS

TEXAS DEPARTMENT OF TRANSPORTATION

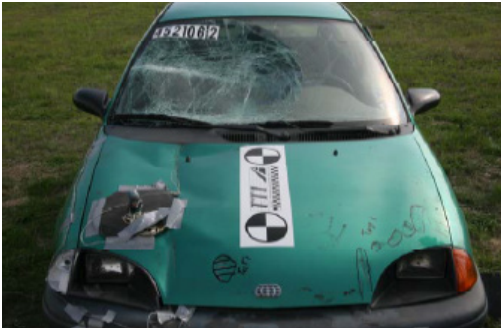
The vehicle sustained minimal damage to the hood and bumper as shown in Figure 2.6(a). The front bumper had a slight indentation at the point of contact with the support, and the hood had an indentation on the impact side that measured 33.5 inches long \times 5.9 inches wide. The windshield

was shattered over an area approximately 31.5 inches in diameter and was deformed 3.2 inches inward toward the occupant compartment. Some of the mailboxes were deformed, but all remained attached to the support. The vertical section of the support was deformed 11.8 inches from the end, and the arc of the support was severely deformed (Figure 2.6[b]).

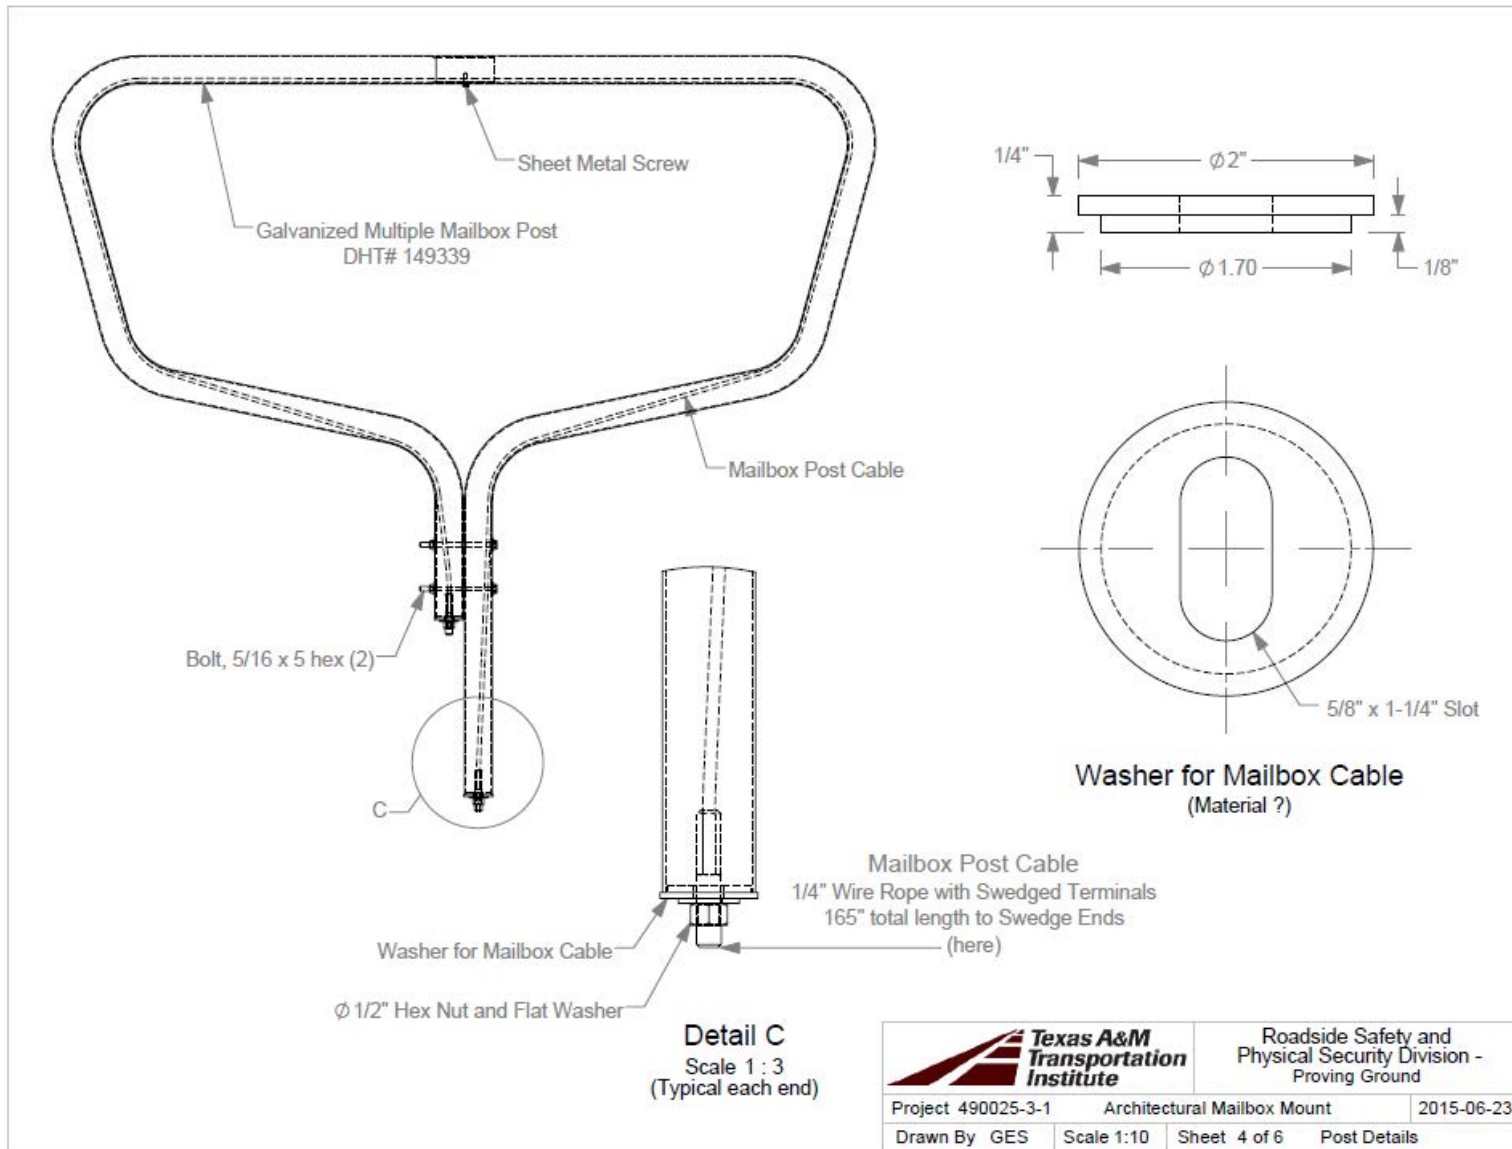
Figure 2.16. Retrofit Design 1: Wire Rope Option.

In the previous tests, the support post ruptured and separated. This resulted in the impacting vehicle submarining under the mailboxes rather than pushing the mailboxes forward. Consequently, the mailboxes interacted with the windshield. In this option, a ¼-inch diameter wire rope is added inside the existing thin-wall steel tube support post. The cable is intended to keep the support post from separating during impact and, thus, preventing the vehicle from submarining under the mailboxes. Figure 2.16 provides details of the wire rope retrofit option.

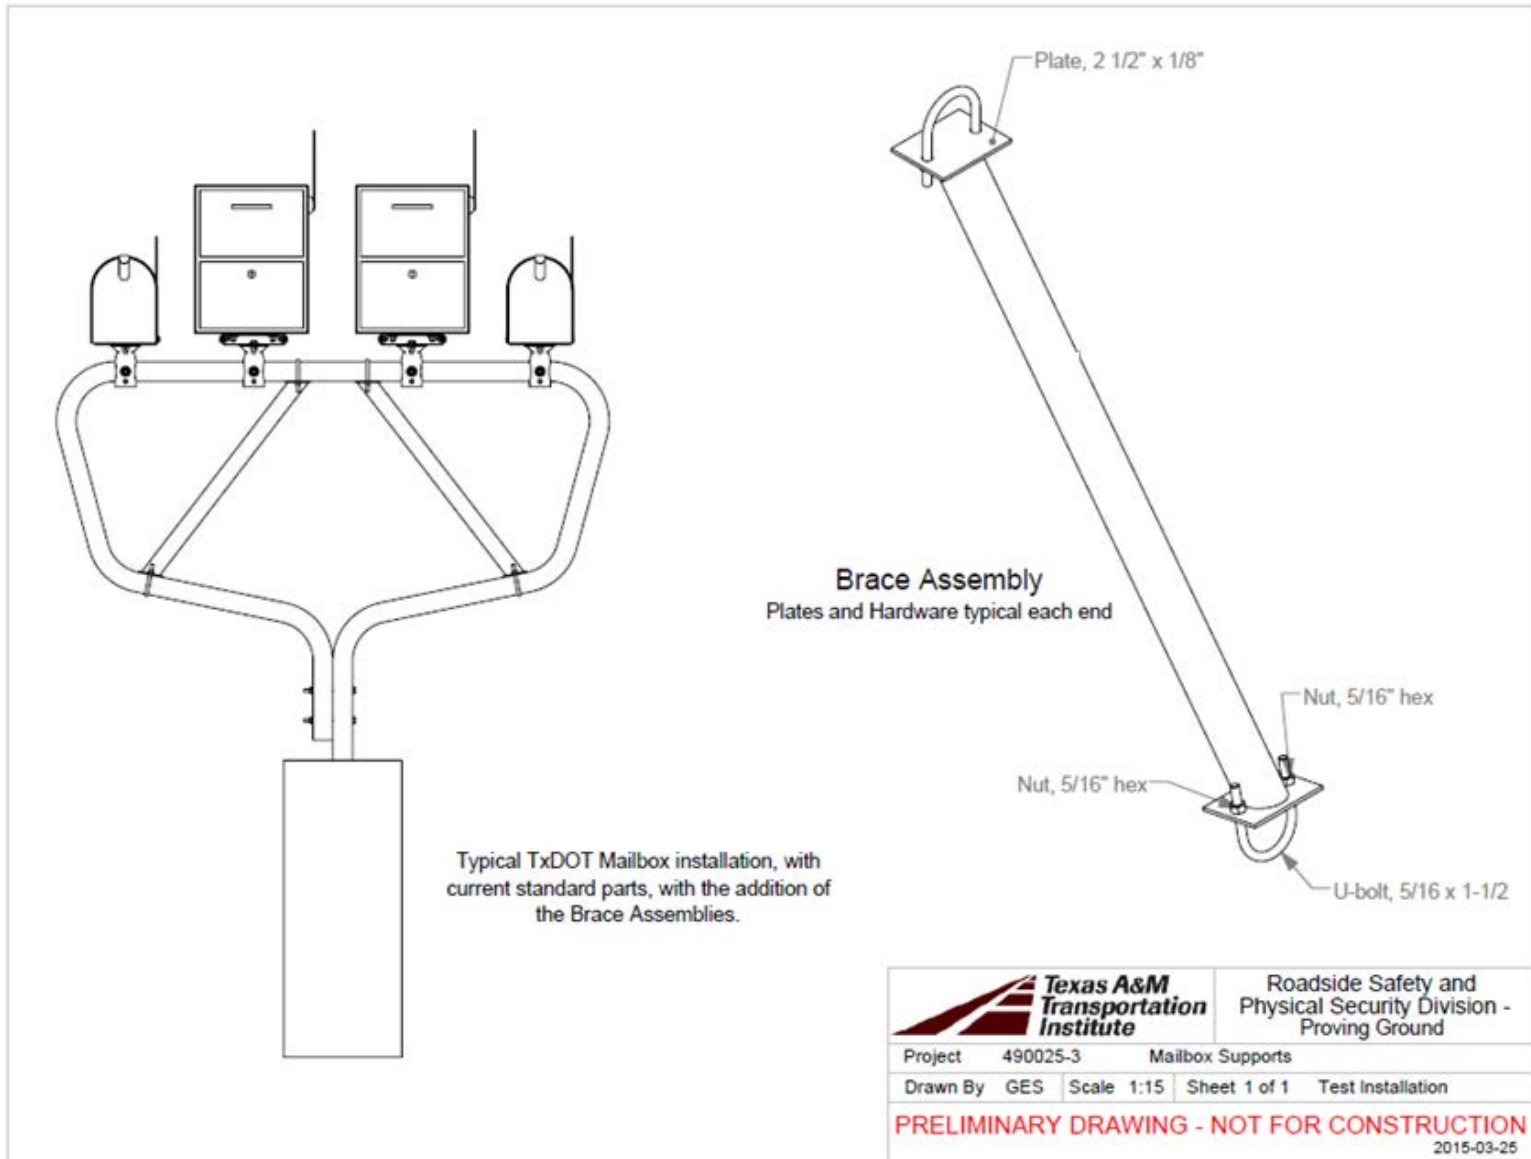
Figure 2.17. Retrofit Design 2: Brace Option.

In this retrofit design, external diagonal braces are added to the existing support post. The braces are clamped onto the support post using plates and U-bolts. The braces are intended to strengthen the support post and enable it to act as a frame that helps distribute the impact forces to other parts of the support post, specifically the horizontal member. The distribution of impact forces to the horizontal member helps transfer momentum to the support and mailboxes and prevent local collapse and rupture of the support post. Figure 2.17 provides details of the braced retrofit option.

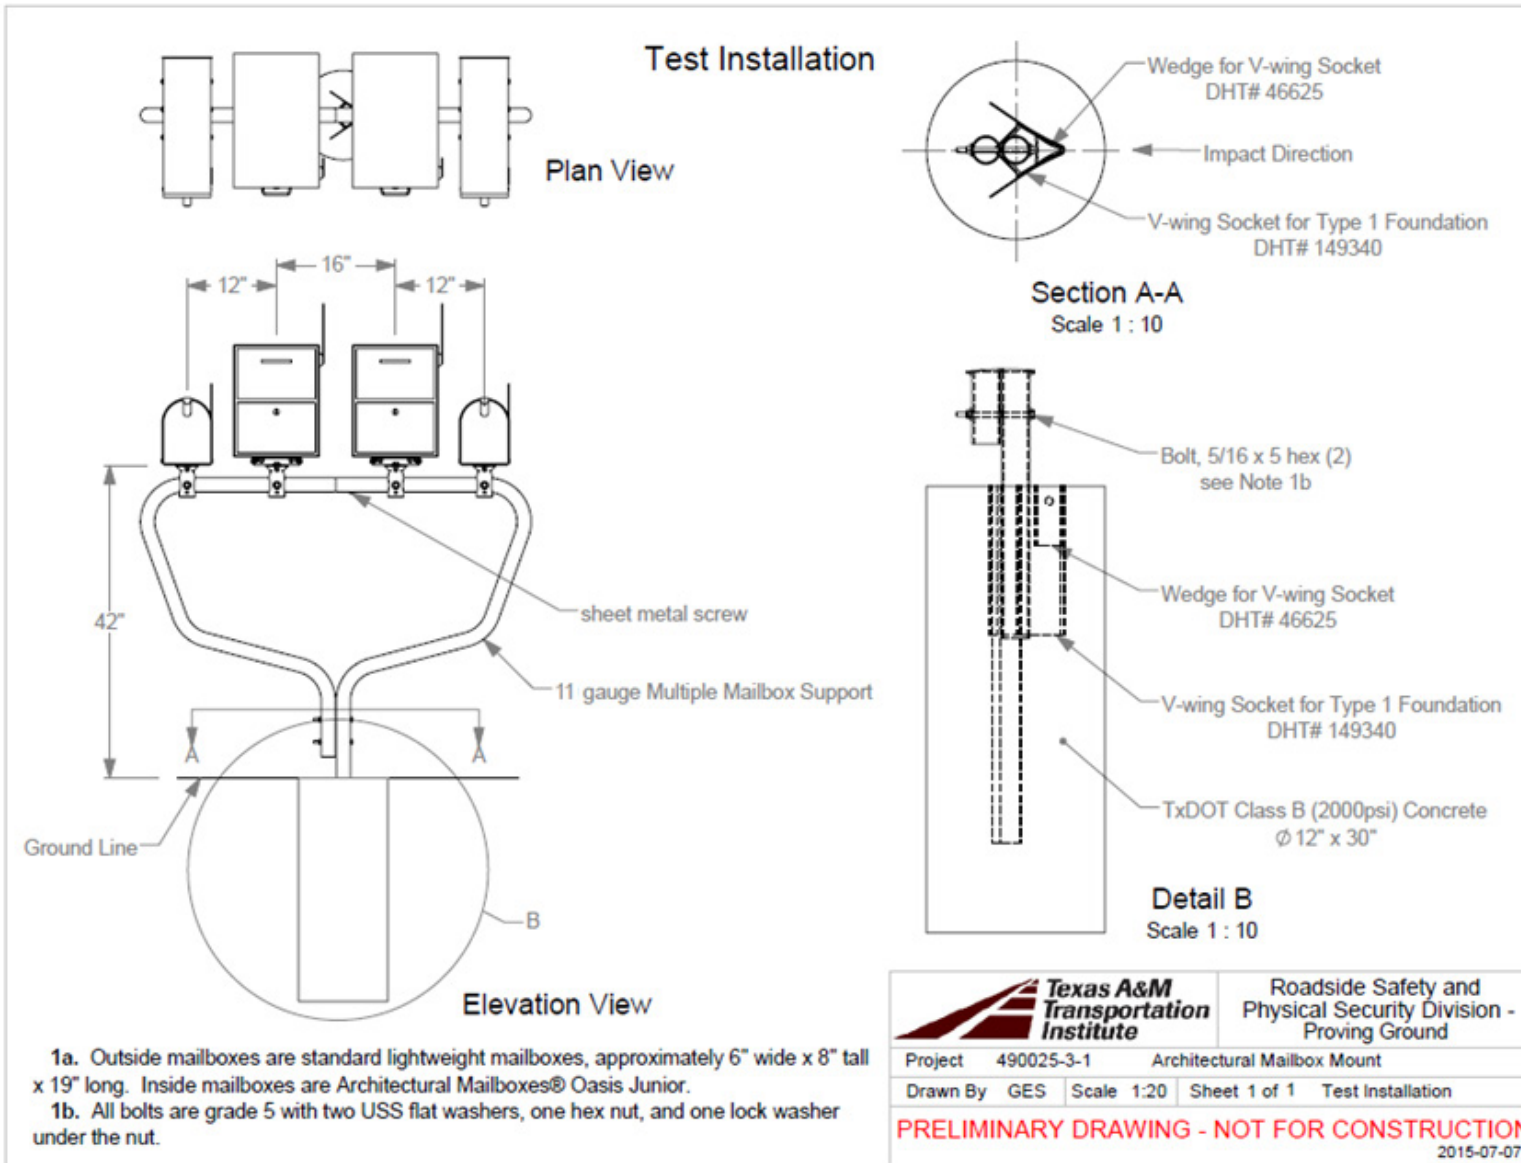
Figure 2.18. New Design 1: Increased Steel Tube Thickness.

In this design, the thickness of the thin-wall steel tube support post is increased to 11 gauge. The increased thickness should strengthen the support and make it more resistant to buckling and fracturing upon vehicle impact. Figure 2.18 provides details of the increased support thickness option.

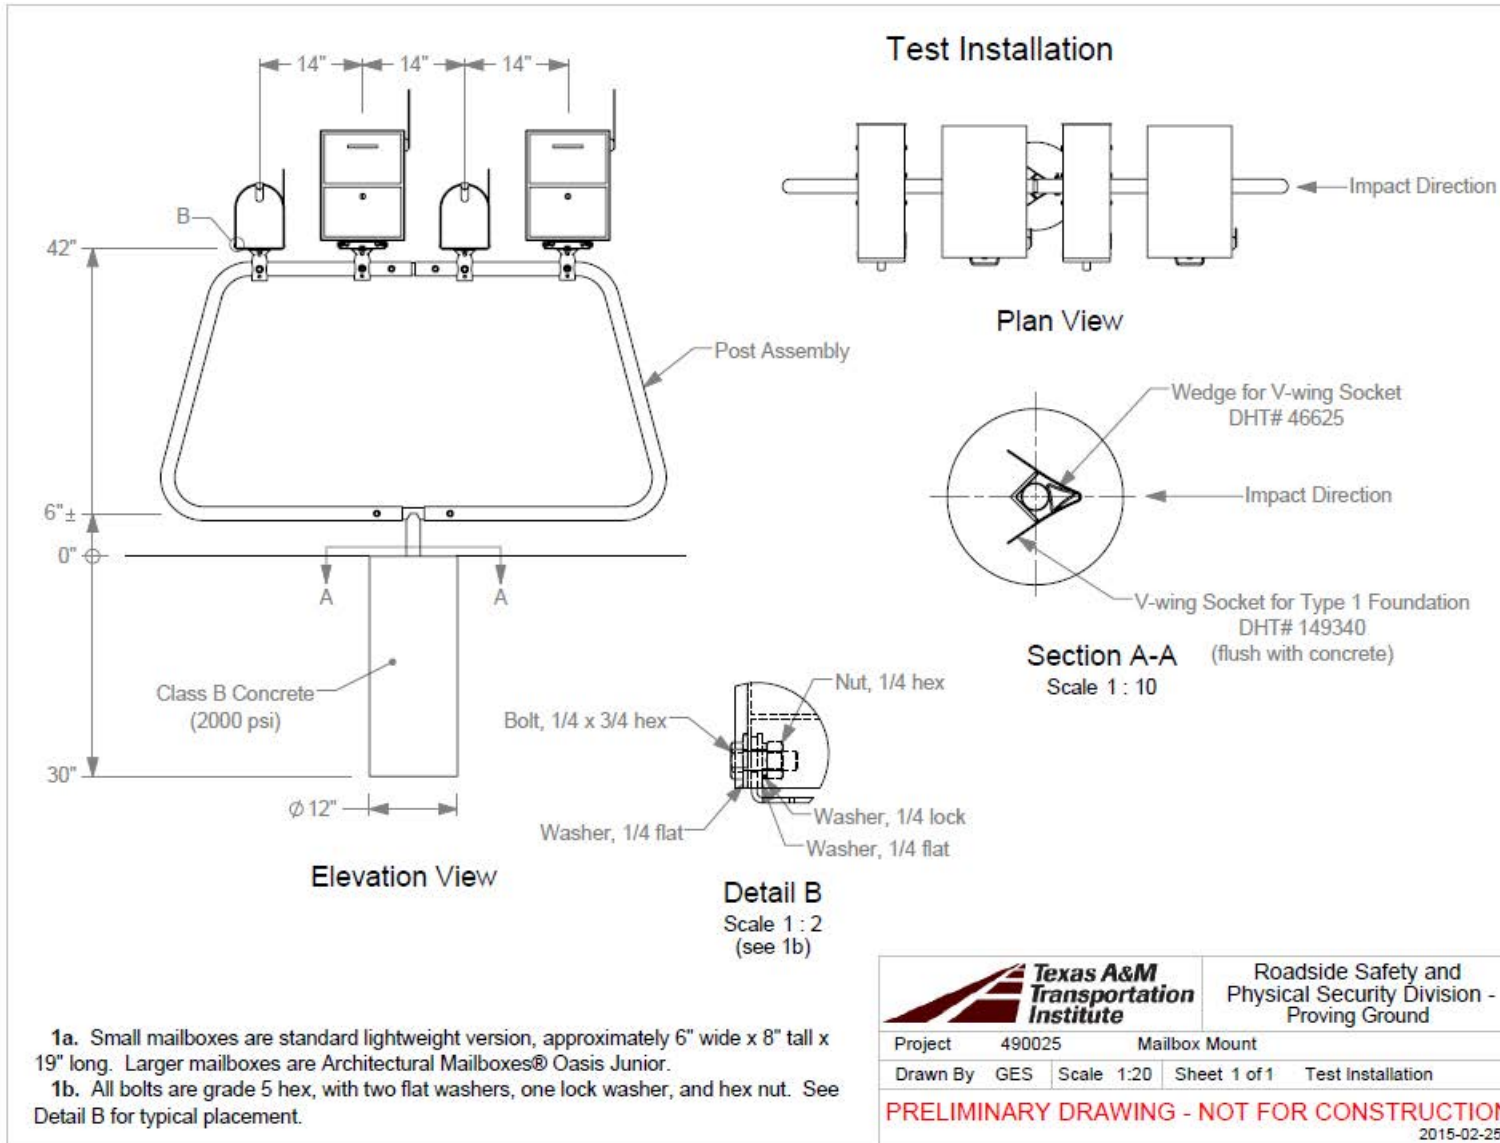
Figure 2.19. New Design 2: Reverse Geometry.

2.2.2.2 *New Design 2: Reverse Support Geometry.* In this option, a new support post design with different geometry is proposed. More specifically, the bottom horizontal member is longer than the upper horizontal member creating a “reverse angle” on the sides of the support compared to the current design. The support post assembly is assembled for two symmetrical sections connected together at the top and bottom. The reverse angle can potentially help push the mailboxes down and in front of the vehicle rather than up and over the hood. Also, at time of contact of the support with the vehicle bumper, the mailboxes have a greater offset from the windshield, which can provide more distance to transfer forward momentum to the support system prior to contact with the windshield. In addition to the change in geometry, the support post thickness has been changed to 11 gauge (2.0-inch OD with wall thickness of 0.125 inch) similar to New Design 1. This modification should increase the strength of the support and help prevent localized buckling and fracture of the support under vehicle impact. Because the reverse geometry might make it more difficult for the support to release from its socket, the embedment has been reduced to 6 inches (from a minimum of 7 inches to a maximum of 9 inches currently used). Figure 2.19 provides details of the reverse support geometry option.

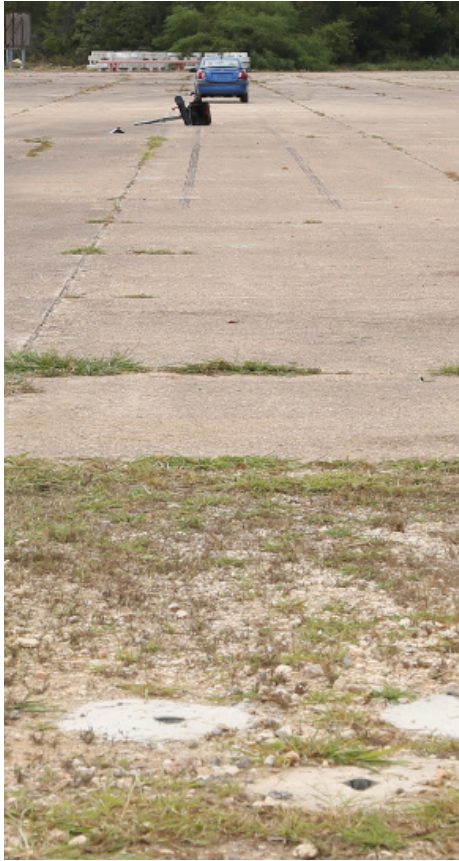
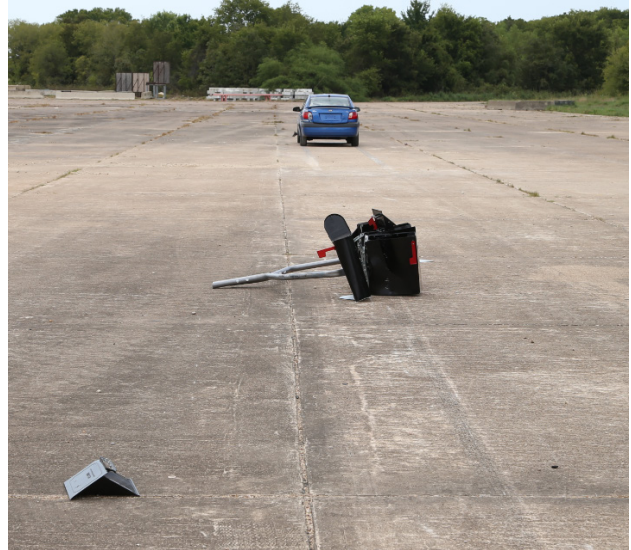
Figure 5.7. Vehicle/Installation Positions after Test No. 490025-3-2.

Figures 5.7 and 5.8 show the damage to the multiple-mailbox support installation. The support post lifted out of the socket as designed. The support post and the mailboxes were deformed, as were the brackets attaching the mailboxes to the support post. The mailboxes remained attached to the support post and the assembly came to rest behind the vehicle 184 ft downstream and 4 ft left of impact, with the support base pointing left relative to the vehicle path.

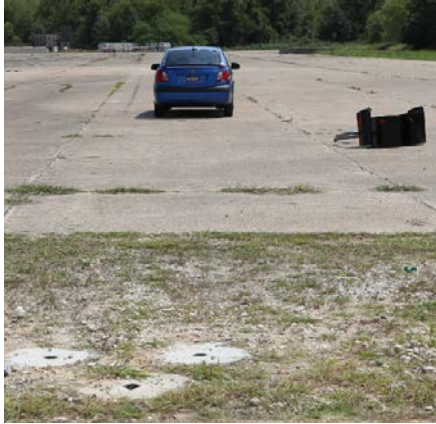
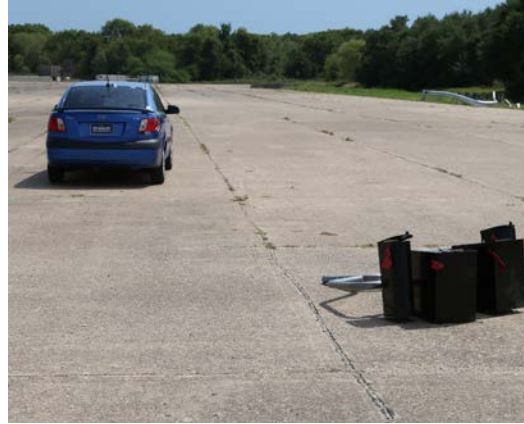
Figure 5.14. Vehicle/Installation Positions after Test No. 490025-3-1.

Figures 5.14 and 5.15 show the damage to the locking architectural multiple-mailbox installation. The support post lifted out of the socket as designed. The support post was kinked and flattened at its lower 4 inches on the vertical stub, but was otherwise undamaged. The mailboxes remained attached to the support post and the assembly came to rest behind the

vehicle 50 ft downstream of impact and 11 ft to the right, with the base of the support pointing downstream-left at approximately 45 degrees.

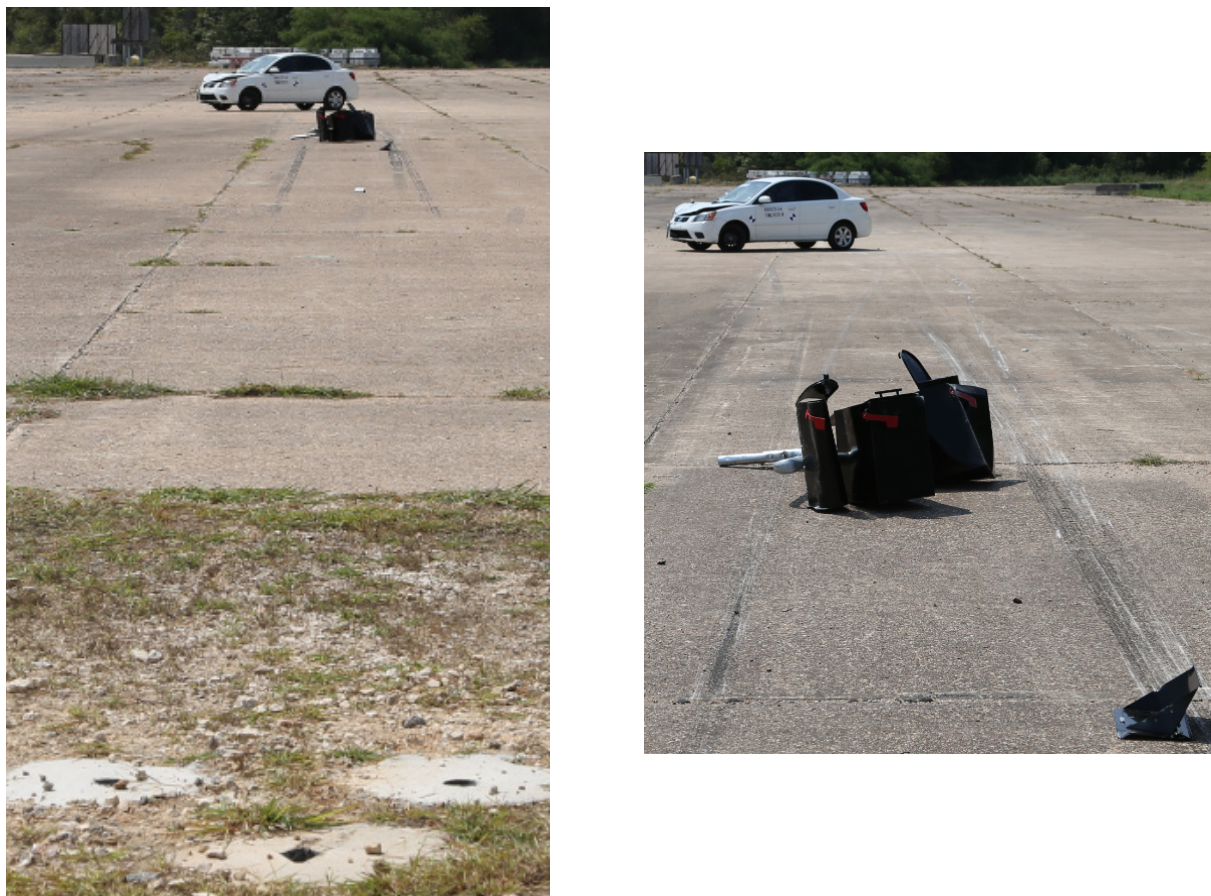
Figure 6.7. Vehicle/Installation Positions after Test No. 490025-3-4.

Figures 6.7 and 6.8 show damage to the mailbox support installation. The support post was lifted out of the socket and was pushed forward by the vehicle in the direction of travel. The support post was deformed and buckled in the area of contact with the vehicle bumper. However, the support did not fracture. The mailboxes and their brackets attaching them to the support post were deformed. The mailboxes remained attached to the support post and the assembly came to rest behind the vehicle 270 ft downstream of impact, with the support base pointing downstream left. The door of the locking architectural mailboxes detached from the mailbox, and came to rest behind the vehicle 158 ft downstream of impact; it did not, however, show potential for penetrating the occupant compartment, or present an undue hazard to other traffic. The single wire rope clip connection used at the longer support end to secure the wire rope slipped off the rope.

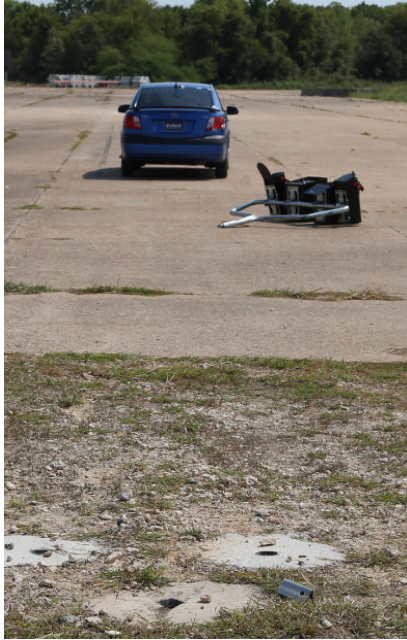
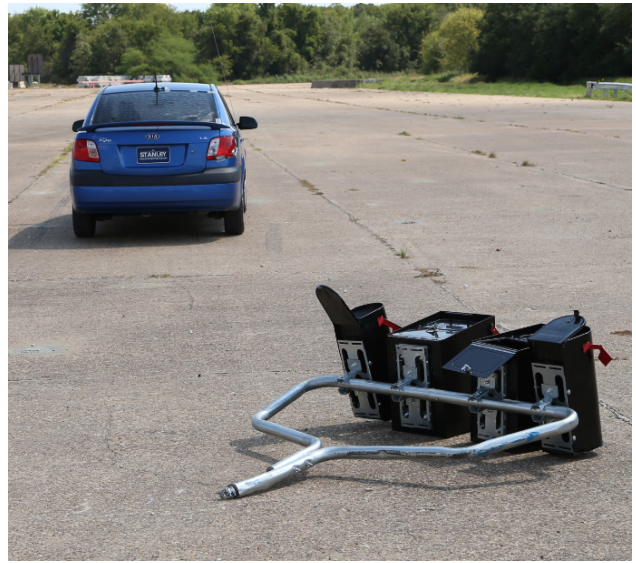
Figure 6.15. Vehicle/Installation Positions after Test No. 490025-3-3.

Figures 6.15 and 6.16 show the damage to the mailbox support installation. The support post was lifted out of the socket and pushed forward by the vehicle in the direction of travel. The support tube was kinked and flattened in the lower 6 inches of the vertical stub, but was otherwise undamaged. The mailboxes remained attached to the support post and the assembly came to rest behind the vehicle 60 ft downstream of impact with the base of the support pointing upstream-left.

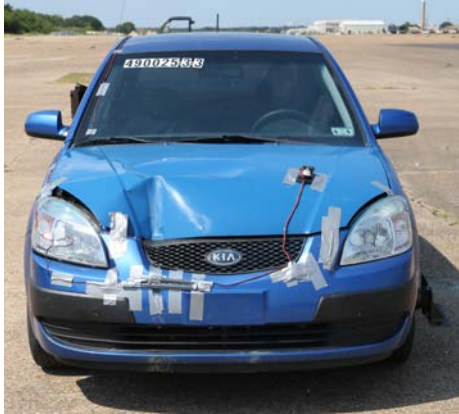
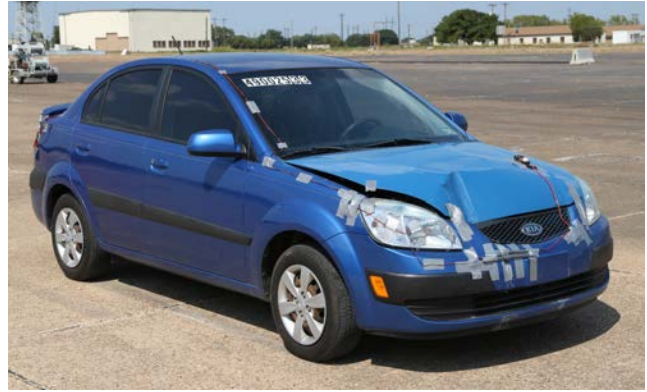
Figure 6.17. Vehicle after Test No. 490025-3-3.

Figure 6.17 shows the damage to the exterior of the vehicle, and Figure 6.18 shows the interior of the vehicle after the test. The hood, bumper, and grill were deformed. The maximum hood deformation was 3.5 inches. There was no contact of any components of the mailbox system with the windshield. Tables E.2 and E.3 in Appendix E.1 provide exterior crush and occupant compartment measurements, respectively.
