MASH EVALUATION OF TxDOT HIGH-MOUNTING-HEIGHT TEMPORARY WORK ZONE SIGN SUPPORT SYSTEM

Test Report 9-1002-15-8

**TEXAS A&M TRANSPORTATION INSTITUTE
COLLEGE STATION, TEXAS**

TEXAS DEPARTMENT OF TRANSPORTATION

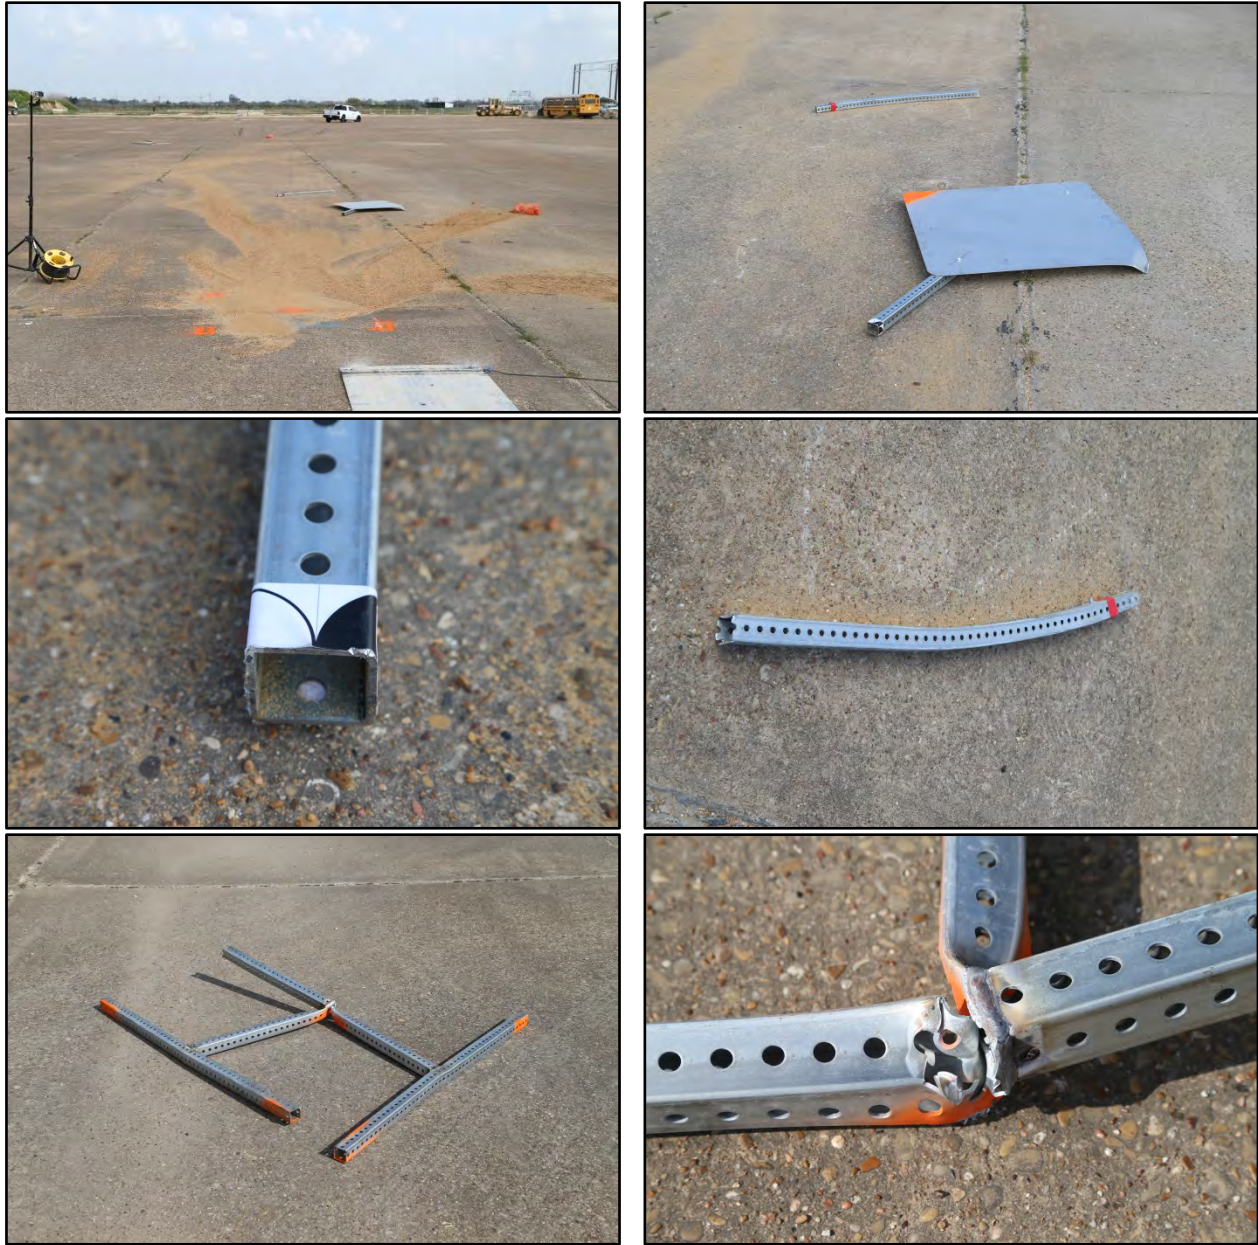
Figure 5.4 shows the damage to the Option A temporary work zone sign support. The sign panel and a portion of the upright came to rest 20 ft downstream of impact and 6 ft to the right of centerline of the impact path. The lower section of the vertical support post fractured 24 inches above grade and the fractured section came to rest 29 ft downstream and 5 ft to the right of centerline. The H-shaped base with the remaining piece of the lower section of the vertical support post came to rest 98 ft downstream of impact and 12 ft left of centerline of the impact path.

Figure 5.4. Option A Temporary Work Zone Sign Support after Test No. 490026-2-1.

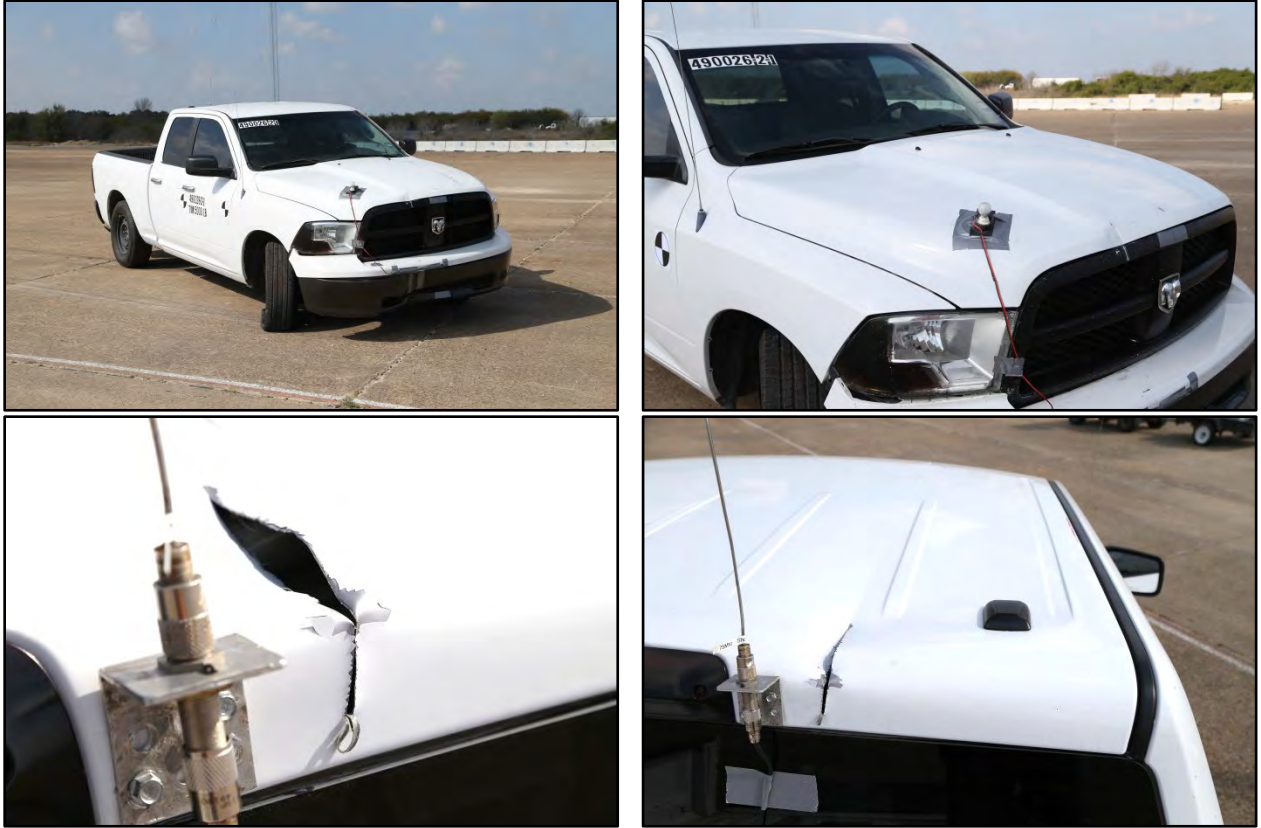
Figure 5.5 shows the damage sustained by the vehicle. The bumper, hood, grill, and roof were damaged. Maximum exterior crush to the vehicle was 2.5 inches in the front plane at the right quarter point at bumper height. On the rear of the roof, there was a 16-inch long scratch that ended in a 5-inch long tear on the outer surface. The cut did not extend into the passenger compartment. The interior roof in the area of the cut was only dented approximately 1 inch, as shown in Figure 5.6. No other occupant compartment deformation or intrusion was noted. Tables A.3 and A.4 in Appendix A1 provide exterior crush and occupant compartment measurements.

Figure 5.5. Test Vehicle after Test No. 490026-2-1.

Results: The Option A temporary work zone sign support released and fractured into three pieces. The sign panel and the attached upper section of the vertical support post contacted the roof of the 2270P vehicle causing a 16-inch long scratch that ended in a 5-inch long tear on the outer surface of the roof at the rear of the cab. This was determined to be of concern for potential intrusion into the vehicle. (FAIL)

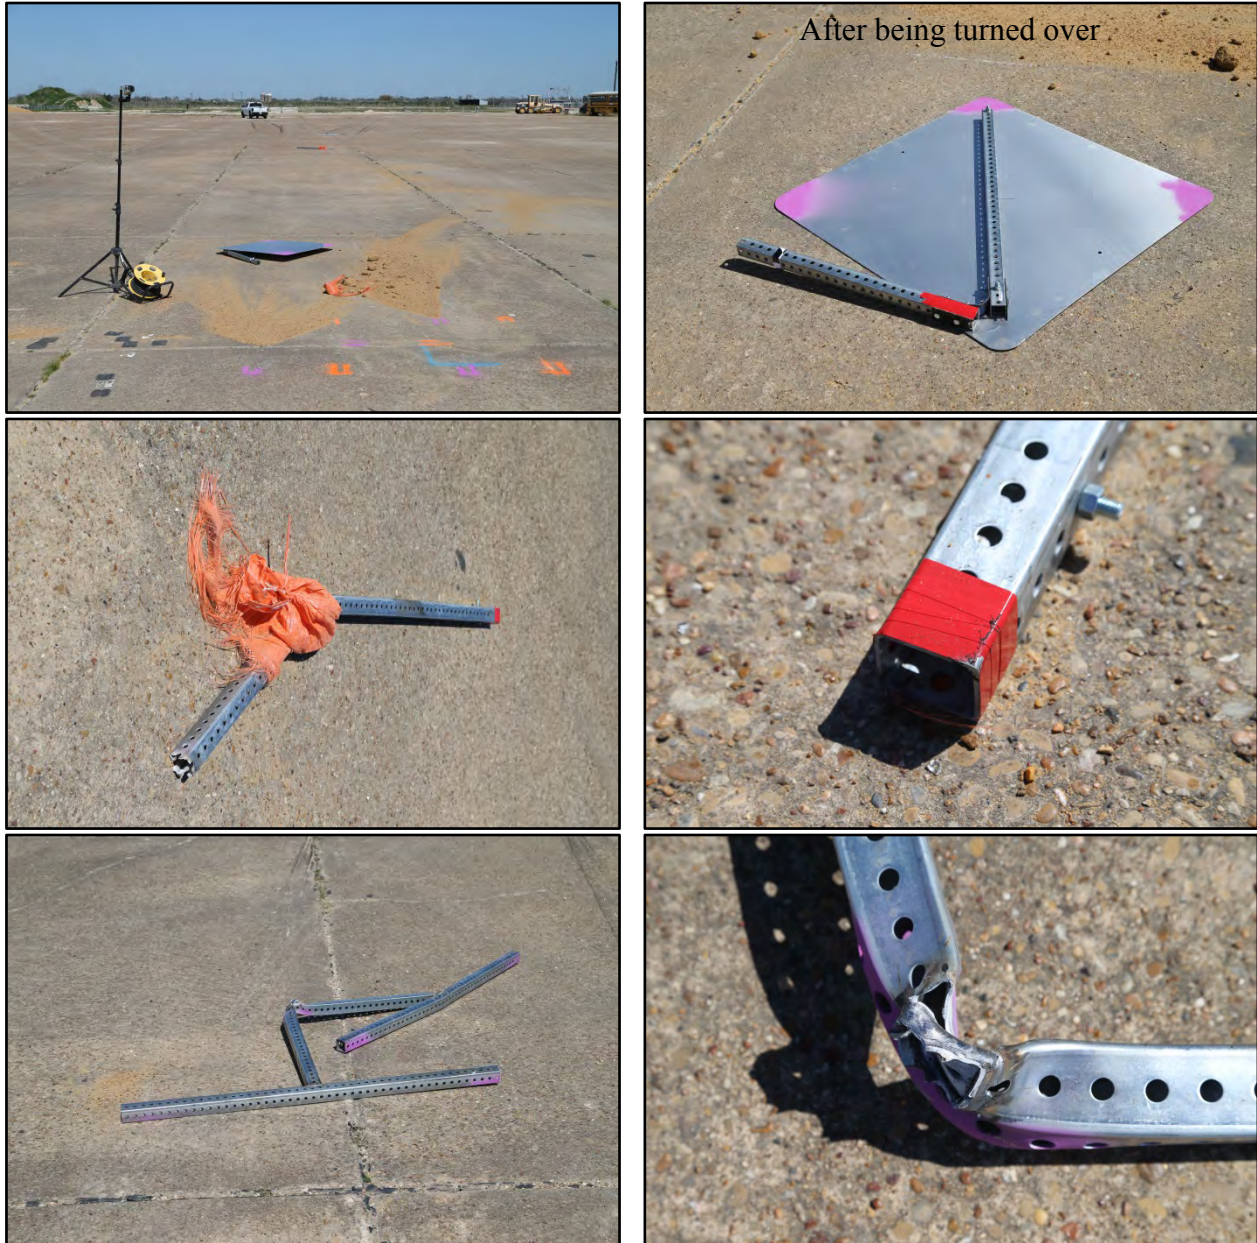
support fractured 24 inches above grade and the piece came to rest 77 ft downstream of impact and 3 ft to the right of centerline of the impact path. The H-shaped base and lower portion of the bottom section of the vertical support came to rest 108 ft downstream of impact and 6 ft right of centerline of the impact path.

Figure 6.4. Option B Temporary Work Zone Sign Support after Test No. 490026-2-2.

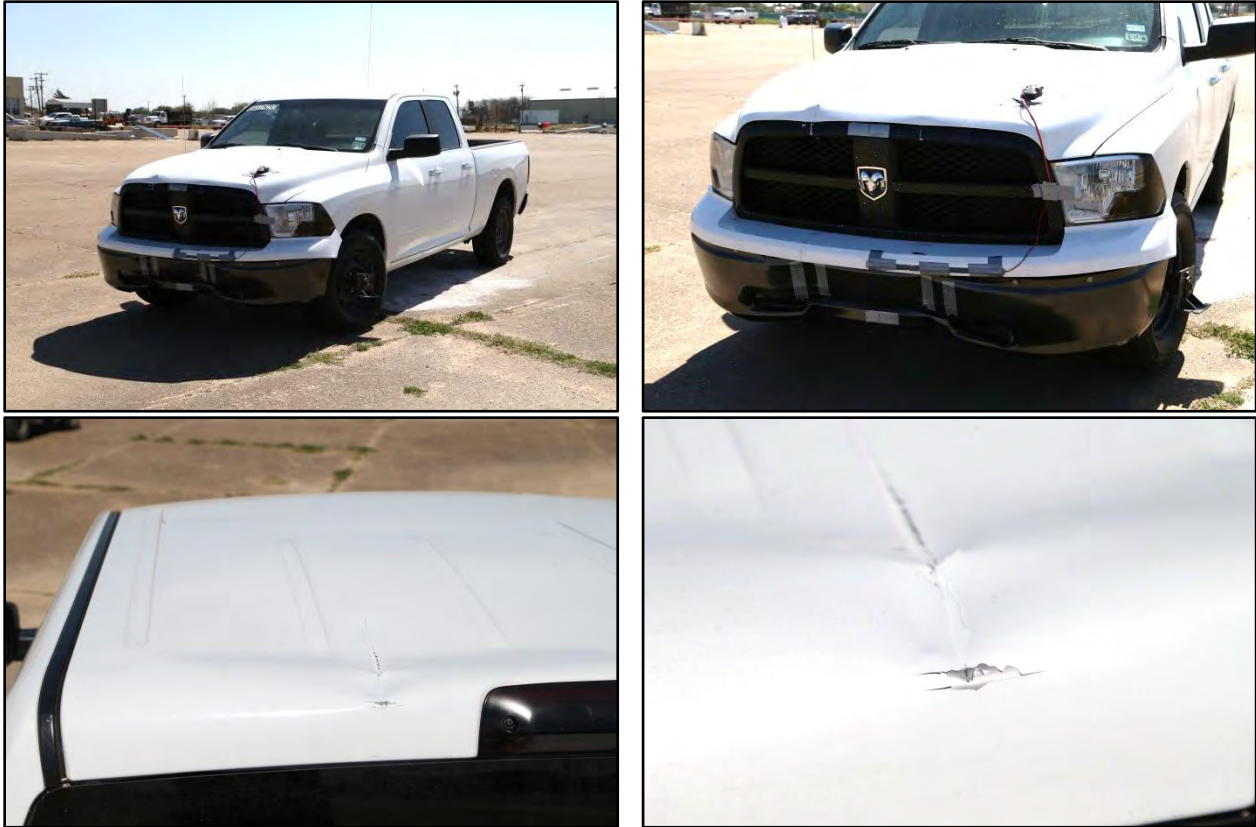
at the left quarter point at bumper height. On the left side of the roof of the cab, there was a 10-inch long dent on the outer surface, but no penetration into the passenger compartment. Figure 6.6 shows the interior of the vehicle. No occupant compartment deformation or intrusion was noted. Tables B.3 and B.4 in Appendix B1 provide exterior crush and occupant compartment measurements.

Figure 6.5. Test Vehicle after Test No. 490026-2-2.

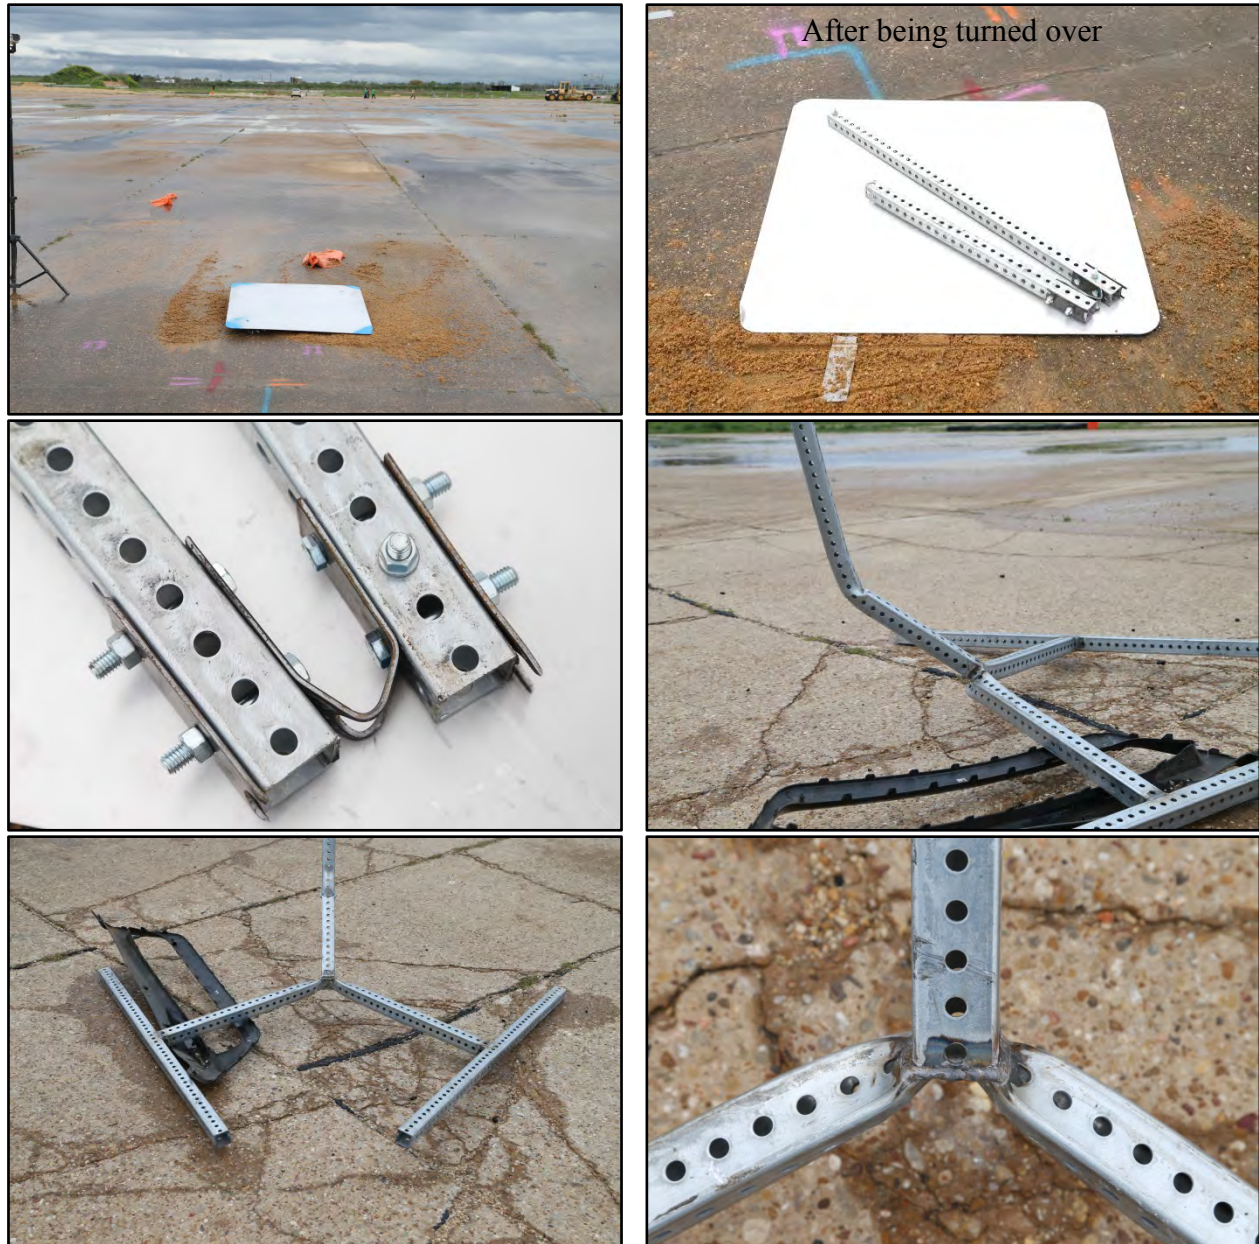
Figure 6.10 shows the damage to the Option B temporary work zone sign support. The sign panel and middle and upper sections of the vertical support came to rest 3 ft downstream of impact and on the centerline of the impact path. The fuse plates connecting the middle and upper section of the support were activated. The remainder of the temporary work zone sign support rode along with the 1100C vehicle. As the vehicle came to a stop, the support slid ahead of the vehicle and came to rest 483 ft downstream of impact and on the centerline of the impact path. The lower section of the vertical support was bent at bumper height.

Figure 6.10. Option B Temporary Work Zone Sign Support after Test No. 490026-2-4.

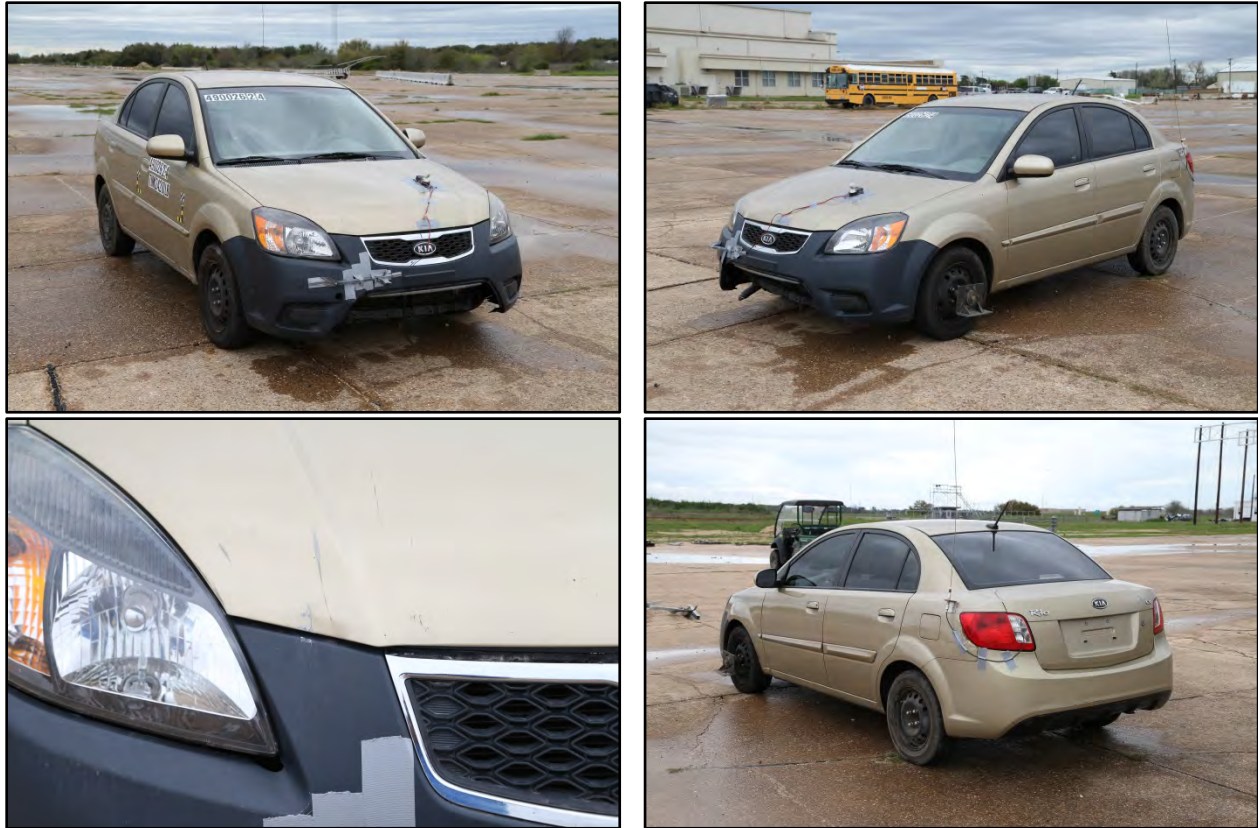
Figure 6.11 shows the damage sustained by the vehicle. The 1100C vehicle sustained only scrapes to the bumper and hood with no measureable exterior vehicle deformation. Figure 6.12 shows the interior of the vehicle. No occupant compartment deformation or intrusion was noted. Tables C.2 and C.3 in Appendix C1 provide exterior crush and occupant compartment measurements.

Figure 6.11. Test Vehicle after Test No. 490026-2-4.

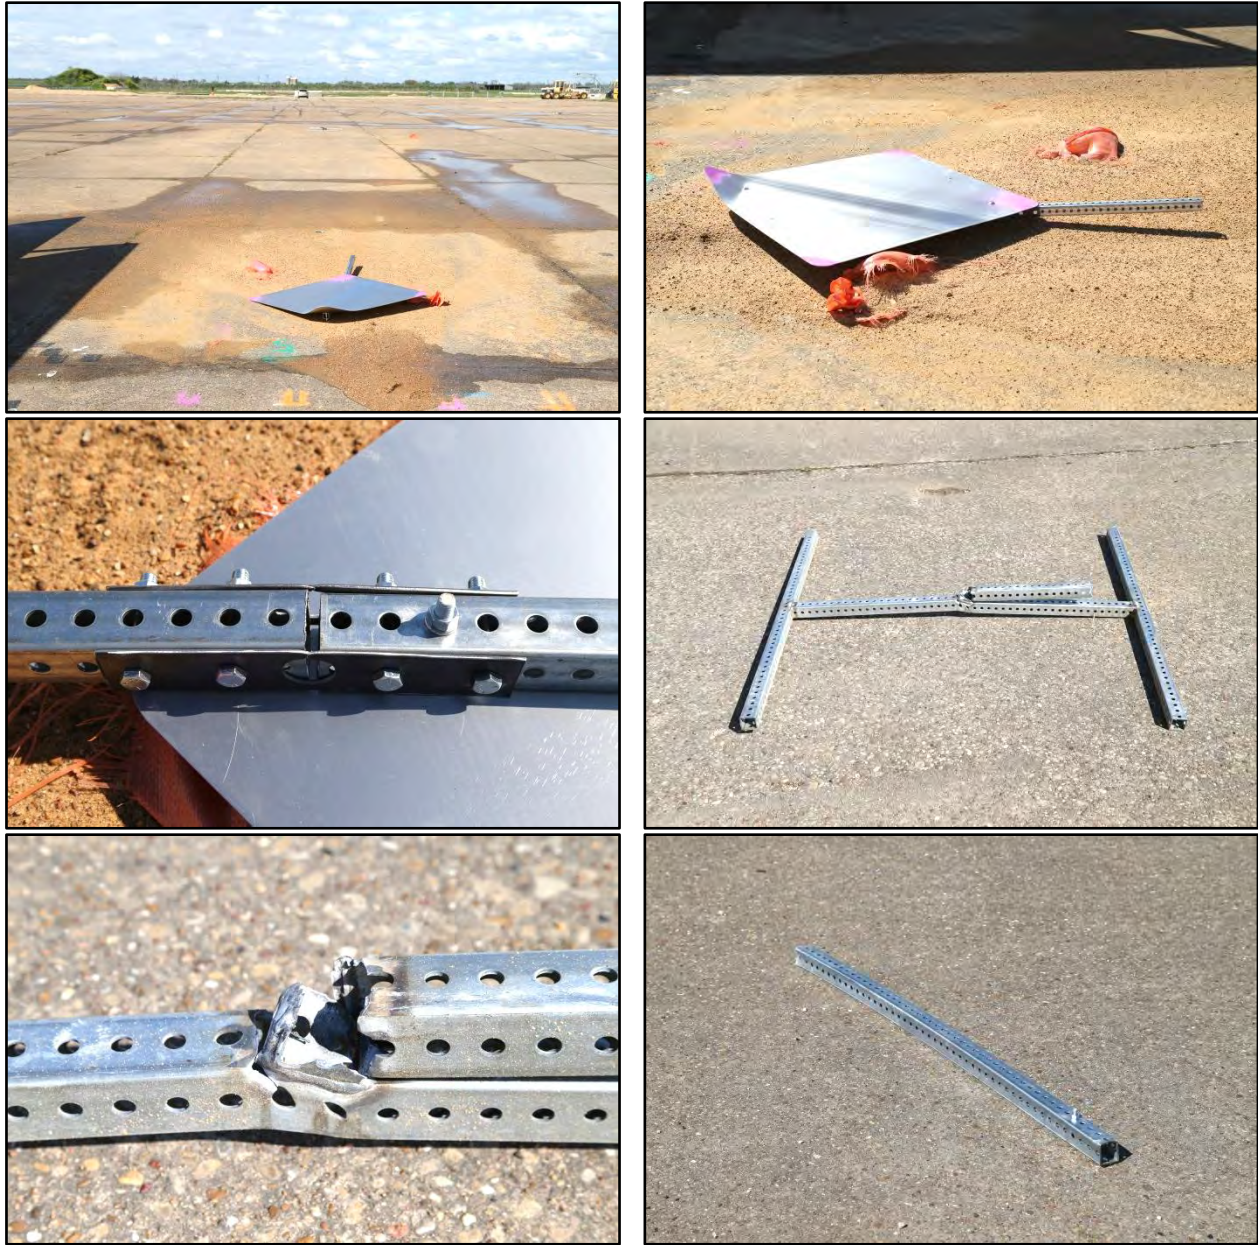
Figure 6.16 shows the damage to the Option B temporary work zone sign support. The sign panel and the attached upper and middle sections of the vertical support came to rest 3 ft downstream of impact. The lower section of the vertical support fractured into two pieces 16 inches above ground level. The upper fractured piece came to rest 185 ft downstream of impact and 12 ft to the right of centerline of the vehicle path. The remaining lower portion and H-base of the temporary work zone sign support came to rest 83 ft downstream of impact.

Figure 6.16. Option B Temporary Work Zone Sign Support after Test No. 490026-2-6.

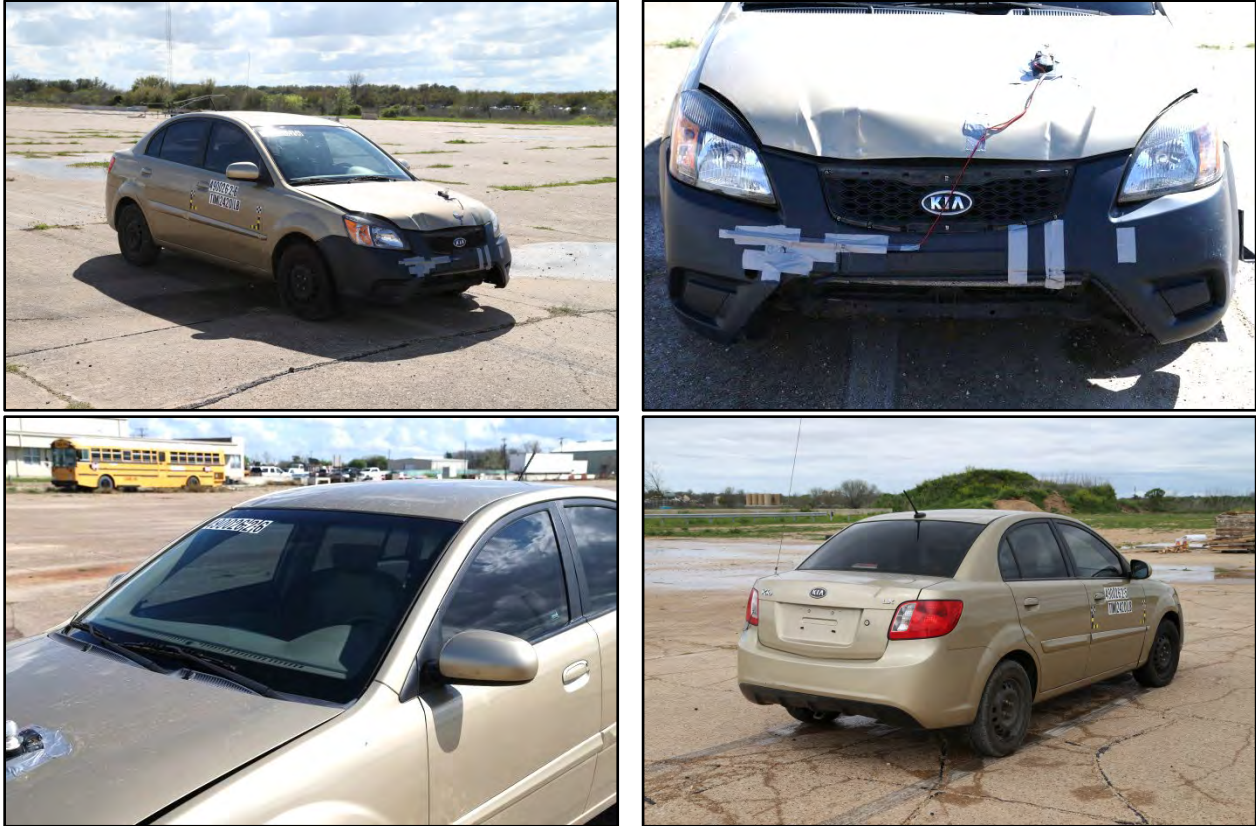
Figure 6.17 shows the damage sustained by the vehicle. The 1100C vehicle sustained only scrapes to the bumper and hood with no measureable exterior vehicle deformation. Figure 6.18 shows the interior of the vehicle. No occupant compartment penetration, deformation, or intrusion was noted. Tables D.2 and D.3 in Appendix D1 provide exterior crush and occupant compartment measurements.

Figure 6.17. Test Vehicle after Test No. 490026-2-6.

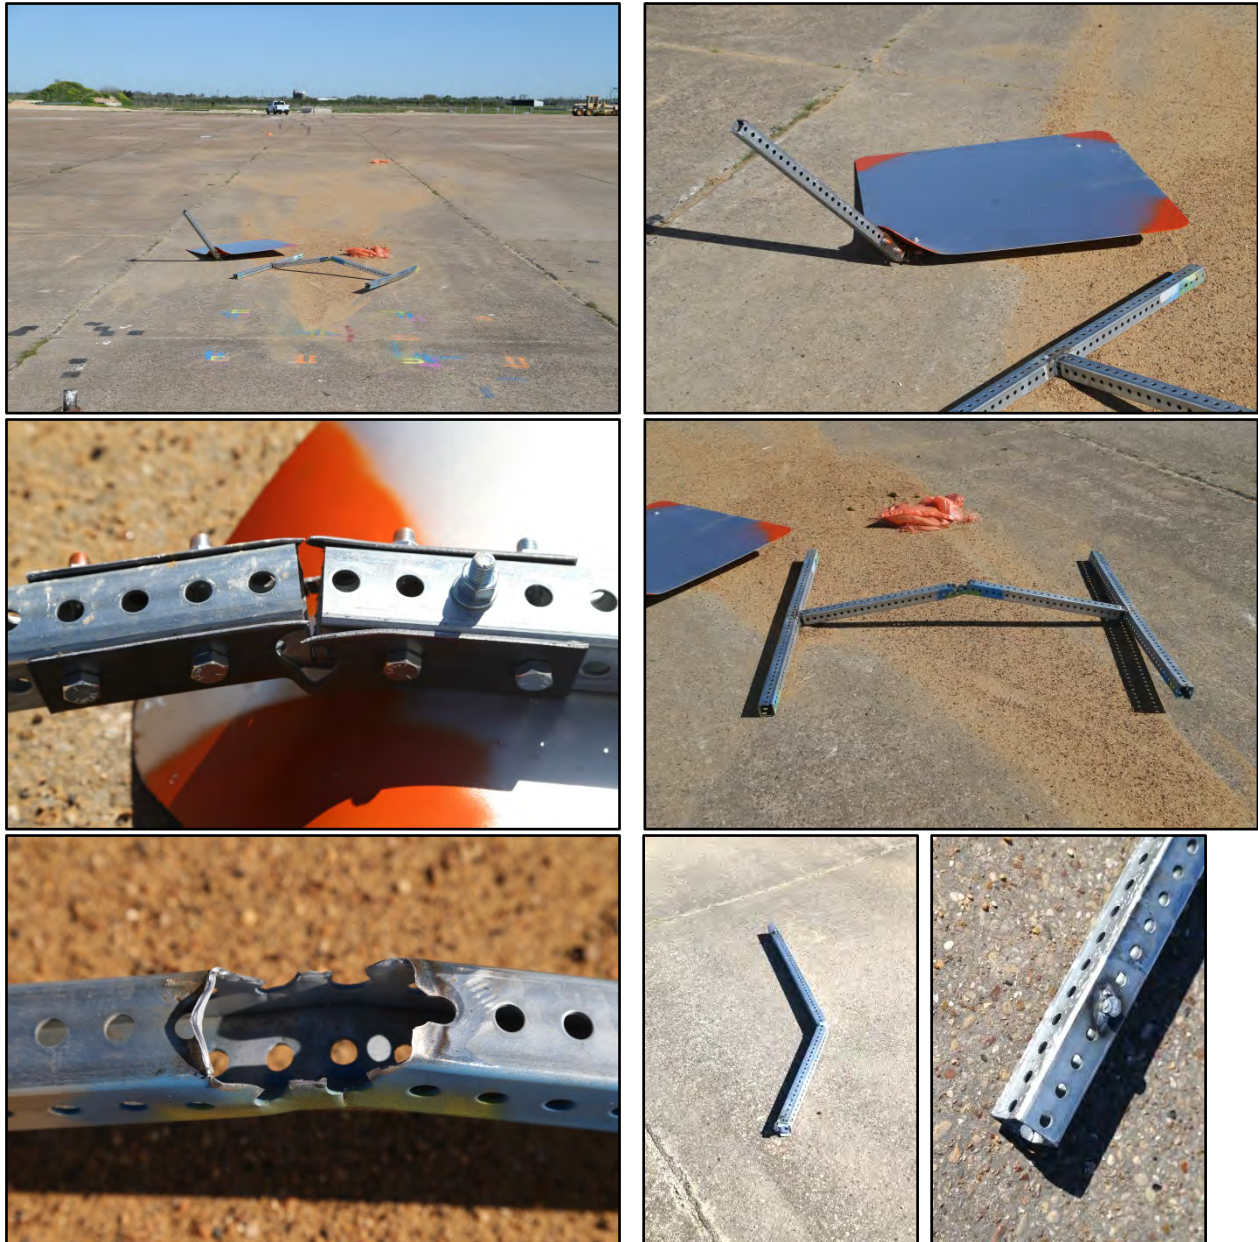
Figure 6.22. Option A Temporary Work Zone Sign Support after Test No. 490026-2-8.

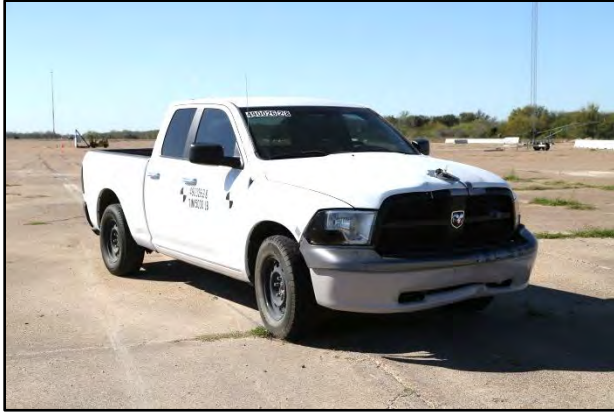
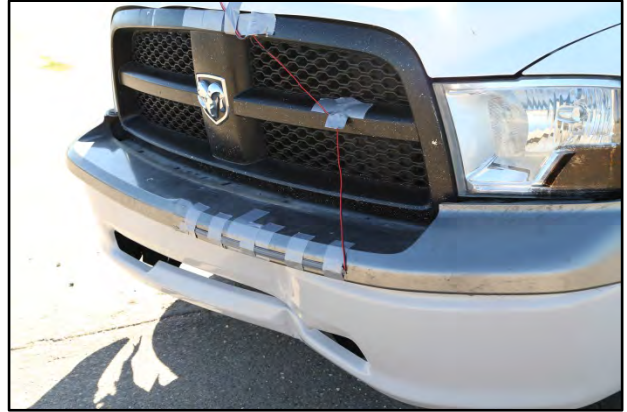
Figure 6.23. Test Vehicle after Test No. 490026-2-8.

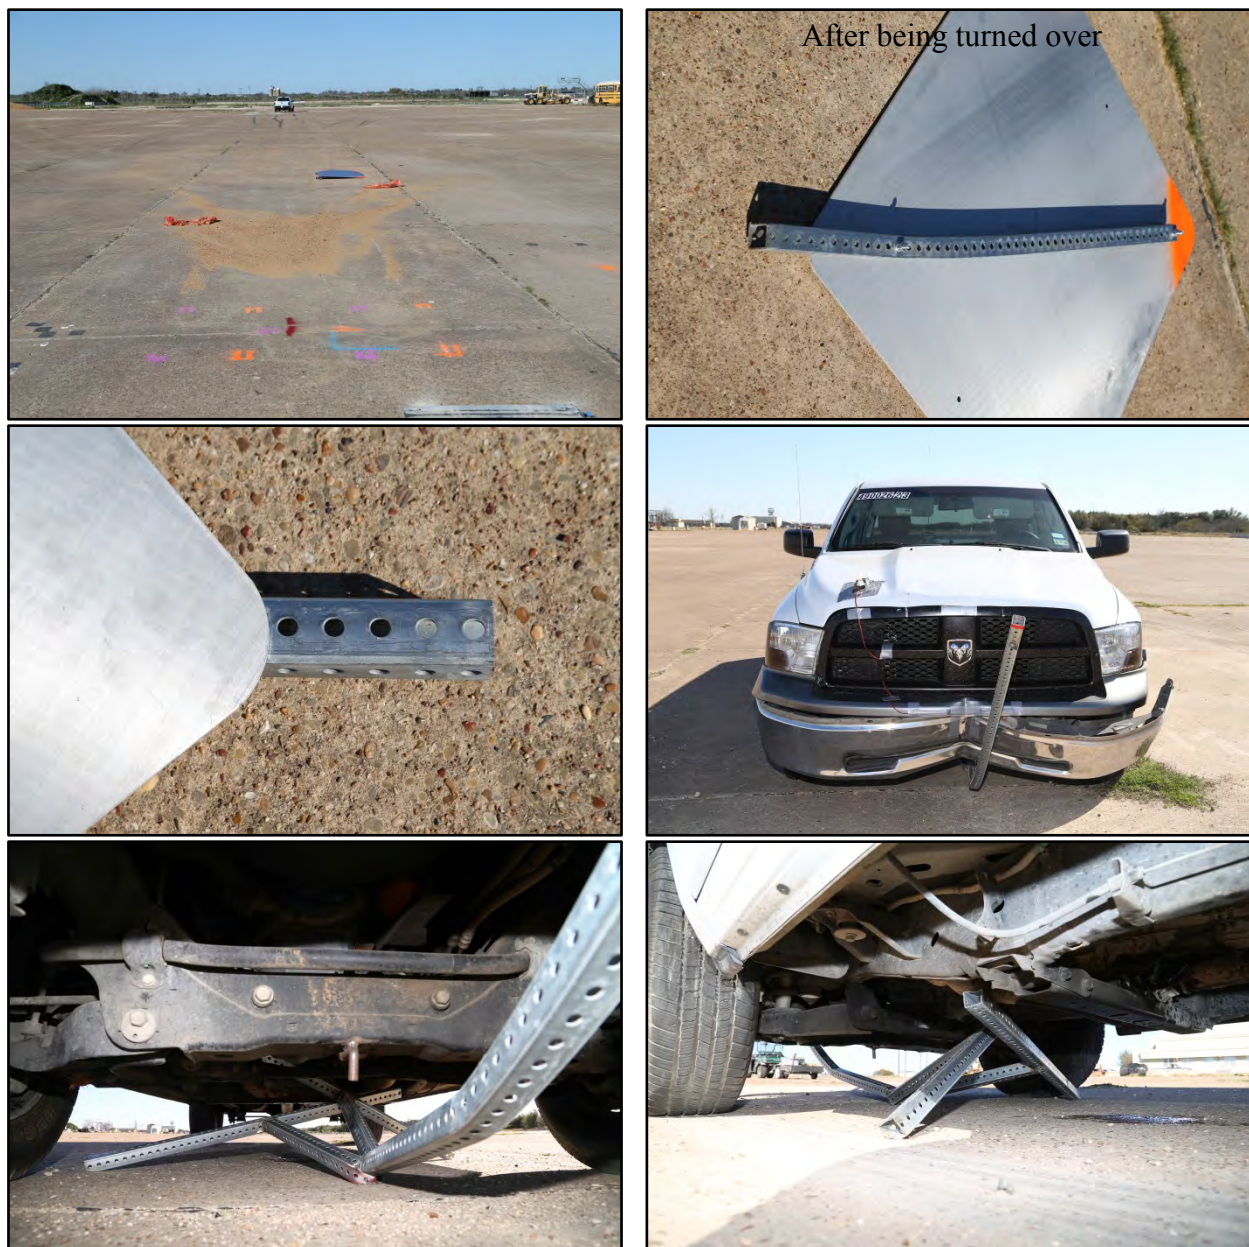
Figure 7.4. Option C Temporary Work Zone Sign Support after Test No. 490026-2-3.

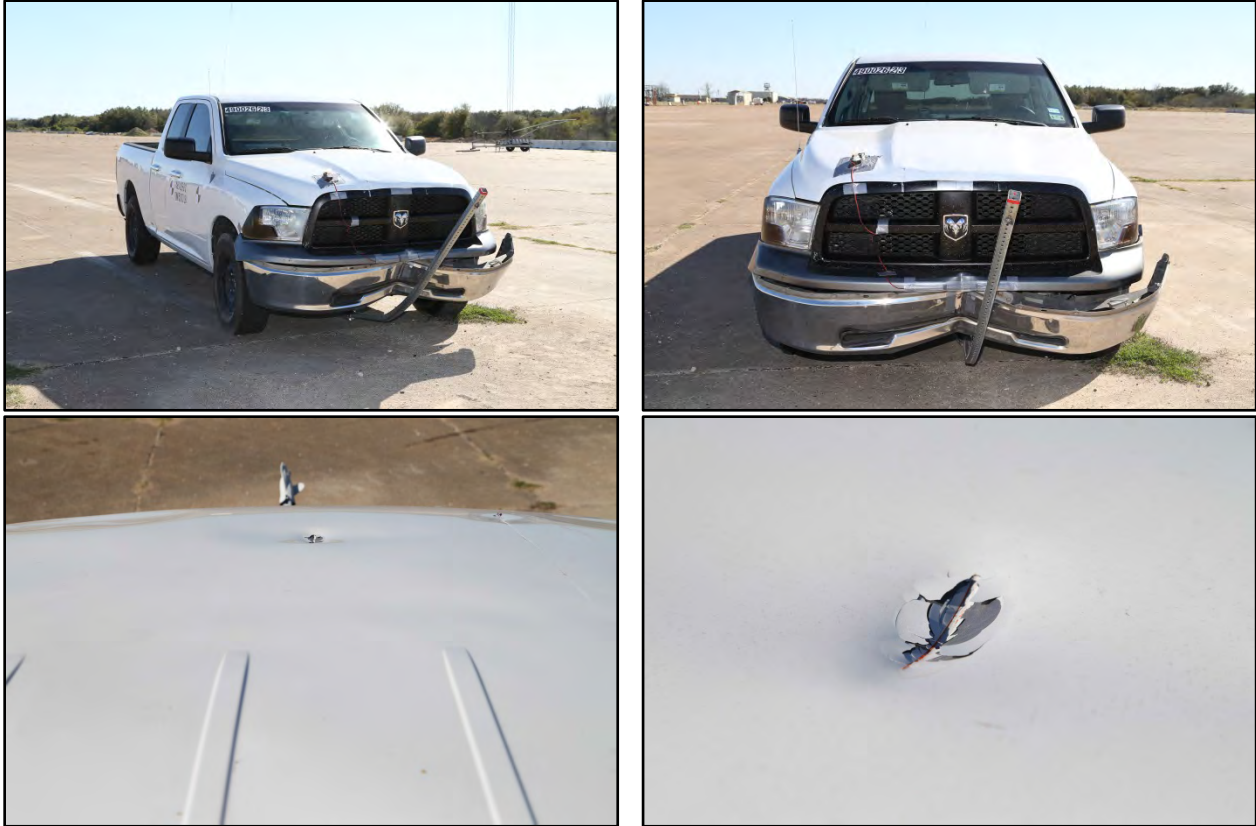
Figure 7.5. Test Vehicle after Test No. 490026-2-3.

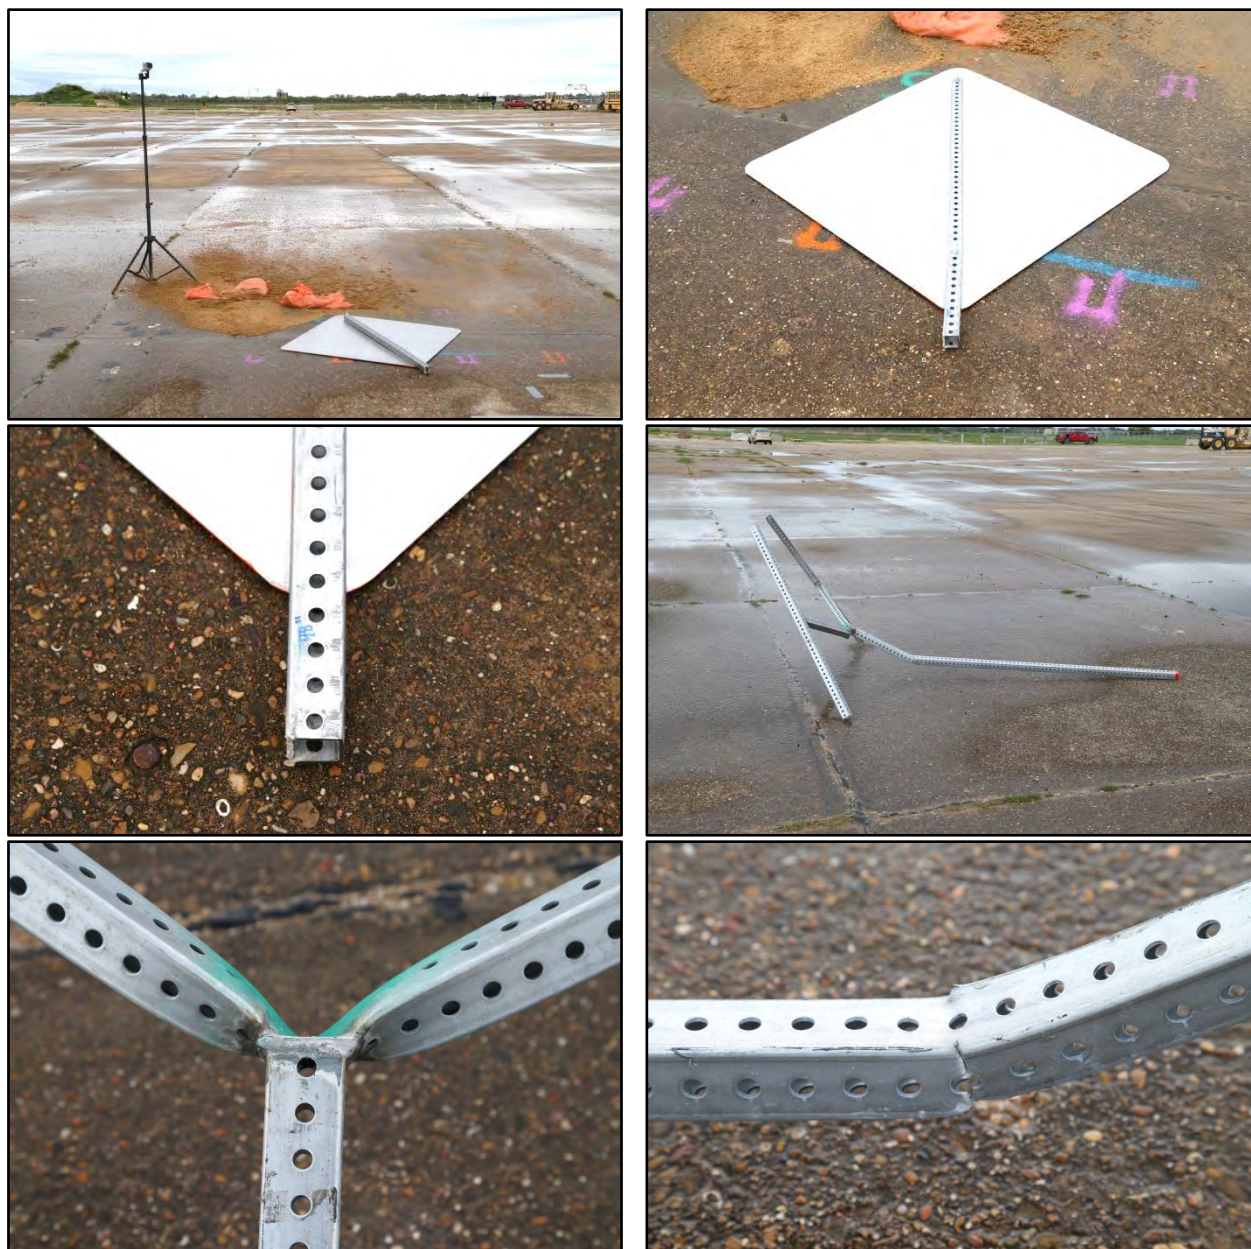
Figure 7.10. Option C Temporary Work Zone Sign Support after Test No. 490026-2-5.

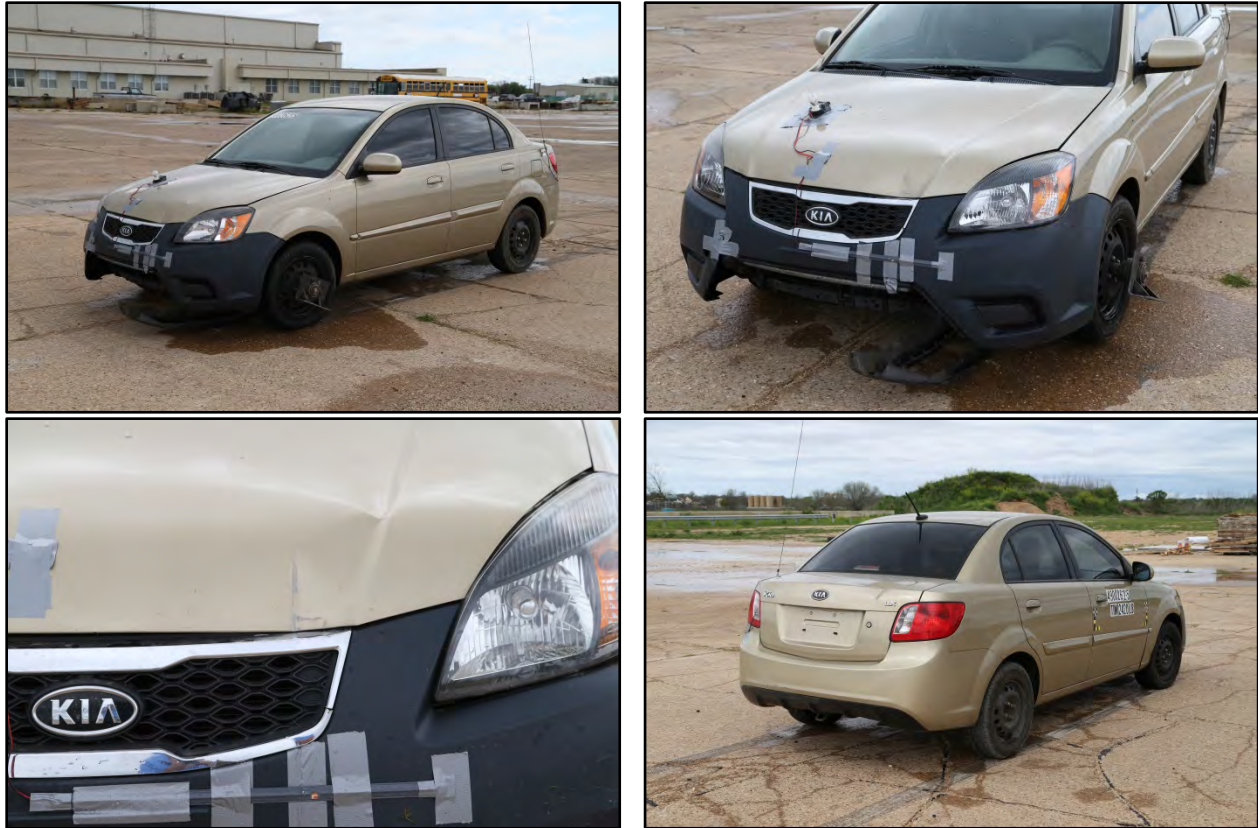
Figure 7.11. Test Vehicle after Test No. 490026-2-5.

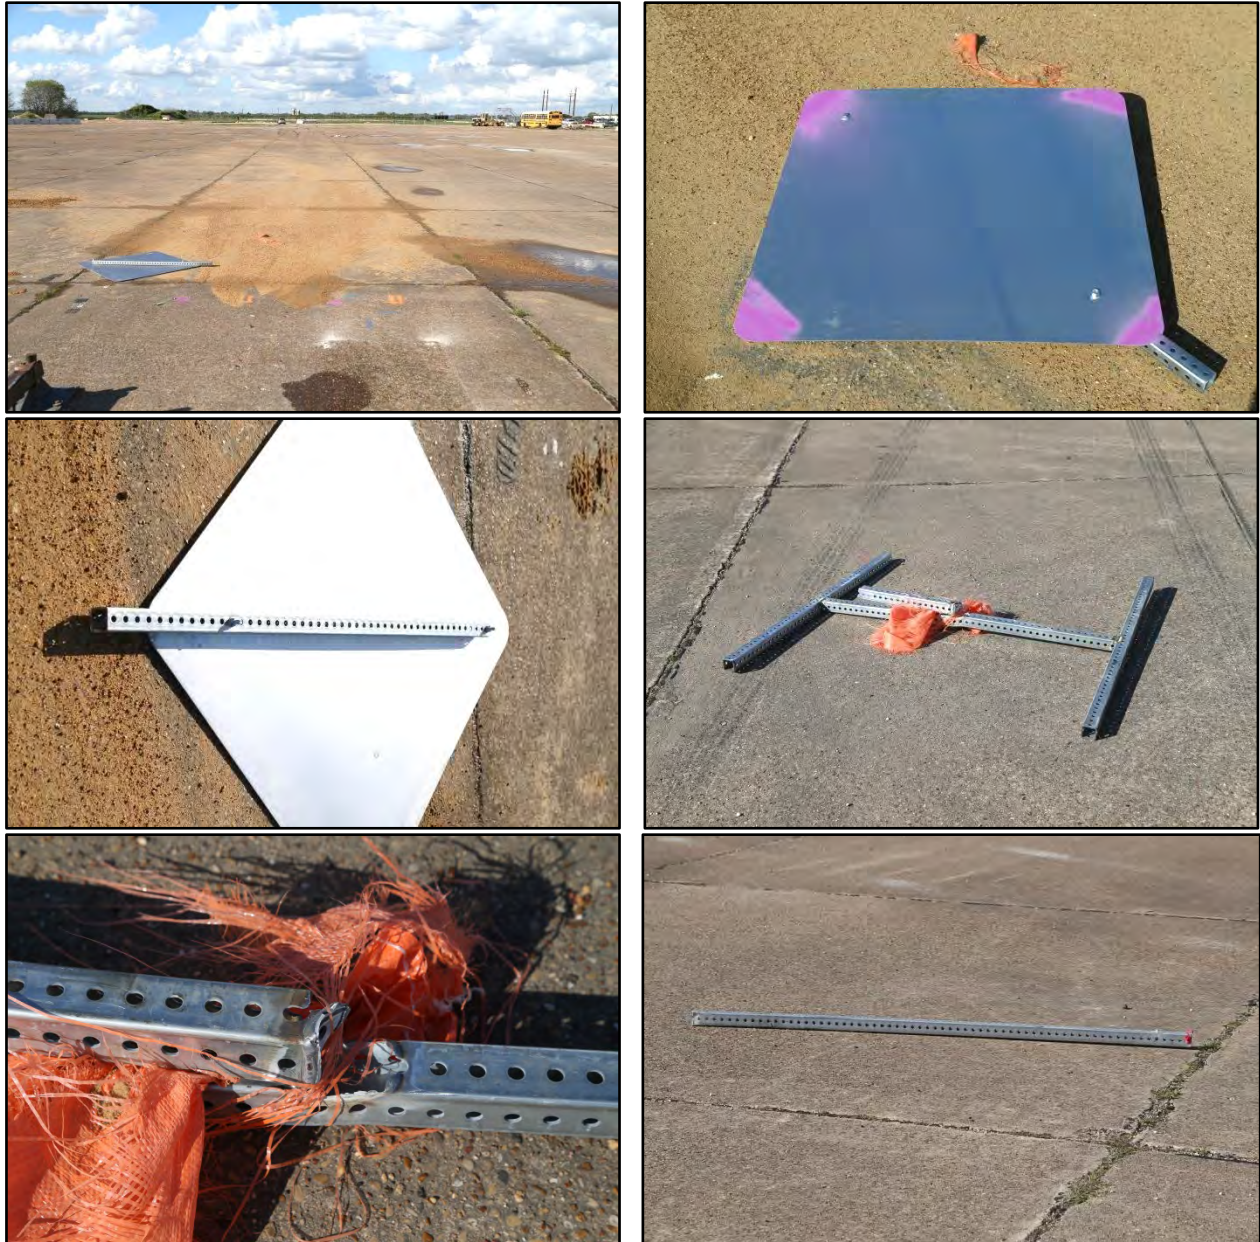
Figure 7.16. Option C Temporary Work Zone Sign Support after Test No. 490026-2-7.

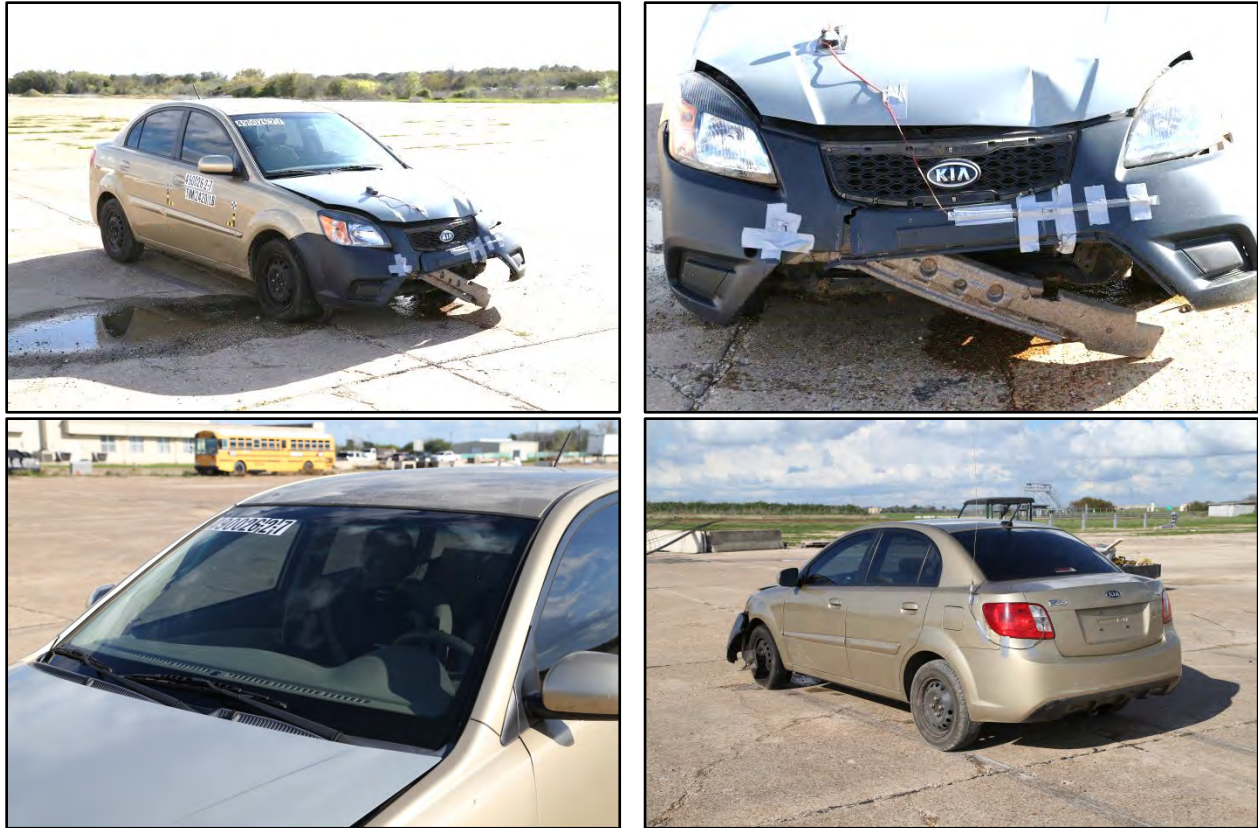
Figure 7.17. Test Vehicle after Test No. 490026-2-7.
