MASH EVALUATION OF TxDOT HIGH-MOUNTING-HEIGHT TEMPORARY WORK ZONE SIGN SUPPORT SYSTEM

Test Report 9-1002-15-8

**TEXAS A&M TRANSPORTATION INSTITUTE
COLLEGE STATION, TEXAS**

TEXAS DEPARTMENT OF TRANSPORTATION

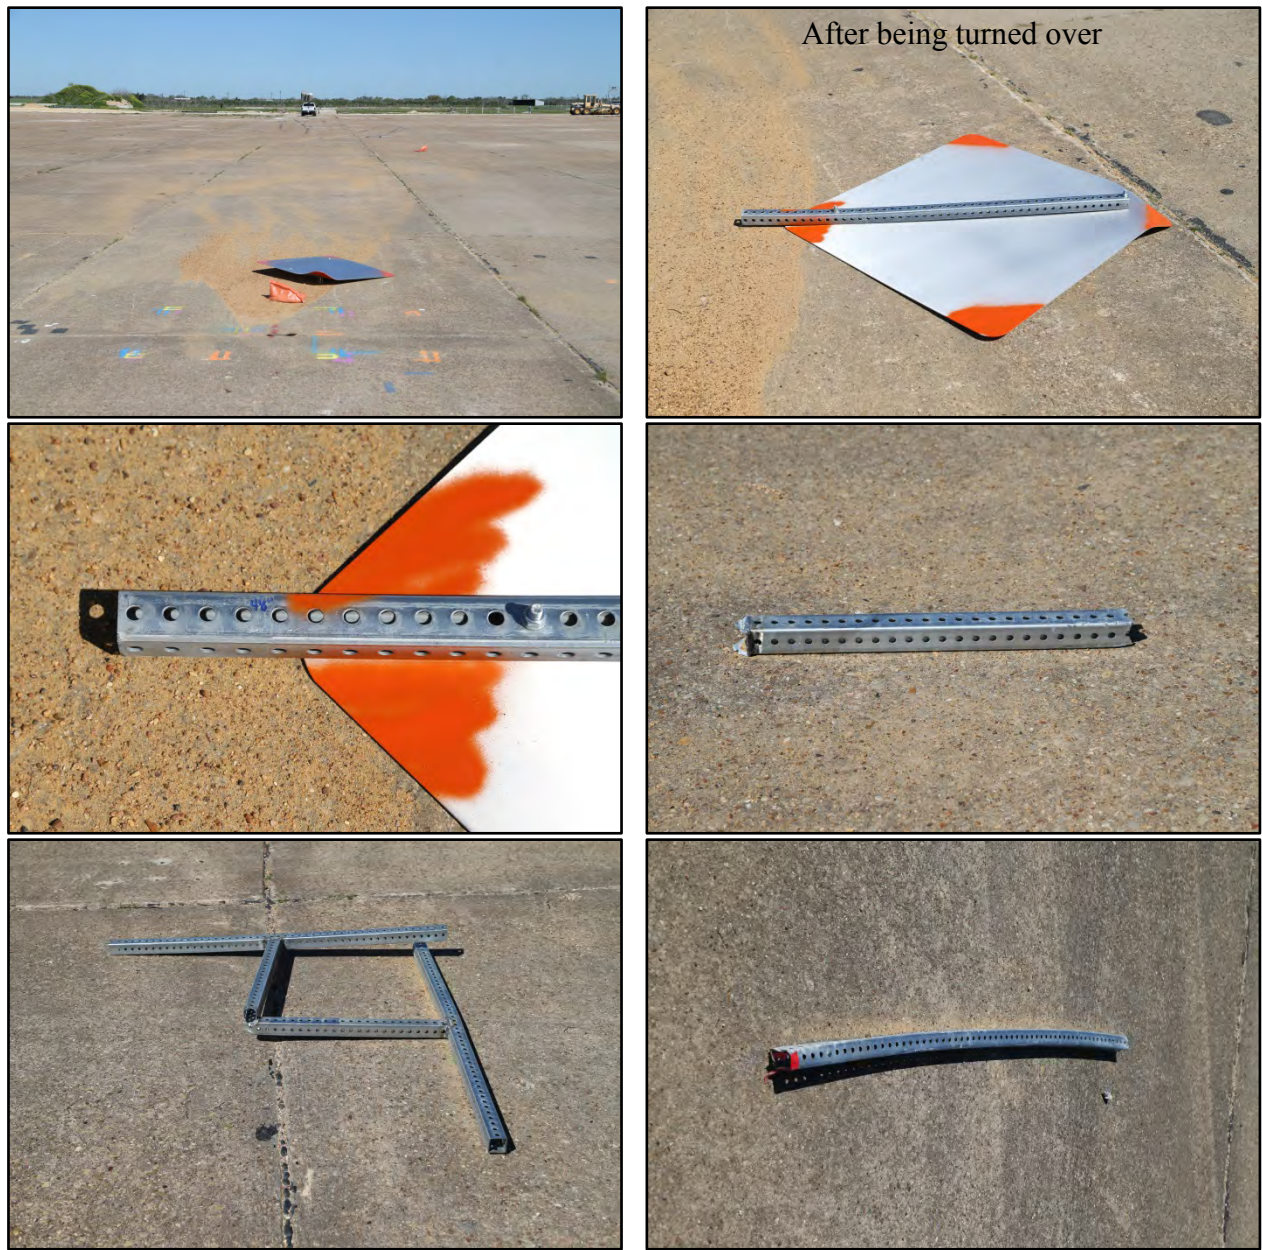
Figure 7.22. Option C Temporary Work Zone Sign Support after Test No. 490026-2-9.

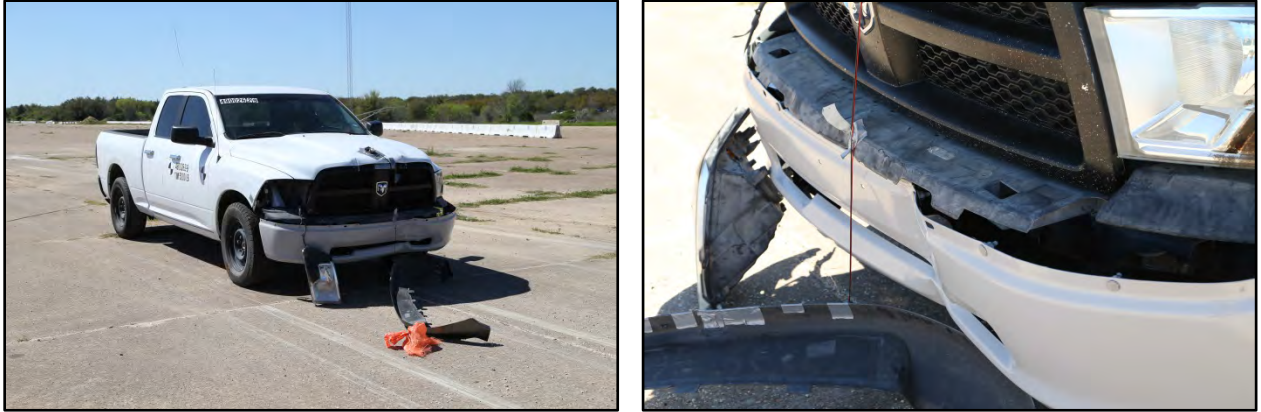
Figure 7.23. Test Vehicle after Test No. 490026-2-9.
