# DEVELOPMENT OF A *MASH* TL-3 MEDIAN BARRIER GATE

**Research/Test Report 9-1002-2**

1. Report No. FHWA/TX-11/9-1002-2		2. Government Accession No.		3. Recipient's Catalog No.	
4. Title and Subtitle <b>DEVELOPMENT OF A MASH TL-3 MEDIAN BARRIER GATE</b>				5. Report Date February 2011 Published June 2011

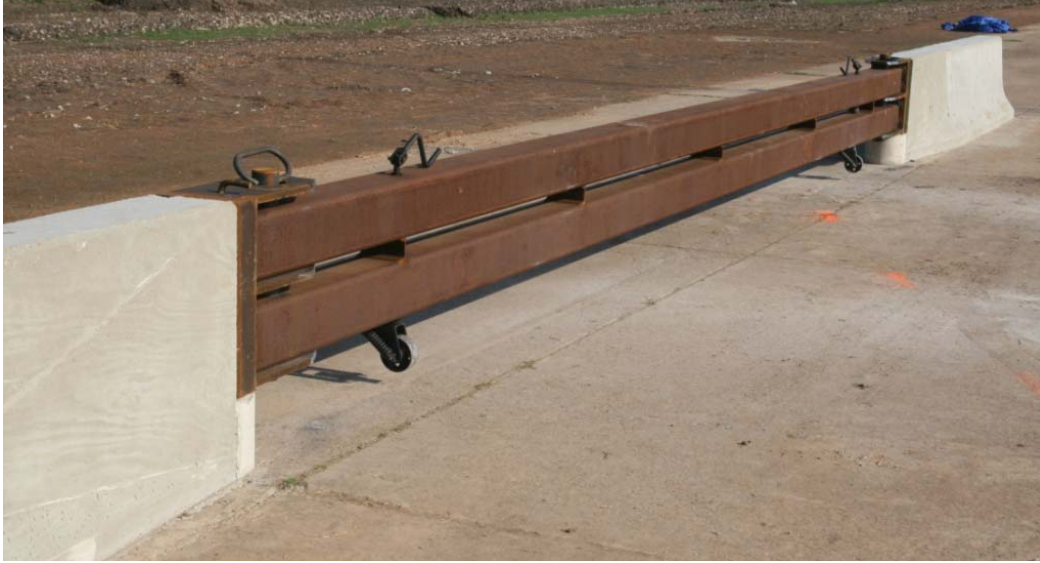
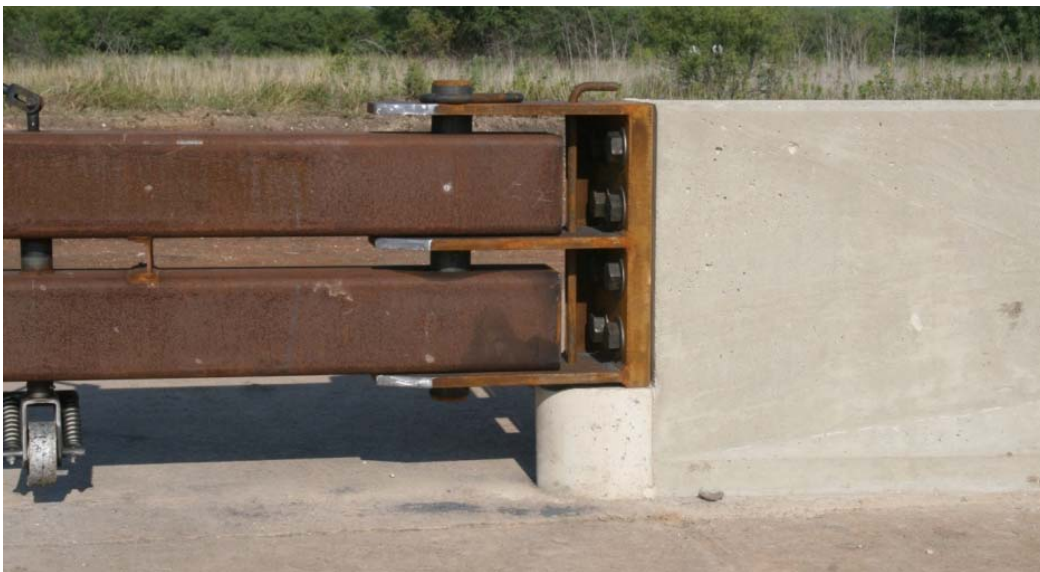
**Figure 1.1. Emergency Opening System (EOS).**

The 1100C test vehicle was contained and redirected. However, the gate failed to comply with *MASH* due to excessive occupant compartment deformation inside the vehicle (3).

Several modifications were made to the end of the EOS to help mitigate the severe vehicle snagging. These changes were developed with retrofit of the existing design as a goal. The horizontal steel plates on the end brackets were replaced with tapered sections of 2 inch  $\times$   $\frac{1}{4}$ -inch thick steel tubing. The ends of the tubular steel beams were cut off and tapered sections of tubing were added. These tubes tapered out 2 inches from the sides of the steel beams and then tapered back down to a width that was less than the width of the end of the concrete parapet to reduce snagging potential from a reverse direction impact. When assembled and installed, the tapered sections of tubing on the steel beams and end bracket overlapped each other to resemble

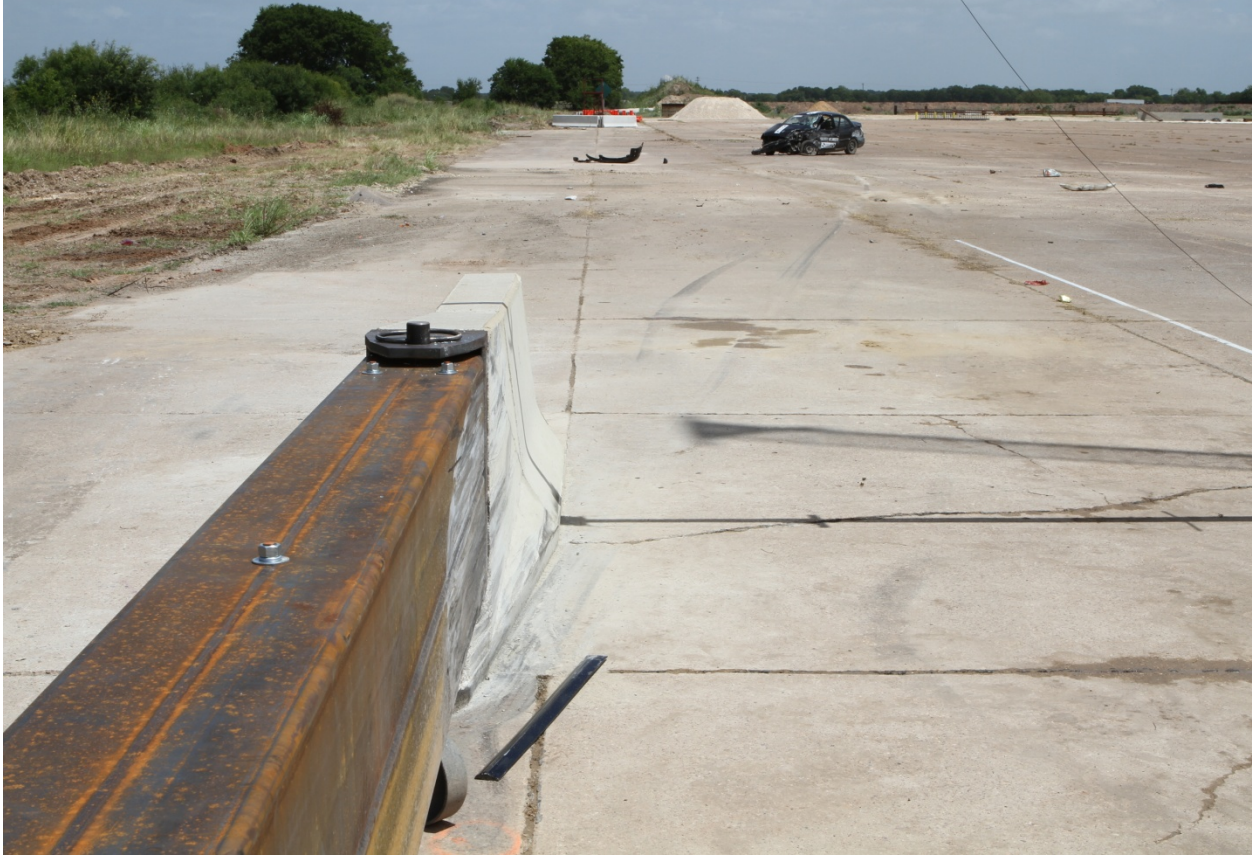
**Figure 6.3. Vehicle/Barrier Positions after Test No. 420020-6.**

Damage to the gate itself was only cosmetic and consisted of scuff marks as shown in [Figures 6.3 and 6.4](#). The end of the upstream concrete parapet sustained two thin stress cracks on the field side. Minor concrete spalling was observed on the field side of the end of the downstream concrete parapet. No rebar was exposed and the spall was considered to be cosmetic in nature. The vehicle was in contact with the installation 10.2 ft. No measurable dynamic or permanent deflection was noted.

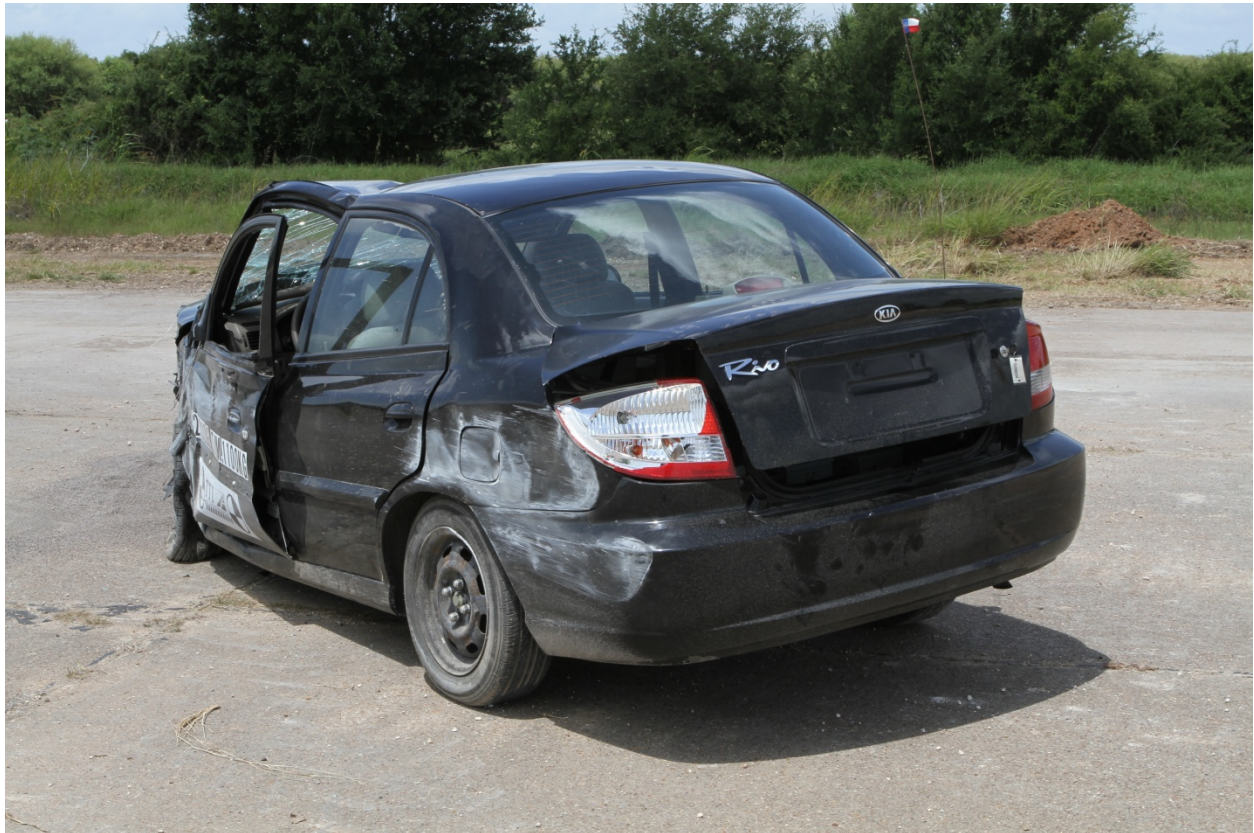
**Figure 6.5. Vehicle after Test No. 420020-6.**

As shown in [Figure 6.5](#), the vehicle sustained damage to the front and left side. The left front strut, strut tower, and A-post were deformed. Also damaged were the front bumper, hood, grill, radiator and support, left front fender, left front tire and wheel rim, left front door and glass, the left rear door, and left rear quarter panel. The roof was deformed and the windshield sustained stress cracking. Maximum exterior crush to the vehicle was 12.0 inches in the side plane at the left front corner at bumper height. Maximum occupant compartment deformation was 3.0 inches in the firewall area near the toe pan on the driver side. [Figure 6.6](#) shows photographs of the interior of the vehicle. Exterior crush and occupant compartment deformation measurements are provided in [Appendix C, Tables C1 and C2](#).

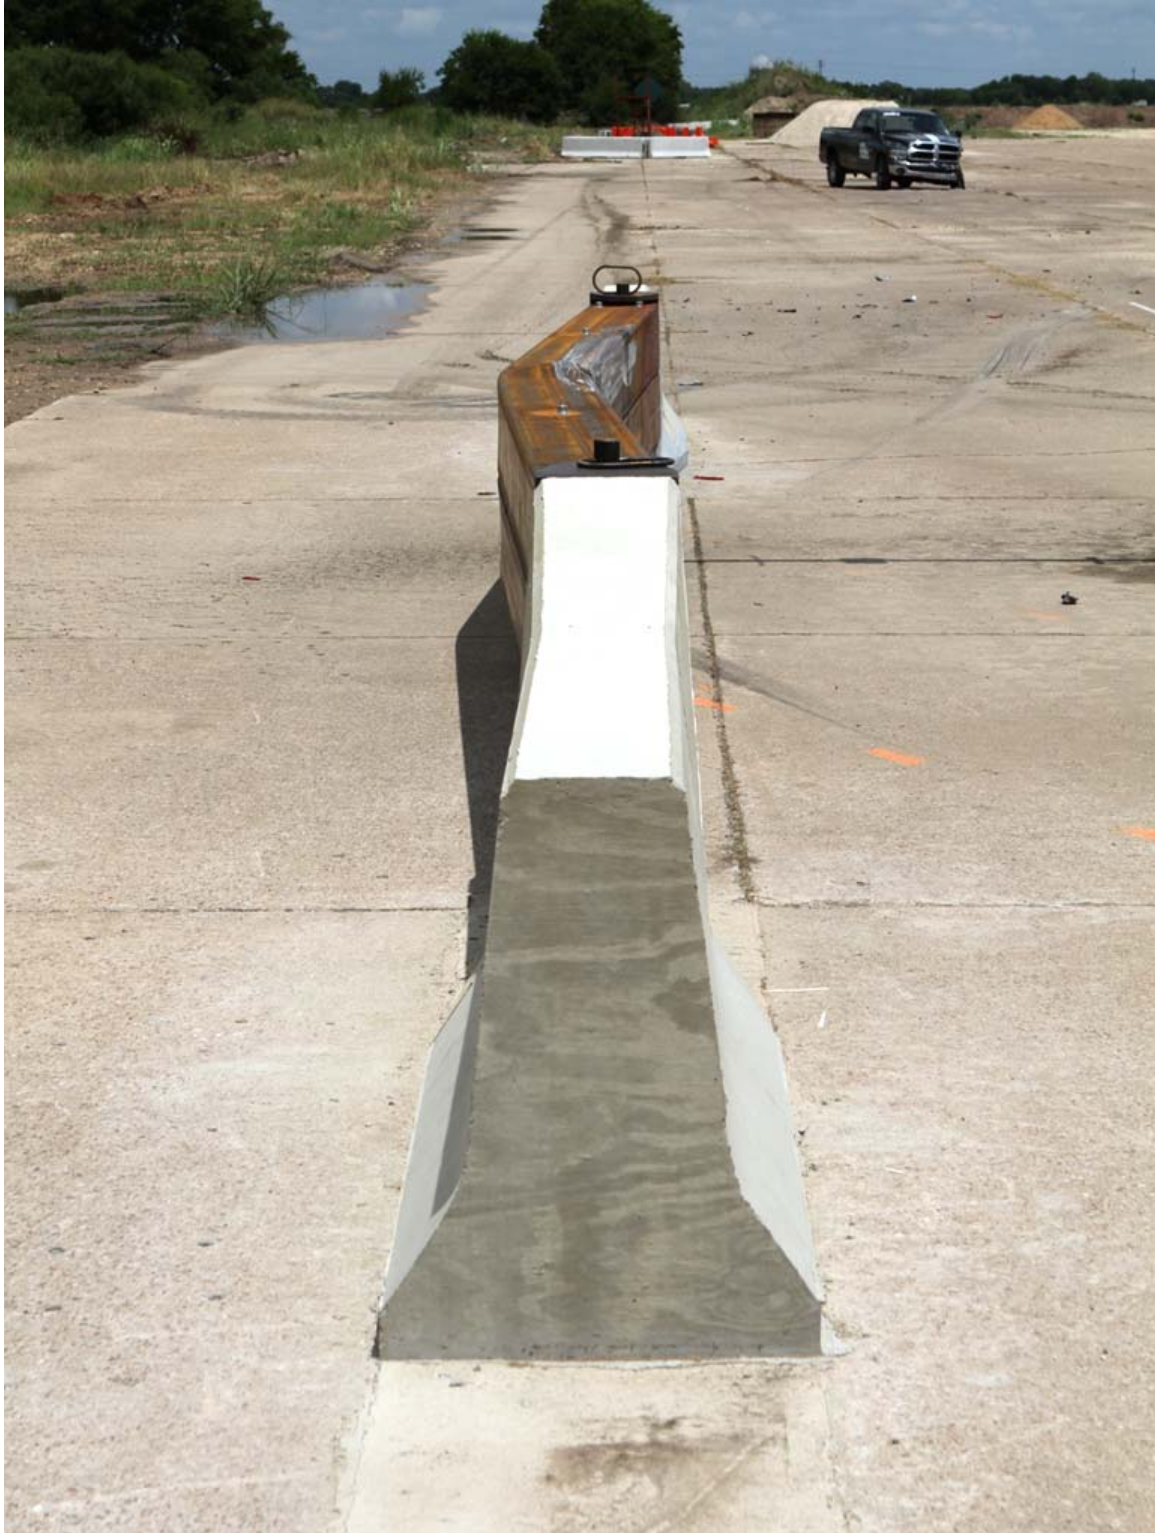
**Figure 7.3. Vehicle/Gate Positions after Test No. 420020-7.**

The steel barrier gate sustained moderate damage as shown in [Figures 7.3 and 7.4](#). The traffic faces of the steel tubes were deformed inward and the tubular rails were buckled near mid-span. There was no damage noted to the concrete parapets. The vehicle was in contact with the installation a distance of 14.9 ft. Working width was 1.1 ft. Maximum dynamic deflection of the median barrier gate during the test was 1.1 ft, and maximum permanent deformation was 0.8 ft.

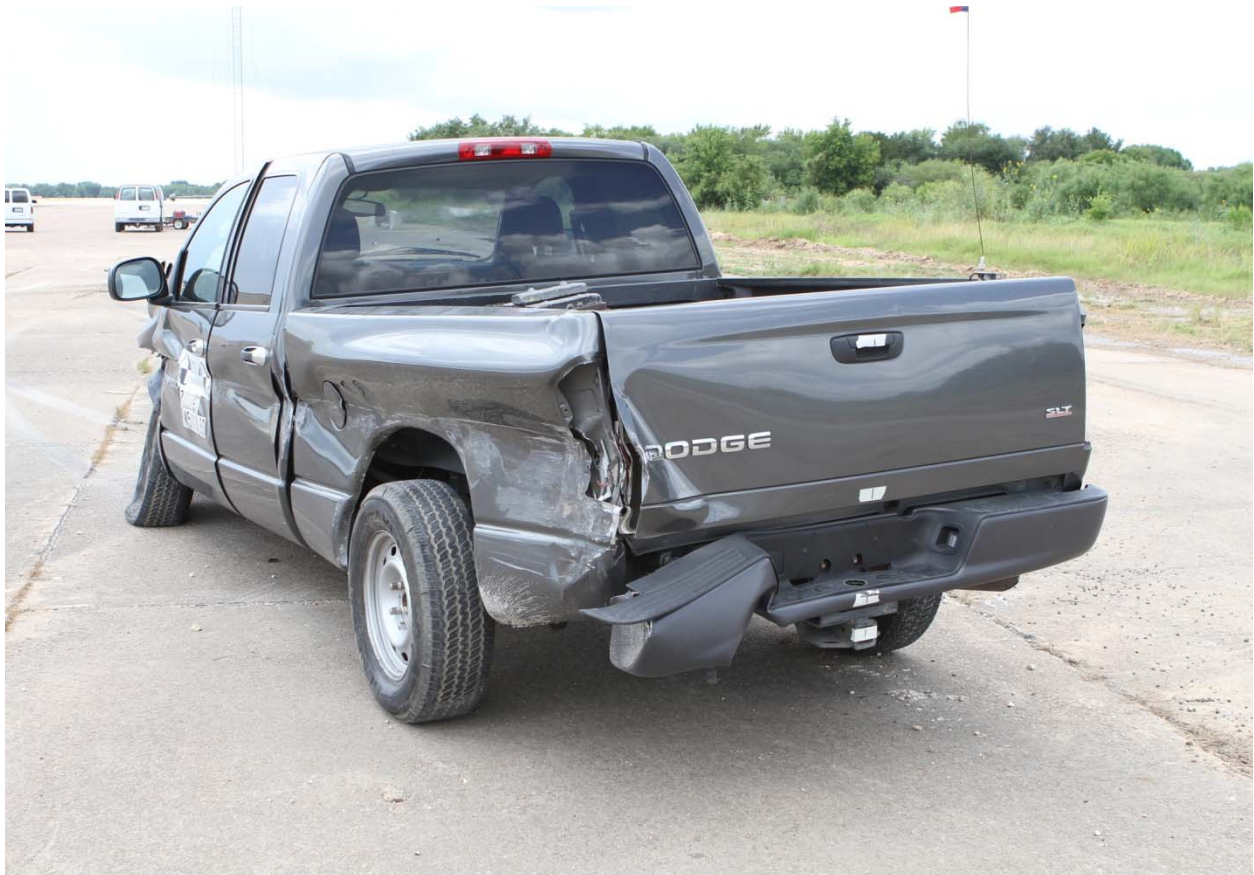
**Figure 7.5. Vehicle after Test No. 420020-7.**

As shown in [Figure 7.5](#), the majority of the damage sustained by the 2270P vehicle was to the left front corner and above the top wheel line along the left side. The left upper A-arm was deformed. Also damaged were the front bumper, grill, left front fender, left front tire and wheel rim, left front and rear doors, rear of the cab, left exterior bed, left rear wheel rim (no loss of air in the tire), rear bumper, and tailgate. Maximum exterior crush to the vehicle was 12.0 inches in the side plane in the left front corner at bumper height. Maximum occupant compartment deformation was 0.5 inches across the cab at hip level on the driver side. [Figure 7.6](#) shows photographs of the interior of the vehicle. Exterior crush measurements and occupant compartment deformation are provided in [Appendix C, Tables C4 and C5](#).
