1. Report No. FHWA/TX-14/9-1529-2		2. Government Accession No.		3. Recipient's Catalog No.	
4. Title and Subtitle CONSTRUCTION AND MONITORING OF THIN OVERLAY AND CRACK SEALANT TEST SECTIONS AT THE PECOS TEST TRACK				5. Report Date Published: October 2014

CONSTRUCTION AND MONITORING OF THIN OVERLAY AND CRACK SEALANT TEST SECTIONS AT THE PECOS TEST TRACK

Report 9-1529-2

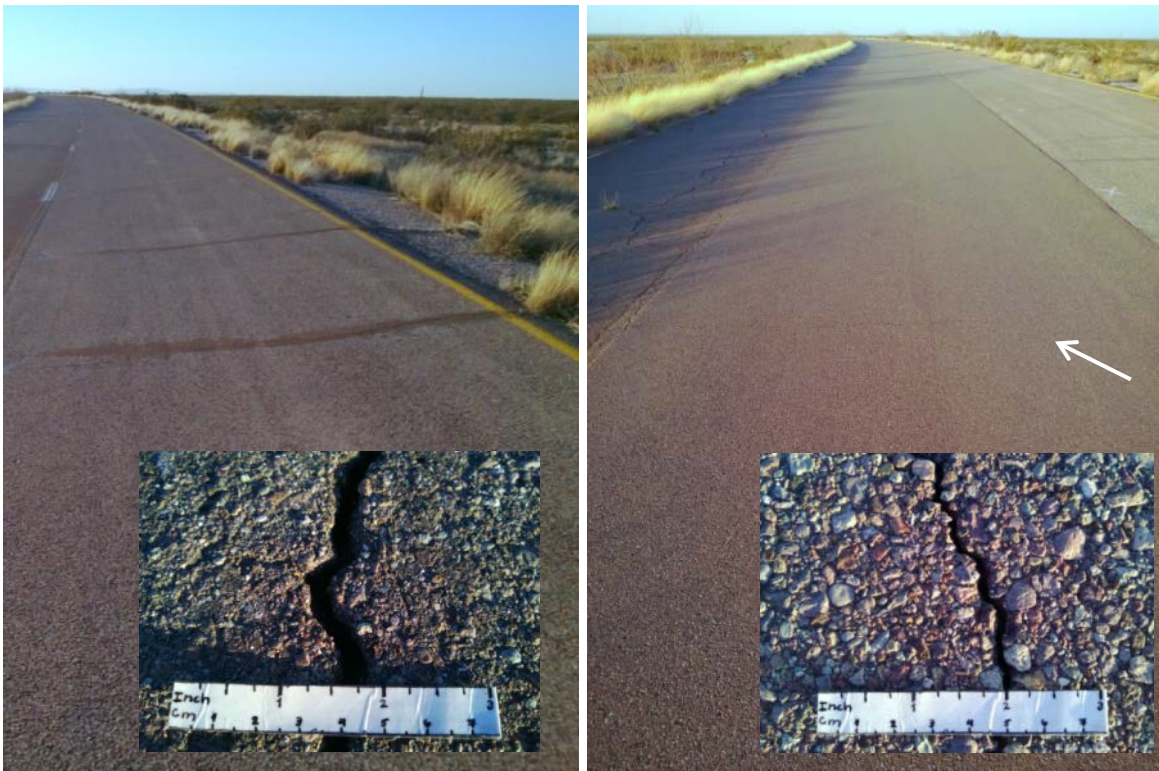
Figure 2. Existing Condition.

The southeast part of the circular track at the Pecos RTC facilities was used for the crack sealant tests (Figure 1). While most of the circular track was heavily distressed, the pavement in this section only had transverse cracking. Both older and newer pavement sections were evaluated (Figure 2). The older pavement was in the outside lane and had well-developed, deep, 1/4-inch wide transverse cracks every 15 to 20 ft. This lane was also super elevated, which led to some issues during sealant construction. The newer pavement consisted of two mill-and-overlay sections in the center lane. It had a mix of full-width and developing transverse cracks. These cracks were much narrower (1/8-inch wide max) and crack spacing was not consistent. The ground penetrating radar (GPR) data indicate that cracking extends to the bottom of the asphalt (see Figure 3).

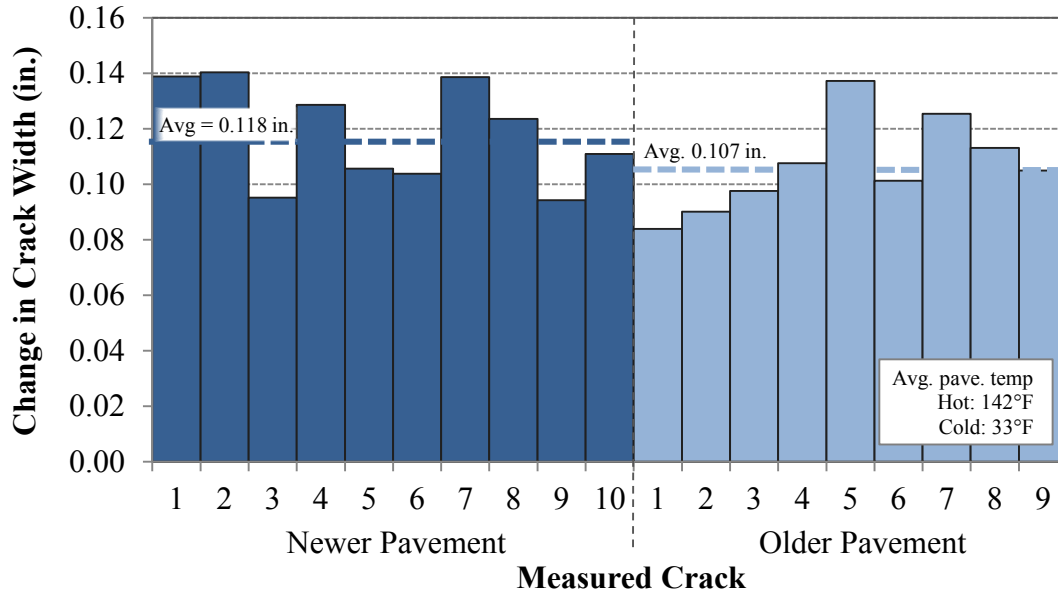
Figure 5. Crack Movement.

Crack movement from winter to summer is summarized in Figure 5. Movement ranged from 0.08 to 0.14 inches over a change in surface temperature of about 100°F. The average crack movement for the newer and older pavements was essentially the same, a little over 0.1 inches. For reference, the definition of an active crack according to the Federal Highway Administration (FHWA) is 0.125 inches of annual movement and is the amount to warrant routing. When testing crack sealant in the Overlay Tester, the maximum opening is set to 0.1 inches, which matches the maximum crack opening observed in the field.

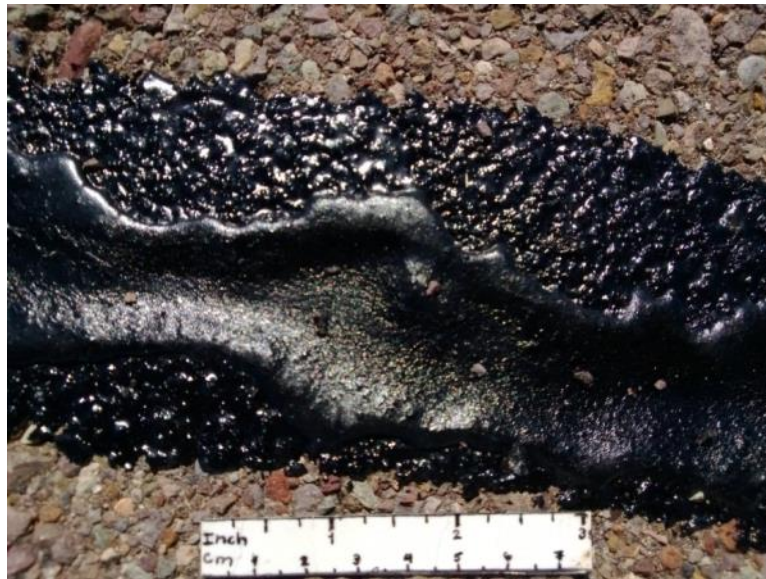
Figure 9. Non-Uniform Seal Caused by Sealant Flow.

Generally, no problems were encountered during application in the newer inside lane. Application in the outside lane, however, was more difficult. First, the cracks in the older pavement were very deep and the less viscous sealants would drain down after the first application. Additional passes of the applicator wand were necessary to completely fill the cracks, which sometimes resulted in excessive sealant in the overband. In some cases, the cracks were only partially filled and were left with a recessed seal. Also, the outside lane was super elevated causing the less viscous sealants to creep down the slope resulting in a non-uniform seal (Figure 9). The lowest-viscosity sealants were TxDOT Class B, Polyflex Type II, and Roadsaver 203 (applied too hot). In applications over thinner cracks, this could be a desirable property because the material would penetrate creating a better seal.

Throughout the application process, the operators took turns applying the sealant. Some would apply the sealant more liberally, especially in the outside lane. This is demonstrated in some of the photos in Appendix A (see Roadsaver 203 and AR Plus).

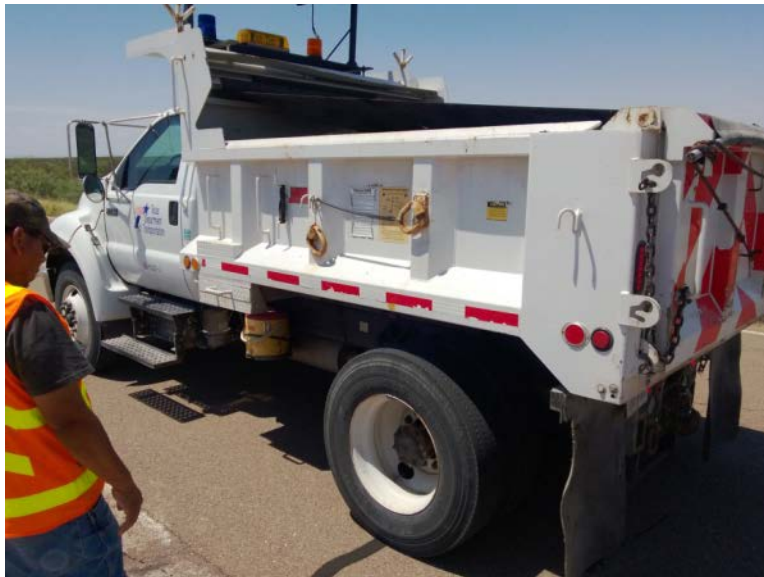
Figure 10. Heavy Traffic Test.

A loaded dump truck was driven at 5 mph across the sealant sections in the middle lane (Figure 10). No damage was observed to any of the sections. The test severity was then increased by parking the front axle over the sealant, turning the wheels, waiting 15 seconds, then slowly driving forward. This method was performed only in the outside lane and did extensive damage to the sealants. It was difficult to distinguish if any sealants were more damaged than others. The seals in three sections (Polyflex Type II, Roadsaver 203, and AR Plus) may have lost a little extra material in the routed sections than the other sealants (Figure 11).

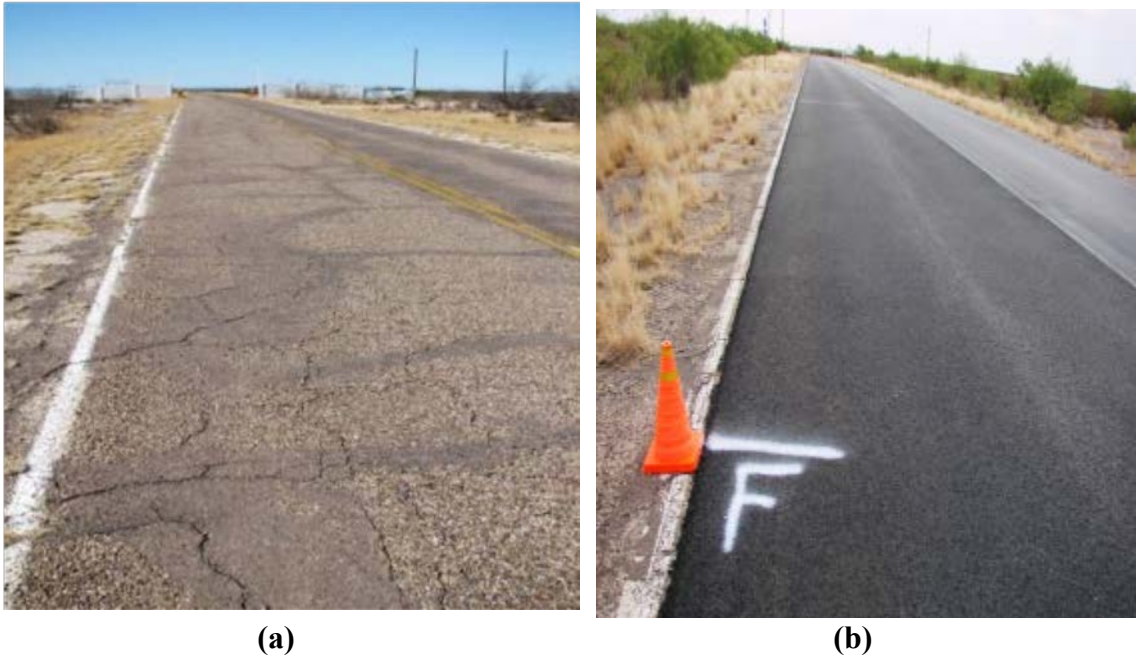
Figure 16. Alligator Cracking on Entry Road: (a) before and (b) after.

Figure 15 and Figure 16 show the schematic of the test sections constructed at the Pecos facility. Figure 16 shows a before and after photo of the roadway condition. These sections have all performed very well and the implementation described later was only possible based on the excellent performance of these original sections.

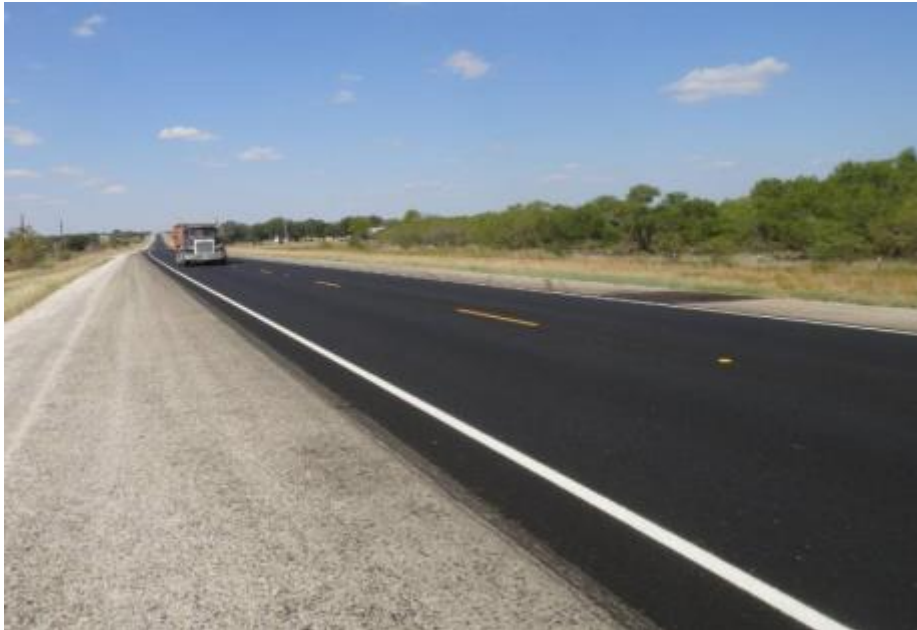
Figure 23. US 183 PFC Three Months after Construction.

Recent discussions with the district engineer have revealed that after nine months of service, the PFC is in excellent condition and TxDOT is pleased with the performance. The surface has also given the district good public relations with the local citizens since the previous project had

performed so poorly and was a source of many public complaints. [Figure 23](#) shows the surface three months after construction.

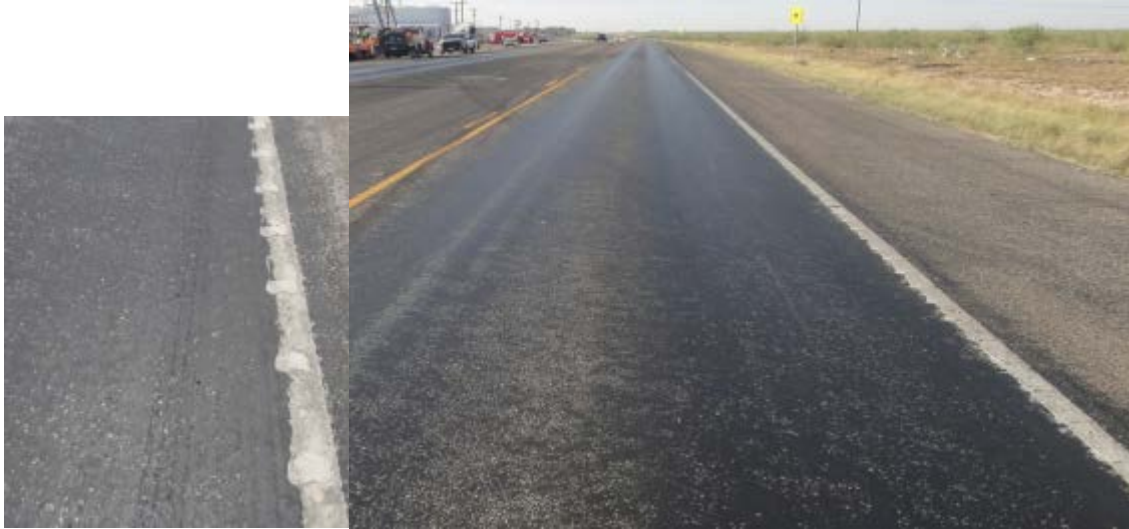
Figure 24. Pre-Existing Condition for Loop 338, Odessa District.

For Loop 338, the district selected the fine PFC option. It was proposed that the district use the best performing PFC placed on the test track, which was the PFC made with the Grade 5 Hoban rock. This is 100 percent Grade 5 rock with 0.3 percent fibers and 6.5 percent Alon PG 76-22 asphalt.

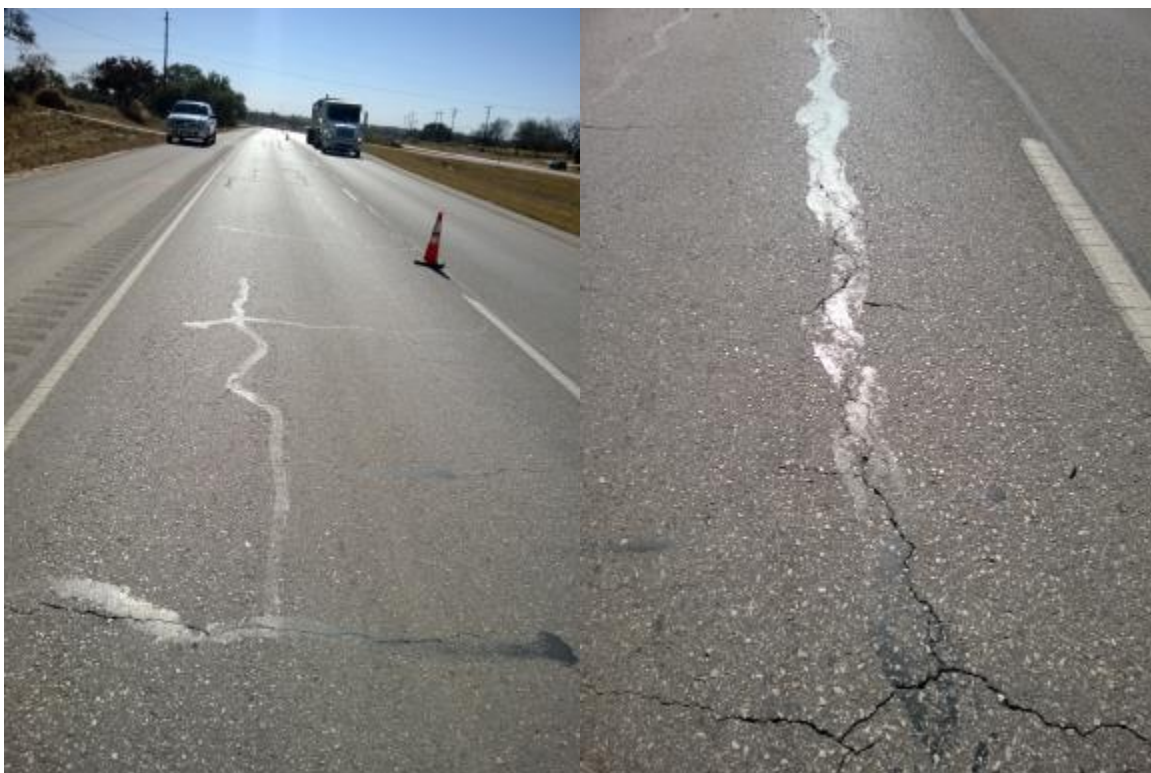
Figure 29. Existing Condition.

This project was located on SH 16 in the San Antonio District, starting on the Bexar-Atascosa County line. Sealant sections were placed in the northbound, outside-lane. The pavement condition was characterized by low- to moderate-severity longitudinal cracking in the wheel path with occasional transverse cracking, as shown in [Figure 29](#) and [Figure 30](#). The cracks had been sealed previously, but most of the cracks had reappeared. The average crack width was 0.25 inch.
