1. Report Number TX-92/953-1F		2. Government Accession No.		3. Recipient's Catalog No.	
4. Title and Subtitle El Paso Moisture Barrier Study				5. Report Date August 31, 1992

EL PASO MOISTURE BARRIER STUDY

Research Study No. 2-24D-88C-953

Texas Transportation Institute
Texas A&M University
College Station, Texas 77843

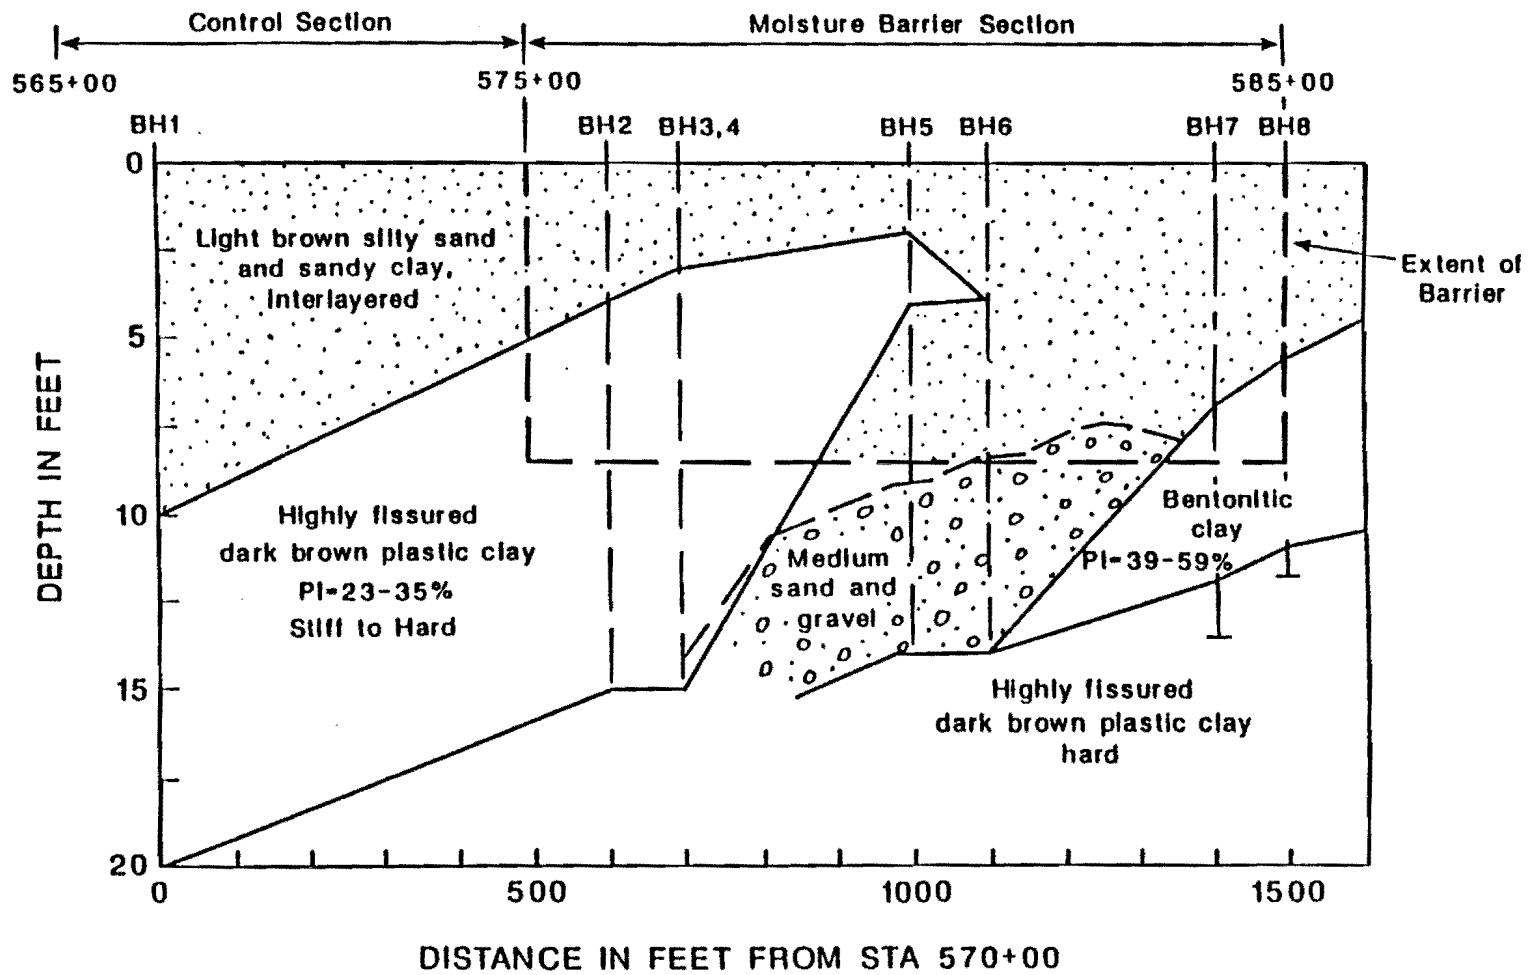
Figure 3. Soil Profile Along Eastbound Lanes IH-10 Sierra Blanca.

Figure 3 shows the soil profile encountered at the site when borings were made to install thermocouple psychrometers used to measure the suction in the soil on the inside and outside of the moisture barriers. A total of eight borings were made as shown in the figure. It is of considerable importance to the interpretation of the measurements that were made to note that the entire area is overlain by a layer of silty sand interbedded with a sandy clay. A stratum of sand and gravel lies between a brown plastic clay and a bentonitic clay. The sand and gravel layers are capable of carrying infiltration water by gravity flow for great distances.

is essentially similar, except that the dark brown plastic clay layer is founded at a greater depth of 4 to 5 ft., within the moisture barrier section. This effectively reduces the depth of the potentially expansive clay layer along the westbound lanes.

At the location of boreholes 7 and 8, the layers of silty sands and sandy clays were encountered to depths of 6.5 to 7.0 feet. Below this depth a 5 foot thick layer of very fine gray bentonitic, highly plastic clay was encountered. The liquid limits obtained from samples of this clay varied from 63 to 84 percent and the plasticity index varied from 39 to 59 percent. Below this depth the highly fissured plastic clay predominated to the end of the boreholes.

The size of fissures in the dark brown plastic clays varied in width from approximately 0.5 inches to fully closed at 12 feet. These fissures were usually filled with sand and crystalline deposits of caliche. Root fibers were also encountered in the borings in which fissured clays were predominant, and these were generally found within fissures attached to the surfaces of the soil peds at depths of up to 12 feet.

- c. Moisture barriers should be installed to a depth equal to the depth of cracks in the clay soil. This can be approximated from the boring logs by noting the greatest depth where root fibers were found.

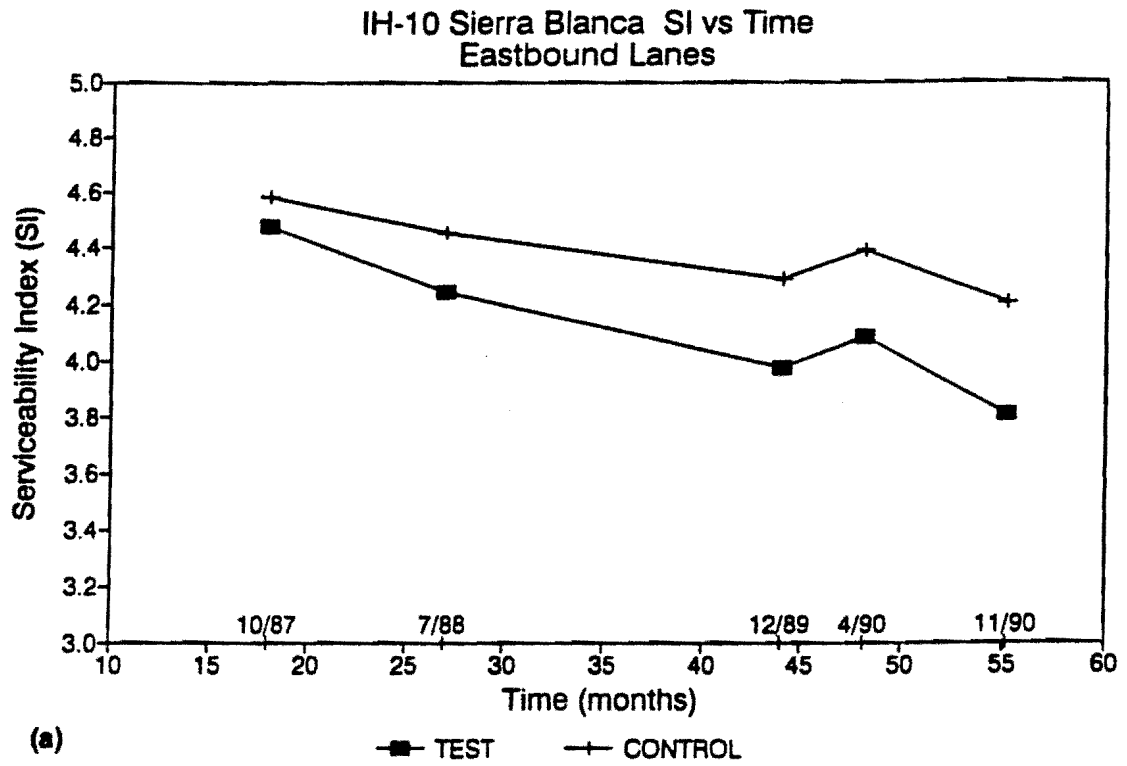
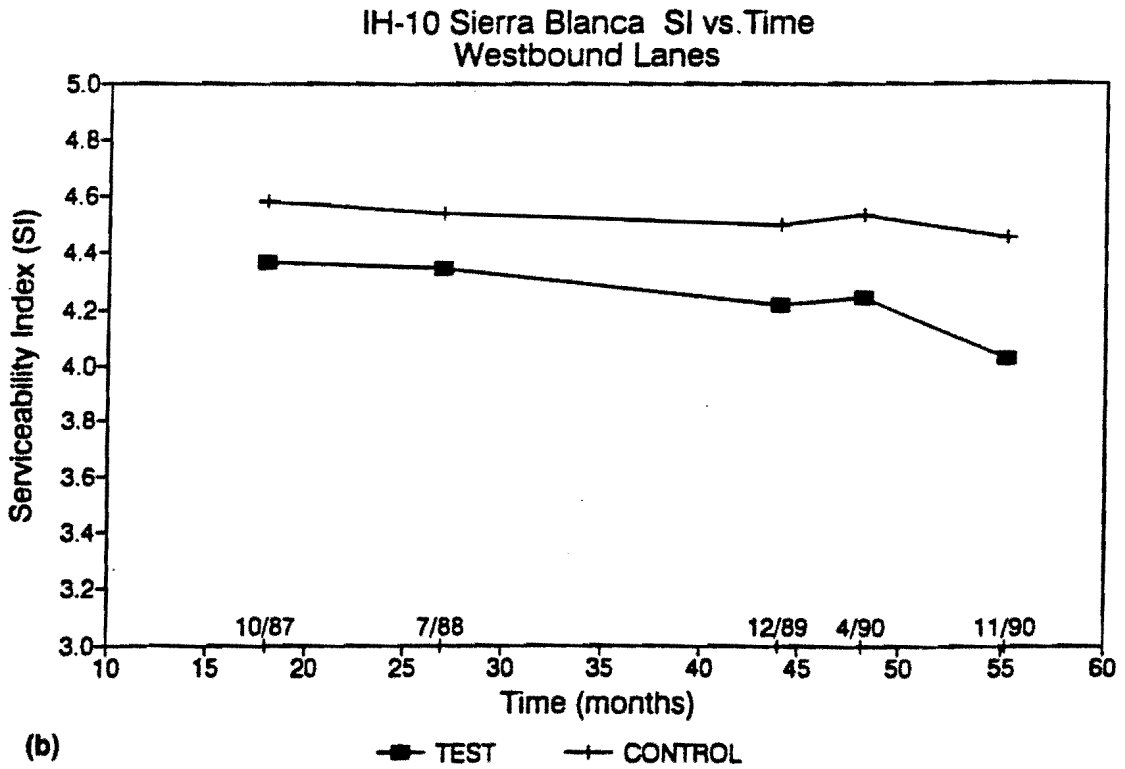
Figure 6. IH-10 Sierra Blanca SI vs Time, (a) Eastbound Lanes, (b) Westbound Lanes.

Both the SI and IRI indicate that all sections are becoming rougher with time and the eastbound lanes are becoming rougher at a rate of approximately twice that of the westbound lanes, as indicated in Table 2. These rates of change are consistent with the subgrade soil conditions provided by the borehole investigations, which indicate that the depths of expansive clay generally occur at a shallower depth on the eastbound lanes. The depth to the expansive clay layer at the eastbound moisture barrier test section is approximately 2.5 ft. compared to 4.5 ft. along the westbound section. As potentially active clays are found at greater depths, confining stresses become sufficiently high to limit the magnitude of swell.

The moisture barrier test sections indicate rates of roughness development of approximately twice that of the control sections as indicated by the SI and IRI parameters. This occurs as the barrier sections are found in areas where clays are predominant and closest to the surface. This is illustrated in Figures 6 and 7 and demonstrated more clearly in Figure 9, where the longitudinal distribution of roughness is examined. Due to the sensitivity of the SI to short wavelengths and the IRI to both short and medium wavelengths, it may be concluded that roughness in this wavelength range is developing over areas of expansive clay.

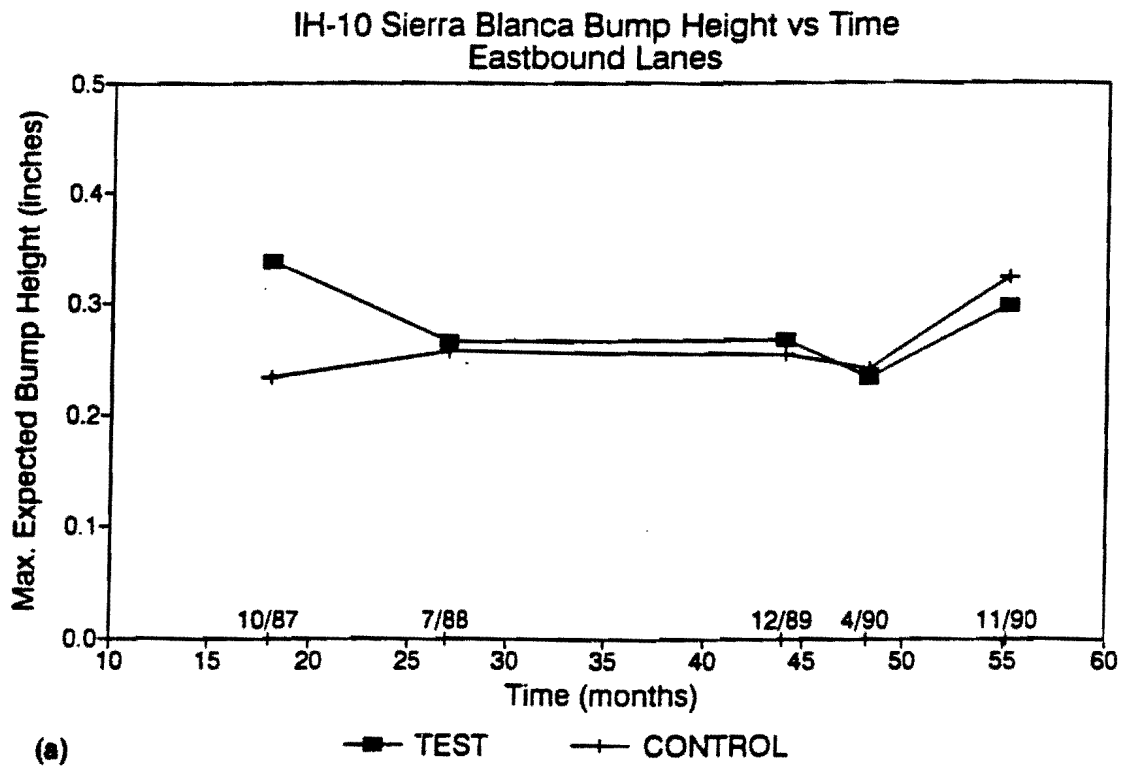
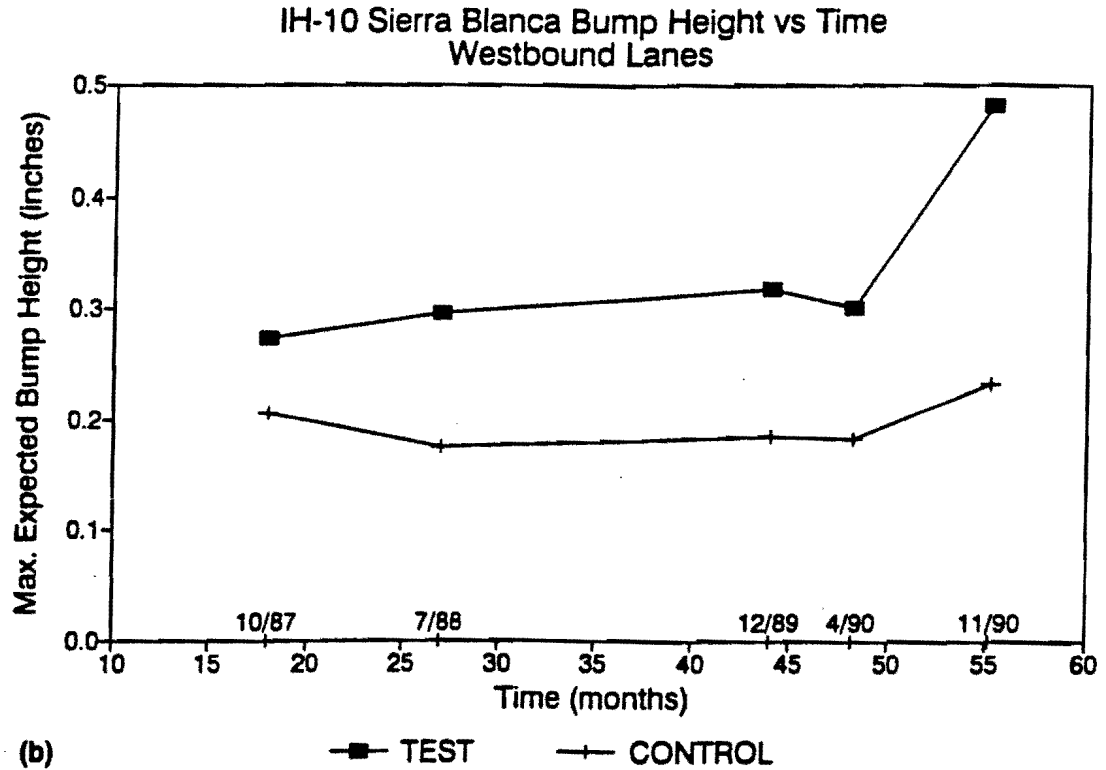
Figure 8. IH-10 Sierra Blanca Bump Height vs Time, (a) Eastbound Lanes, (b) Westbound Lanes.

The Maximum Expected Bump Height parameter in Figure 8 indicates that the eastbound barrier test section is becoming rough at a slower rate than the control sections, which is opposite to that indicated by the SI and IRI parameters. This may be attributed to the fact that the Bump Height parameter is particularly sensitive to longer wavelengths (> 32 ft.) which is likely to occur as the expansive clay activity is initiated at greater depth. This phenomenon is indicated on the west bound test section where the depth of expansive clay is approximately 4.5 ft. deep and the rate of

increase of Bump Height is .073 inches/year compared to .033 inches/year in the eastbound test section where the clay depth is 2.0 ft closer to the surface. However, over the period of observation the Maximum Expected Bump Height remains relatively constant except for the changes between April 1990 and November 1990 as illustrated in Figure 8.

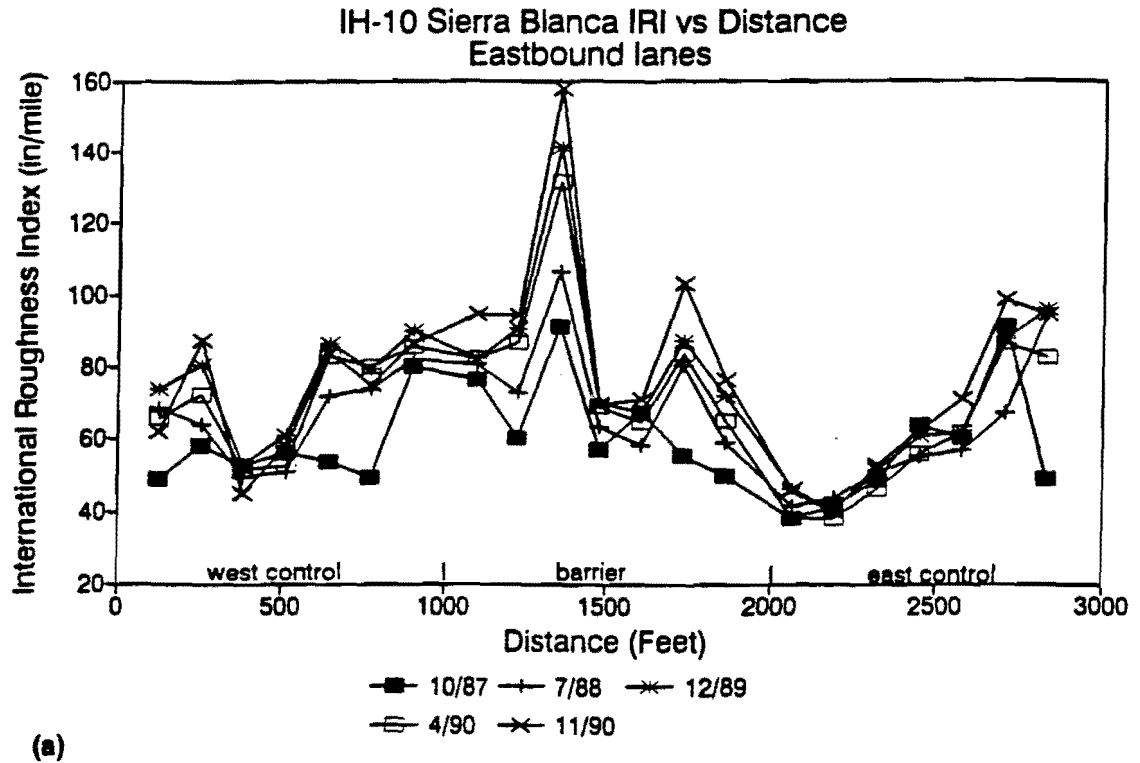
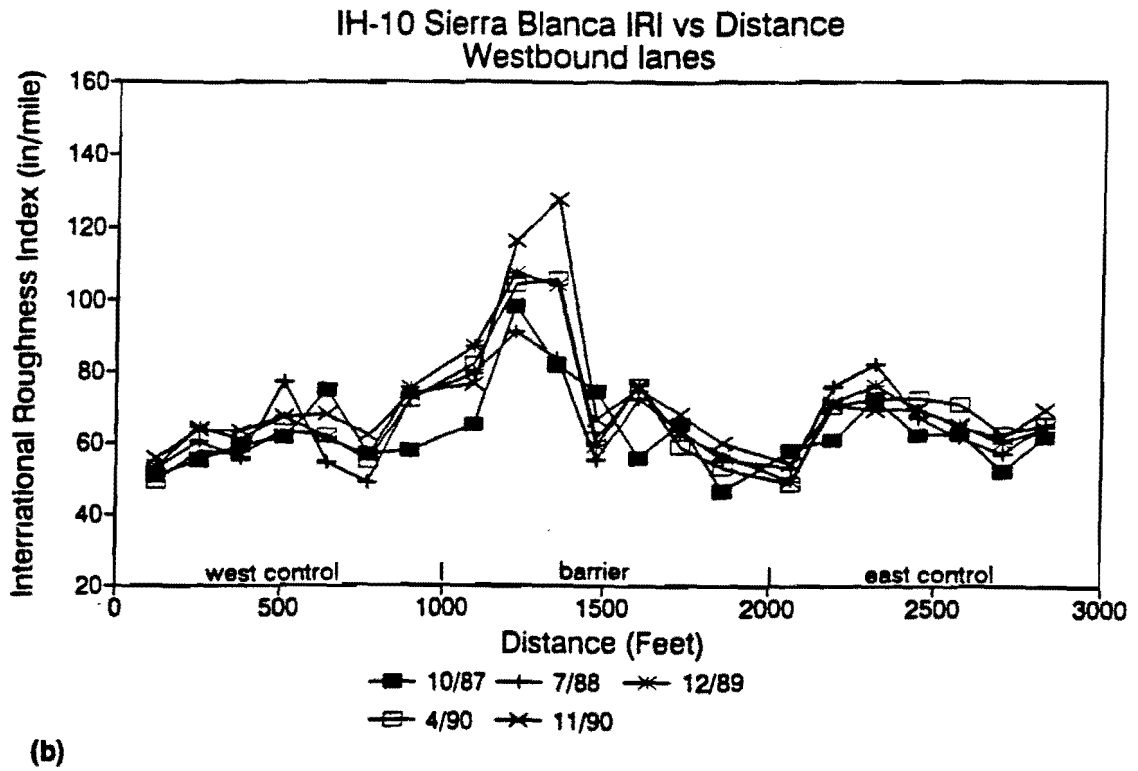
Figure 9. IH-10 Sierra Blanca IRI vs Distance, (a) Eastbound Lanes, (b) Westbound Lanes.

Longitudinal distribution of roughness: The distribution of roughness over the length of the test and control sections as indicated by the International Roughness Index and Bump Height are illustrated in Figures 9 and 10. From these distributions the activity of the underlying clay is clearly illustrated, as the sections on which clays are found closest to the surface indicate significantly higher levels of roughness compared to sections founded primarily on sandy subgrade soils. Both of the roughness distributions of the eastbound and westbound lanes indicate the presence of the active clays, with the eastbound profile indicating a higher level of roughness, consistent with the relative depths of the clay layer. Roughness development is therefore spatially correlated to the soil conditions as illustrated in Figure 11, where the soil profile along the eastbound lanes is superimposed under the values of IRI.

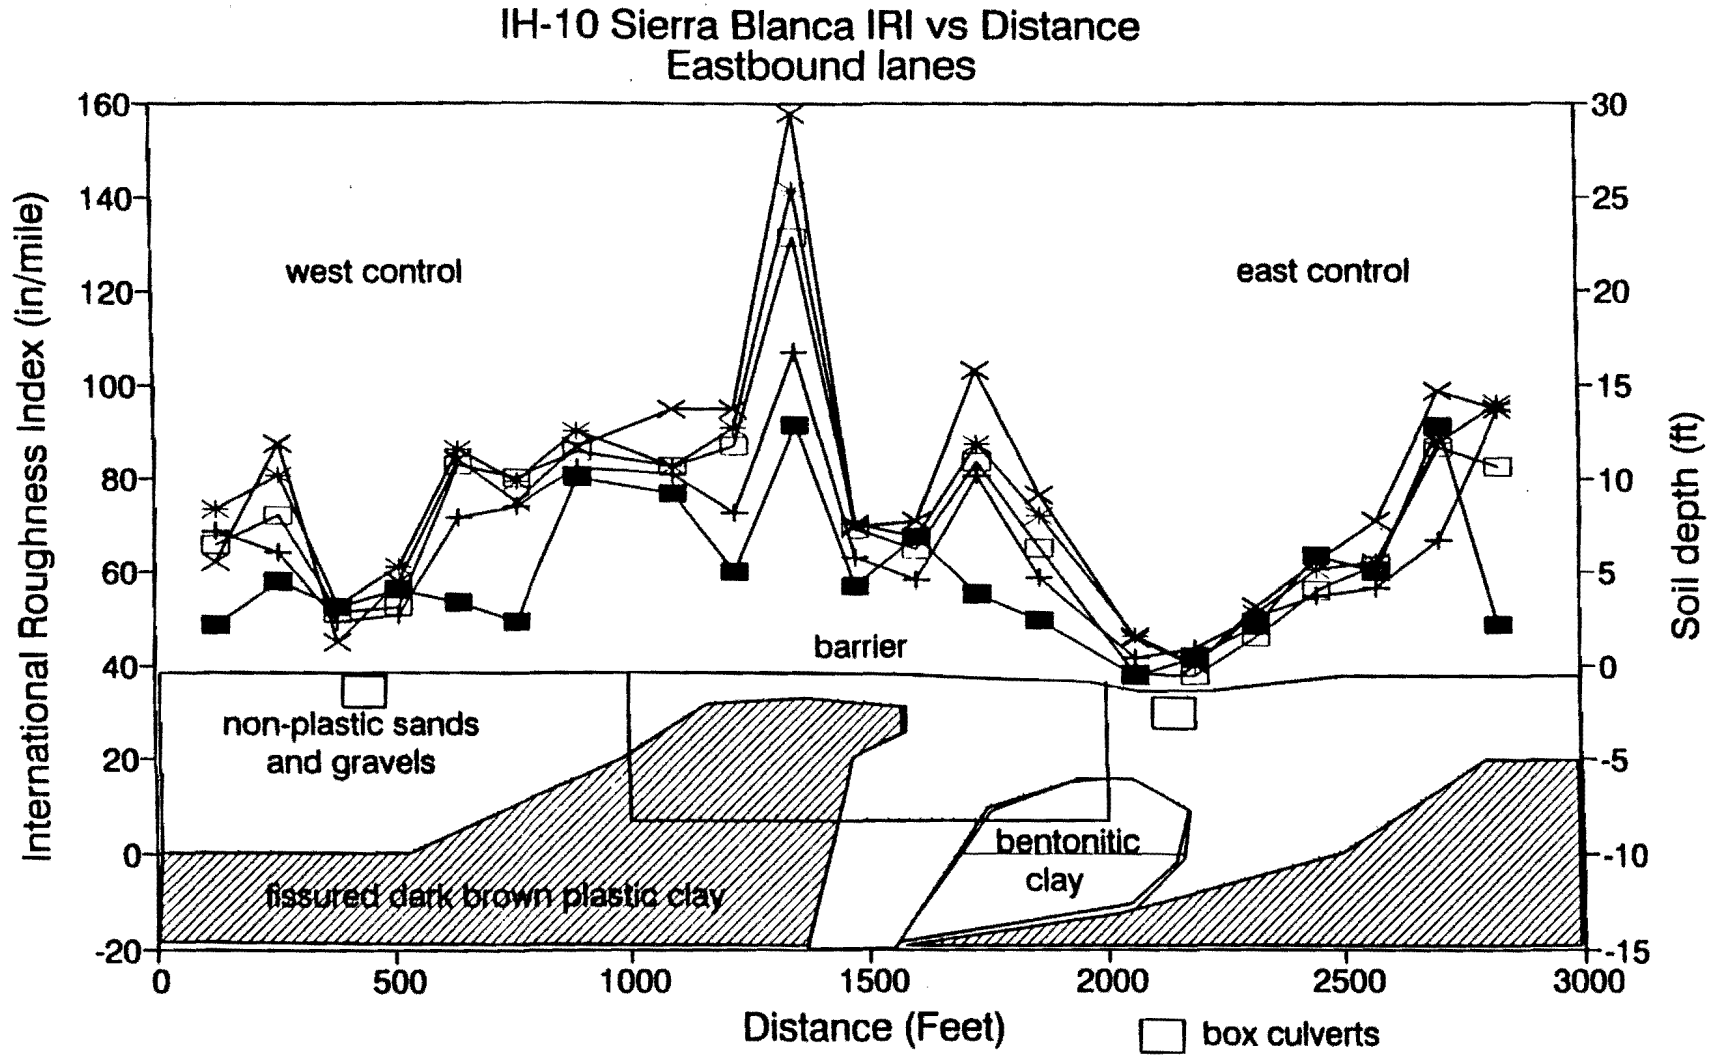
Figure 11. Spatial Correlation of Roughness and Expansive Clay Subgrade Soils IH-10 Sierra Blanca.

These observations illustrate the effect of environmentally induced roughness as opposed to load related roughness development, as the configuration of the test and control sections ensure that both experience exactly the same traffic loading conditions.

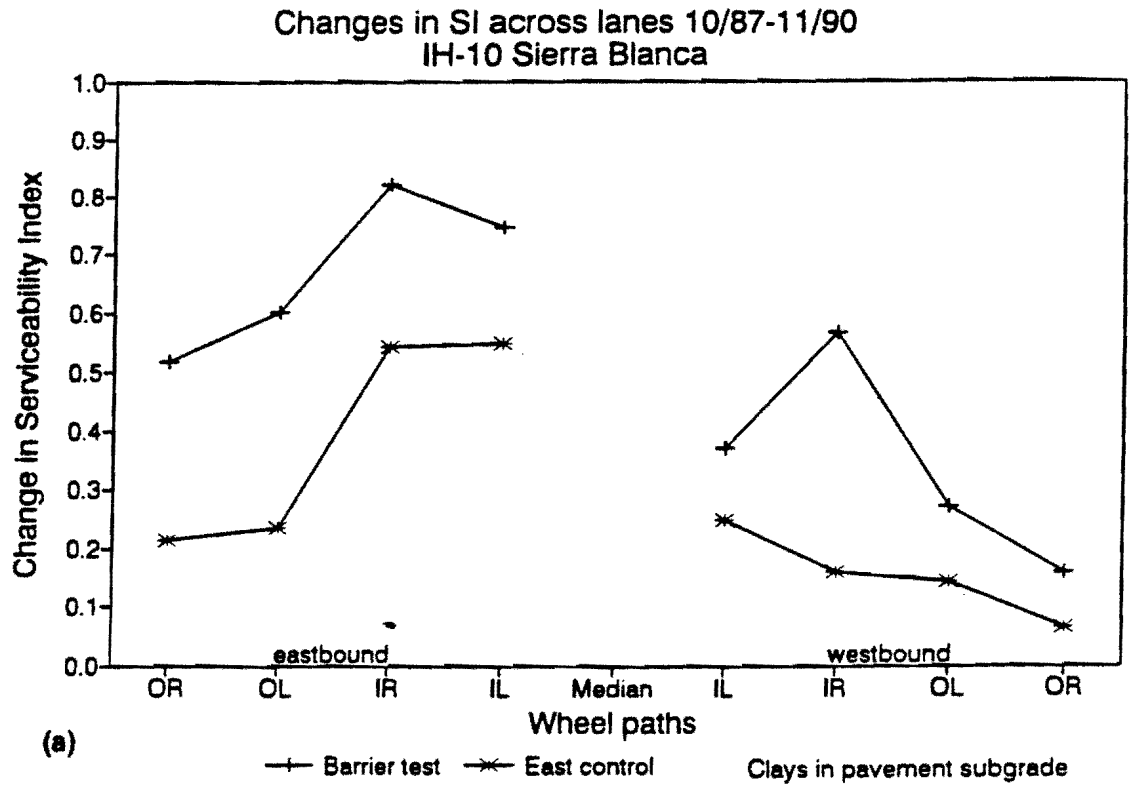
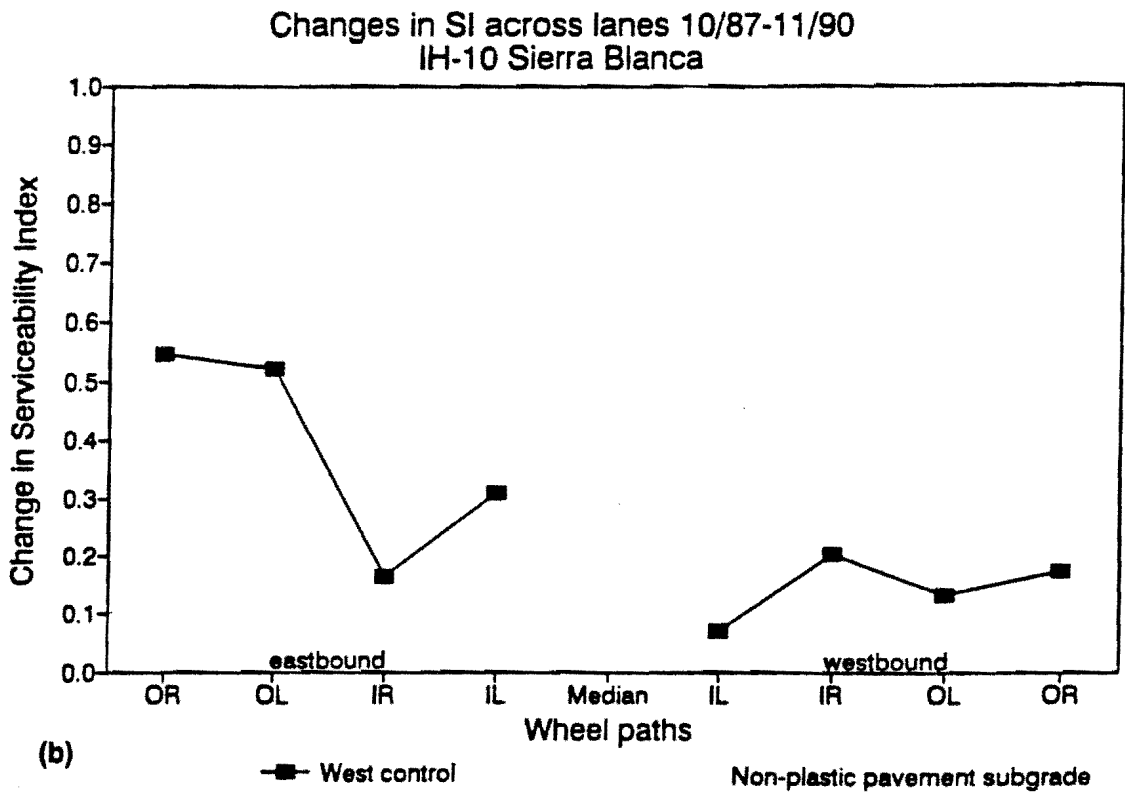
Figure 15. IH-10 Sierra Blanca Change in SI Across Section, (a) Clay Subgrade, (b) Sand Subgrade.

In order to examine the roughness development more closely, the changes in roughness in each wheelpath are determined by evaluating the difference in roughness values between August, 1987 and November, 1990. These results are illustrated in Figures 15 through 17 for the SI, IRI and Bump Height parameters respectively. All three roughness measures indicate that changes of roughness in the inside wheelpaths of the test and east control sections are greater than changes in the outside wheelpaths, with changes along the eastbound lanes being consistently greater than those of the westbound lanes. The greater changes of the eastbound lane sections are consistent with soil conditions as previously indicated. However, this pattern of roughness development also indicates that moisture variation is taking place to a greater degree beneath the inside lanes of the highway section, despite the presence of the moisture barrier. It should be noted that this trend of roughness development is opposite to that expected from traffic loading, where the outside lanes generally experience a higher rate of roughness development due to the greater number of equivalent 18 Kip. axle loads to which outside lanes are usually subjected.

The changes in roughness on the west control sections which are founded predominantly on sandy subgrade soils, indicate a pattern of roughness development that is consistent with traffic loading, as illustrated in Figures 16 and 17. In these sections the increase in roughness of the outside wheelpaths is greater than that of the inside wheelpaths. It is significant that the pattern of roughness development is completely reversed over a distance of 2,000 ft. where the predominant subgrade soils change from expansive clays to non-plastic soils.

This reversal of the pattern of roughness development is not due only to the presence of clays but appears to be associated with the effect of the sodded median and drainage ditch. Sodded highway medians are usually constructed with gradients to allow the efficient collection and runoff of water. However, under relatively heavy rainfall, ponding of water generally occurs due to poorly maintained landscaping or the presence of debris. In areas where expansive clays predominate, the infiltration is generally high due to the presence of surface cracks. At this site, the surface soils comprise coarse sands overlying fissured clays. This configuration is also conducive to the efficient passage of moisture to the underlying clays, due

A third conclusion that can be implemented is to crown and pave all median strips in expansive clays wherever that is possible in order to reduce the roughness caused by water entering the subgrade in the median.

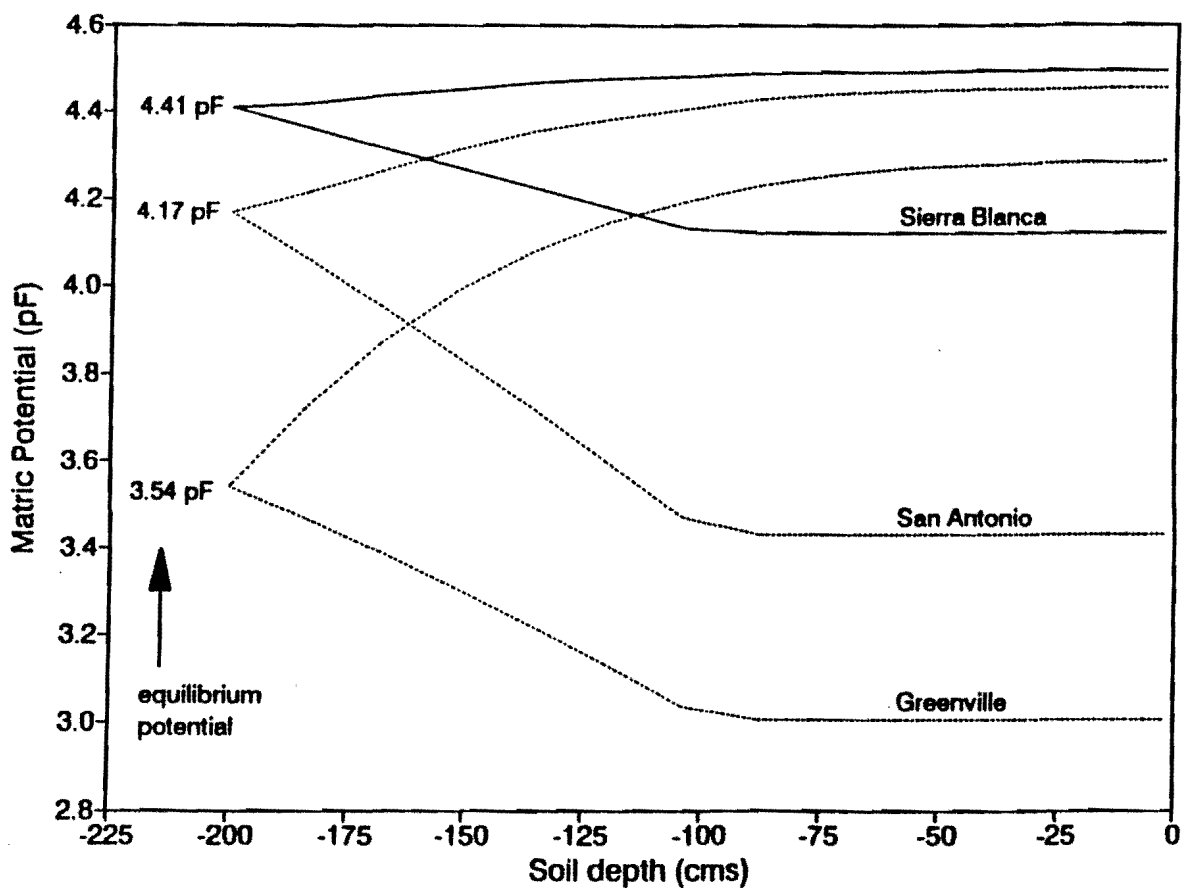
Figure 18. Wet and Dry Matrix Potential Profiles at Moisture Barrier Locations.

From these measurements it is seen that the moisture barriers were effective in reducing the range of moisture fluctuation beneath the pavement, despite the disadvantage afforded by the pervious sand and gravel layers interbedded with the clays.

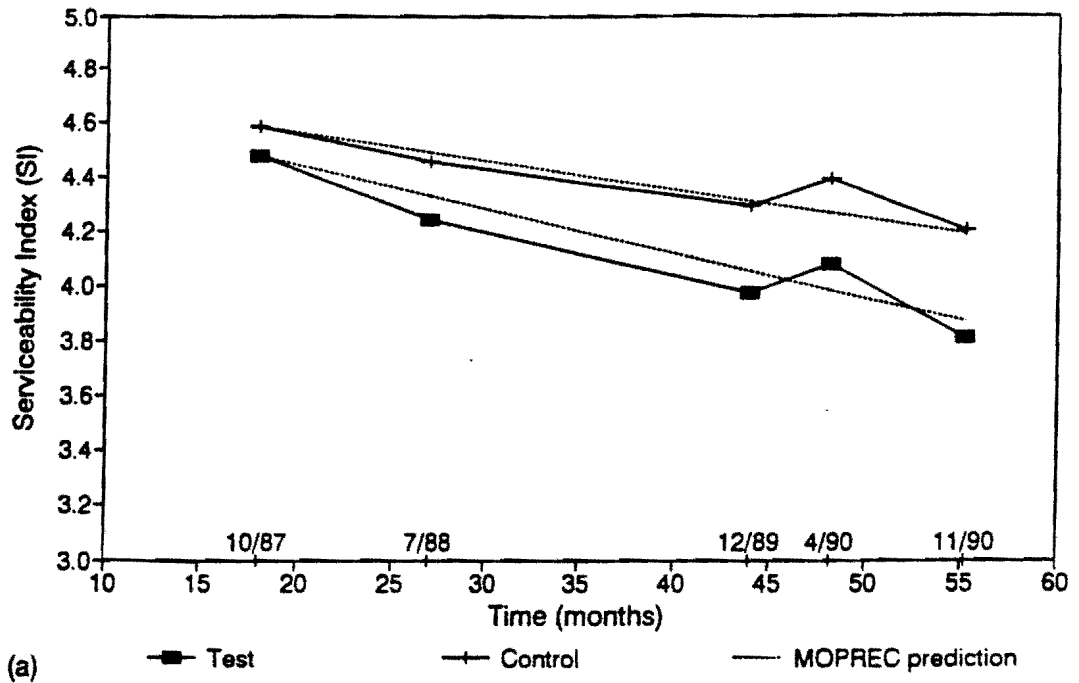
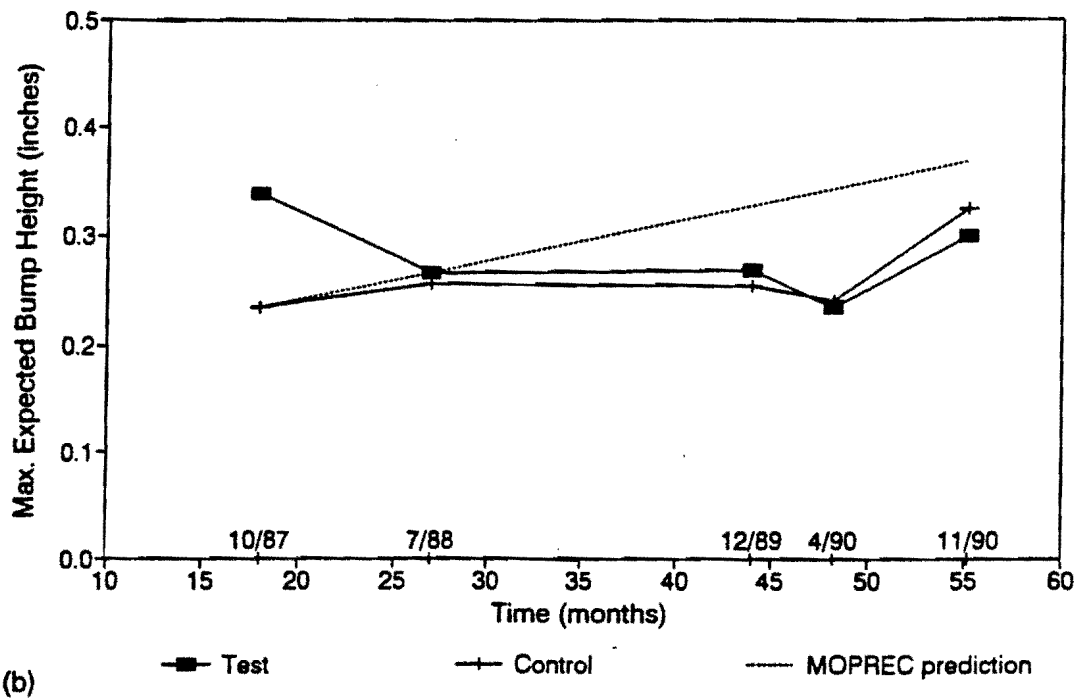
Figure 20. Comparison of MOPREC Predictions and Field Results, IH-10 Sierra Blanca Test Sections (a) SI, (b) Bump Height.

Models developed in Study 1165 were used to predict the Serviceability Index and the Bump Height expected at the Sierra Blanca site. The results are shown in Figure 20. The models predict the expected loss of Serviceability Index in both the control and Moisture Barriers Test sections very well, while overpredicting the Maximum Expected Bump Height.

This indicates that the effects of the moisture barrier on this site can be anticipated prior to its installation if the local soil, ground water, and climatic conditions are known.
