Implementation: Mitigation of High Sulfate Soils in Texas
Development of Design and Construction Guidelines

Final Report 5-6618

Texas Department of Transportation

August 2016

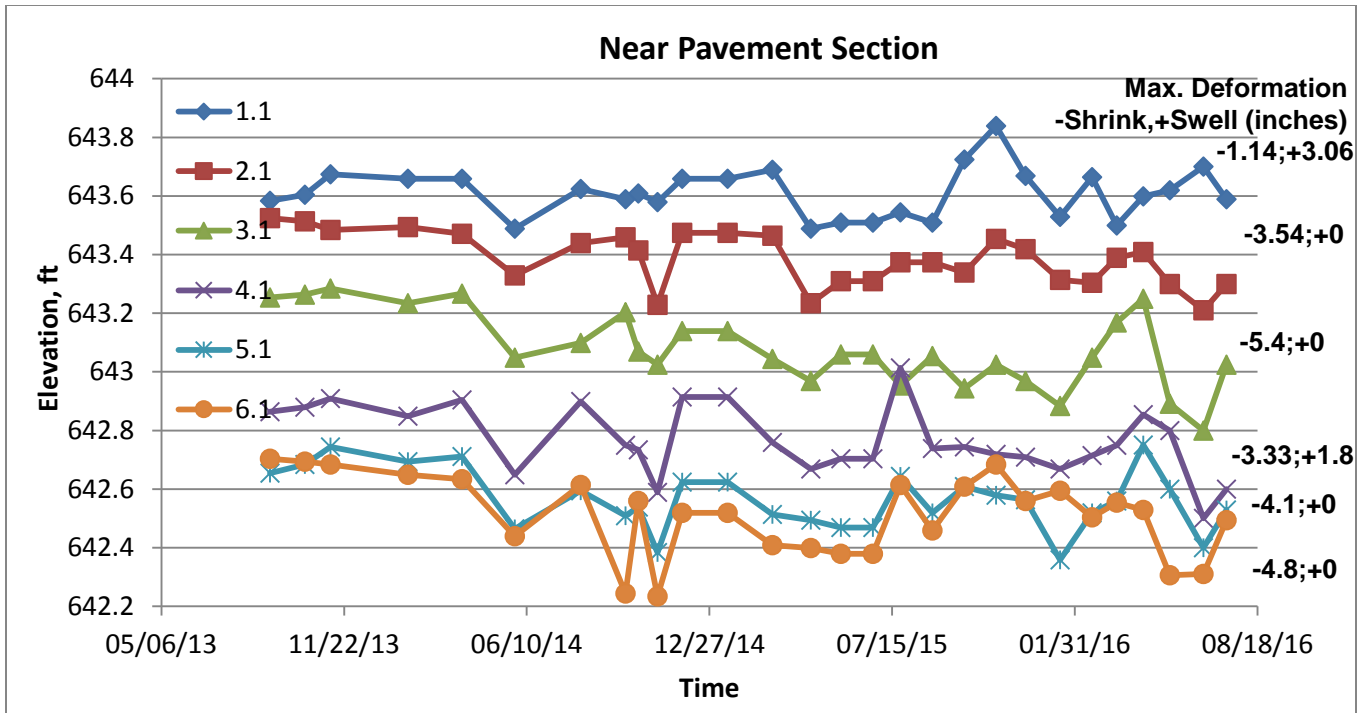
Details of the deformation trends are presented in Figure 9 for near pavement control section and Figure 10 for far pavement control section. A maximum swell of 3 inches is observed at near pavement control section and 0.48 inches for far pavement control section. A maximum shrinkage of 4.8 and 5.8 inches was observed for top and bottom control sections, respectively.

Figure 9: Deformations recorded at “Near” pavement section of test section 3

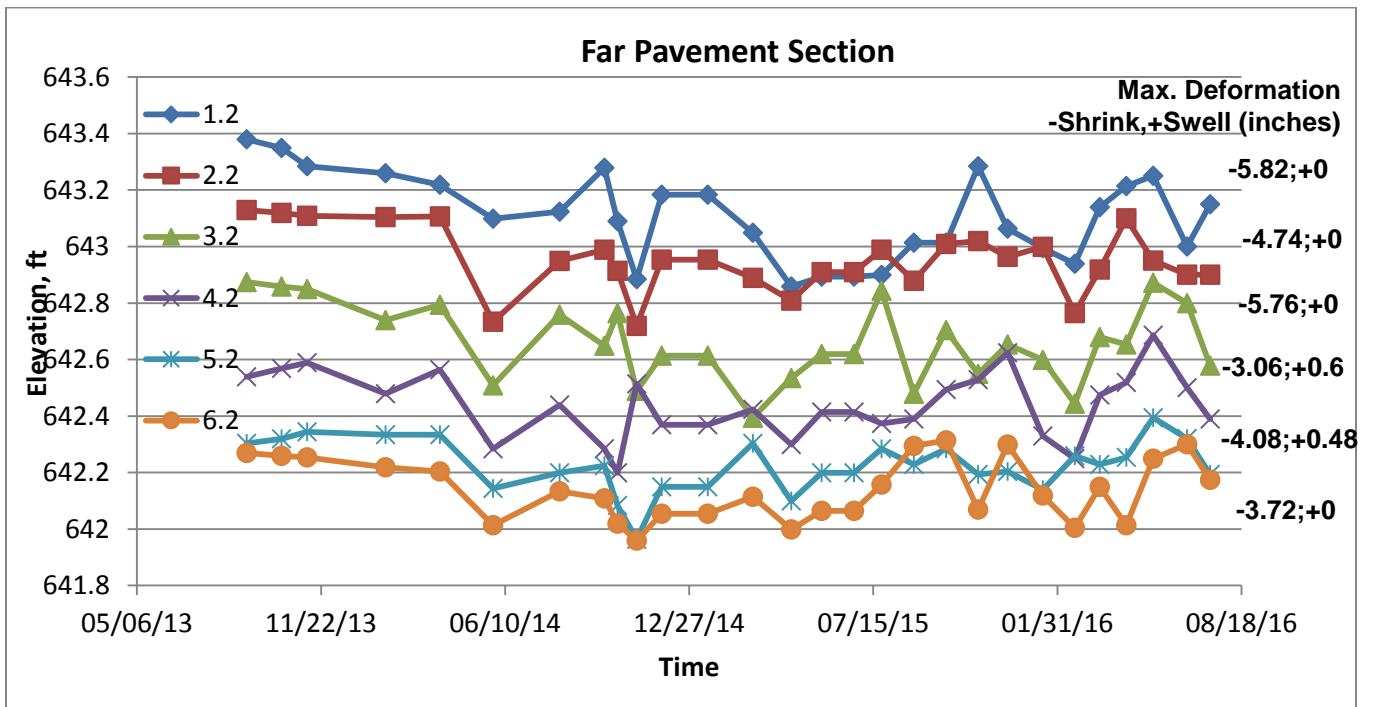
Figure 10: Deformations recorded at “Far” pavement section of test section 3

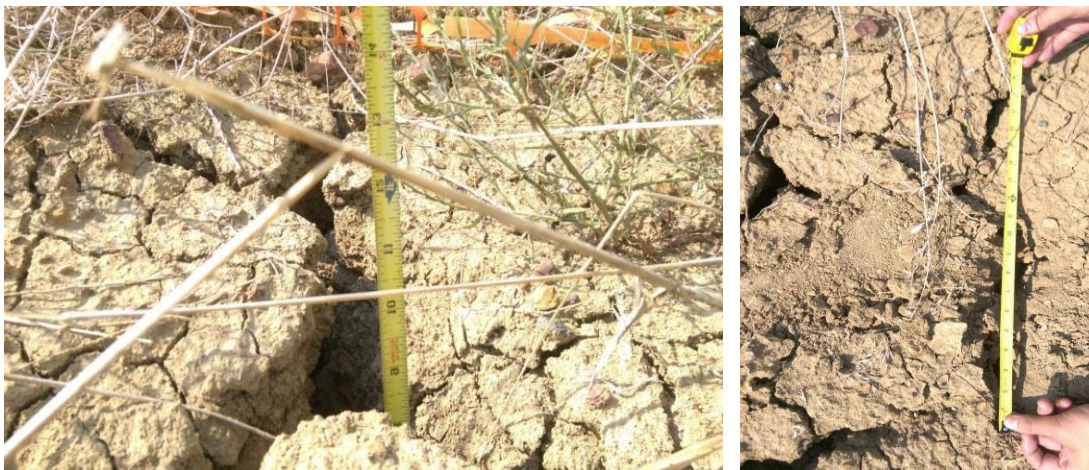
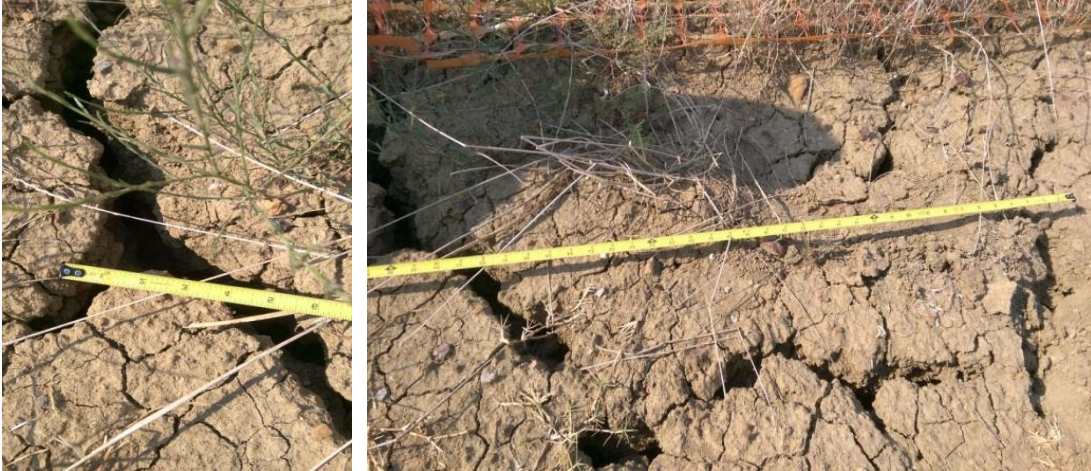
Due to the climatic variant cycles and potential formation of mineral Ettringite, the control section exhibited large movements which were captured from elevation studies. Some of these movements and associated cracking in soils extending up to 1 ft. deep and 3 in. wide are shown in Figure 13 below.

Figure 13: Cracks observed at test section 3 (control section)

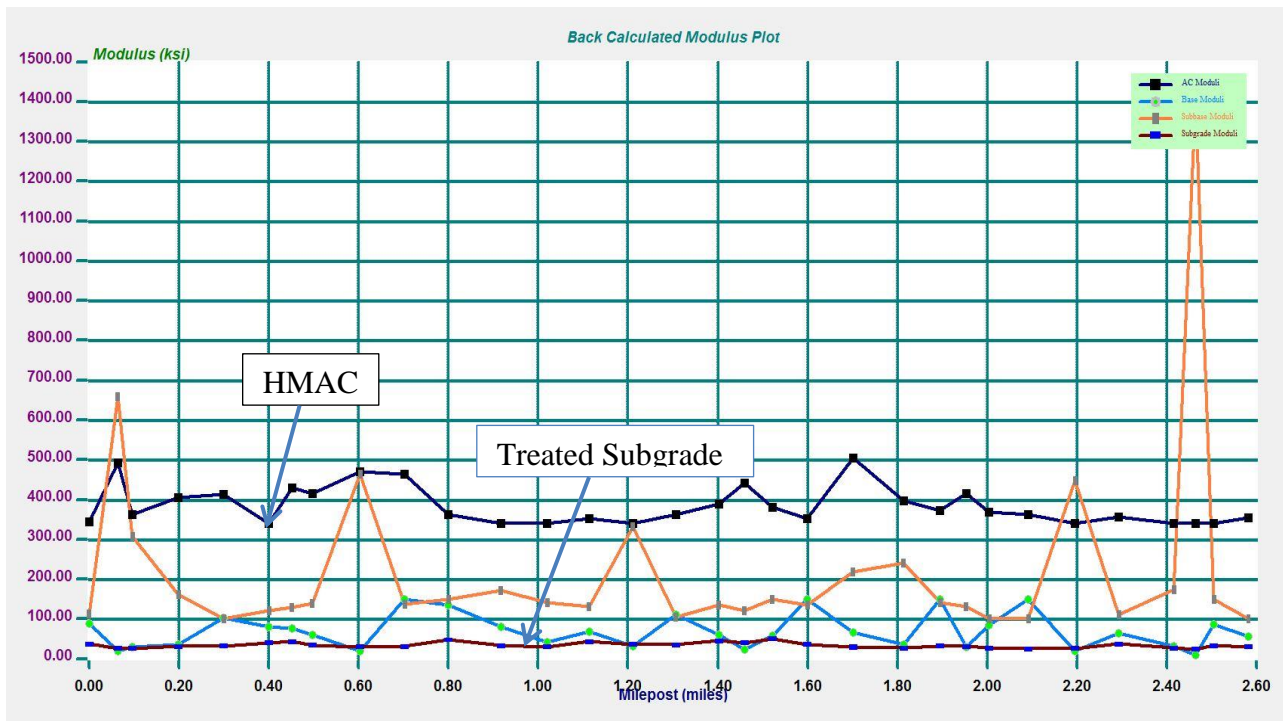
Figure 15: Variation of modulus in test section 1 on 6/15/2014

Table 2 provides the mean modulus of the subgrade and standard deviation obtained at test section 1 from the analysis. FWD analysis conducted in June 2014 revealed that the layer strengths and remaining years to be “Very Good”. This means that the pavement is sound right after construction. Recent FWD analysis conducted in July 2016 revealed that remaining years columns are designated to be “Very Good” as shown in Figure 17. 10+ years in the final column of Figure 17 represent pavement is structurally sound and no load associated problems are anticipated. However, rut remaining life has been reduced to 2-5 years suggesting an imminent problem.

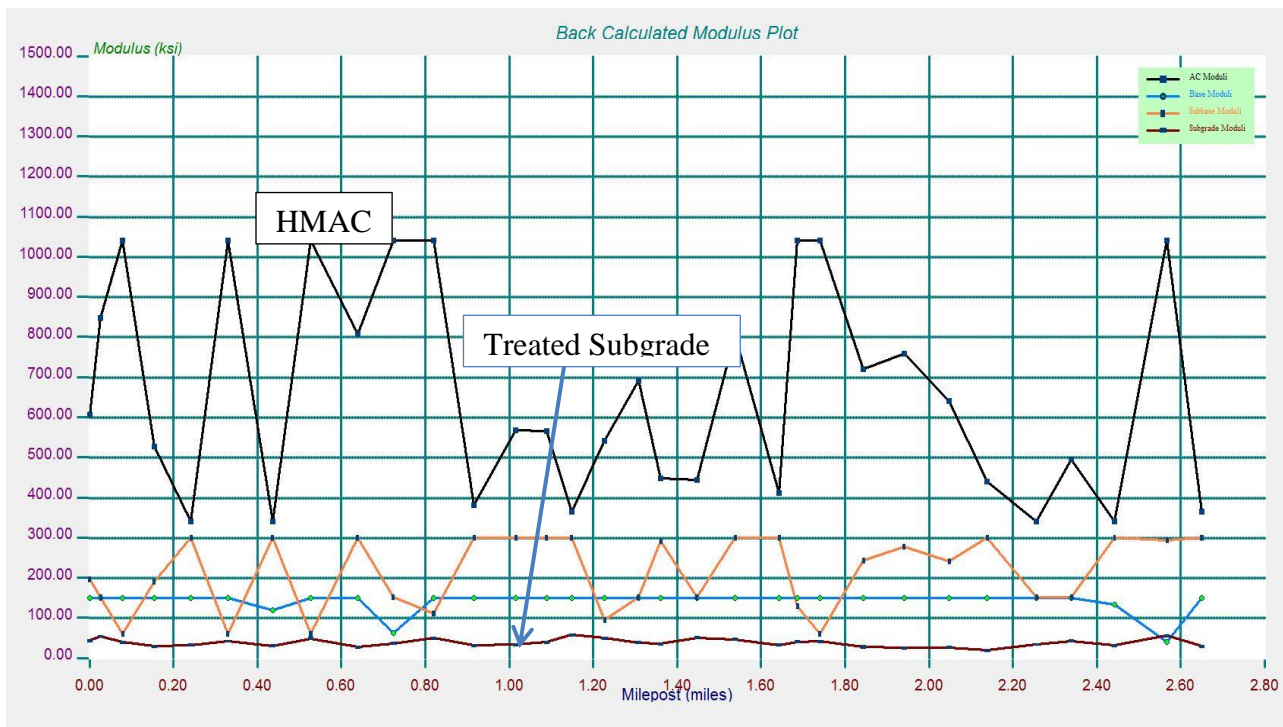
Figure 16: Variation of modulus in test section 1 on 7/15/2016

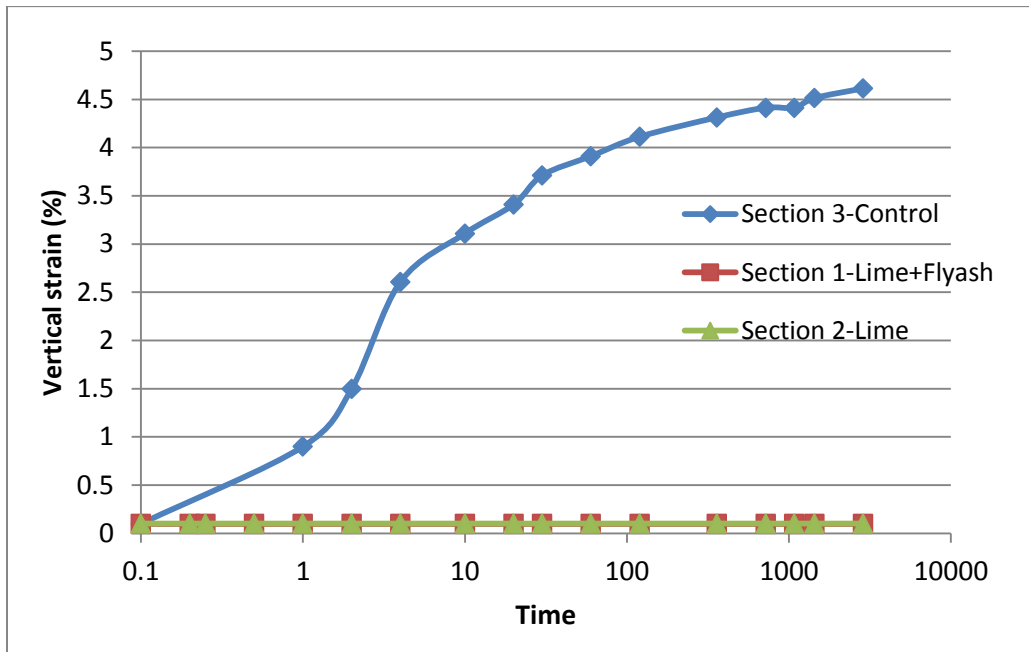
Figure 31: One Dimensional Swell test results during pavement reconstruction

It can be noticed that control soil with lime treatment has shown considerable vertical swell strain of 4.5%, whereas lime + fly ash treated subgrade with extended mellowing did not show any strains.

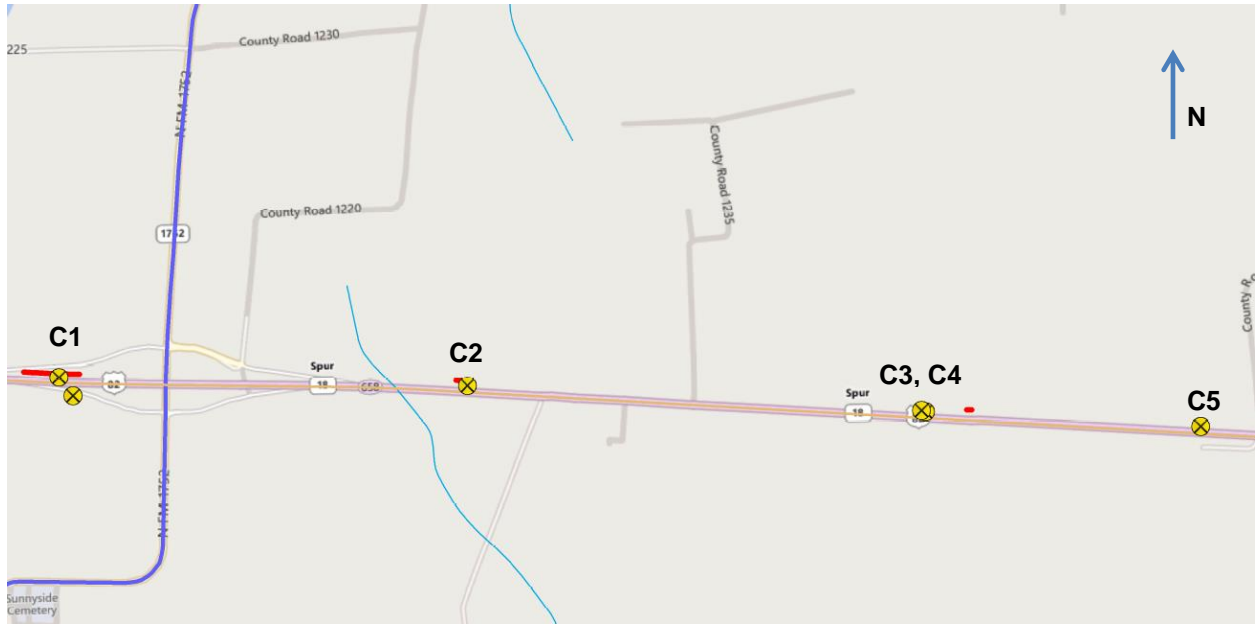
From recent investigations conducted on April 2015, five core samples were retrieved from US82 pavement section where cracking and heaving is observed. The cores are numbered sequentially beginning at the East End #1 and towards Westbound #5 as shown in Figure 35. Core 1 is within test Section 1 (where lime + FA treatment is conducted), whereas, cores 2, 3, 4 and 5 are collected from pavement with conventional lime with 3 day mellowing construction. Table 5 presents the reactive alumina and silica measurements obtained from the core samples retrieved.

Figure 35: Core samples retrieved from US 82 pavement site

Table 5 summarized reactive alumina (Al) and silica (Si) levels of the samples retrieved from five coring sites along US 82 pavement section. All locations have lower reactive Al levels compared to initial reading of 323 ppm prior to construction (TxDOT 6618 report). Similarly, silica levels at locations C3, C4 and C5 decreased from their initial reading of 187 ppm. This shows that portion of the available Al and Si might have been consumed towards Ettringite formation prior to construction. However, at locations C1 and C2, reactive Si levels increased to

269 and 226, respectively. This could be attributed to the addition of fly ash during the stabilization process near test section 1.
