1. Report No. FHWA/TX-08/1401-1		2. Government Accession No.		3. Recipient's Catalog No.	
4. Title and Subtitle <b>Bending Fatigue Response of Grouted Stay Cables</b>				5. Report Date July 2008

## **Bending Fatigue Response of Grouted Stay Cables**

CTR Research Report:	0-1401-1
Report Date:	July 2008
Research Project:	0-1401
Research Project Title:	Determination of Fatigue Damage in Stay Cables
Sponsoring Agency:	Texas Department of Transportation
Performing Agency:	Center for Transportation Research at The University of Texas at Austin

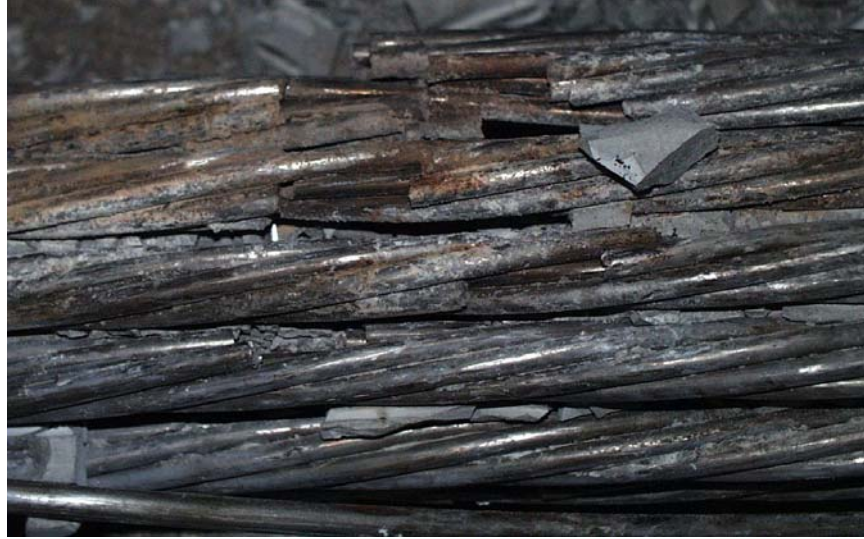
At midspan, wire breaks in the inner layers of strands were more common, especially when most of the wires in the outer layer fractured. Corroded fretting product was often observed in the vicinity of the wire breaks (Figure 3.9). The amount of observed corrosion tended to increase as the number of wire breaks increased.

**Figure 3.9 Corroded Fretting Product on Surface of Strand at Midspan – Specimen 12**

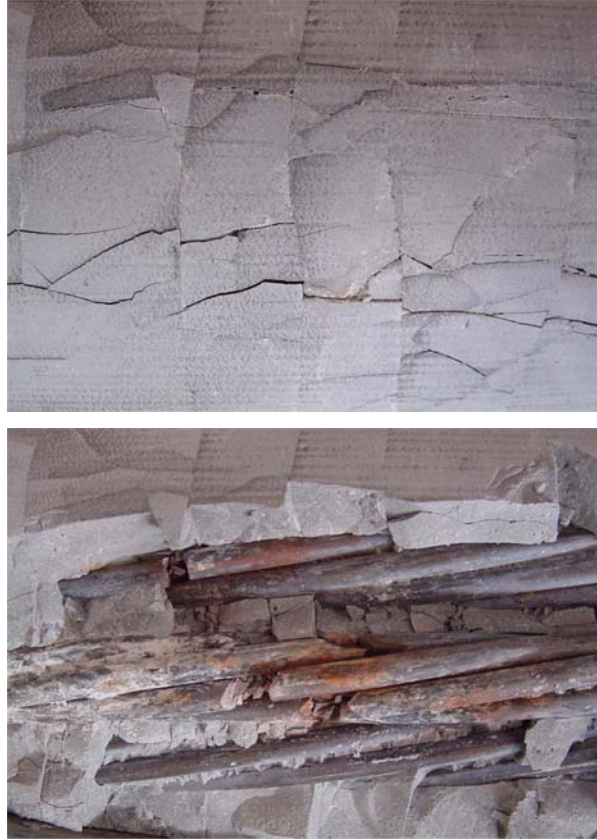
**Figure 3.11 Longitudinal Cracks in Grout, Corrosion of Strand, and Wire Breaks near Midspan of Specimen 1**

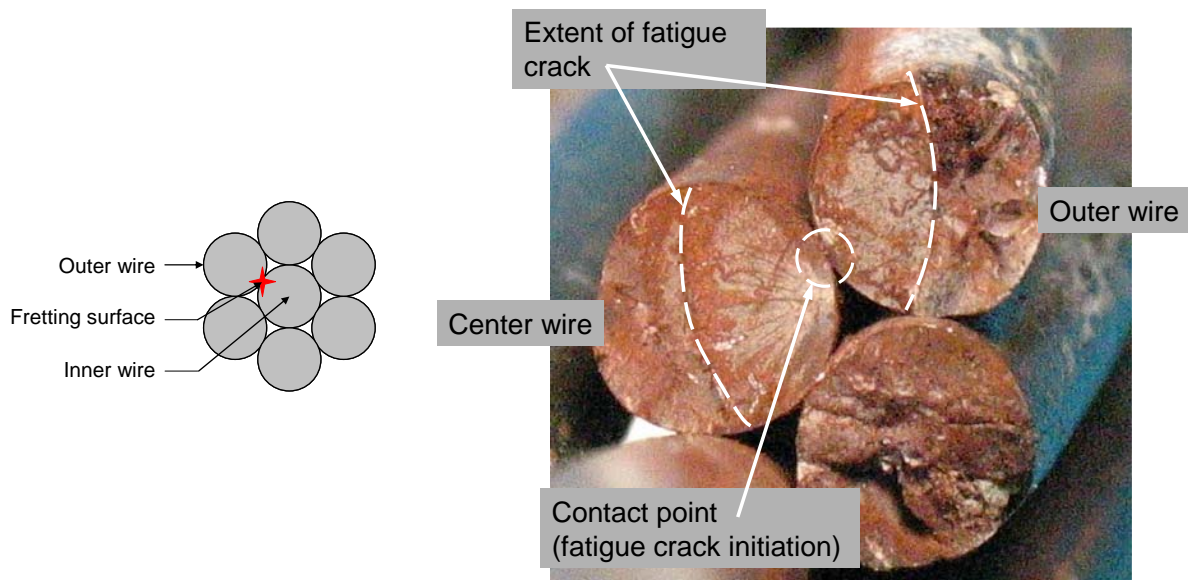
Occasionally fatigue failures were also observed to initiate at a point where an exterior wire was not in contact with the other wires in the strand. It is unknown what caused this type of failure, although possible sources are corrosion, defects on the wire, or fretting with the helical spacer wire (Figure 3.25). The remaining 5% of the wire breaks were in this category.

**Figure 3.20 Fretting between Center Wire and an Outer Wire**

**Figure 3.21 Fretting between Adjacent Outer Wires**

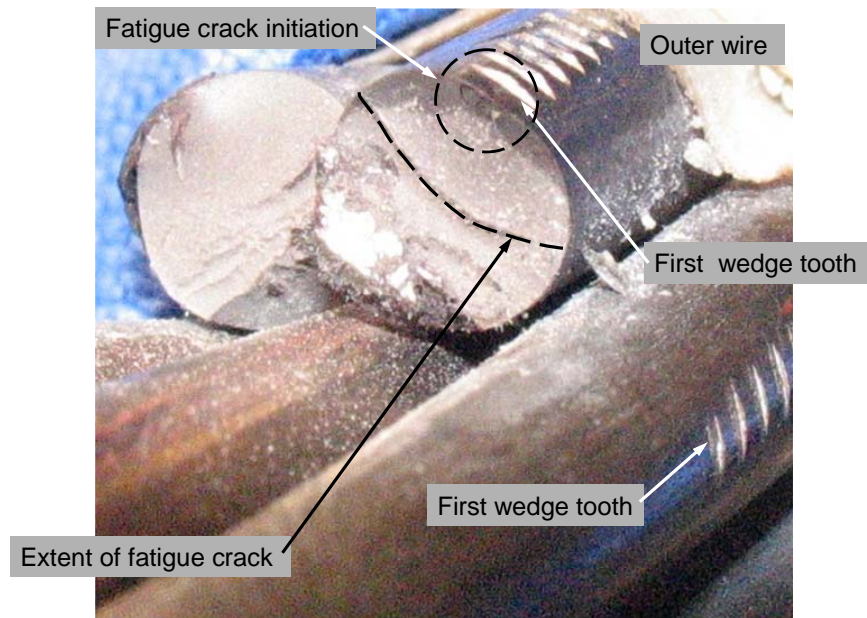
**Figure 3.22 Isolated Fatigue Failure at Wedge**

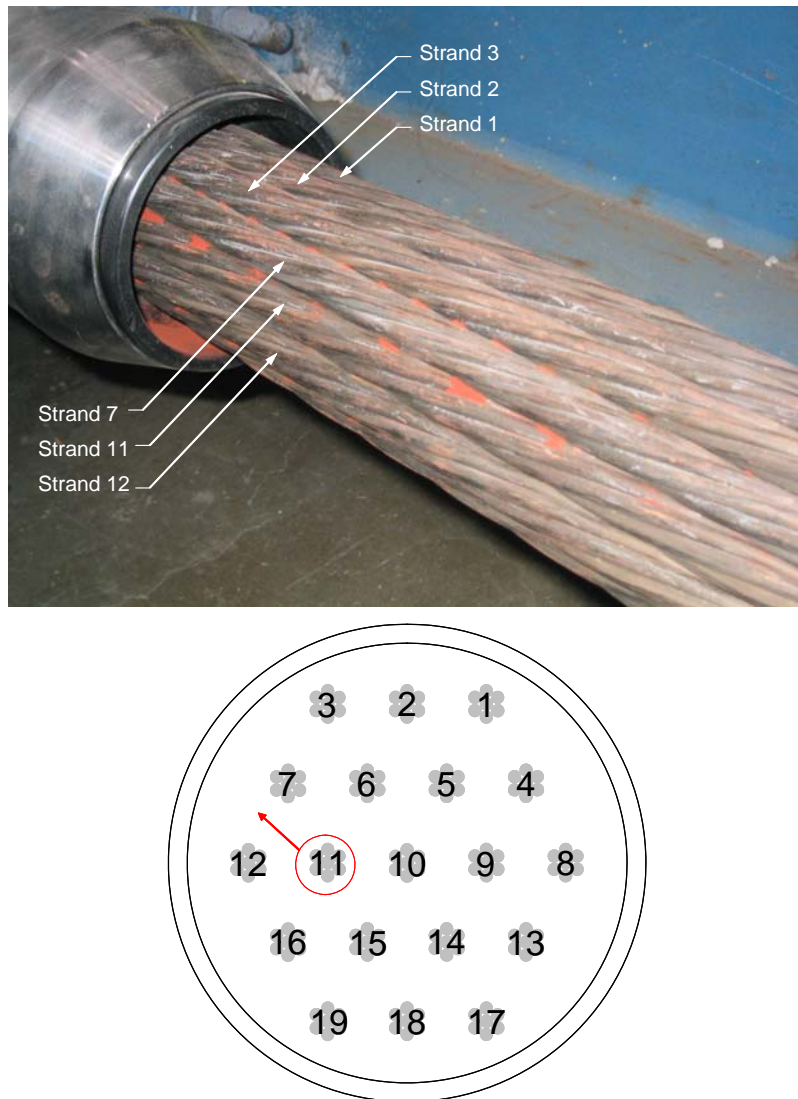
Specimen 8 was ungrouted, but strain gages were not attached to the strands. During construction, one of the interior strands from the middle row was caught between two of the exterior strands near the tension ring at the deck end (Figure B.38). The strands were not crossed, but the misalignment caused extensive fretting between adjacent strands near the tension ring.

**Figure B.38 Misalignment of Strands at Deck Tension Ring – Specimen 8**

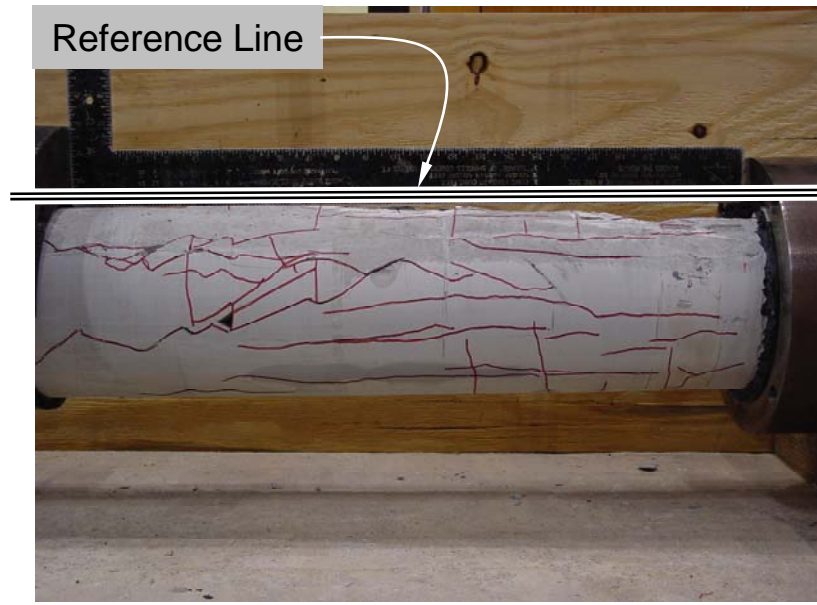
**Figure D.3 Grout Void near Tower Anchorage – Specimen 1**

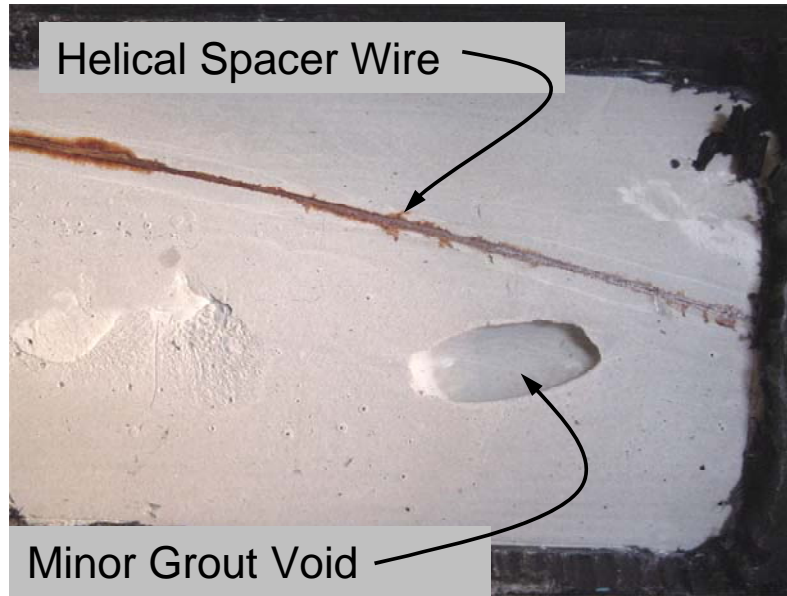
**Figure D.5 Grout Surface Defect and Corrosion on Spacer Wire – Specimen 1**

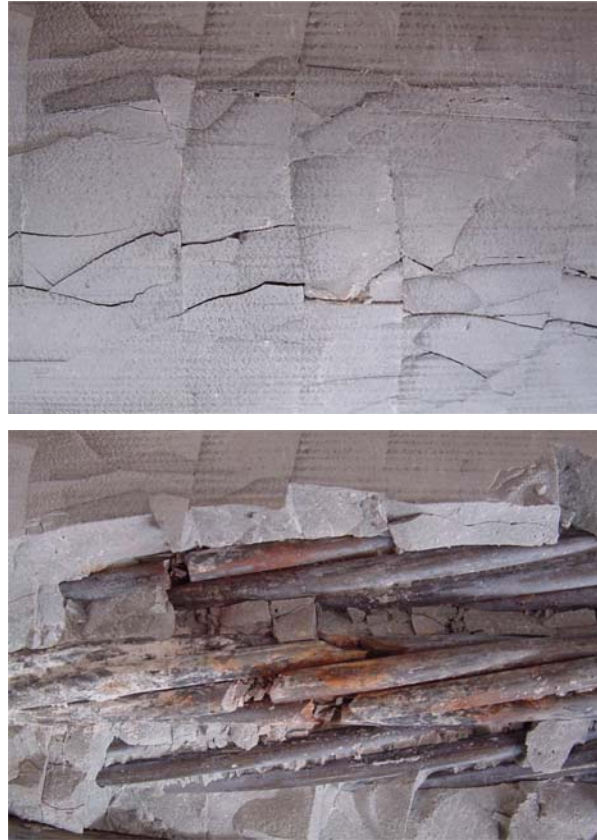
**Figure D.8 Longitudinal Cracks in Grout, Corrosion of Strand, and Wire Breaks near Midspan of Specimen 1**

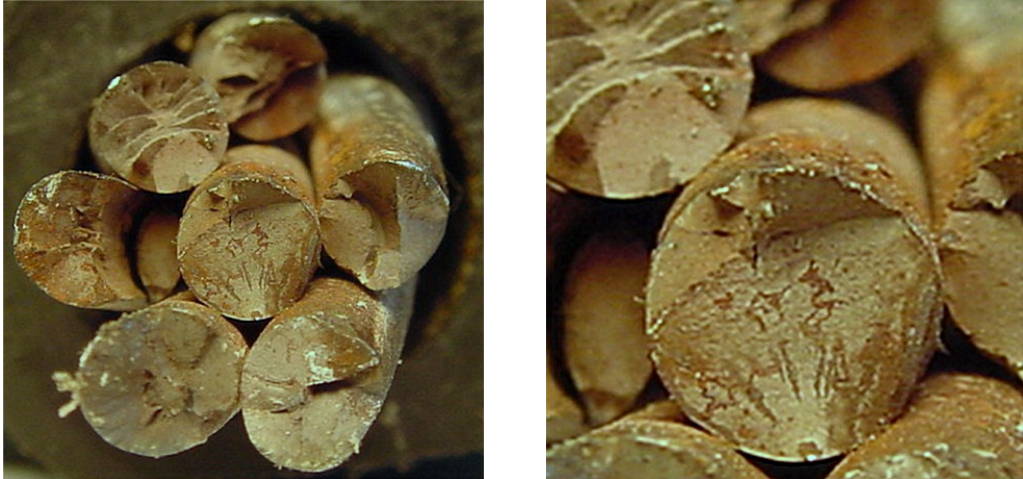
**Figure D.24 Fracture Surfaces for Strand 1 near Tower Anchor Head – Specimen 2**

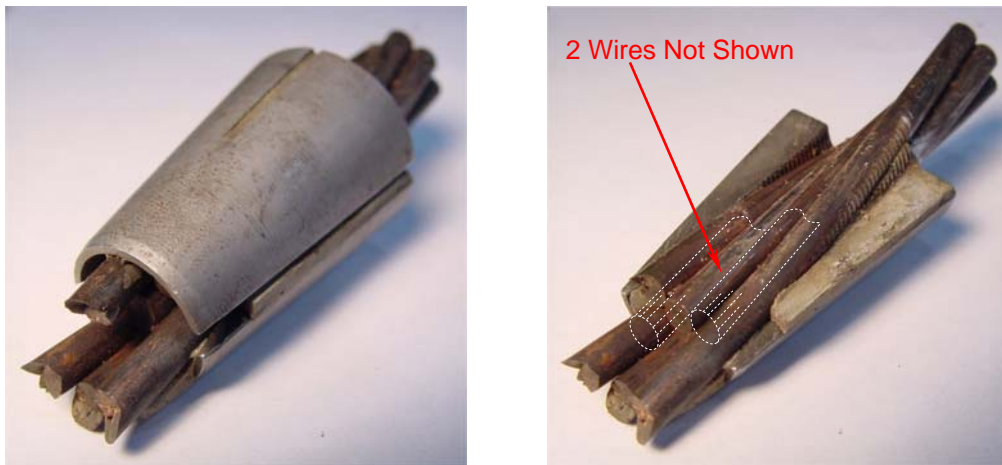
**Figure D.25 Opened Wedges and Wire Fractures for Strand 2 near Tower Anchor Head – Specimen 2**

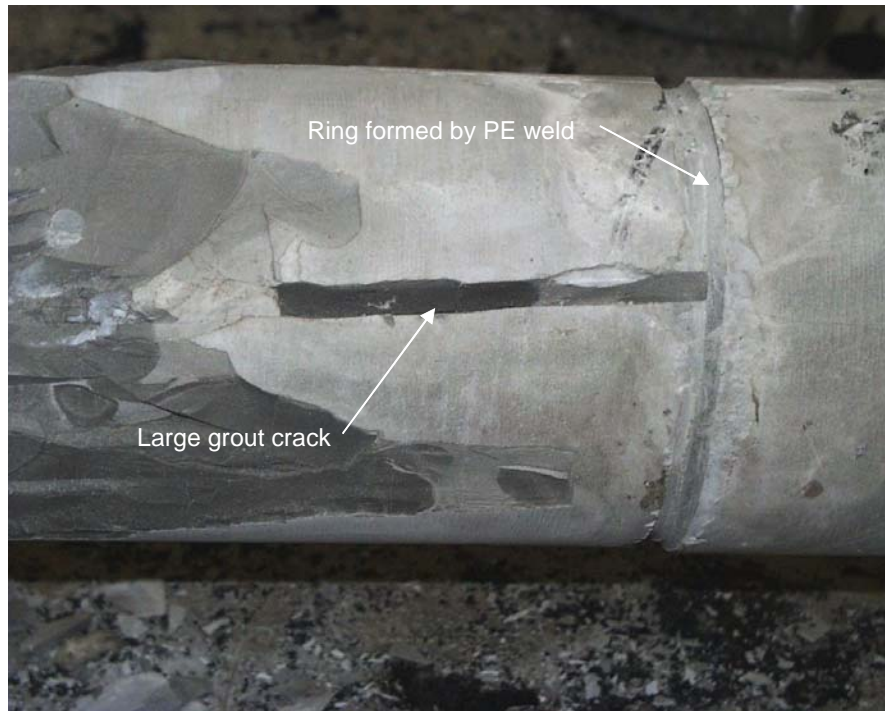
**Figure D.57 Large Grout Crack near Deck Anchorage – Specimen 6**

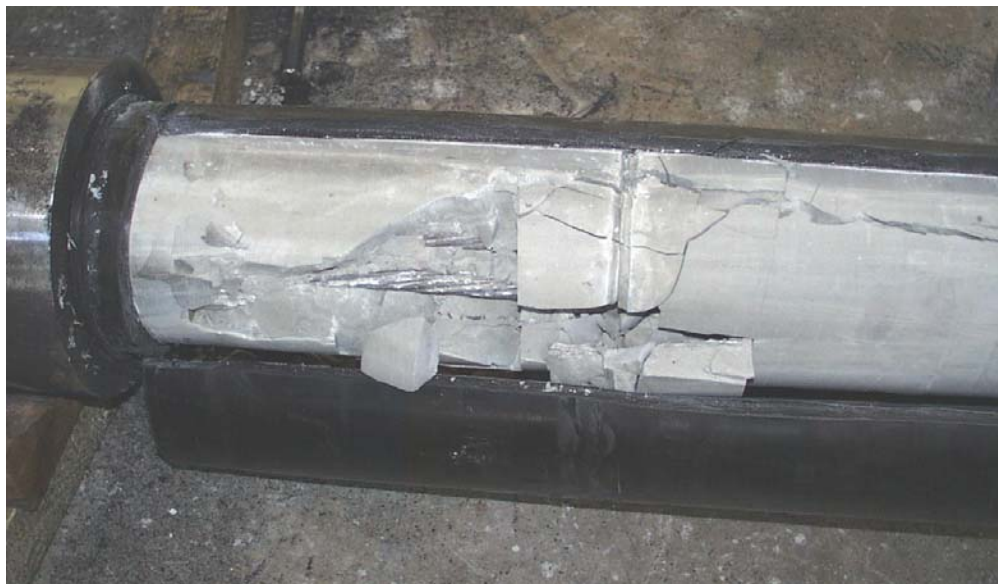
**Figure D.58 Grout Cracking near Tower End – Specimen 6**

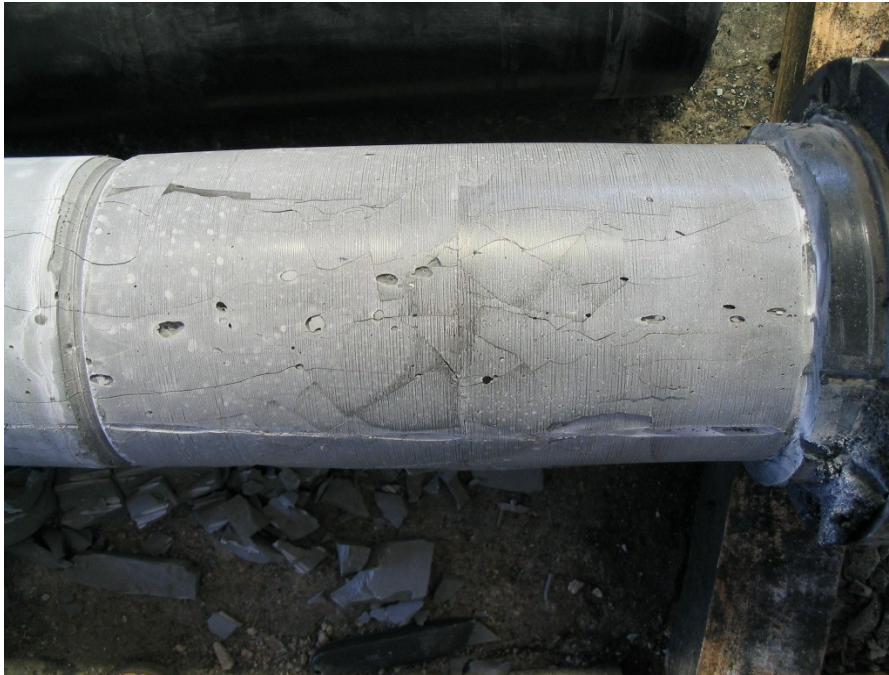
**Figure D.72 Condition of Grout at Tower End - Specimen 7**

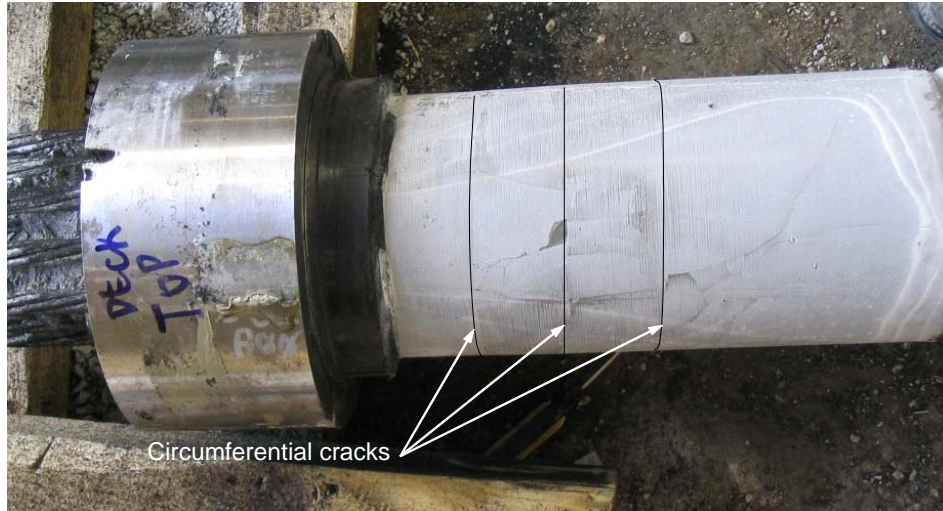
**Figure D.73 Condition of Grout near Deck Anchor Head Immediately after Removing Polyethylene Pipe – Specimen 7**

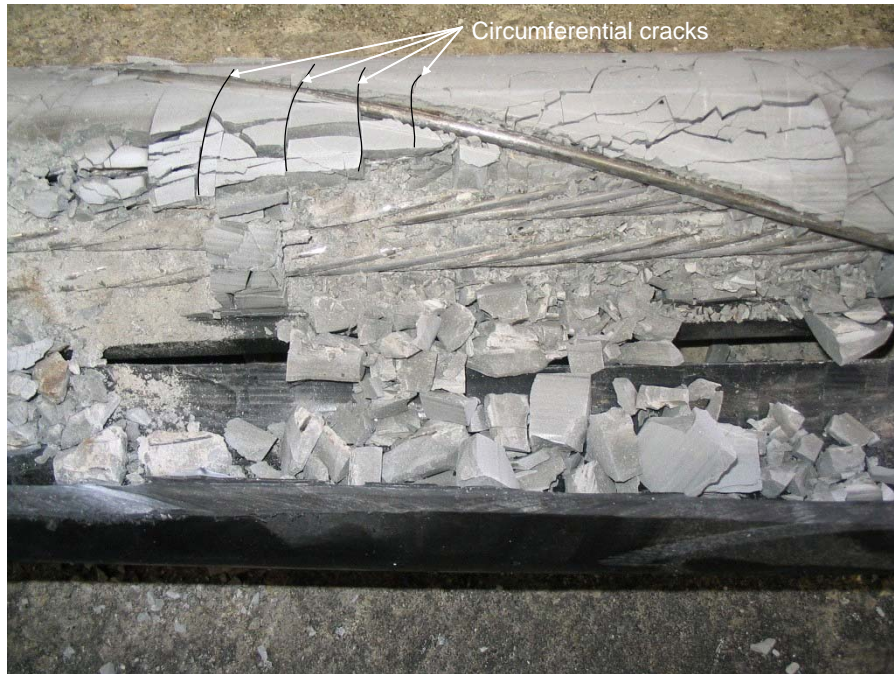
**Figure D.75 Condition of Grout under Load Point – Specimen 7**

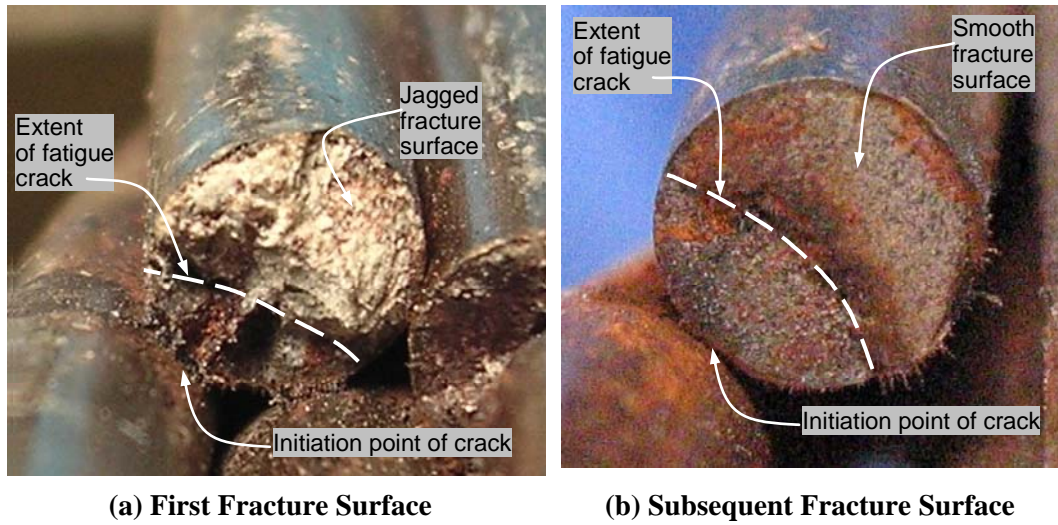
**Figure D.81 Two Wire Breaks in the Same Wire near the Tower End – Specimen 7**

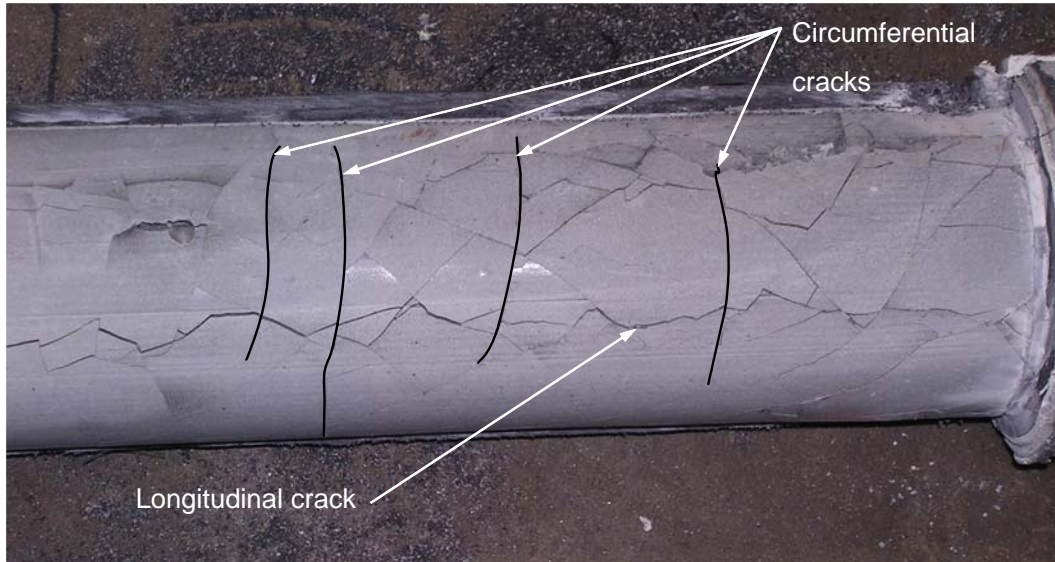
**Figure D.90 Condition of Grout in Center Section of Specimen 8**

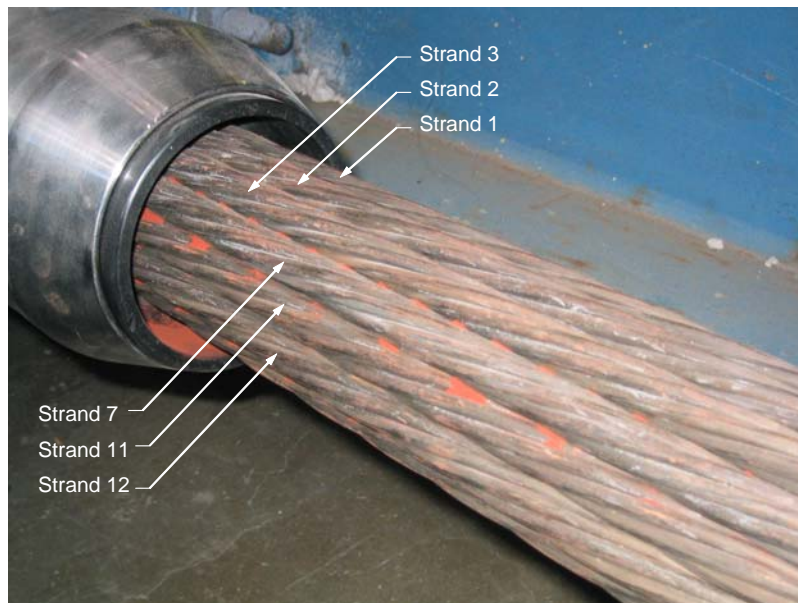
**Figure D.91 Evidence of Fretting Fatigue at Deck Tension Ring – Specimen 8**

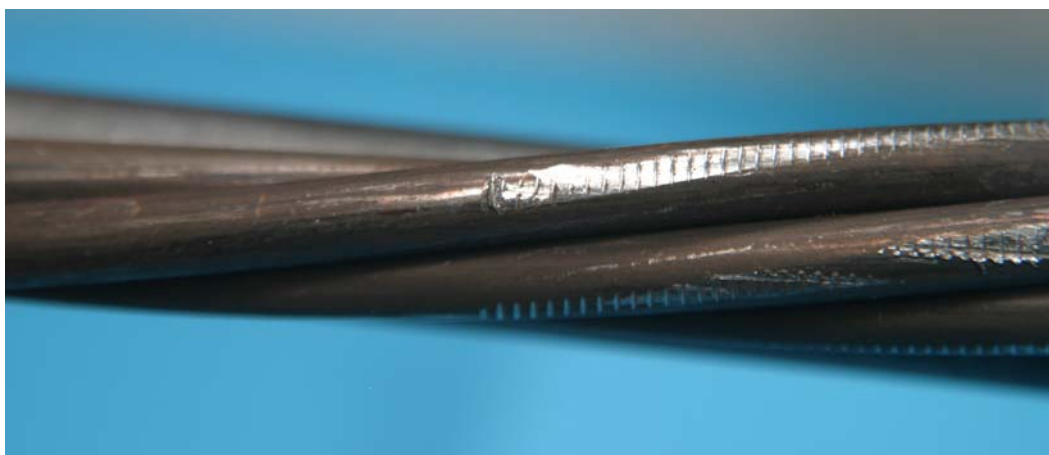
**Figure D.97 Scraping of Strand Due to Stressing at Tower End – Specimen 8**

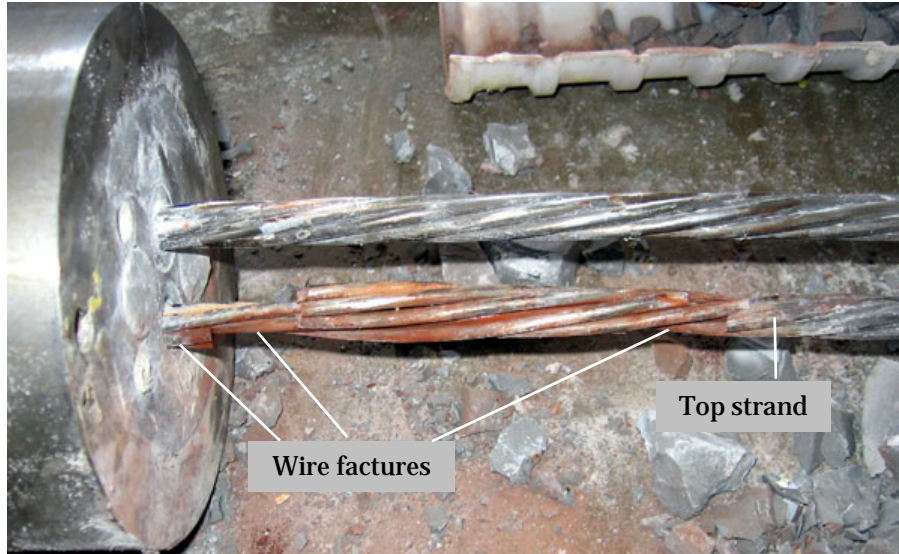
**Figure E.15 Wire Fractures at North Anchor Head for Specimen 2**

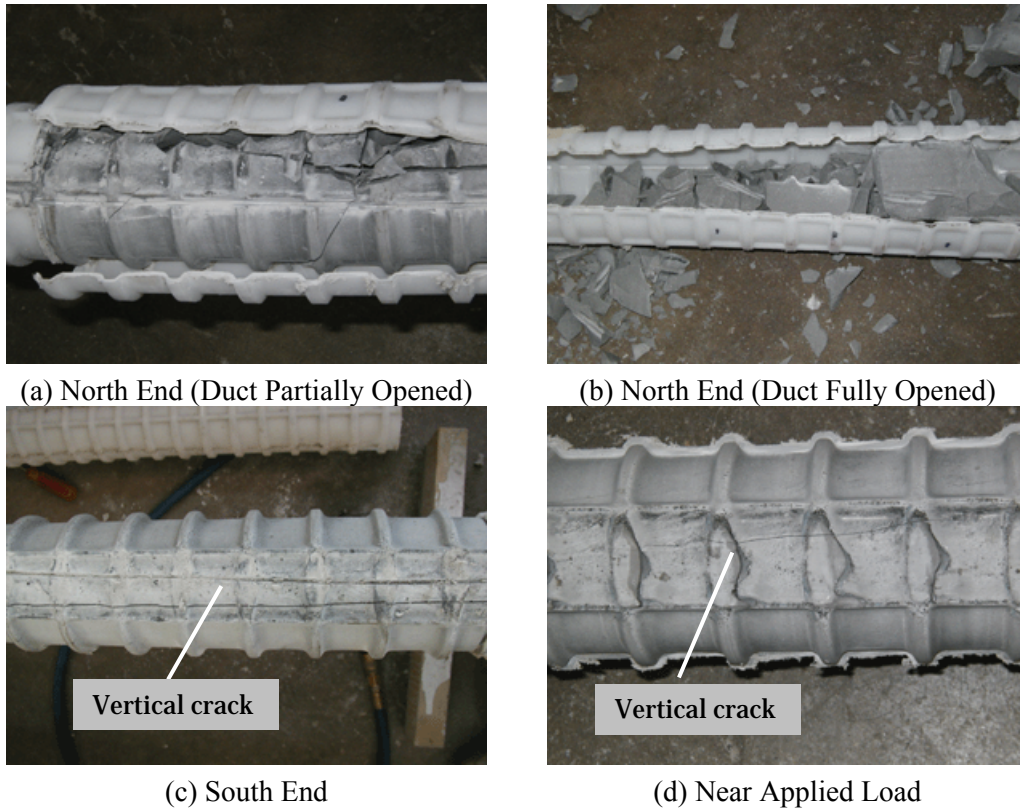
**Figure E.23 Observed Condition of Grout – Specimen 3**
