1. Report No. FHWA/TX-03/0-1857-4		2. Government Accession No.		3. Recipient's Catalog No.	
4. Title and Subtitle Bridges with Premature Concrete Deterioration: Damage Indices, Strand-Pullout Tests, and Field Observations				5. Report Date December 2002

Bridges with Premature Concrete Deterioration: Damage Indices, Strand-Pullout Tests, and Field Observations

Research Report 0-1857-4

*STRUCTURAL ASSESSMENT OF IN-SERVICE BRIDGES
WITH PREMATURE CONCRETE DETERIORATION*

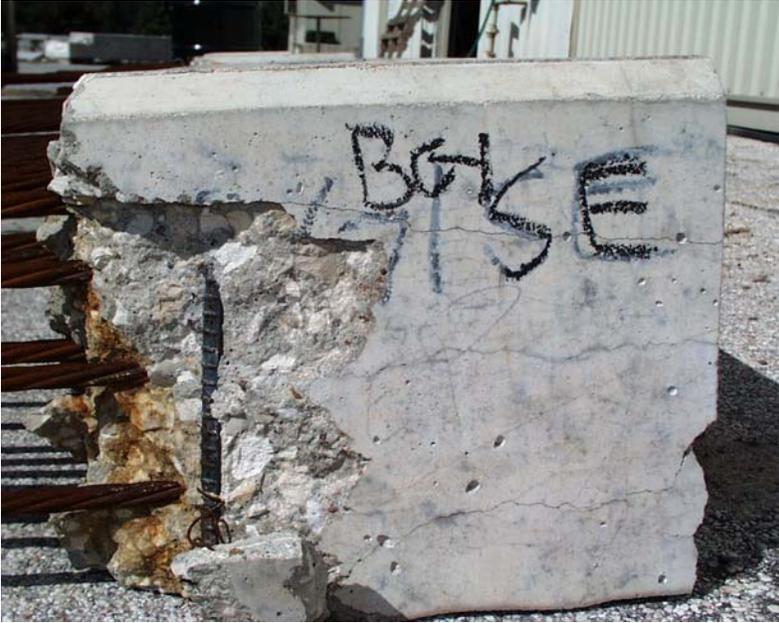
Figure 3.12: Cracking on left face of Slice BG1S

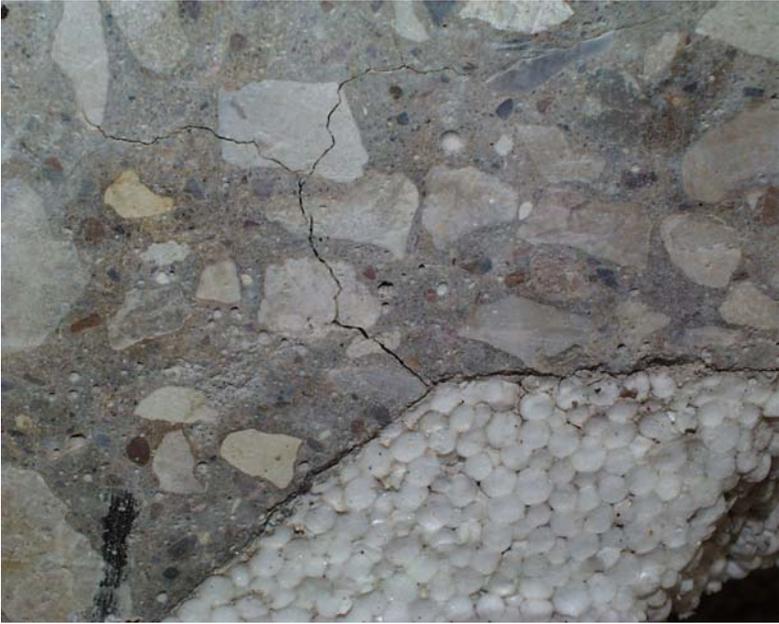
Figure 3.13 shows a close-up of typical damage to the concrete in the left inside corner. Cracking through the aggregate was typical of the damage observed in the specimens.

Figure 3.13: Cracks at left inner corner of Slice BG1S

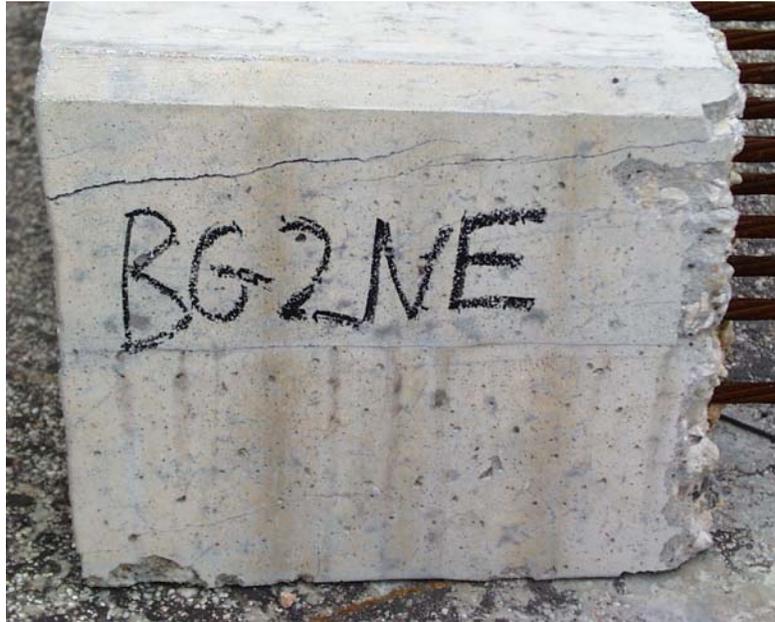
Wide cracks (0.64 mm and wider) existed on the left and right side faces. Figure 3.14 shows the right web of Slice BG2N in which a wide crack is present. Also, longitudinal cracks aligned with the bottom of the void can be seen (Boenig 2000).

Figure 3.14: Cracking on right face of Slice BG2N

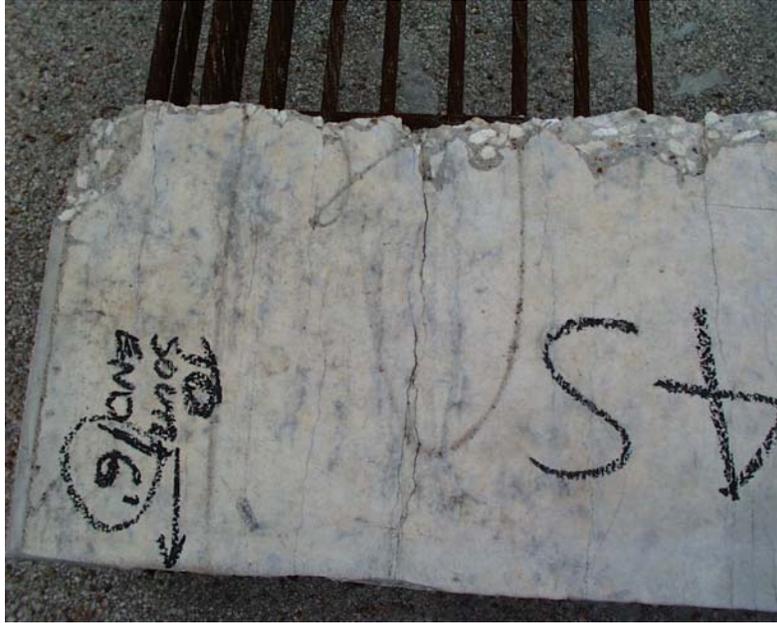
Figure 3.17: Cracking on bottom face of Slice BG4S1

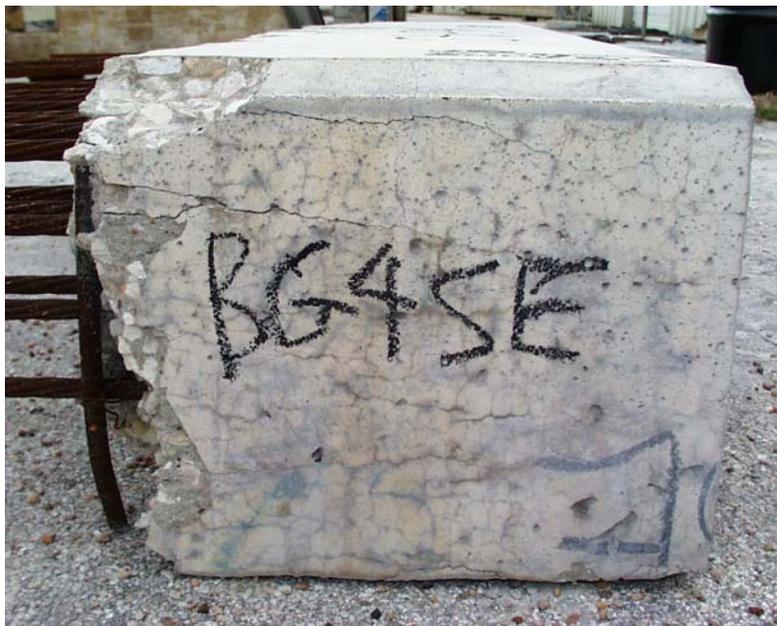
The right web surface was lightly damaged compared to the bottom face. On the other hand, the left face contained several cracks, some of them of medium width (0.18 mm – 0.51 mm). Figure 3.18 shows the visible damage on the left web face.

Figure 3.18: Cracking on left face of Slice BG4S1

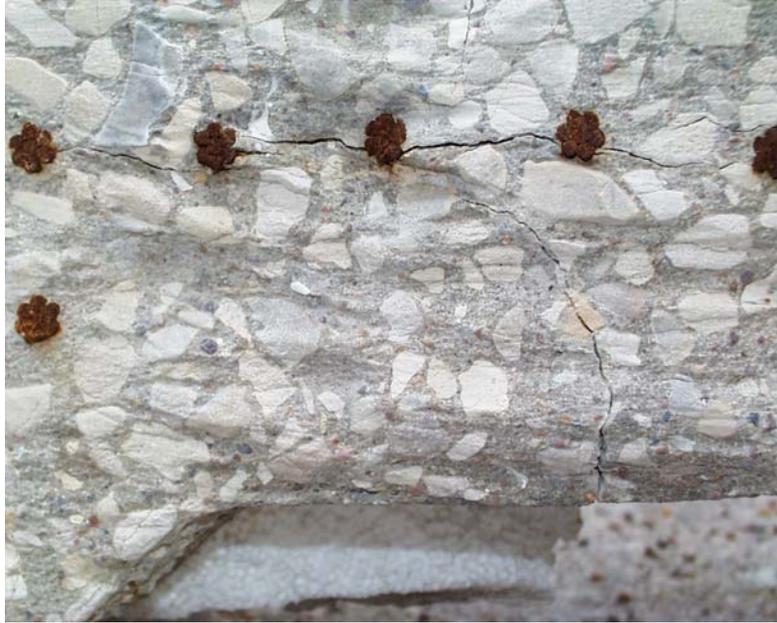
Cracking in the cross section, while not nearly as bad as for Slice BG2N, was still present. Figure 3.19 shows a typical example of damage in the concrete in the back face of Slice BG4S1. Separation is seen between the strands and the surrounding concrete.

Figure 3.19: Damage to cross section of Slice BG4S1 (back face)

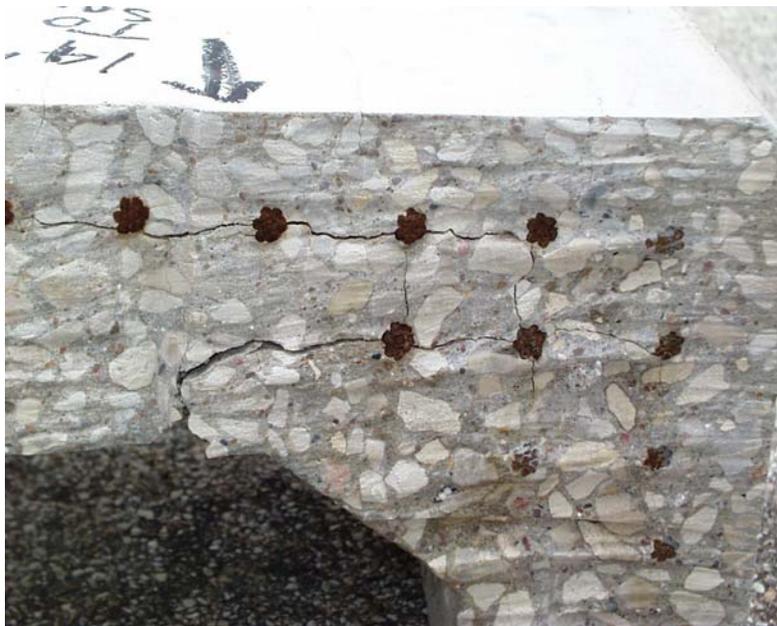
Damage in Slice BG4S2 was similar to the damage present in Slice BG4S1 since both slices were cut at the same location in Girder BG4S. Crack patterns were similar, but the degree of damage was slightly less in Slice BG4S2. Figure 3.20 shows significant cracking between prestressing strands in the left side of the back face, and Figure 3.21 shows more typical longitudinal cracks on the bottom face.

Figure 3.20: Cracking in back face of Slice BG4S2

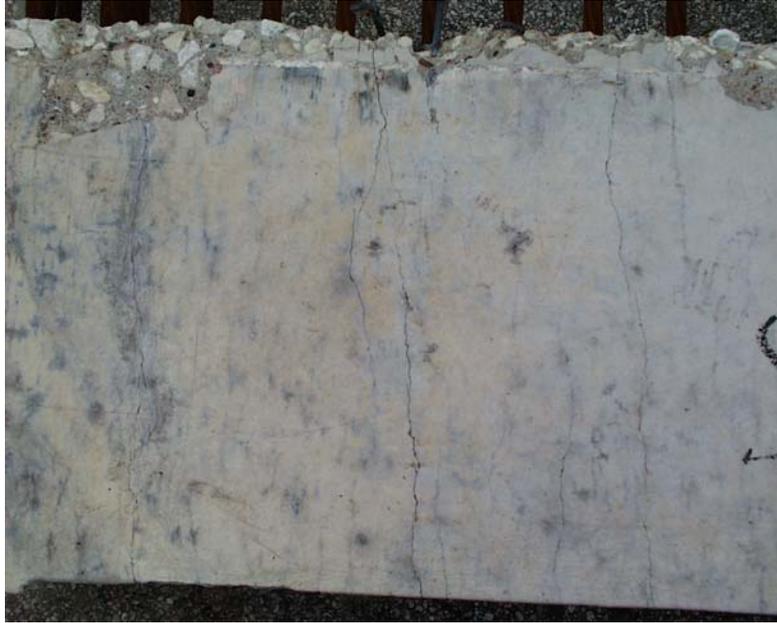
Figure 3.21: Cracking on bottom face of Slice BG4S2

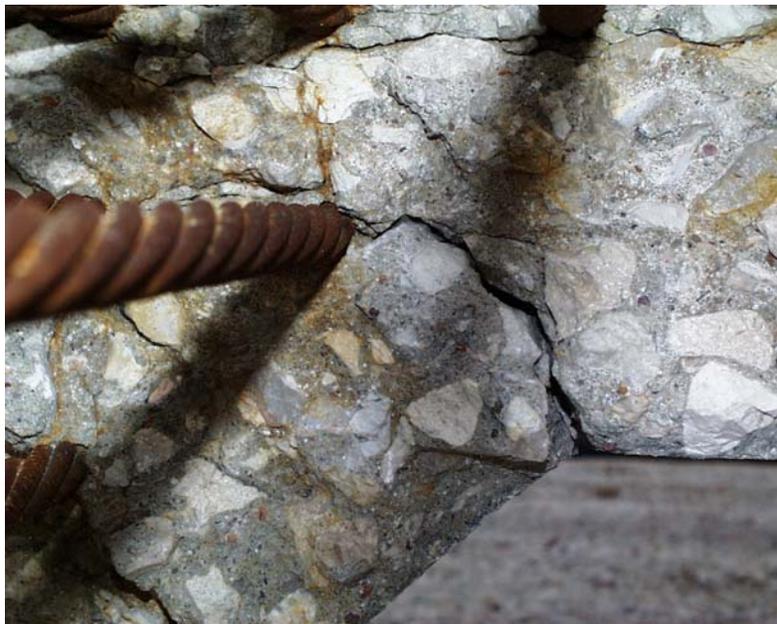
Figure 3.22 shows a good example of cracking in the cross section that can be seen from the front face. Both the left and right inside corners of the void had cracks extending along the entire width of the specimen. Figure 3.22 shows the front view of the right corner. This is the same crack shown in Figure 3.20.

Figure 3.22: Front view of right inside corner of Slice BG4S2

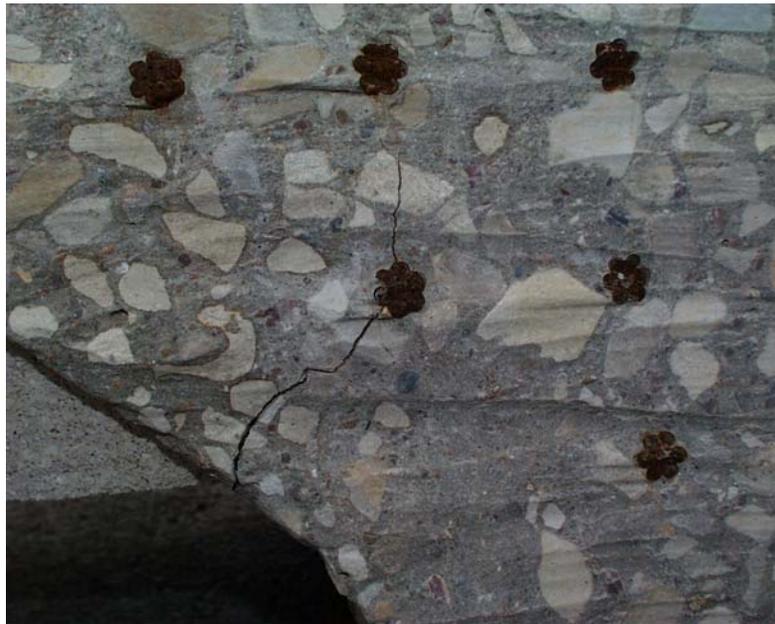
Strand BG4S1_17R, tested on February 19, 2002, had a significant initial crack at the back of the strand. The crack extended from the edge of the inner void of the girder cross section, around Strand BG4S1_17R, and towards Strand BG4S1_14R (Figure 4.7).

Figure 4.7: Crack in back of Slice BG4S1 at Strand 17R (Center)

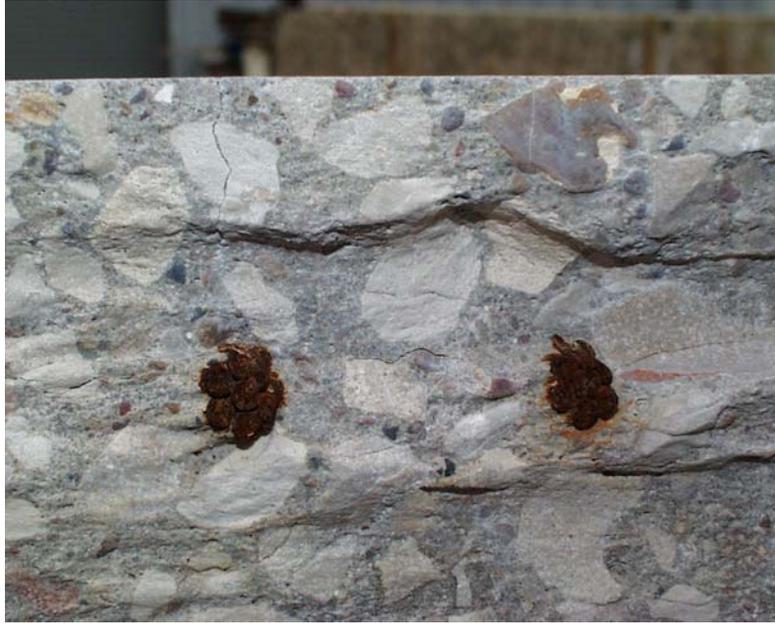
Strand BG4S1_4R was tested on February 15, 2002. The concrete around the strand in the back face had some cracking through the concrete paste and aggregates (Figure 4.11). The length of Strand BG4S1_4R embedded in concrete prior to testing was measured to be approximately 13.8 in. (0.35 m).

Figure 4.11: Back view of Strand BG4S1_4R (right) and Strand BG4S1_5R (left)

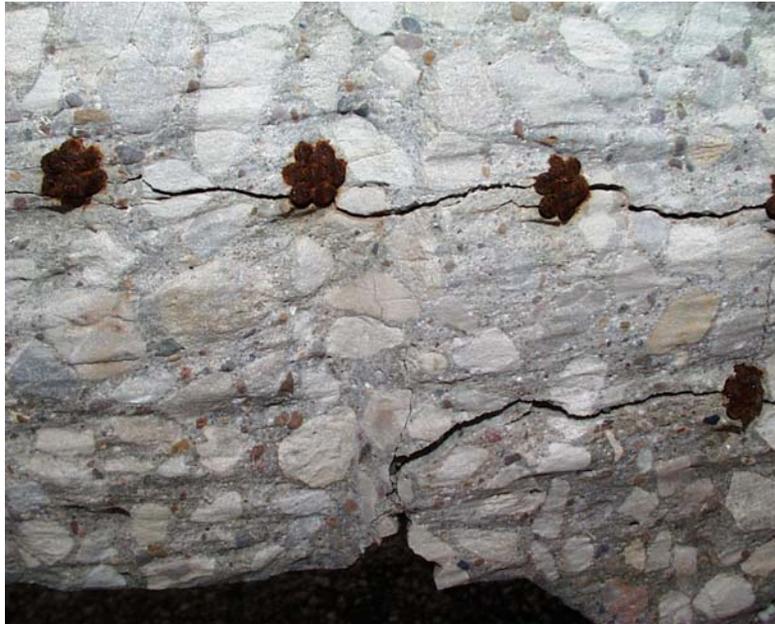
Strand BG4S2_5R was tested on January 18, 2002. Cracking was significant around the back of the strand and the adjacent strands (Figure 4.16). The length of Strand BG4S2_5R embedded in concrete prior to testing was measured to be approximately 12.4 in. (0.31 m).

Figure 4.16: Back View of Strand BG4S2_5R (Top Row, Second From Left)

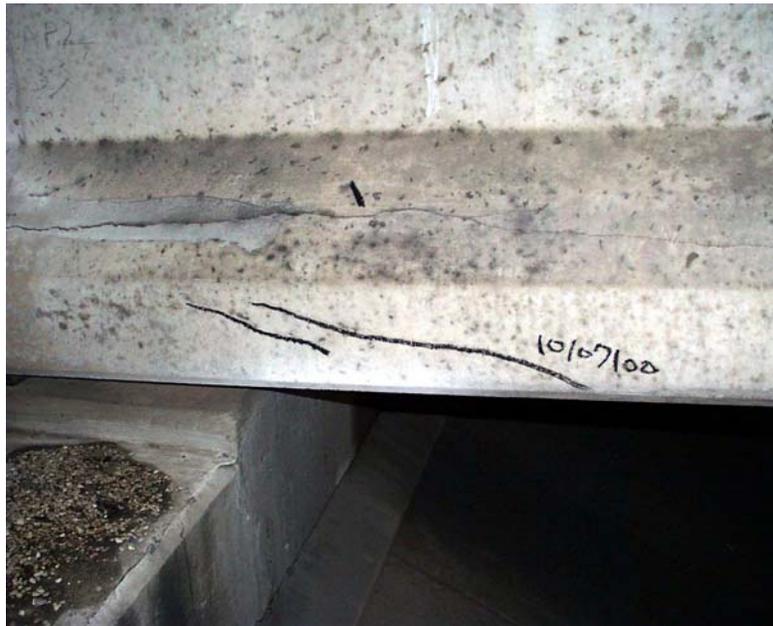
On October 7, 2000, diagonal cracks had become visible on the side faces of the bottom flanges (Face 5) on several girders near the west abutment. Figure 7.3 shows an example of this cracking (below Point 1 on SW Girder 4).

Figure 7.3: New diagonal cracks on I-10 SW Girder 4, Face 5 (10/7/00)

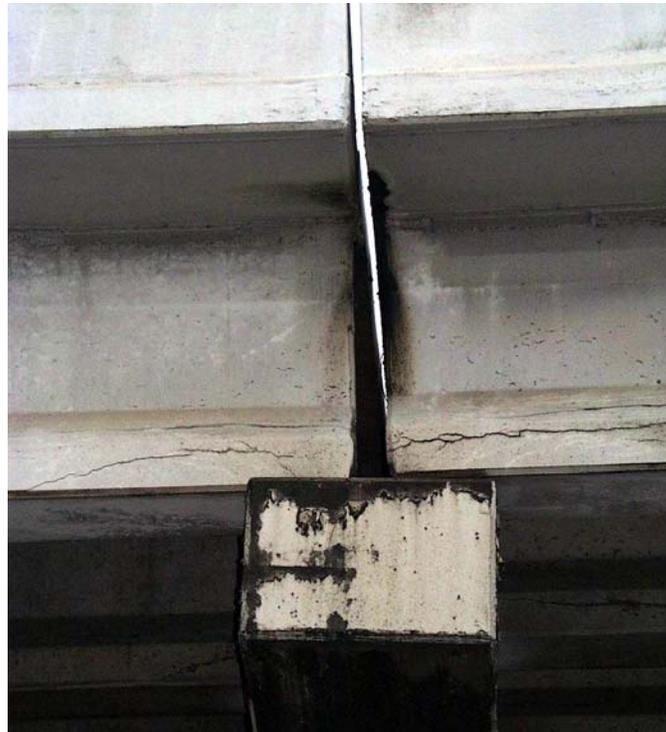
At the first bent east of the west abutment, cracks in Face 5 at the ends of the two south exterior girders were noticeably wider (Figure 7.5). An expansion joint is present at this bent. Staining on the bent cap indicates that the joint seal had not protected the girders or bent cap from exposure to rainwater. Cracks were not monitored closely at this location because lifting equipment would have been required.

Figure 7.5: Cracks at first bent east of west abutment, I-10 (10/7/00)

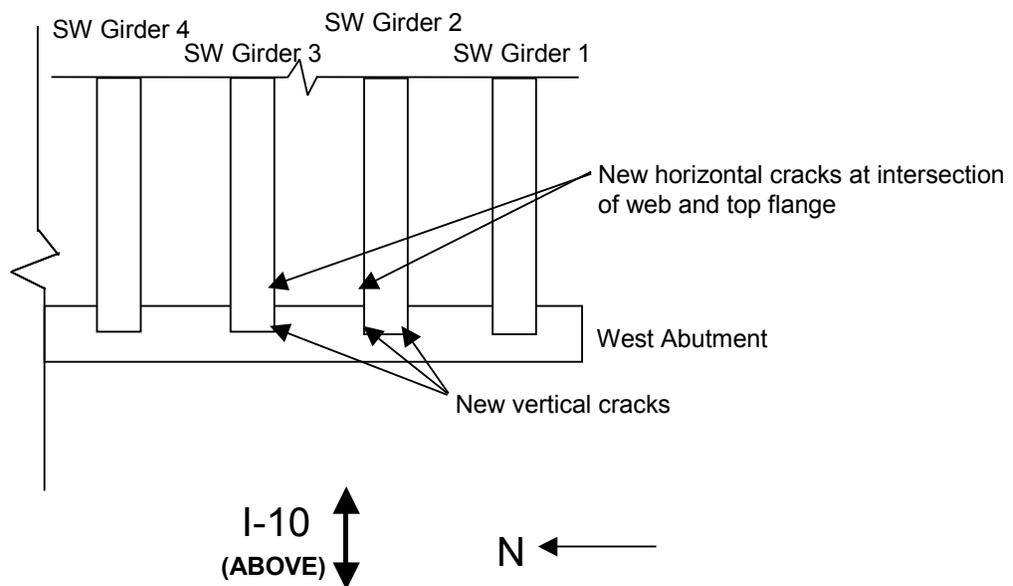
Figure 7.6: Location of new cracks on I-10 structure (plan view) (12/10/01)

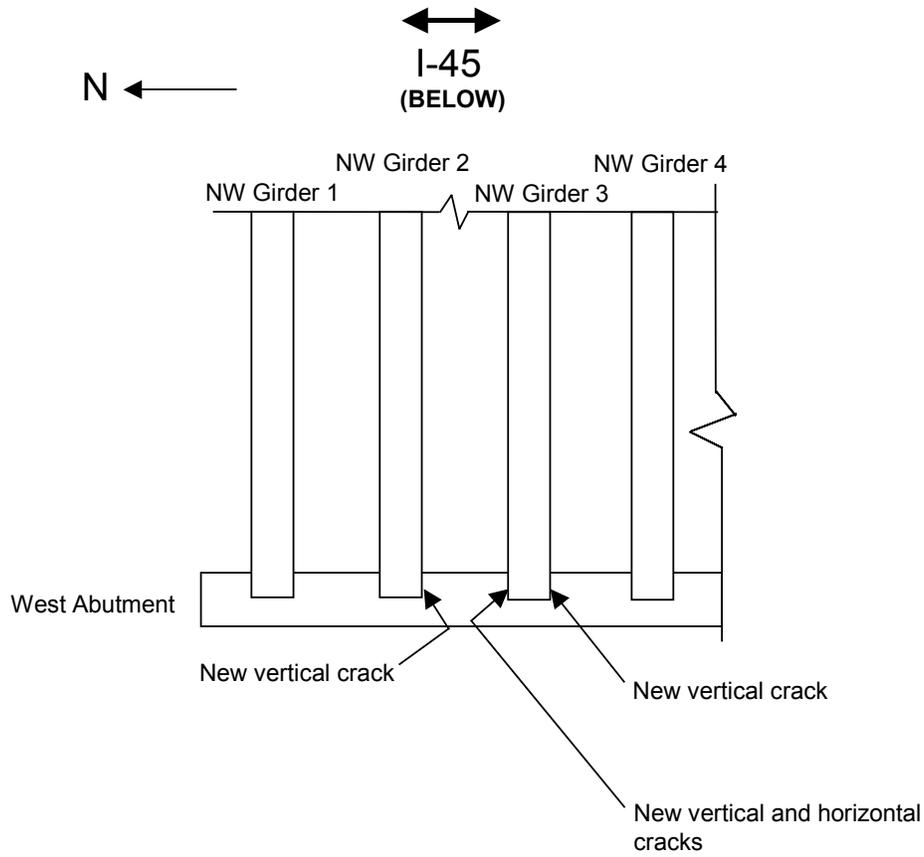
Figure 7.21: Location of new cracks on Robinson Road structure (plan view) (12/10/01)

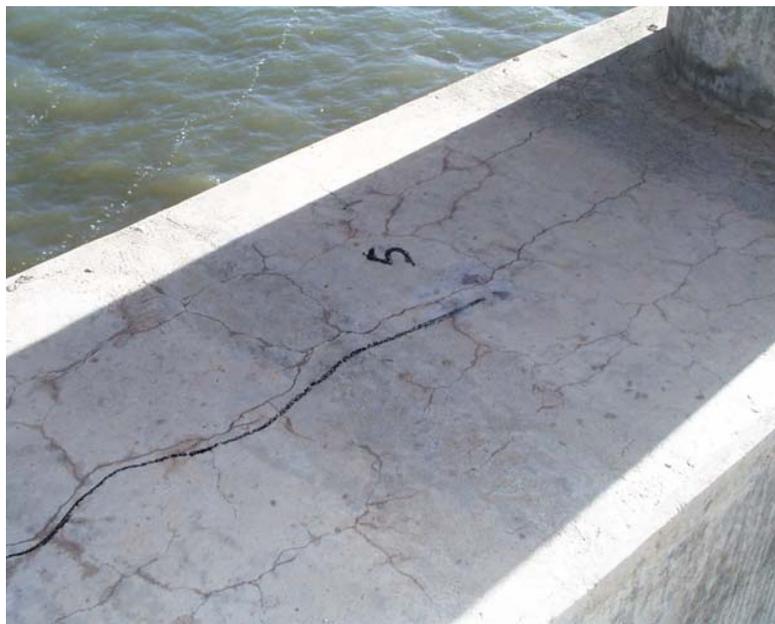
Figure 7.40: Map cracking on tie beam, Bent 5 (12/18/00)

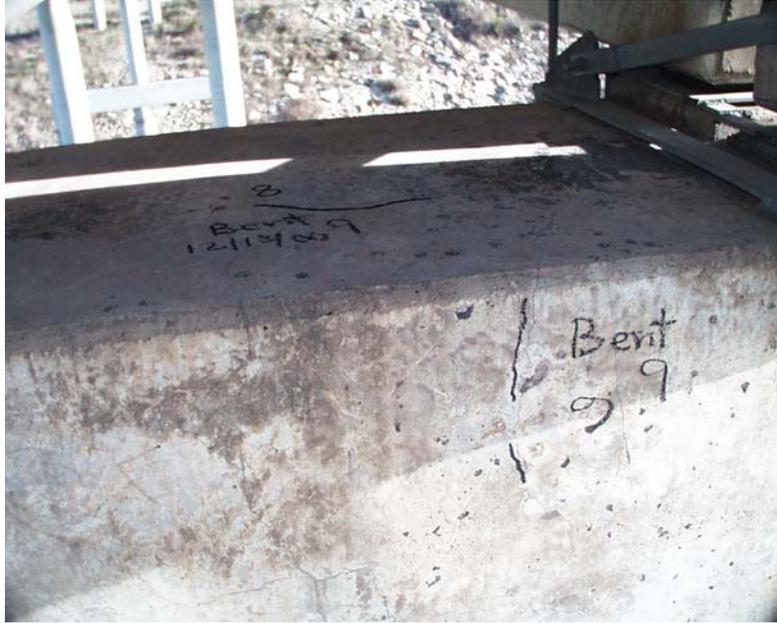
Figure 7.41: Cracking on bent cap, Bent 9 (12/18/00)
