Corrosion Resistance Recommendations from Long-Term Exposure Testing of Post-Tensioning Systems

CTR Technical Report:	0-4562-5F
Report Date:	May 2013
Project:	0-4562
Project Title:	Corrosion Resistance of Grouted Post-Tensioning Systems
Sponsoring Agency:	Texas Department of Transportation
Performing Agency:	Center for Transportation Research at The University of Texas at Austin

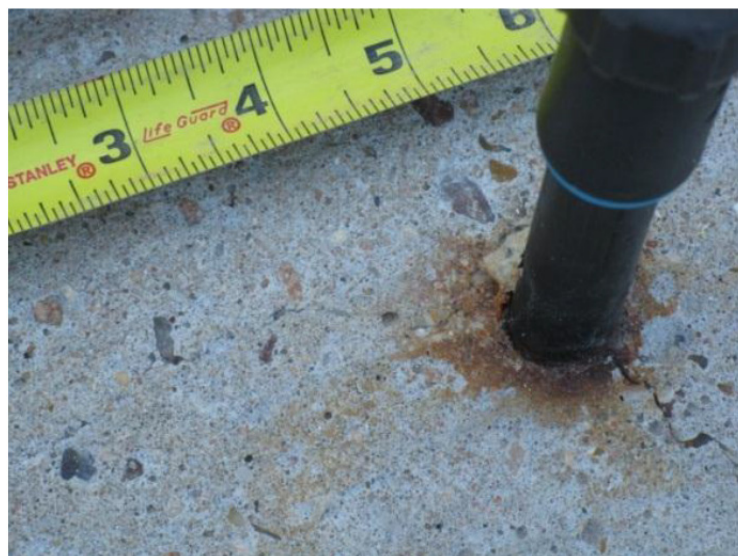
The surface concrete of all specimens developed scaling in and around the saltwater tray. In many cases, the north and south faces of the specimens were also affected. Shallow surface air voids were visible in the saltwater trays of all specimens. Isolated spalling was found around the surface cracks and pourback joints of some specimens. Corrosion staining as shown in Figure 5.10 was visible on the top surface of several specimens, most often near the base of one or both grout vents.

Figure 5.10 – Staining at Grout Vent

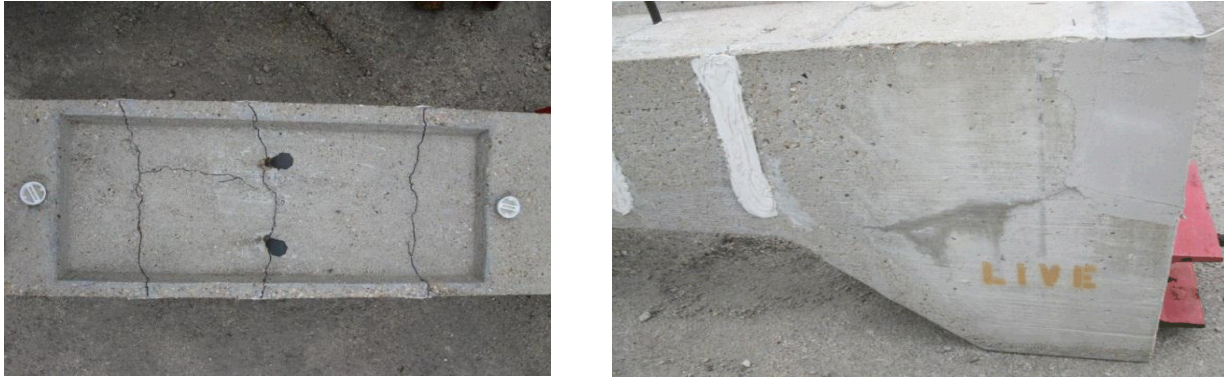
The visual inspection procedures developed by Salas⁸ were used to examine the visible surfaces of each specimen for cracking, surface flaws, discoloration and corrosion staining, and efflorescence. Each specimen was photographed before it was unloaded and autopsied. Surface cracks in the ponding area were measured, marked, photographed, and mapped using a crack scope, crack comparator, grid, and camera. The cracks were traced with a marker for visibility and photographed from approximately four feet above the center line of the ponding area.

Figure 5.11 – Cracking across Ponding Region (left) and at Corbel (right)

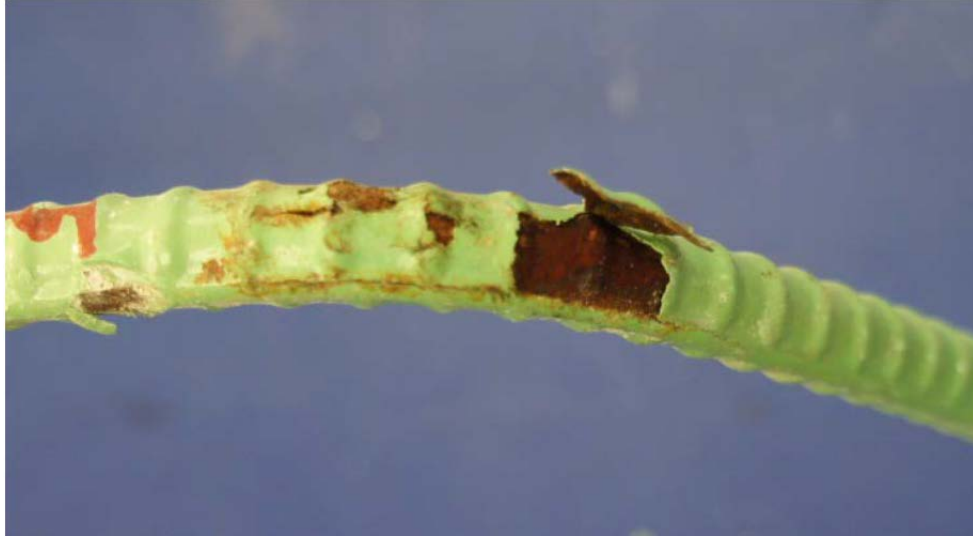
Overall, the specimens' epoxy-coated mild reinforcing elements were in good condition. Corrosion damage was minor and limited to small isolated areas of some bars or stirrups. In between these regions, the epoxy coating was completely intact. Discoloration and corrosion tended to occur at locations where damage to the epoxy coating was likely to have occurred, such as points where the bars had been tied, lifted with a crane, or bent as shown in Figure 5.14. Pitting and area loss were extremely rare. Discoloration was the most common form of corrosion damage.

Figure 5.14 – Epoxy-Coated Mild Steel Reinforcement Corrosion

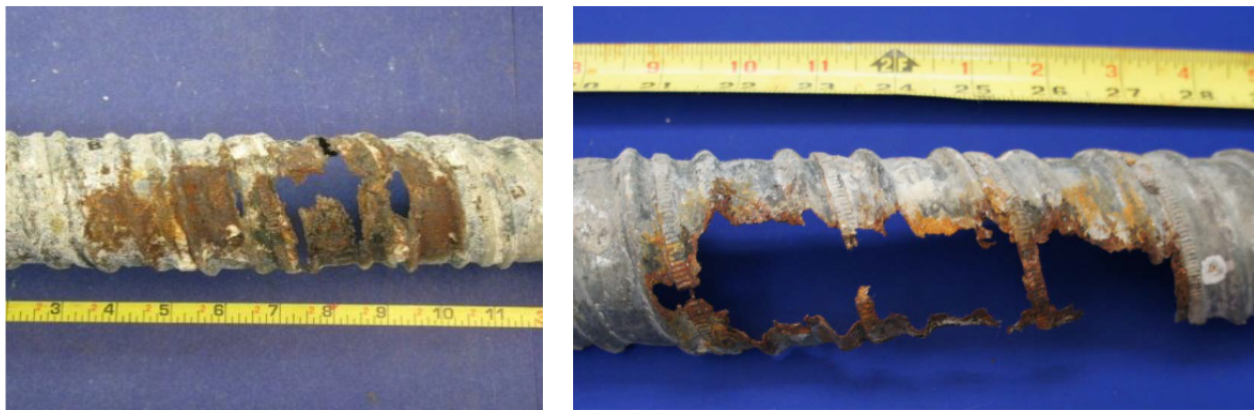
As expected, the results from the galvanized duct and the plastic duct were substantially different. Galvanized steel ducts performed very poorly, with every specimen showing area loss and pitting over a portion of its length. Substantial area loss and pitting were present at locations of grout voids. Corrosion and discoloration were less localized, appearing over larger portions of the ducts' length. Damage was most severe along the portions of duct which were located beneath each specimen's transverse cracks. The smallest cover was underneath the ponding region where most of these cracks were located. This resulted in aggressive corrosion in those regions, seen in Figure 5.16.

Figure 5.16 – Galvanized Duct Corrosion with Severe Pitting

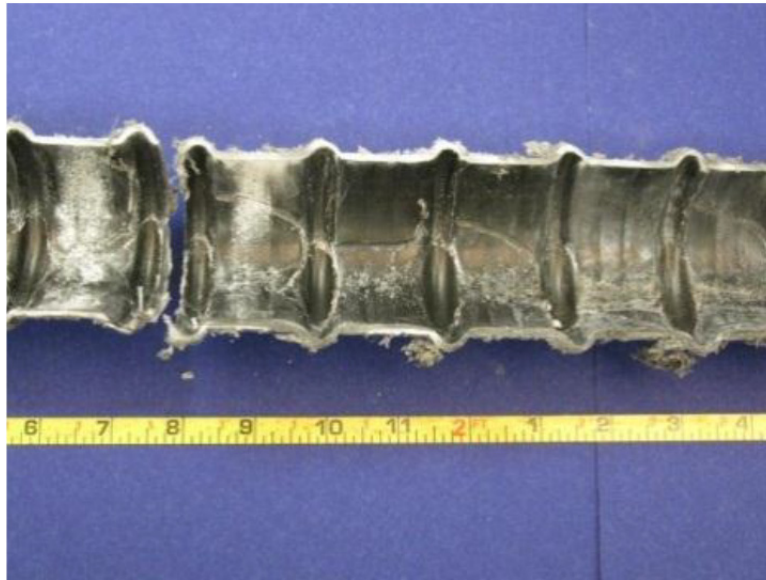
that contained stainless steel strand. The highly curved stainless steel strand scratched interior walls of the ducts during strand placement, resulting in high damage ratings for Specimen 4.2.

Figure 5.17 – Damage Caused by Stainless Steel Strand

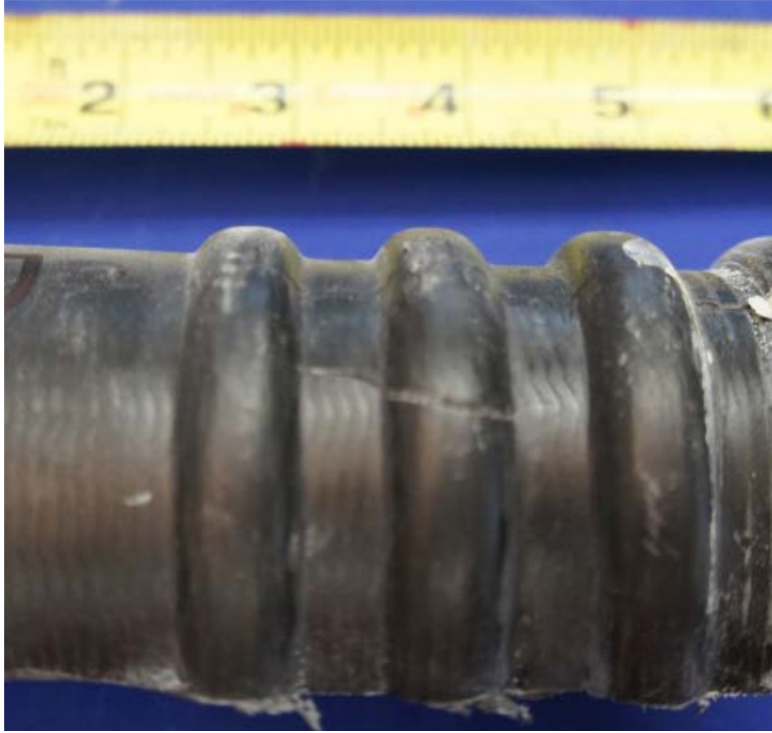
Figure 5.18 – Crack in Specimen 7.2

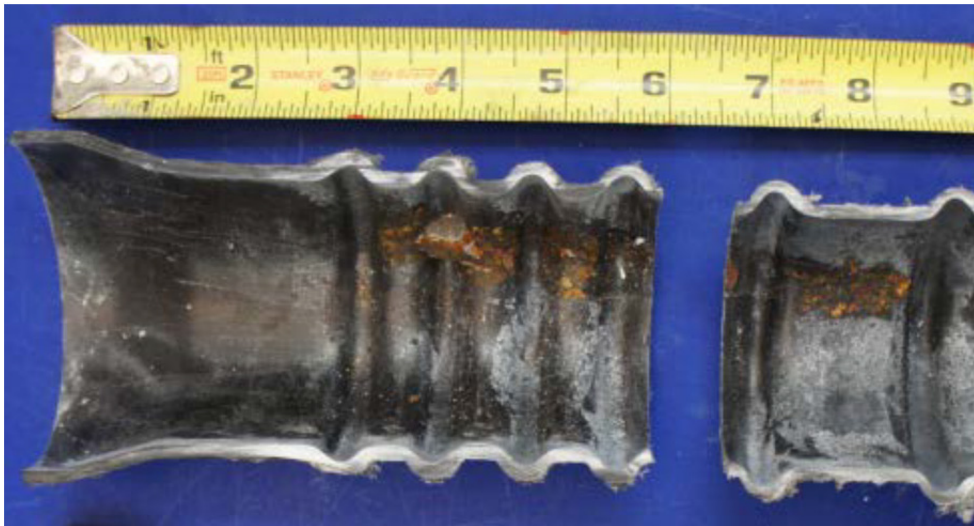
Figure 5.19 – Mild Staining of Plastic Duct

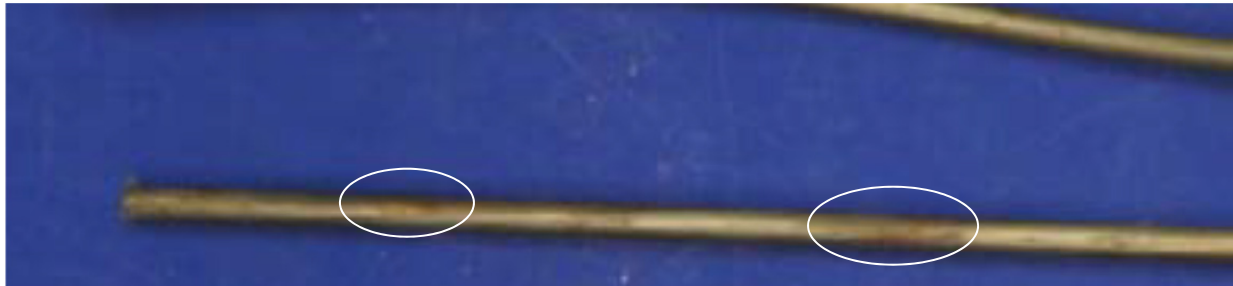
Figure 5.26 – Highlighted Mild Discoloration on Interior of Flow-Filled Strand

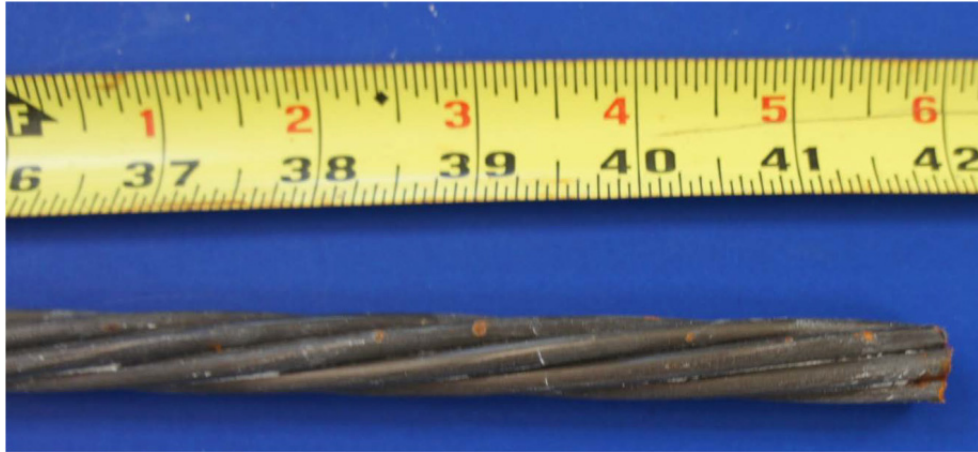
Figure 5.27 – Discoloration on Conventional Strand

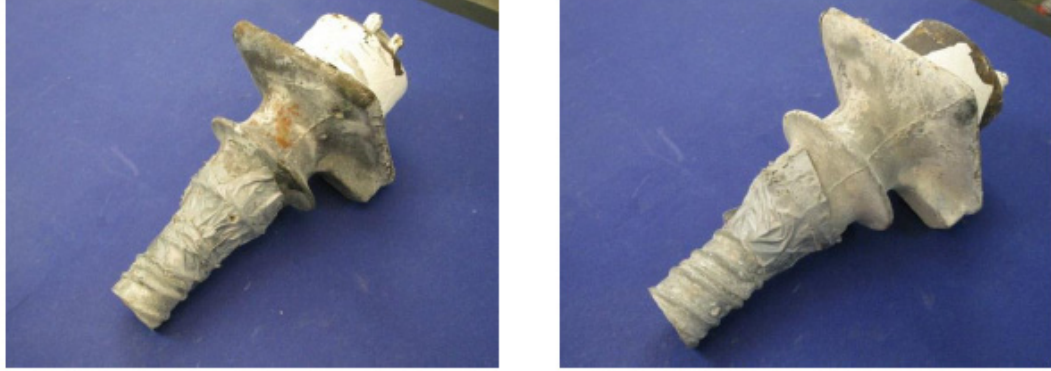
Figure 5.28 – Underside View of Anchorage with Non-Galvanized Bearing Plate (left) and Galvanized Bearing Plate (right)

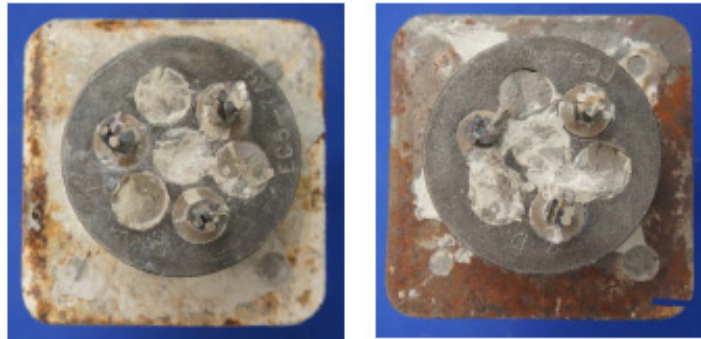
Figure 5.29 – Corrosion on Exposed Faces of Galvanized (left) and Non-Galvanized (right) Anchorage Plates
