1. Report No. FHWA/TX-05/0-4893-1		2. Government Accession No.		3. Recipient's Catalog No.	
4. Title and Subtitle Preliminary Findings of Performance of Old Concrete under Thin Overlays				5. Report Date September 2005, Rev. May 2006

Preliminary Findings of Performance of Old Concrete Under Thin Overlays

CTR Research Report:	0-4893-1
Report Date:	September 2005, Rev. May 2006
Research Project:	0-4893
Research Project Title:	Performance of Old Concrete Under Thin Overlays
Sponsoring Agency:	Texas Department of Transportation
Performing Agency:	Center for Transportation Research at The University of Texas at Austin

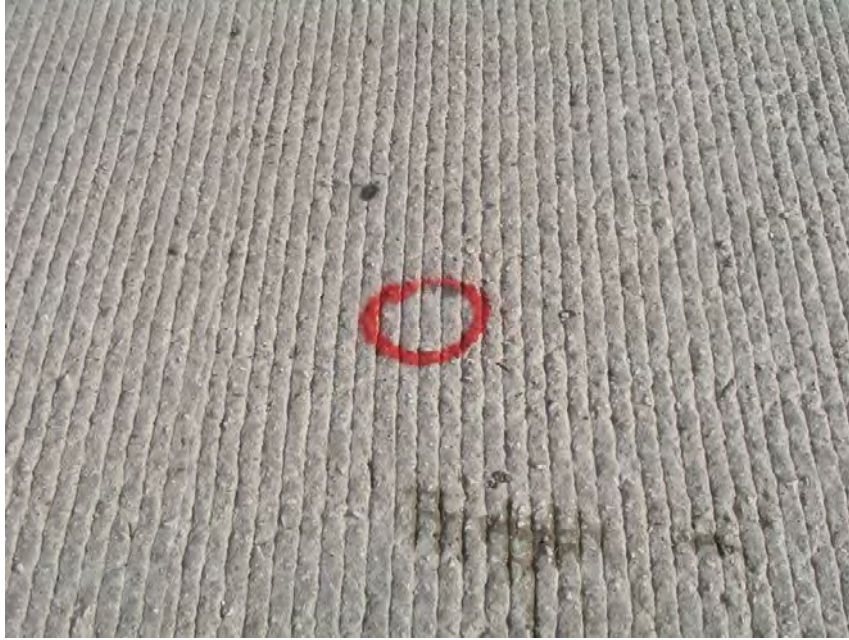
The general appearance of the section is good. The photograph in Figure 3.2 shows a view of the overlay in good condition, which was typical for most of the segment investigated. That image also shows the location of one of the six core samples extracted.

Figure 3.2 Area in good condition, indicating the location of a core sample

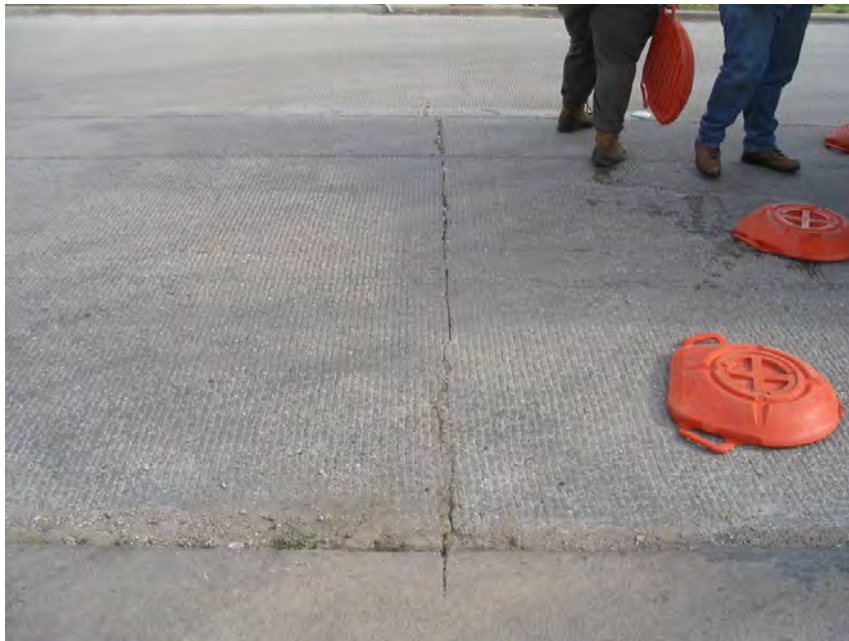
However, there are some delaminated areas surrounding working cracks and joints that are reflected from the original CRCP. Some other distresses observed occurred where a transverse crack in the curb has propagated to the adjacent overlay as a result of a lack of a separation layer between the curb and the overlay, such as the one illustrated in Figure 3.3, and, in more detail, in Figure 3.4 .

Figure 3.3 Propagation of transverse crack from the curb to the overlay

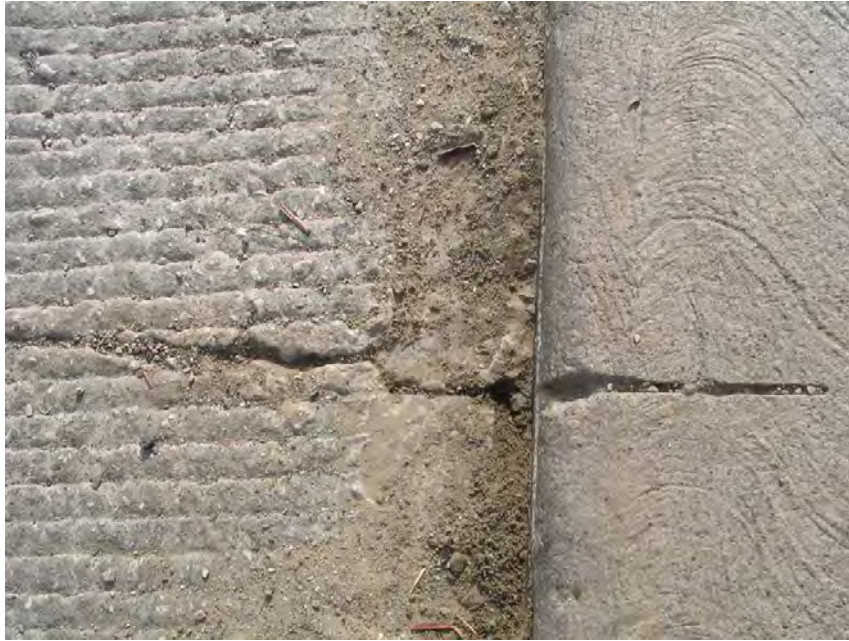
Figure 3.4 Detail of crack propagation from curb to overlay

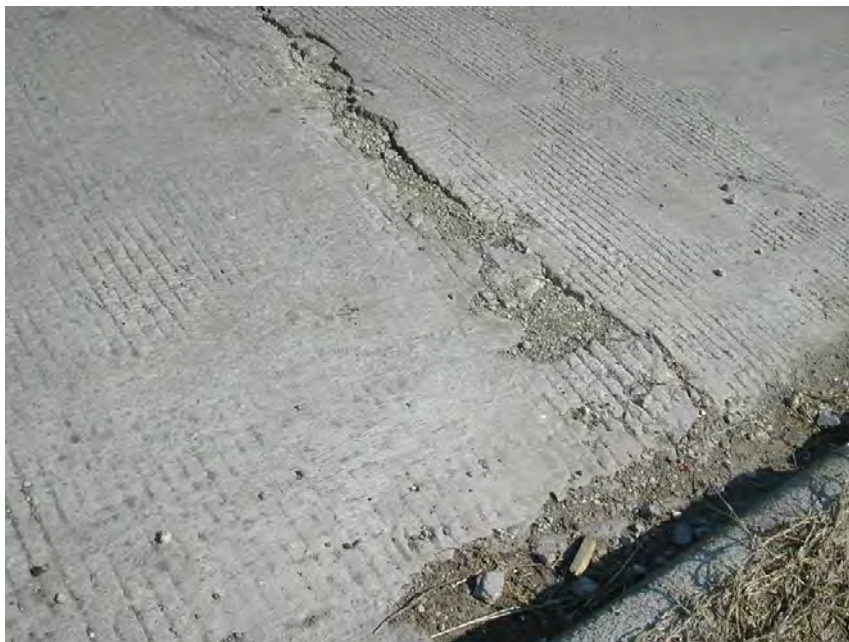
Another common occurrence regarding distresses is the development of spalled areas around working cracks and joints, which have reflected from the old CRCP, such as the one illustrated in Figure 3.5. The reflective characteristic of these cracks is evident in Figure 3.6, which shows the drilled hole after the sample extraction and the crack originated from the old CRCP.

Figure 3.5 Spalled crack

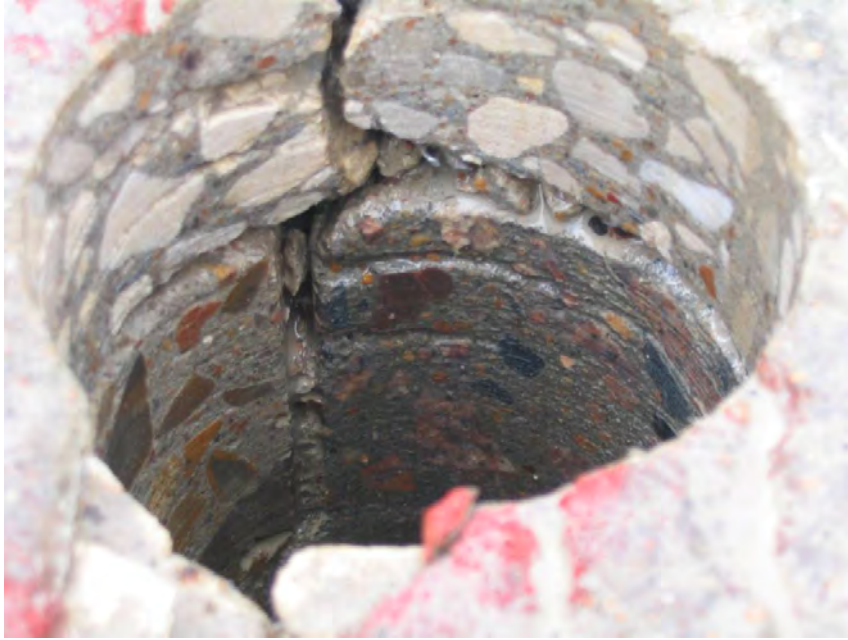
Figure 3.6 Crack reflected from old CRCP to the BCO

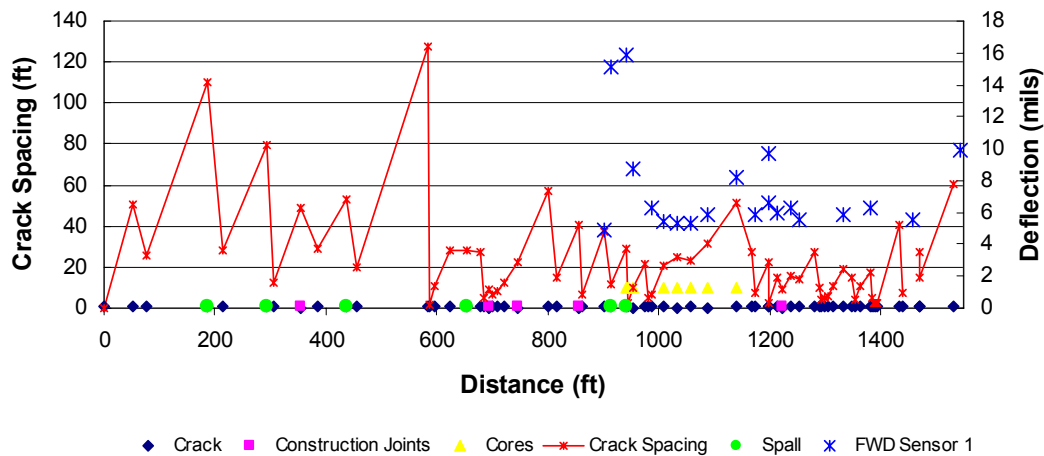
Figure 3.7 shows the results of the deflection tests, along with the crack spacing, crack, spall, and core locations. These deflections correspond to the first sensor of the FWD and to the second drop, which corresponds to a load of about 9,000 lb. It can be seen that the first segment of the surveyed section was not tested for deflections or coring, and this was because of traffic control constraints. However, the visual survey was conducted on the entirety of the section. A closer view of that plot focusing on the second segment is presented in Figure 3.8.

Figure 3.7 Core locations, condition survey, and deflection testing results

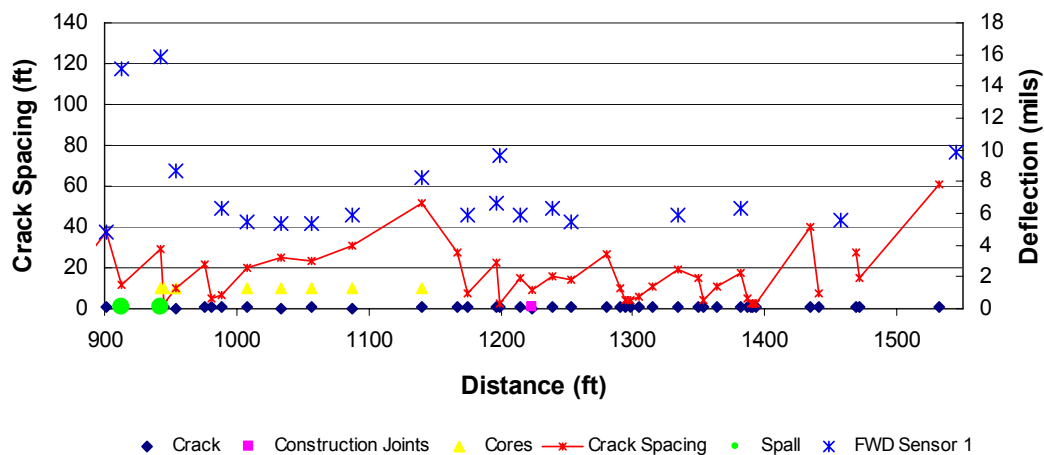
Figure 3.8 Detailed plot of FWD testing

The deflections, except for a few outliers that correspond to the spalled cracks were generally low and fairly uniform. The average for the Sensor 1 deflections, using the second drop of the FWD was 7.4 mils, with a standard deviation of 3.1 mils and a coefficient of variation of 42 percent.

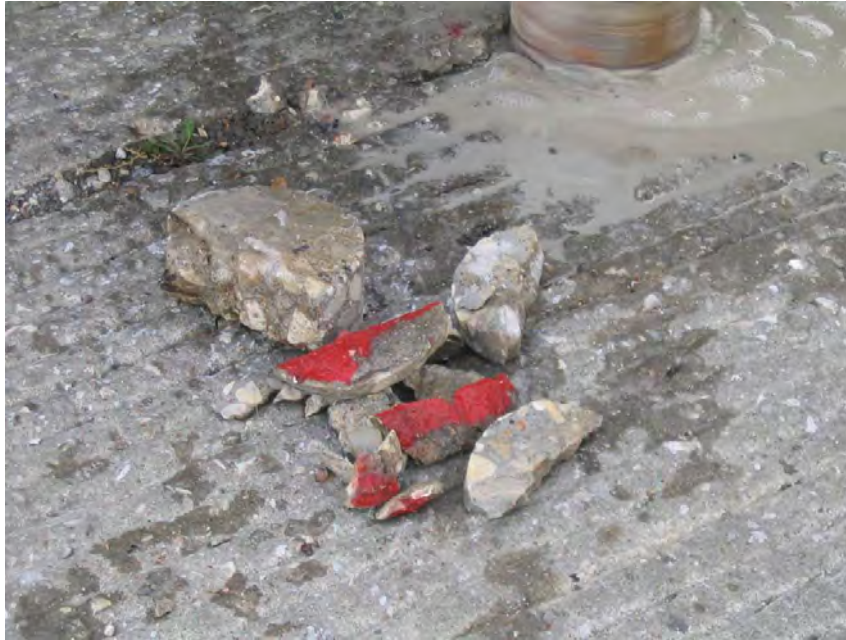
Six cores were extracted, from areas in both good and distressed condition. Some of the cores with spalls or delaminations broke during the drilling process, such as the one shown in Figure 3.9.

Figure 3.9 Delaminated portion of BCO in a core sample broken during drilling operation

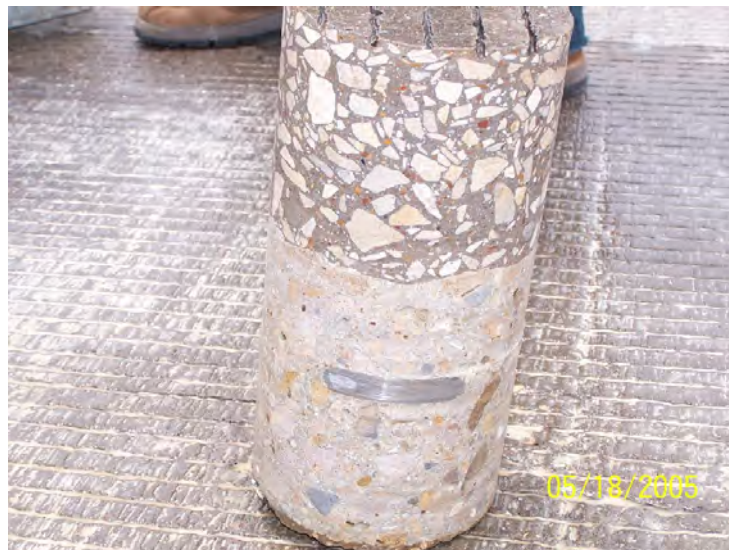
As shown in Figure 3.11, the coarse aggregate for the old CRCP is a silica-based gravel, while the aggregate used for the overlay was limestone. Five 6-inch-diameter cores were extracted from the pavement, three of which came out unbonded, and two more came out bonded. Figure 3.11 shows one of the samples that came out intact, demonstrating the good bond between the old CRCP and the BCO.

Figure 3.11 Core obtained from IH 30 in Fort Worth

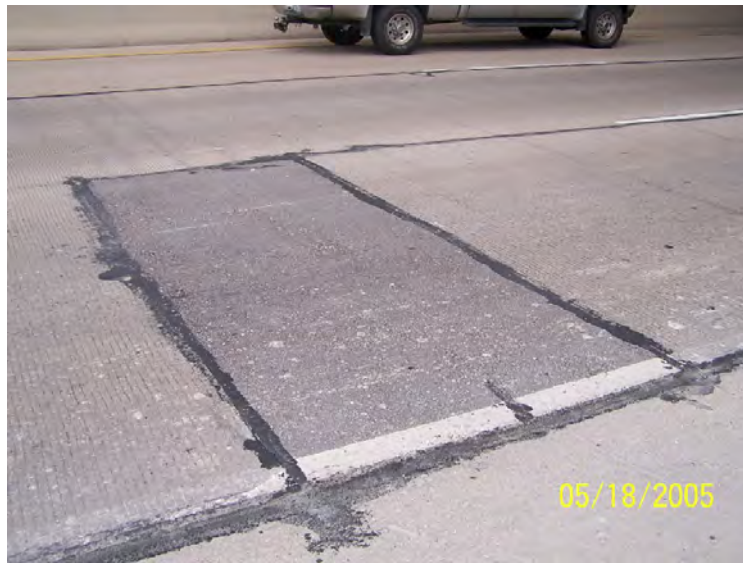
The visual inspection conducted for this section showed that the pavement was in fair to good condition, with no major distresses. Only transverse cracks, various AC patches, and very few spalls were found. Figure 3.12 shows one of the AC patches found in the section. It is important to note that the condition of all the patches was very good both visually and structurally, as demonstrated by deflection values measured at those locations. No significant difference was found between deflections measured at AC patches and at the BCO, as described in the following section.

Figure 3.12 AC patch found in pavement section under study

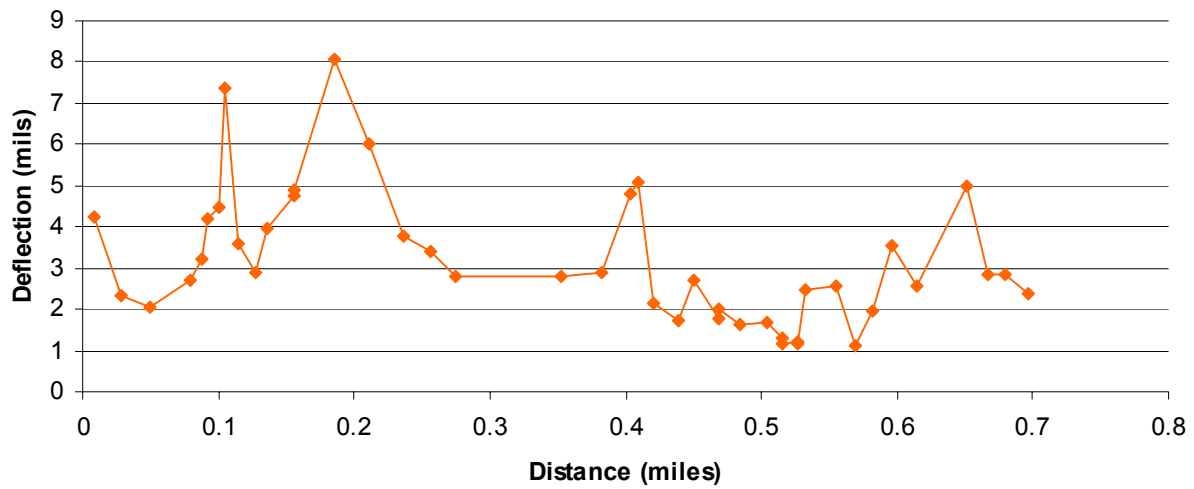
As a general procedure in all the projects, sounding testing was conducted along the test section to detect the presence of delaminations. For this project, only isolated points were found delaminated. Next, the FWD was used to measure deflections at specific locations. In this particular case, the results of the FWD showed that the mean deflection of the pavement measured by Sensor 1 was 3.2 mils for a load of approximately 9,000 lbs, with a standard deviation of 1.6 mils and a coefficient of variation of 50.4 percent. Several deflection locations were picked on AC patches, like the one shown in Figure 3.12. If those deflections were eliminated from the previous calculations, the average deflection would be 3.1 mils, the standard deviation 1.4 mils, and the coefficient of variation 45 percent. These numbers show that the deflections did not vary too much when taken on AC patches. Figure 3.13 shows the deflection profile.

Figure 3.13 Deflection profile of test section on IH 30 in Fort Worth

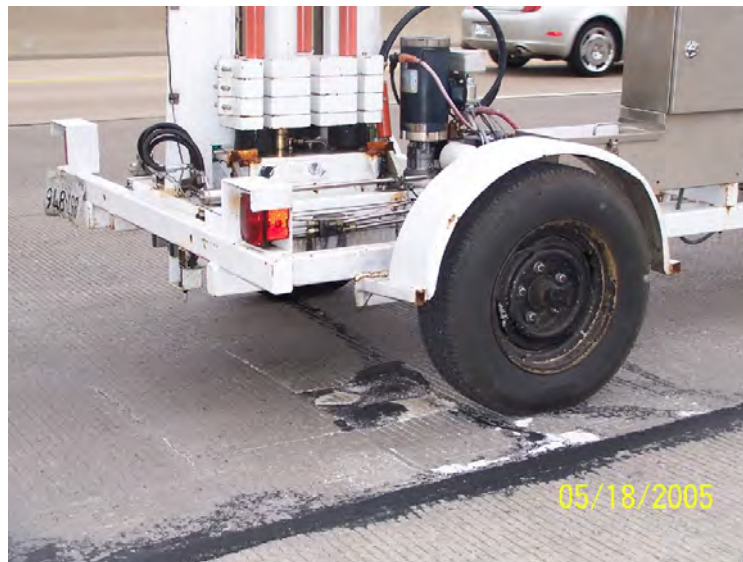
Figure 3.14 shows the FWD test being conducted in one of the most distressed areas of the pavement section studied. Figure 3.15 presents another view of the FWD test. In this image, it can be seen that when the weight of the testing equipment was dropped, water came out through the pavement cracks from the bottom of the slab along with fines from the subbase layer underneath, indicating that the subbase/subgrade is saturated and pumping has occurred.

Figure 3.14 FWD test of a distressed area of the pavement

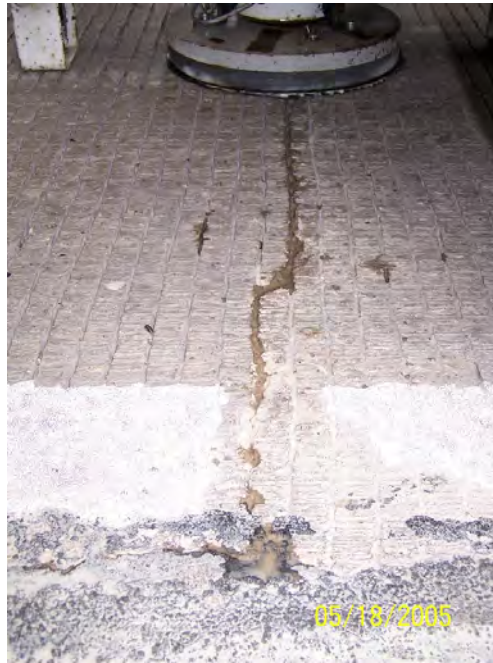
Figure 3.15 Pumping effect caused by FWD testing in a crack

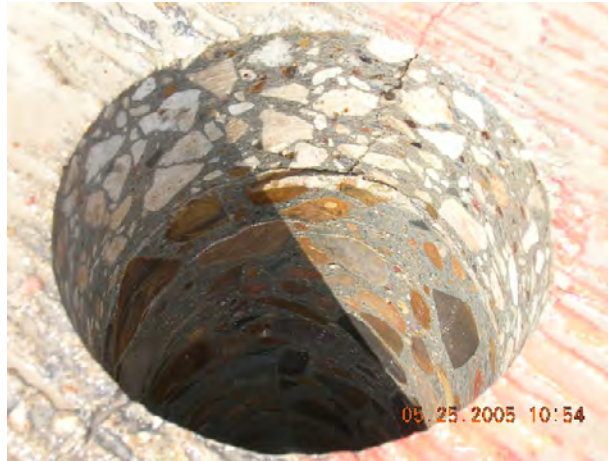
Figure 3.17 clearly shows that the coarse aggregate of the old CRCP is siliceous river gravel (SRG) and the aggregate in the BCO is limestone.

Figure 3.17 Hole in the Beltway 8 pavement after a core was drilled

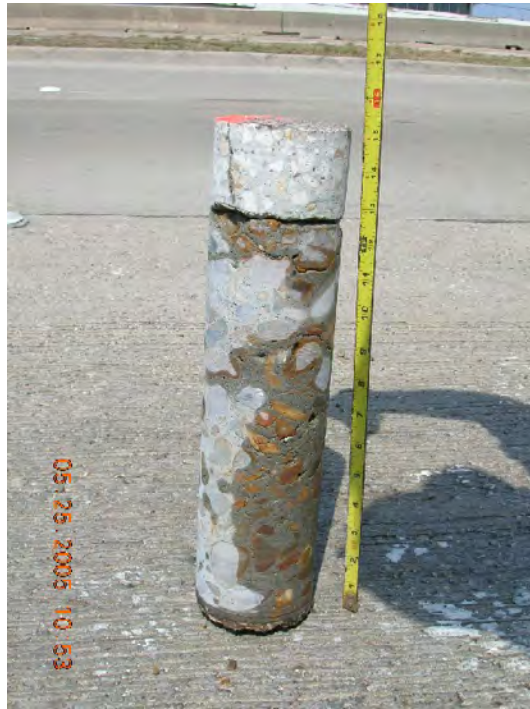
During the time frame for which traffic control was provided, a total of five 4-inch-diameter cores were obtained from the pavement. Four cores came out unbonded and one came out bonded. Figure 3.18 shows one of cores that came out in two pieces, separated at the interface between the old CRCP and the BCO layer. The image shows that the BCO had a full depth crack which is not a reflection crack and that the bond at the interface was broken. The four unbonded cores taken from the pavement section had a very similar aspect.

Figure 3.18 Unbonded core taken from BW-8

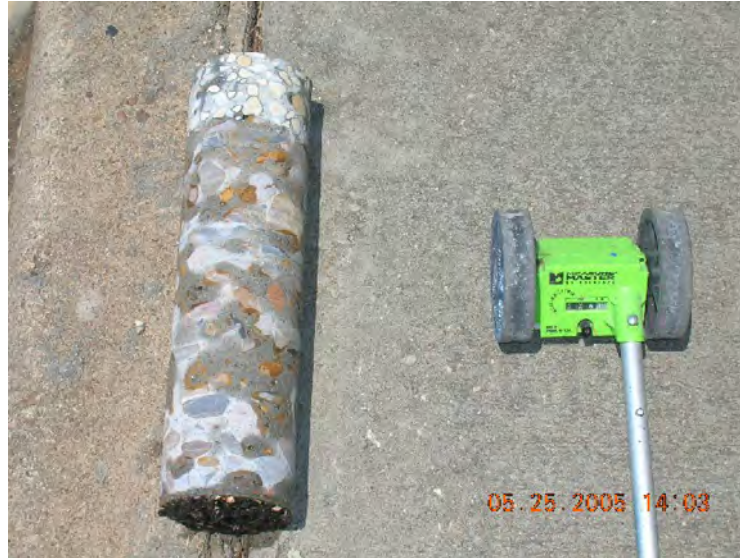
The only core that came out intact was taken from the outer third or outside wheelpath of the lane. Figure 3.19 displays the core that was fully bonded. The concrete strength values obtained from core samples were found to be within expected ranges. Strength and modulus of elasticity values for the concrete pavement layer are presented later in this chapter.

Figure 3.19 Bonded core taken from BW-8 test section

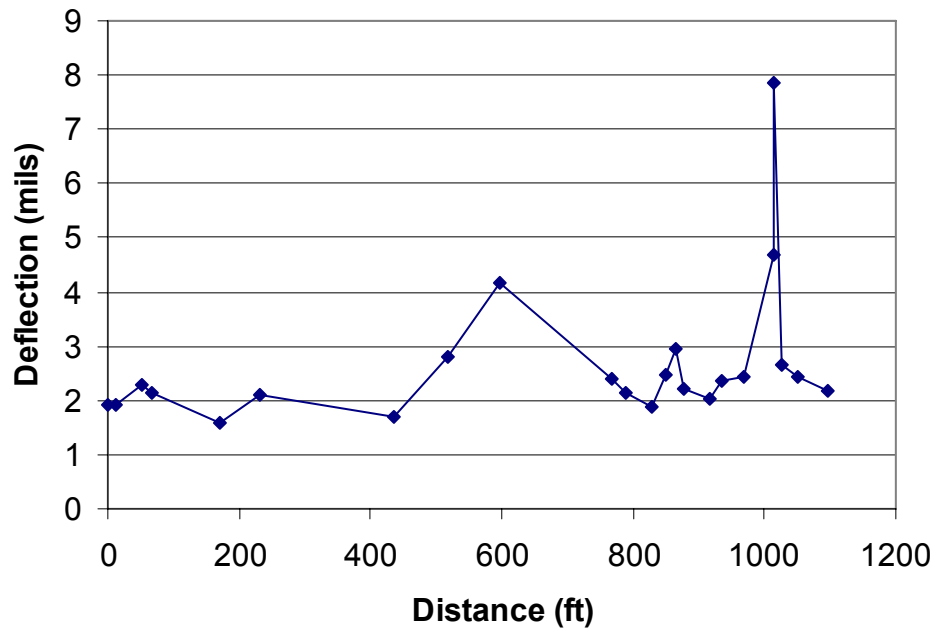
As in previous projects, sounding testing was conducted all along the section that had traffic control, that is, the outside lane, and it was noticed that there were widespread delaminated areas, mainly from the left wheel path to the left edge of the lane. In contrast, from the center of the lane to the right edge of the lane, next to the curb, there were no delaminations. The exact cause for this is not known at this point. The results of the FWD showed deflection values ranging from 1.60 to 4.18 mils measured by Sensor 1 at the center of the lane for the load of approximately 9,000 lbs. It can be seen that higher deflections were measured in the second part of the section, which corresponds to the tined segment. For the carpet drag segment, the average deflection was 2.0 mils, the standard deviation was 0.2 mils, and the coefficient of variation was 12.1 percent. For the tined segment, the average deflection was 2.9 mils, the standard deviation was 1.5 mils, and the coefficient of variation was 51.2 percent. It was not possible to conduct FWD testing on the left side of the lane where the debonding areas were detected. This would have required the FWD to encroach to the middle lane, which was open to traffic (only one lane could be closed to traffic). Figure 3.20 displays the deflection profile obtained for the test section on Beltway 8.

Figure 3.20 Deflection profile of test section on BW-8 in Houston

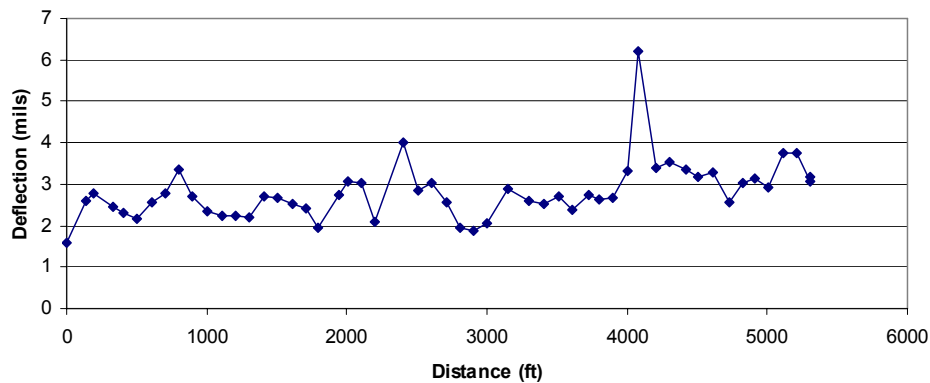
The deflections, as shown in Figure 3.21 (corresponding to the first sensor and the second load drop of the FWD), were low in general and fairly uniform, with only one outlier data point (6.2 mils), which happened to be at the most deteriorated of the cracks found. The average deflection of the section was 2.80 mils, the standard deviation was 0.7 mils, and the coefficient of variation was 25 percent.

Figure 3.21 Sensor 1 FWD deflections

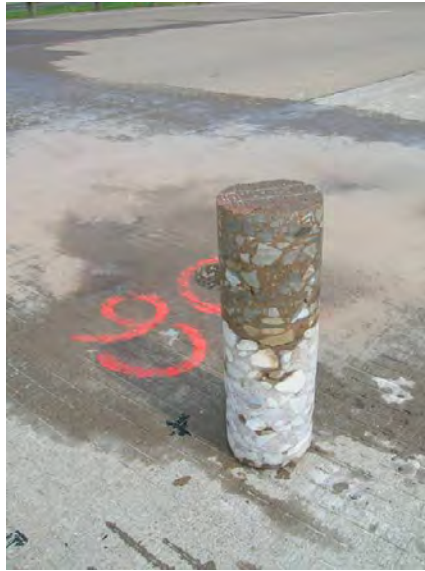
Nine core samples were taken from the section. Figure 3.22 shows one of them, which is in good condition, as were most of the samples extracted.

Figure 3.22 Core in good condition

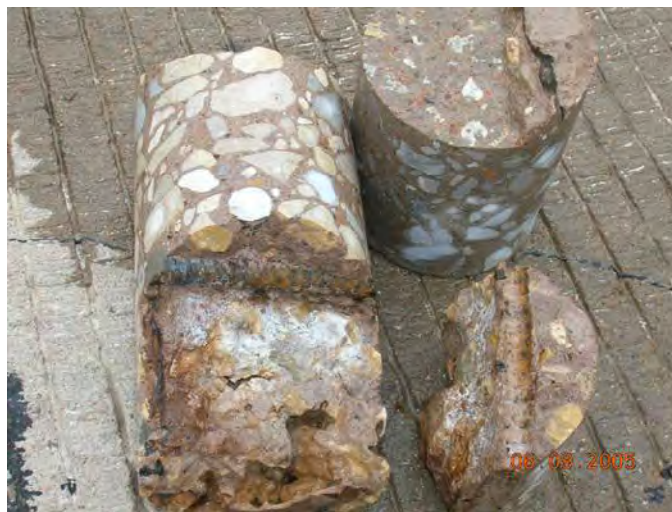
However, some deterioration was found in one of the cores; this is the core that was drilled at the location where the hollow sound was identified with the sounding test. As shown in Figure 3.23, the core had some voids in it, which are in the old concrete layer. The overlay came out delaminated when the drilling was performed. Nevertheless, the overlay part of the core was in sound condition. Thus, the deterioration is confined to the existing CRCP.

Figure 3.23 Old concrete deterioration in one of the cores

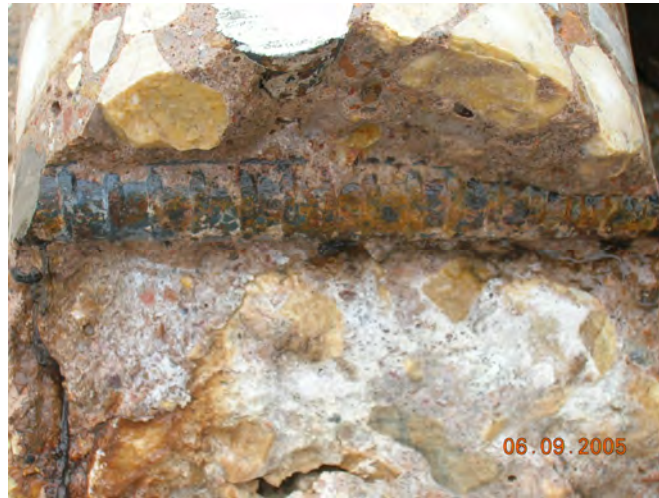
Figure 3.24 Detail of old concrete deterioration in one of the core samples

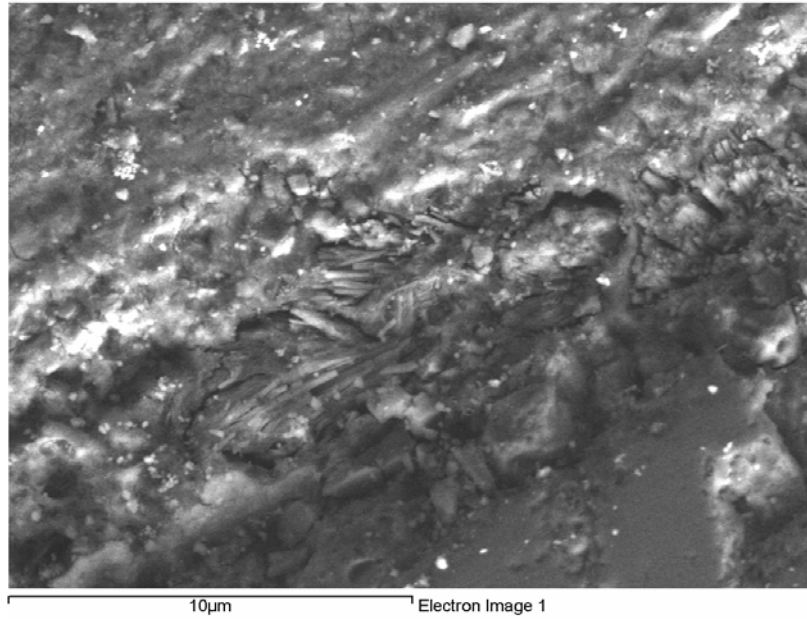
Petrographic analyses were conducted by Edward Morgan, a geologist at TxDOT, on the cores obtained in the field evaluations. No evidence of ASR or other chemical reactions were observed, with the exception of one core from the IH 610 Houston project where an abundance of ettringite was noted. Figure 3.28 shows an image obtained from a microscope that demonstrates the presence of ettringite. However, in this case ettringite does not appear to have caused distresses in the surrounding concrete.

Figure 3.28 Ettringite deposits in crack adjacent to aggregate revealed by petrographic analysis
